Real-Time Water Quality Deployment Report

Marathon Gold Corp Network

November 3 to
December 1, 2022

Government of Newfoundland & Labrador
Department of Environment & Climate Change
Water Resources Management Division

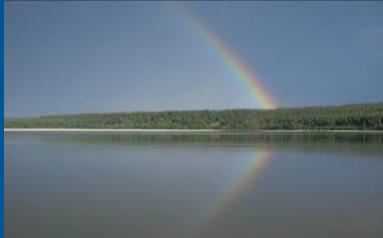
- pH ranged between 6.78 and 7.14 pH units throughout the deployment period, with a median value of 6.85 units (Figure 3).
- All values during the deployment are within the CCME Guidelines for the Protection of Aquatic Life (between 6.5 and 9 pH units). pH fluctuates slightly during the day and night.
- Significant rainfall on November 12th (evident as a rise in stage levels) caused a slight dip in pH level. This is a common occurrence in freshwater as the slightly acidic rain influences the overall pH of the river for a short period of time.
- Overall, pH was relatively stable for the deployment, but was influenced by large precipitation events.

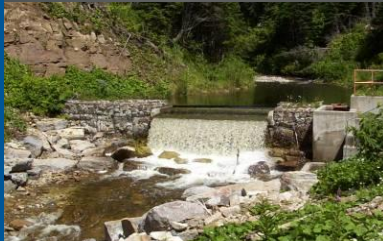
- Specific conductivity ranged from 23.4 to 54.7 $\mu\text{S}/\text{cm}$ (Figure 4) with a median of 26.6 $\mu\text{S}/\text{cm}$.
- Specific conductivity steadily decreased over the course of this deployment period, except during periods of high precipitation which caused stage increases and corresponding increases in conductivity for a short time. This indicates the precipitation may cause particulates in the river sediment to re-suspend into the water column, increasing the conductivity for a short period of time before it settles out again.

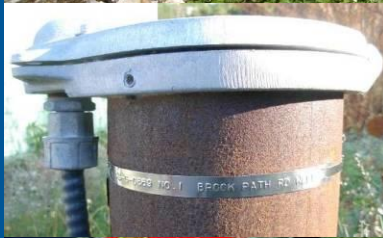
- The saturation of dissolved oxygen ranged from 90.9% to 102.4% and a range of 10.54 to 14.65 mg/l was found for the concentration of dissolved oxygen with a median value of 12.99 mg/l (Figure 5).
- All values were above the minimum CCME Guidelines for the Protection of Other Life Stages and Early Life Stage of Cold Water Biota. The guidelines are indicated in blue on Figure 5.
- Dissolved oxygen content fluctuates diurnally, displaying the inverse relationship to water temperature. Dissolved oxygen increased steadily during the deployment period as water temperatures cooled into winter. The only exception was November 8th when water temperatures increased and dissolved oxygen took a short-term corresponding decrease.

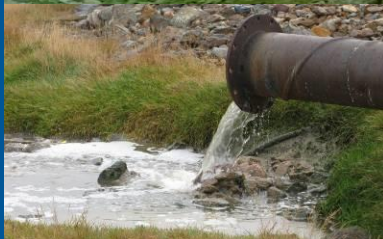
- Precipitation and stage during the deployment period are graphed below (Figure 7). Stage was increasing gradually throughout deployment, influenced by several major precipitation events, particularly the largest event on November 12th which caused a significant rise in stage.
- It is notable from the data that smaller precipitation events did not always lead to an increase in stage at this location.

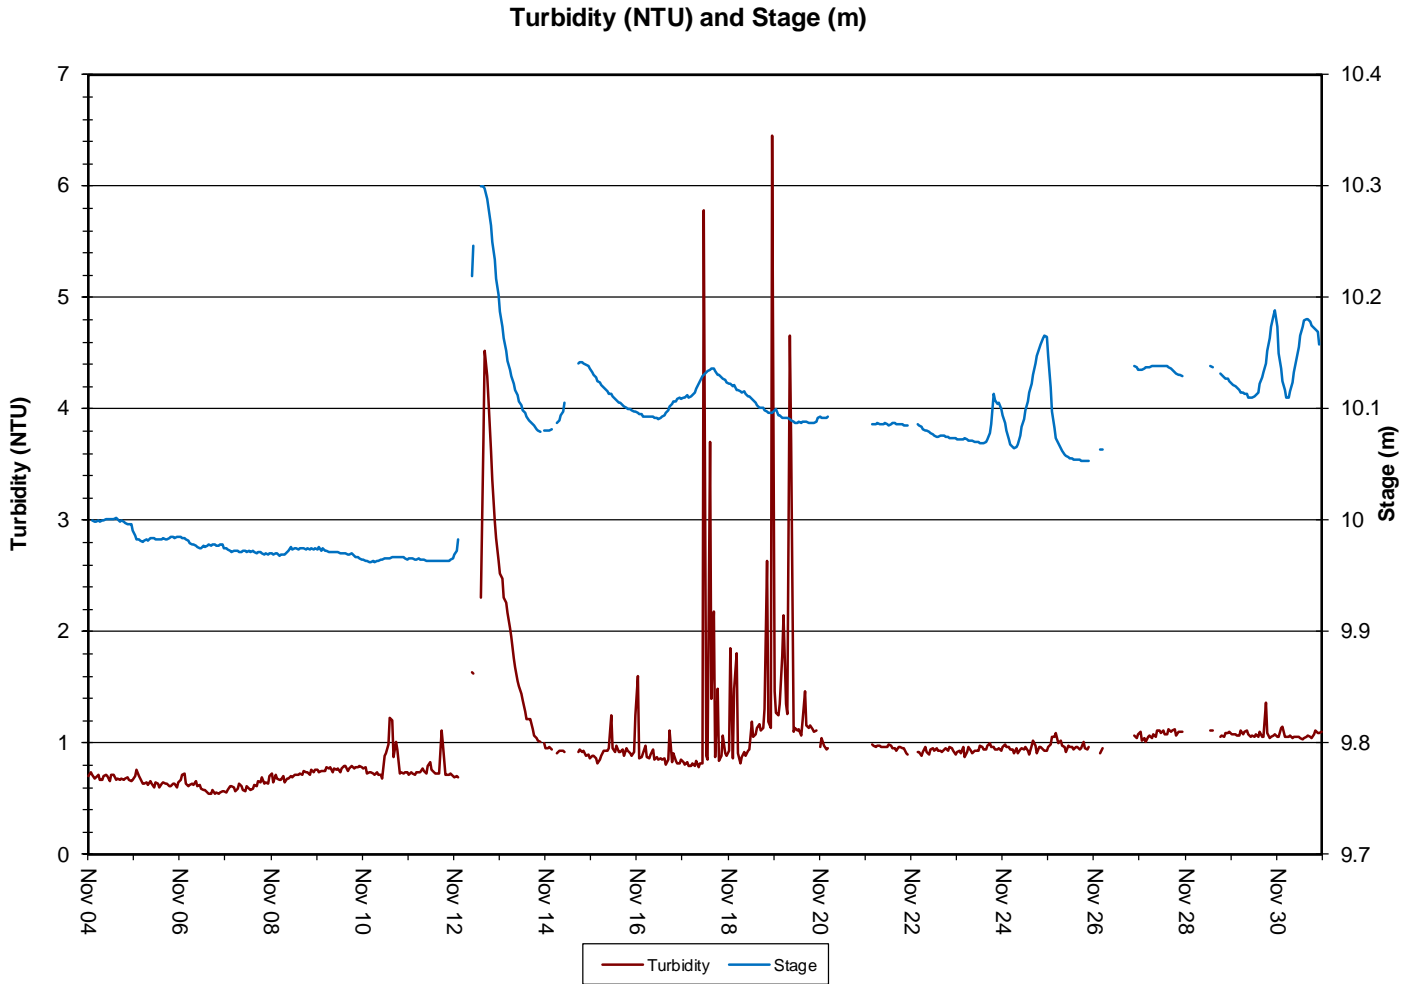
Figure 6: Turbidity and Stage

- Turbidity values range from 0.5 NTU to 6.5 NTU with a median of 0.9, indicating very clear background turbidity.
- Turbidity remained very low throughout deployment with a slight increasing trend. Turbidity increased temporarily during stage events associated with precipitation. (Figure 6). This indicates rainfall associated with stage increases may stir up sediments in the area for a brief period of time before returning to background levels.

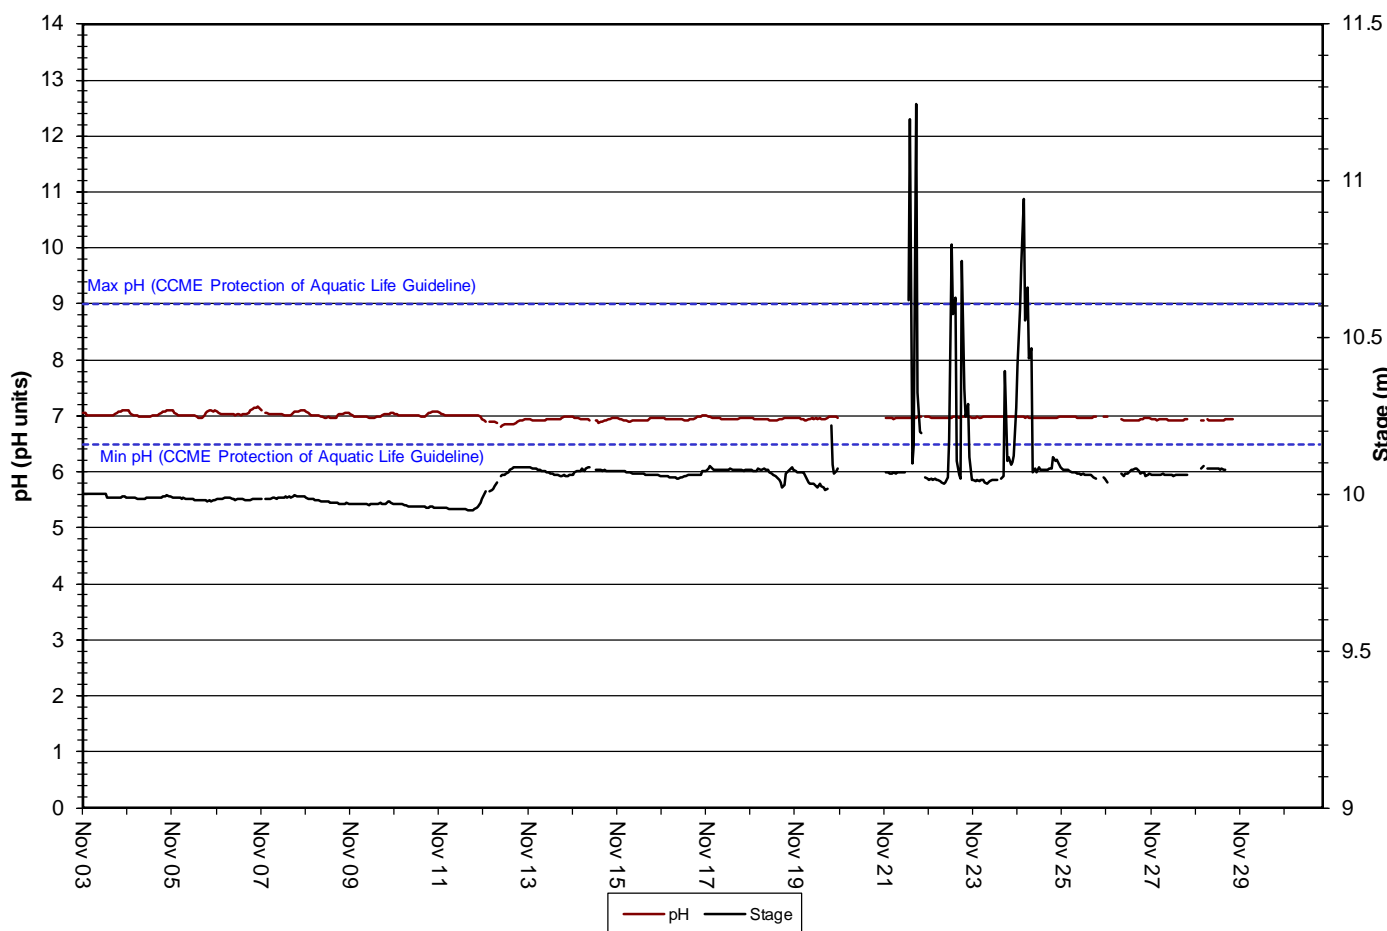
Figure 9: Water pH and Stage

- pH ranged between 6.81 and 7.16 pH units throughout the deployment period, with a median value of 6.97 units (Figure 9).
- All values during the deployment are within the CCME Guidelines for the Protection of Aquatic Life (between 6.5 and 9 pH units). pH fluctuates slightly during the day and night.
- Significant rainfall on November 12th (evident as a rise in stage levels) caused a slight dip in pH level. This is a common occurrence in freshwater as the slightly acidic rain influences the overall pH of the river for a short period of time. This was also observed at the Victoria River station.
- Overall, pH was relatively stable for the deployment, but was influenced by large precipitation events.

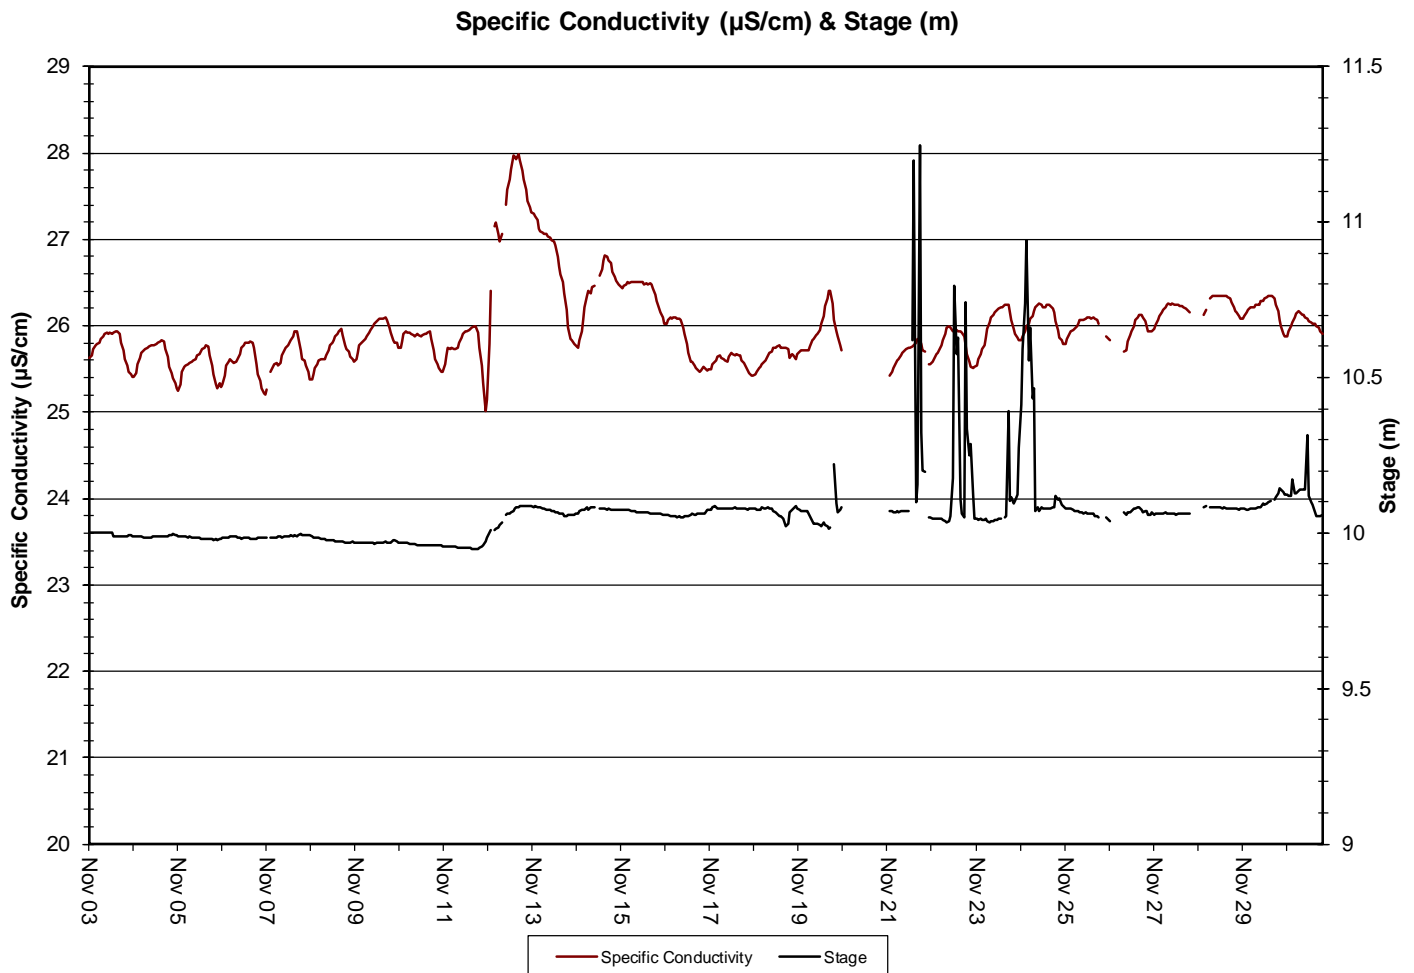
Figure 10: Specific Conductivity of Water and Stage

- Specific conductivity ranged from 25.0 to 28.0 $\mu\text{S}/\text{cm}$ (Figure 10) with a median of 25.9 $\mu\text{S}/\text{cm}$ (Figure 10).
- Specific conductivity was relatively stable over the course of this deployment period, except during periods of high precipitation which caused stage increases and corresponding increases in conductivity. This indicates the precipitation may cause particulates in the river sediment to re-suspend into the water column, increasing the conductivity for a short period of time before it settles out again.

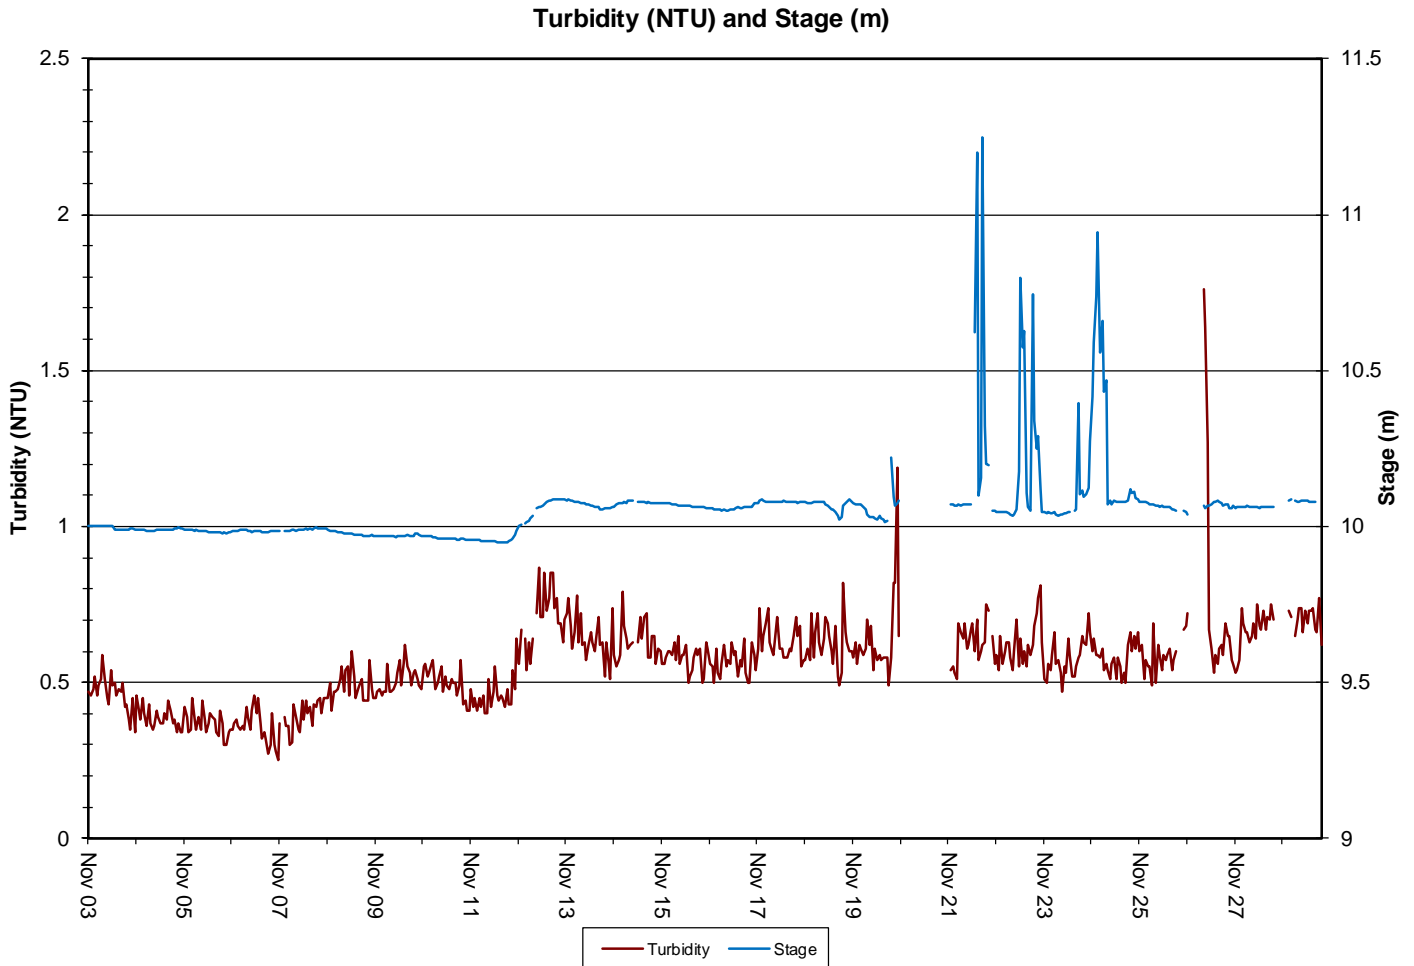
Figure 12: Turbidity and Stage

- Turbidity values range from 0.3 NTU to 2.0 NTU with a median of 0.6, indicating very clear background turbidity.
- Turbidity remained very low throughout deployment with a slight increasing trend. Turbidity increased temporarily during stage events associated with precipitation (Figure 12). This indicates rainfall associated with stage increases may stir up sediments in the area for a brief period of time before returning to background levels.

- Precipitation and stage during the deployment period are graphed below (Figure 13). Stage was increasing gradually throughout deployment, influenced by several major precipitation events, particularly the largest event on November 12th which caused a significant rise in stage.
- It is notable from the data that smaller precipitation events had more of an effect on this river than they did in Victoria River. The increases in stage in late November are likely the result of ice interfering with the hydrometric equipment as the increased were very short lived when analyzing hourly data (Figure 12 above).

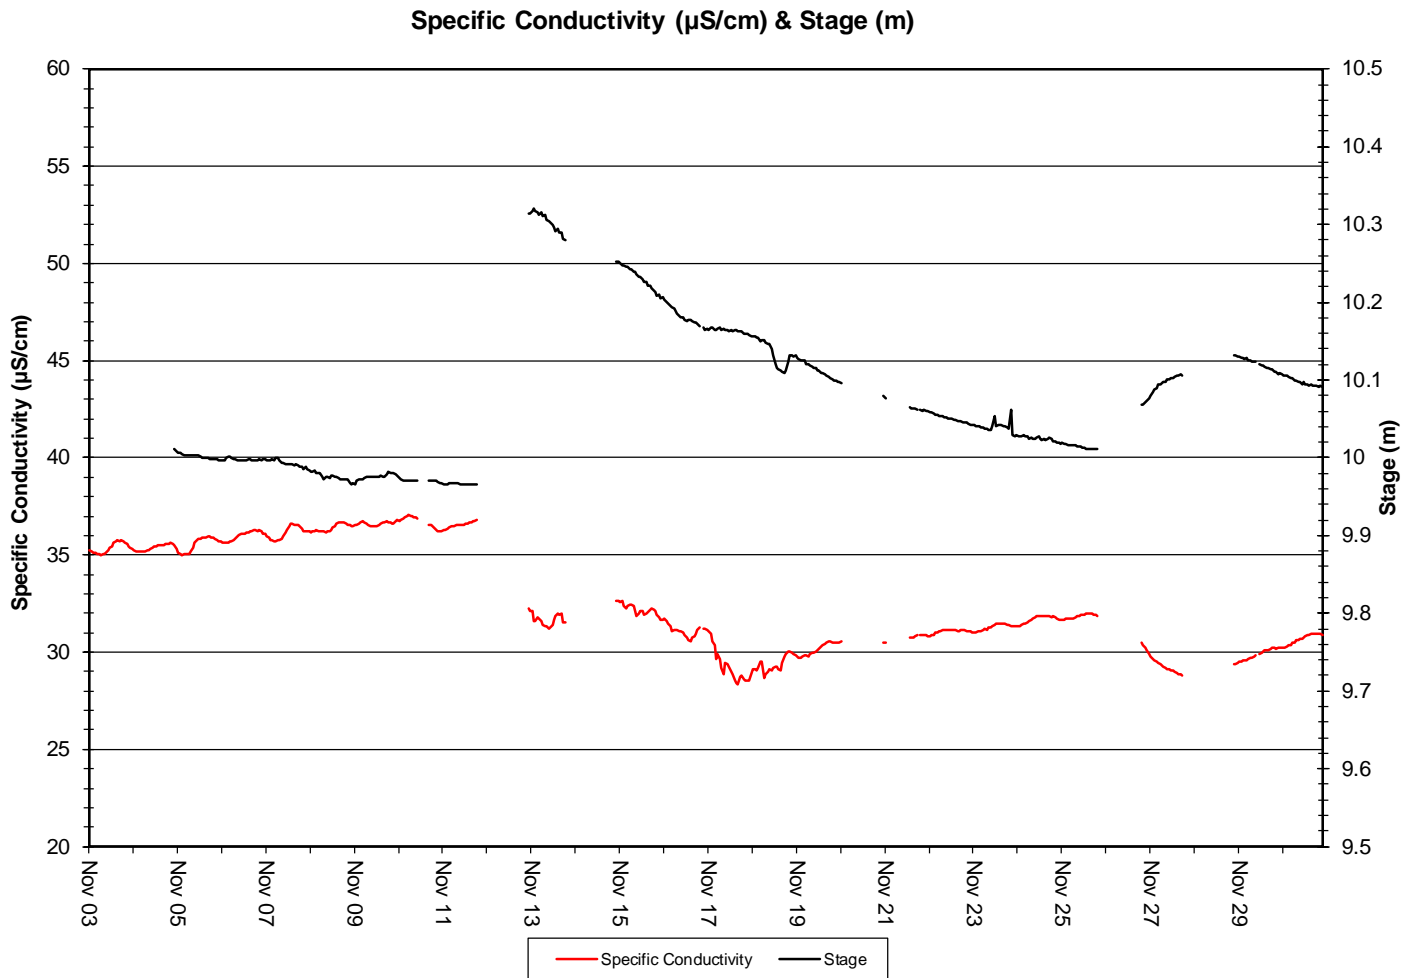
Figure 16: Specific Conductivity of Water and Stage

- Specific conductivity ranged from 28.4 to 37.0 $\mu\text{S}/\text{cm}$ (Figure 16) with a median of 32.3 $\mu\text{S}/\text{cm}$.
- Specific conductivity steadily decreased over the course of this deployment period. During periods of high precipitation and corresponding stage increases, conductivity in Roebucks Brook decreased. This is different from Victoria and Valentine Rivers.
- This drop in conductivity as more water is added the system indicates that there may be little organic debris and sediment in the area to re-suspend during higher flows. Instead, the additional water dilutes the system, decreasing the conductivity. Further data collection will be useful to further analyze conductivity patterns at this location as data was limited due to transmission issues.

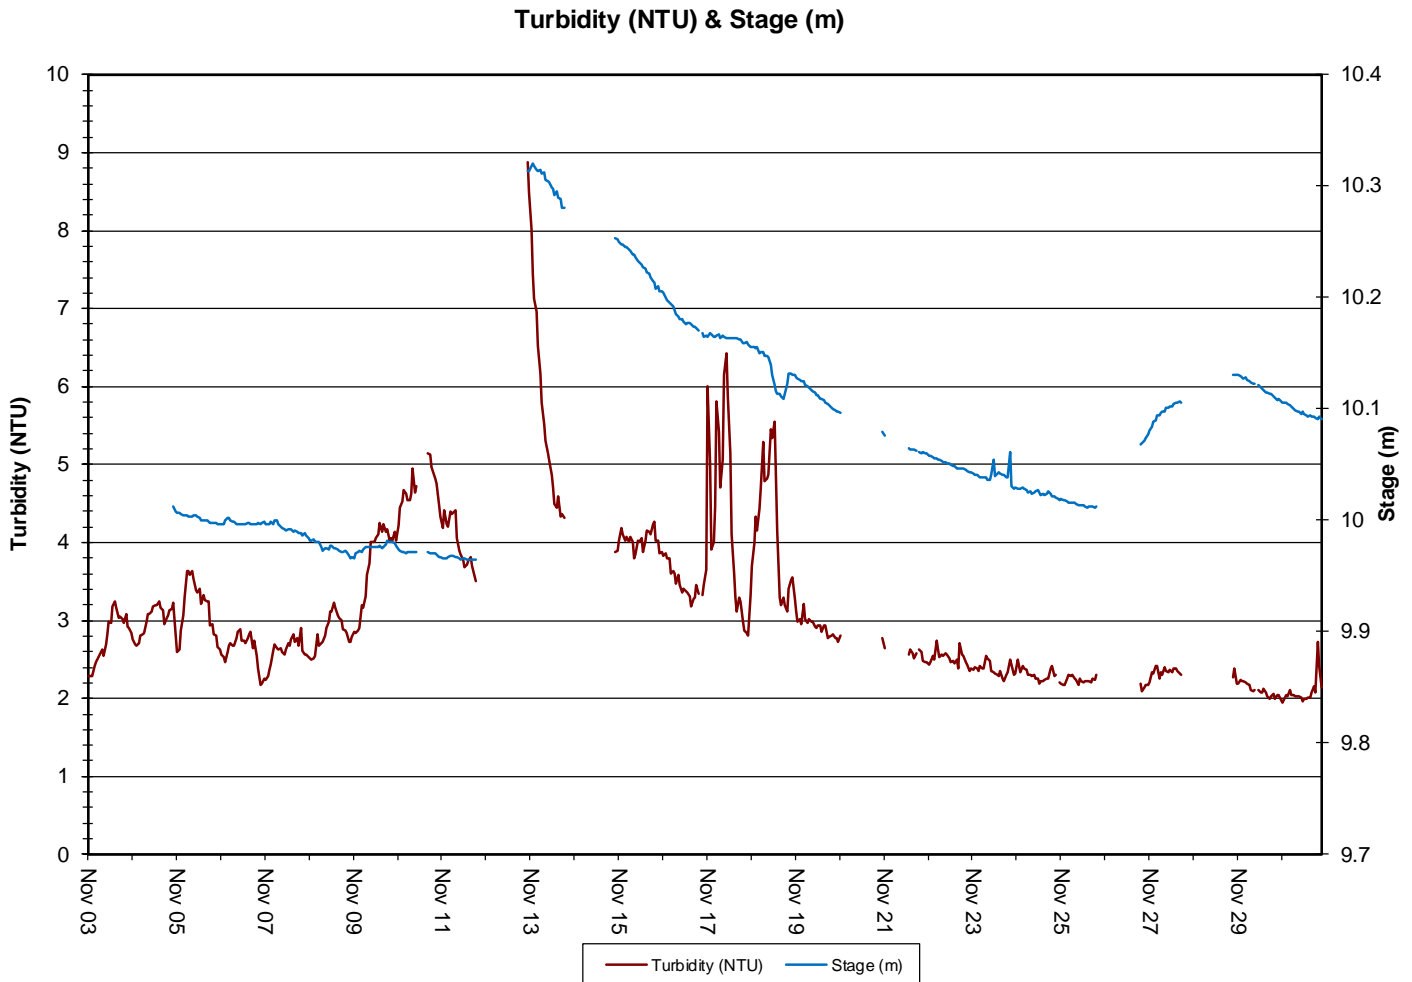
Figure 18: Turbidity and Stage

- Turbidity values range from 2.2 NTU to 8.9 NTU with a median of 3.0, indicating low background turbidity which was higher than Victoria or Valentine Rivers (Figure 18).
- Turbidity remained relatively stable throughout deployment with a slight decreasing trend. Turbidity increased temporarily during stage events associated with precipitation such as November 12th (Figure 18). This indicates rainfall associated with stage increases may stir up sediments in the area for a brief period of time before returning to background levels.

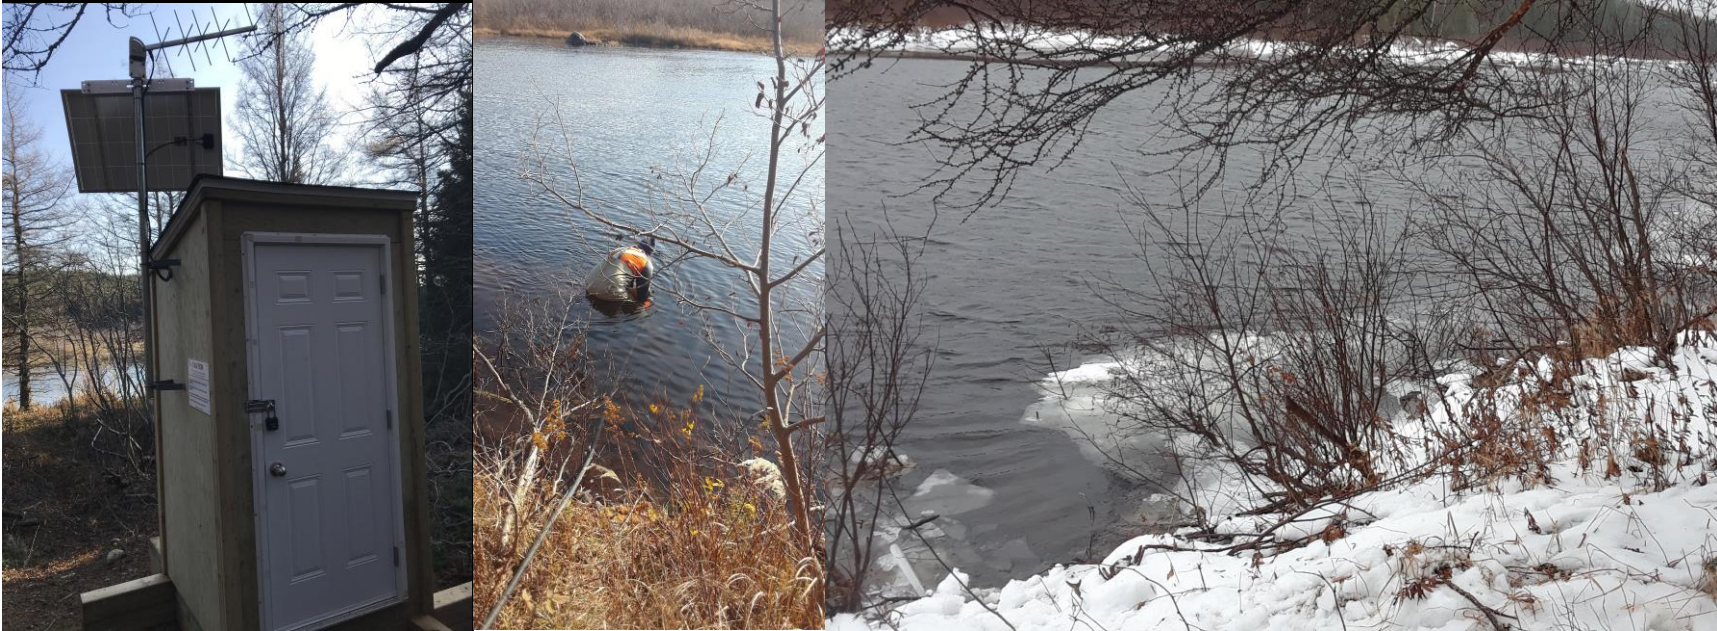
Station Location: Victoria River 6.3km downstream of Victoria dam, below quarry pit. Station setup on western shoreline. Access via ATV trail below quarry pit.

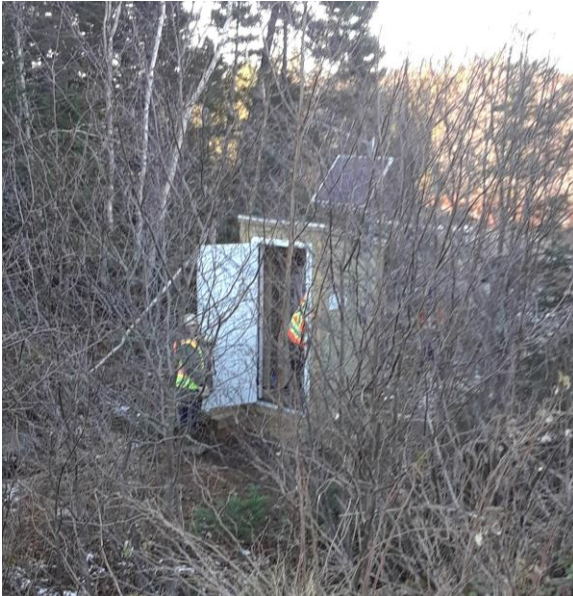
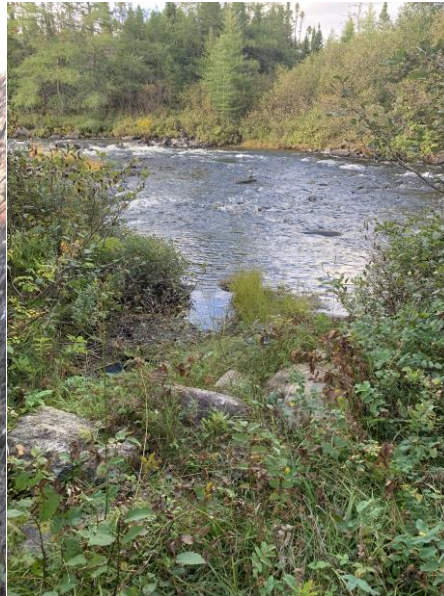
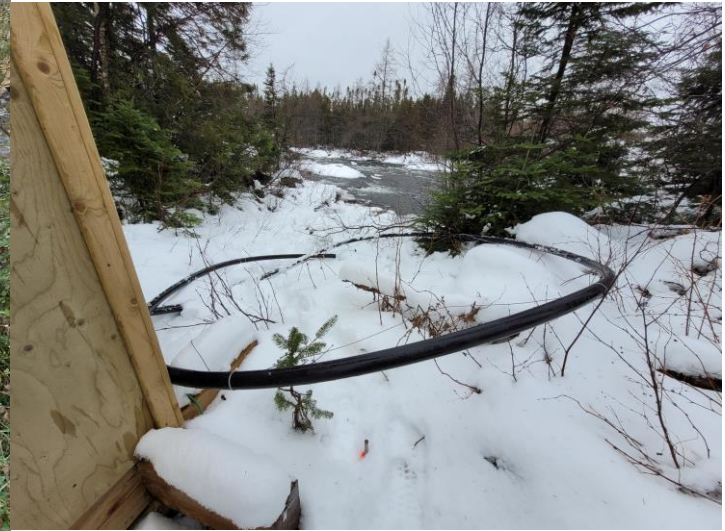
Station Location: Valentine River at access road, 1.9km downstream of Valentine Lake outlet. Station located 15m upstream of access road crossing bridge on southern shoreline.

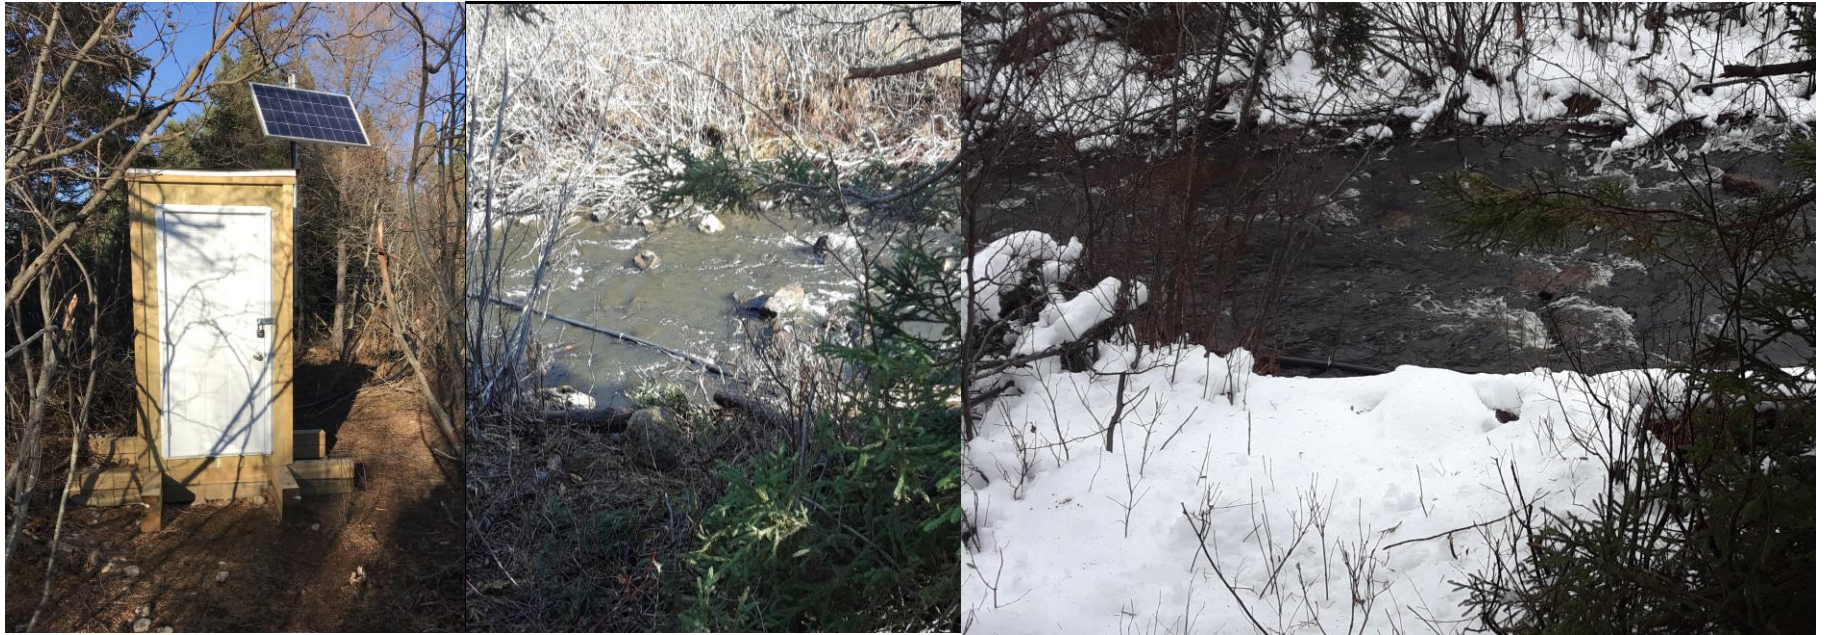
Station Location: Roebucks Brook 30m downstream of access road bridge crossing on western shoreline. Station is 1.6km downstream of Roebucks Lake outlet.
