CENTRAL

Site Code	NF02YN0045		
Name	Tributary to Buchans Brook		
<b>Date Sampled</b>	Sept. 14, 2010		
<b>Ecoregion(s)</b>	Long Range Mountains/Central Nfld		
<b>Stream Order</b>	4		
Basin	Exploits River		
Sampled By	NL		
	Sampled upstream of bridge on		
Accessibility	trailway, 1.8 km off of access road to		
	Buchans airstrip.

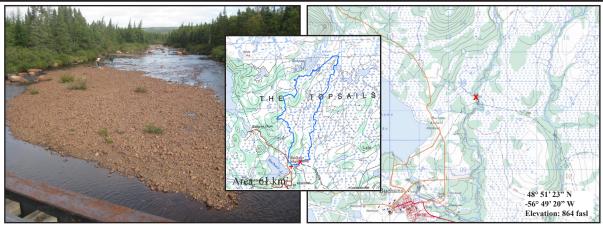
Substitute					
Dominant Substrate	large pebble				
2nd Dominant Substrate	small cobble				
Surrounding Material	coarse sand				
Embeddedness	unembedded				
Median Particle Size	5.75 cm				
<b>Geometric Mean Particle Size</b>	6.40 cm				
Photo of Substrate	• Casalin de la casa
