Real-Time Water Quality Deployment Report

Teck Duck Pond Operations 2022

Real-time water quality (RTWQ) monitoring of surface and groundwater quality on Teck Duck Pond Operations (DPO) site is carried out by the Department of Environment and Climate Change, Water Resources Management Division. Work is undertaken in circumstances where industrial development has the potential to impact water bodies. The RTWQ program consists of more than 30 stations across the province.

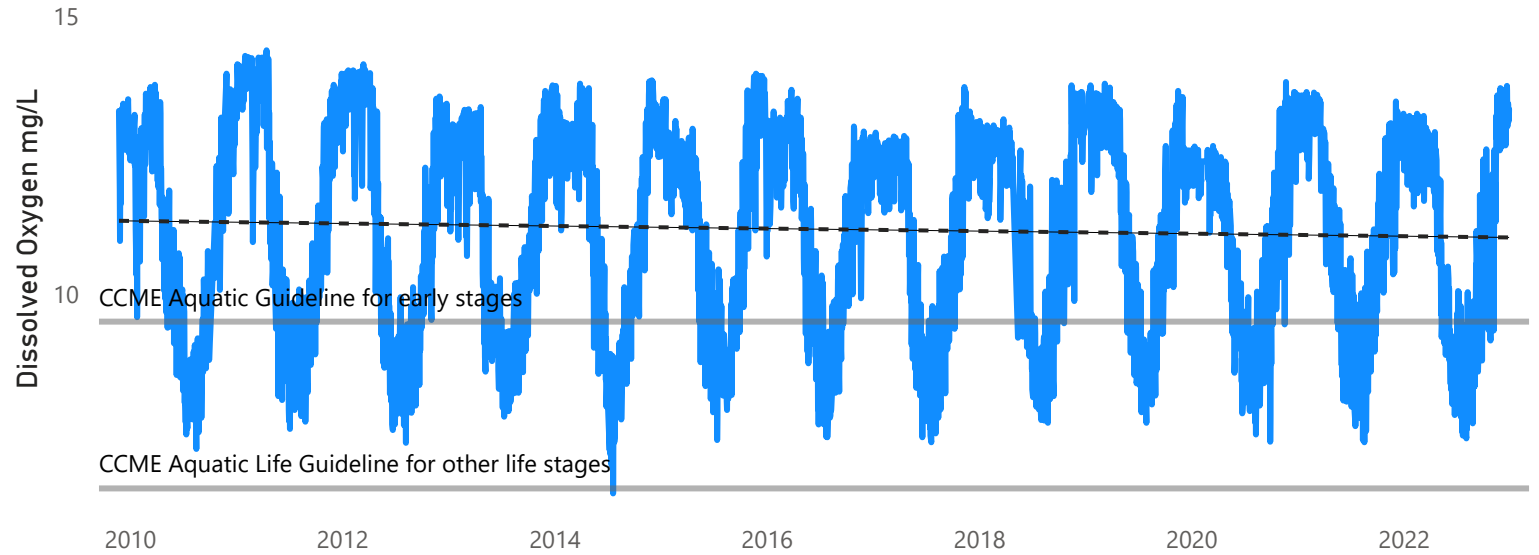
Dissolved Oxygen in Tributary to Gills Pond Brook

Dissolved oxygen (DO) is a metabolic requirement for life. The [CCME guidelines](#) for the protection for other life stages (6.5 mg/L) and the guideline for the protection for early life stages (9.5 mg/L) is indicated in grey on the DO graphs to the right. During 2022, both rivers met the CCME's guideline for other life stages; however, there were periods when both rivers did not meet the CCME's guidelines for early life stages.

The amount of dissolved oxygen in water depends on several factors, particularly water temperature. Cooler water can hold more dissolved oxygen; as a result of increasing water temperatures, the dissolved oxygen levels are decreasing. The trend lines, indicated with a black dashed line, for Gills Pond Brook and East Pond Brook illustrate this decreasing trend.

Over the 12 year deployment, cyclical fluctuations are apparent. During the winter when air and water temperatures are colder, dissolved oxygen levels are higher, and during the summer, the opposite it true.

Gills Pond Brook 2022	Average	11.07	7.40	13.74
			Minimum	Maximum
2010-2021	Average	11.18	6.41	14.38
			Minimum	Maximum
East Pond Brook 2022	Average	10.67	6.82	13.50
			Minimum	Maximum
2010-2021	Average	11.33	6.94	14.44
			Minimum	Maximum

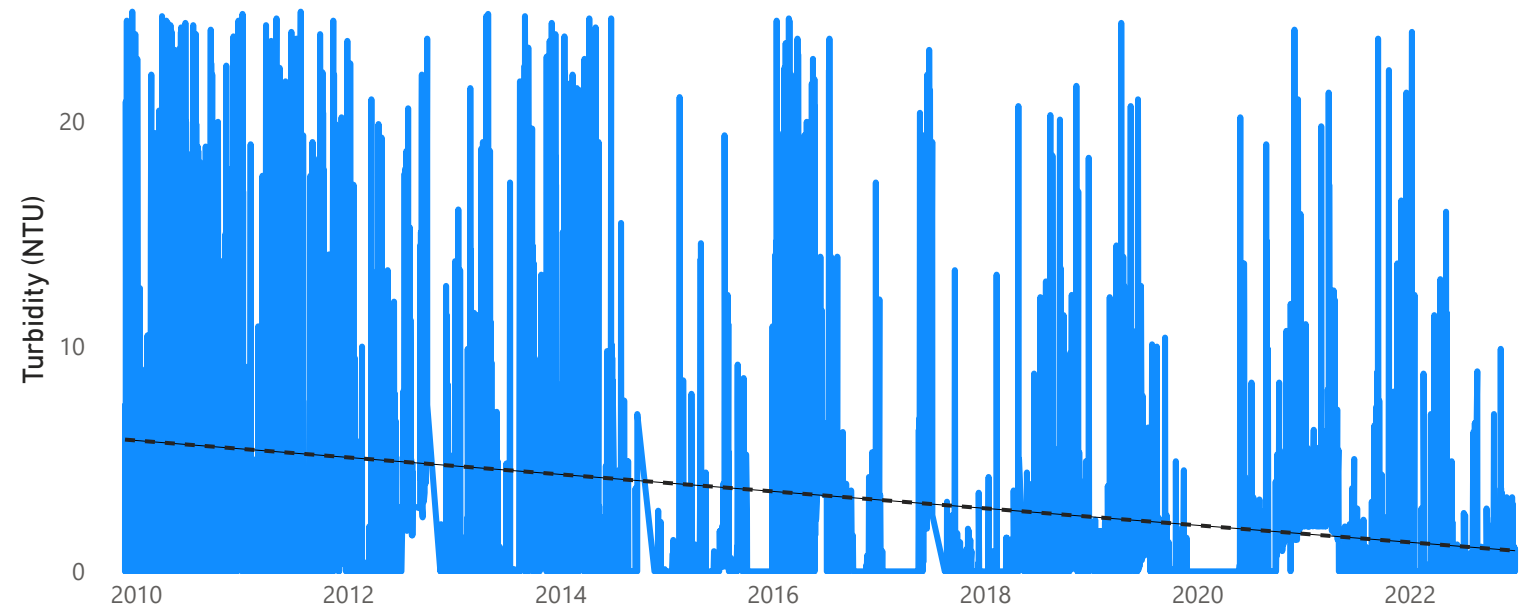
Turbidity in Tributary to Gills Pond Brook

Turbidity levels at Gill's Pond Brook and East Pond brook are both generally low; however, turbidity sensors are prone to errors from debris that can get caught around the sensors. During the 12 years of deployment at Gills Pond Brook, the quality assurance and quality control readings and grab samples have recorded values ranging from 0.0 NTU to 2.4 NTU and 0.2 to 4.1 NTU respectively. During the 12 years of deployment at East Pond Brook, the quality assurance and quality control readings and grab samples have recorded values ranging from 0.0 NTU to 3.1 NTU and 0.2 to 2.3 NTU respectively. The deployed sensors will often return readings much higher throughout the deployment due to sediment becoming trapped in the sensor's protective cage. In order to see an accurate picture of the fluctuations at the site, readings above 25 NTU were omitted from this report.

A trendline For Gills Pond Brook values shows how turbidity dropped after nearby mining operations concluded. Conversely, turbidity at East Pond Brook has marginally increased during this same time frame; possibly as a result of increased extreme weather events.

Gills Pond Brook	0.21	0.00
2022	Average	Median
2010-2021	0.88	0.00
	Average	Median
East Pond Brook	1.53	0
2022	Average	Median
2010-2021	0.65	0
	Average	Median
