**Construction  
of  
Indian Head Salmon Hatchery  
Stephenville, NL**

**PROJECT DESCRIPTION  
AND REGISTRATION**

Silk Stevens Limited  
35 Main Street  
St. George, NB  
E5C 3H9

**November 2010**

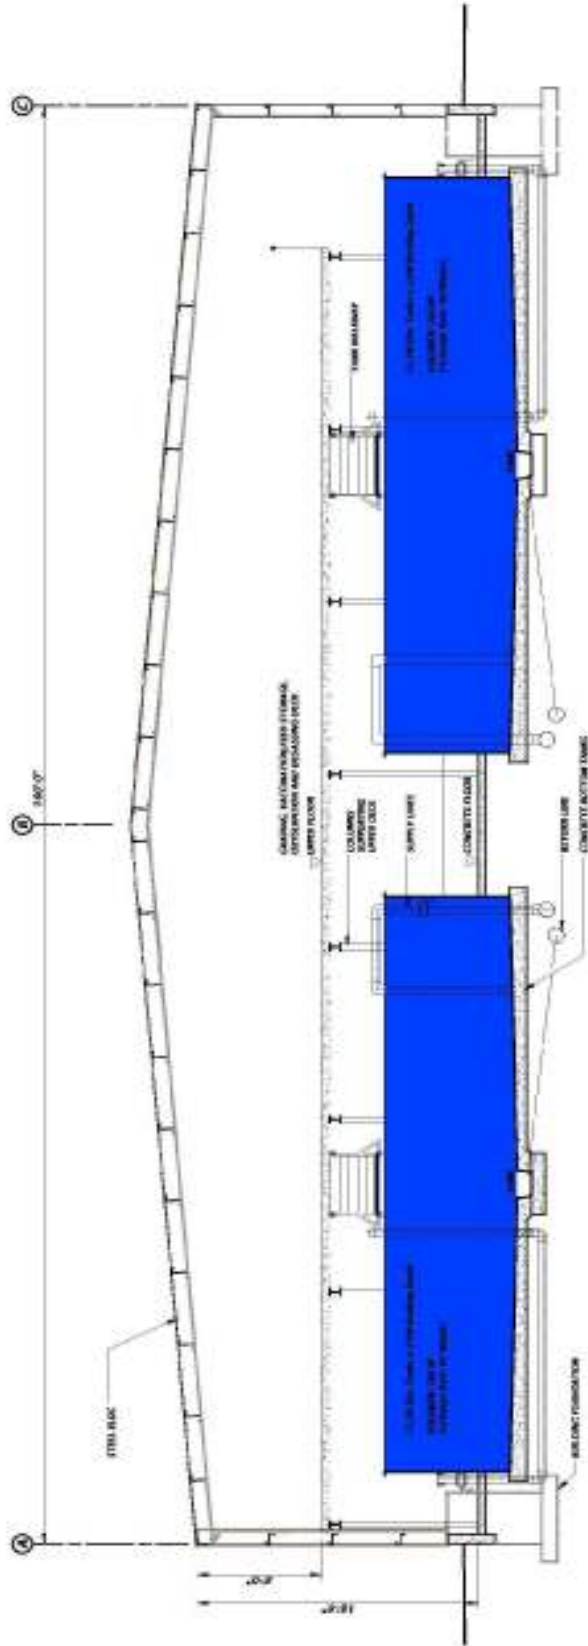
**1** CROSS SECTION A-A THRU 12M TANKS  
SCALE 1/4" TO 1' @ 11' 10 1/2"  
SCALE 1/4" TO 1' @ 12' 10 1/2"

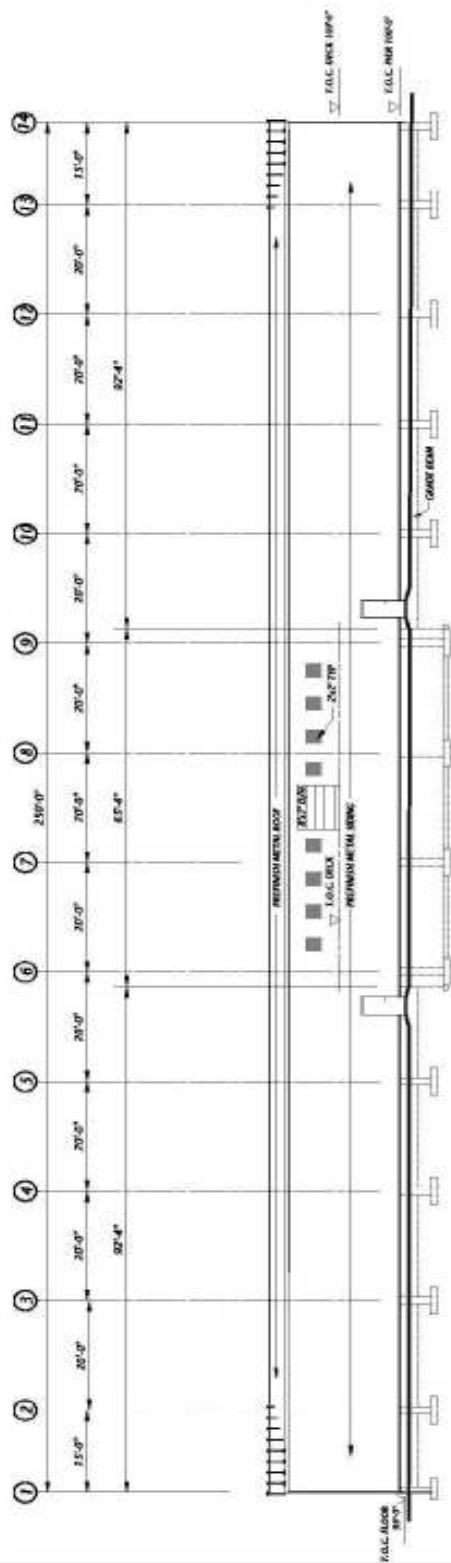
1 RIGHT WALL ELEVATION  
SCALE 1/8" = 1'-0" (1/4" = 1'-0")  
SCALE UP TO 1'-0" (1/4" = 1'-0")

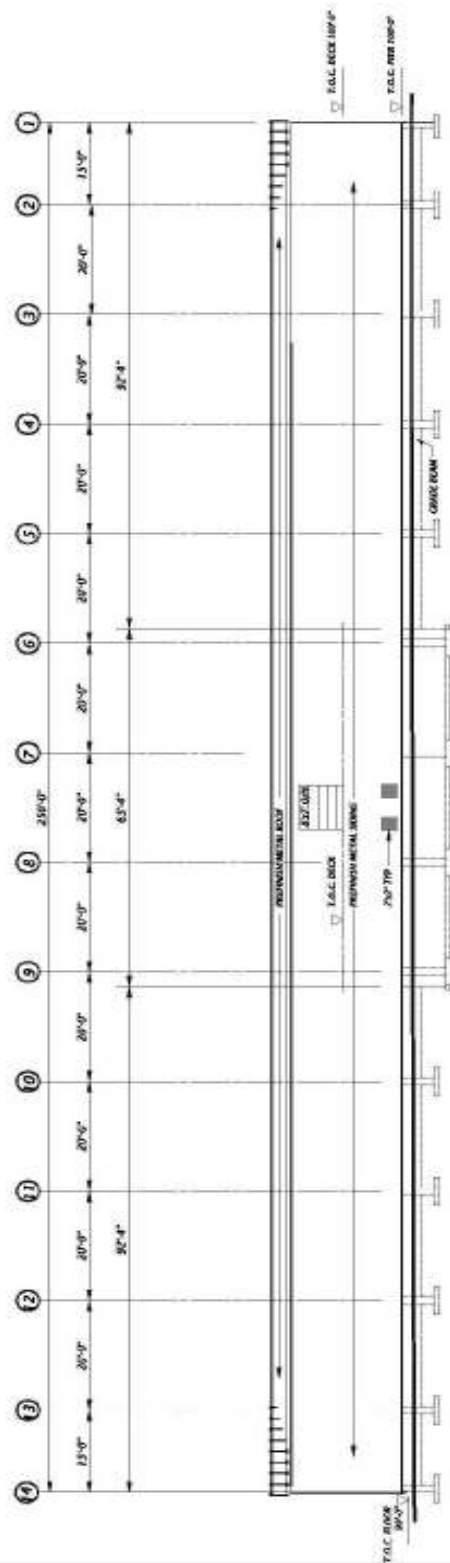
2 LEFT WALL ELEVATION  
SCALE 1/8" = 1'-0" (1/4" = 1'-0")  
SCALE UP TO 1'-0" (1/4" = 1'-0")

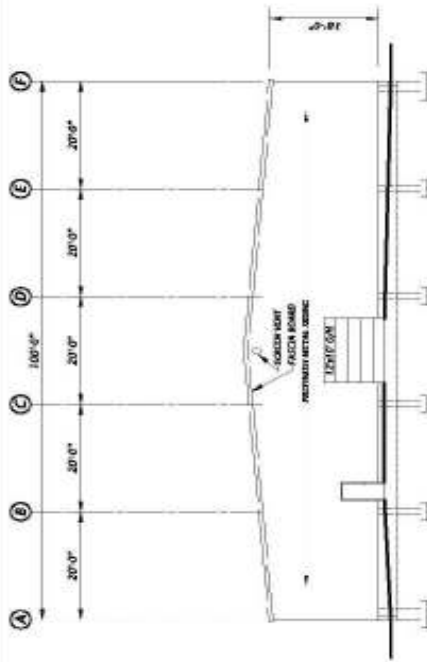
1 FRONT SIDE ELEVATION  
SCALE 1/16" = 1'-0"  
SCALE 1/16" = 1'-0"

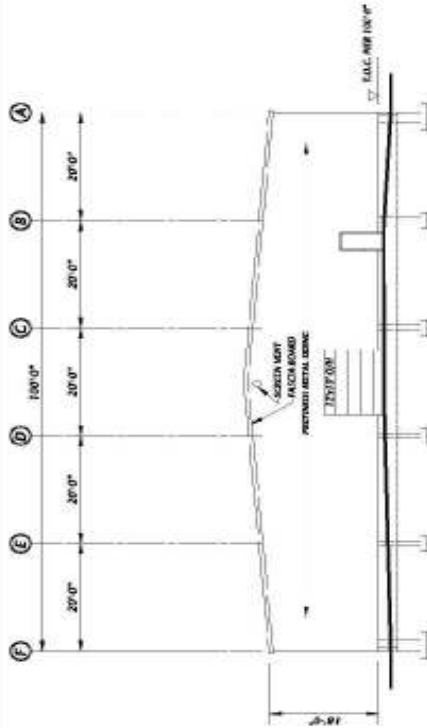
2 BACK SIDE ELEVATION  
SCALE 1/16" = 1'-0"  
SCALE 1/16" = 1'-0"

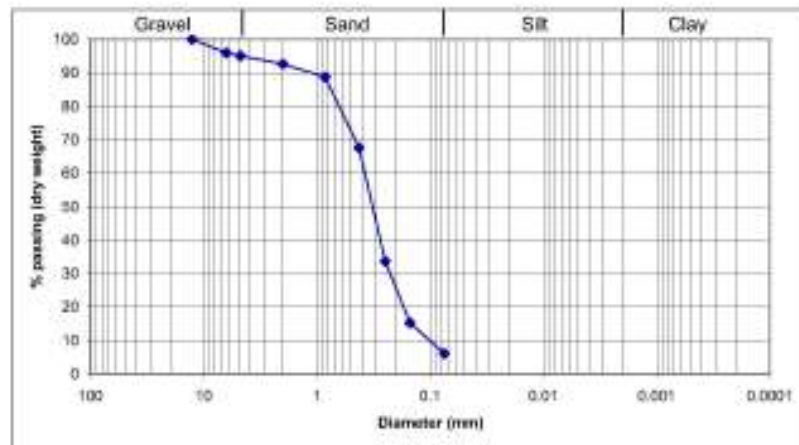
Sieve	Opening (mm)	Retained (g)	% Retained	Cumulative % Ret	% Passing
2	50.8	---	---	---	---
1	25.4	---	---	---	---
1/2"	12.7	0.00	0.00	0.00	100.00
1/4"	6.35	6.42	4.14	4.14	95.86
4	4.75	1.40	0.90	5.05	94.95
10	2.00	3.73	2.41	7.46	92.54
20	0.85	5.94	3.83	11.29	88.71
40	0.425	32.74	21.14	32.43	67.57
60	0.25	52.57	33.94	66.37	33.63
100	0.15	28.39	18.33	84.69	15.31
200	0.075	14.25	9.20	93.89	6.11
pan	---	9.46	6.11	100.00	---
		154.90

$$D_{10} = 0.1$$

$$D_{30} = 0.23$$

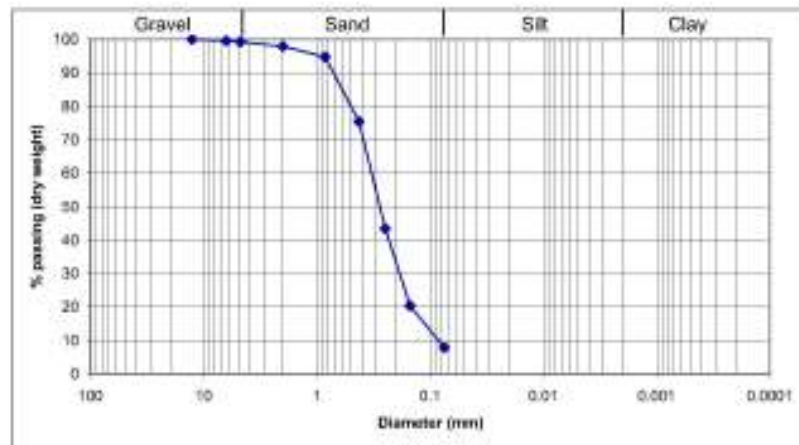
Sieve	Opening (mm)	Retained (g)	% Retained	Cumulative % Ret	% Passing
2	50.8	---	---	---	---
1	25.4	---	---	---	---
1/2"	12.7	0.00	0.00	0.00	100.00
1/4"	6.35	0.55	0.40	0.40	99.60
4	4.75	0.39	0.28	0.68	99.32
10	2.00	1.92	1.39	2.07	97.93
20	0.85	4.47	3.23	5.30	94.70
40	0.425	26.58	19.23	24.54	75.46
60	0.25	44.31	32.06	56.60	43.40
100	0.15	31.79	23.00	79.61	20.39
200	0.075	17.26	12.49	92.10	7.90
pan	---	10.92	7.90	100.00	---
		138.19

$$D_{10} = 0.084$$

$$D_{30} = 0.18$$

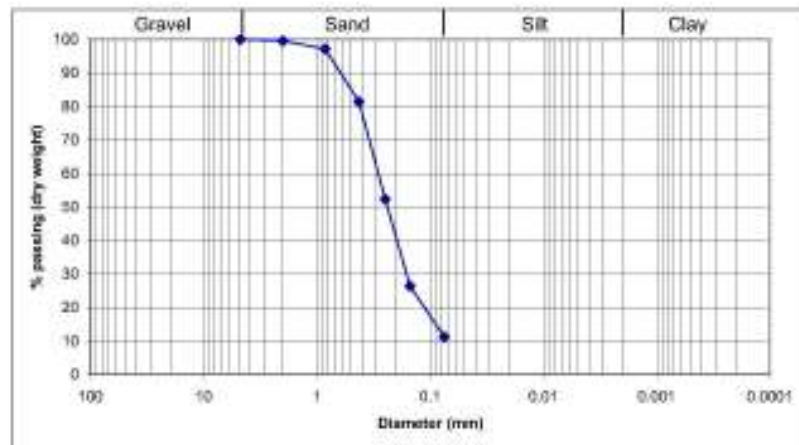
Sieve	Opening (mm)	Retained (g)	% Retained	Cumulative % Ret	% Passing
2	50.8	—	—		
1	25.4	—	—		
1/2"	12.7	—	—		
1/4"	6.35	—	—		
4	4.75	0.00	0.00	0.00	100.00
10	2.00	0.52	0.42	0.42	99.58
20	0.85	3.04	2.48	2.91	97.09
40	0.425	19.25	15.73	18.63	81.37
60	0.25	35.84	29.12	47.75	52.25
100	0.15	31.66	25.86	73.61	26.39
200	0.075	18.85	15.24	88.85	11.15
pan	—	13.65	11.15	100.00	—
		122.41

$$D_{10} = 0.07$$

$$D_{30} = 0.16$$

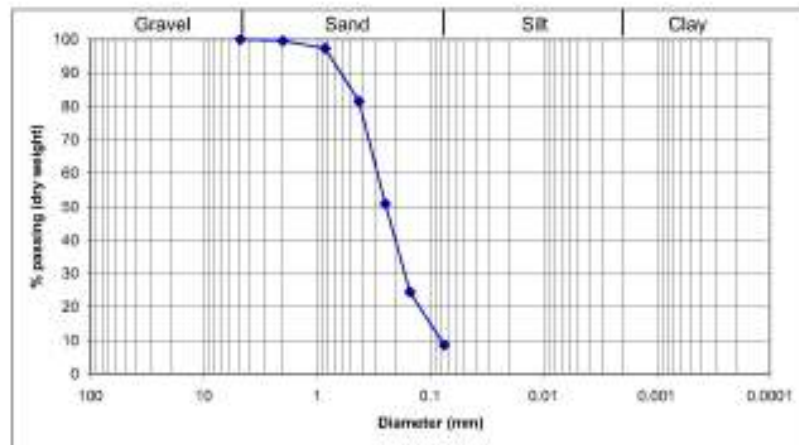
Sieve	Opening (mm)	Retained (g)	% Retained	Cumulative % Ret	% Passing
2	50.8	—	—		
1	25.4	—	—		
1/2"	12.7	—	—		
1/4"	6.35	—	—		
4	4.75	0.00	0.00	0.00	100.00
10	2.00	0.58	0.41	0.41	99.59
20	0.85	3.25	2.29	2.70	97.30
40	0.425	22.49	15.83	18.53	81.47
60	0.25	43.59	30.68	49.21	50.79
100	0.15	37.48	26.38	75.59	24.41
200	0.075	22.42	15.78	91.38	8.62
pan	—	12.25	8.62	100.00	—
		142.06

$$D_{10} = 0.08$$

$$D_{50} = 0.17$$

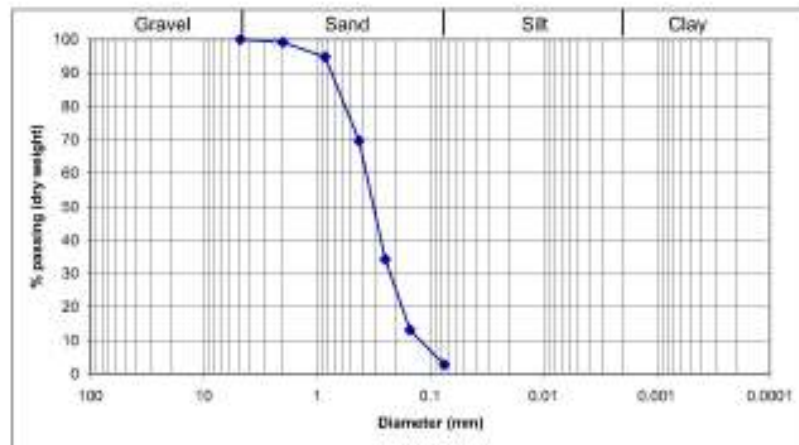
Sieve	Opening (mm)	Retained (g)	% Retained	Cumulative % Ret	% Passing
2	50.8	—	—		
1	25.4	—	—		
1/2"	12.7	—	—		
1/4"	6.35	—	—		
4	4.75	0.00	0.00	0.00	100.00
10	2.00	1.34	0.90	0.90	99.10
20	0.85	6.50	4.38	5.29	94.71
40	0.425	37.03	24.97	30.26	69.74
60	0.25	52.54	35.43	65.69	34.31
100	0.15	31.46	21.22	86.90	13.10
200	0.075	15.43	10.41	97.31	2.69
pan	—	3.99	2.69	100.00	—
		148.29

$$D_{10} = 0.12$$

$$D_{30} = 0.22$$

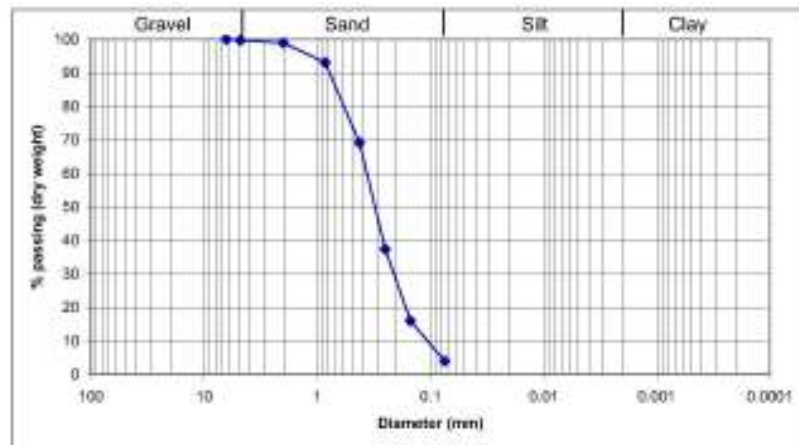
Sieve	Opening (mm)	Retained (g)	% Retained	Cumulative % Ret	% Passing
2	50.8	—	—		
1	25.4	—	—		
1/2"	12.7	—	—		
1/4"	6.35	0.00	0.00	0.00	100.00
4	4.75	0.45	0.35	0.35	99.65
10	2.00	0.92	0.71	1.05	98.95
20	0.85	7.66	5.88	6.94	93.06
40	0.425	31.13	23.91	30.85	69.15
60	0.25	41.32	31.74	62.60	37.40
100	0.15	27.97	21.49	84.08	15.92
200	0.075	15.64	12.02	96.10	3.90
pan	—	5.08	3.90	100.00	—
		130.17

$$D_{10} = 0.105$$

$$D_{30} = 0.21$$

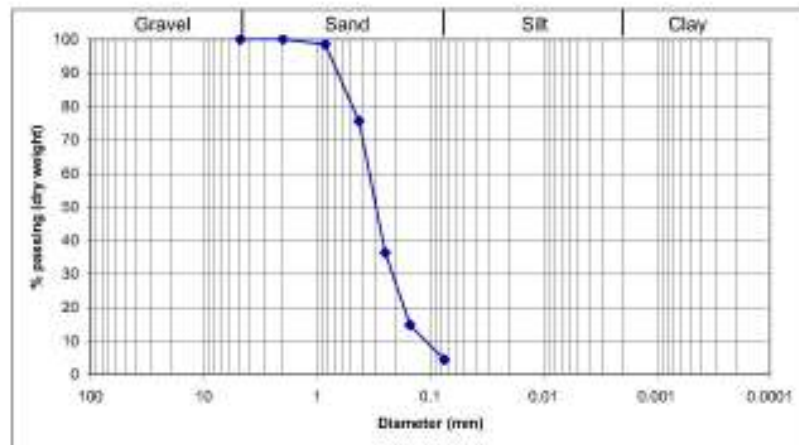
Sieve	Opening (mm)	Retained (g)	% Retained	Cumulative % Ret	% Passing
2	50.8	—	—		
1	25.4	—	—		
1/2"	12.7	—	—		
1/4"	6.35	—	—		
4	4.75	0.00	0.00	0.00	100.00
10	2.00	0.06	0.03	0.03	99.97
20	0.85	3.40	1.55	1.57	98.43
40	0.425	50.10	22.79	24.36	75.64
60	0.25	86.64	39.41	63.77	36.23
100	0.15	47.09	21.42	85.19	14.81
200	0.075	22.94	10.43	95.62	4.38
pan	—	9.63	4.38	100.00	—
		219.86

$$D_{10} = 0.11$$

$$D_{30} = 0.22$$

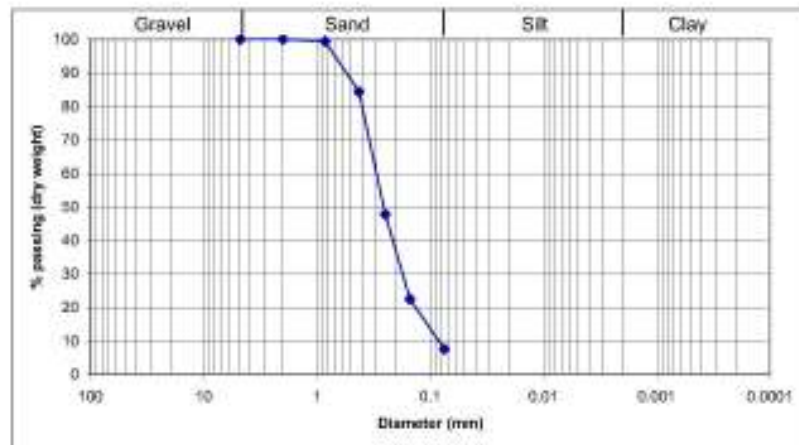
Sieve	Opening (mm)	Retained (g)	% Retained	Cumulative % Ret	% Passing
2	50.8	---	---		
1	25.4	---	---		
1/2"	12.7	---	---		
1/4"	6.35	---	---		
4	4.75	0.00	0.00	0.00	100.00
10	2.00	0.00	0.00	0.00	100.00
20	0.85	0.95	0.60	0.60	99.40
40	0.425	23.70	15.02	15.63	84.37
60	0.25	57.67	36.56	52.18	47.82
100	0.15	40.10	25.42	77.60	22.40
200	0.075	23.49	14.89	92.49	7.51
pan	---	11.84	7.51	100.00	---
		157.75

$$D_{10} = 0.085$$

$$D_{30} = 0.175$$

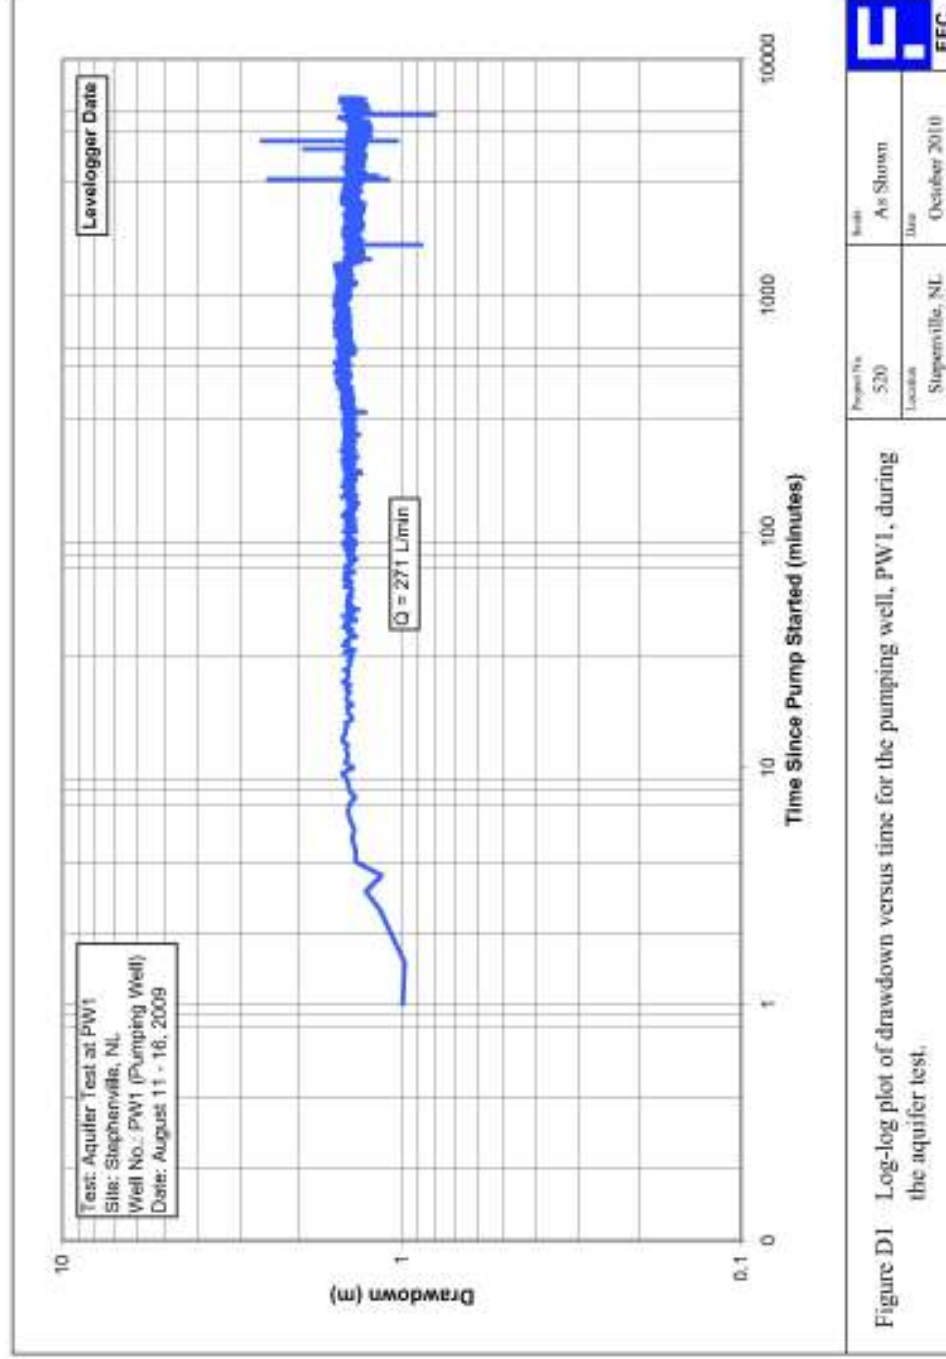
Figure D1 Log-log plot of drawdown versus time for the pumping well, PW1, during the aquifer test.

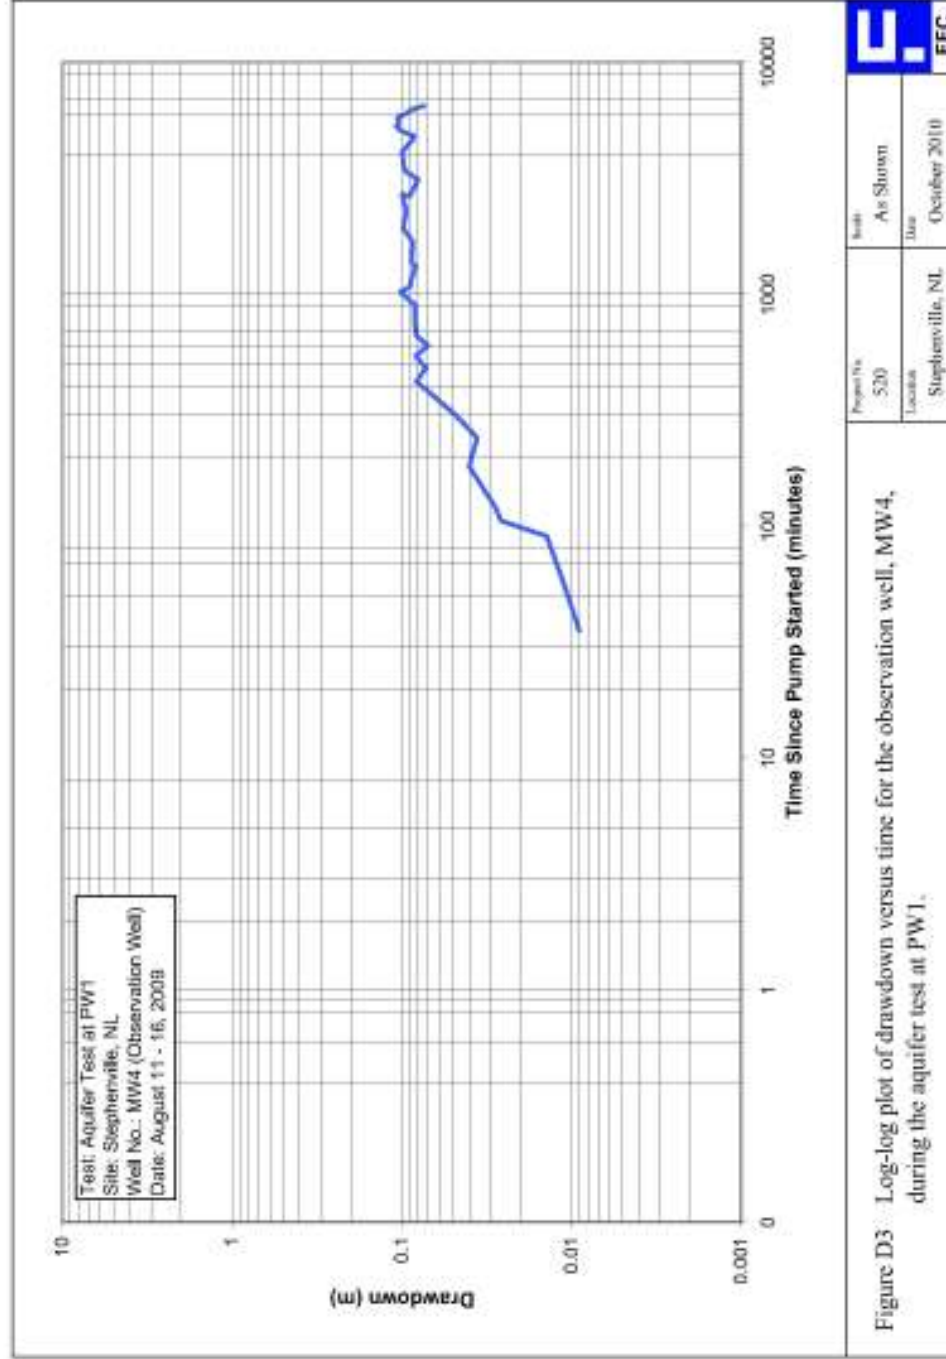
Figure D3 Log-log plot of drawdown versus time for the observation well, MW4, during the aquifer test at PW1.

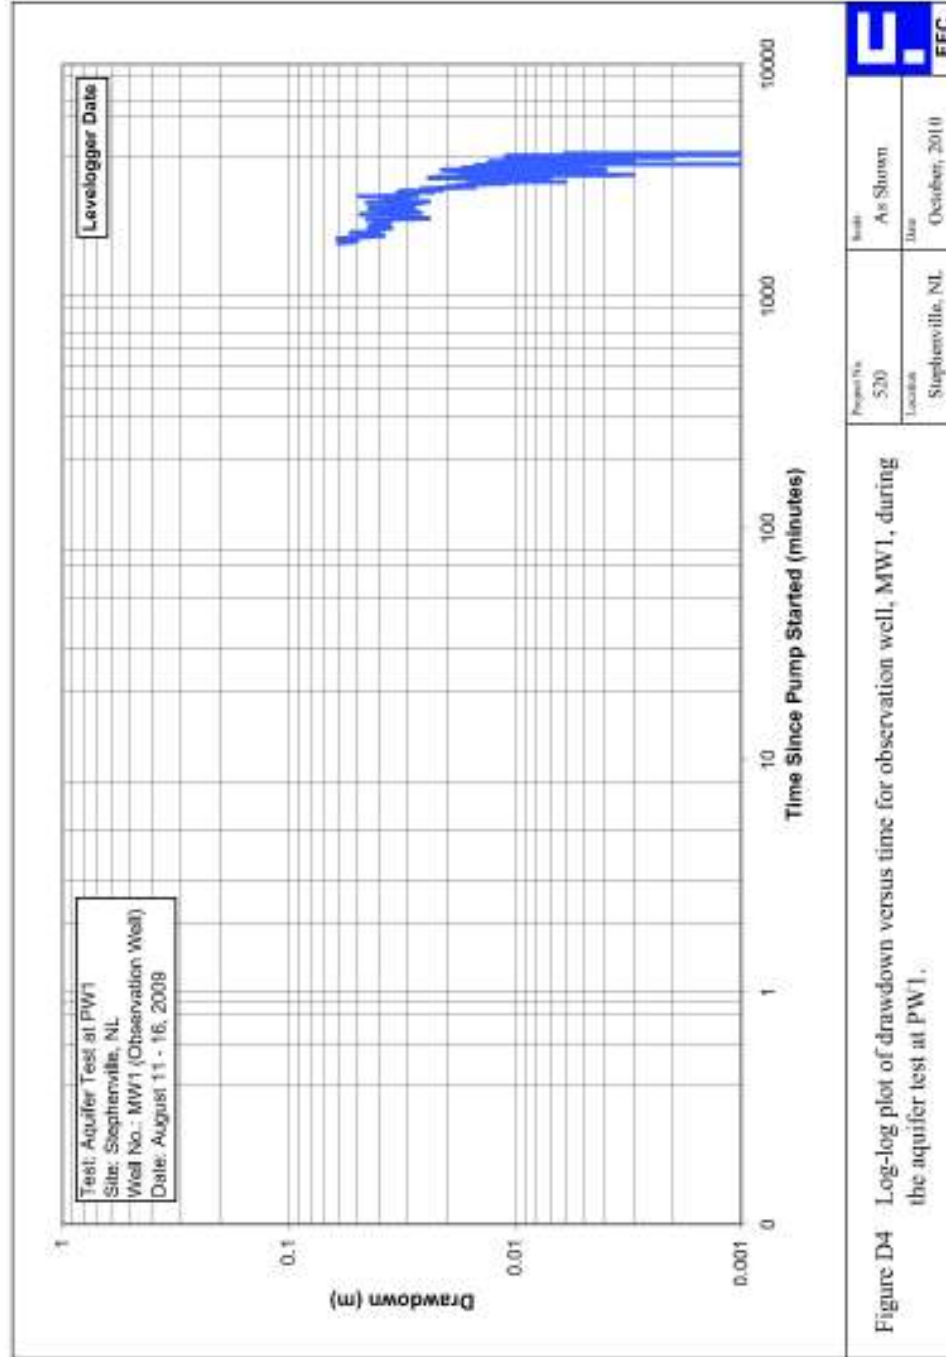
Figure D4 Log-log plot of drawdown versus time for observation well, MW1, during the aquifer test at PW1.

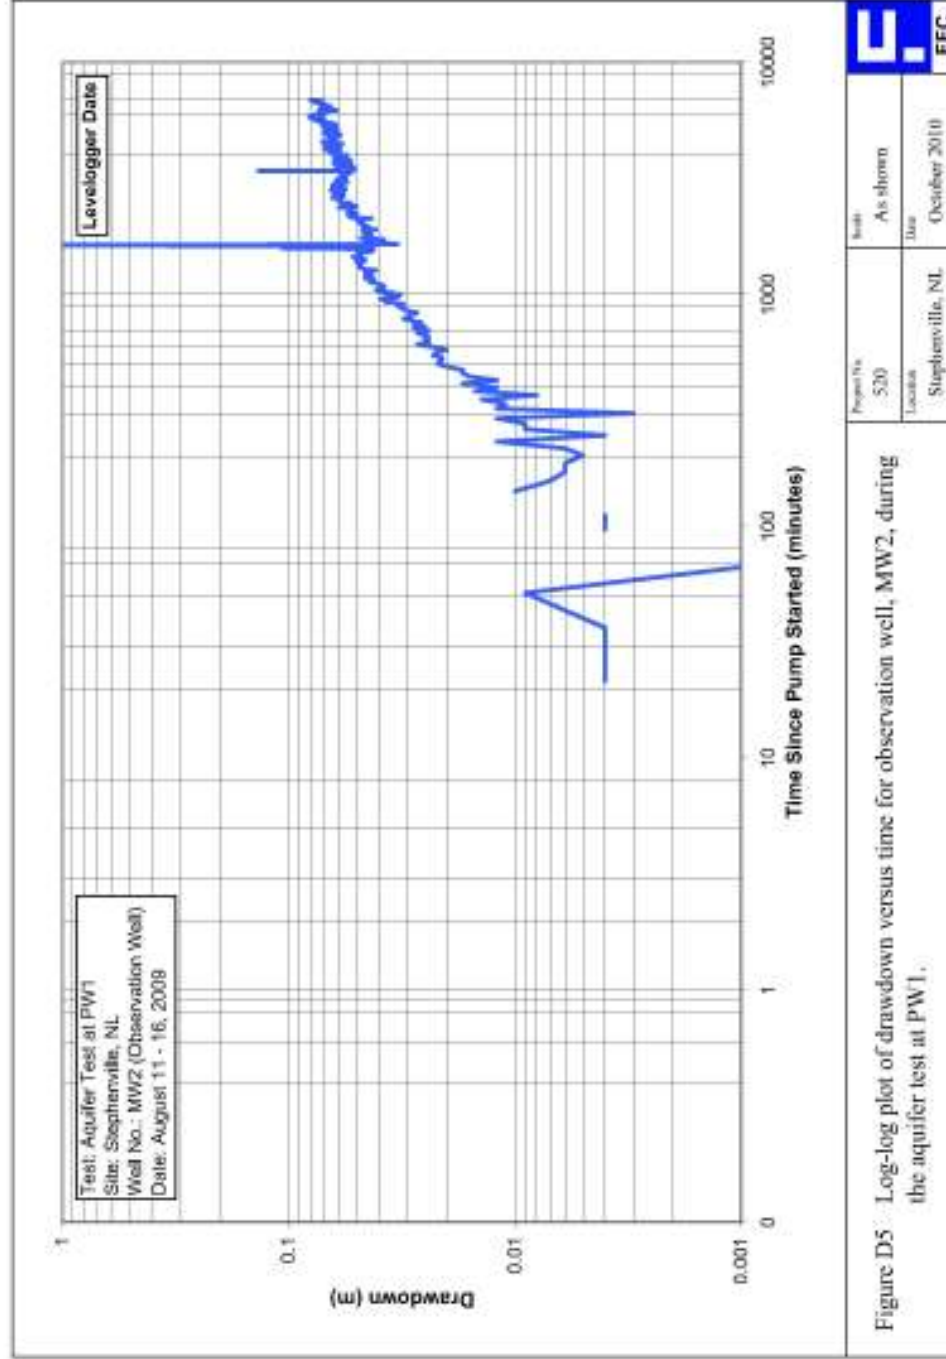
Figure D5 Log-log plot of drawdown versus time for observation well, MW2, during the aquifer test at PW1.

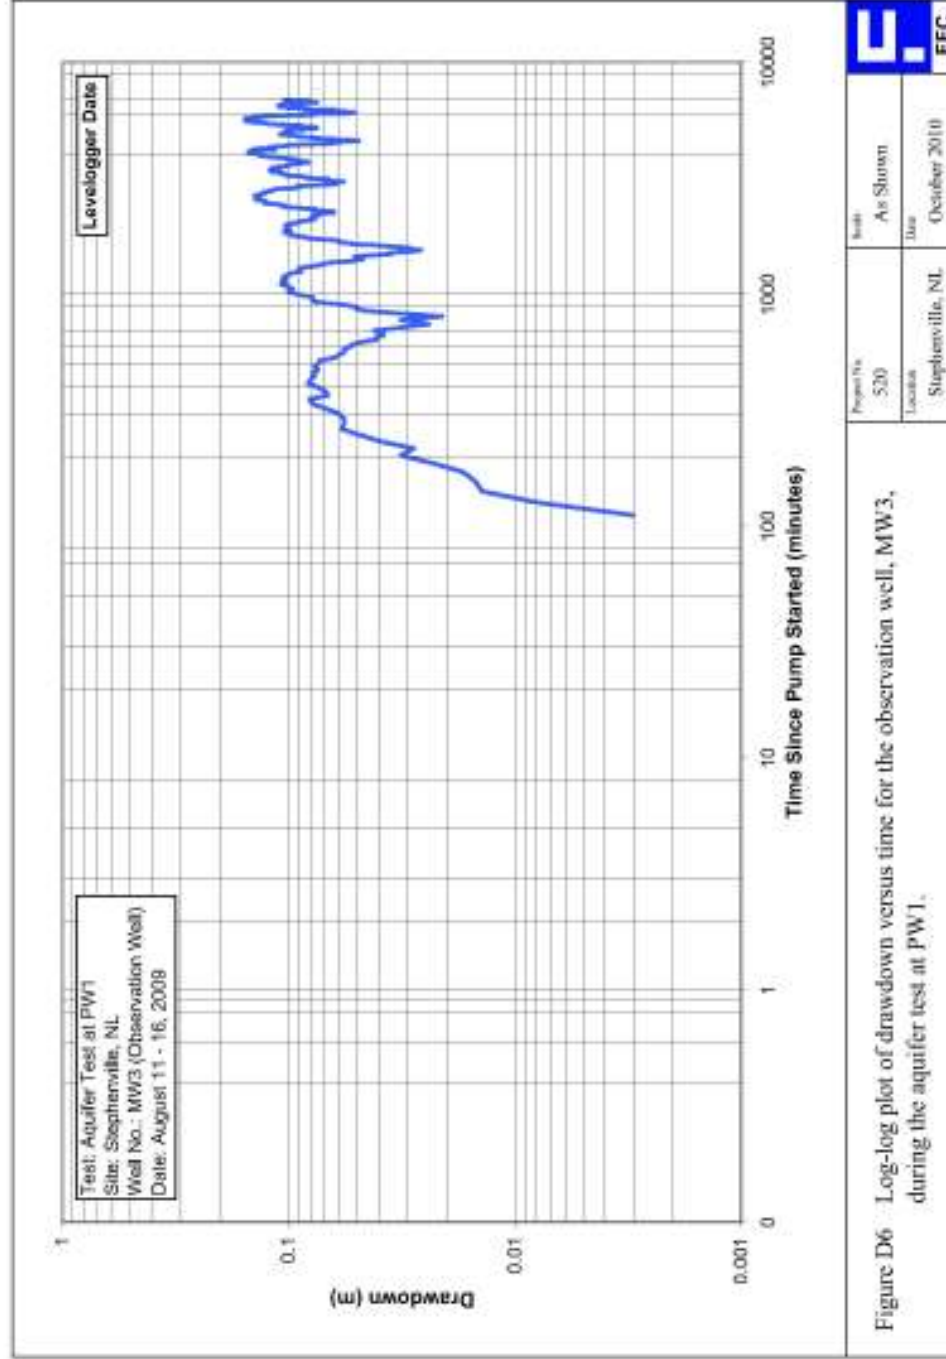
Figure D6 Log-log plot of drawdown versus time for the observation well, MW3, during the aquifer test at PW1.

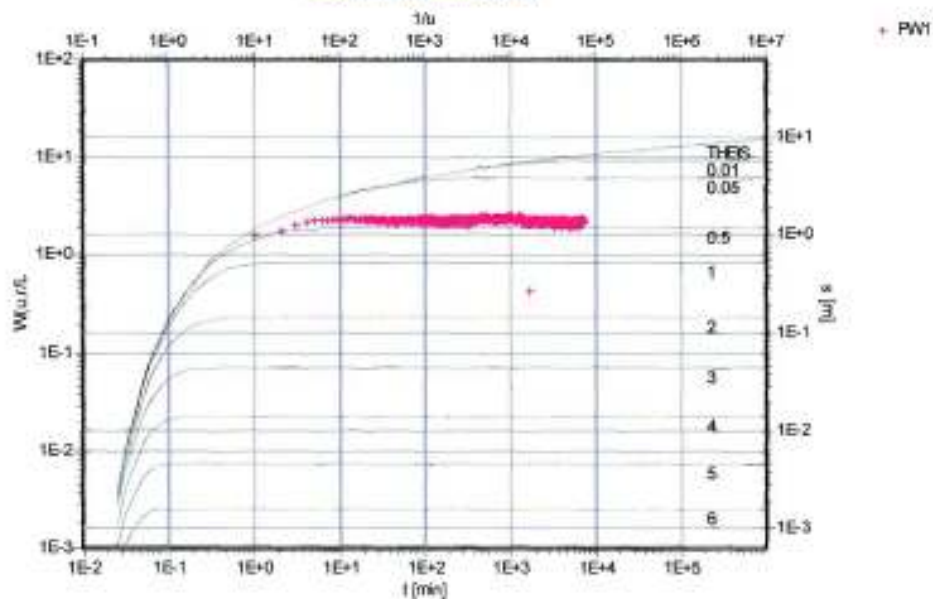
Pumping Test (Hantush-Jacob)

Analysis method: Hantush-Jacob

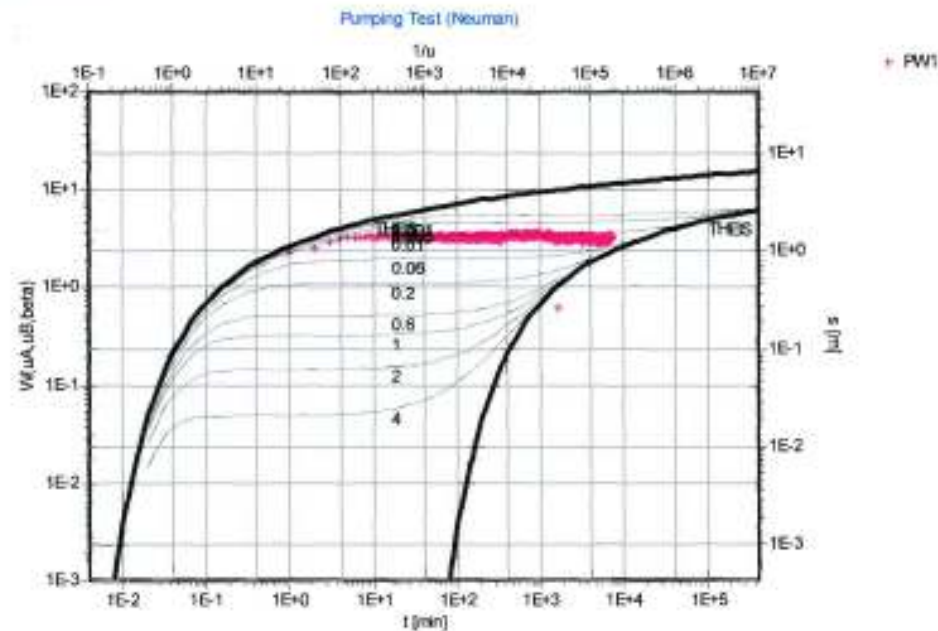
Analysis method: Neuman

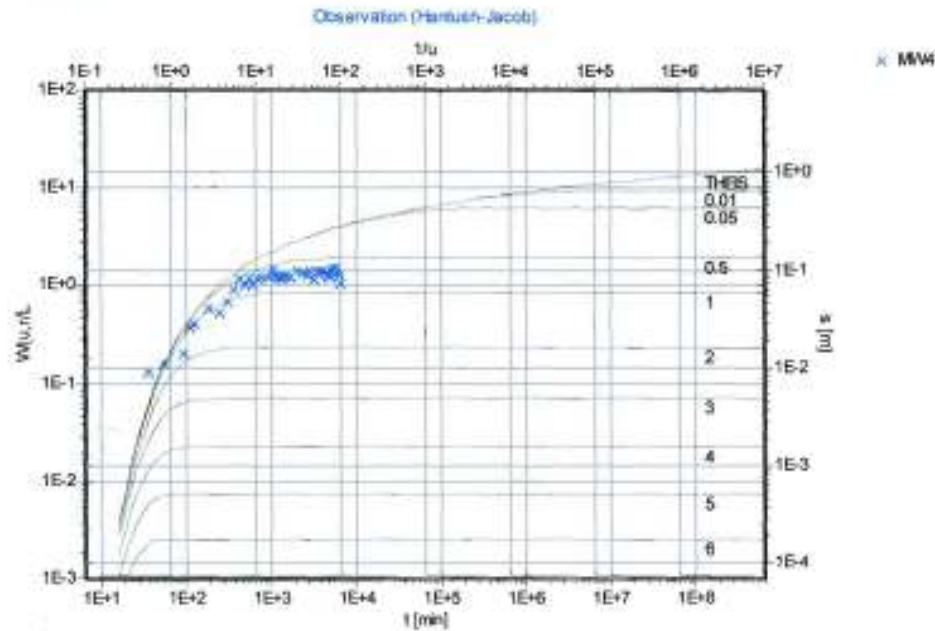
Analysis method: Hantush-Jacob

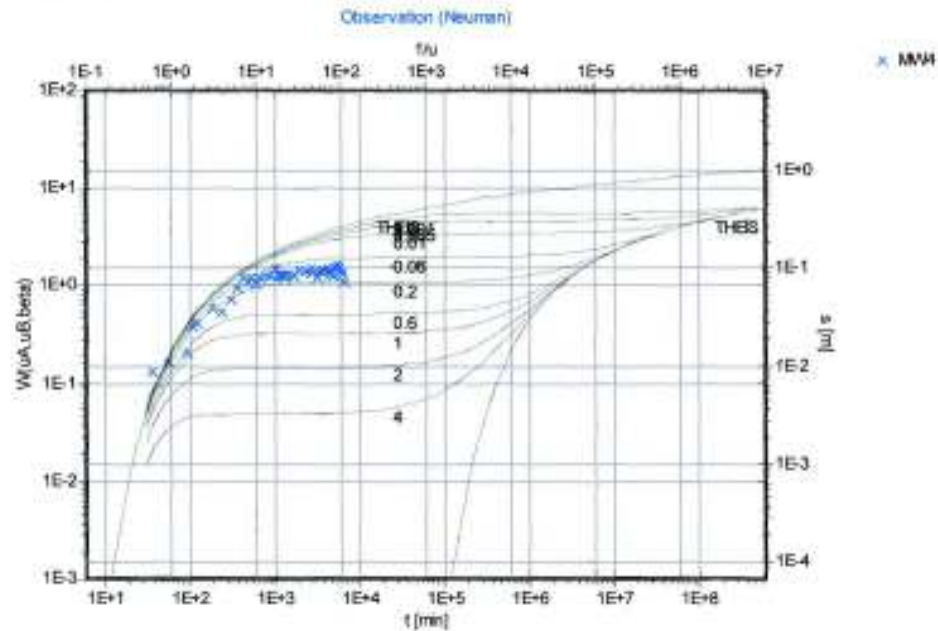
Analysis method: Neuman

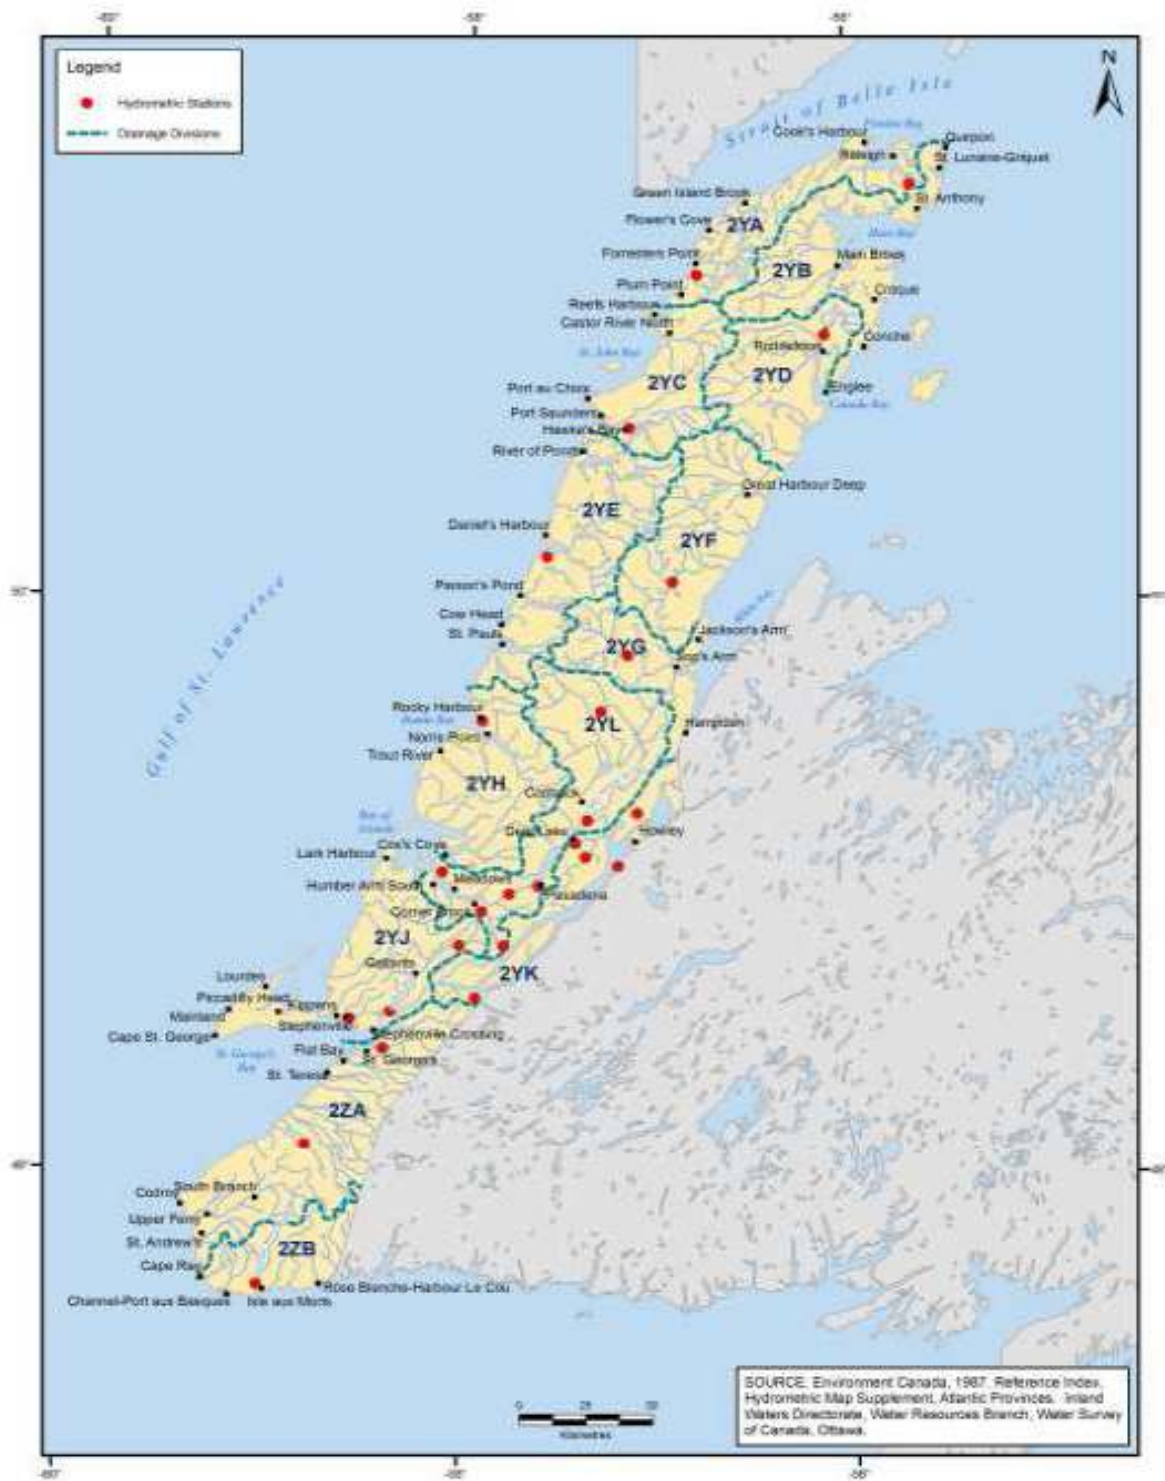
Figure 5.1: Drainage Divisions Covering the Study Area
