Final Report

Level II Groundwater Supply Assessment
Proposed Cottage Lot Development
Ocean Pond Property
Newfoundland and Labrador

SJN-00215494-A0

August 2015

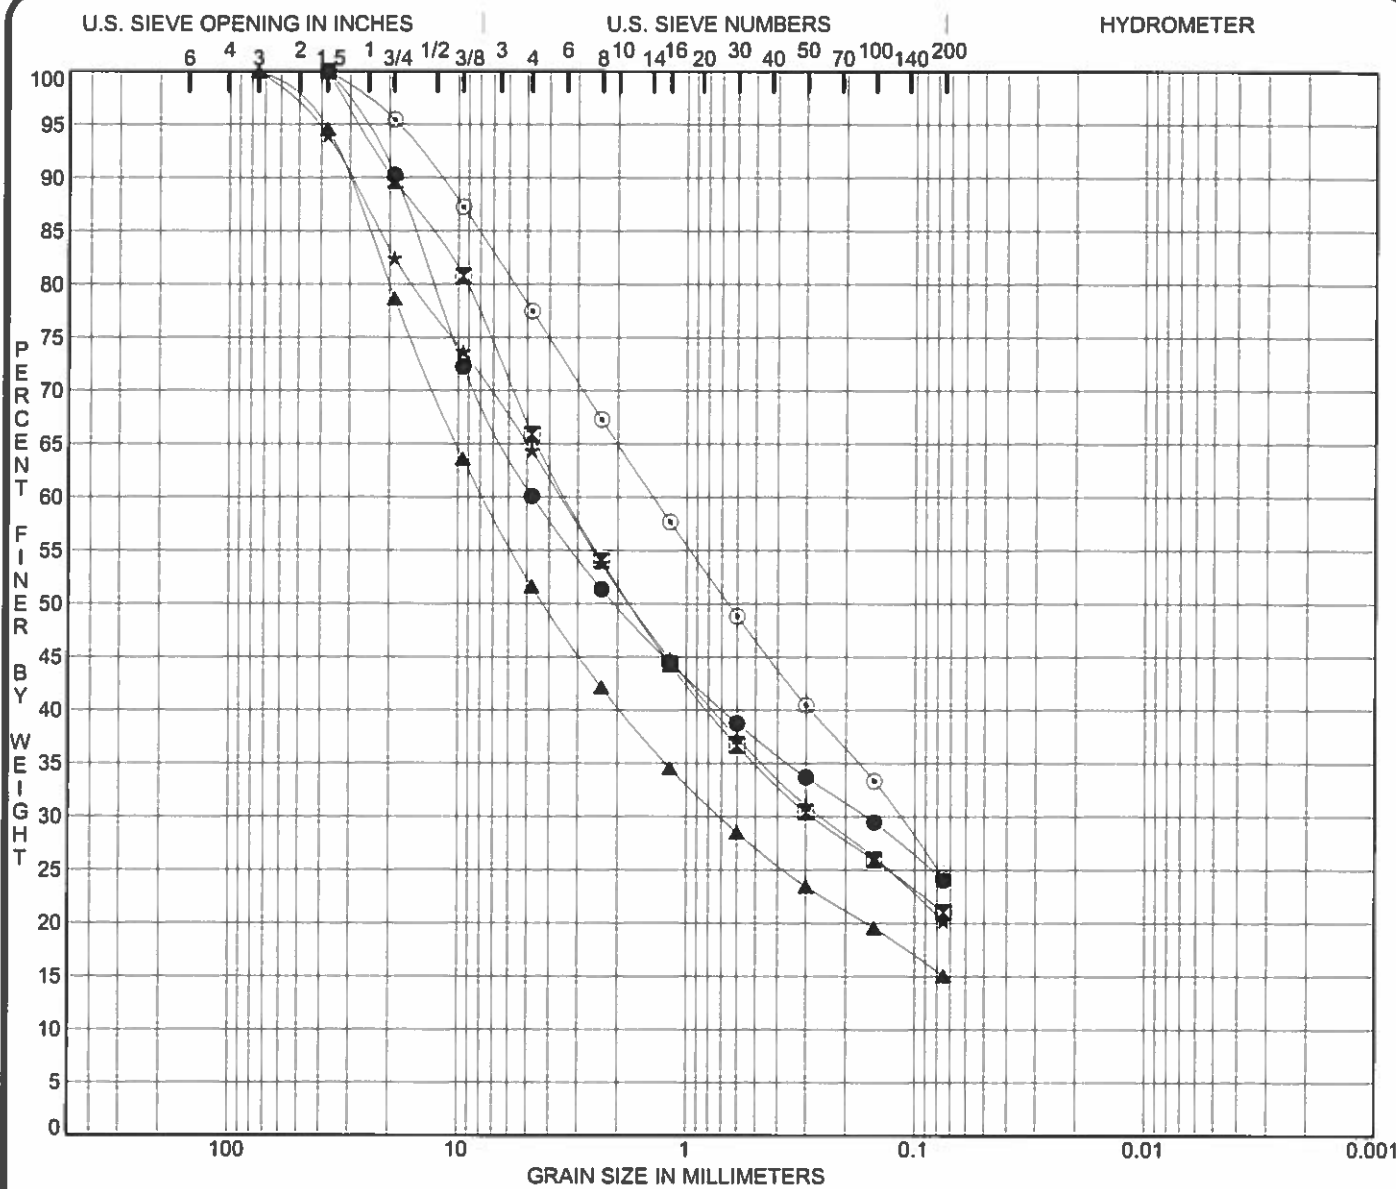
GRADATION CURVES

Location	Depth (m)	Classification (USCS)				MC%	LL	PL	PI	Cc	Cu
●	TP02	2.0	Silty GRAVEL and SAND (GM)				8.6				
⊗	TP05	2.0	Gravelly, silty SAND (SM)				8.6				
▲	TP08	1.6	GRAVEL and SAND; some silt (GM)				11.5				
★	TP12	3.1	Silty SAND and GRAVEL (SM)				8.2				
⊙	TP15	3.2	Silty, gravelly SAND (SM)				9.1				
Location	Depth (m)	D100	D60	D30	D10	%Gravel	%Sand	%Silt	%Clay		
●	TP02	2.0	37.50	4.72	0.163	39.9	36.0	24.1			
⊗	TP05	2.0	37.50	3.36	0.281	34.1	44.8	21.1			
▲	TP08	1.6	75.00	7.72	0.708	48.4	36.5	15.1			
★	TP12	3.1	75.00	3.56	0.258	35.6	44.2	20.2			
⊙	TP15	3.2	37.50	1.39	0.116	22.6	53.2	24.2

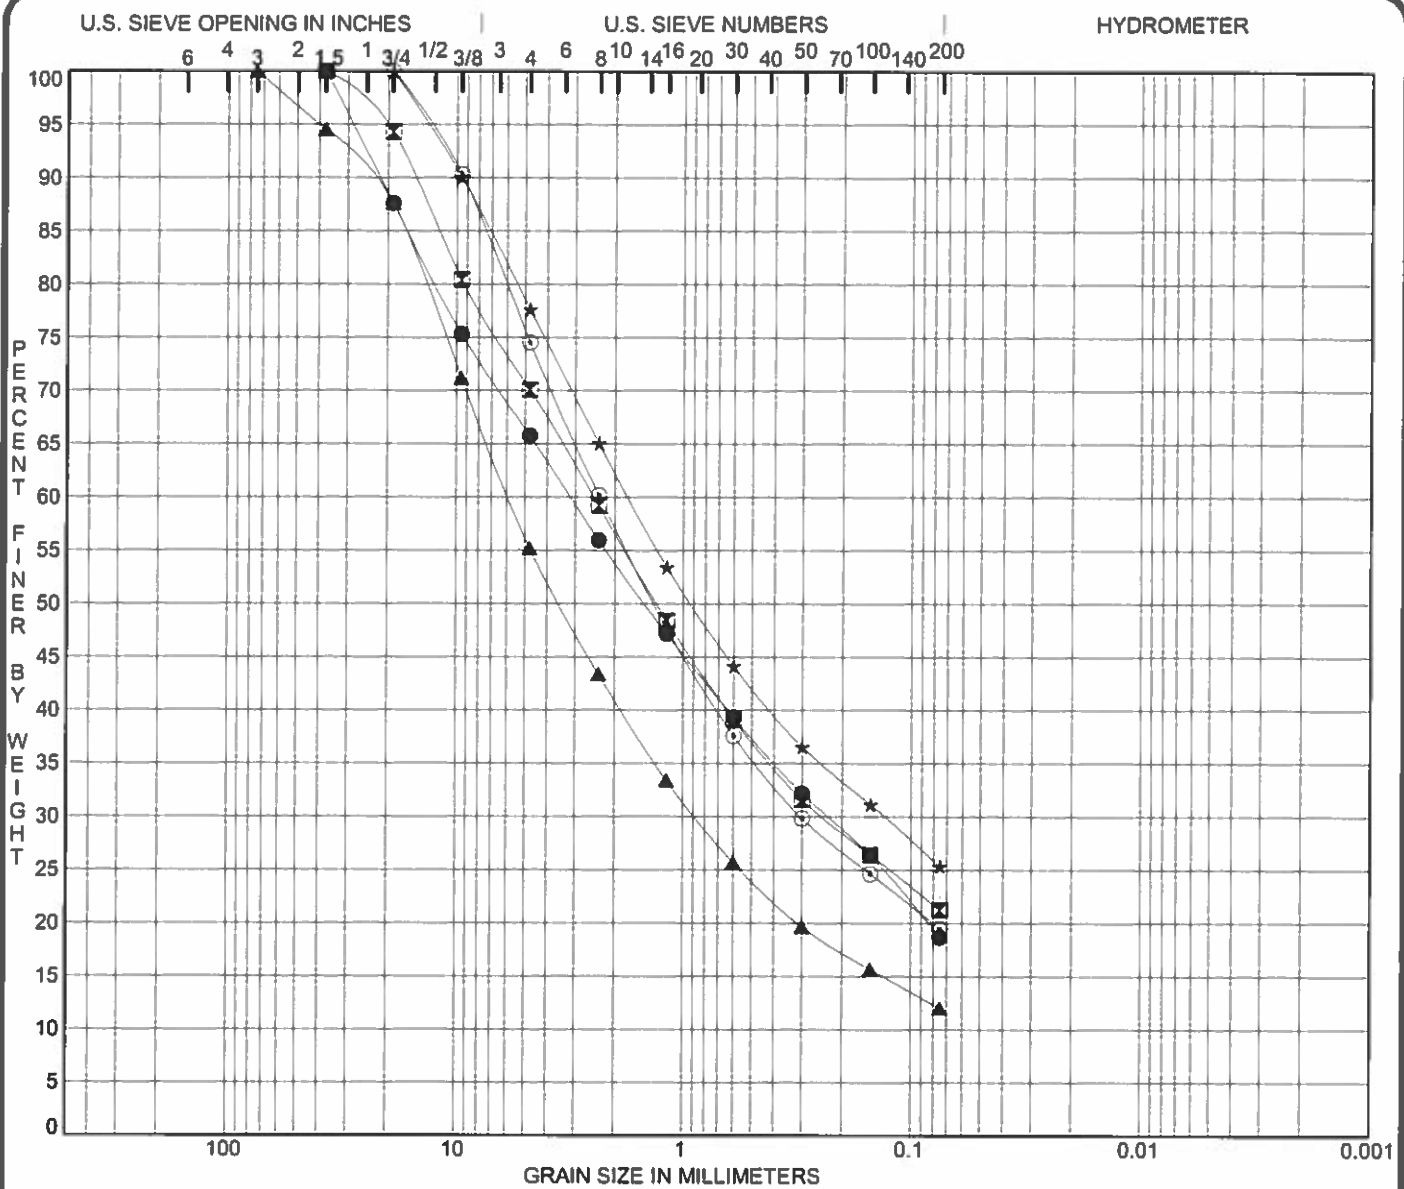
Location	Depth (m)	Classification (USCS)				MC%	LL	PL	PI	Cc	Cu
● TP16	1.8	Gravelly SAND; some silt (SM)				11.4					
⊗ TP18	2.7	Gravelly, silty SAND (SM)				8.3					
▲ TP20	1.1	GRAVEL and SAND; some silt (GW-GM)				5.8				2.56	115.0
★ TP23	2.6	Silty, gravelly SAND (SM)				9.1					
⊙ TP24	2.2	Gravelly SAND; some silt (SM)				8.4

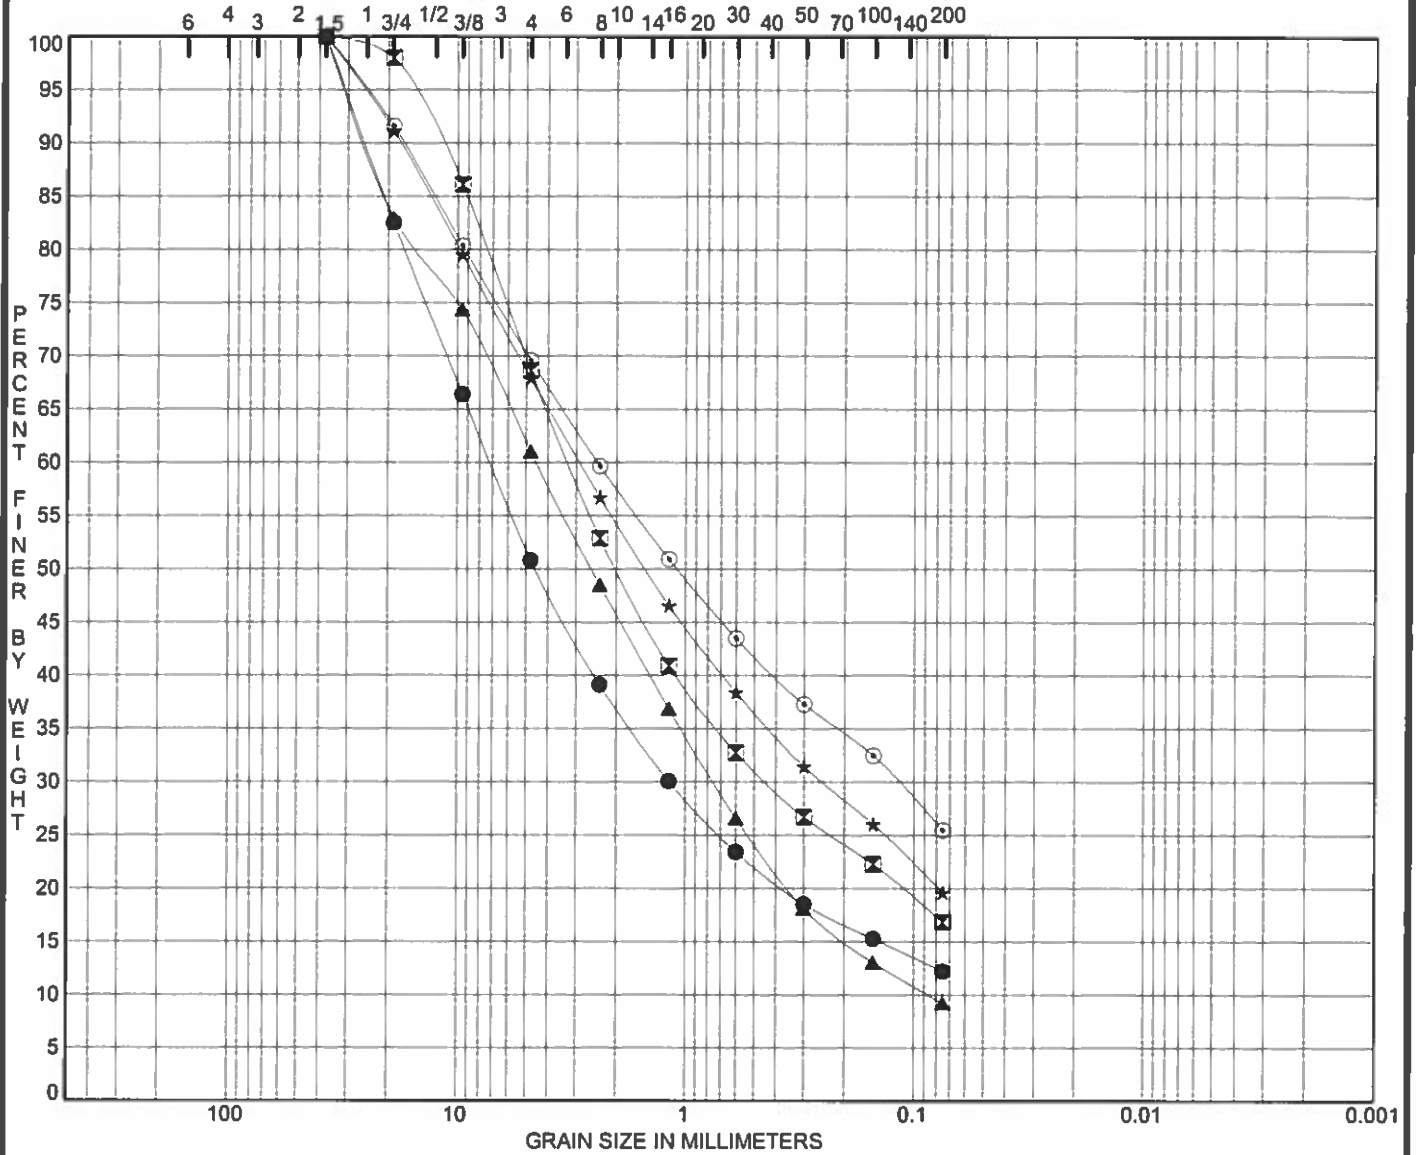
GRADATION CURVES

Location	Depth (m)	Classification (USCS)				MC%	LL	PL	PI	Cc	Cu	
●	TP27	2.0	GRAVEL and SAND; some silt (GM)				6.5				4.22	157.4
⊗	TP30	1.2	Gravelly SAND; some silt (SM)				11.1					
▲	TP31	1.8	SAND and GRAVEL; trace silt (SW-SM)				6.3				1.45	51.9
*	TP34	3.3	Gravelly SAND; some silt (SM)				11.1					
○	TP37	1.9	Gravelly, silty SAND (SM)				8.9

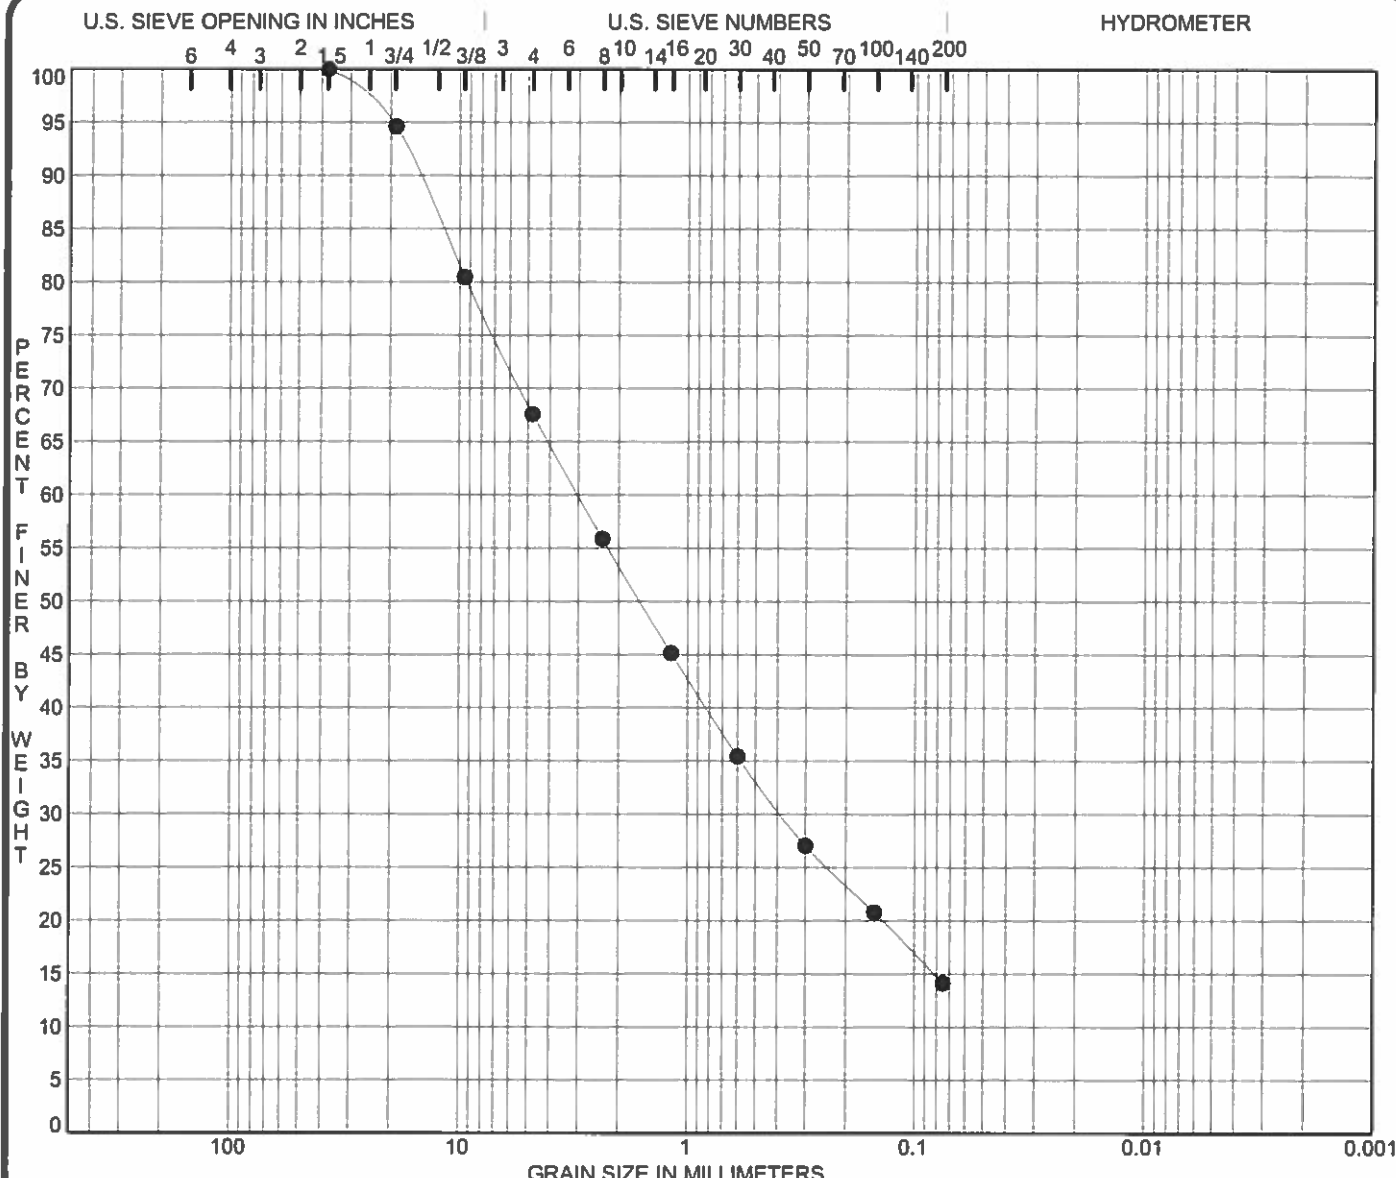
GRADATION CURVES
 exp Services Inc.
 St. John's, NL

Location	Depth (m)	Classification (USCS)	MC%	LL	PL	PI	Cc	Cu
● TP38	1.6	Gravelly SAND; some silt (SM)	5.6

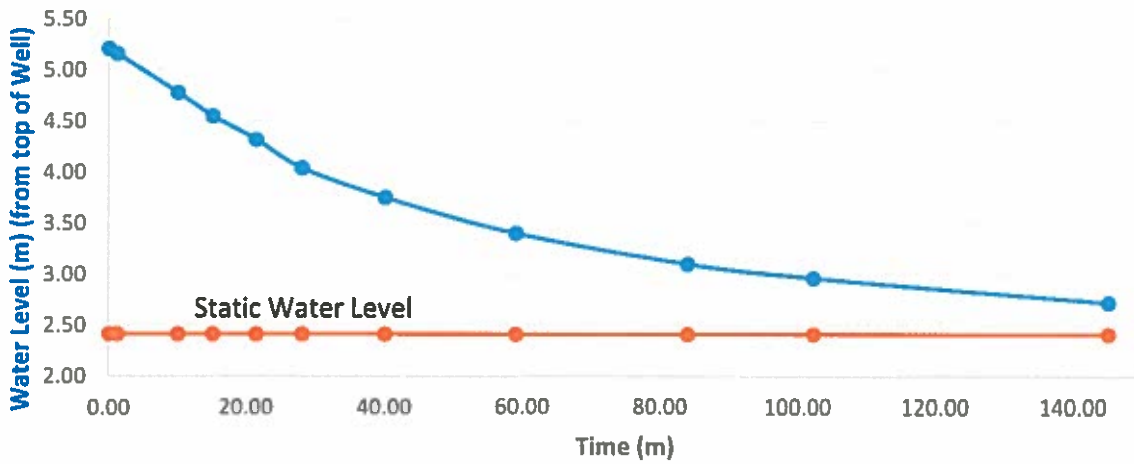
Time vs. Water Level (m) Ocean Pond Well #1

Time (Min)	Depth to Water (m)
0.00	5.21
1.26	5.16
10.01	4.78
15.15	4.55
21.40	4.32
28.00	4.04
40.05	3.75
59.02	3.40
84.00	3.10
102.16	2.96
145.10	2.72

Hydraulic testing comprised pumping the well dry a number of times at varying rates (Well 1 – 72 L/m; Well 2 – 31 L/m; Well 3 – 60 L/m; Well 4 – 63 L/m; Well 5 – 62 L/m) and then recording water level rise during the last recovery period. Pump

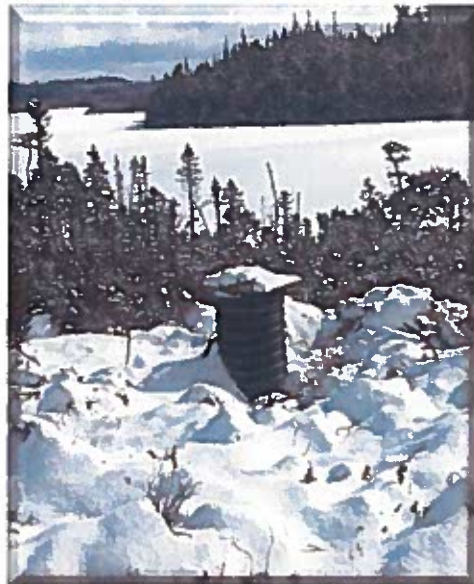
January 26th, 2015

Static Water Level - 2.41m

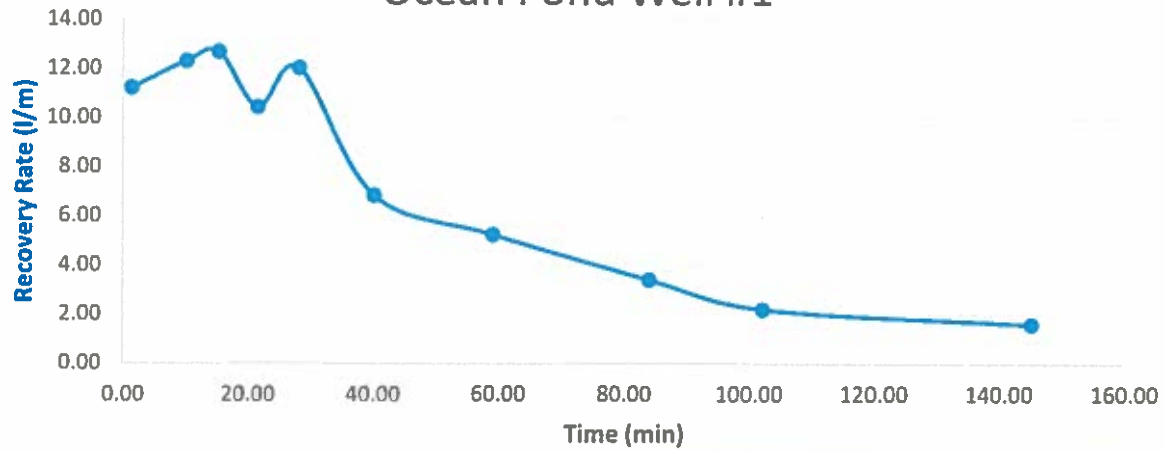
Time vs. Recovery Rate (l/m) Ocean Pond Well #1

Time (Min)	Recovery Rate (l/m)
0.00	0.00
1.26	11.21
10.01	12.30
15.15	12.68
21.40	10.43
28.00	12.02
40.05	6.82
59.02	5.23
84.00	3.40
102.16	2.19

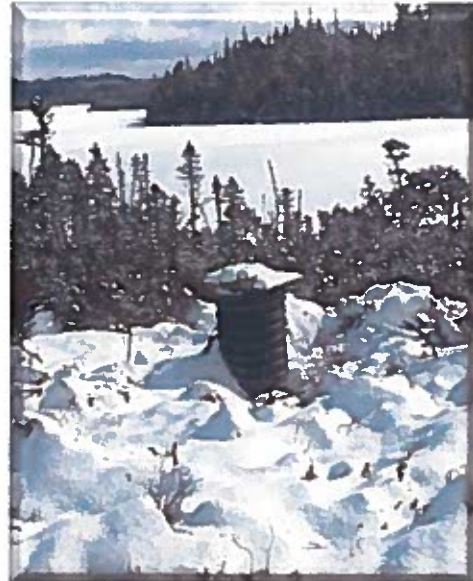
January 26th, 2015

Static Water Level - 2.41m

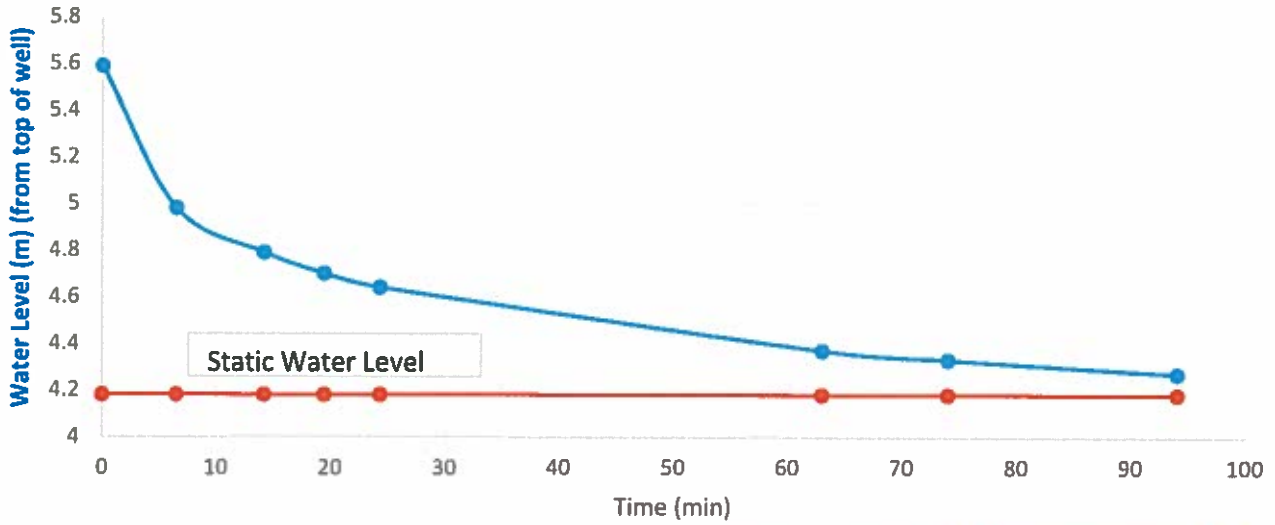
Time vs. Water Level (m) (from top of well casing) Ocean Pond Well #2

Time (Min)	Depth to Water (m)
0	5.59
6.53	4.98
14.2	4.79
19.48	4.7
24.37	4.64
63.01	4.37
74.01	4.33
94.1	4.27

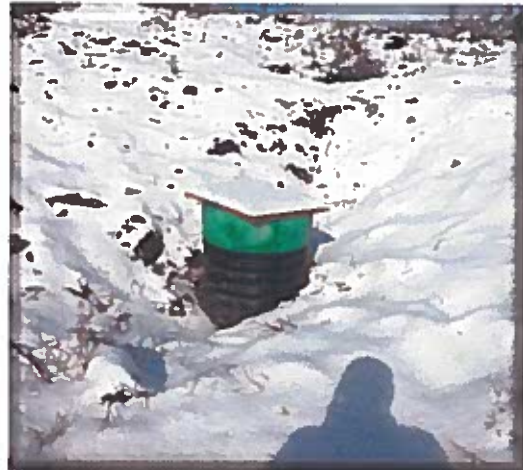
January 26th, 2015

Static Water Level - 4.18m

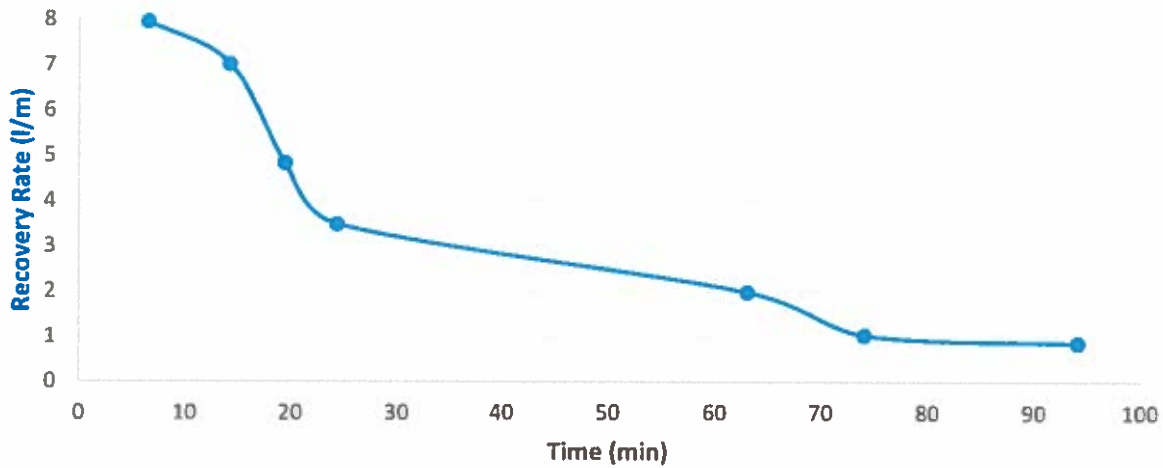
Time vs. Recovery Rate Ocean Pond - Well #2

Time (Min)	Recovery Rate (l/m)
0	0
6.53	7.95
14.2	7.02
19.48	4.83
24.37	3.48
63.01	1.98
74.01	1.03
94.1	0.85

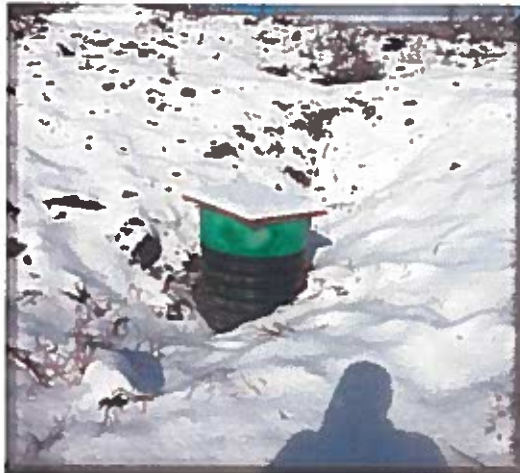
January 26th, 2015

Static Water Level - 4.18m

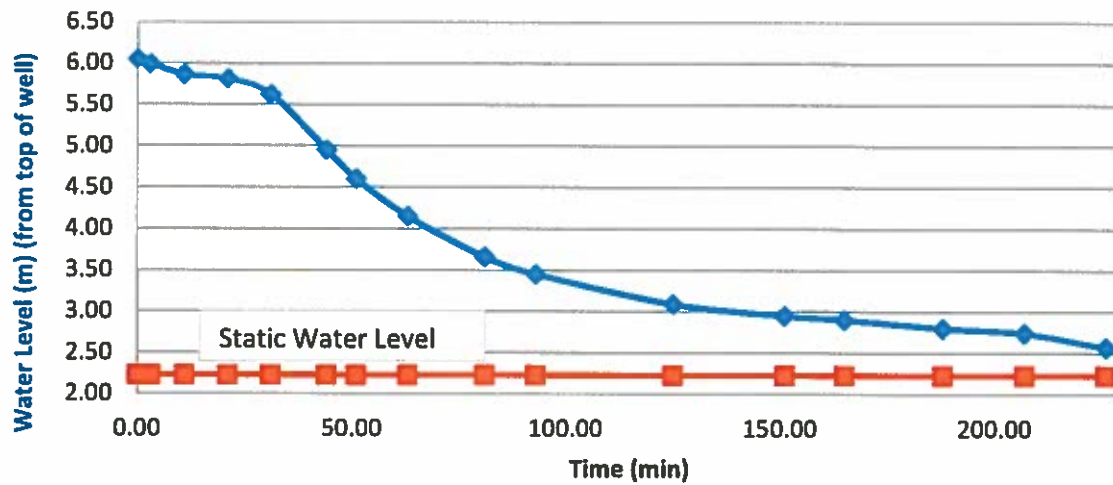
Time vs. Water Level (m) (from top of well casing) Ocean Pond Well #3

Time (min)	Water Level (m) (from top of well casing)
0.00	6.05
3.00	5.99
11.00	5.86
21.00	5.81
31.00	5.62
44.00	4.95
51.00	4.60
63.00	4.15
81.00	3.66
93.00	3.45
125.00	3.09
151.00	2.95
165.00	2.90
188.00	2.80
207.00	2.74

Note: At 31 minutes, holes were drilled to perforate bottom of well casing.
- Large inflow of water noted.

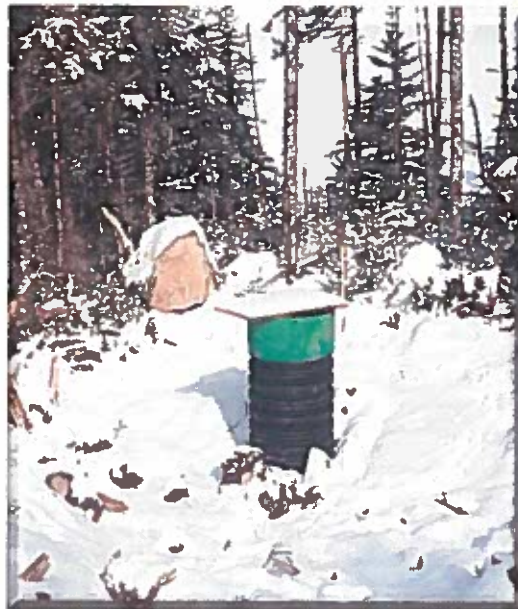
February 7, 2015

Static Water Level - 2.23m

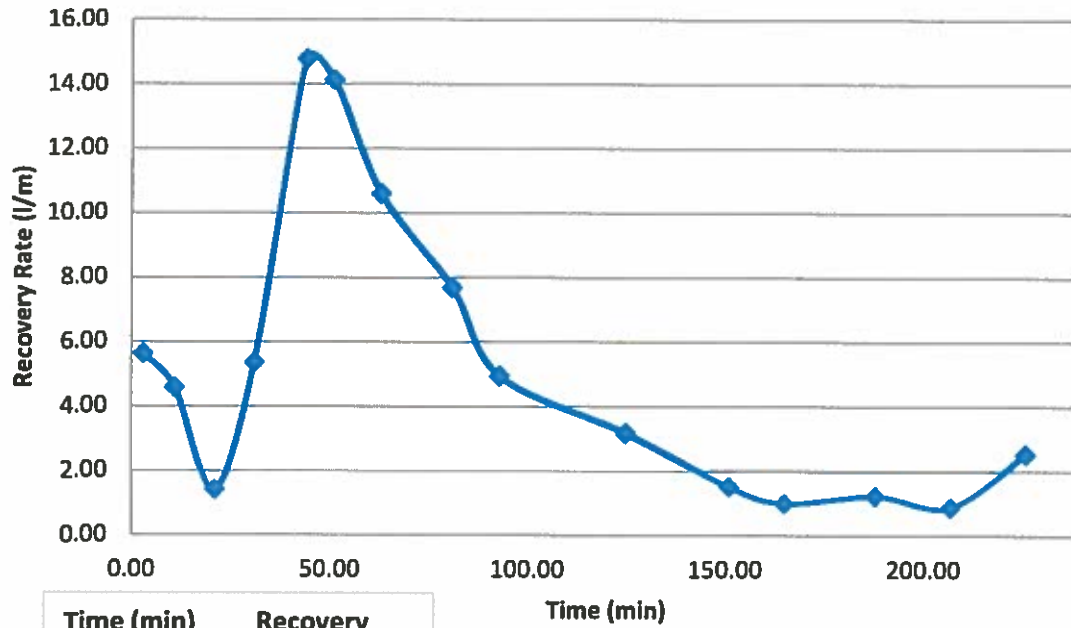
Time vs. Recovery Rate Ocean Pond Well #3

Time (min)	Recovery Rate (l/min)
0.00	0.00
3.00	5.65
11.00	4.59
21.00	1.41
31.00	5.37
44.00	14.78
51.00	14.13
63.00	10.59
81.00	7.69
93.00	4.95
125.00	3.18
151.00	1.52
165.00	1.01
188.00	1.23
207.00	0.89

Note: At 31 minutes, holes were drilled to perforate bottom of well casing.
- Large inflow of water noted.

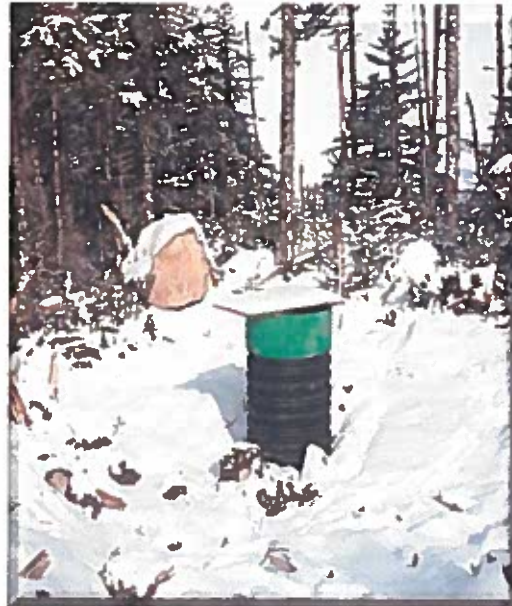
February 7, 2015

Static Water Level - 2.23m

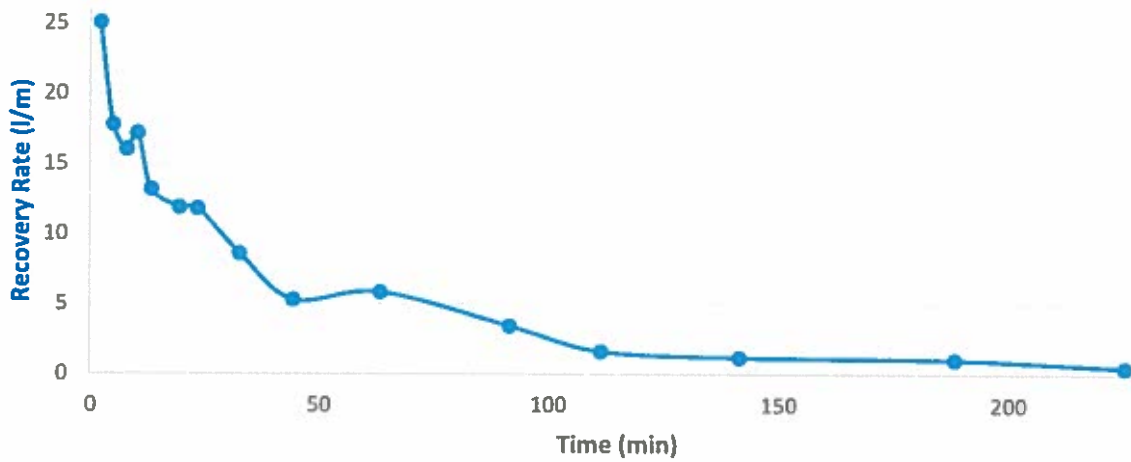
Time vs. Recovery Rate Ocean Pond Well #4

Time (min)	Recovery Rate (l/min)
2.14	25.09
5.00	17.79
8.00	16.01
10.30	17.20
13.30	13.19
19.47	11.91
23.30	11.81
32.50	8.60
44.20	5.31
63.20	5.85
91.20	3.43
111.20	1.62
141.20	1.19

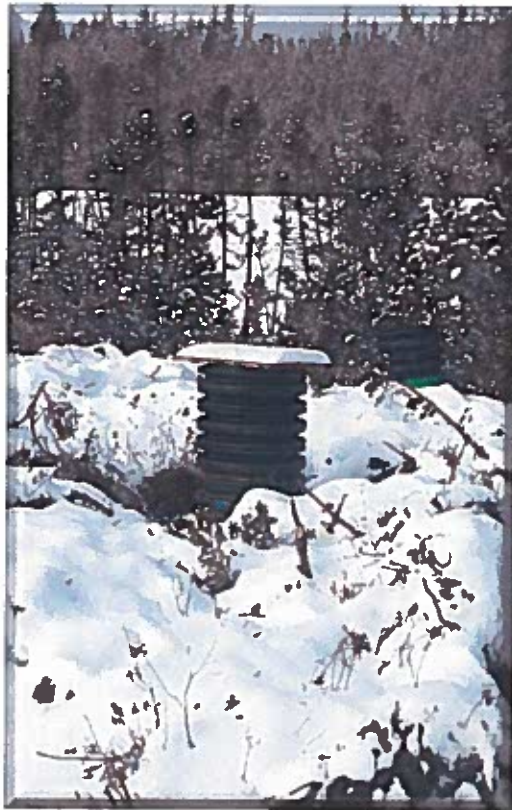
February 7th, 2015

Static Water Level - 2.045m

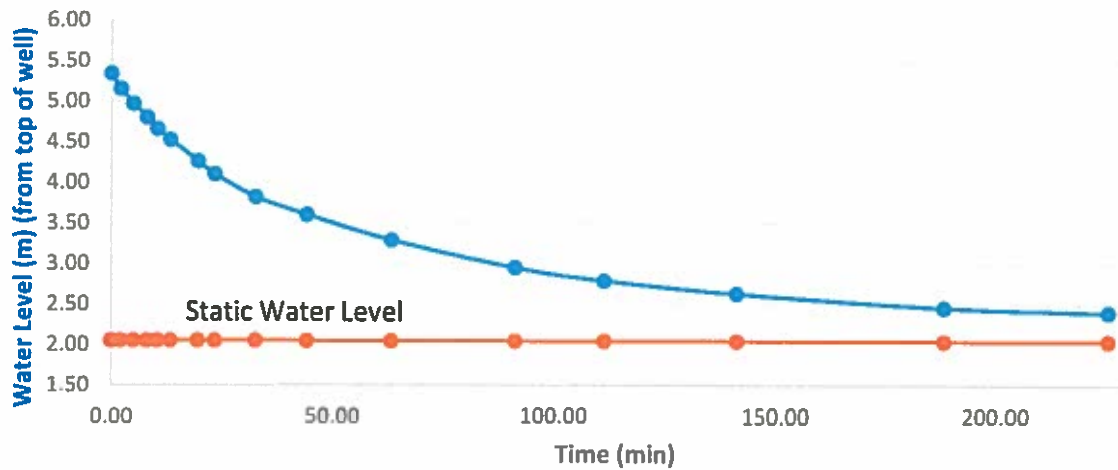
Time vs. Water Level (m) (from top of well casing) Ocean Pond Well #4

Time (min)	Water Level (m) (from top of well casing)
0.00	5.34
2.14	5.15
5.00	4.97
8.00	4.80
10.30	4.66
13.30	4.52
19.47	4.26
23.30	4.10
32.50	3.82
44.2	3.60
63.20	3.29
91.20	2.95
111.20	2.79
141.20	2.63

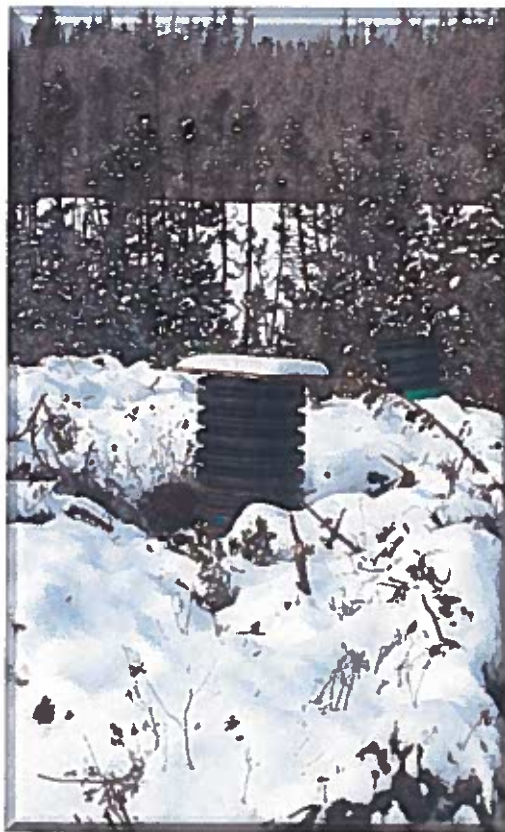
February 7th, 2015

Static Water Level - 2.045m

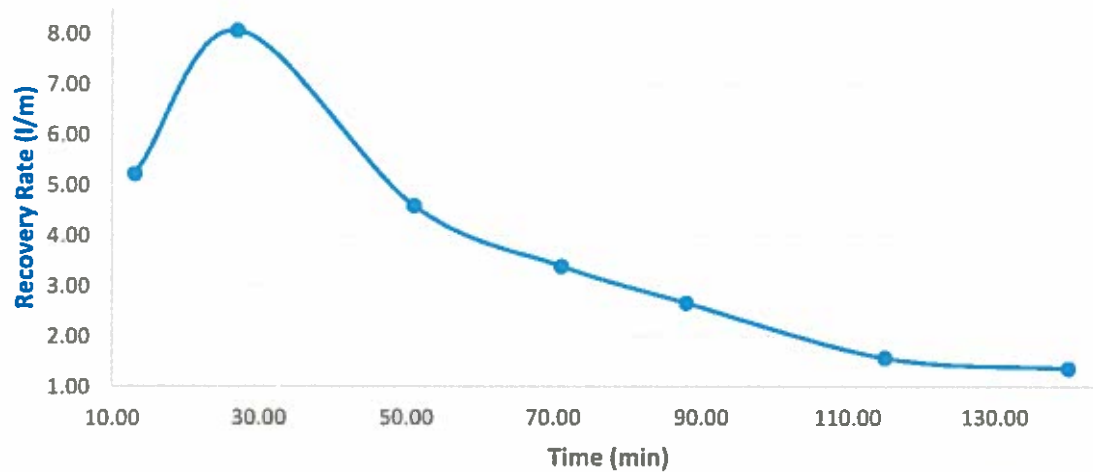
Time vs. Recovery Rate (l/m) Ocean Pond Well #5

Time (min)	Recovery Rate (l/m)
0.00	0.00
13.00	5.22
27.00	8.07
51.00	4.59
71.00	3.39
88.00	2.66
115.00	1.57
140.00	1.36

Note: Very large flow encountered in the bottom of this well. Pumped continuously, for 40 minutes, at level 5.73 metres, but could not drop level below 5.73 metres.

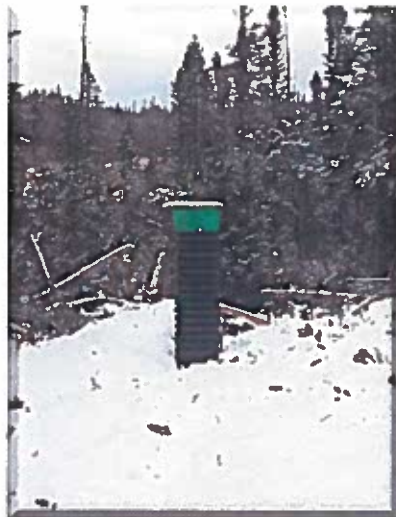
February 7th, 2015

Static Water Level - 3.76m

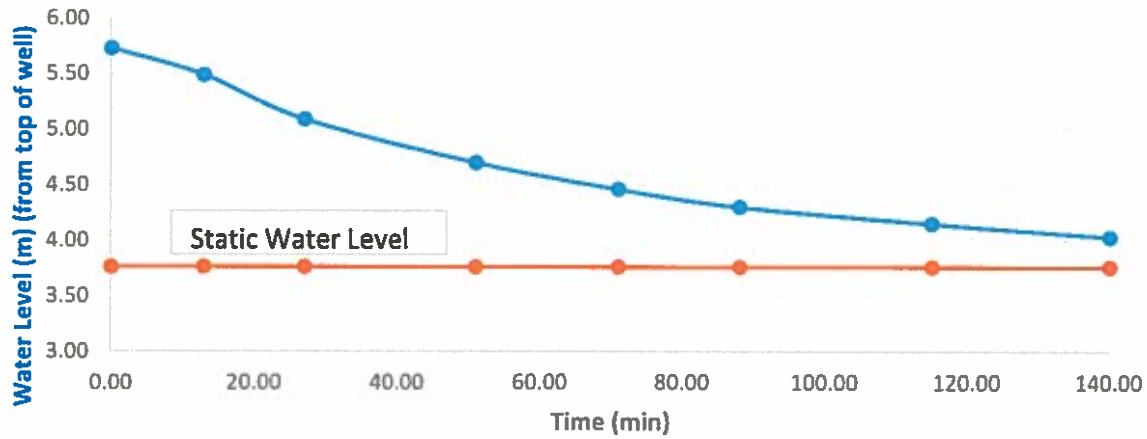
Time vs. Water Level Ocean Pond Well #5

Time (min)	Water Level (m) (from top of well casing)
0.00	5.73
13.00	5.49
27.00	5.09
51.00	4.70
71.00	4.46
88.00	4.30
115.00	4.15
140.00	4.03

Note: Very large flow encountered in the bottom of this well. Pumped continuously, for 40 minutes, at level 5.73 metres, but could not drop level below 5.73 metres.

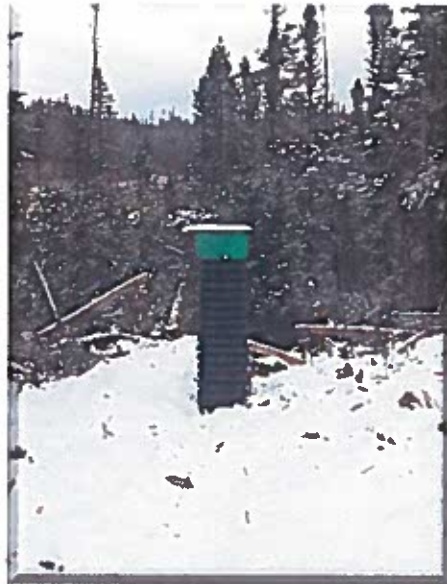
February 7th, 2015

Static Water Level - 3.76m
