Environmental Assessment Registration  
File Ref No. 200 20 2489

**NAME OF UNDERTAKING:** Replacement of St. Vincent's Breakwater

(i) **Name of Corporate Body:** Town of St. Vincent's-St. Stephen's-Peter's River

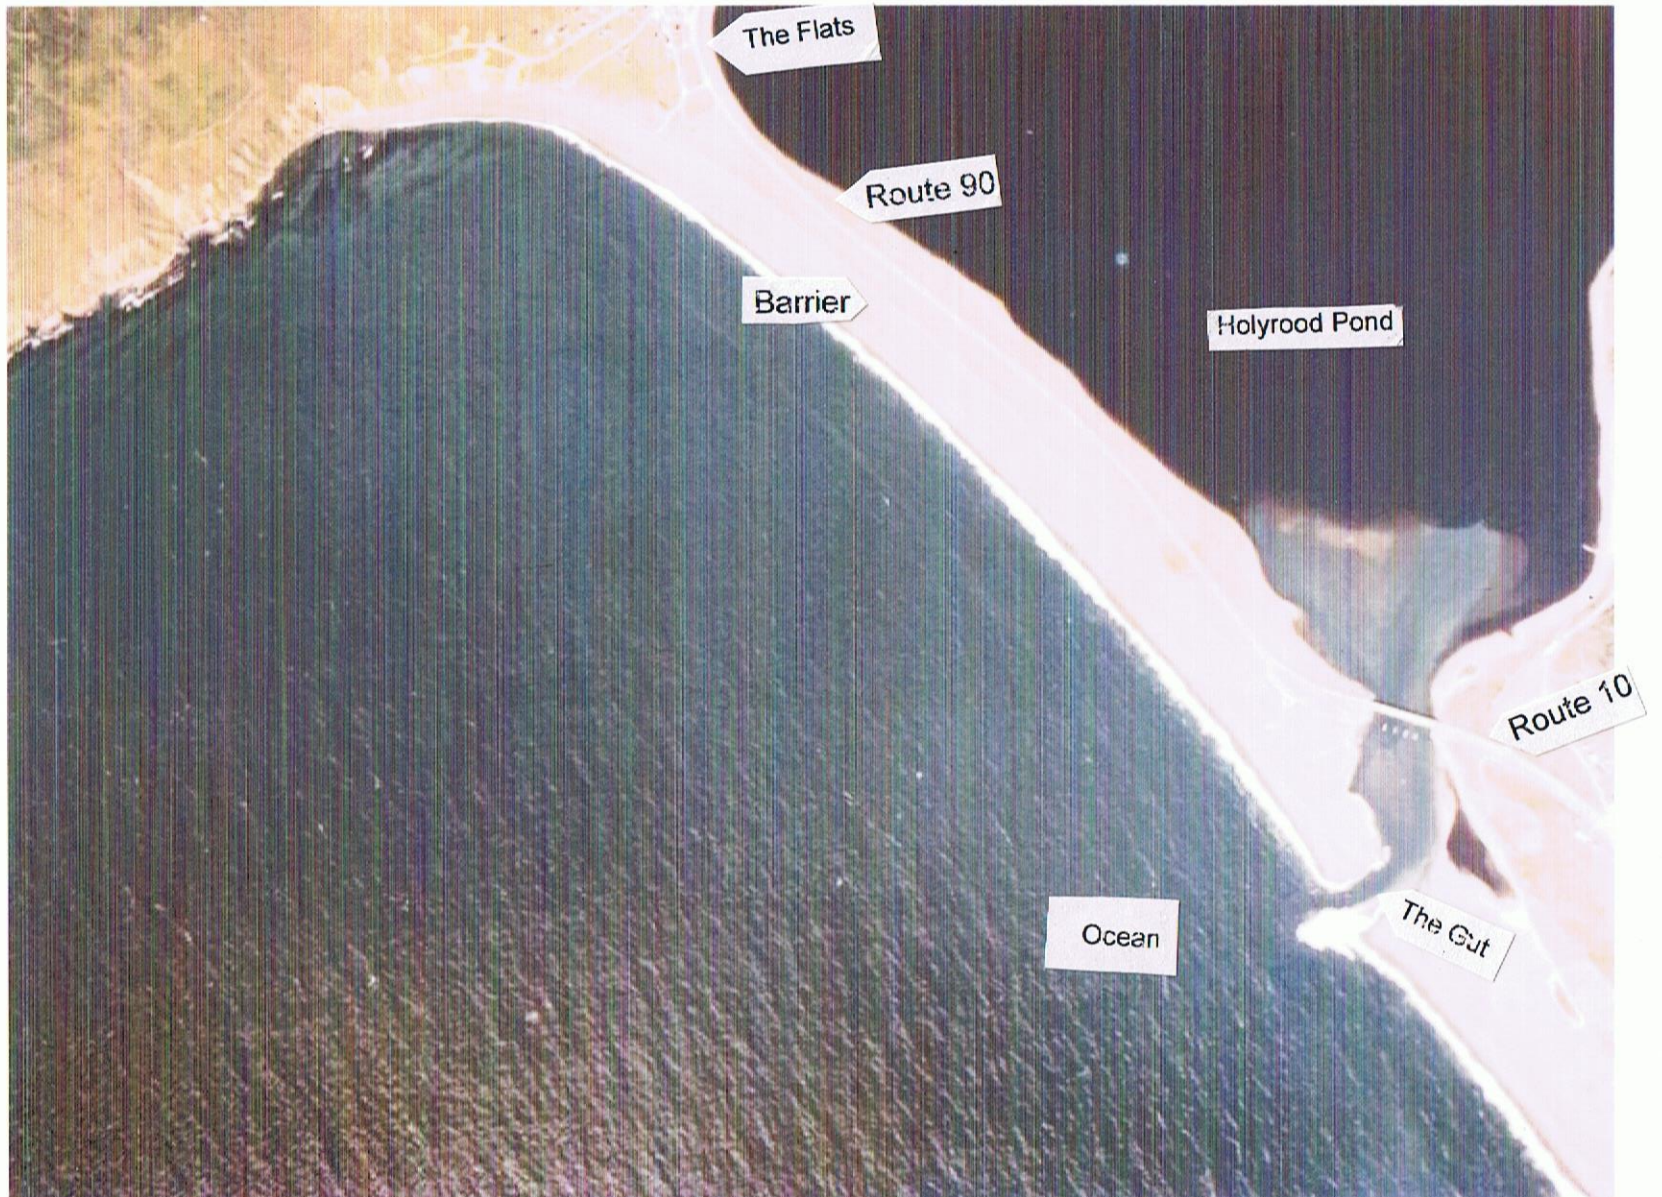
Fig.3 Barrier System from the open Gut to the Flats(2009)

- Figure 1. Map of the location of St. Vincent's on the Avalon Peninsula.
- Figure 2. Aerial Photo of the entire beach system from St. Vincent's to Peter's River.
- Figure 3. Barrier system from the open Gut to The Flats. (2009)
- Figure 4. Barrier system from the closed Gut to the Flats. (2008)

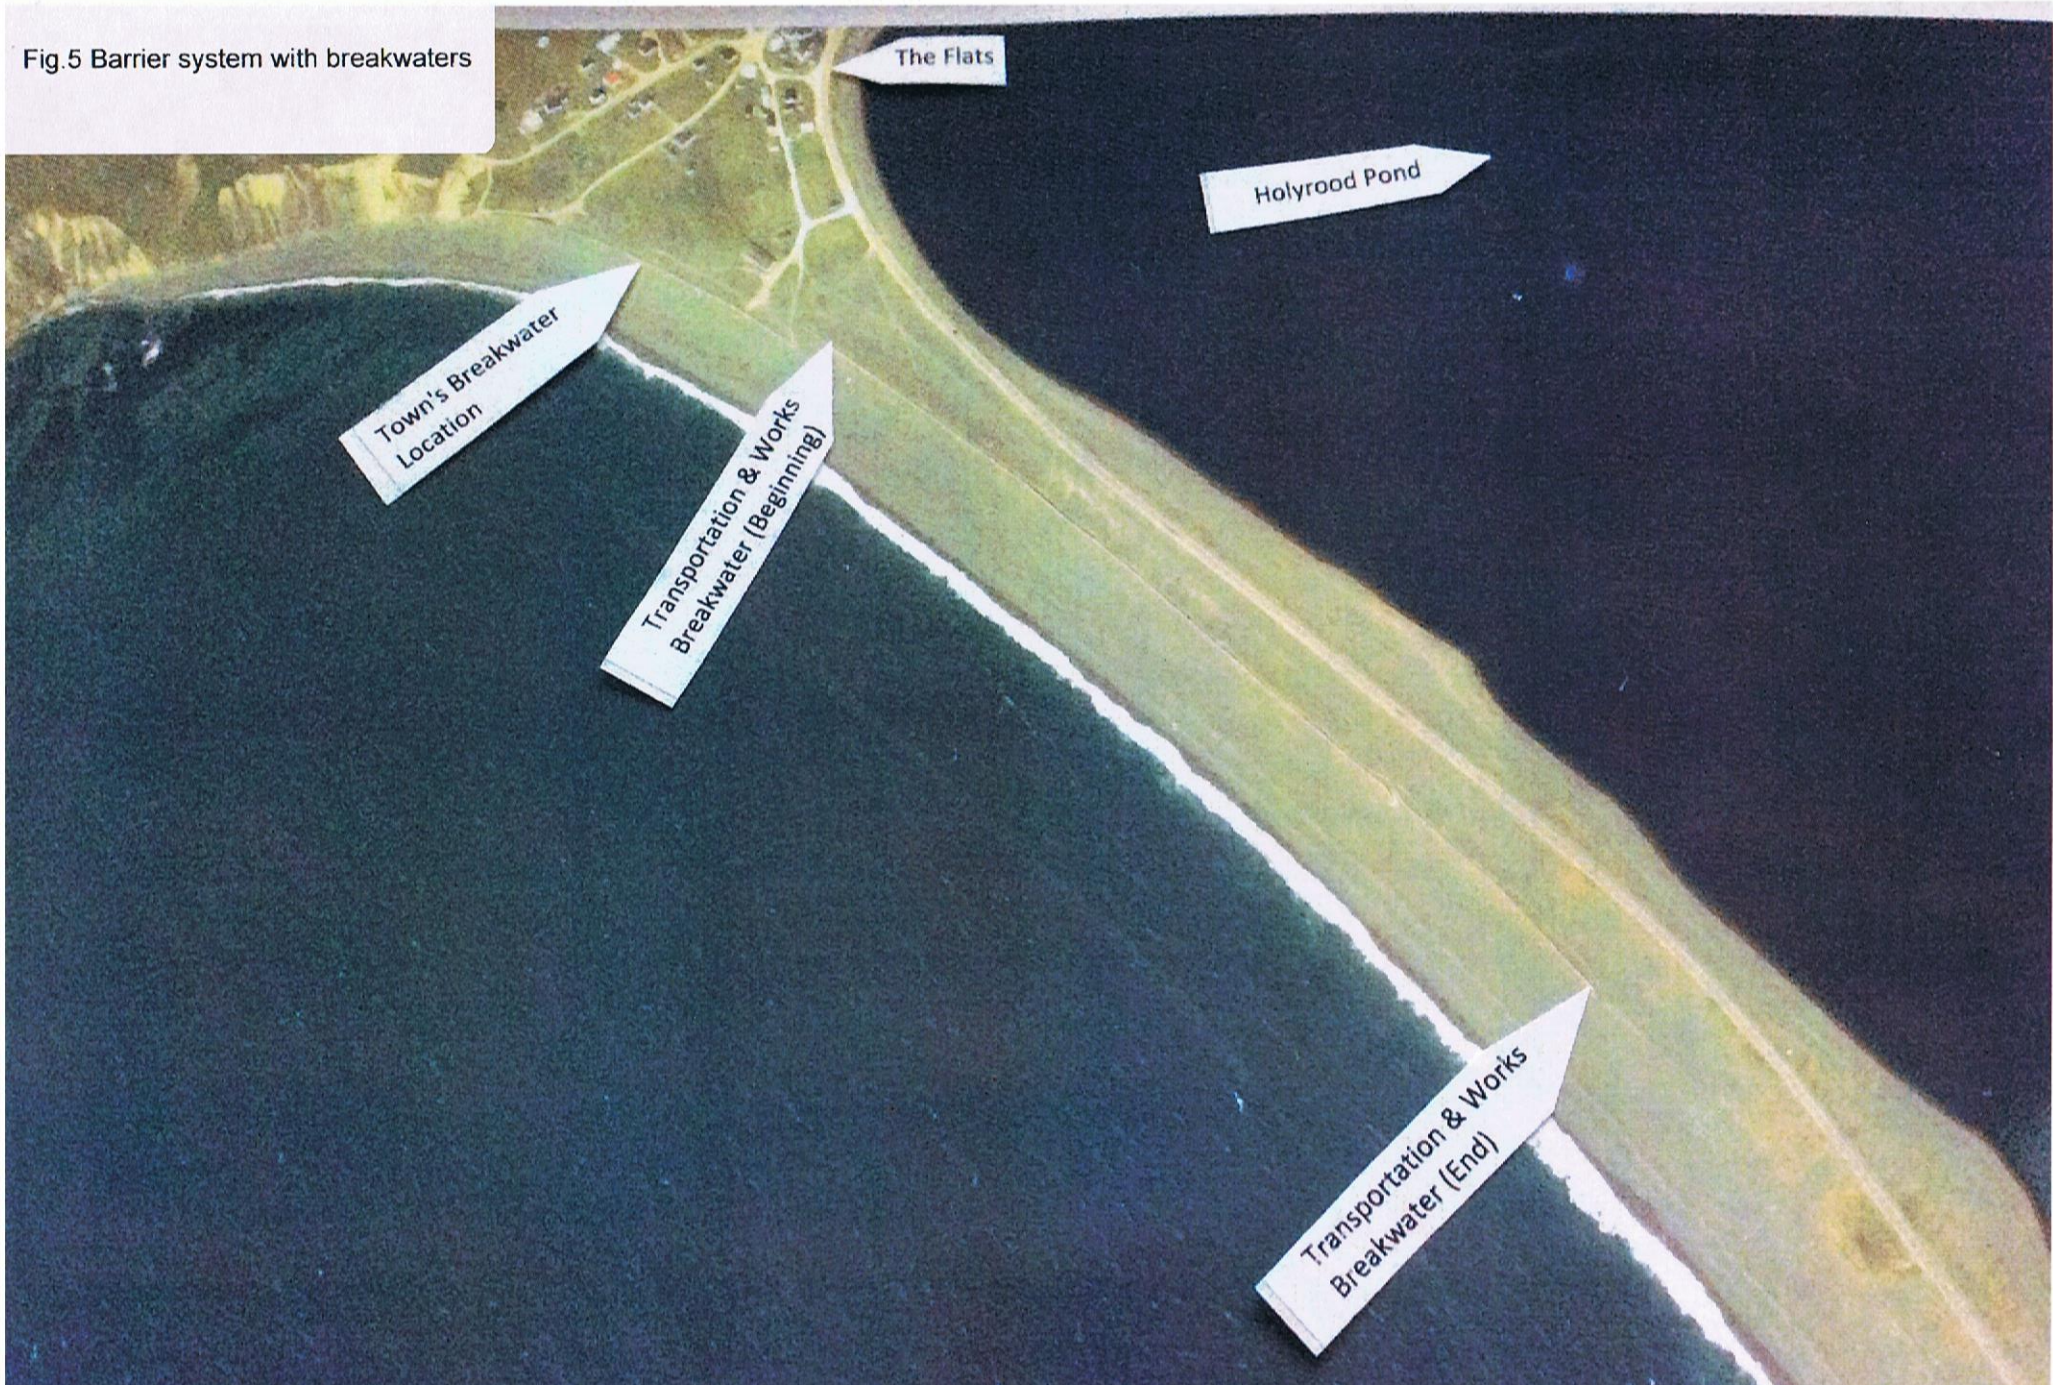
Fig.5 Barrier system with breakwaters

- Figure 5. Map of St. Vincent's beach indicating the Town's and the Dept. of Transportation's breakwaters.
- Figure 6. Aerial photo of opening between the Town's breakwater and the Dept. of Transportation's breakwater.

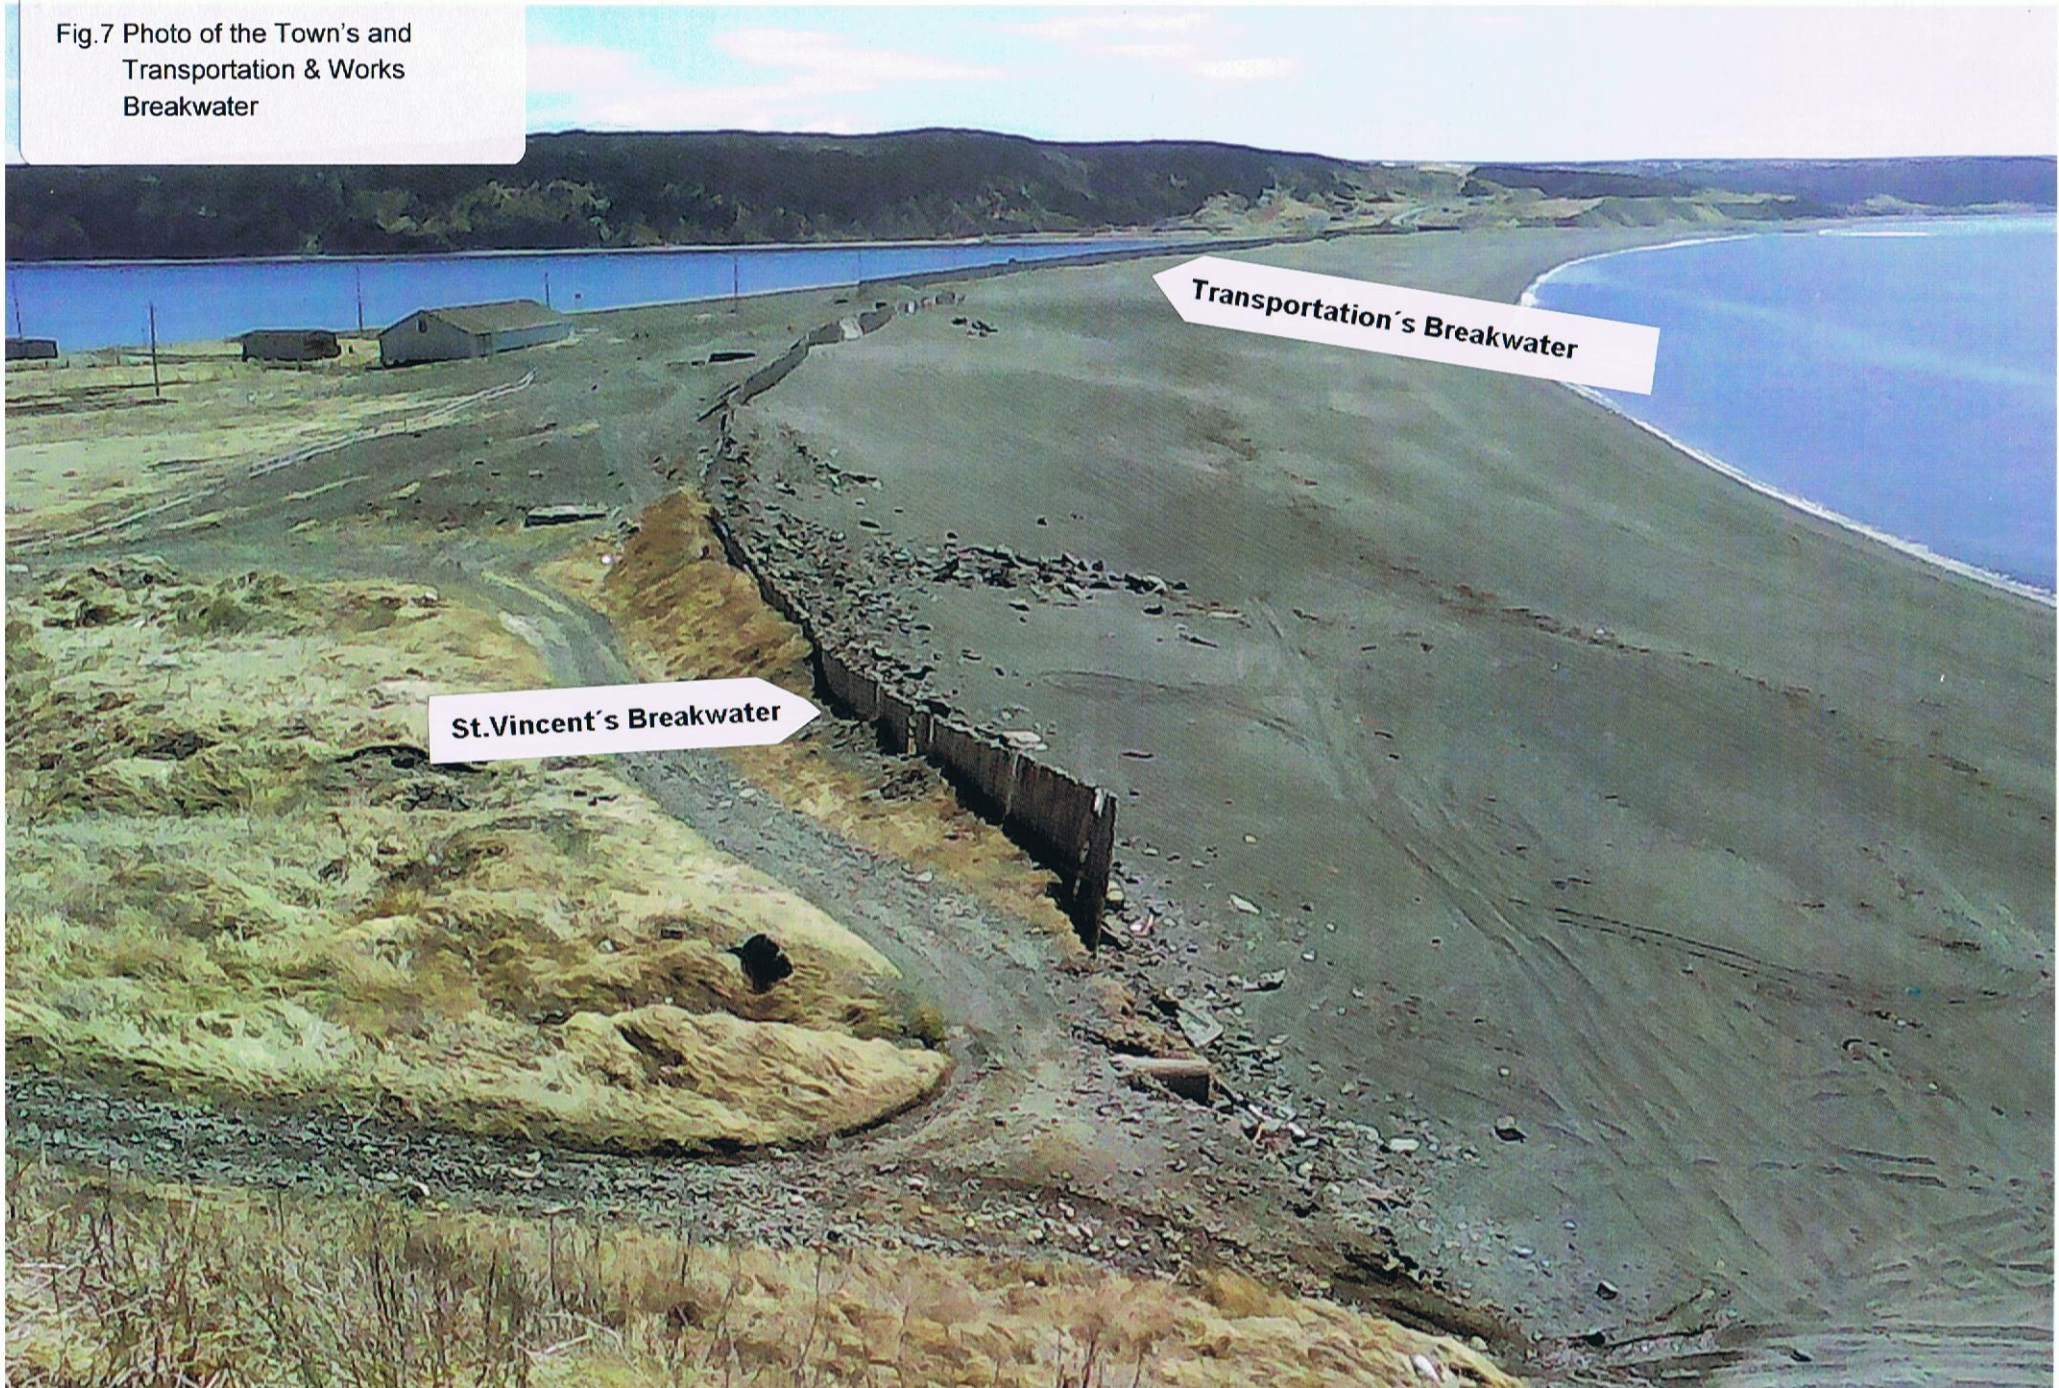
Fig.7 Photo of the Town's and Transportation & Works Breakwater

- Figure 7. Photo of the Town's breakwater and the Dept. of Transportation's Breakwater.
- Figure 8. Photo of high waves/storm surge on the entire beach. Please note the wave action on the Gut.

St. Vincent's Breakwater

Transportation's Breakwater

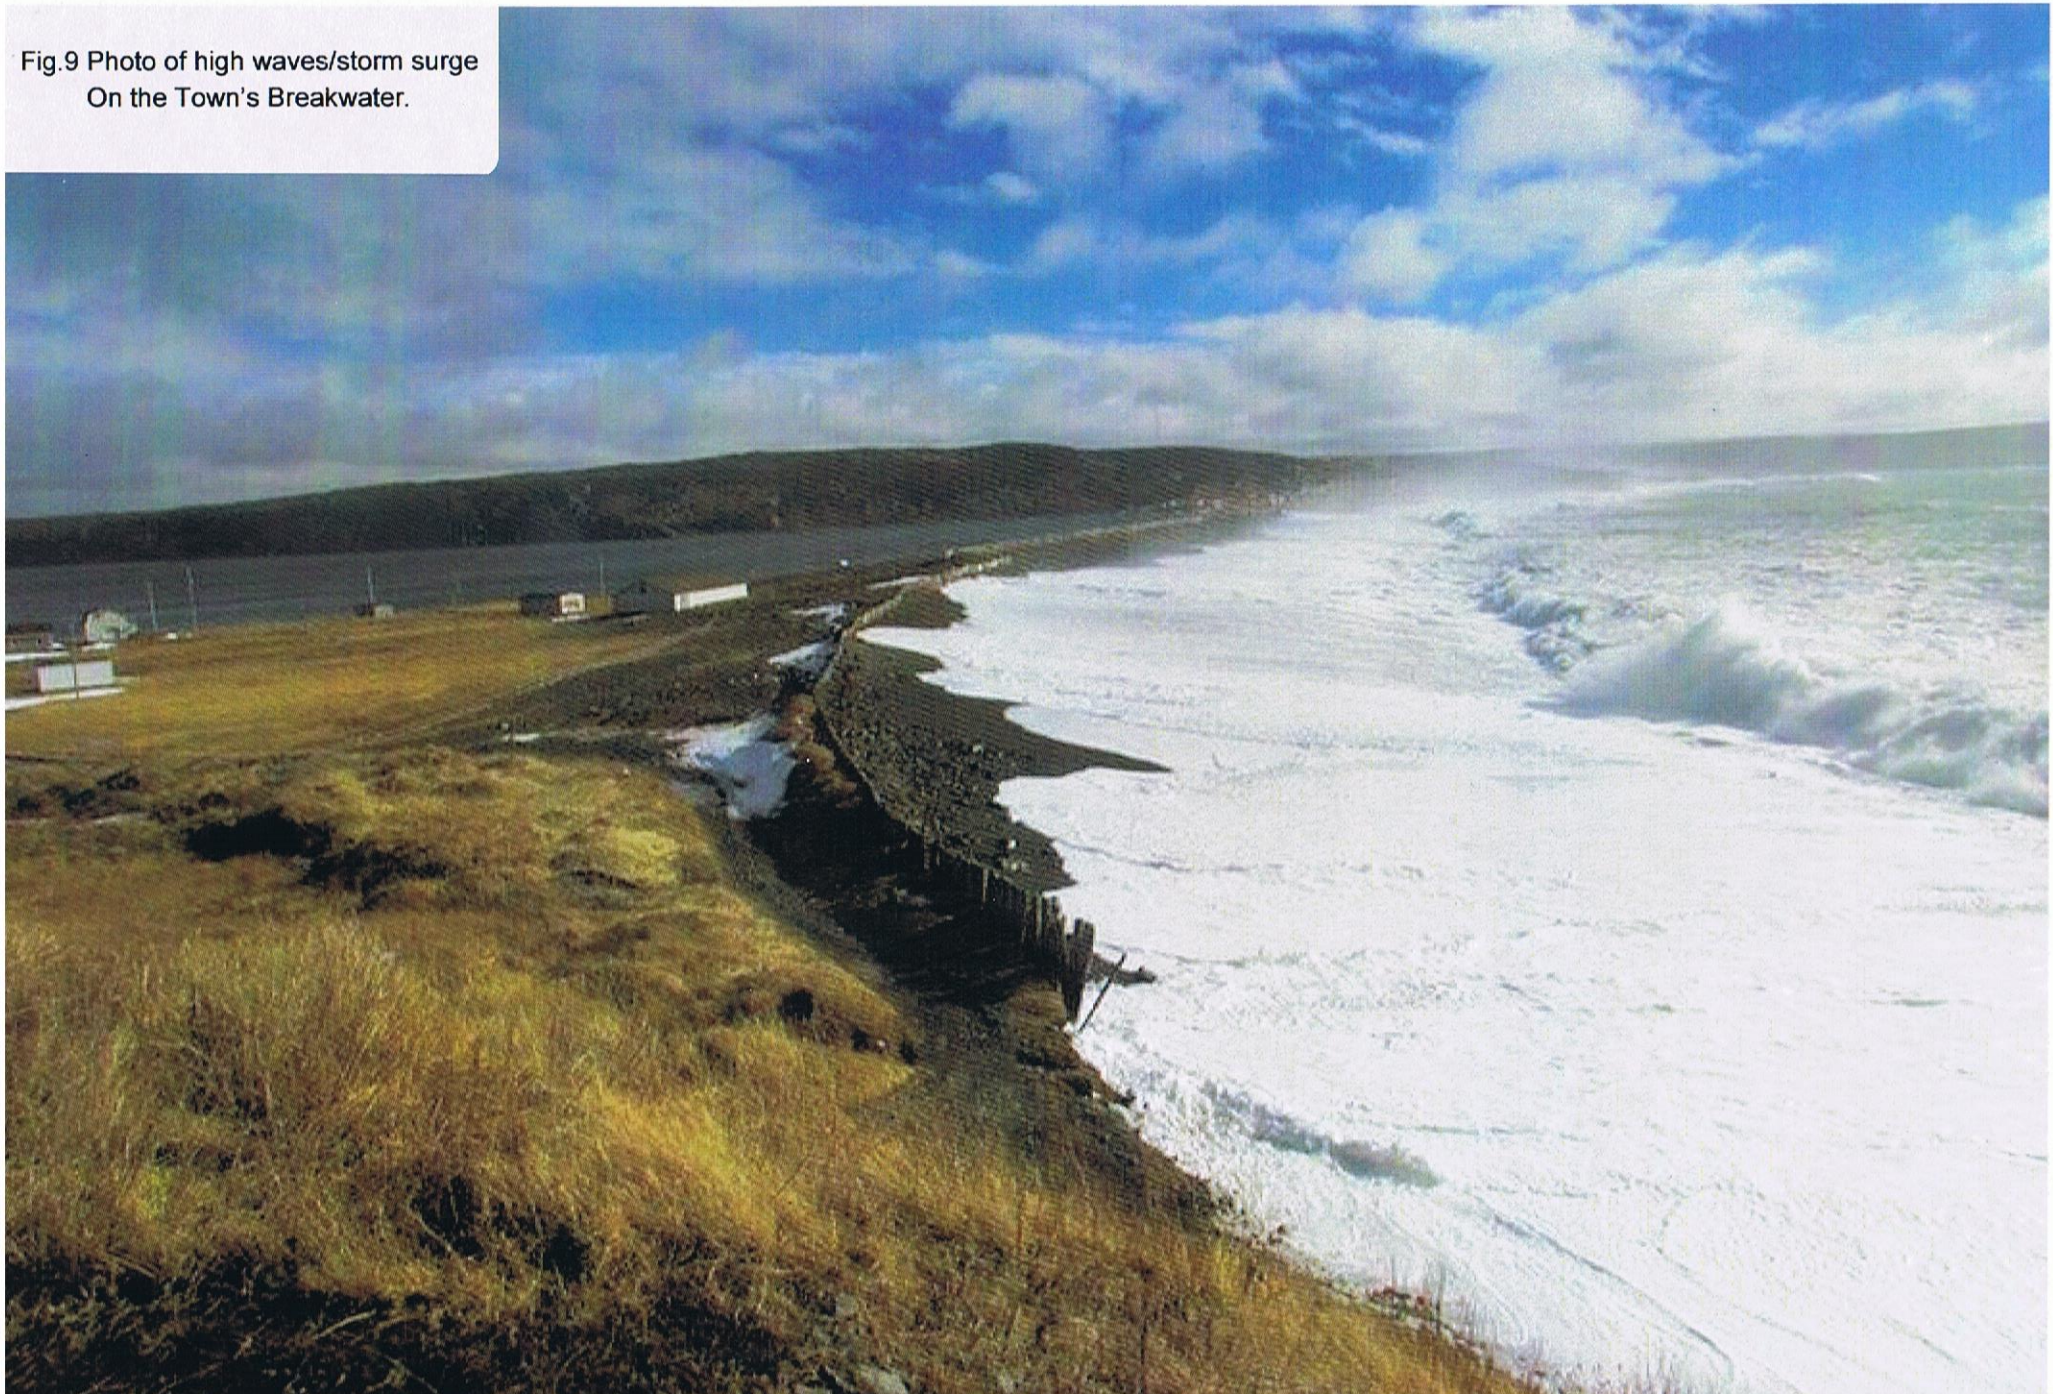
Fig.9 Photo of high waves/storm surge  
On the Town's Breakwater.

- Figure 9. Photo of high waves/storm surge on the Town's breakwater.
- Figure 10. Photo of high waves/storm surge on the Dept. of Transportation's Breakwater and the Gut.

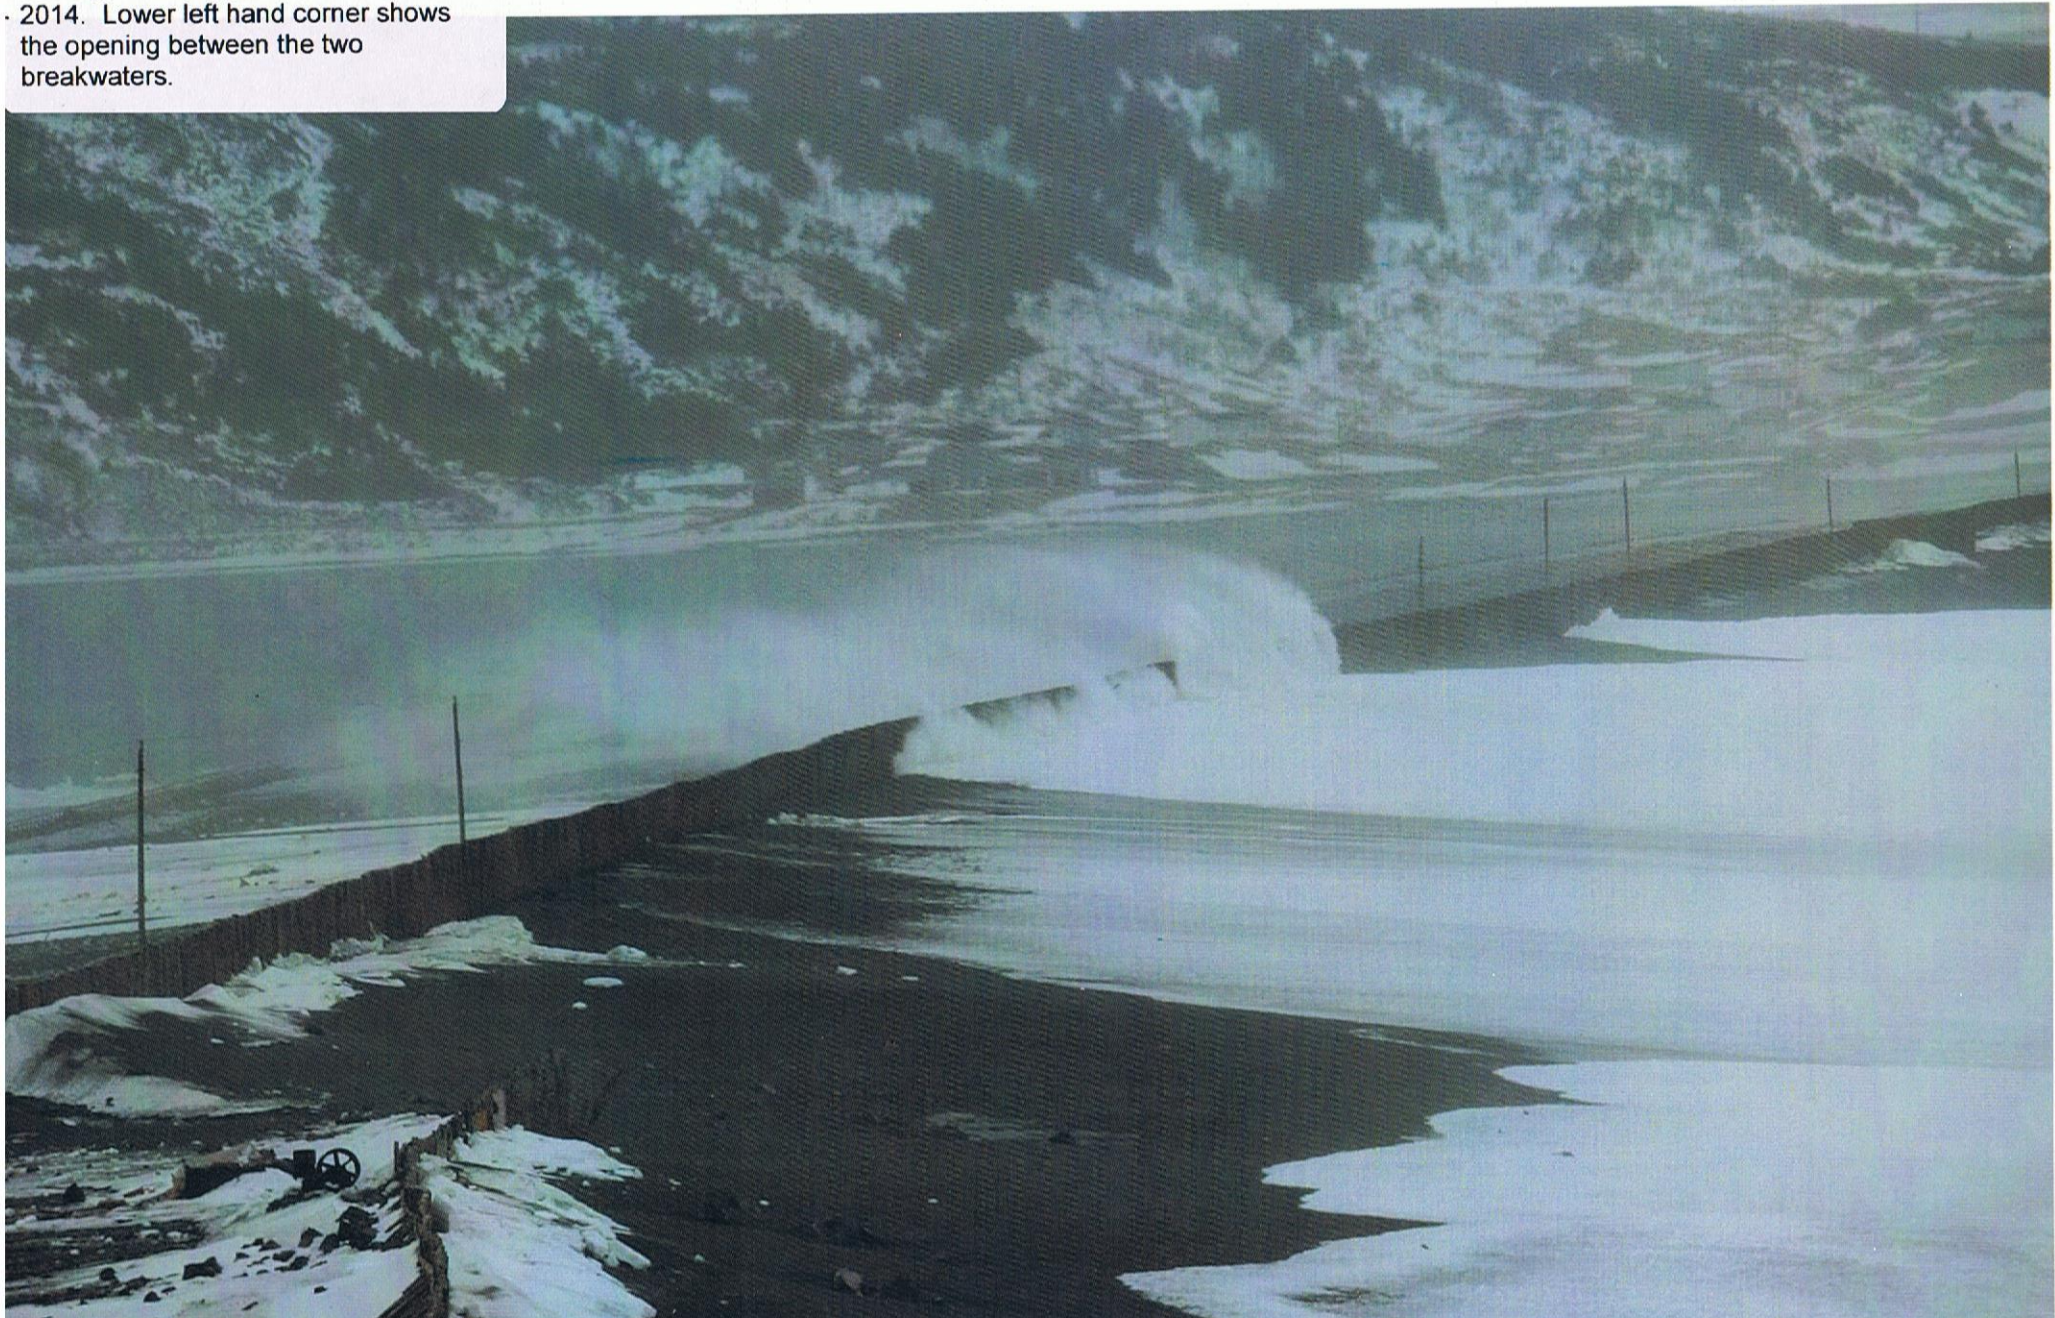
Fig.11 Photo of high waves going over the Highroads breakwater in March 2014. Lower left hand corner shows the opening between the two breakwaters.

- Figure 11. Photo of high waves going over the Dept. of Transportation's Breakwater in March, 2014.
- Figure 12. Photo of high waves going over the breakwater and damaging Route 90 in March 2014.

- (i) **Physical Features:** The major physical feature of the undertaking is that it is a wooden breakwater constructed with spruce timber. Access to the site is from Route 90 onto our local gravel road known as Boat Shed Road (Figure 6). There are no residents on this road. There is another breakwater on the St. Vincent's Beach that is the responsibility of the Department of Transportation and Works. It is also constructed from timber and runs from our breakwater to the bridge which is the end of Route 90 and the beginning of Route 10. There is an opening of 86ft between the Town's breakwater and the Department of Transportation's breakwater (Figure 6). When there are high seas the water sometimes comes in through this opening (Figure 11).

**Period of operation:** This is a permanent facility. The breakwater will provide protection for our residents and our Town's infrastructure from the destruction of high waves and storm surge. The Town will monitor the breakwater to correct any breaches that may occur in the structure. Special attention will be focused on the build up of sediment in front of the breakwater as this allows waves to run up and over the breakwater (Figure 11).

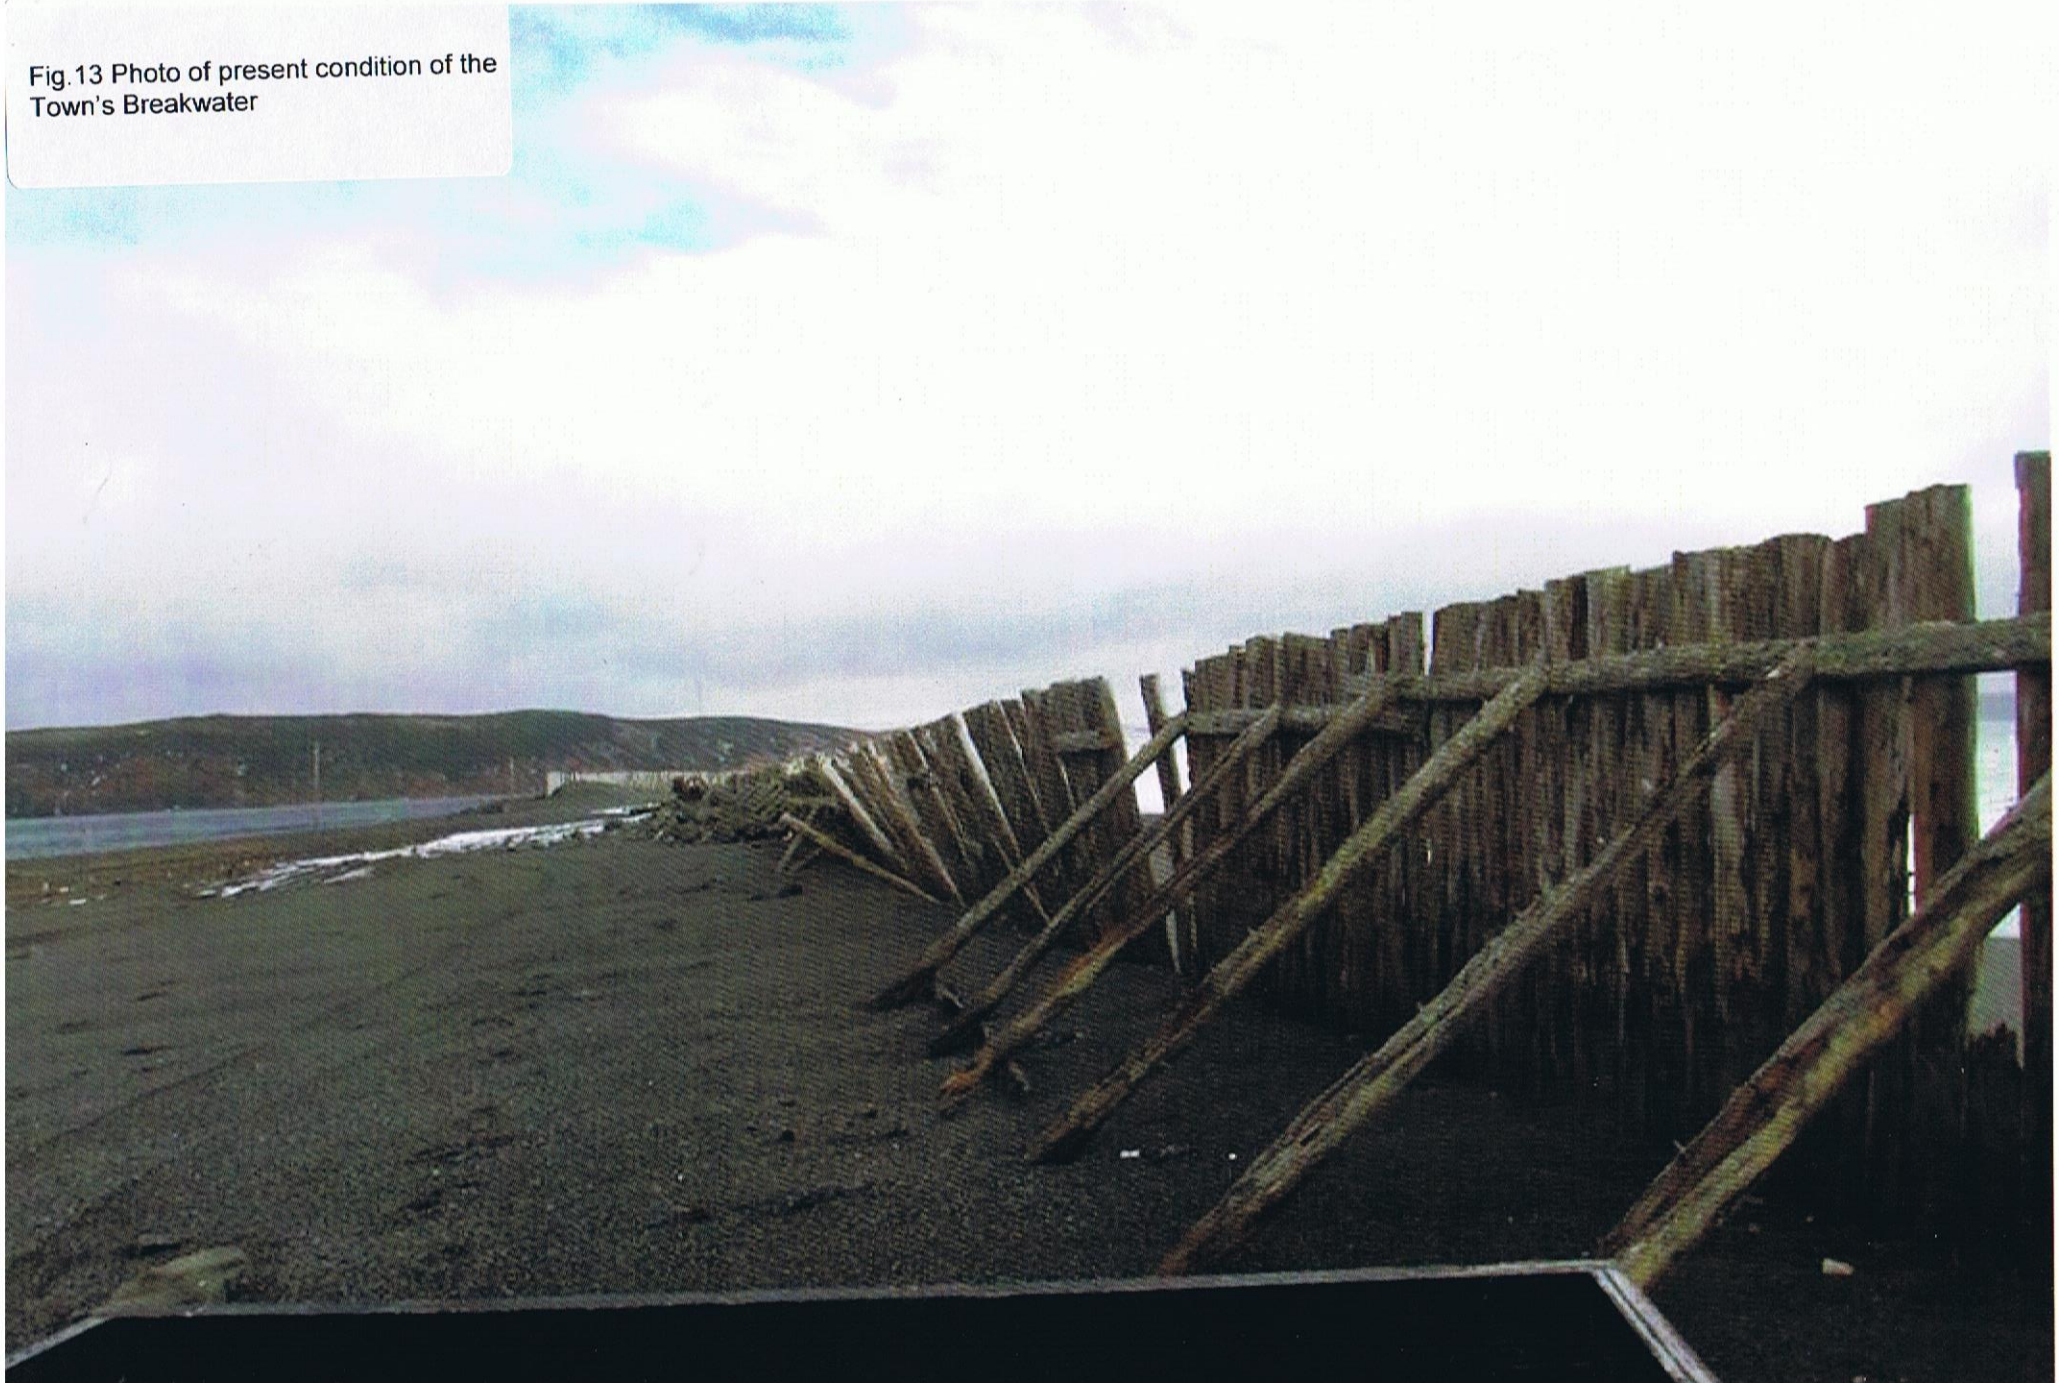
Fig. 13 Photo of present condition of the Town's Breakwater

- Figure 13. Photo of present condition of the Town's breakwater.
- Figure 14. Drawing of the proposed new breakwater.

- (i) **Name of Undertaking:** Replacement of St. Vincent's Breakwater
- (ii) **Purpose/Rationale/Need for the undertaking:** The existing breakwater has been there for 40+ years and is in disrepair (Figure 13). It is constructed of spruce timber. When we have strong winds, high waves and storm surge, the ocean water washes over and between the breakwater, threatening the fourteen homes that are in the direct path of the potential flooding. There is also a boatshed owned by the Fishermen's Committee and two local roads owned by the Town that can and have been damaged by high seas. When there is a storm surge and high seas with the waves reaching and going through the breakwater there has been flooding of our local roads, Beach Road and Boat Shed Road,(Figure 6) and destruction of parts of the breakwater with a lot of the actual sticks being broken down and washed away. (Figure 13)

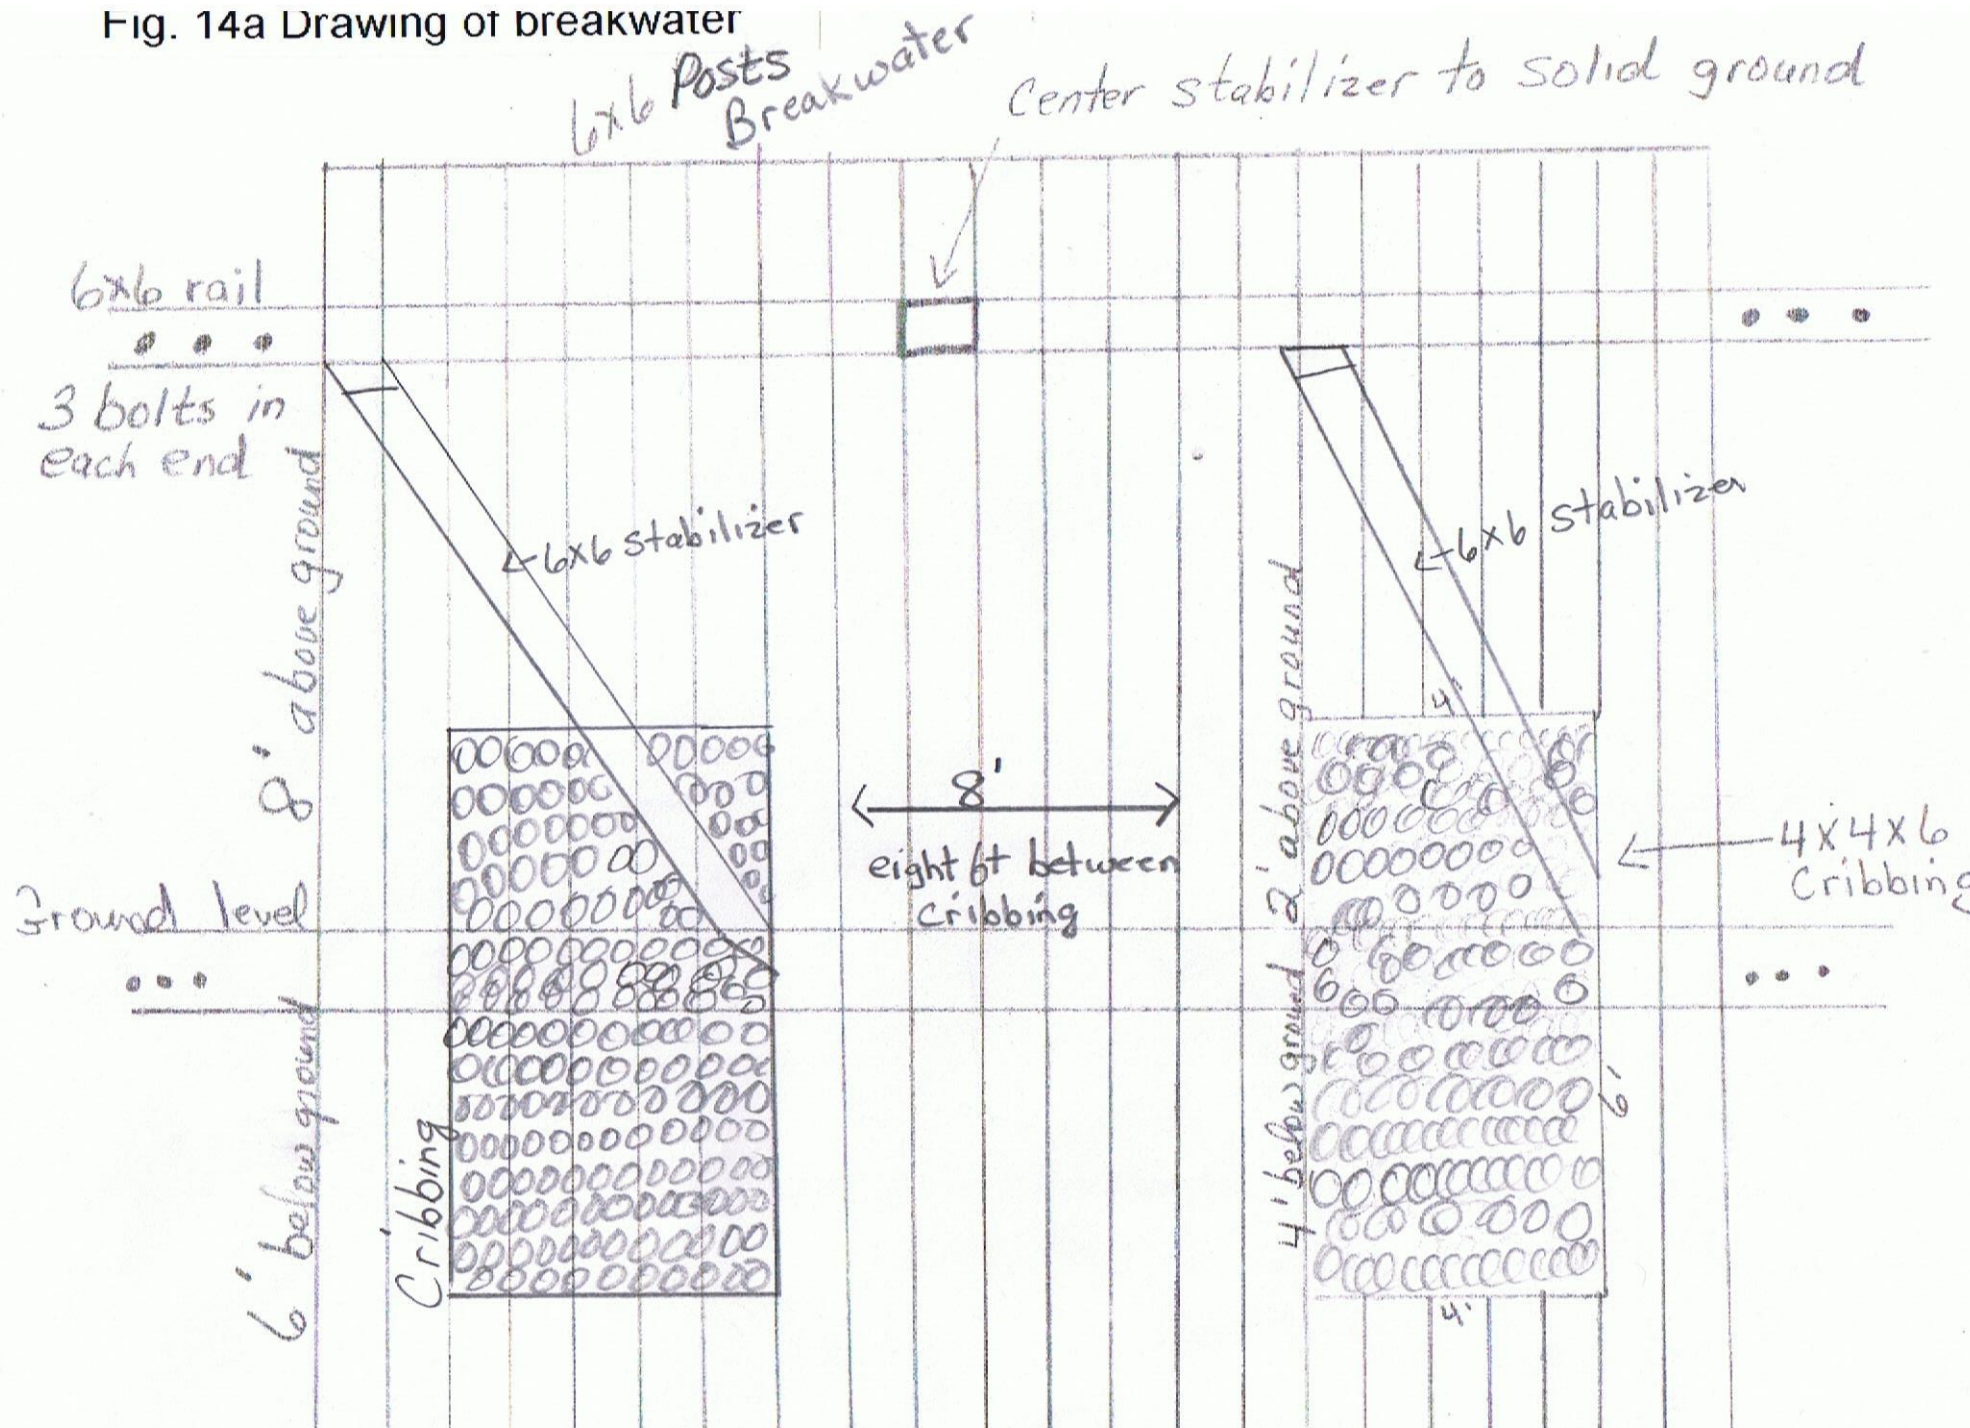
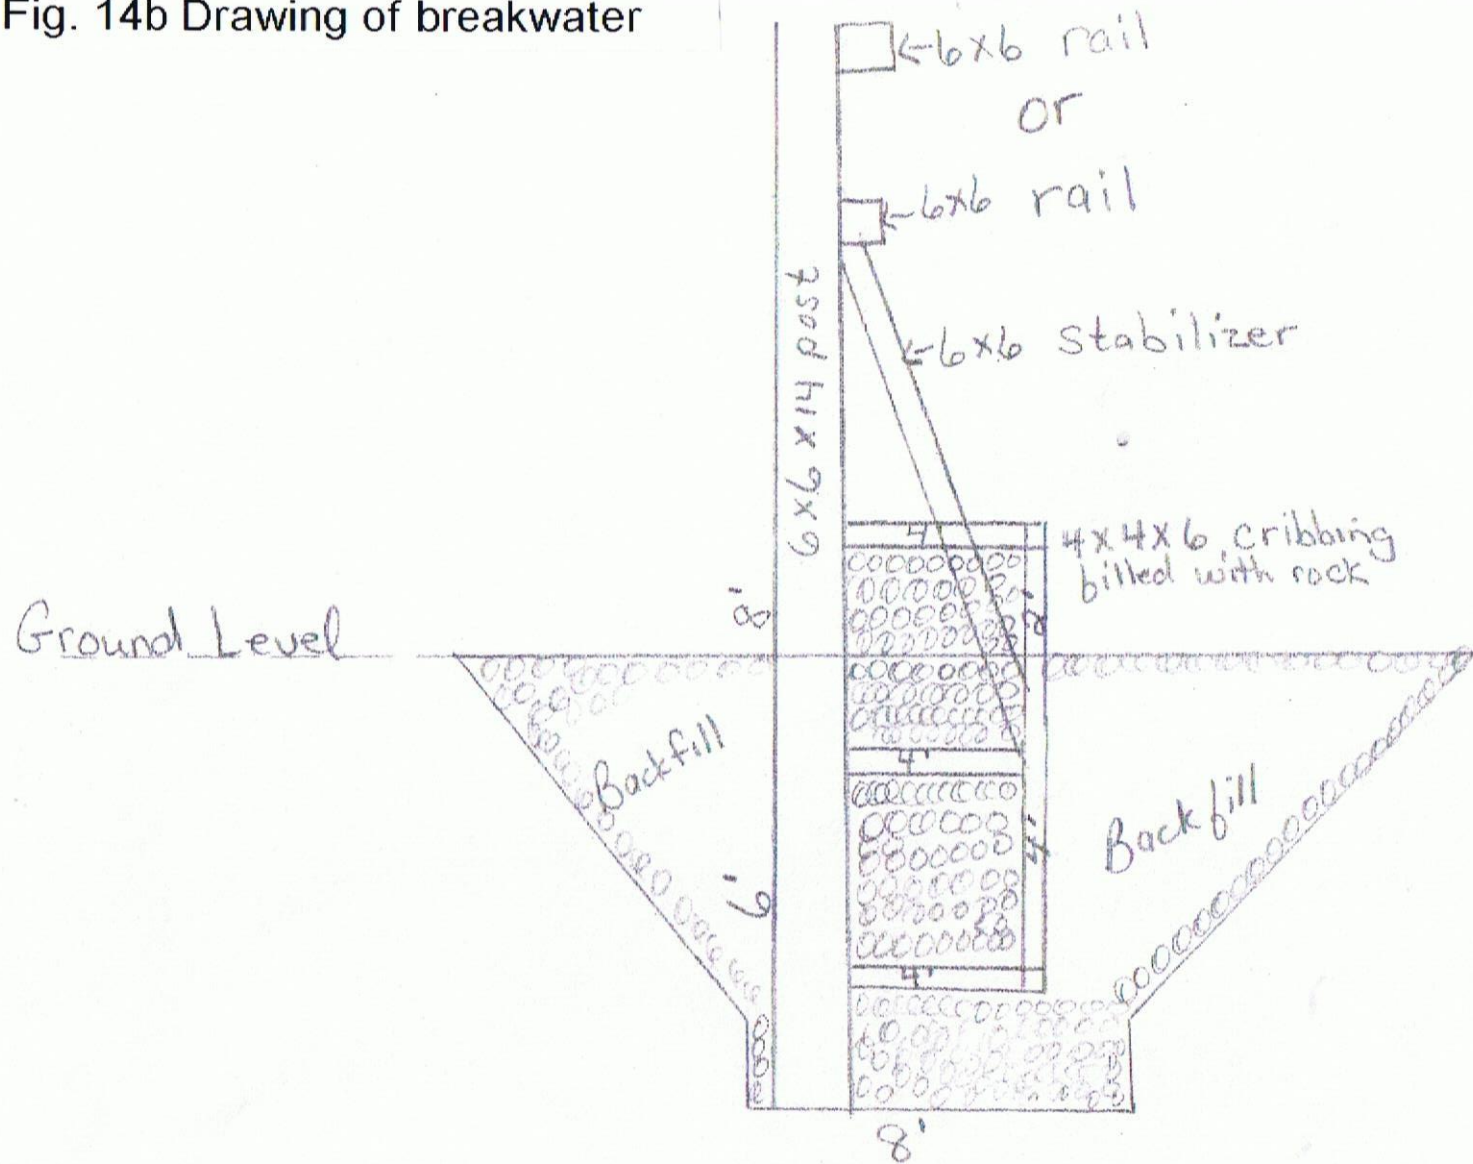
Fig. 14a Drawing of breakwater

(Figure 14) There will be a rock base in the bottom of the trench. The 14ft. 6x6 breakwater posts will be 6ft. underground and 8ft. above ground. 4x4x6 cribbing will be placed in the trench every 8ft to stabilize the breakwater. The cribbing will be 2ft. above ground and 4ft. below ground.

Not sure if we will be using 6x6x14 (salt water treated lumber) or black spruce 8" x 14 '
