ENVIRONMENTAL ASSESSMENT  
RagnaRöck Northern Brewing Company Ltd  
223-227 West St  
St Anthony, NL  
A0K4S0

**NAME OF UNDERTAKING:** RagnaRöck Northern Brewing Company Ltd, a Craft Brewery

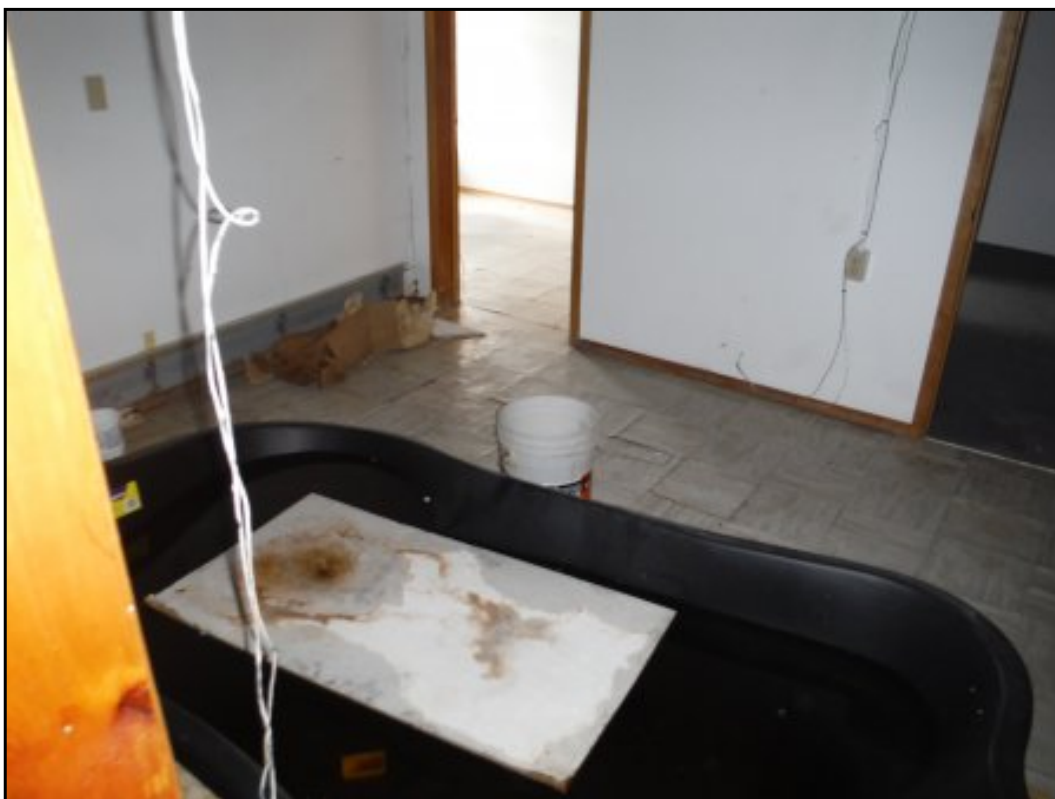
Evidence of water intrusion into the site building

- On-site concern: water damaged materials and suspected mould were observed throughout the site building. It was reported that the source of the water intrusion (i.e., leaks from the roof) has been remedied. Proper handling methodology should be used for water damaged materials and mould-impacted building materials in accordance with appropriate health and safety and environmental protocols including Mould Guidelines for the Canadian Construction Industry (CCA, 2004).

- On-site concern: water damage: water damaged materials and suspected mould were observed throughout the site building. It was reported that the source of the water intrusion (i.e., leaks from the roof) has been remedied. Proper handling methodology should be used for water damaged materials and mould-impacted building materials in accordance with appropriate health and safety and environmental protocols including Mould Guidelines for the Canadian Construction Industry (CCA, 2004).

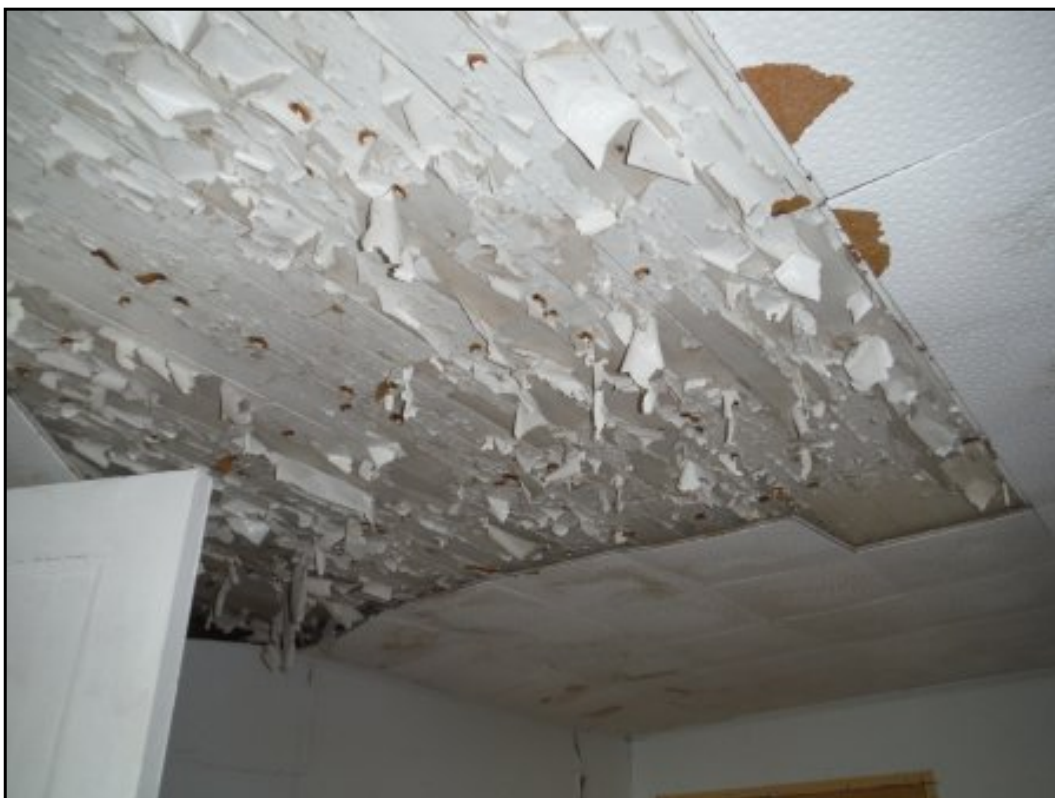
Based on the age of the site building, lead-based products may be present on the Site. Some potential lead-containing paints appeared to be in poor condition and flaking in some areas of the site building at the time of the site visit.

Evidence of water damage and peeling paint in the site building

- On-site concern: asbestos, lead, and PCB containing materials: a hazardous materials survey should be conducted to determine the presence or absence of asbestos, PCBs, and lead prior to any demolition or renovation of the site building. Suitable precautions and approved contractors should be used for all activities which may disturb hazardous materials.

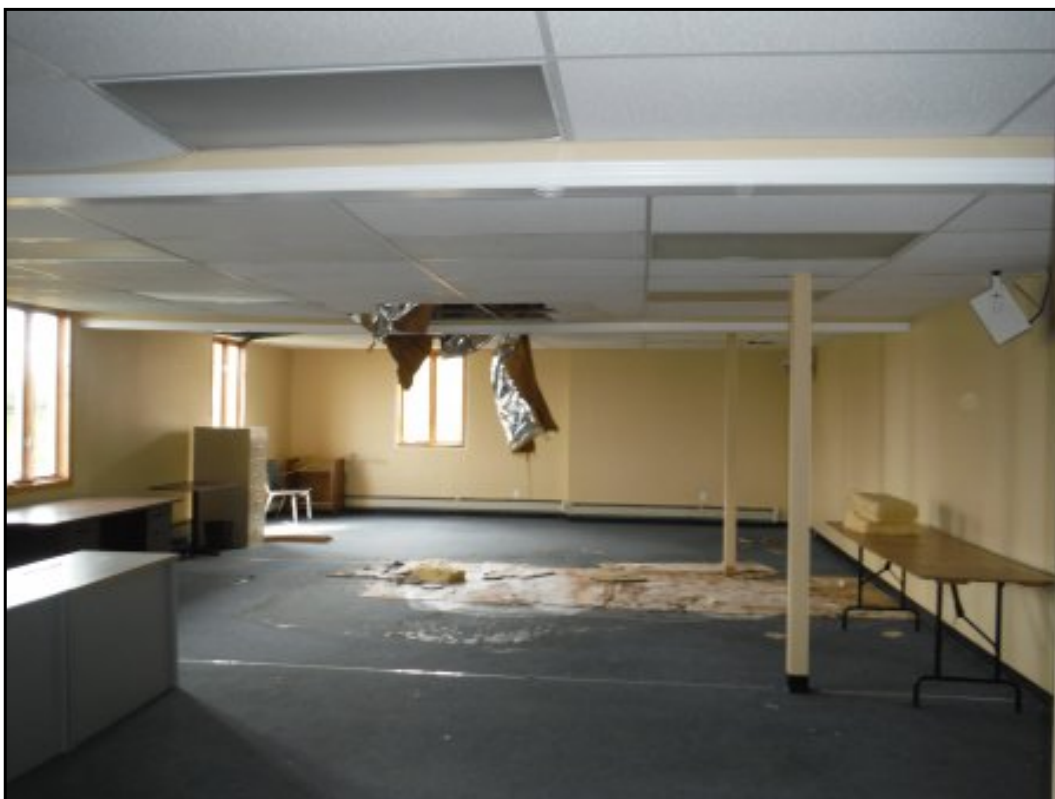
Water damaged materials in the former Academy Canada portion of the site building

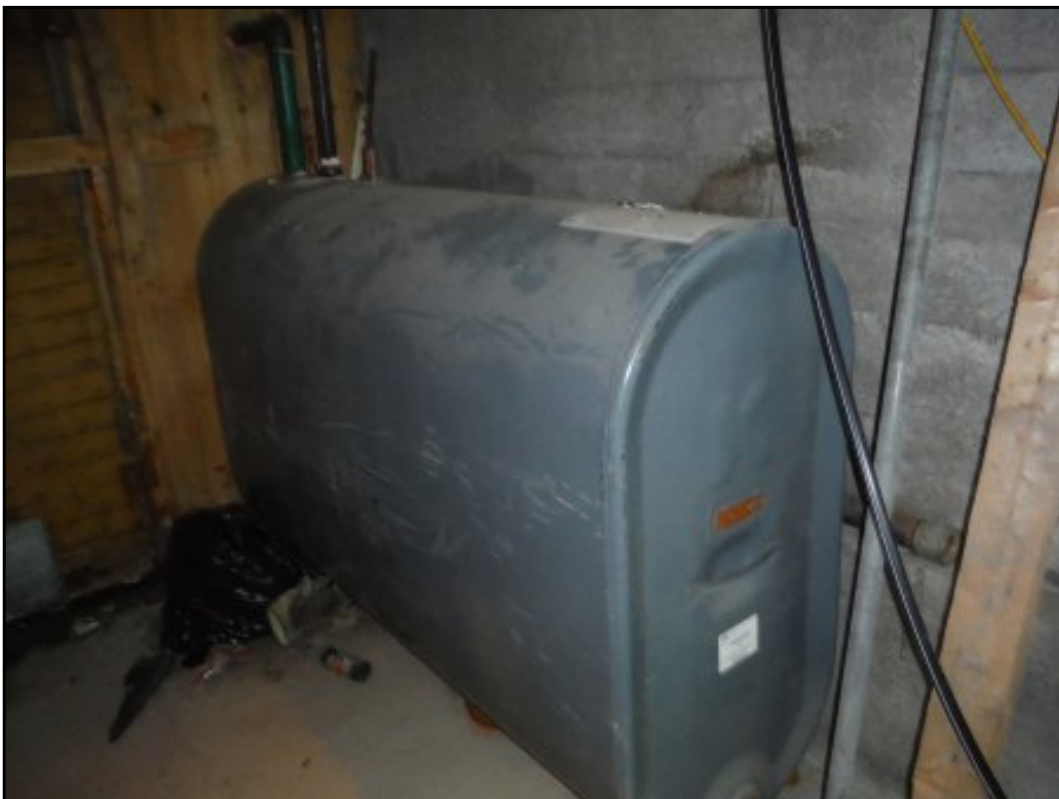
Two (2) ASTs are located in the basement of the site building. Both ASTs were reported to be empty, unused tanks that were reportedly previously used for storage of furnace oil to supply on-site boilers for heating purposes. The smaller of the two ASTs with an approximate capacity of 1,137 L appears to be in fair condition. The larger of the ASTs was observed to be supported with wood cribbing. No apparent staining on the concrete floor of the basement in the area of the ASTs was observed at the time of the site visit.

Inactive 1,137 L AST in the basement of the site building

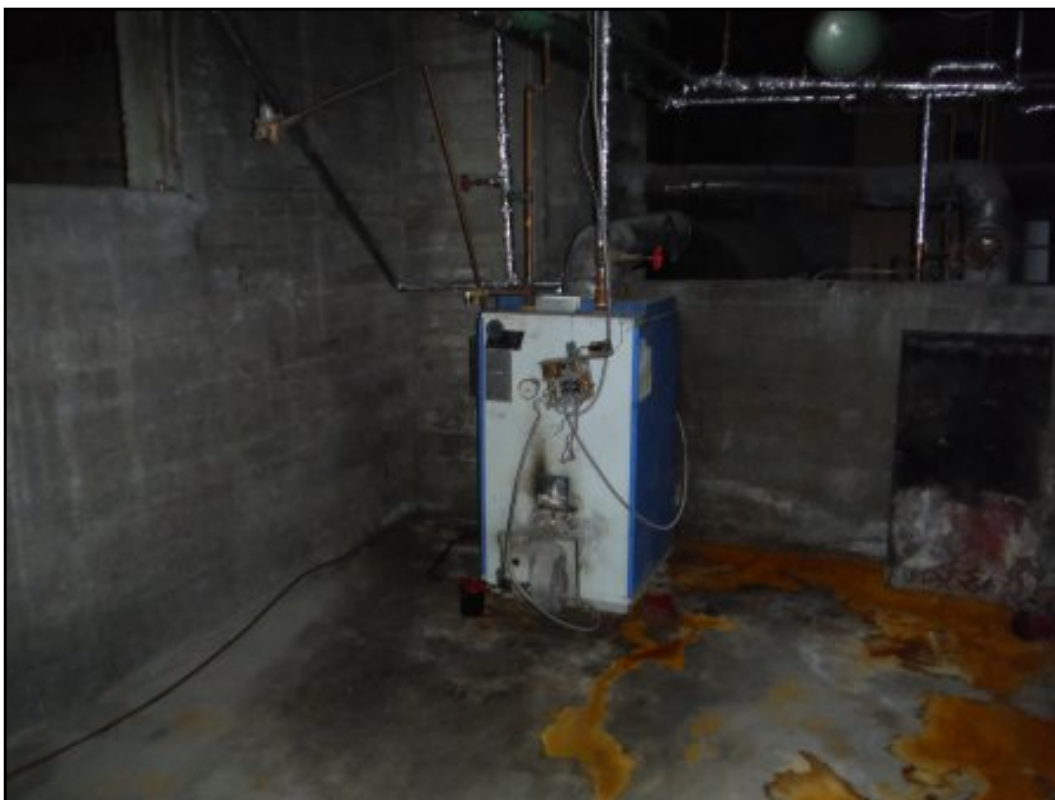
No heating or cooling systems are operational at the Site. Oil, electric, and wood heating equipment is located in the site building, but is not in use. Rust-like staining was observed on the concrete floor of the basement in the area of the furnaces.

Rust-like staining on the concrete floor of the site building

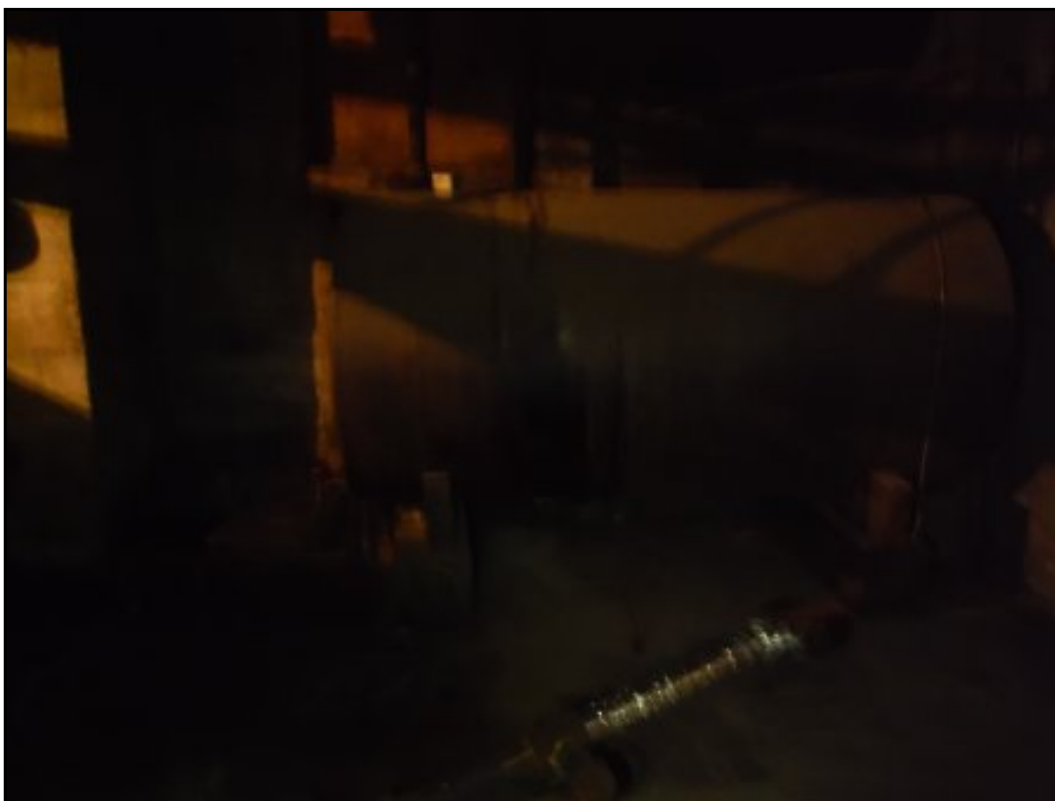
Old, inactive AST (unknown volume) in the basement of the site building

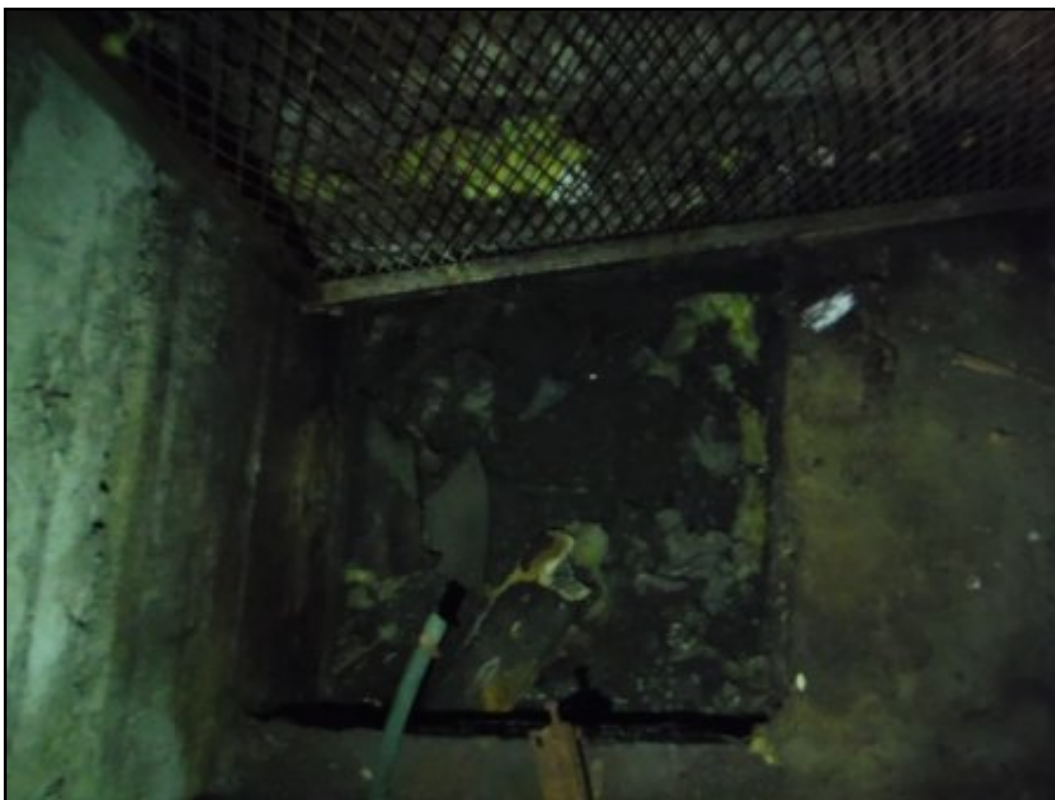
A dirt floor pit is located in the floor of the basement of the site building, adjacent to an inactive fuel storage tank. A metal grate covers the pit. No evidence of petroleum hydrocarbon surface staining was noted upon visual assessment of the pit. No other floor drains, sumps, septic systems, interceptors, or separators are identified on the Site. The presence of the dirt floor pit in the basement furnace room is a potential environmental concern for the Site.

Pit in floor of the basement of the site building, adjacent to the large AST

- On-site concern: a dirt floor pit is located in the concrete floor of the furnace room in the basement, adjacent to an inactive fuel storage tank. No field evidence of petroleum hydrocarbons was noted upon visual assessment of the pit. Sampling of the soil within the pit for petroleum hydrocarbons would be required to determine if potential environmental impacts are present within the pit.

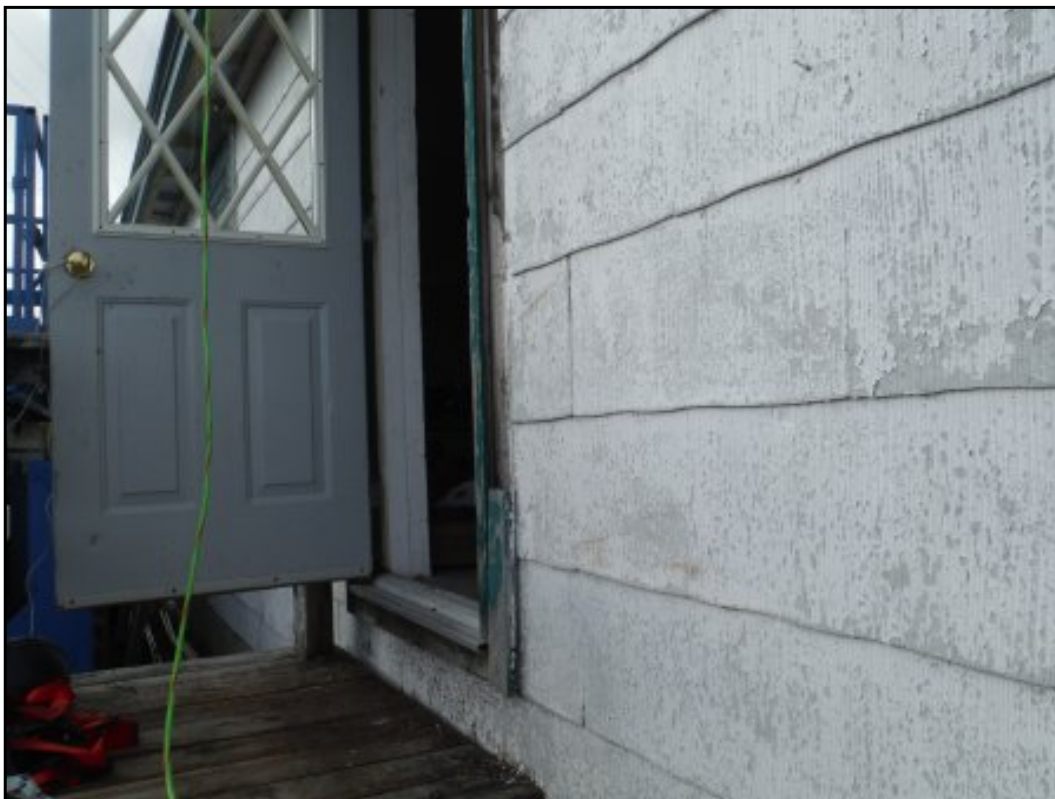
Based on the age of the site building, ACMs may be present on the Site. Potential ACMs observed (i.e., vinyl flooring, drywall joint compound and transite siding) appeared to be in good condition at the time of the site visit.

Potential asbestos-containing exterior siding on the southeast side of the site building

- On-site concern: asbestos, lead, and PCB containing materials: a hazardous materials survey should be conducted to determine the presence or absence of asbestos, PCBs, and lead prior to any demolition or renovation of the site building. Suitable precautions and approved contractors should be used for all activities which may disturb hazardous materials.

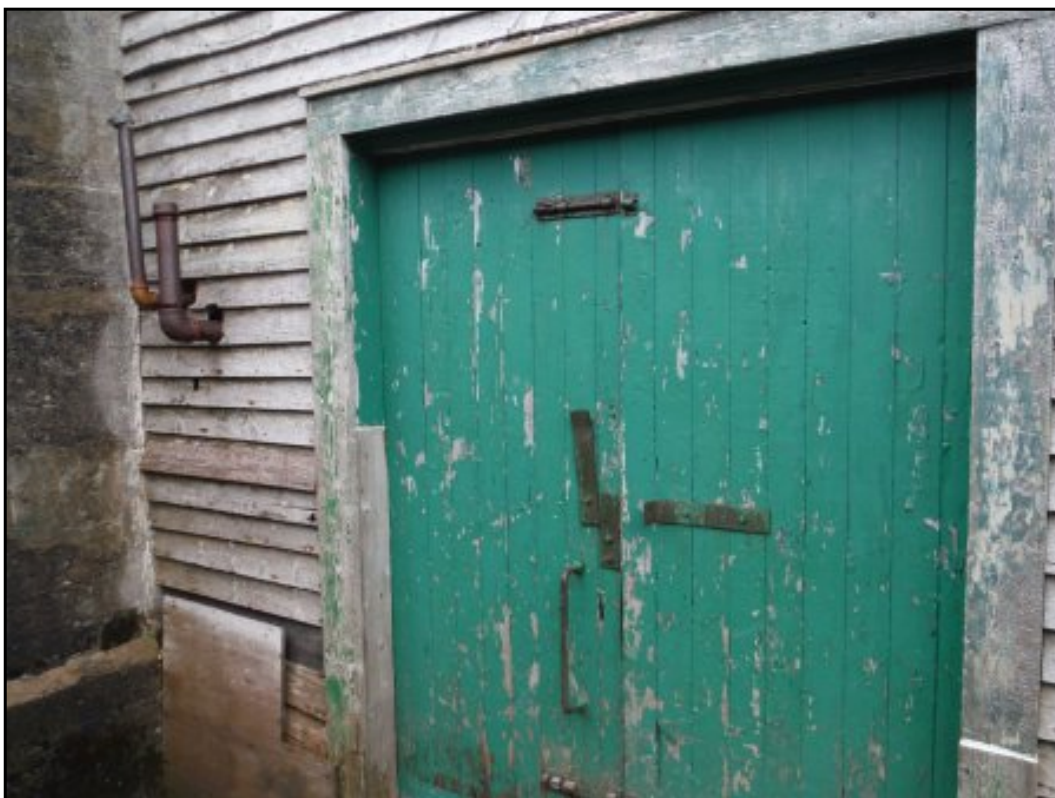
Fill and vent pipes on the north wall of the site building

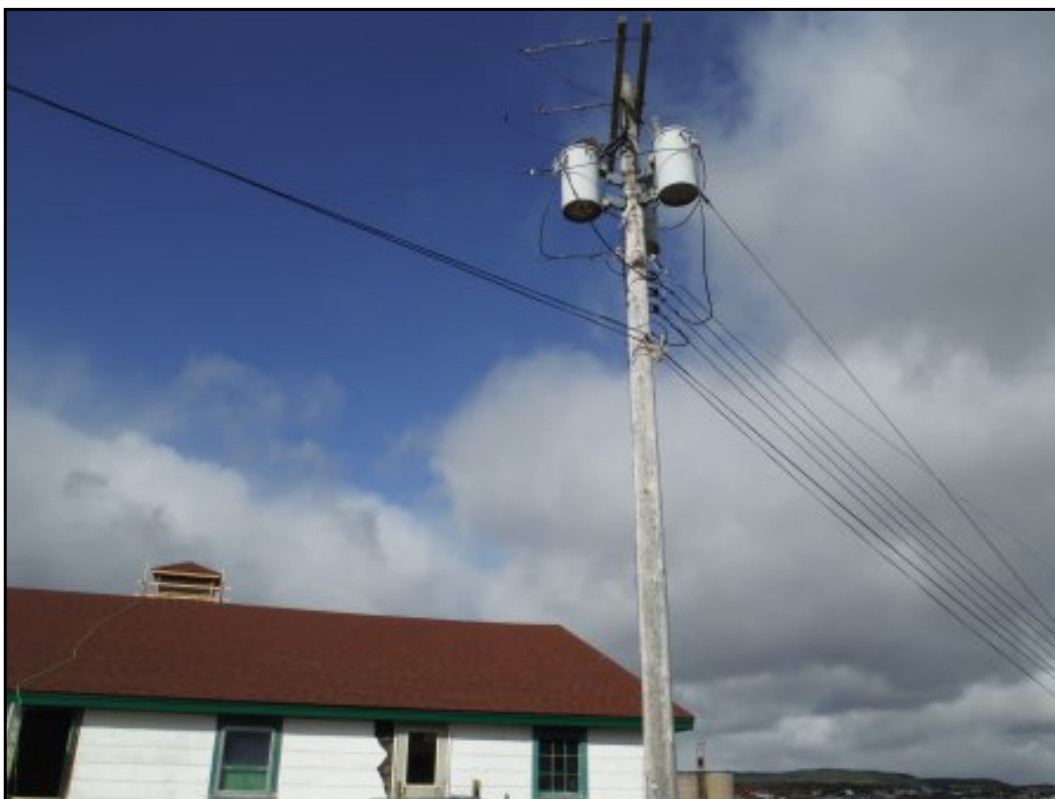
Transformers located on the northeast portion of the Site, looking northwest
