Turtle Technologies Inc. Building Retrofit Corner Brook, Newfoundland and Labrador

Environmental Assessment Registration Package

September 24, 2018

BeeHighVE Inc. Cannabis Production Facility

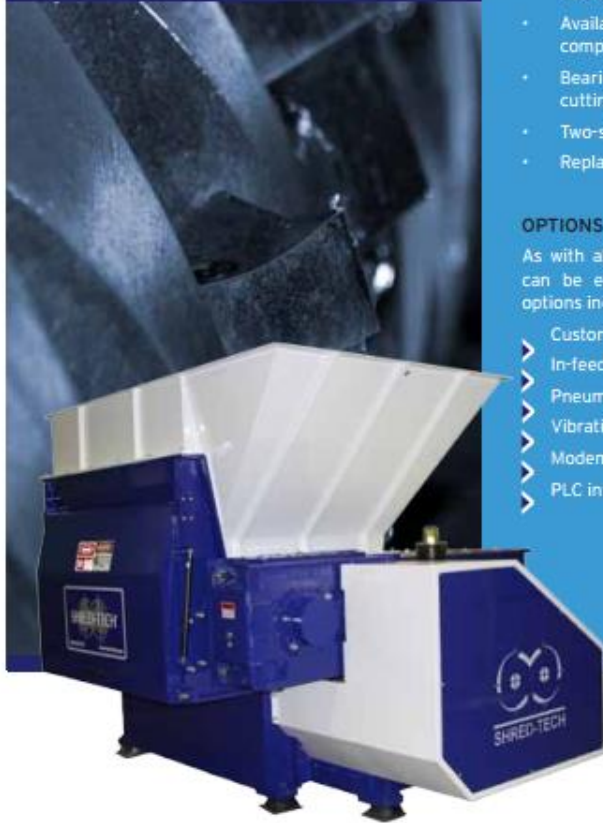
STS-2 Single Rotor Shredder

The STS-2 is well suited for the reduction of computer and electronic scrap as well as off-spec pre-consumer products. It does more so you can DO MORE!

- Reinforced all welded construction - prevents screen damage from tramp metal and other unshreddable objects.
- Available abrasion resistant wear components decrease operating costs.
- Bearings & seals - mounted outboard of the cutting chamber to avoid contamination.
- Two-speed ram for efficient processing.
- Replaceable ram guides.

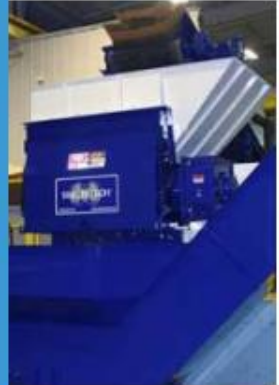
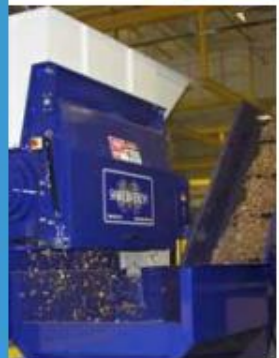
STS-2 Single Rotor Shredder

As with all Shred-Tech shredders, the STS line can be equipped with a full compliment of options including:

- Custom hoppers and stands
- In-feed and discharge conveyors
- Pneumatic discharge and dust control
- Vibrating, magnetic or rotary separation
- Modern capabilities
- PLC interfacing for peripheral equipment

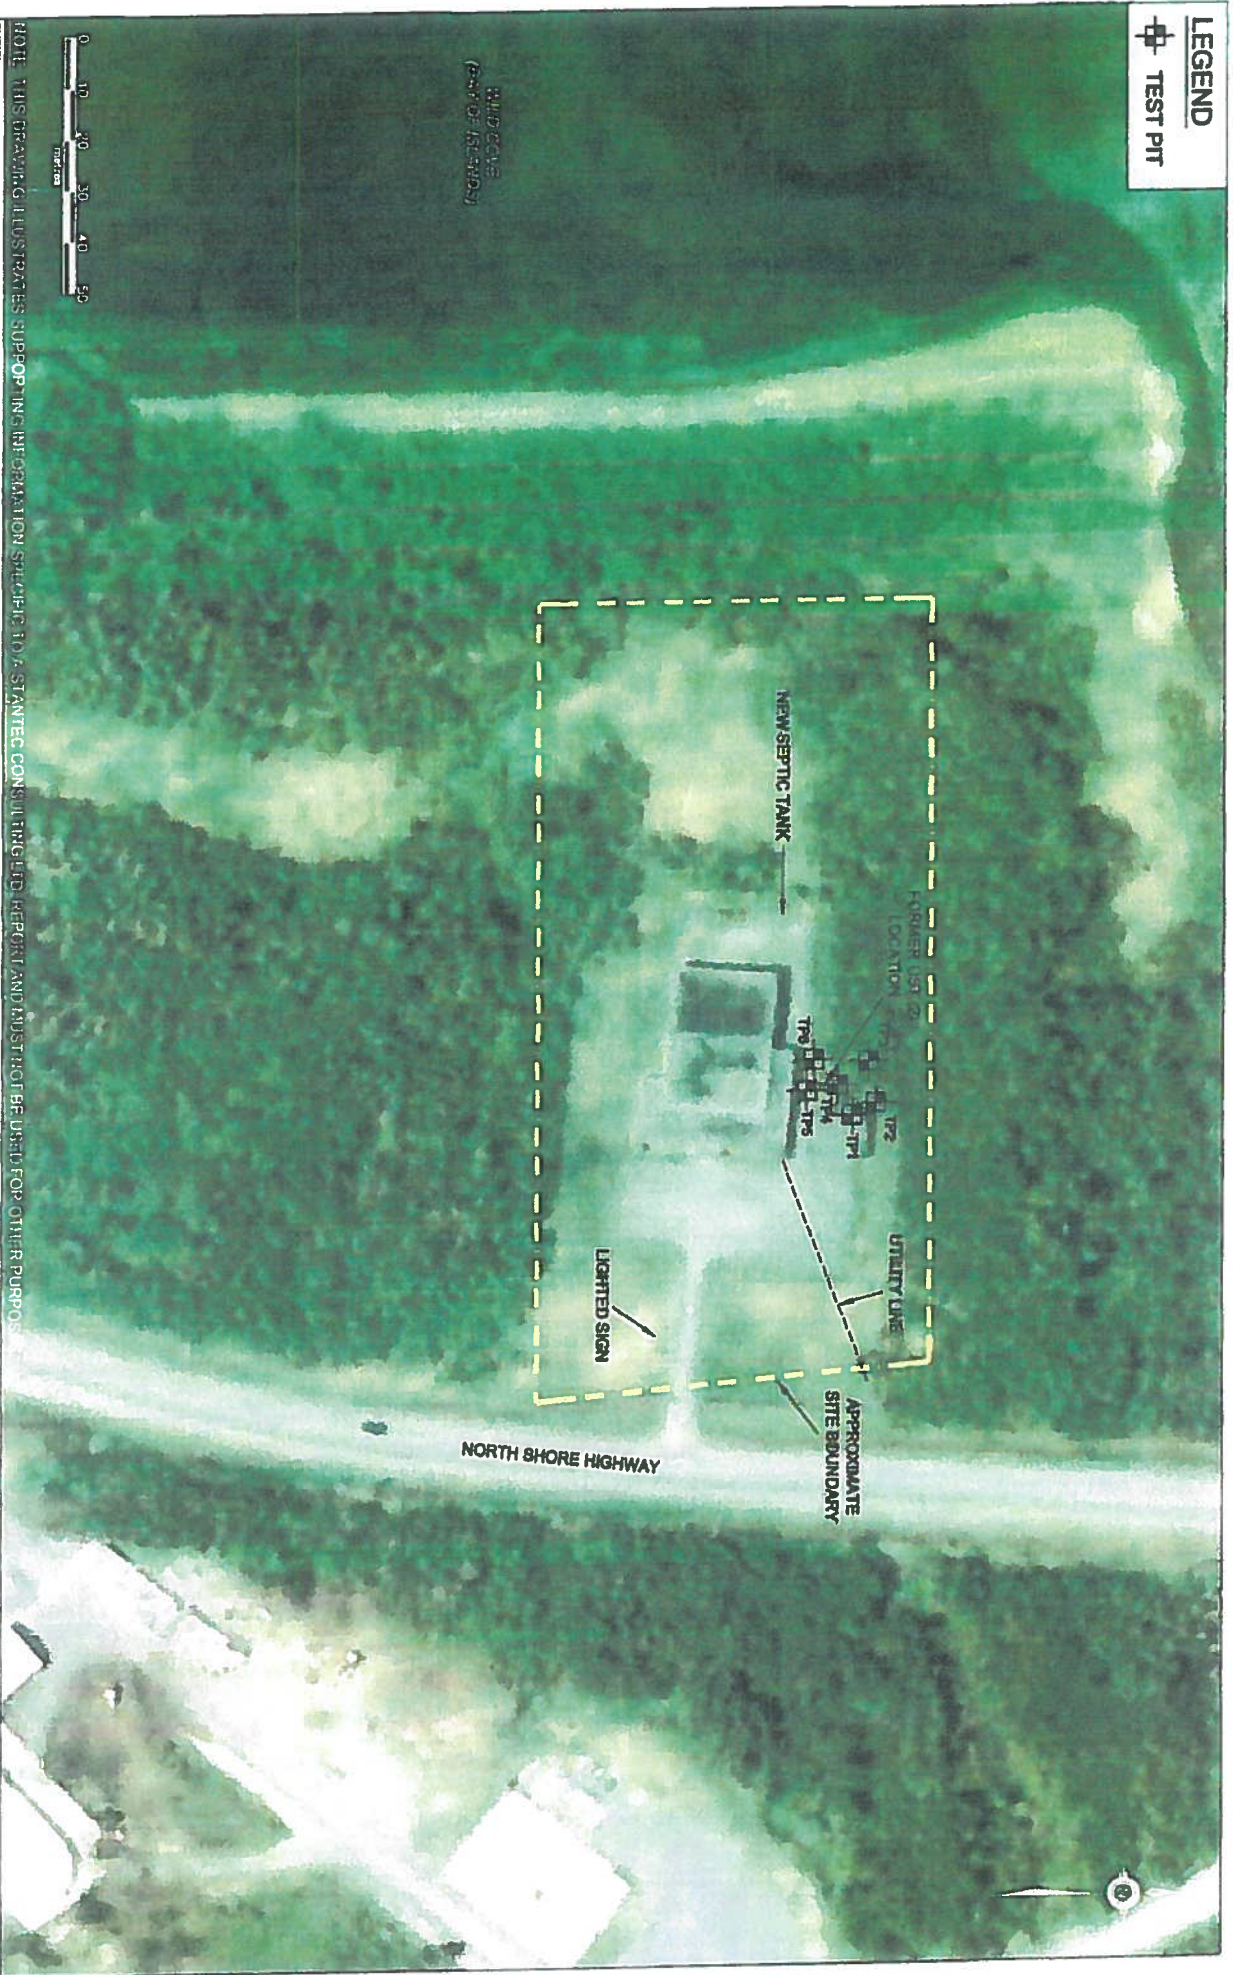
TEST PIT

BLIND CONC
 (PART OF FOUNDATION)

The six (6) test pits were excavated using a track-mounted excavator provided by Humber Arm Contracting of Corner Brook, NL under the supervision of Stantec personnel. Test pits were excavated to final depths ranging from 5.0 metres below ground surface (mbgs) in test pits TP2-TP6 to 8.0 mbgs in test pit TP1. The locations of the test pits (shown on Drawing No. 121412093-EE-01 in Appendix A) were established in the field by Stantec personnel based on the location of the former USTs provided by the property owner. Subsurface conditions encountered in the test pits were logged by Stantec personnel at the time of excavating and are described in Section 3.1 Subsurface Conditions.

The stratigraphy in the test pits generally consists of loose to very dense, brown and grey silty sand and gravel (possible fill material) and a dense, reddish-brown to brown clay with silty sand and gravel with a mix of trace organics. Bedrock was not encountered in any of the test pits
