Limited Phase I Environmental Site Assessment and File Review

Commercial Property
5 Western Drive
Barachois Brook, Newfoundland and Labrador

Back Home Medical Cannabis
Corporation (Back Home Grow)

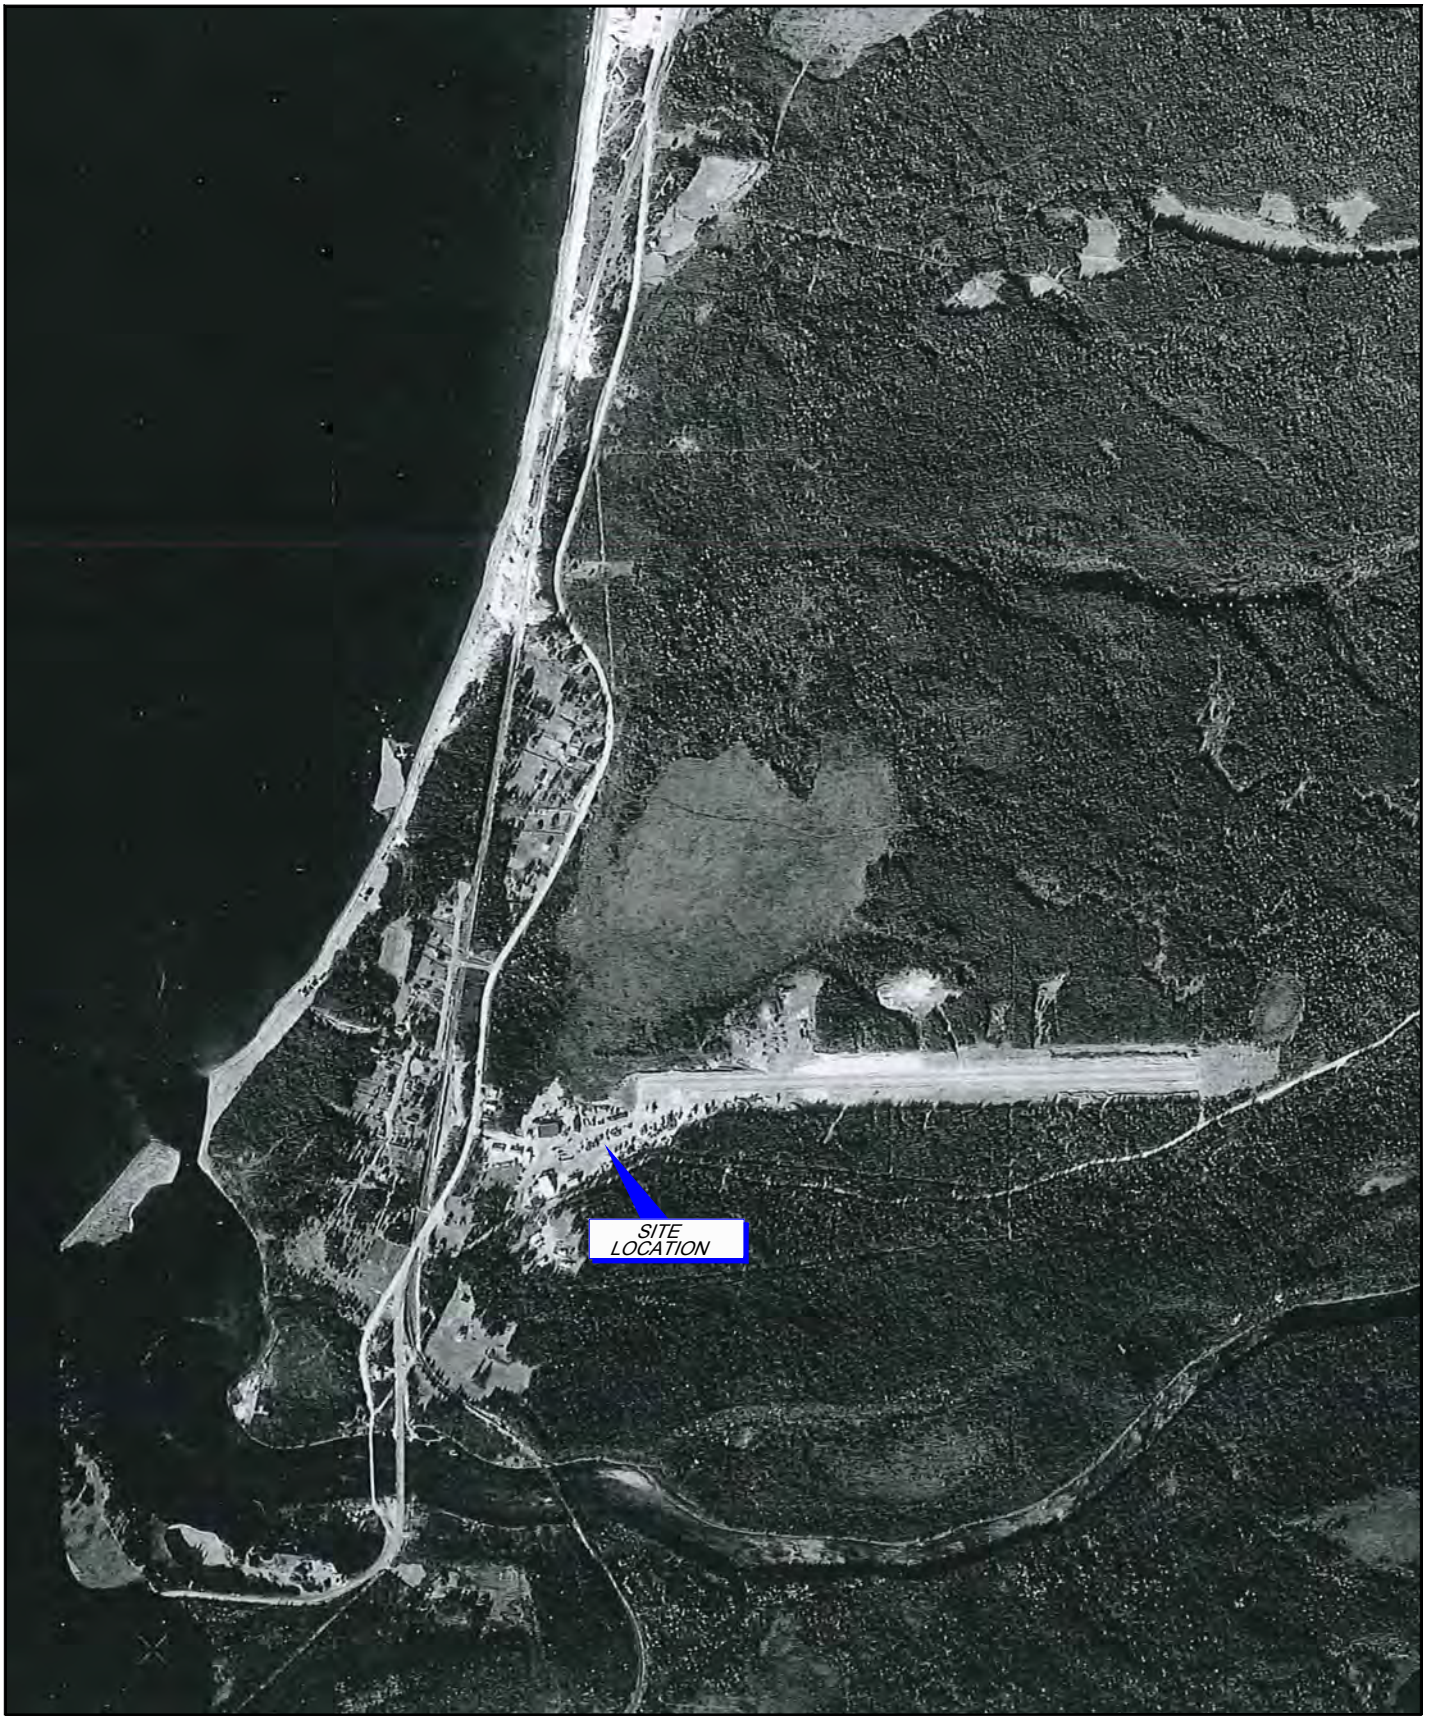
FIGURE E3

The 1973 aerial photograph shows trailers visible north of the Site. Also, the Site building noted in the 1966 aerial photograph is clearly visible. A cleared area with some buildings or trailers were visible southwest of the Site and an additional commercial building (paint shop) is visible west of the Site.

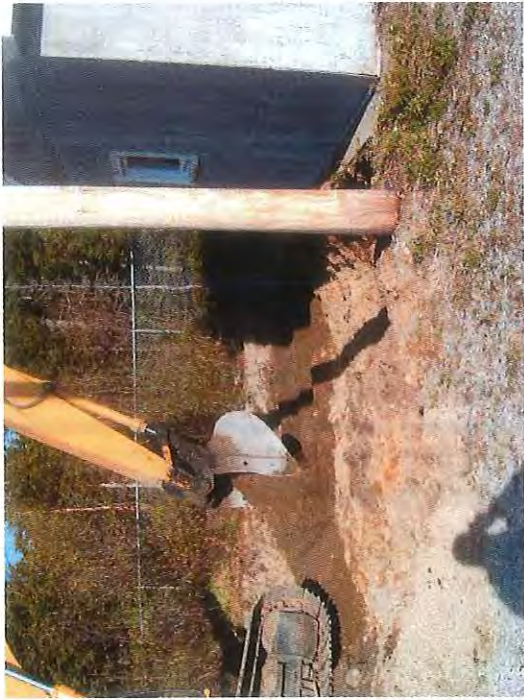
Photo 1: View looking west at Oil Shed excavation.

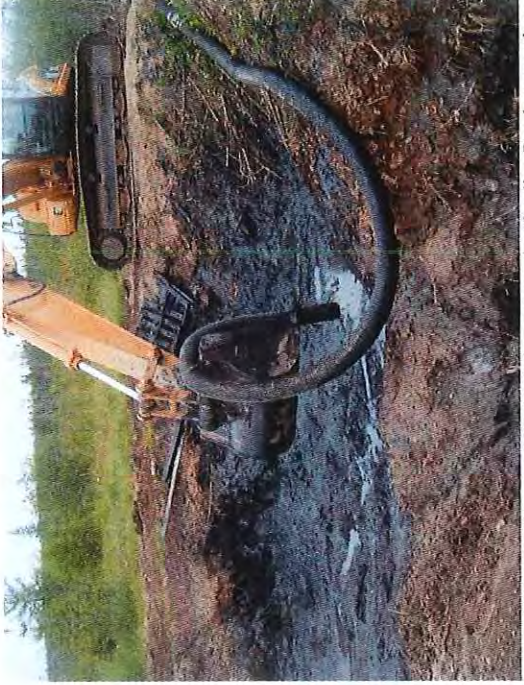
Photo 2: Water and sludge being removed at Settling Pond excavation.

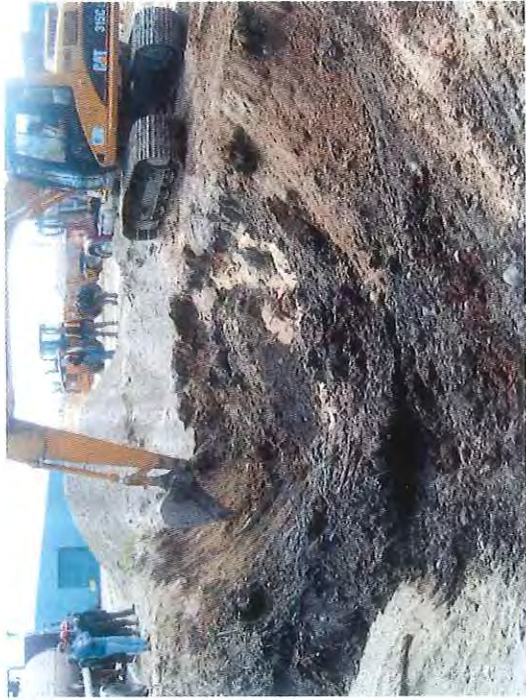
Photo 3: View looking south at Settling Pond excavation.

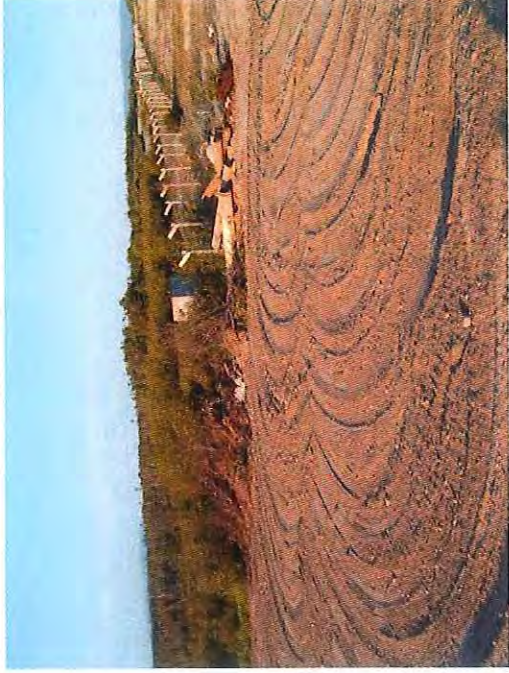
Photo 4: View looking northeast at area of remediated Settling Pond.

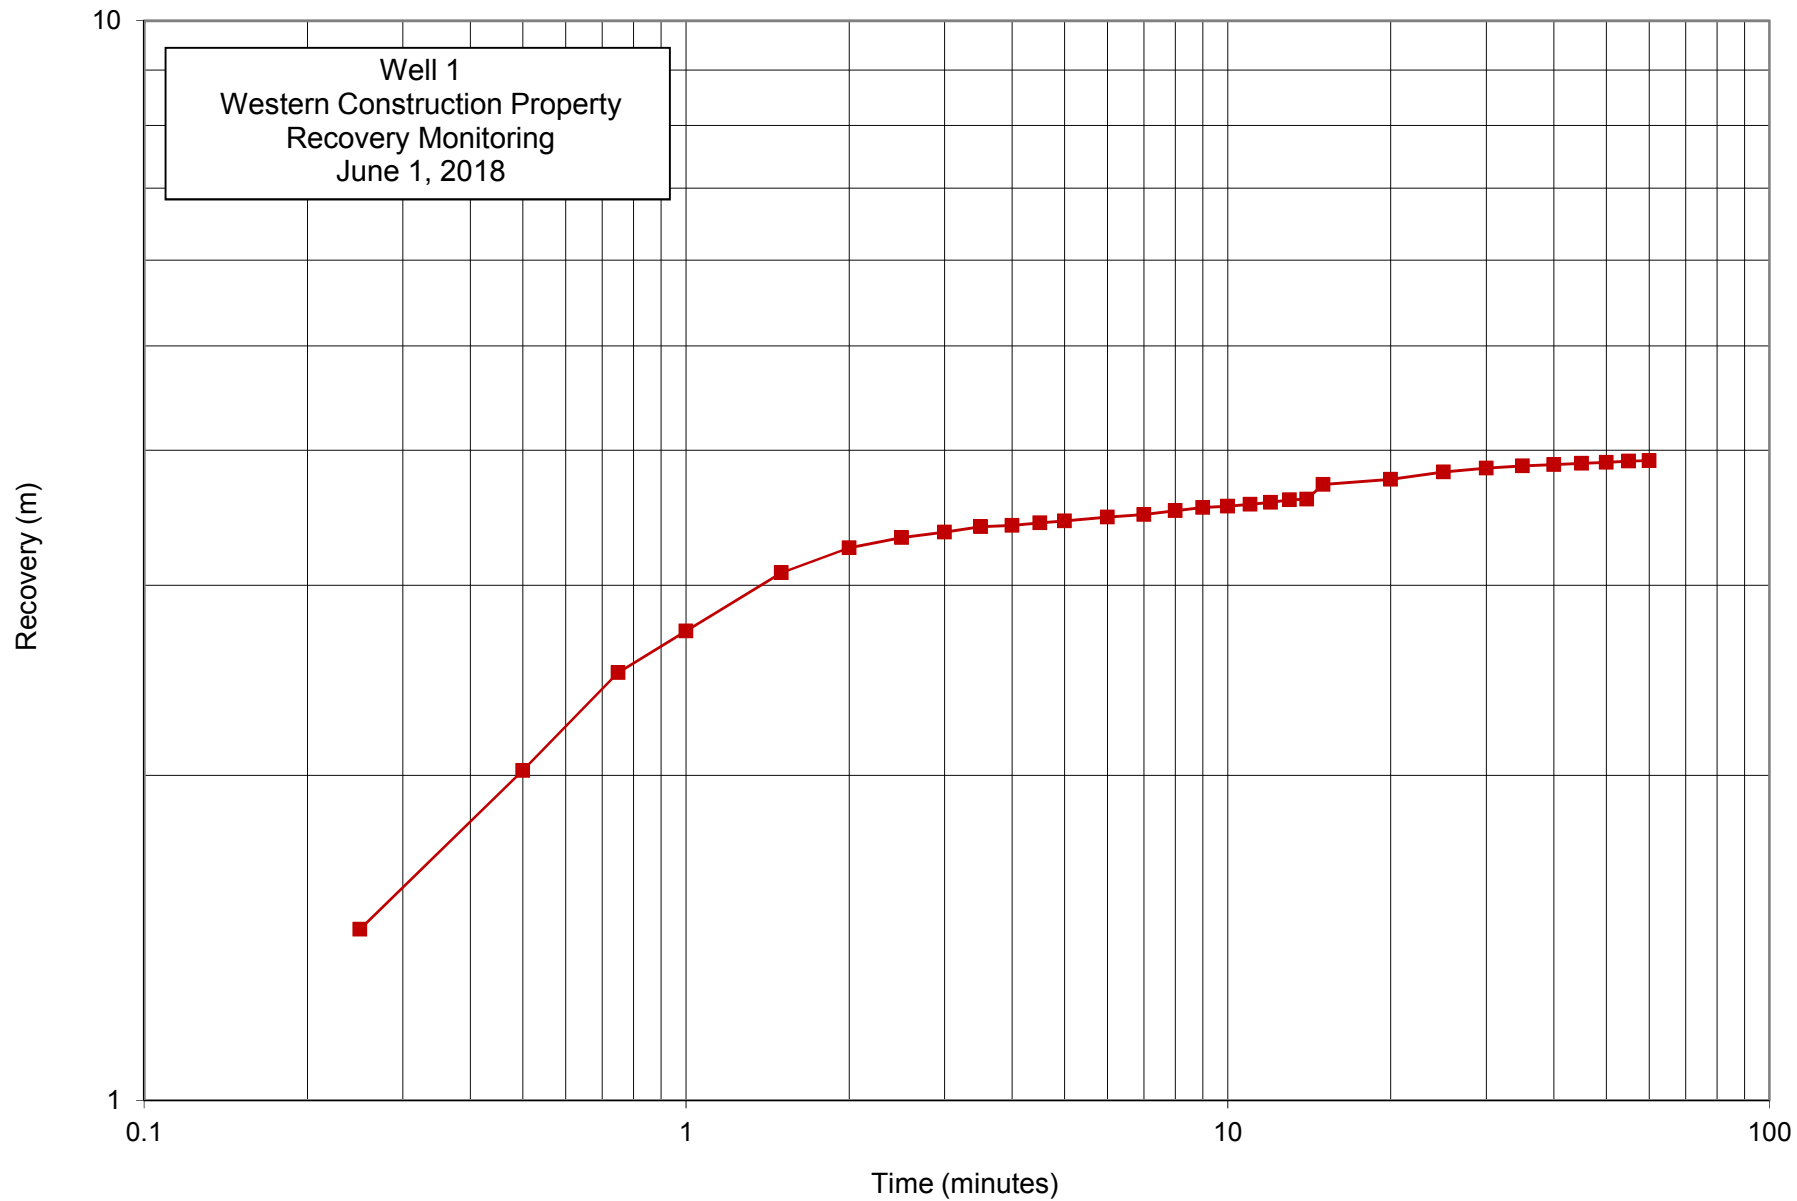
Figure D-4 Log-Log Plot of Water Level Recovery Versus Time for Constant Rate Test

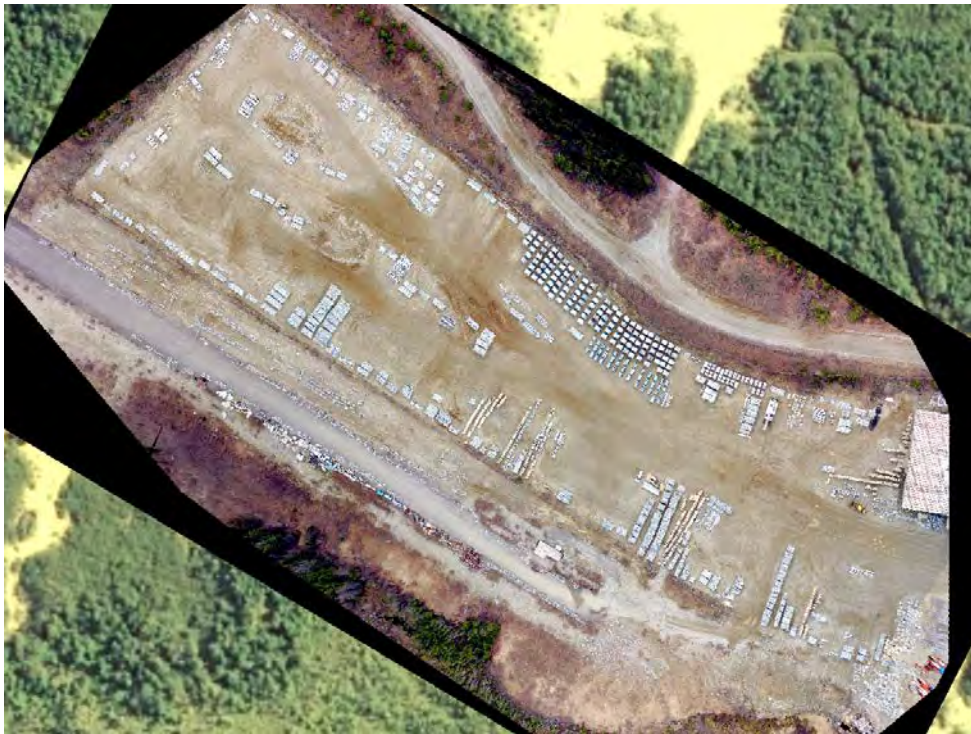
Photo 2 – 2018 aerial drone view looking down on western side of Site while being used as laydown yard for Maritime Link Project (provided by Back Home Grow).

A diesel pick-up truck wreck was stored in the former laydown yard from September 2016 to February 2018 while the Maritime Link contractor occupied the Site. An unknown quantity of diesel fuel leaked from the fuel tank over the 18 month period and was estimated at less than 100 Litres (the capacity of the fuel tank). Based on this information, 10 test pits (TP1 to TP10) were excavated in the former laydown yard area with one test pit (TP3) located in the area of observed surface soil staining where the wreck was located. One soil sample (TP3-SS5) and its field duplicate (TP3-SSB) collected at 2.4 to 3.0 mbgs, reported Total Petroleum Hydrocarbon (TPH) exceedances for a commercial property with potable groundwater and coarse-grained soil using the Atlantic Risk-Based Corrective Action (RBCA) Tier I Risk-Based Screening Level (RBSL) criterion. The petroleum hydrocarbon impacts were delineated vertically and laterally by other test pits in the area. Based on a potable water exclusion zone applied at the impacted area where the truck wreck was located with a 30 metres radius around the impact area, the localized area of TP3 was revised to a non-potable groundwater condition. As a result, TPH concentrations from the soil sample (TP3-S5) and its field duplicate (TP3-SB) were below the Tier I criterion for a commercial property with non-potable groundwater.

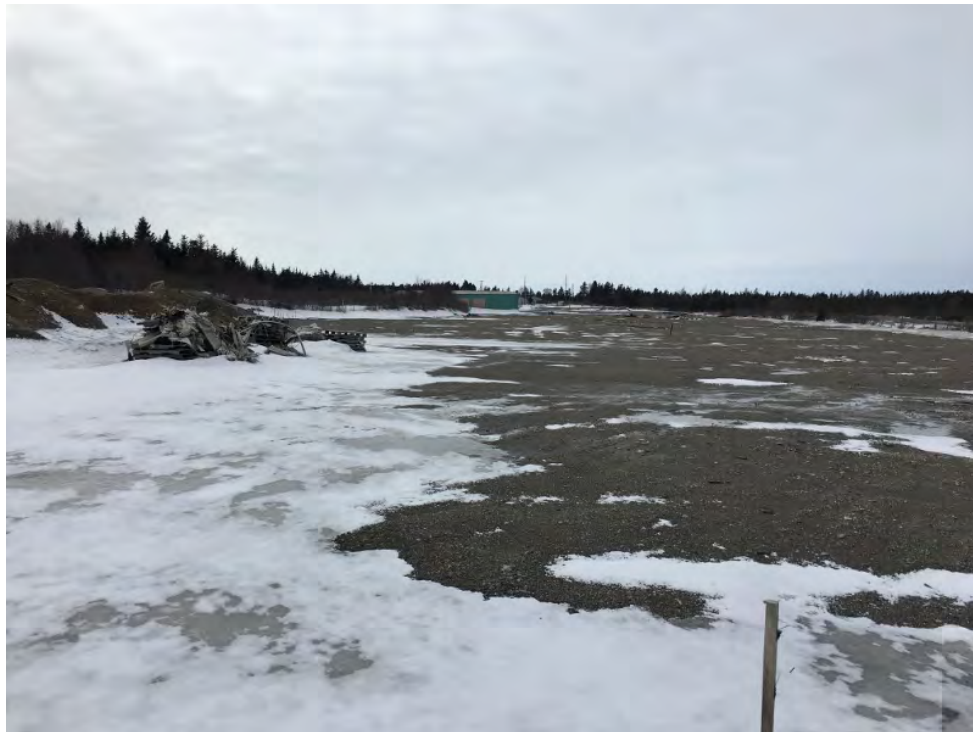
Photo 4 – View, looking west, toward Warehouse (former Repair Shop) and across former laydown yard with miscellaneous debris at left of photograph (provided by Back Home Grow).

Solid Waste: Various piles of miscellaneous debris were noted in the western area of the Site, which were reportedly a result of clean-up operations following the expiry of the property use for the Maritime Link. Solid waste items included tires, wood dunnage, and scrap metal, all of which will be removed in the spring of 2019 when weather allows.

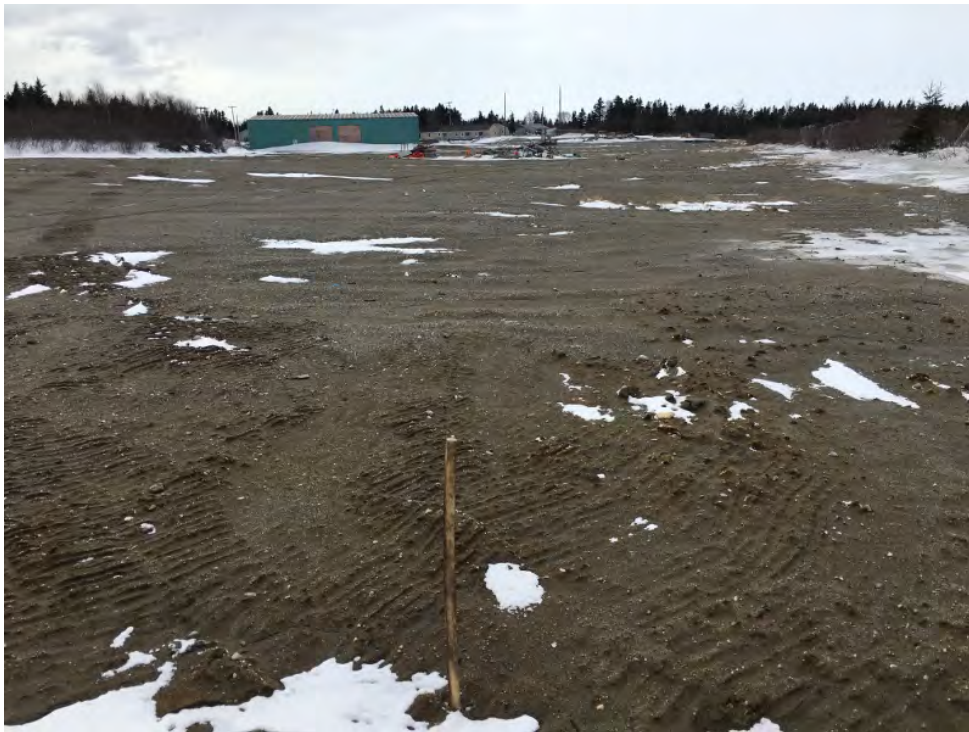
Photo 6 – View, looking west, toward Warehouse (former Repair Shop) with miscellaneous debris at centre of the photograph (provided by Back Home Grow).

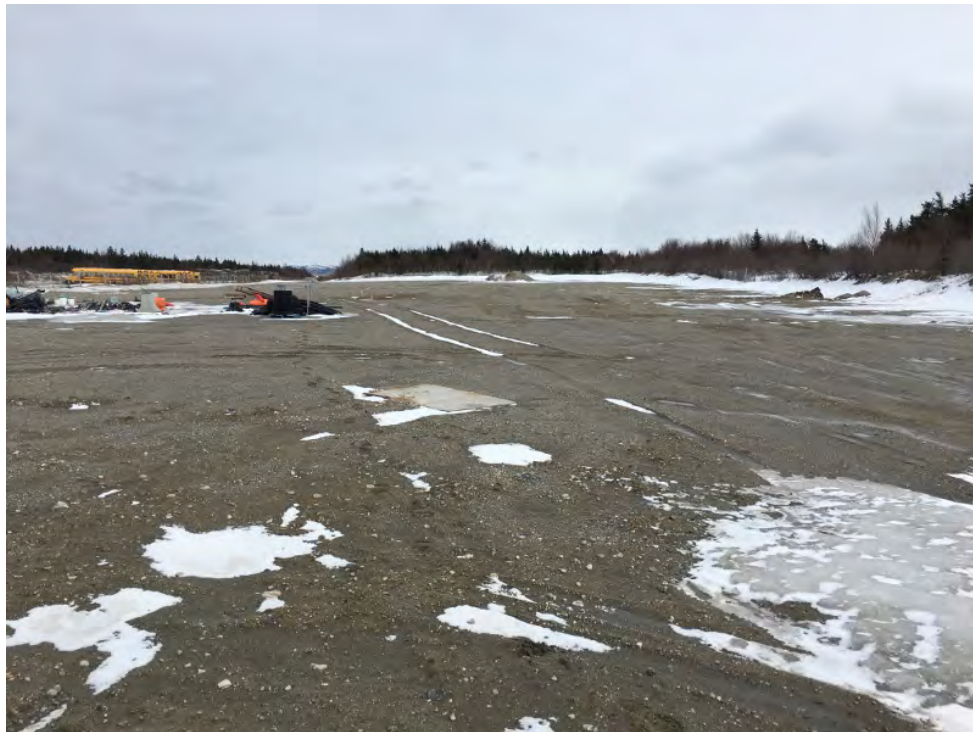
Photo 7 – View, looking east, across former laydown yard with miscellaneous debris at centre left of photograph with bus parking area off site on the former airstrip (provided by Back Home Grow).
