Final Report
**PHASE II ENVIRONMENTAL
SITE ASSESSMENT
DIESEL GENERATOR SITE
BUTTERPOT PROVINCIAL PARK
TRANS-CANADA HIGHWAY,
NEWFOUNDLAND AND LABRADOR**

Prepared for:
**Government of Newfoundland and Labrador
Department of Environment and Conservation
Parks and Natural Areas**

(ADI File 26-3665-005.1)

April 2009

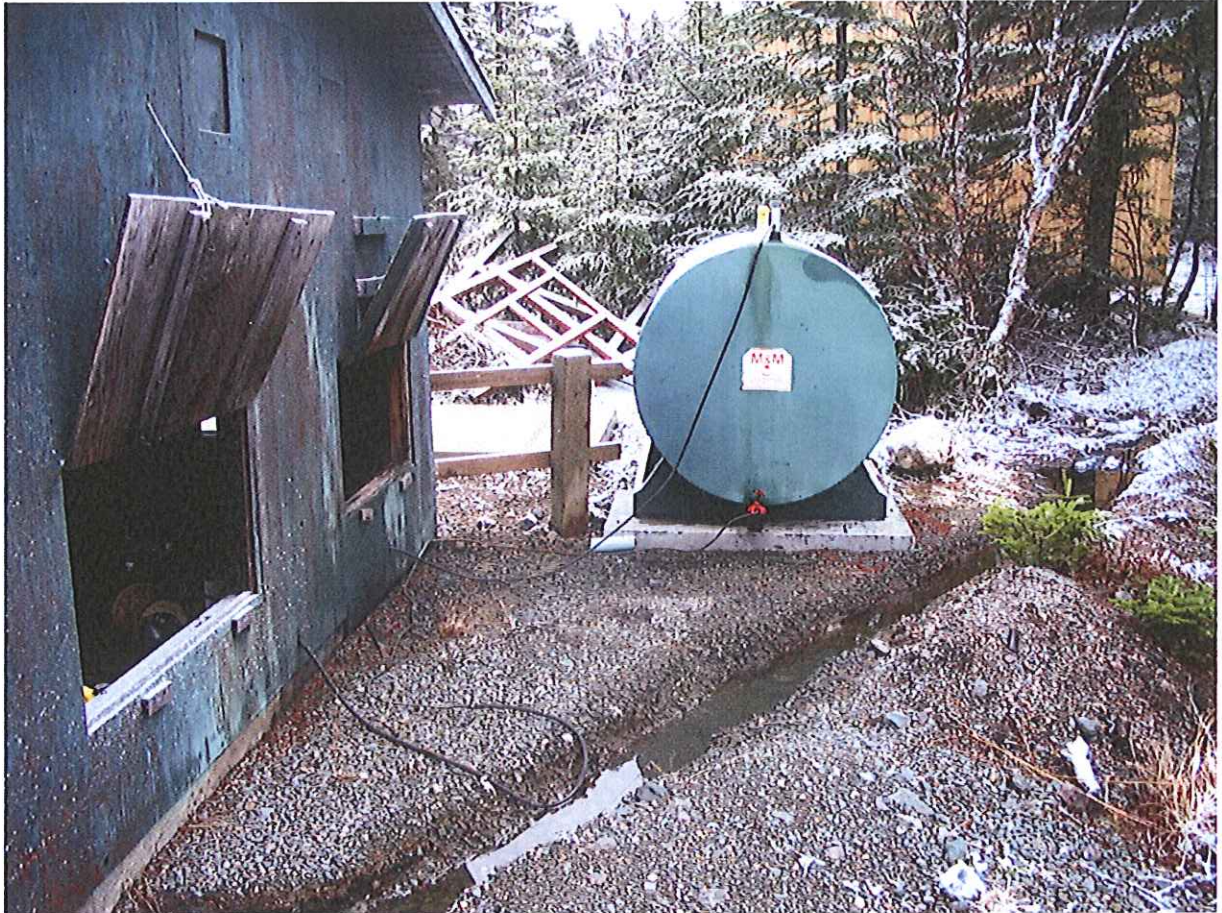
Photo#1: Looking southeast at back of generator shed. Note former AST & soil staining.

Based on the findings of the current investigation, *ADI Limited* recommend completion of a Phase III Environmental Site Assessment (ESA)/site-specific Human Health Risk Assessment (HHRA) at the site to further delineate the extent of petroleum hydrocarbon contamination in soils/ groundwater and to develop a Remedial Action Plan for the site.

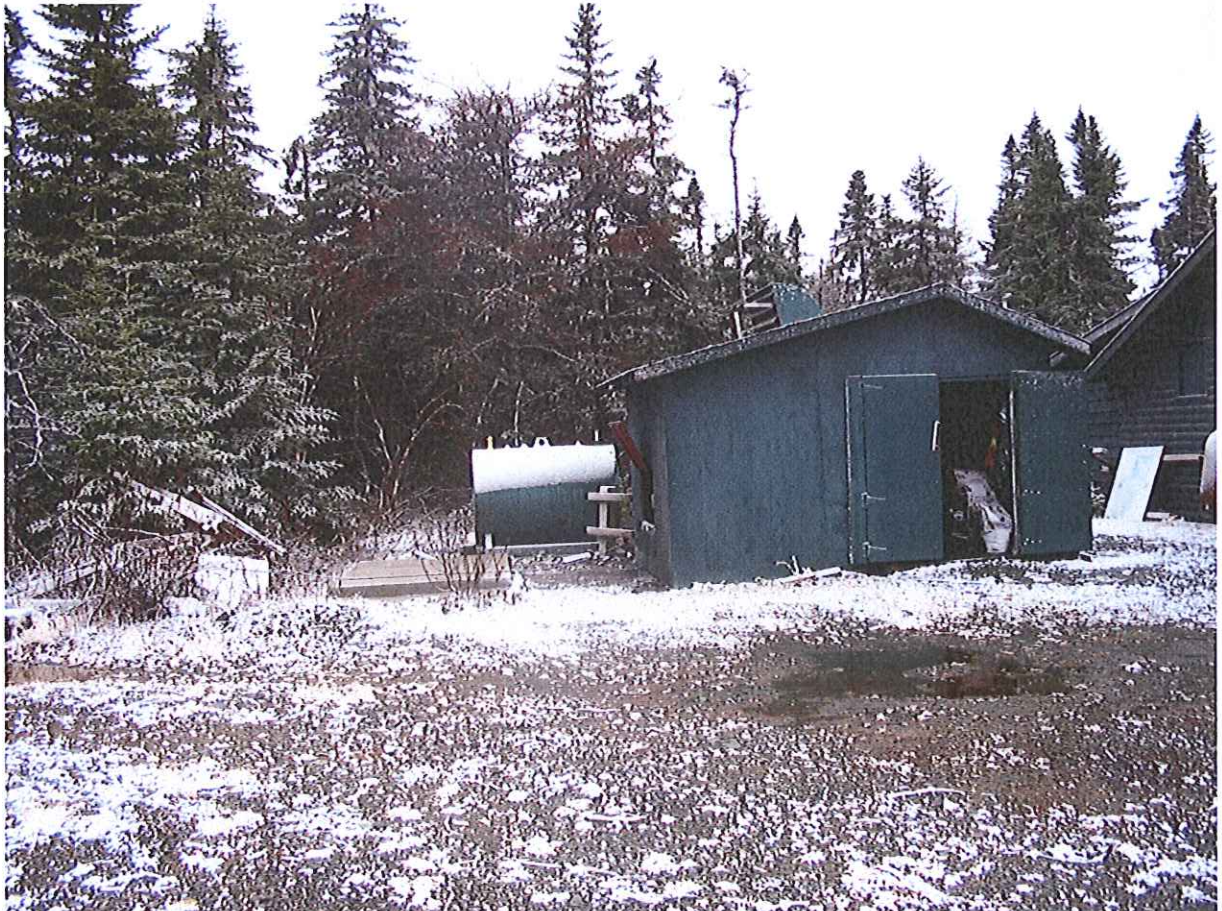
Photo#2: Looking southwest at generator shed, with shop at right. Note concrete pad at left-location of new diesel AST.
