Reference No. 11111591

**Re: Ambient Air Sampling and Closure Report  
Butter Pot Provincial Park, Newfoundland and Labrador**

NEWFOUNDLAND AND LABRADOR PARKS  
AND NATURAL AREA DIVISION  
BUTTER POT PROVINCIAL PARK  
AMBIENT AIR SAMPLING & CLOSURE REPORT  
SITE LOCATION MAP

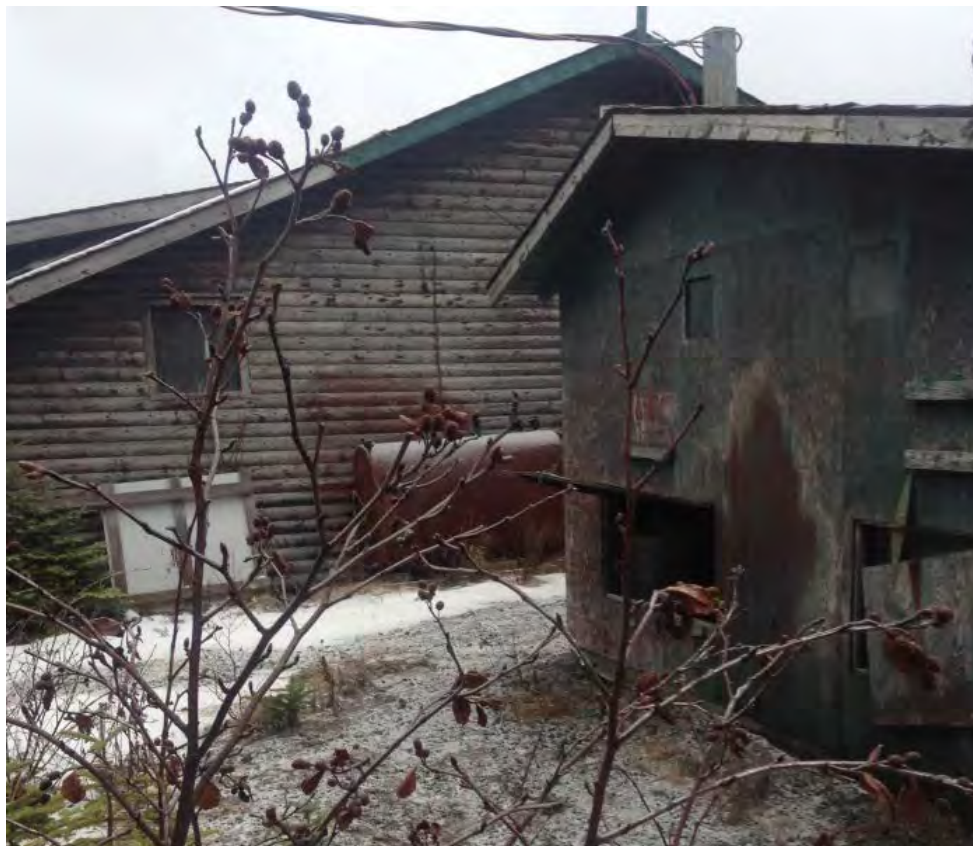
Photo 1 – View, looking northwest towards the generator shed and workshop during the December 2015 Site inspection.

The back wall of the Generator shed with petroleum impacts was removed and replaced in August 2018. In addition, the lower portion of the right front door was observed to be rotted, which was also repaired while on Site.

Photographs showing the original condition of the back of the Generator shed in December 2015 along with the completed repairs from August 2018 are presented in Attachment E.

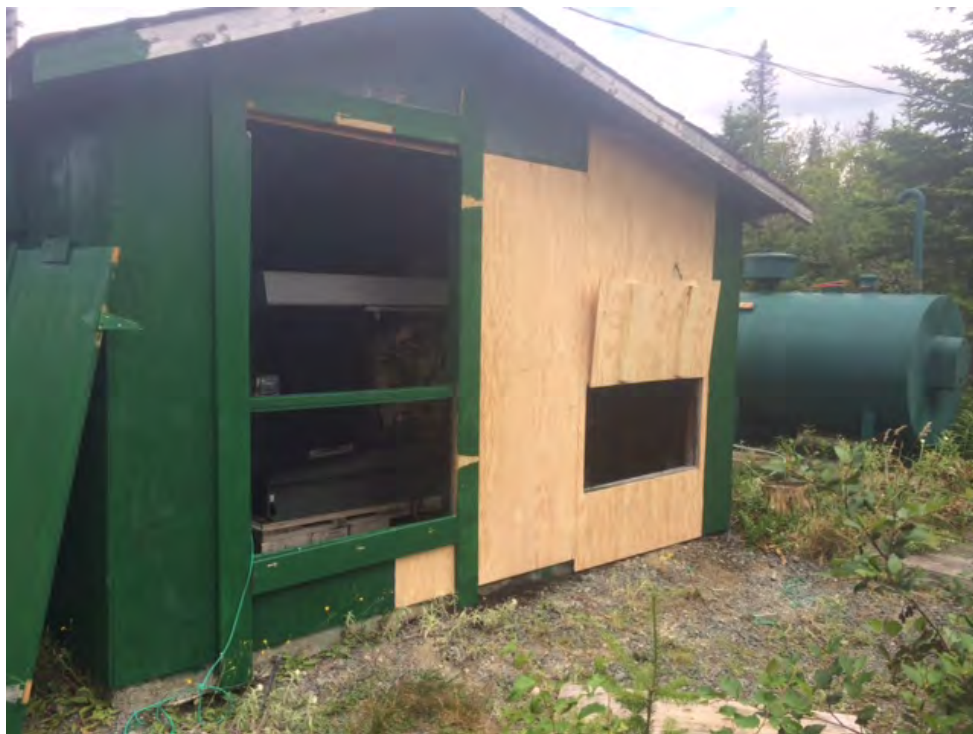
Photo 2 – View, looking east, that shows replacement of the petroleum impacted shed wall during the August 2018 Site inspection.

In addition, the rear wall of the Generator shed exhibiting petroleum hydrocarbon staining was replaced to prevent further soil contamination, and ensure a safe working environment for Park employees.

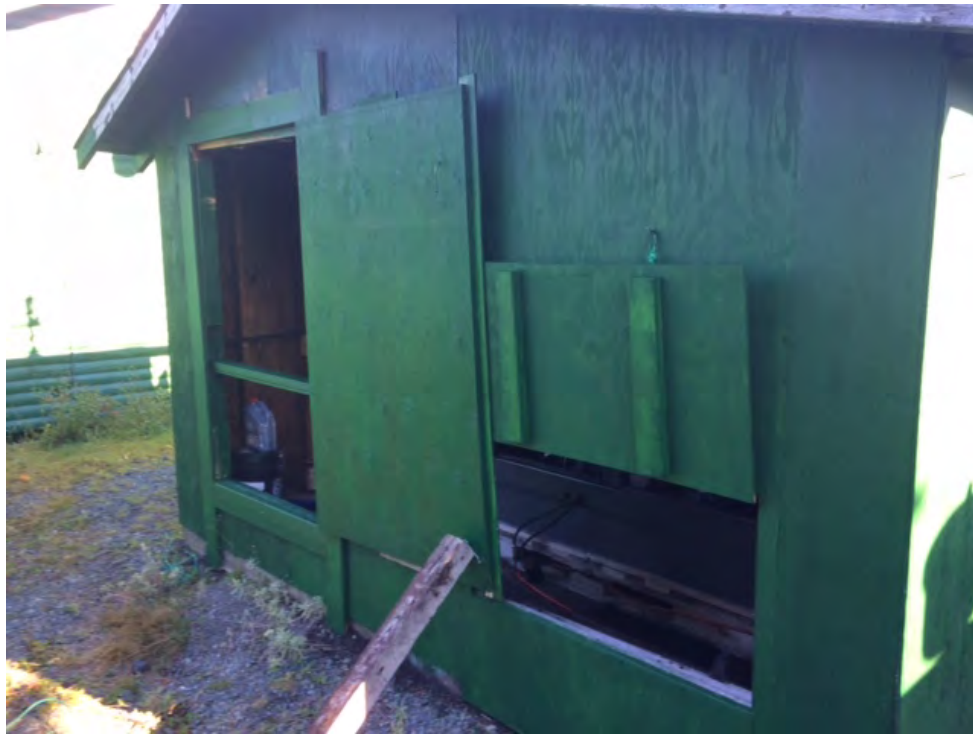
Photo 3 – View, looking northwest towards the generator shed and workshop during the September 2018 Site inspection after the generator shed repairs and painting.

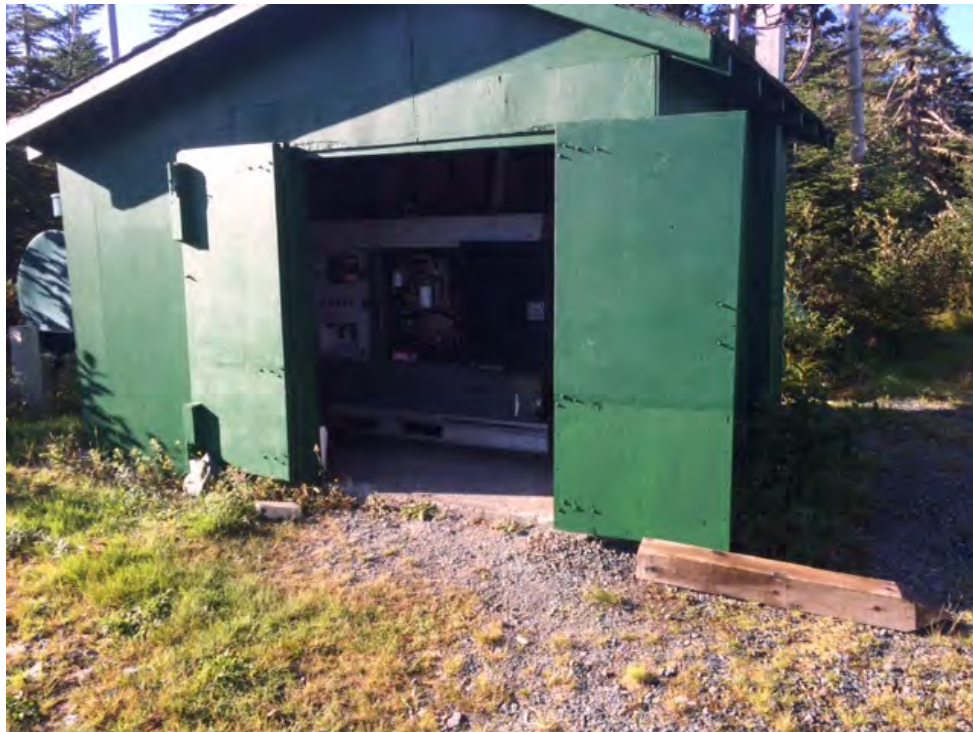
Photo 4 – View, looking south towards the generator shed during the September 2018 Site inspection after the generator shed after rot was repaired on the lower right door.

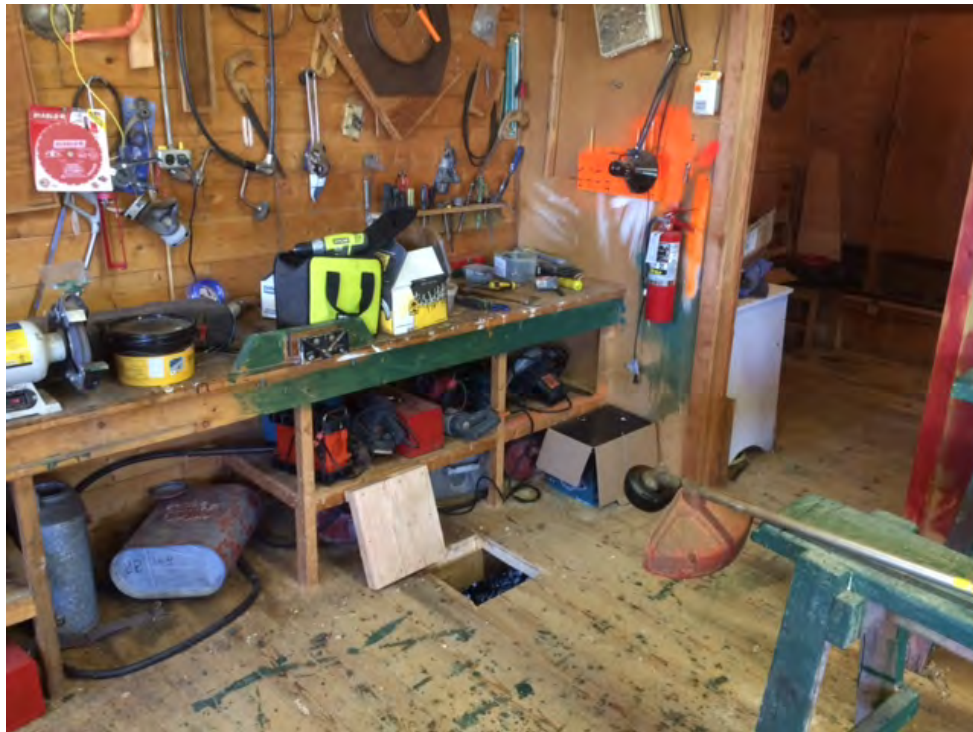
Photo 5 – View of the east side of the Workshop showing the location of the access hatch for collection of ambient air samples under the floor during the September 2018 Site inspection.

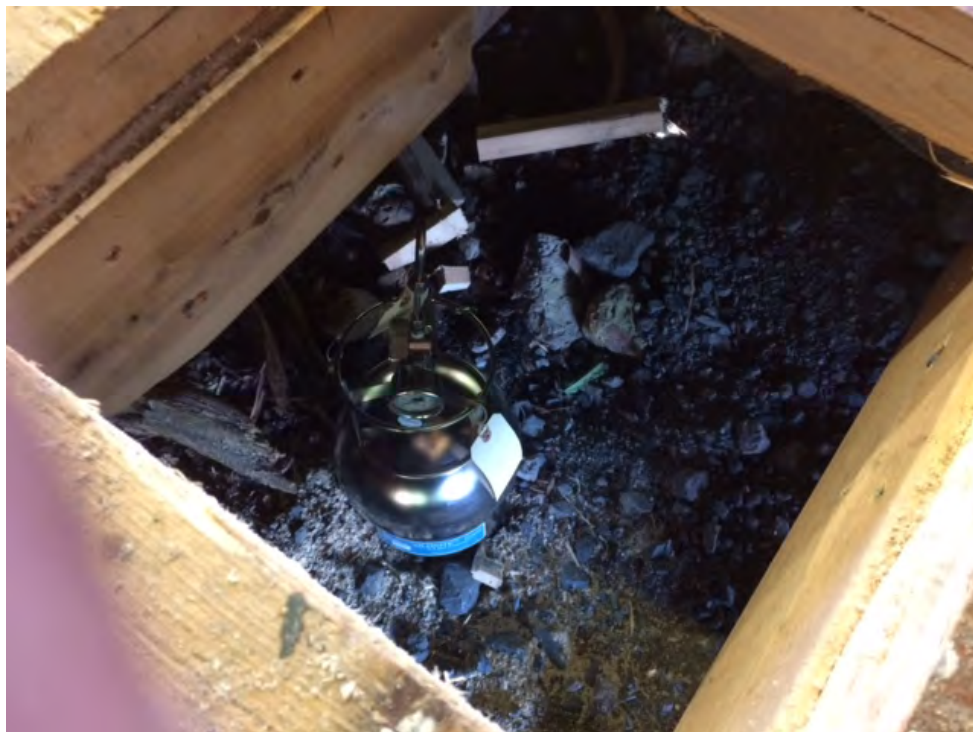
Photo 6 – View of the ambient air sample collection Suma canister in the access hatch of the Workshop during the September 2018 sampling event.
