PHASE III ENVIRONMENTAL SITE ASSESSMENT

Butter Pot Provincial Park, NL

Department of Environment and Conservation

Rev. 1 > Internal ref. 620891

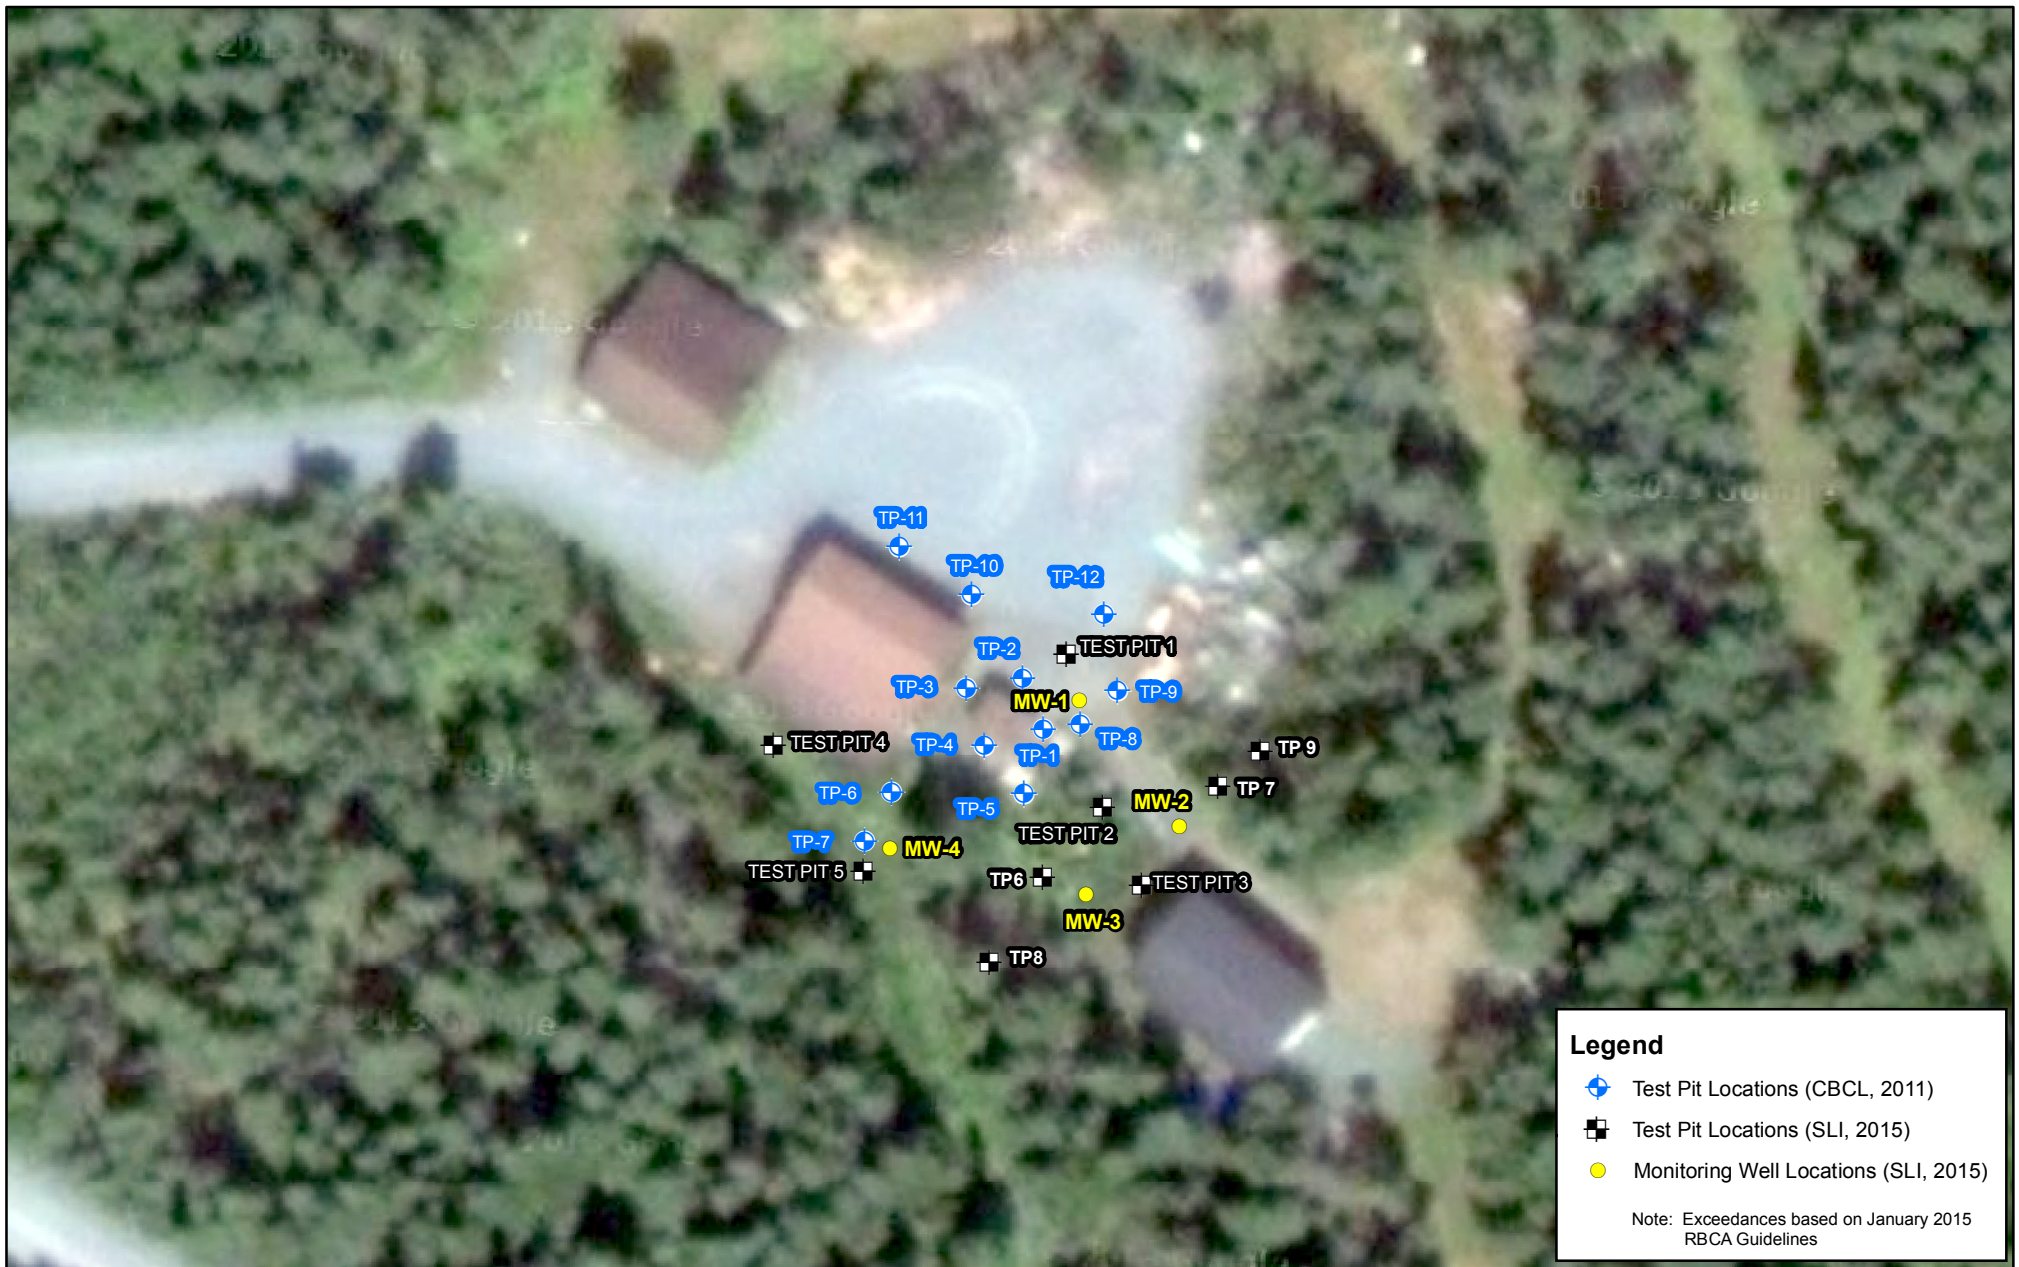
As each test pit was advanced, the ground profile was logged for soil type, moisture content and evidence of contamination. Soil sample locations are illustrated in Appendix A, Figure 2. Figure 2 also contains the historical sample locations from the November 2011 CBCL Sub-Surface Assessment Report. Test Pit logs for the Phase III ESA are provided in Appendix F.

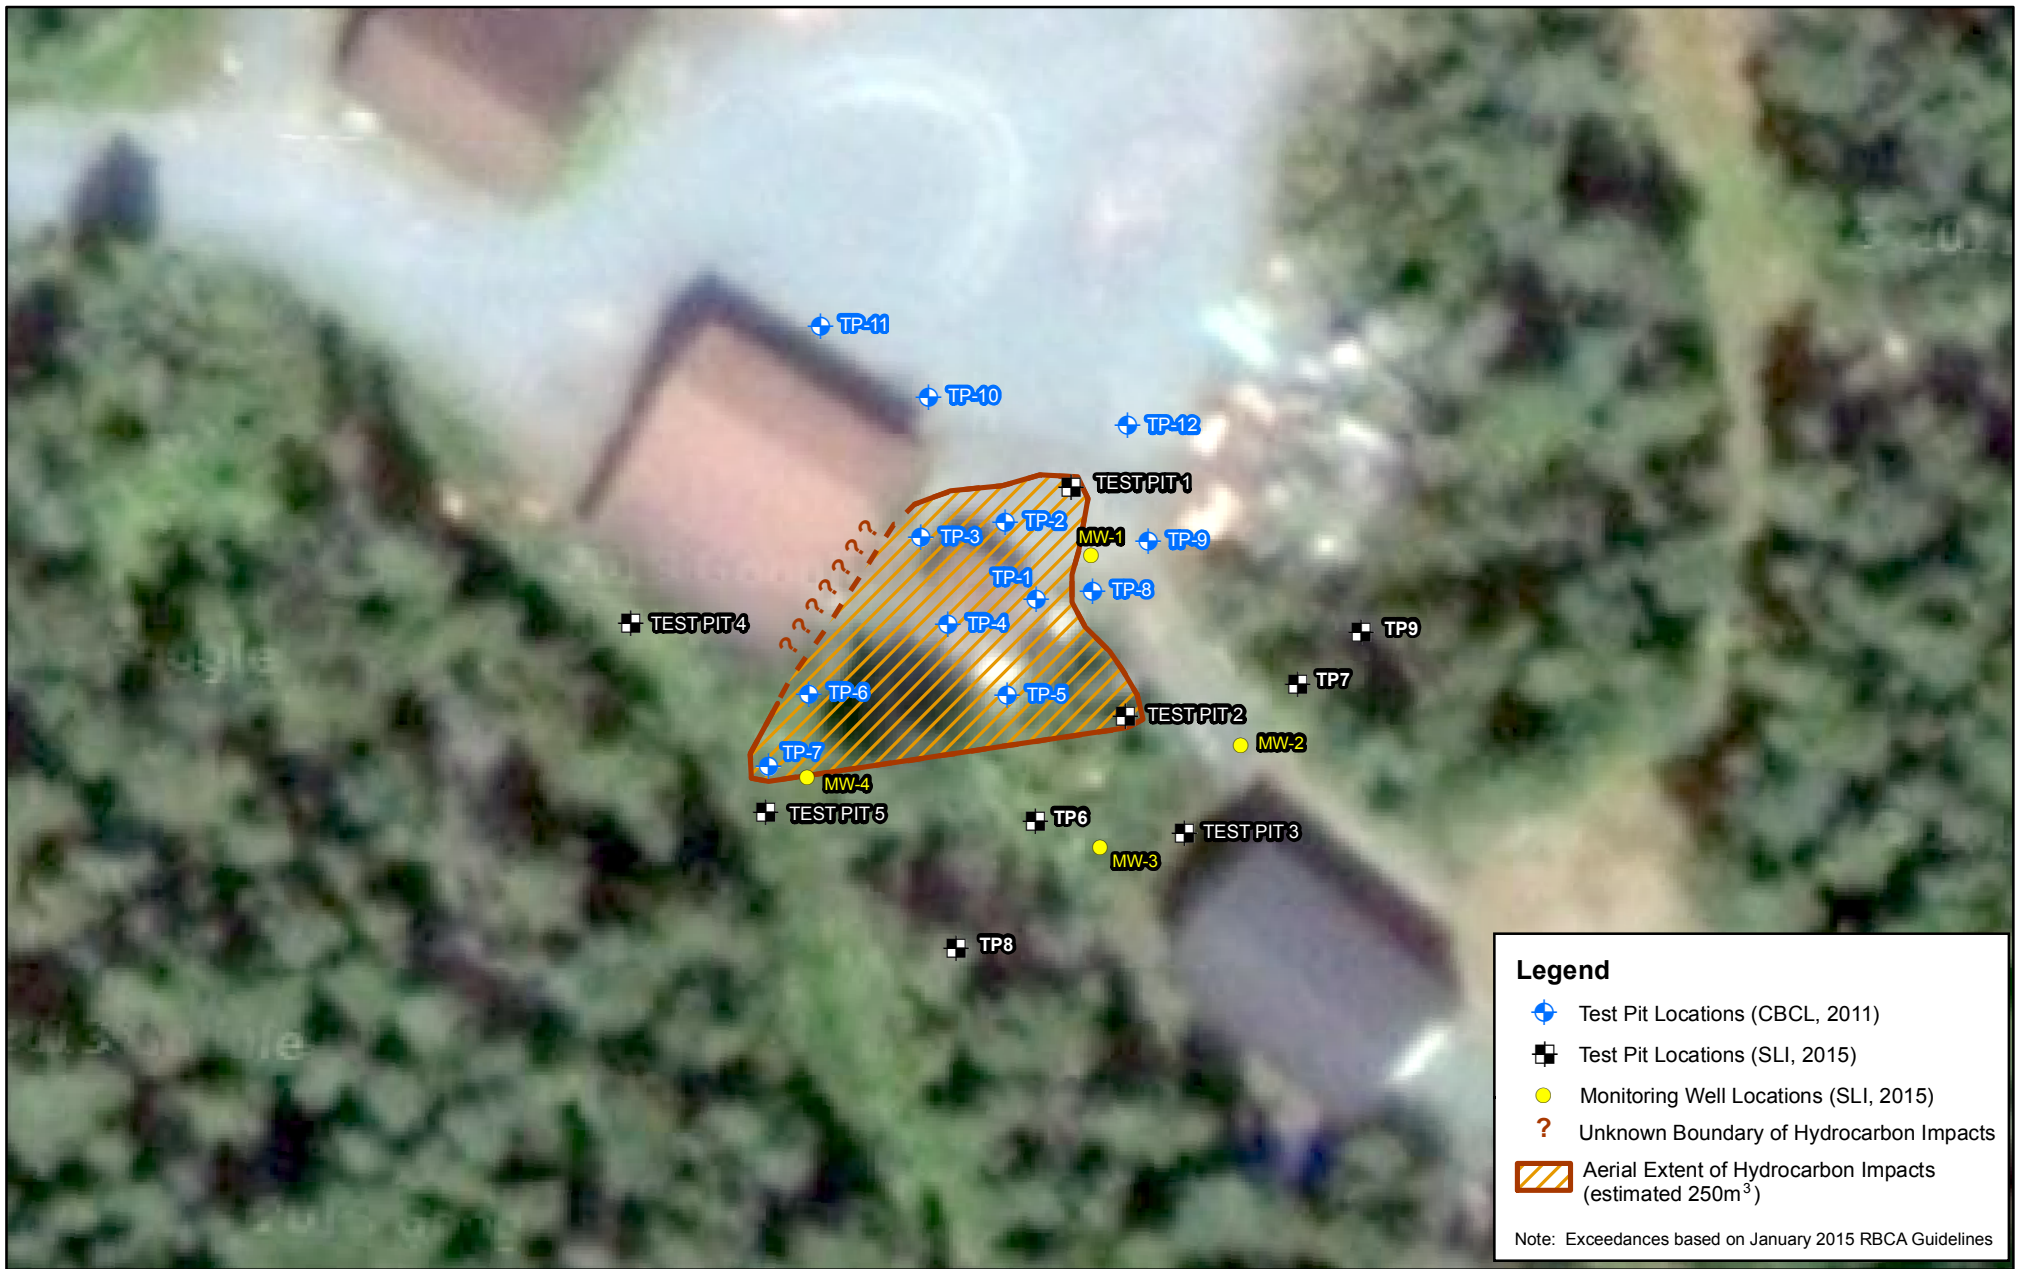
- ◆ Test Pit Locations (CBCL, 2011)
- Test Pit Locations (SLI, 2015)
- Monitoring Well Locations (SLI, 2015)
- ? Unknown Boundary of Hydrocarbon Impacts
- ▨ Aerial Extent of Hydrocarbon Impacts (estimated 250m³)

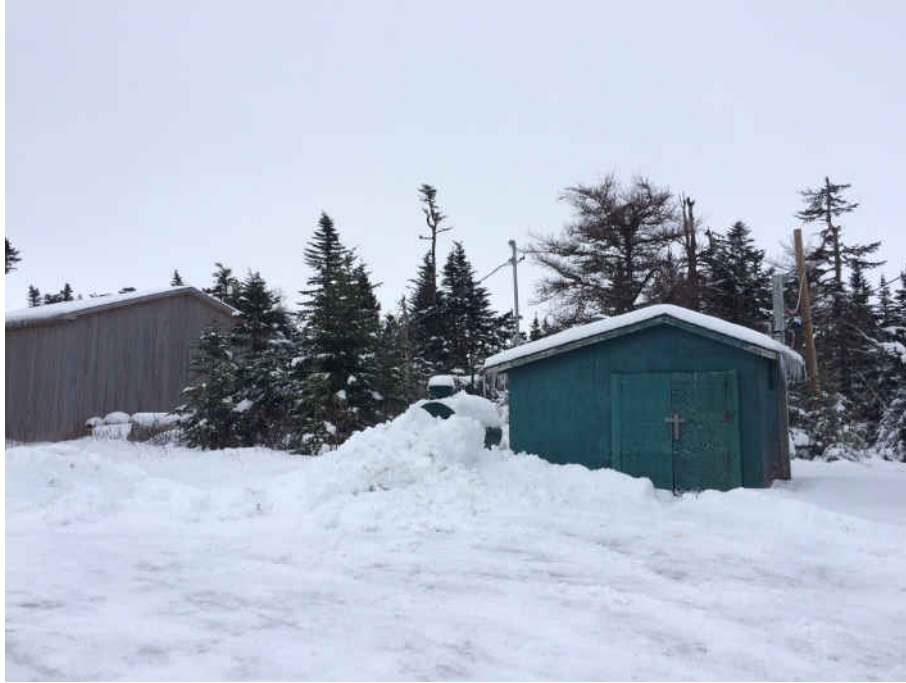
Photo 1: View of the storage shed (Left), diesel fuel tank and generator shed.

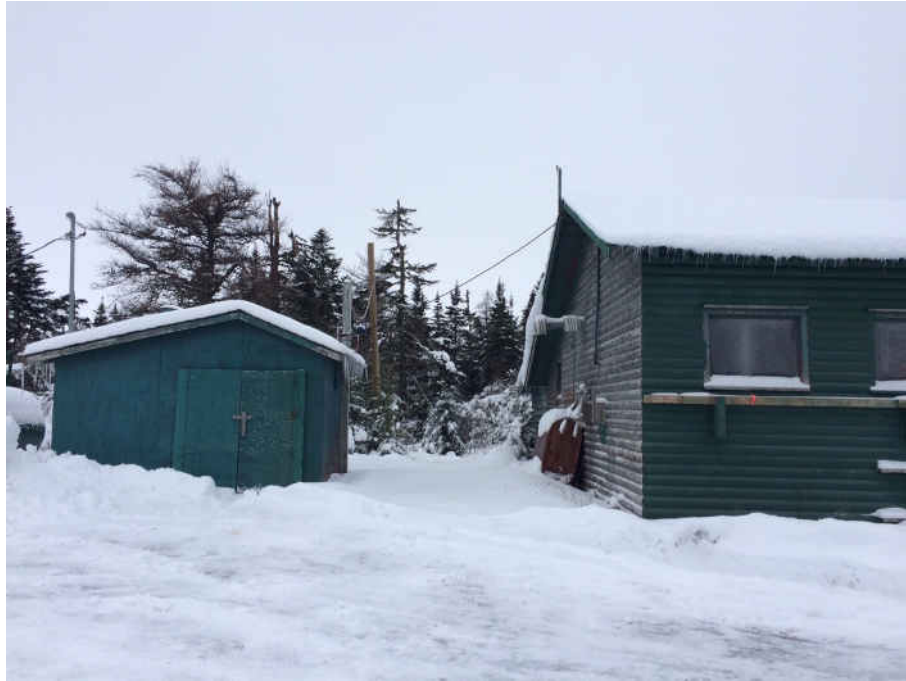
Photo 2: View of generator shed (Left) and workshop (Right).

- Remove the wooden walls of the generator shed contaminated with petroleum hydrocarbons to prevent any further soil contamination and ensure a safe working environment for park employees. Petroleum hydrocarbons can pose a fire/explosion hazard, especially if vapours are present in a confined space.

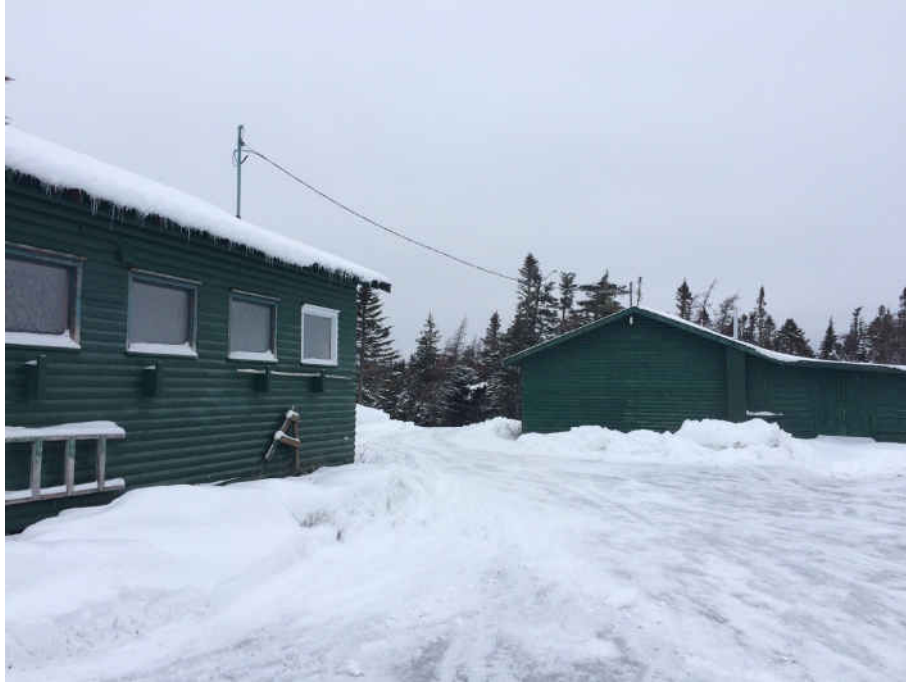
Photo 3: View of workshop (Left) and warm-up building (Right).

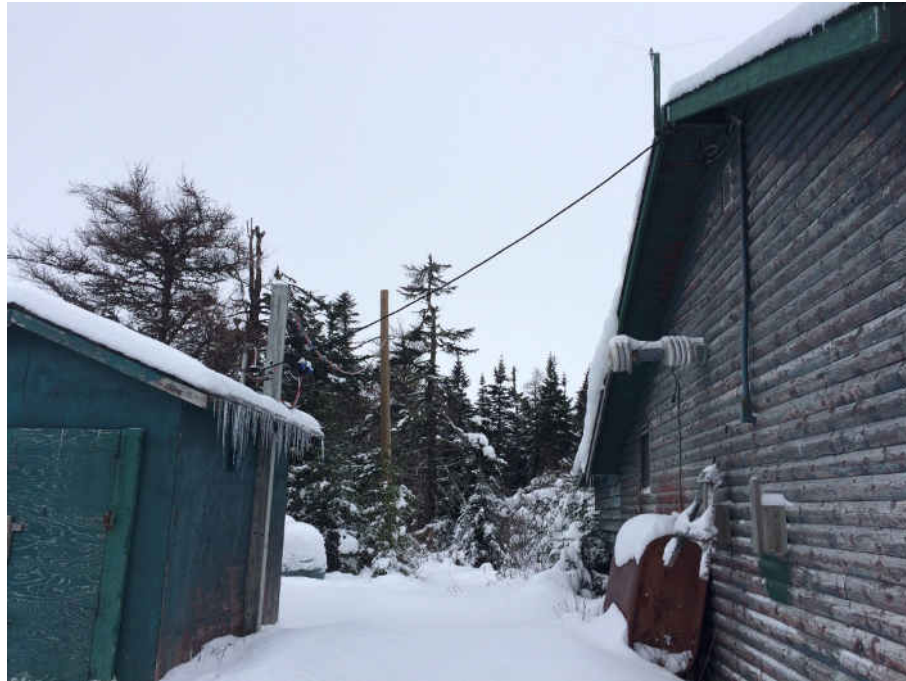
Due to the low hanging power lines connecting the building structures at the site, several proposed test pit locations were not able to be excavated during the January 19th site visit as they presented a safety hazard for the excavator operator. As a result, the remaining test pit locations were excavated at a later date with a smaller excavator that was able to maneuver in the areas of the low hanging wires.

Photo 4: Low hanging power lines between generator shed and workshop.

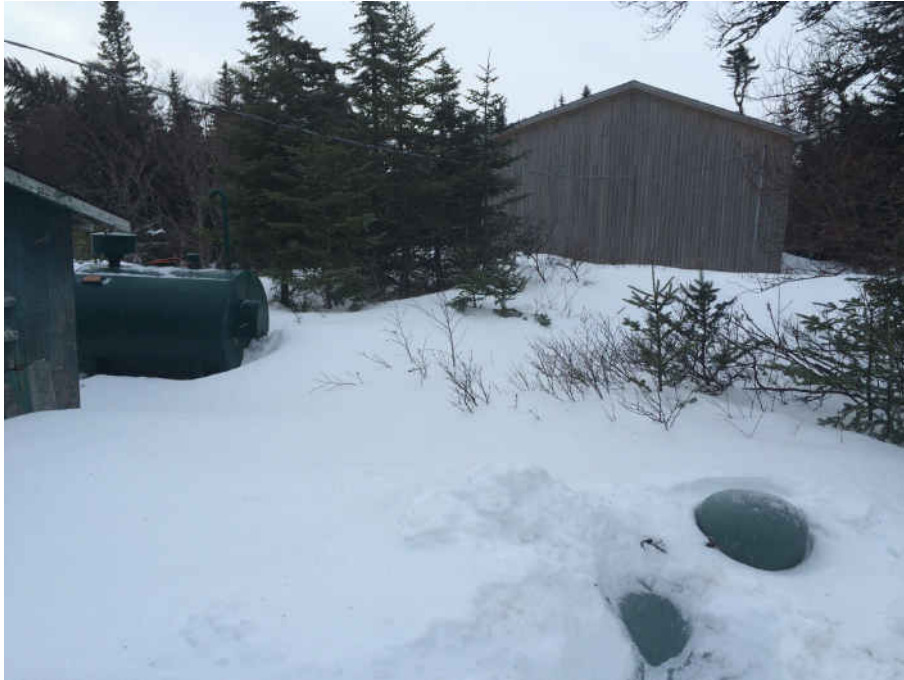
Photo 5: Low hanging power lines preventing access to dig test pits.

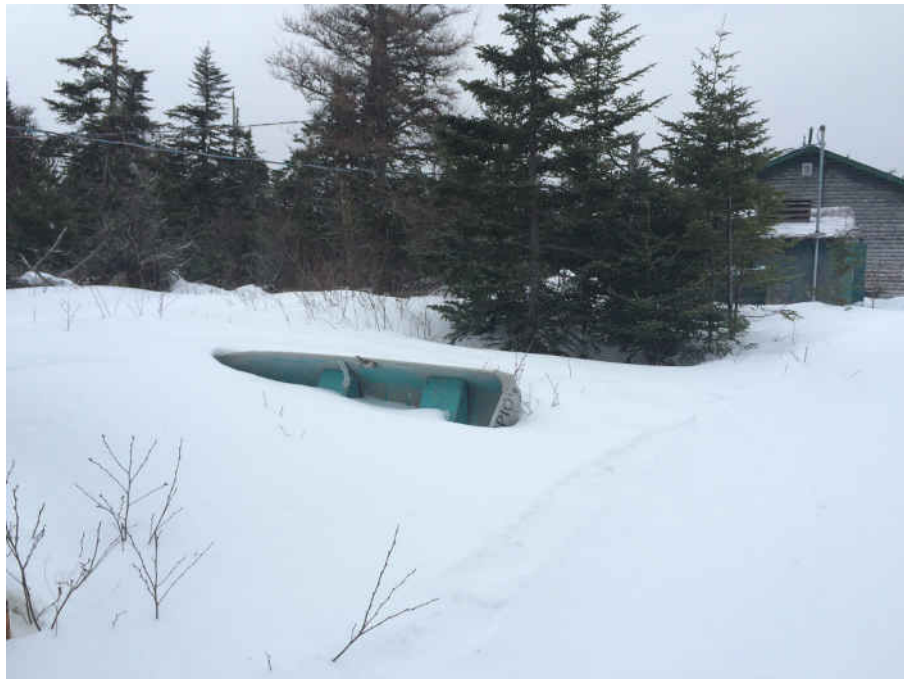
Mr. Brown stated that he preferred that any further work at the site be delayed until most of the snow had melted. He was concerned that any heavy equipment such as a drill rig or excavator may damage snow buried equipment (ex. boats, building materials) that were located under the snow within the Diesel Generator Site.

Photo 6: Boat buried in snow at proposed sampling area.

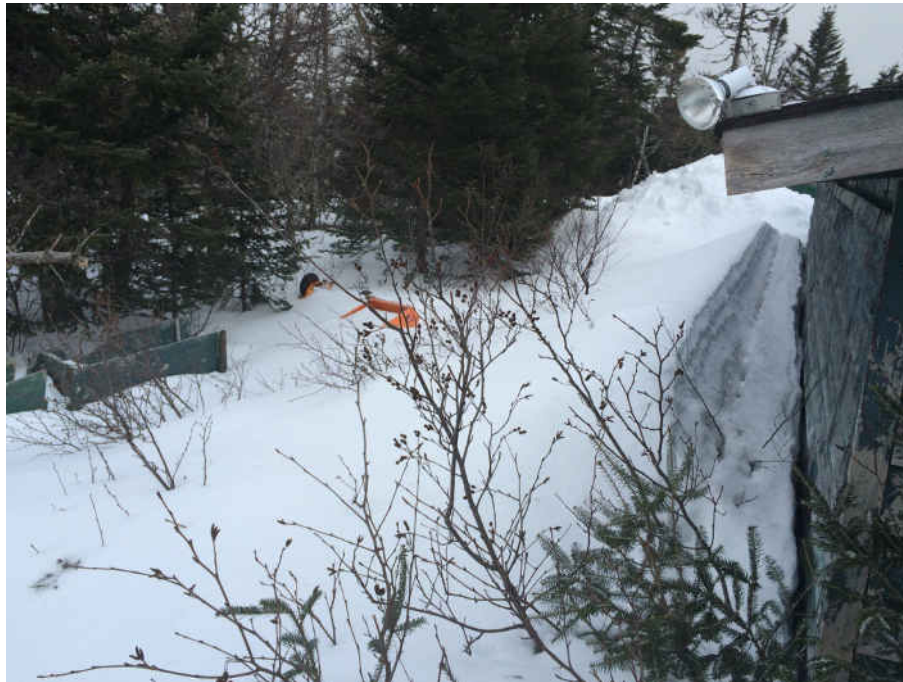
Photo 7: Trailers and building materials buried in the snow at proposed sampling area.

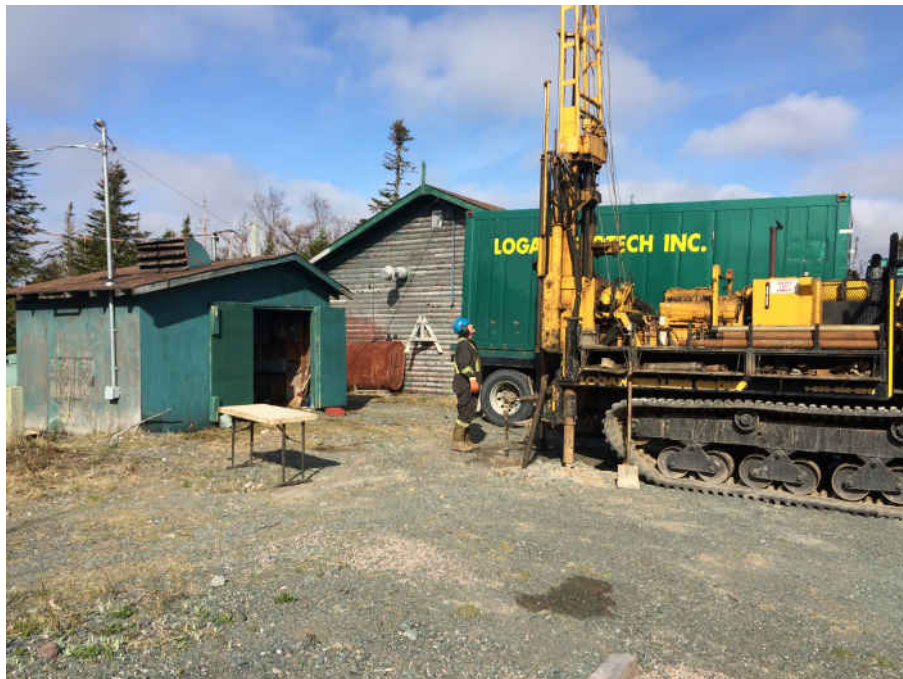
Photo 8: Monitoring Well MW-1 Installation.

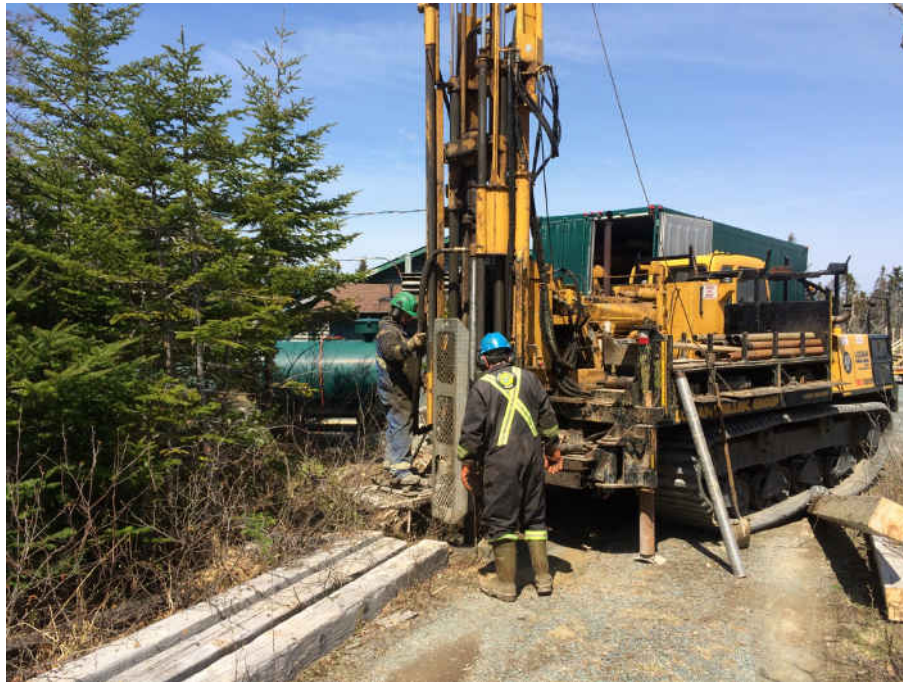
Photo 9: Monitoring Well MW-2 Installation.

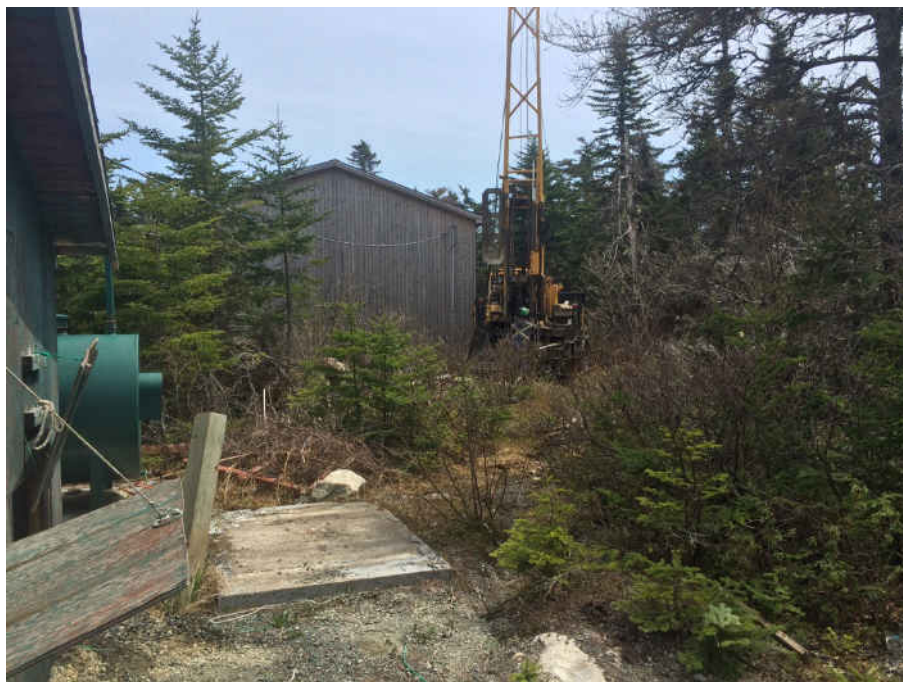
Photo 10: Monitoring Well MW-3 Installation.

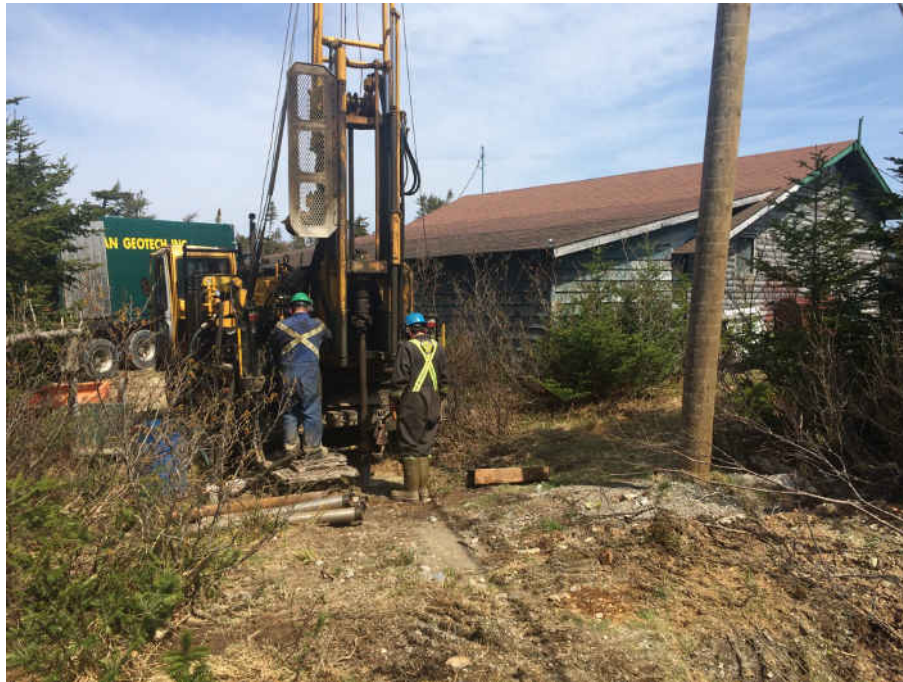
Photo 11: Monitoring Well MW-4 Installation.

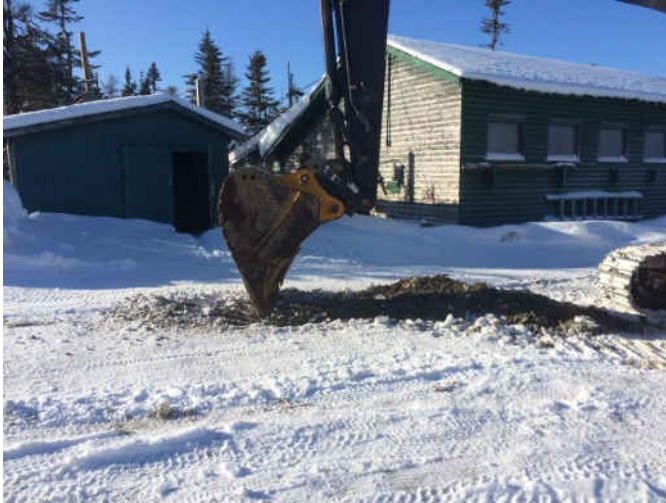
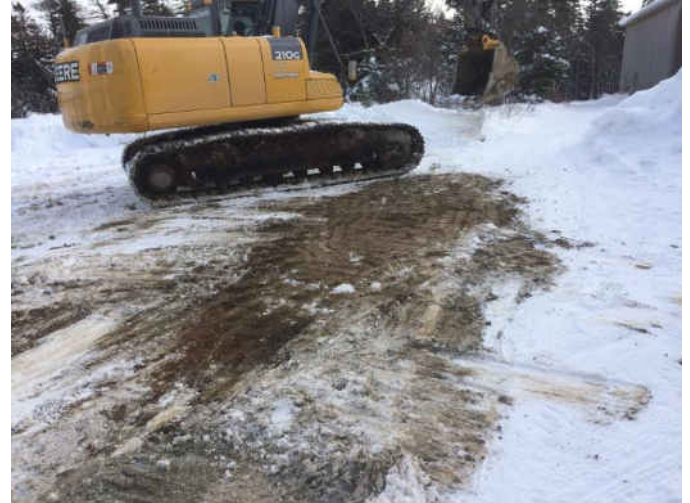
Location of Test Pit 1.

Test Pit 1 after being backfilled.

Test Pit Identification Number	Depth	Soil Description
Test Pit 1 5249687N 345687E	0.0 – 0.15	Dark brown, dry, loose, soil/gravel with organics.
	0.15 – 1.0	Brown, dry, loose, soil/gravel.
	1.0 – 1.5	Brown, dry, loose, soil/gravel. Test pit terminated due to bedrock.

- Located directly in front of the parks generator shed, in a parking lot.
- Buckle's Contracting subcontracted to perform test pit operations.
- 210 John Deere excavator used for test pit digging.

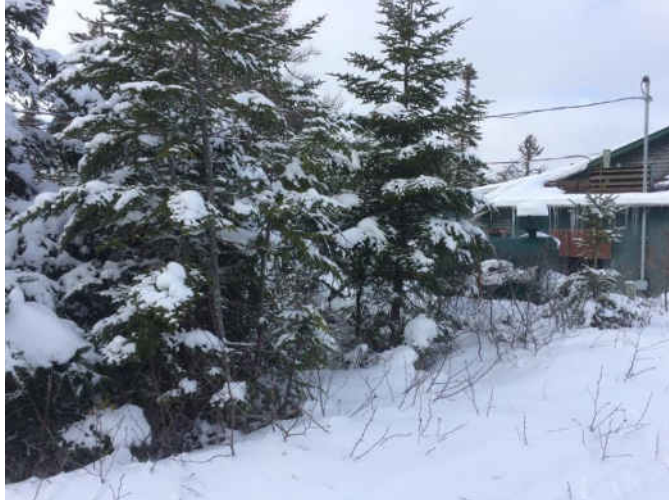
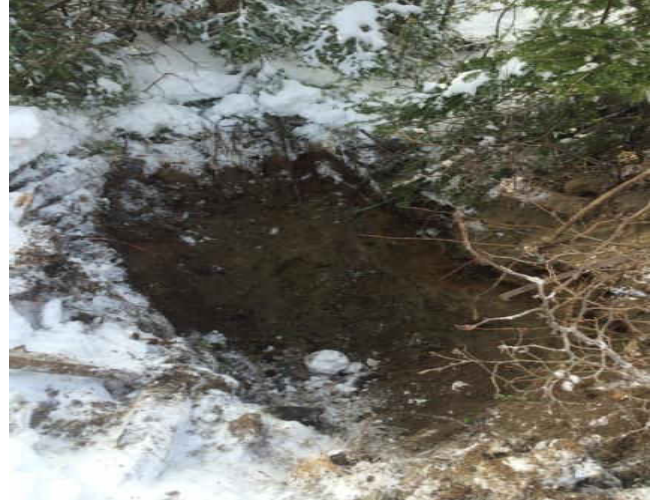
Location of Test Pit 2.

Test Pit Identification Number	Depth	Soil Description
Test Pit 2 5249674N 345692E	0.0 – 0.15	Dark brown dry, soil/gravel with organics.
	0.15 – 1.0	Light Brown, dry, loose, soil/gravel.
	1.0 – 1.6	Light Brown, dry, loose, soil/gravel. Test pit terminated due to bedrock.

- Located in wooded area alongside the generator shed, with trees, branches and bushes.
- Buckle's Contracting subcontracted to perform test pit operations.
- 210 John Deere excavator used for test pit digging.

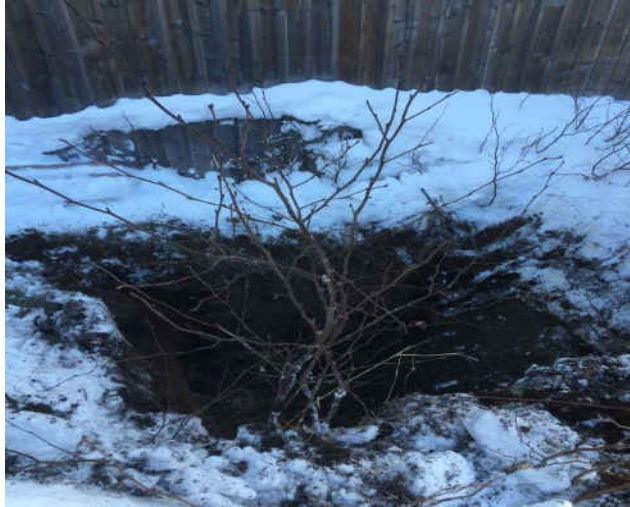
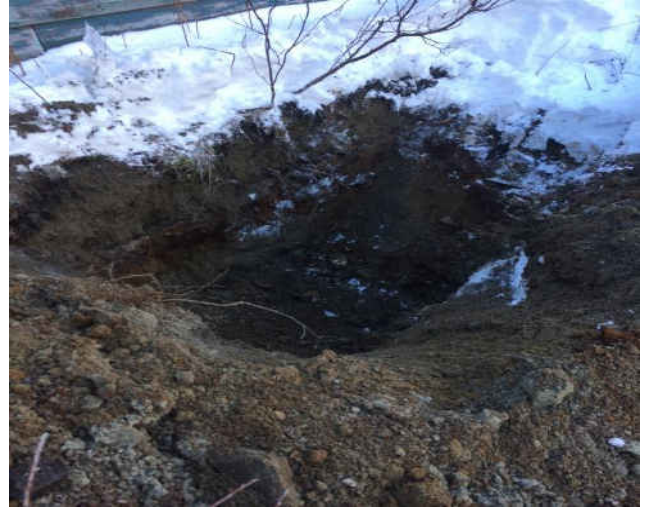
Test Pit 3.

Test Pit Identification Number	Depth	Soil Description
Test Pit 3 5249666N 345696E	0.0 – 0.15	Dark Brown, dry, loose, topsoil with organics.
	0.15 – 1.0	Light Brown, dry, fine, loose, soil/gravel.
	1.0 – 1.9	Light Brown, dry, loose, soil/gravel. Test pit terminated due to bedrock.

- Located in alongside a shed, with branches, low growing shrubs and bushes.
- Buckle's Contracting subcontracted to perform test pit operations.
- 210 John Deere excavator used for test pit digging.

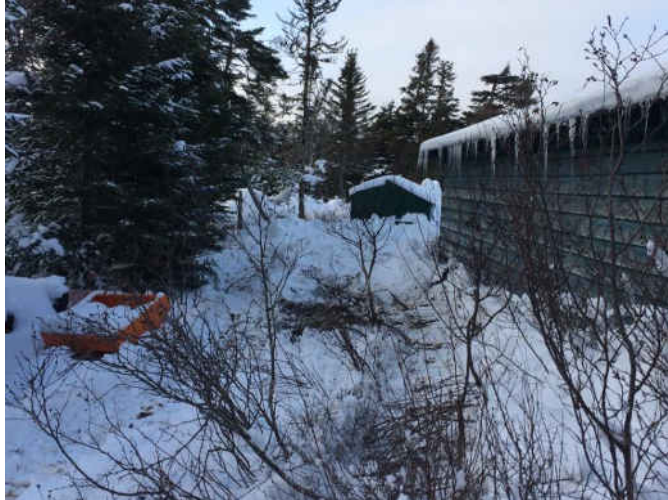
Test Pit 4 Location.

Test Pit Identification Number	Depth	Soil Description
Test Pit 4 5249678N 345667E	0.0 – 0.15	Light brown dry, topsoil/gravel with organics.
	0.15 – 1.0	Light brown dry, topsoil/gravel.
	1.0 – 1.8	Light brown dry, topsoil/gravel. Test pit terminated due to bedrock.

- Located between workshop and wooded area, with grass, branches and bushes.
- Buckle's Contracting subcontracted to perform test pit operations.
- 210 John Deere excavator used for test pit digging.

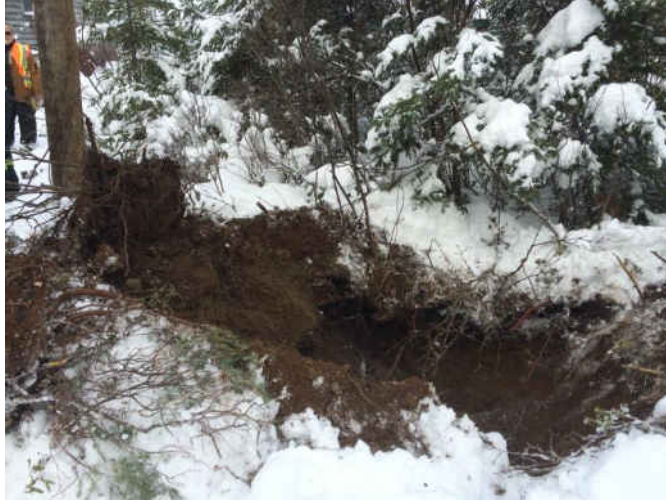
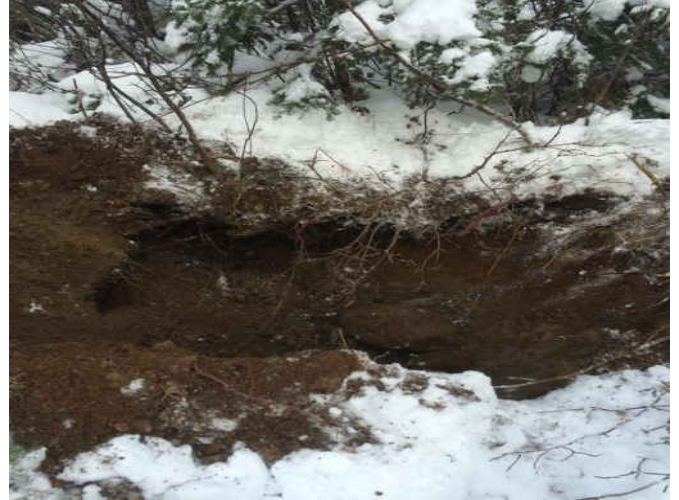
Test Pit 5.

Test Pit Identification Number	Depth	Soil Description
Test Pit 5 5249668N 345676E	0.0 – 0.15	Dark brown dry, topsoil/gravel with organics.
	0.15 – 1.0	Light brown dry, topsoil/gravel. Test pit terminated due to bedrock.

- Located in wooded area, with tree stumps and branches, low growing shrubs, bushes, and mosses. Public trail alongside test pit location.
- Buckle's Contracting subcontracted to perform test pit operations.
- 210 John Deere excavator used for test pit digging.
- Test pit repositioned to accommodate excavator access.

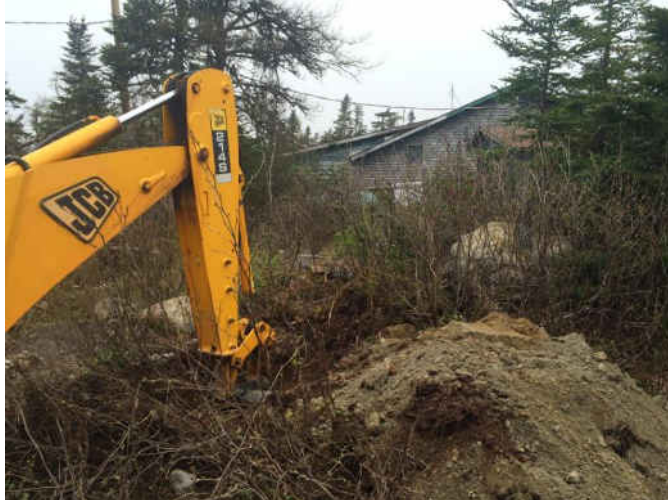
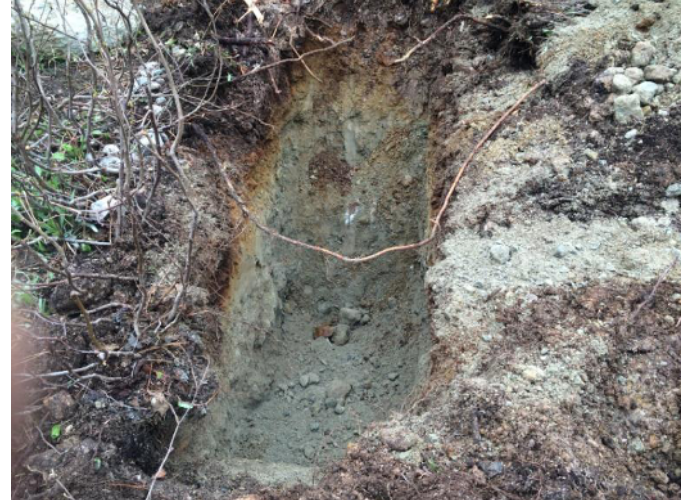
Test Pit 6.

Test Pit Identification Number	Depth	Soil Description
Test Pit 6 5249667N 345692E	0.0 – 0.2	Dark brown dry, topsoil/gravel with organics.
	0.2 – 1.5	Light grey dry, coarse pebble and gravel. Test pit terminated due to bedrock.

- Located between generator shed and storage shed, with tree stumps and branches, low growing shrubs, bushes, and mosses.
- Larry Kings Excavating subcontracted to perform test pit operations.
- Rubber Tire Backhoe used for test pit digging.

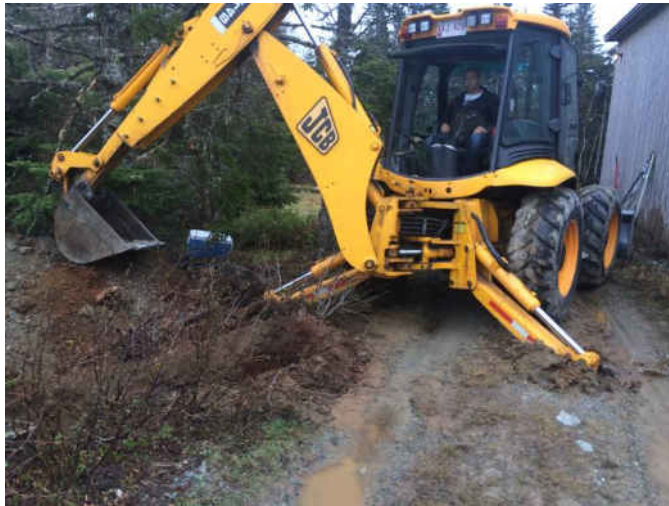
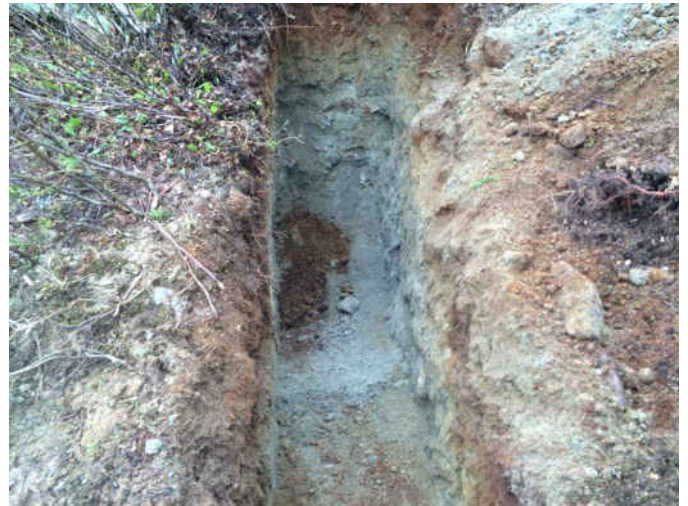
Test Pit 7.

Test Pit Identification Number	Depth	
Test Pit 7 5249675N 345703E	0.0 – 0.3	Dark brown dry, topsoil/gravel with organics.
	0.3 – 1.9	Light grey dry, coarse pebble and gravel. Test pit terminated due to bedrock.

- Located north of the storage shed, with tree stumps and branches, low growing shrubs, bushes, and mosses.
- Larry Kings Excavating subcontracted to perform test pit operations.
- Rubber Tire Backhoe used for test pit digging.

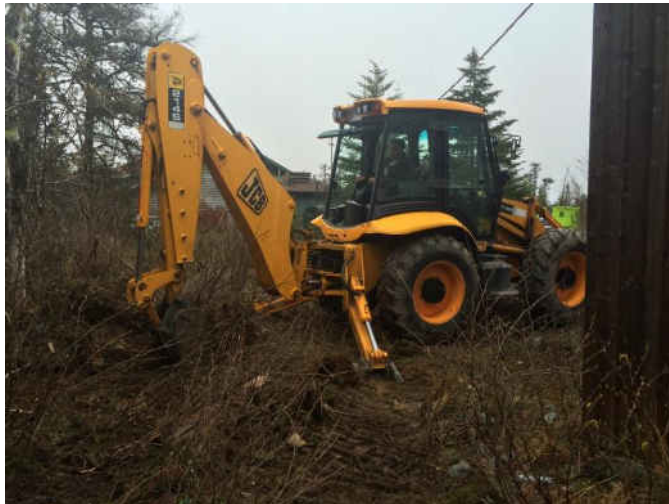
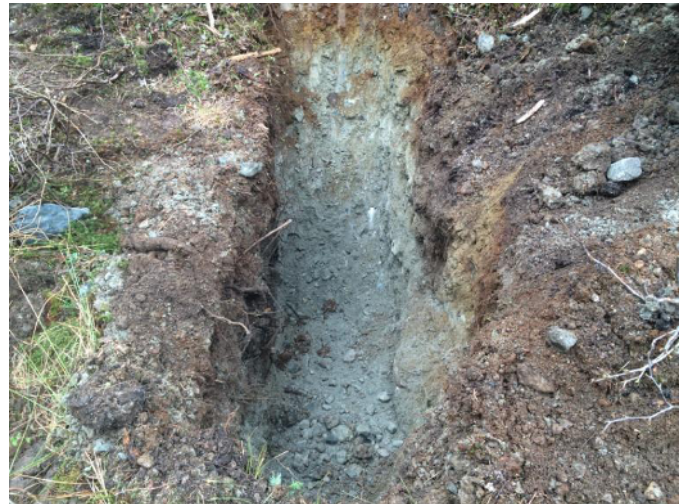
Test Pit 8.

Test Pit Identification Number	Depth	
Test Pit 8 5249669N 345691E	0.0 – 0.4	Dark brown dry, topsoil/gravel with organics.
	0.4 – 1.8	Light grey dry, coarse pebble and gravel. Test pit terminated due to bedrock.

- Located south of the storage shed, with tree stumps and branches, low growing shrubs, bushes, and mosses.
- Larry Kings Excavating subcontracted to perform test pit operations.
- Rubber Tire Backhoe used for test pit digging.

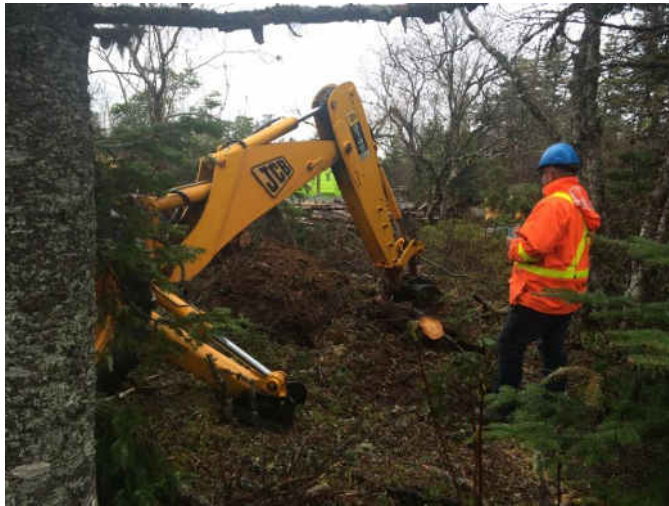
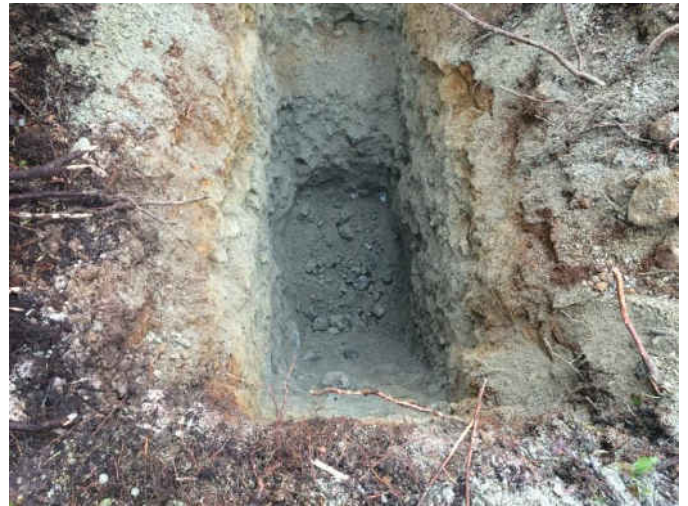
Test Pit 9.

Test Pit Identification Number	Depth	
Test Pit 9 5249679N 345705E	0.0 – 0.3	Dark brown dry, topsoil/gravel with organics.
	0.3 – 1.8	Light grey dry, coarse pebble and gravel. Test pit terminated due to bedrock.
