### ANNUAL SUMMARY REPORT

2010/2011 MONITORING AND MAINTENANCE PROGRAM COME BY CHANCE SECURE LANDFILL COME BY CHANCE, NEWFOUNDLAND AND LABRADOR

Prepared by: Conestoga-Rovers & Associates

MARCH 2011 Ref. no. 056680 (3)

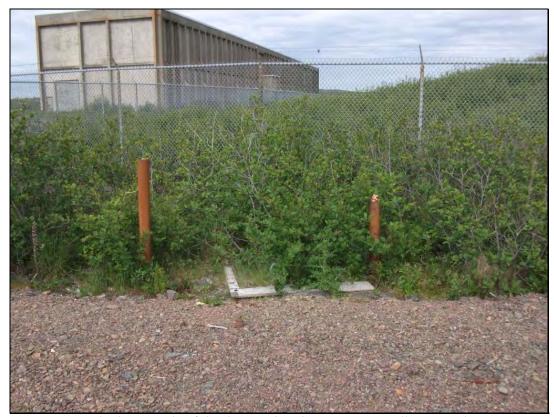
Two existing stick-up monitor wells (MW93-3 and MW93-3A) located immediately adjacent to the exterior northwest corner of the landfill fencing were previously damaged and unable to be sampled (Refer to Photograph 1 of Appendix A); therefore, two new monitor wells were required to complete groundwater sampling at this location. The two damaged wells were decommissioned in accordance with GD-PPD-024 rev.1 (Appendix D of the Guideline Document for the Management of Impacted Sites).

**Photo 1:** View, looking north, of the damaged stick-up monitor wells 93-3 and 93-3A.

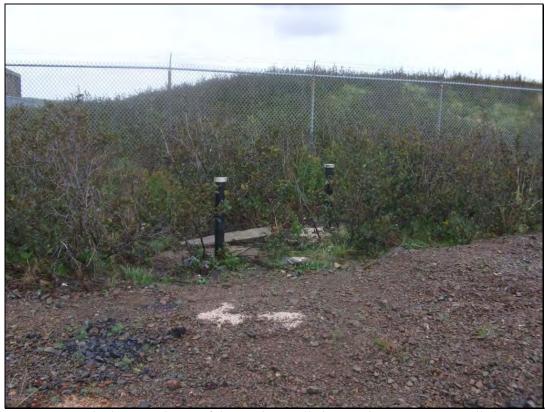
**Photo 2:** View, looking northeast, of the newly installed groundwater monitor wells (MW10-1 and MW10-1A).

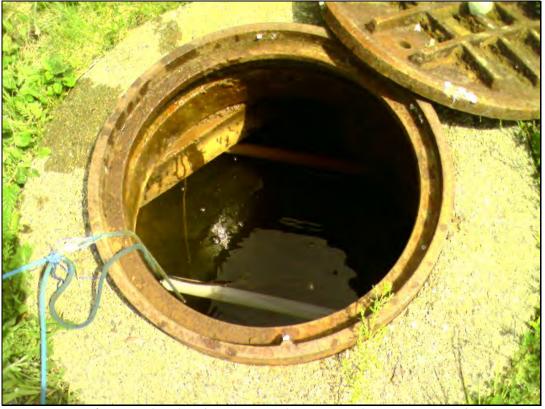
**Photo 3:** View of PLCS valve chamber prior to July 2010 sampling event. Note discharge hose floating in the chamber (upper corner).

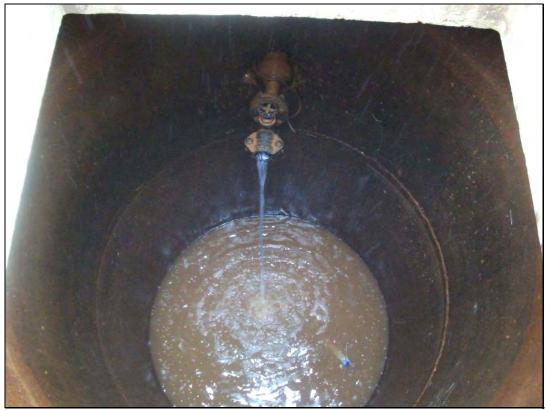
During the first leachate pumping event in August 2010, it was observed that the PLCS and SLCS valves were in the open position with the discharge hose no longer connected to the PLCS valve (Refer to Photograph 2 of Appendix A). CRA determined in-flow rates by pumping down each valve chamber, measuring the change in head over a fixed period of time, then calculated in-flow. Maintaining these valves in the open position does not create any integrity issues for containment as the hydraulic head in the two leachate valve chambers has not risen above the ground surface, even shortly after the Hurricane Igor precipitation event in September 2010.

**Photo 4:** View of PLCS valve chamber with discharge hose disconnected.

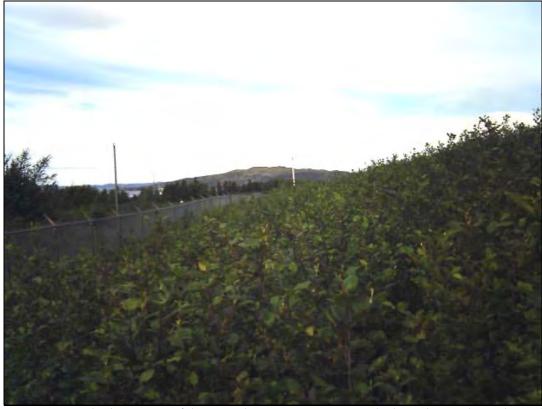
- Vegetation height reaching 1.5 metres, typically alders, which exceeds the OMM requirement of maximum vegetation height of 0.3 metres;
- Landfill vents in good condition and not obstructed;
- No evidence of erosion or animal burrows on the landfill cover;
- Slopes in good condition and covered with vegetation with no signs of erosion; and
- Lateral drains dry with occasional areas of standing water.

**Photo 5:** View, looking west, of the typical vegetative overgrowth along the southern slope of the landfill cover.

**Vegetation Control:** CRA recommend that all vegetation on the landfill cover that measures over 0.3 metres in height should be cut down. This work can be completed in conjunction with vegetation control in the monitor well locations outside the fenced area of the landfill.

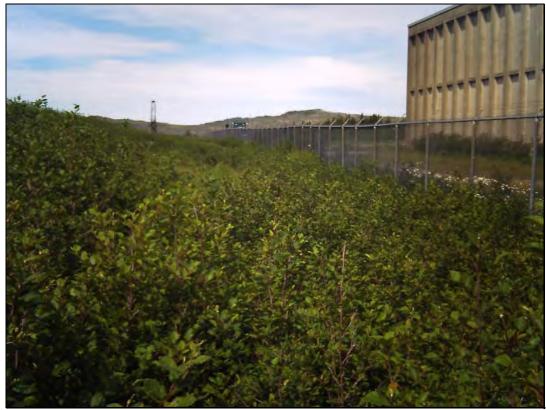
**Photo 6:** View, looking east, of the typical vegetative overgrowth along the northern slope of the landfill cover.

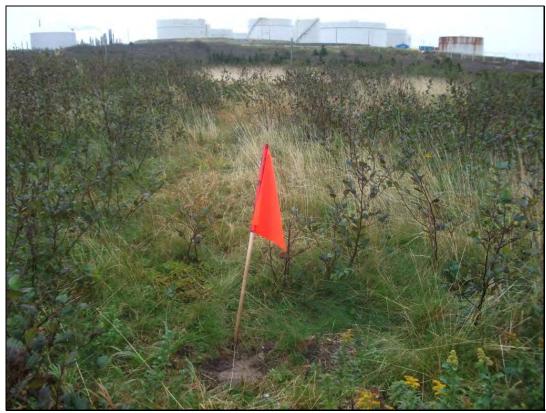
Upon reviewing the results of the elevation control survey, it was noted the elevation control points decreased in elevation by an average of 40 millimetres between August and December 2010. The elevation control points were installed in August 2010 and may have settled slightly due to their recent installation; therefore, additional

**Photo 7:** View, looking east, of a typical elevational survey control point installed on the landfill cover.

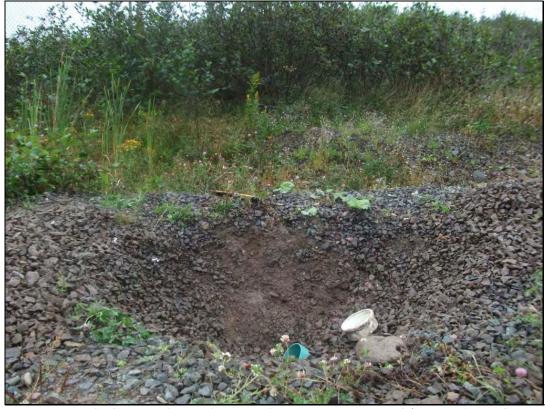
Photo 8: View, looking southeast, showing Clean-out 2 prior to modifications (typical).

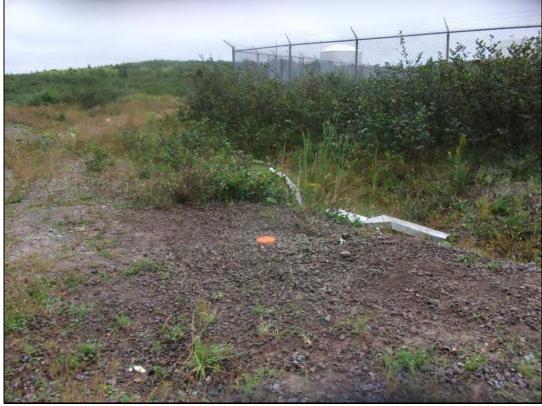
**Photo 9:** View, looking northeast, showing Clean-out 2 after modifications (typical) with painted flushmount cover.

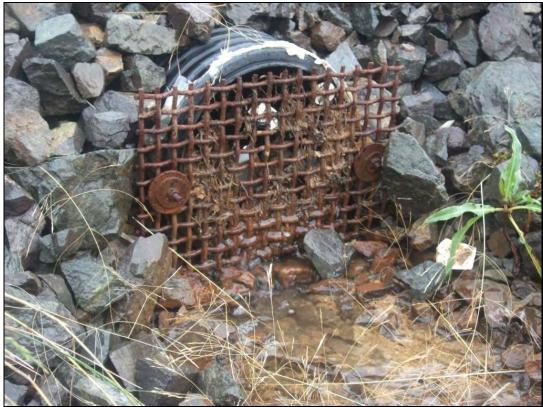
Water was not observed discharging from the drainage system into the swale on the west side of the gravel service road during the July 2010 Site visit. An impromptu inspection of the groundwater drainage system on September 25, 2010 confirmed that water was flowing from the discharge on the west side of the gravel service road (Refer to Photograph 10 of Appendix A). The observed water discharge in September 2010 was likely a result of a recent and very high precipitation event (Hurricane Igor) compared to limited precipitation in the weeks prior to the July 2010 Site visit.

Photo 10: View, looking northeast, showing groundwater discharge from the groundwater drainage system beyond the service road.
