**Phase II/III Environmental Site
Assessment, Human Health and
Ecological Risk Assessments and
Remedial Action / Risk Management
Plan for the Former U.S. Military Site
and Residential Subdivision at
Hopedale, Labrador**

Newfoundland and Labrador
Department of Environment and
Conservation

Final Report

Date: May 17, 2010

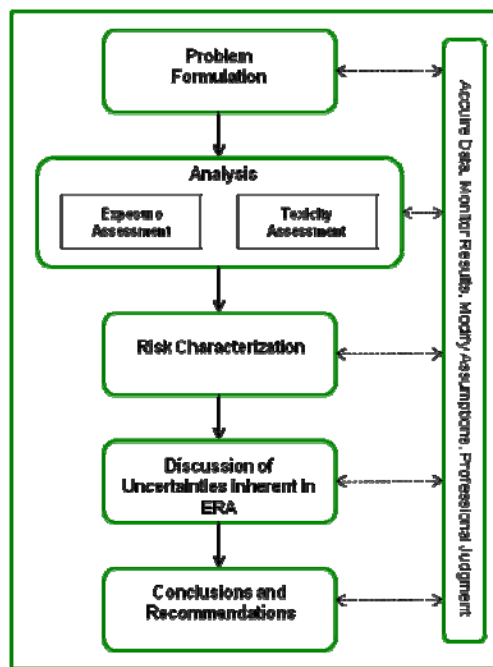
Figure 8.1 ERA Framework

Following this, a discussion of the uncertainties inherent to ERA, and conclusions and recommendations stemming from the assessment are discussed. The ERA framework is conceptually illustrated in Figure 8.1 below.
