PROJECT TITLE:
IMPLEMENTATION OF REMEDIAL ACTION PLAN - YEAR 1, FORMER U.S. MILITARY SITE AND RESIDENTIAL SUBDIVISION, HOPEDALE, NL

Site Photographs

Site Photographs – Implementation of Remedial Action Plan – Year 1, Former U.S. Military Site and Residential Subdivision, Hopedale, NL

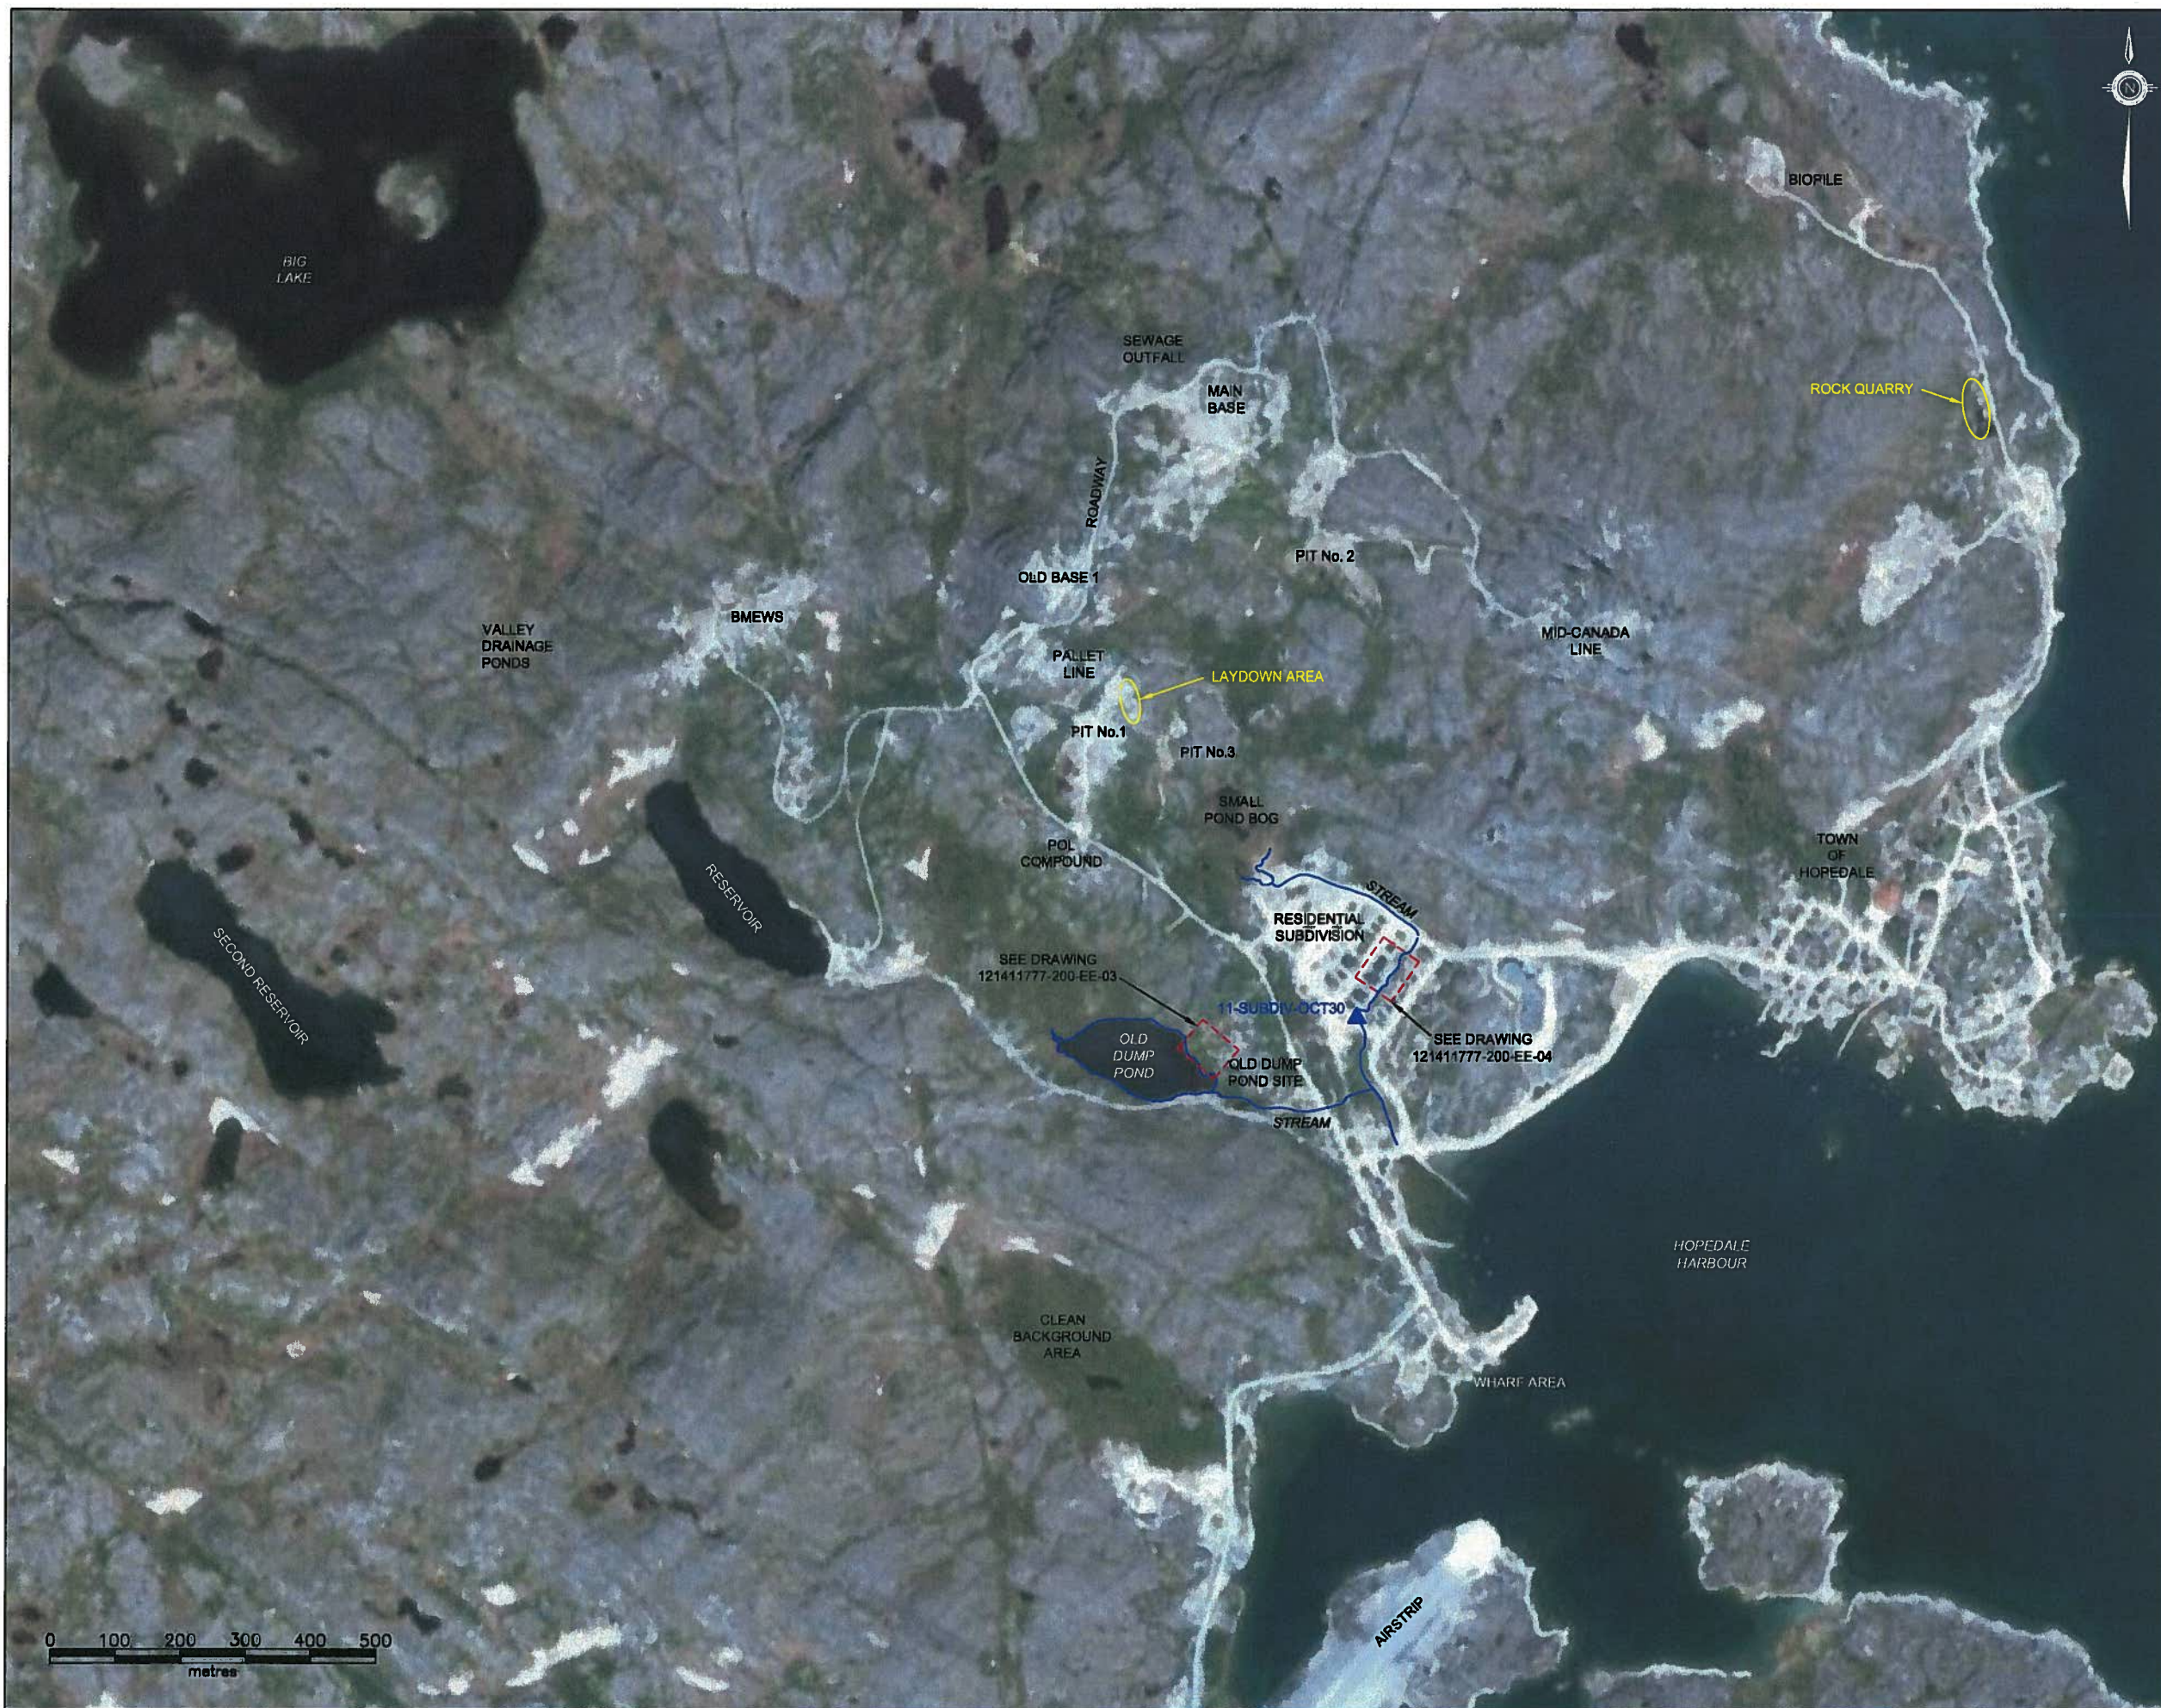
DRAWING TITLE:
SITE PLAN

- STREAM
- ▲ SURFACE WATER SAMPLE LOCATION (STANTEC, 2011)

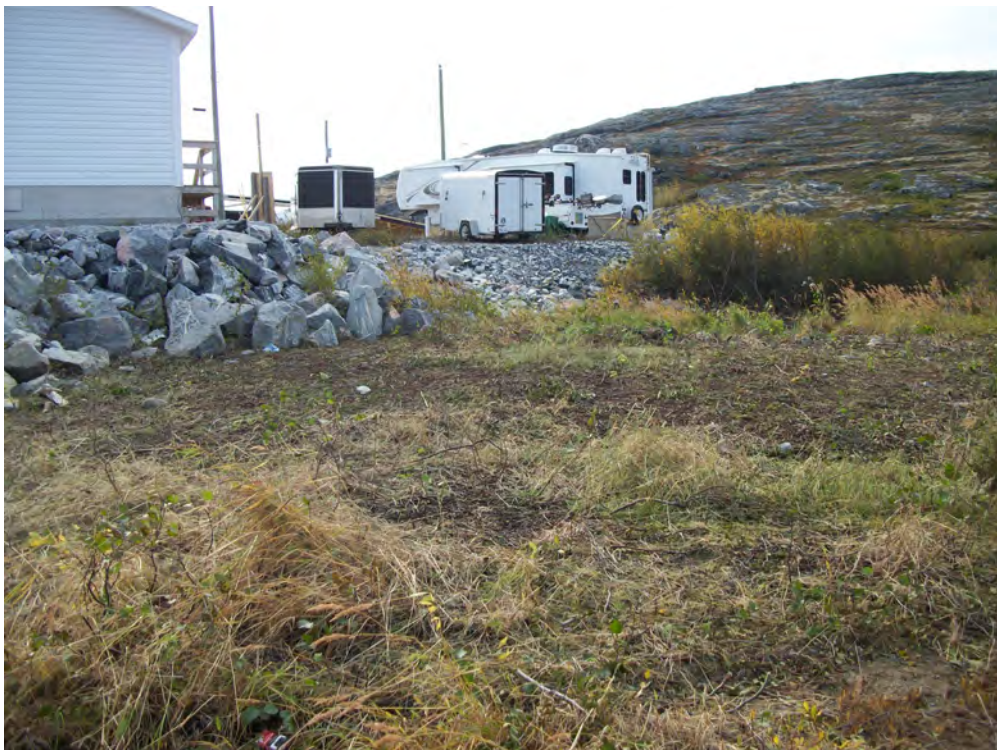
Photo 2 View of area requiring remediation surrounding MW-61 following site clearing and grubbing, looking south.

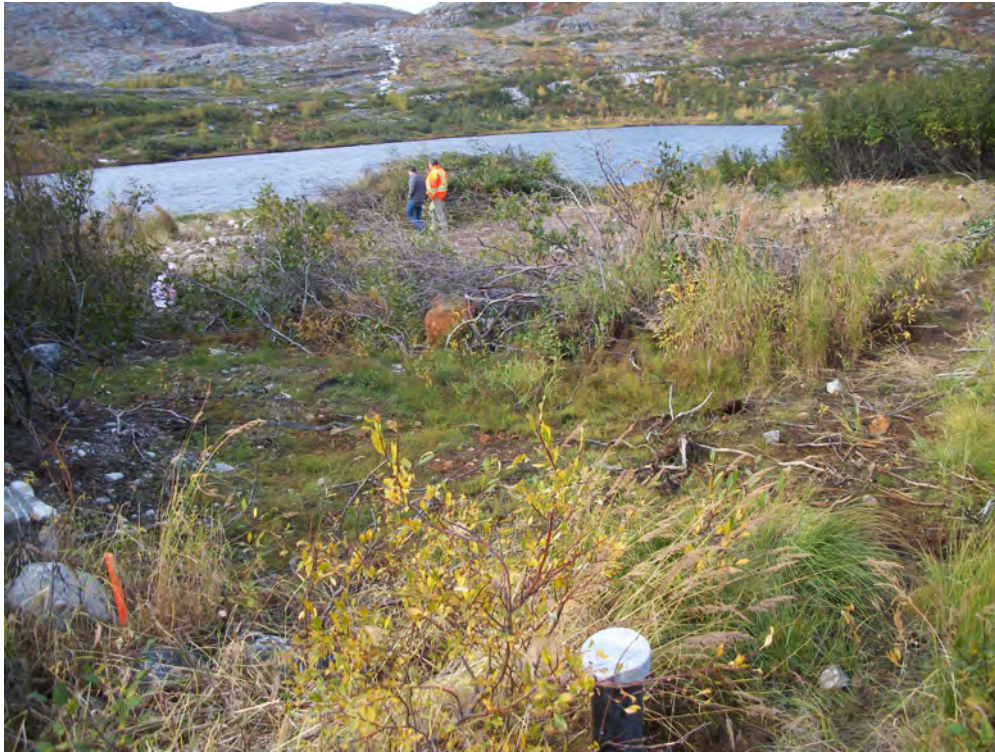
Photo 3 View of area requiring remediation surrounding MW-61 looking southwest towards Old Dump Pond.

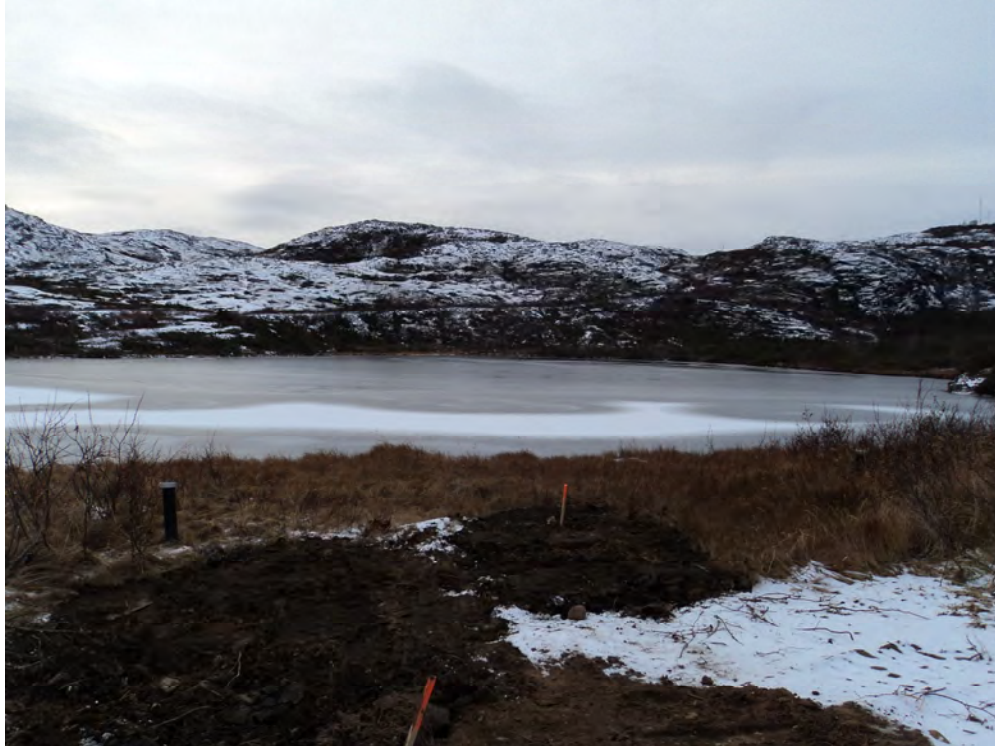
Photo 5 View of monitor wells MW-32 and MW-33 and survey stakes showing location of soil samples 11-ODP-BS7 and 11-ODP-BS8.

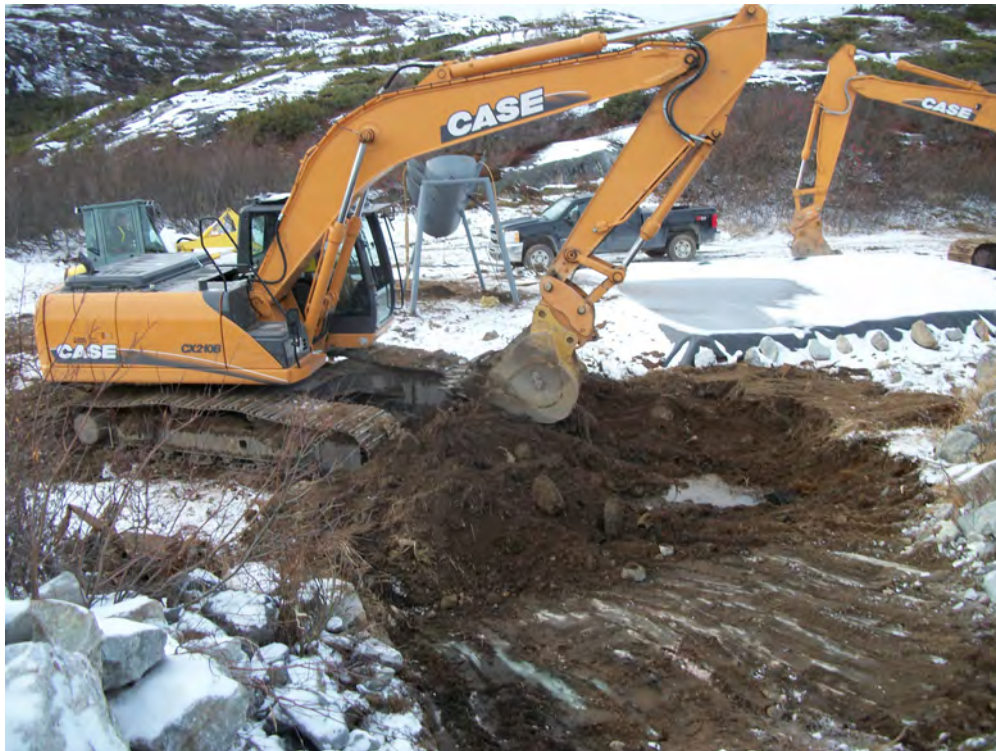
Photo 7 View of start of remedial activities in the vicinity of former monitor well MW-61 on October 31, 2011.

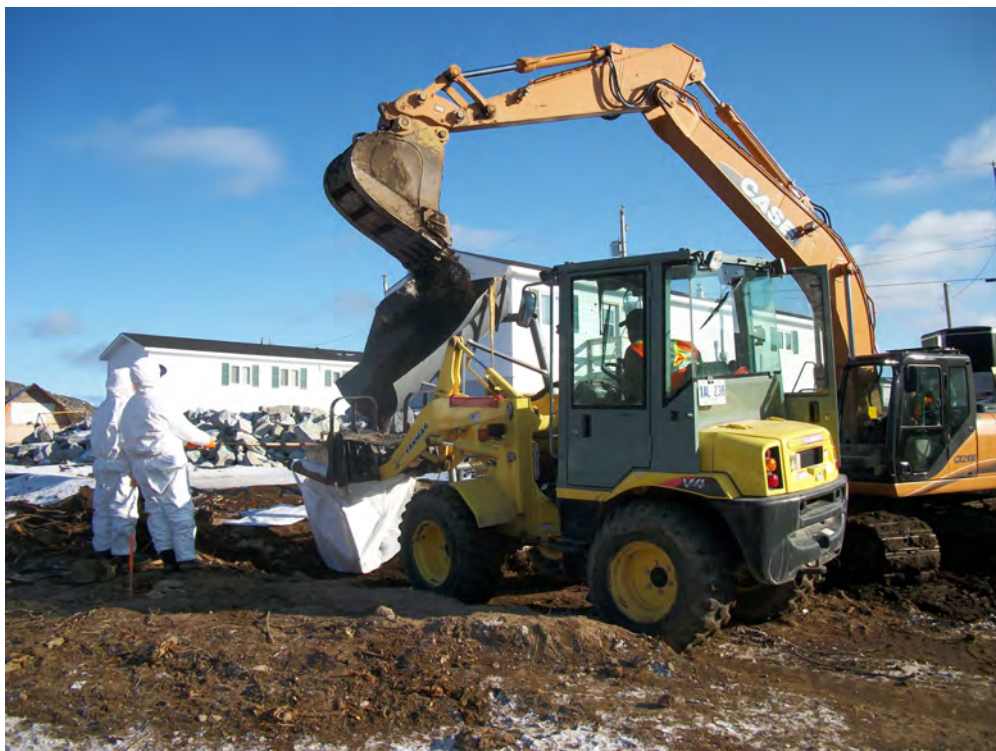
Photo 8 View of soil being loaded into bag on November 1, 2011.

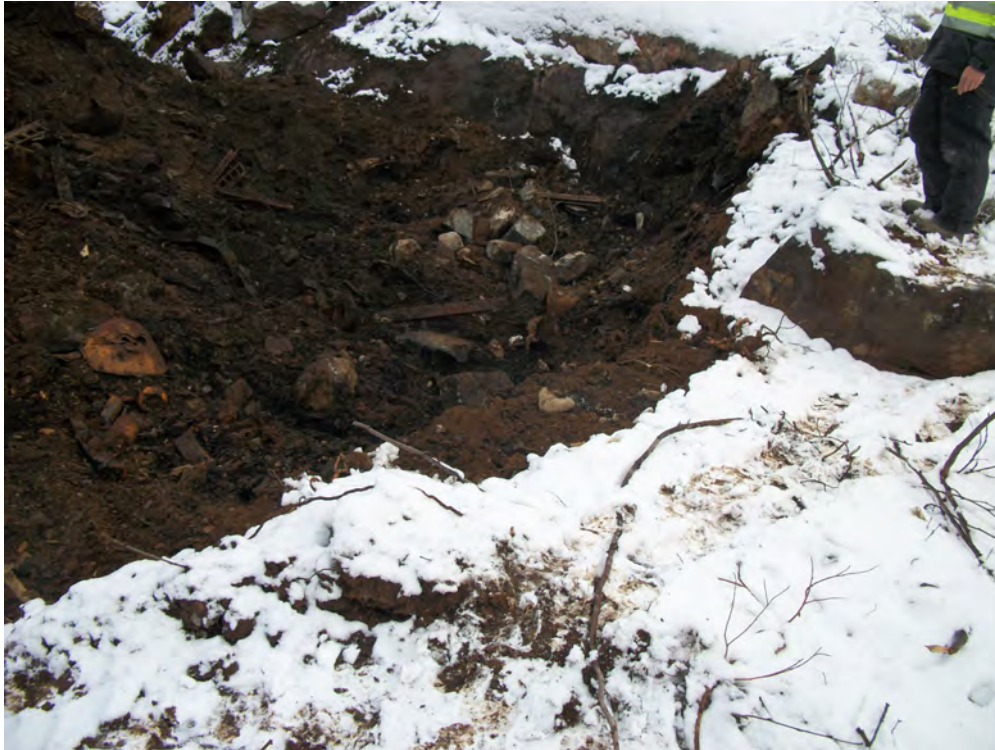
Photo 9 View of buried debris encountered in the remedial excavation.

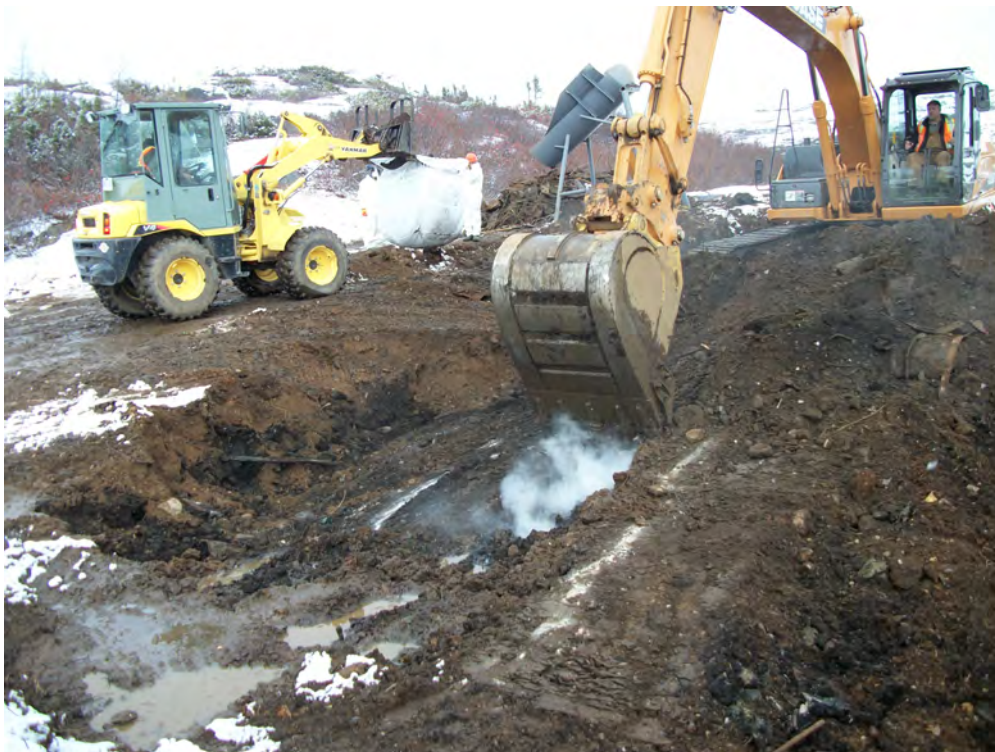
Photo 10 View of bedrock encountered at the base of the remedial excavation.

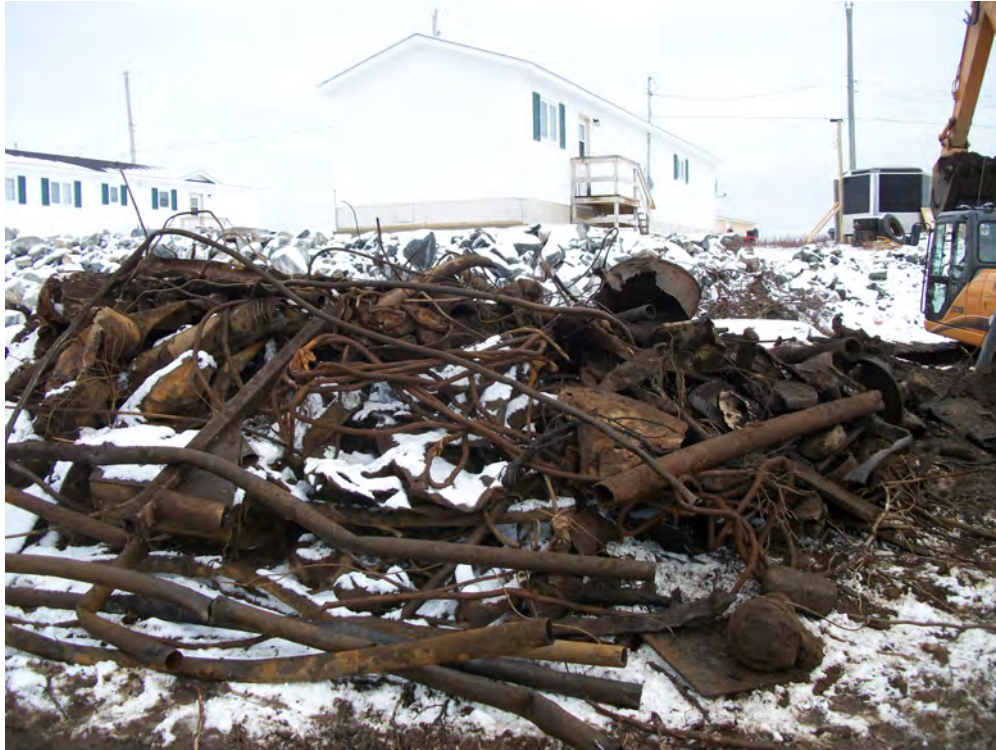
Photo 11 View of scrap metal pile on November 3, 2011.

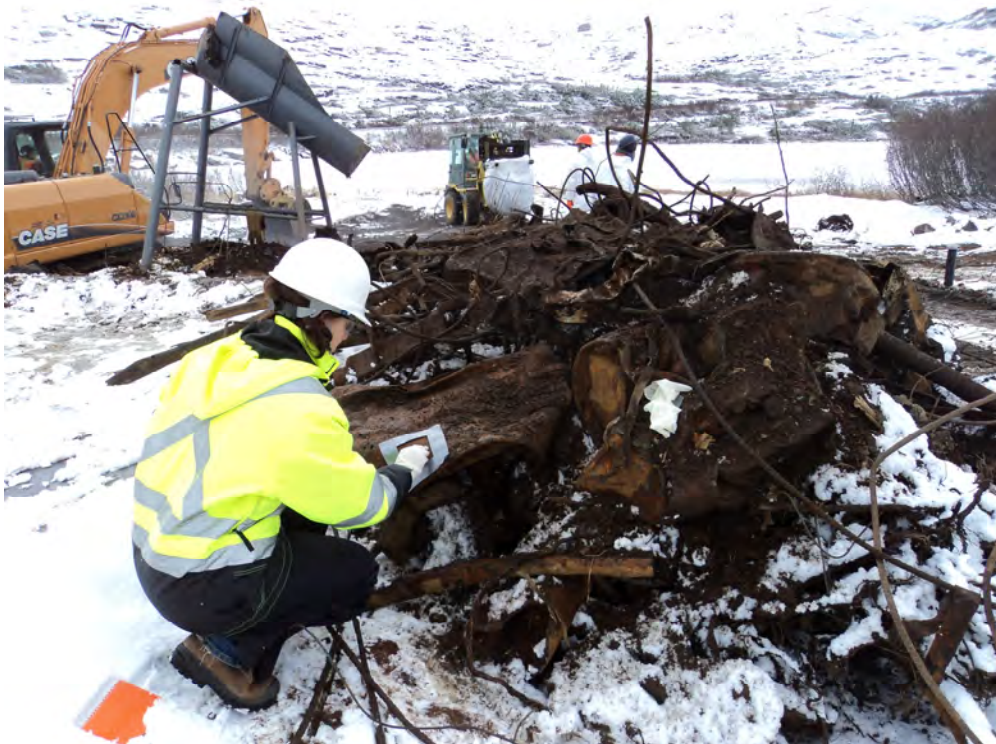
Photo 12 View of collection of swab sample 11-ODP-Swab1.

Sample ID	Sample Location	Polychlorinated Biphenyls (PCBs)	Comments
	RDL	5	-
	Units	µg	-
2011 Sampling - Stantec			
11-ODP-SWAB1	Rusted barrel (unwashed)	<5	-
11-ODP-SWAB2	Scrap metal (unwashed)	<5	-
11-ODP-SWAB3	Scrap metal (unwashed)	<5	-

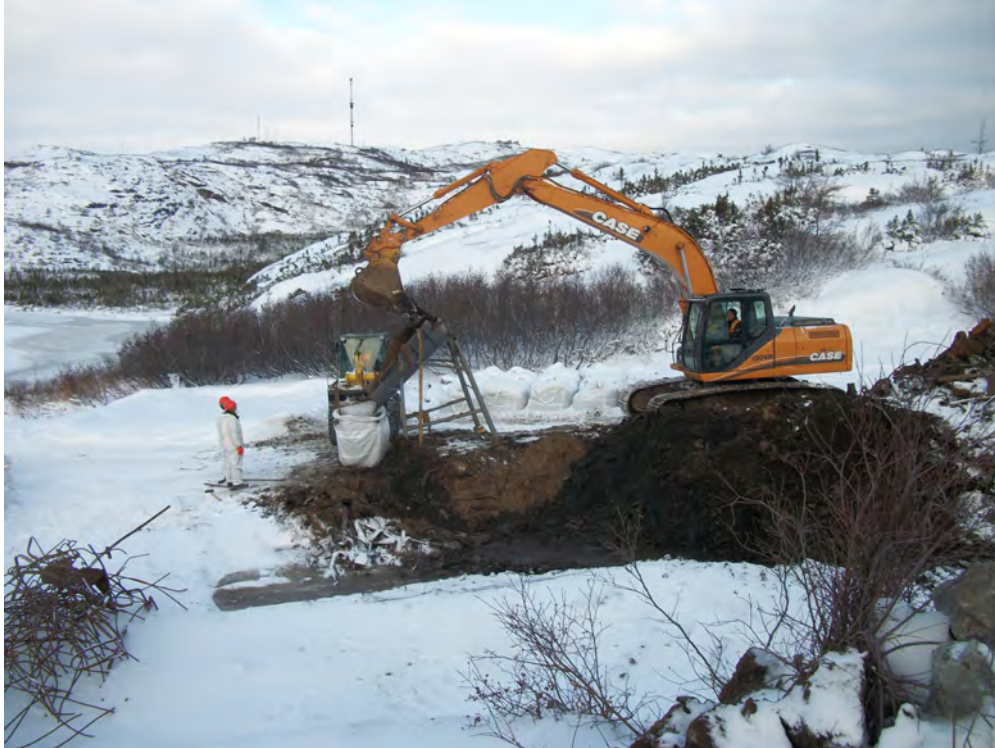
Photo 13 View of remedial excavation on November 5, 2011.

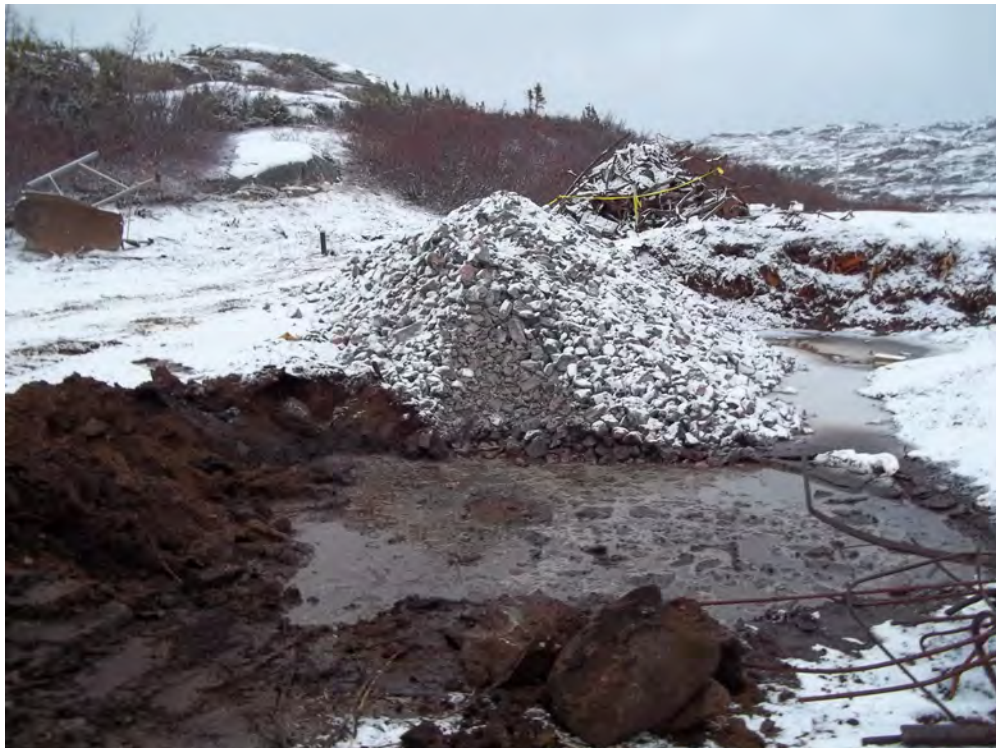
Photo 14 View of site during backfilling on November 16, 2011.

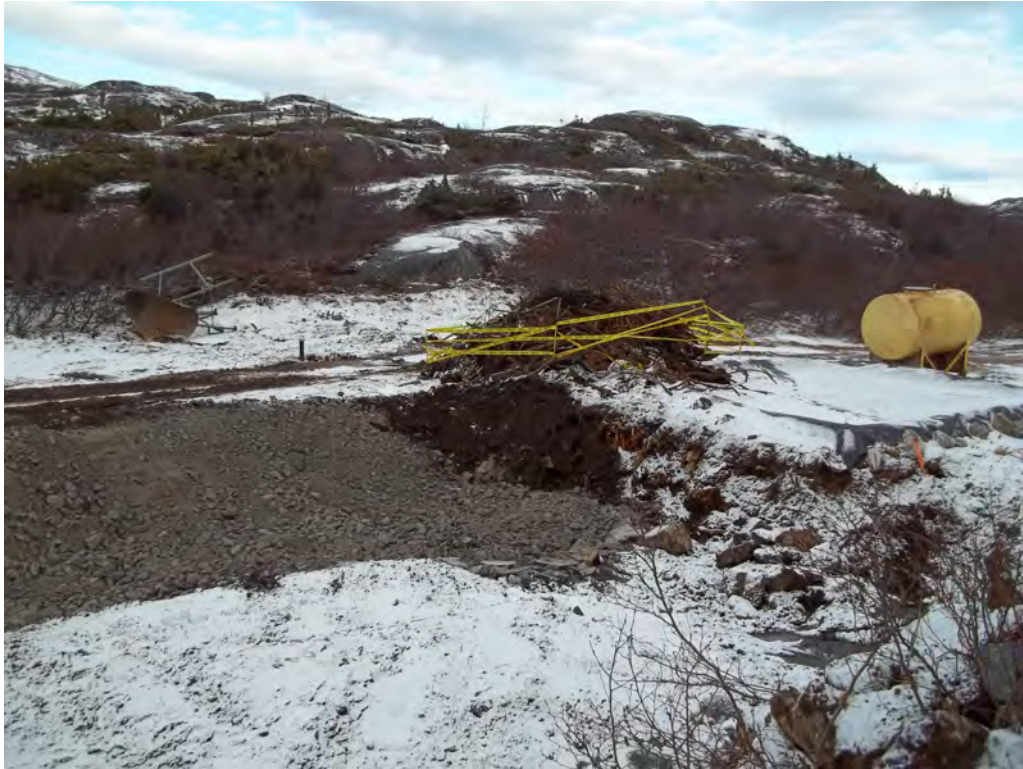
Photo 15 View of scrap metal and backfilled excavation at Old Dump Pond on November 16, 2011, looking north.

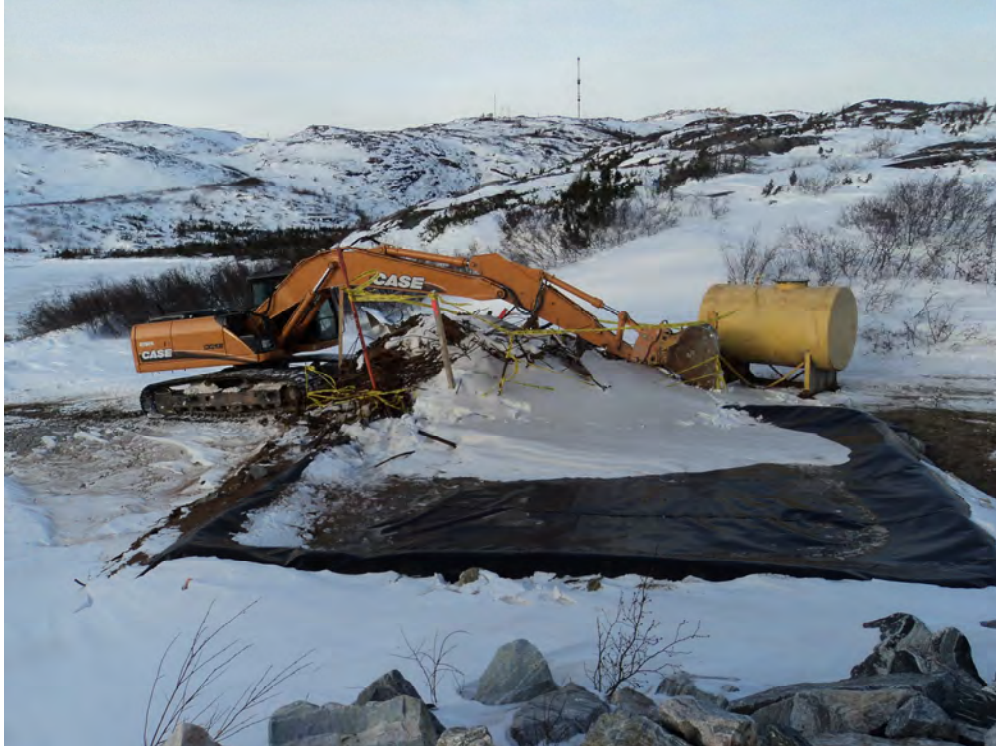
Photo 17 View of scrap metal covered with excavator bucket at the Old Dump Pond site on December 15, 2011.

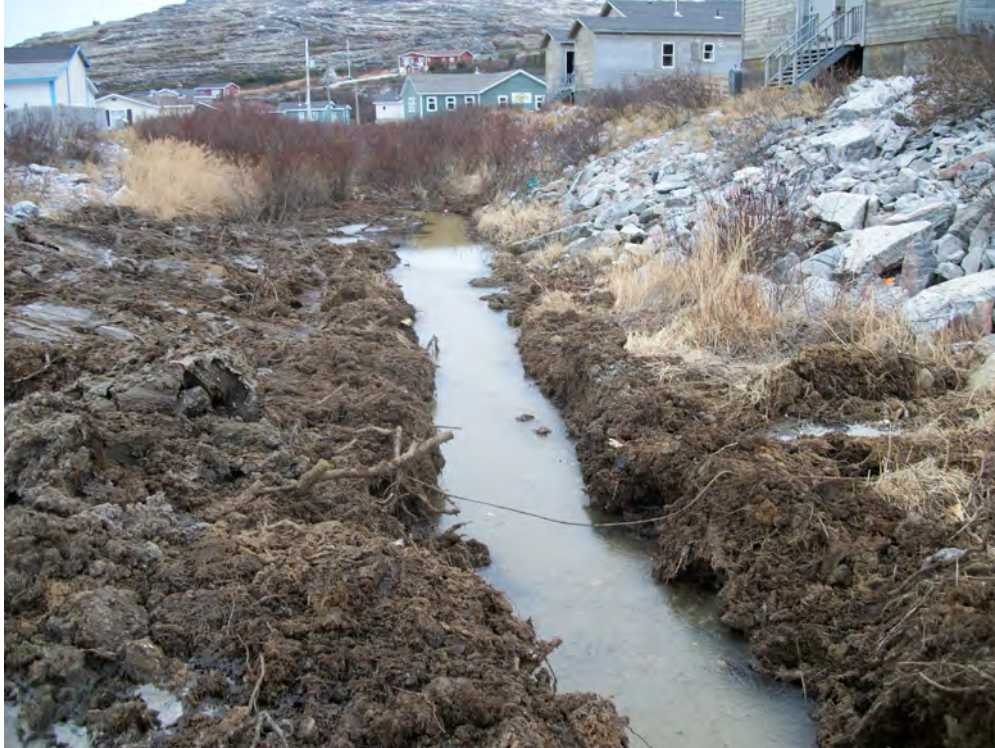
Photo 22 View of trenched stream on October 30, 2011.

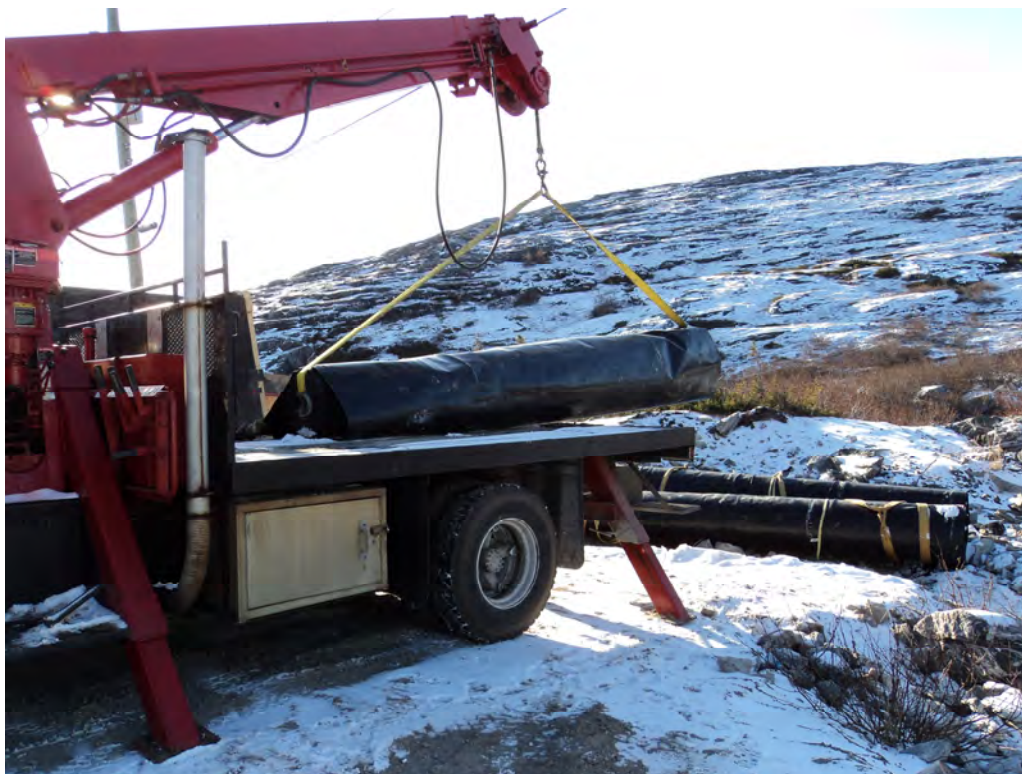
Photo 24 View of liner installation at the laydown area on November 1, 2011.

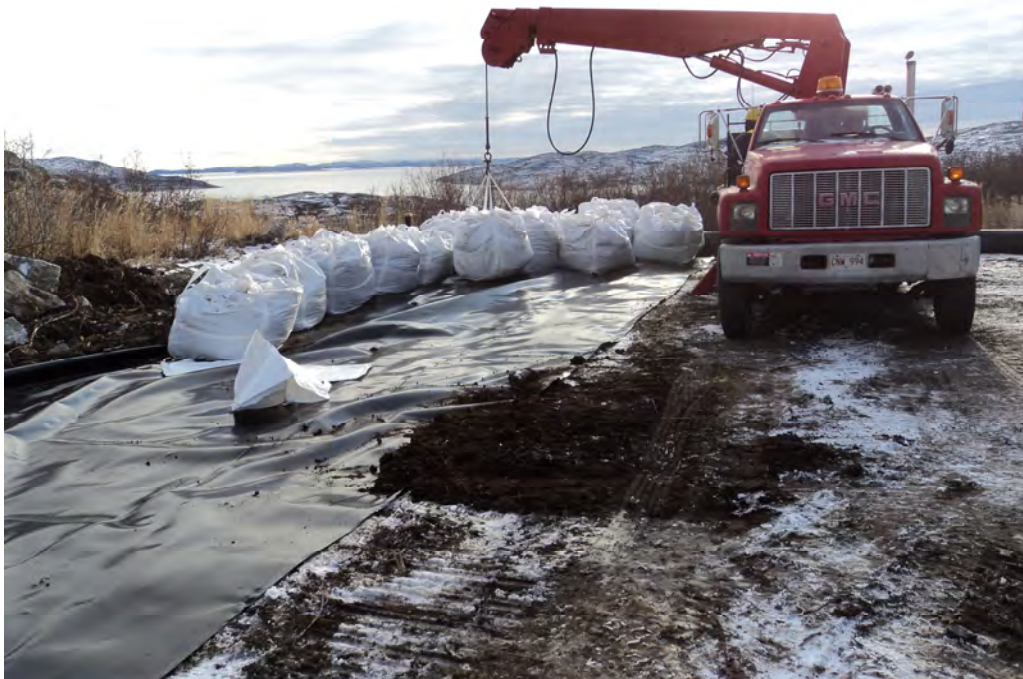
Photo 25 View of bag placement at the laydown area on November 2, 2011.

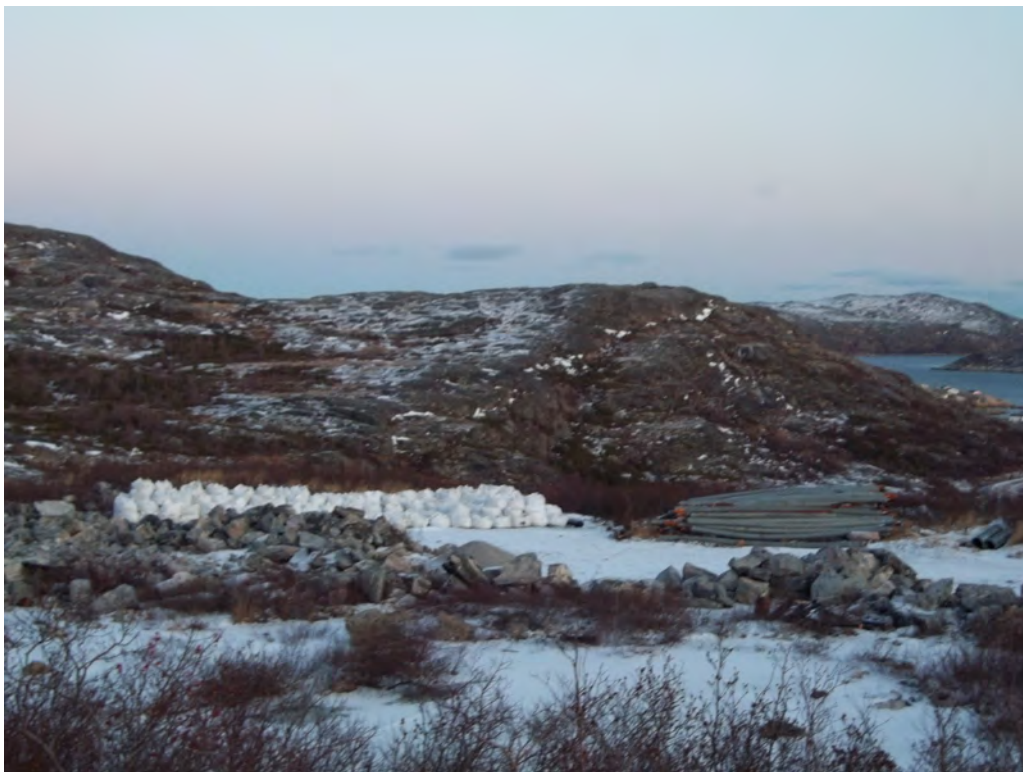
Photo 26 View of bags at laydown area at Pit No. 1 on November 16, 2011, looking east from the main access road.
