**Implementation of Remedial
Action Plan – Year 2, Former
U.S. Military Site and
Residential Subdivision,
Hopedale, Labrador**

Final Report

File No. 121411777.300

Date: February 4, 2014

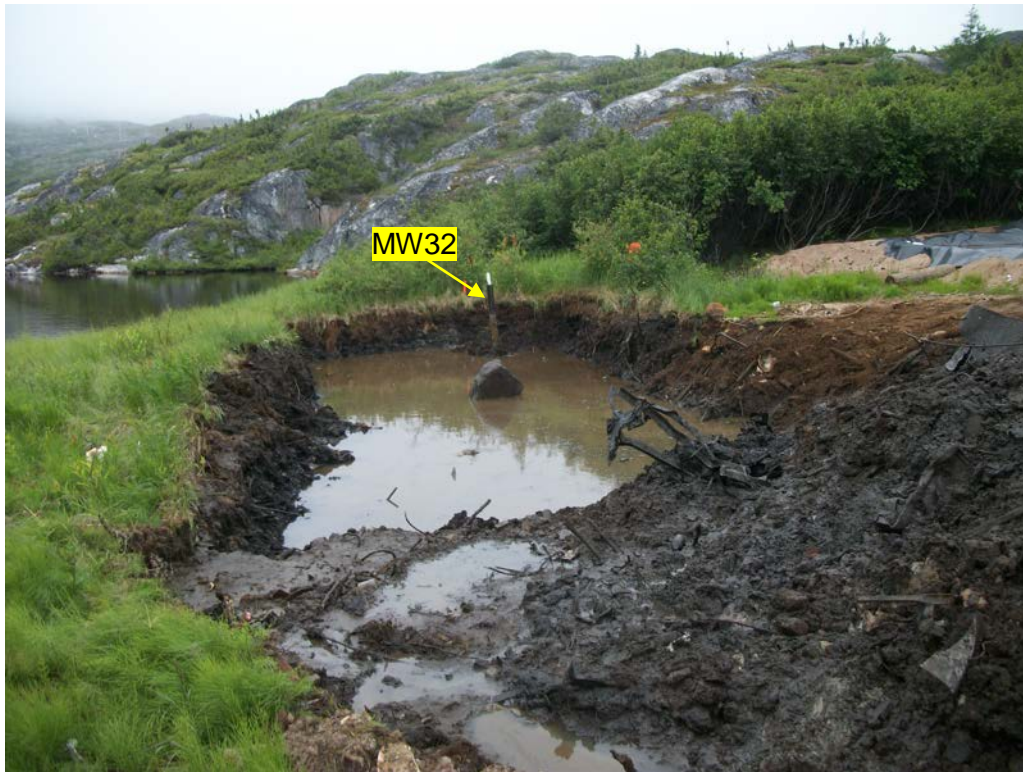
Photo 1 Soil removal at Old Dump Pond (ODP) – Area 2 on July 12, 2012.

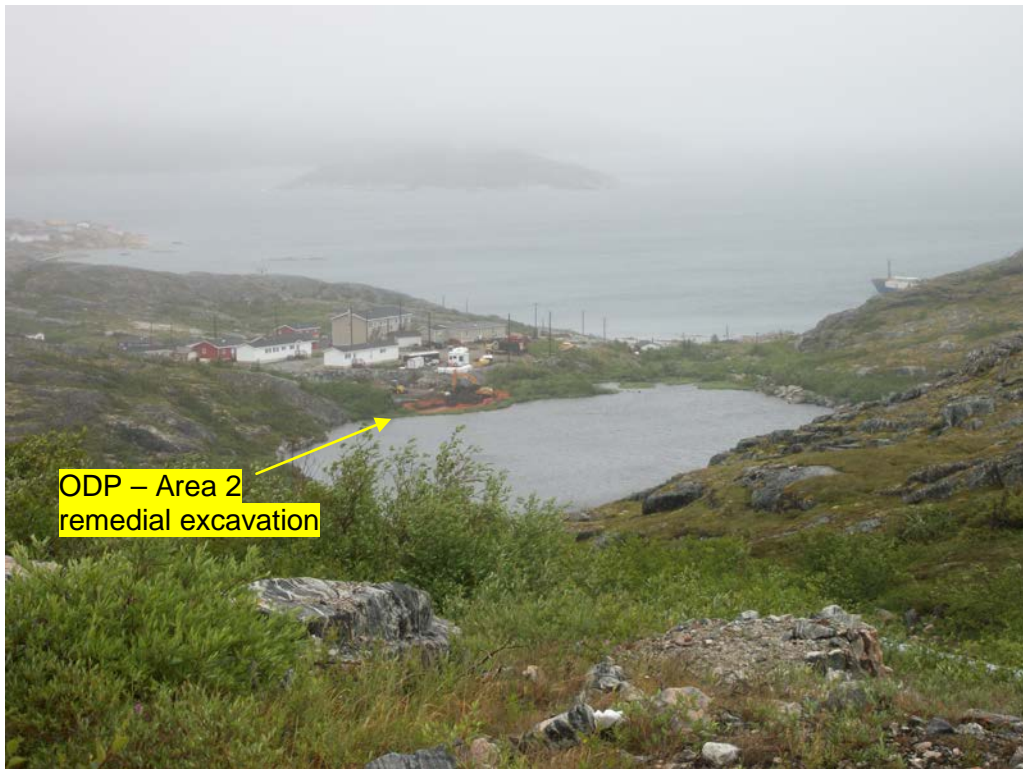
Photo 2 Remedial excavation overlooking Old Dump Pond.

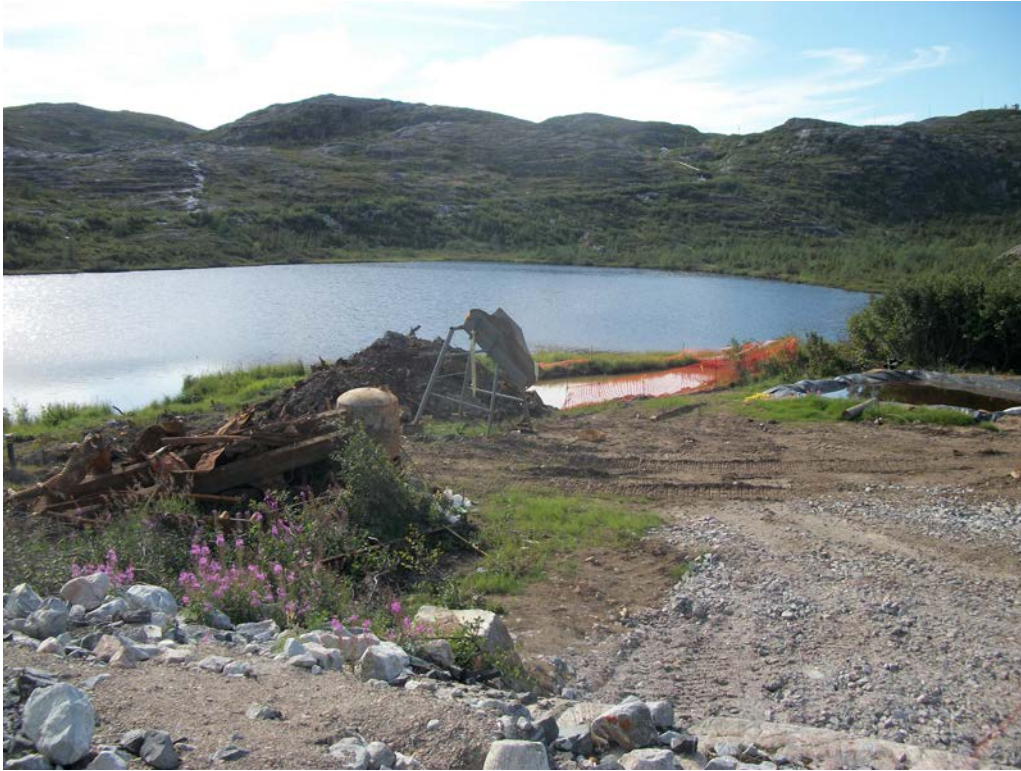
Photo 3 ODP – Area 2 on August 20, 2012.

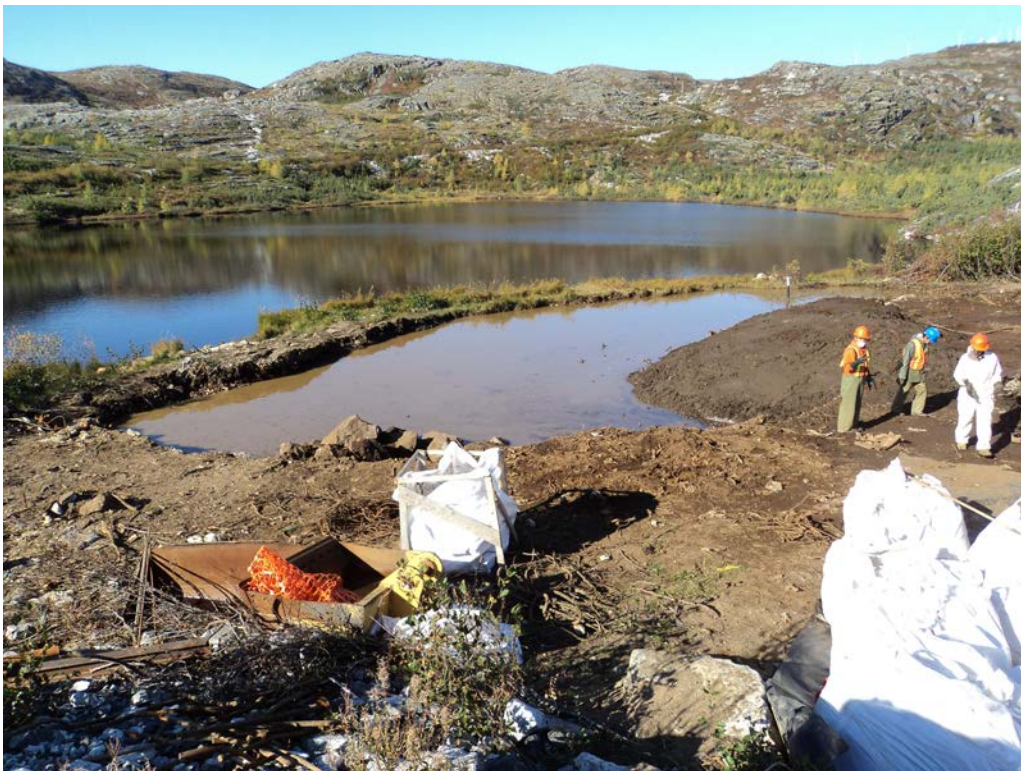
Photo 4 Final limits of ODP – Area 2 remedial excavation.

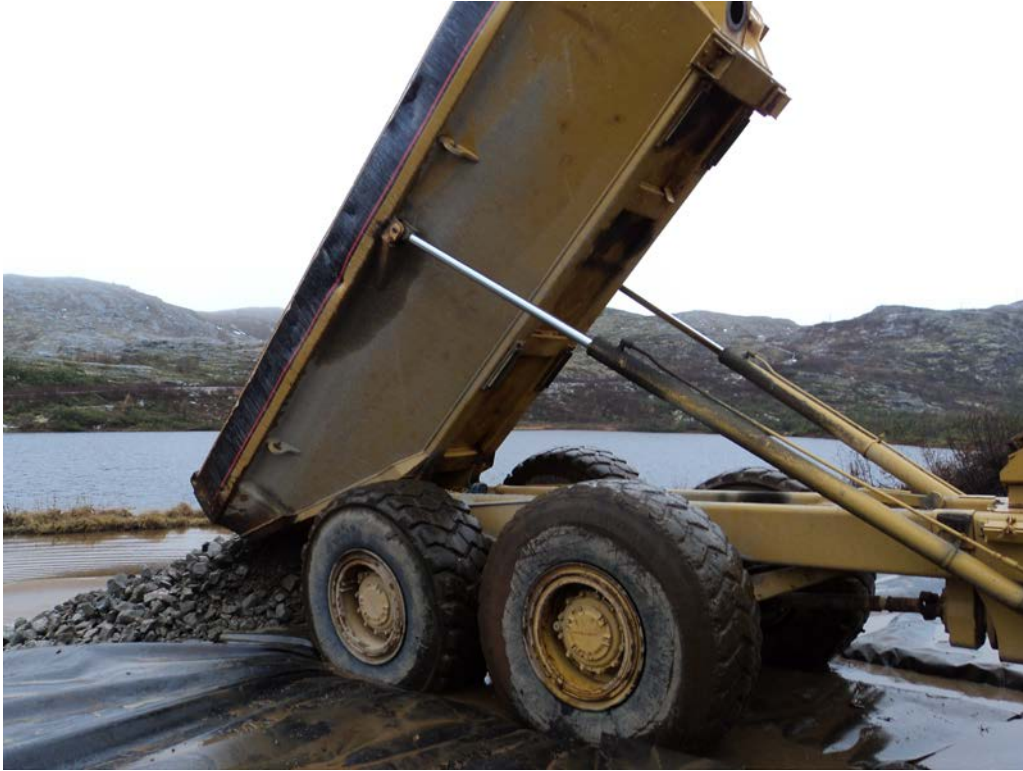
Photo 5 Backfilling at ODP – Area 2.

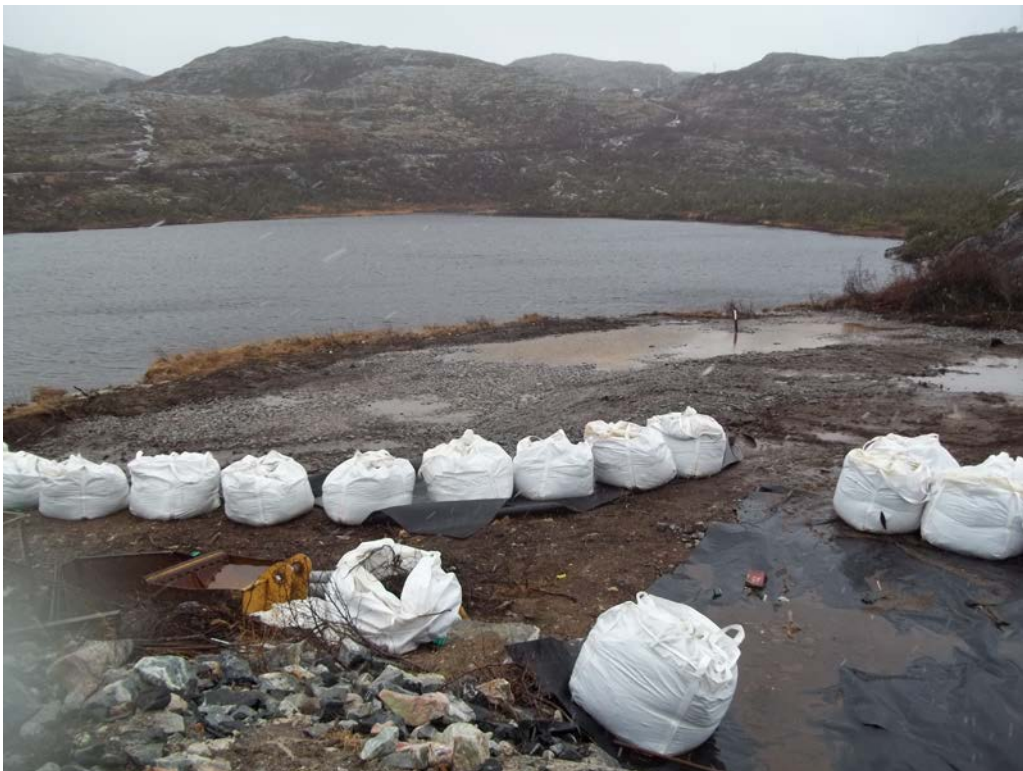
Photo 6 ODP – Area 2 following backfilling.

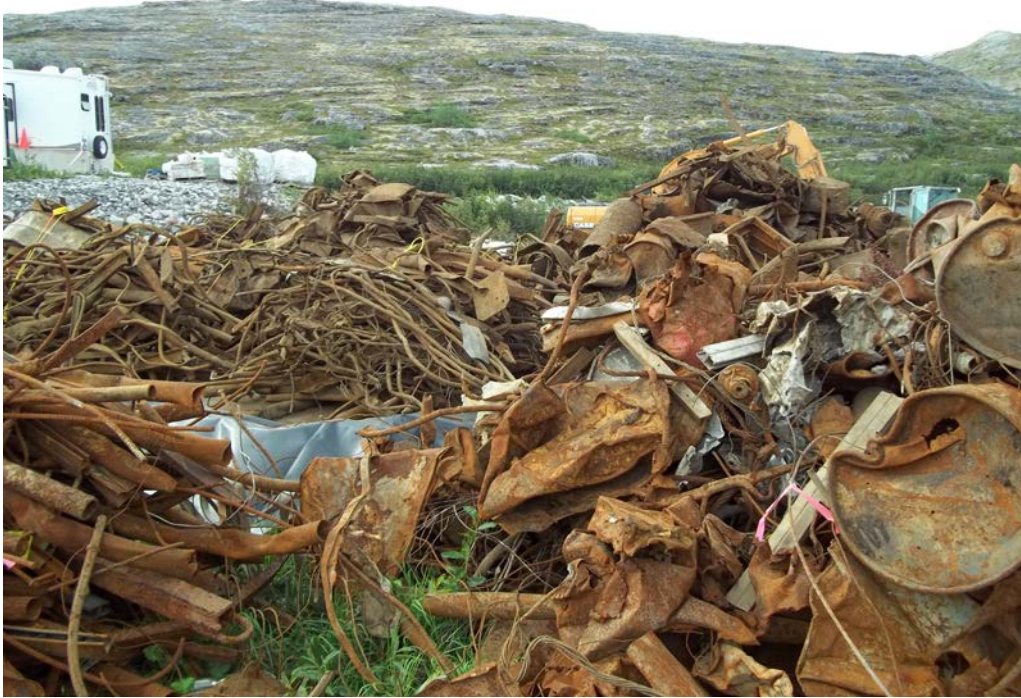
Large pieces of scrap metal that were encountered in the remedial excavation at the Old Dump Pond, Stream and Wharf sites were stockpiled north of the ODP – Area 2 remedial excavation, next to the Year 1 metal stockpile. High visibility caution tape was placed around the metal stockpile to alert potential recreational vehicle users of the physical hazard when passing through the area. The portion of metal with detected concentrations of PCBs has been segregated and will be bagged and treated in the same manner as PCB-contaminated soil during Year 3 of the Implementation of the RAP. The remaining un-impacted metal will be transported to a metal recycling facility in Year 3. Photos of the metal stockpile are provided in Appendix B.

Photo 7 Metal stockpile at Old Dump Pond site.

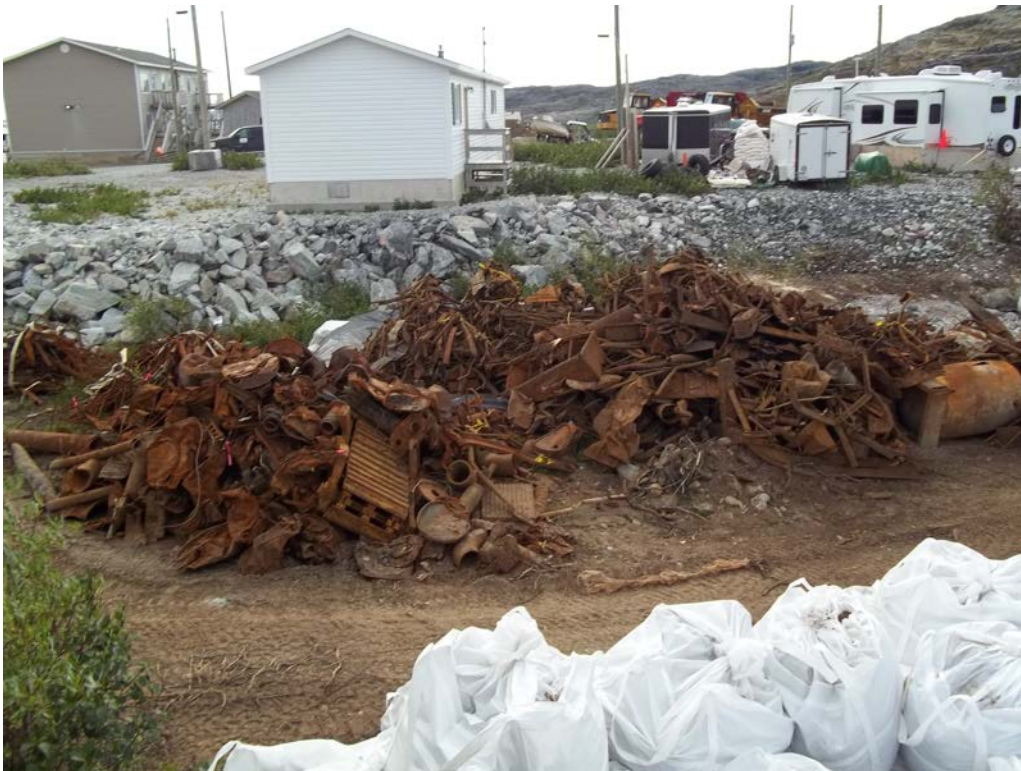
Photo 8 Metal stockpile at Old Dump Pond site.

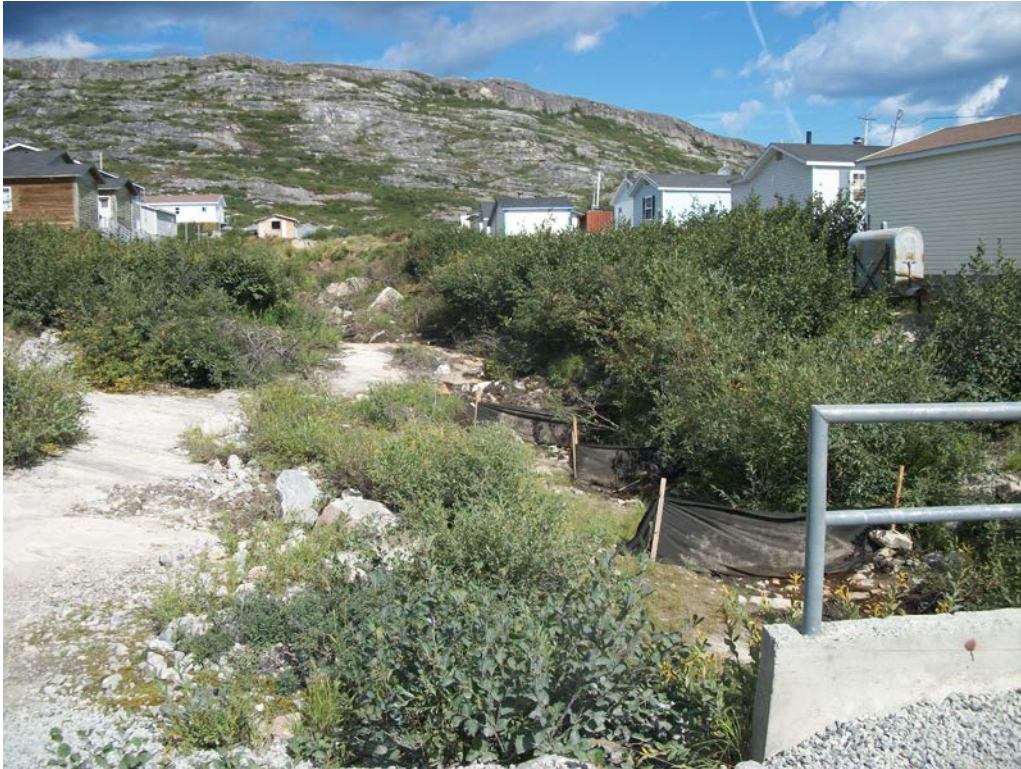
Photo 9 Silt fences installed downstream of the Stream site work area.

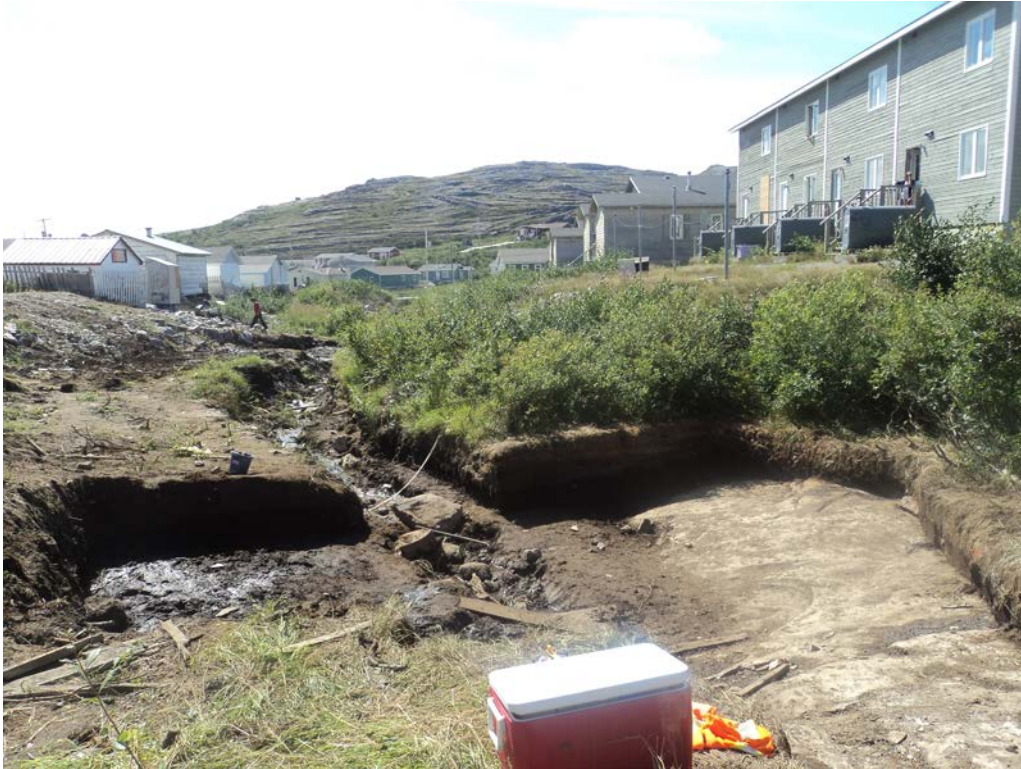
Photo 11 Upper portion of the stream on August 14, 2012 (looking south), following additional soil removal.

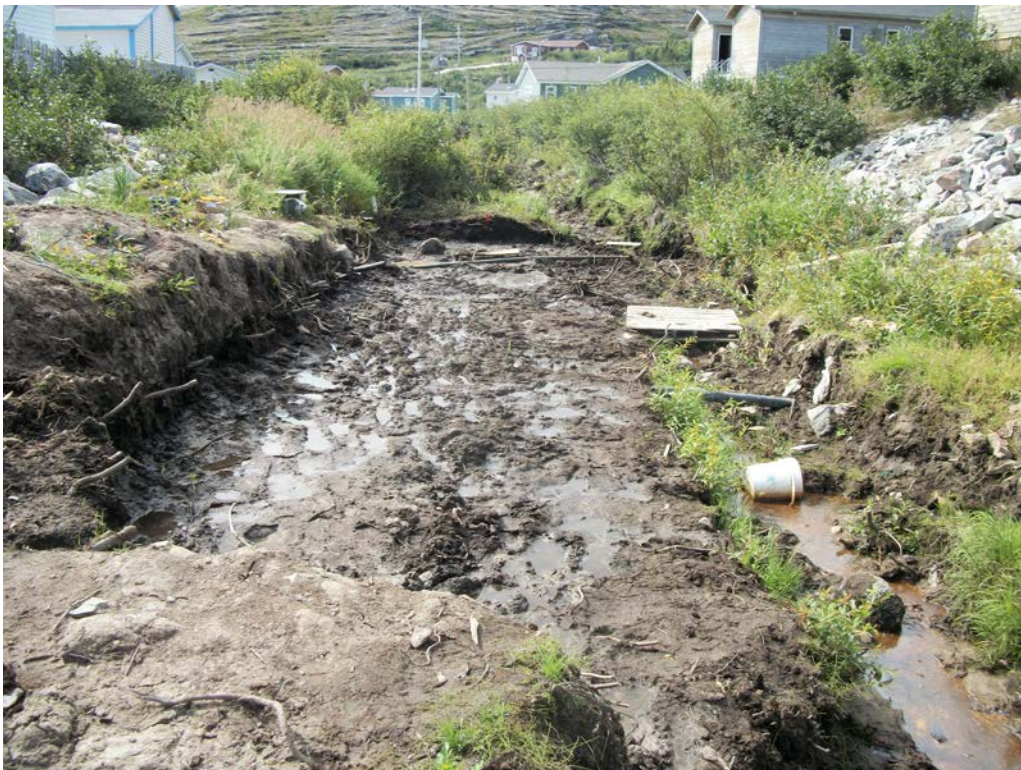
Photo 12 Lower portion of the stream on August 26, 2012 (looking southwest), following additional soil removal

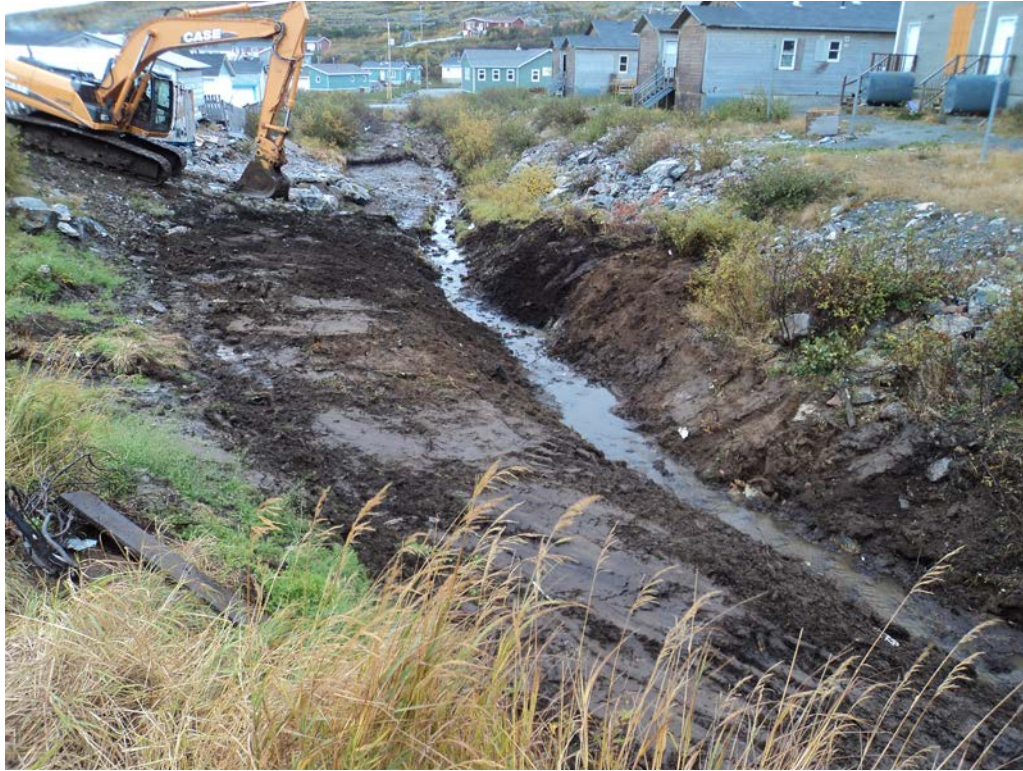
Photo 13 Stream site reinstatement, looking southwest.

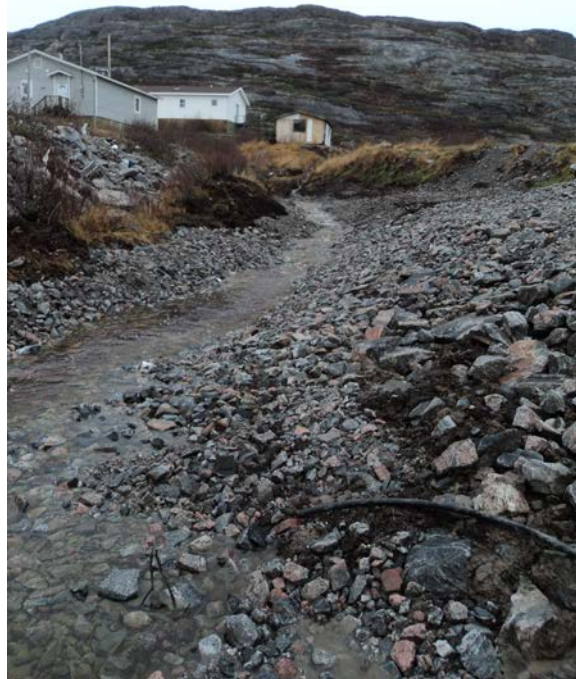
Photo 14 Stream site following backfilling, looking north.

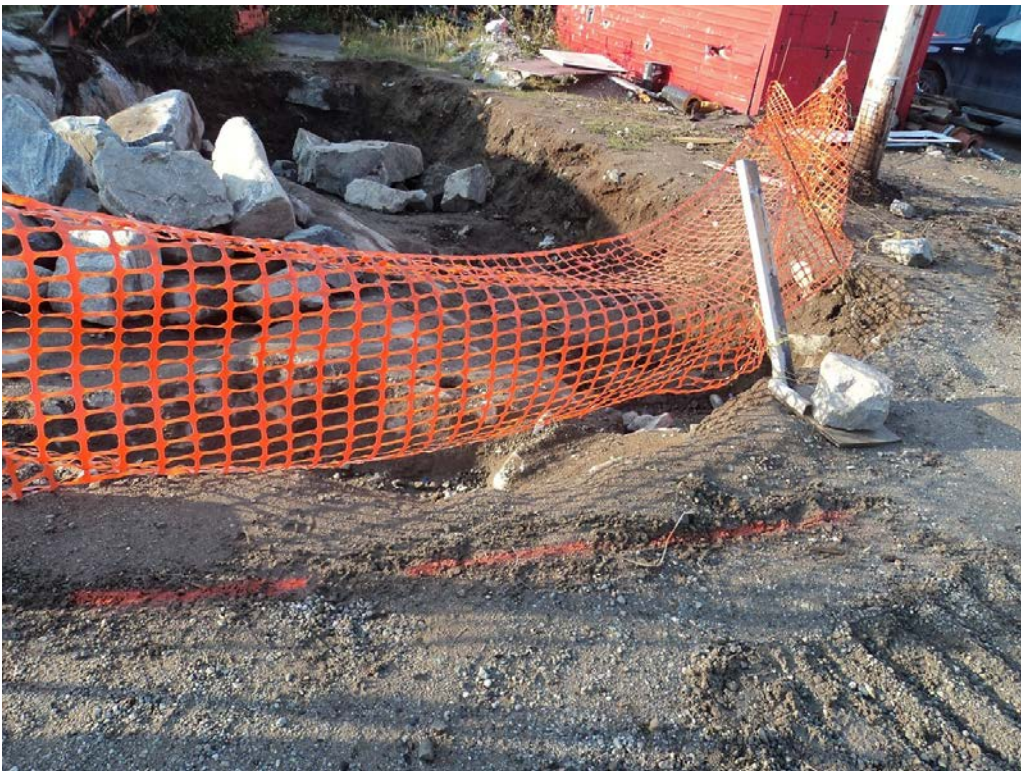
Photo 20 Area south of the road at the Wharf site during soil removal (terminated on bedrock).

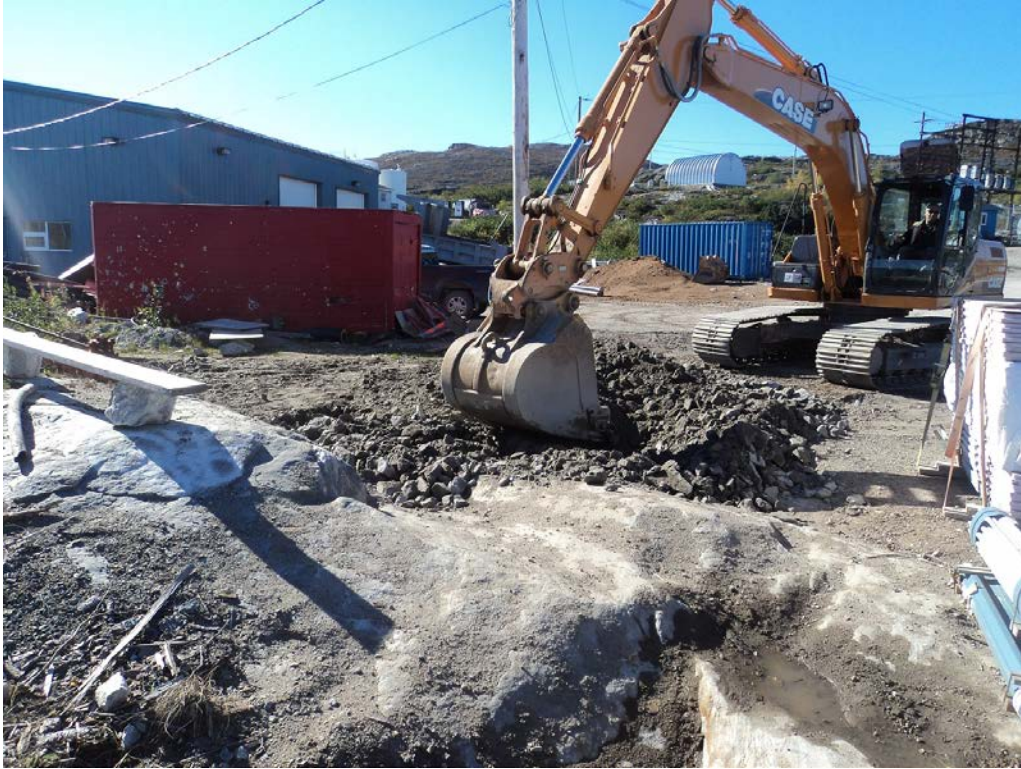
Photo 21 Backfilling of area south of the road at the Wharf site on September 18, 2012.

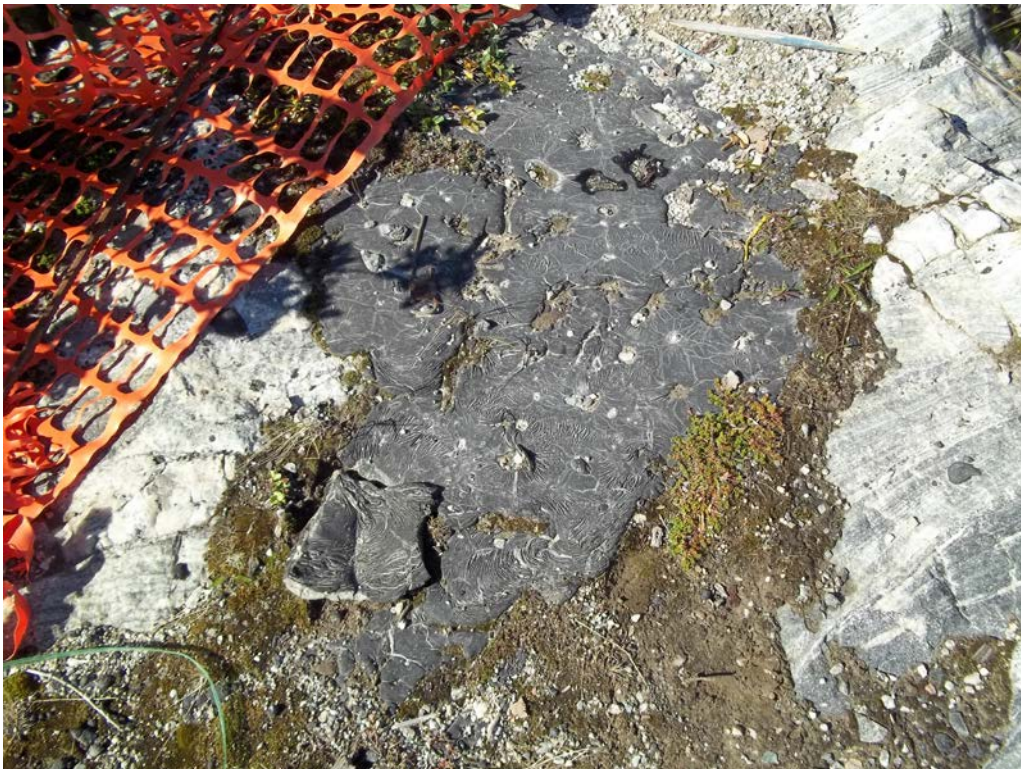
Photo 22 Tar-like material discovered at the Wharf site prior to removal.

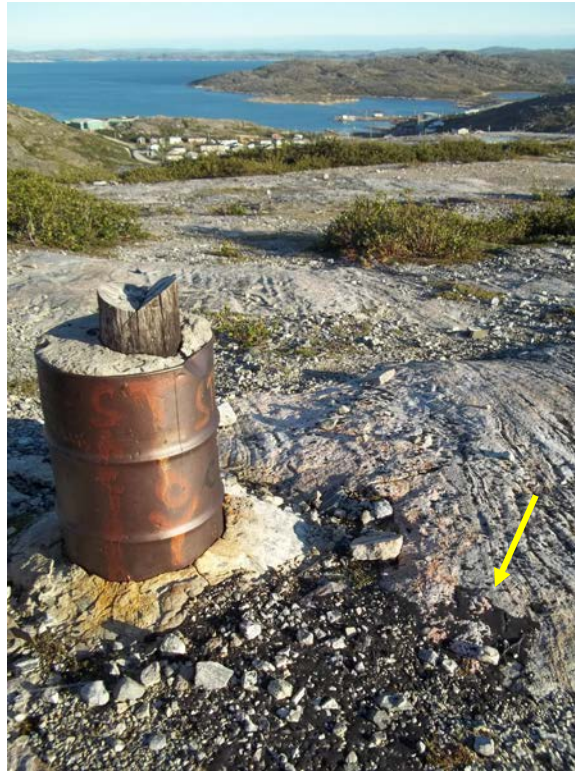
Photo 23 Tar-like material discovered at the Pallet Line site prior to removal.

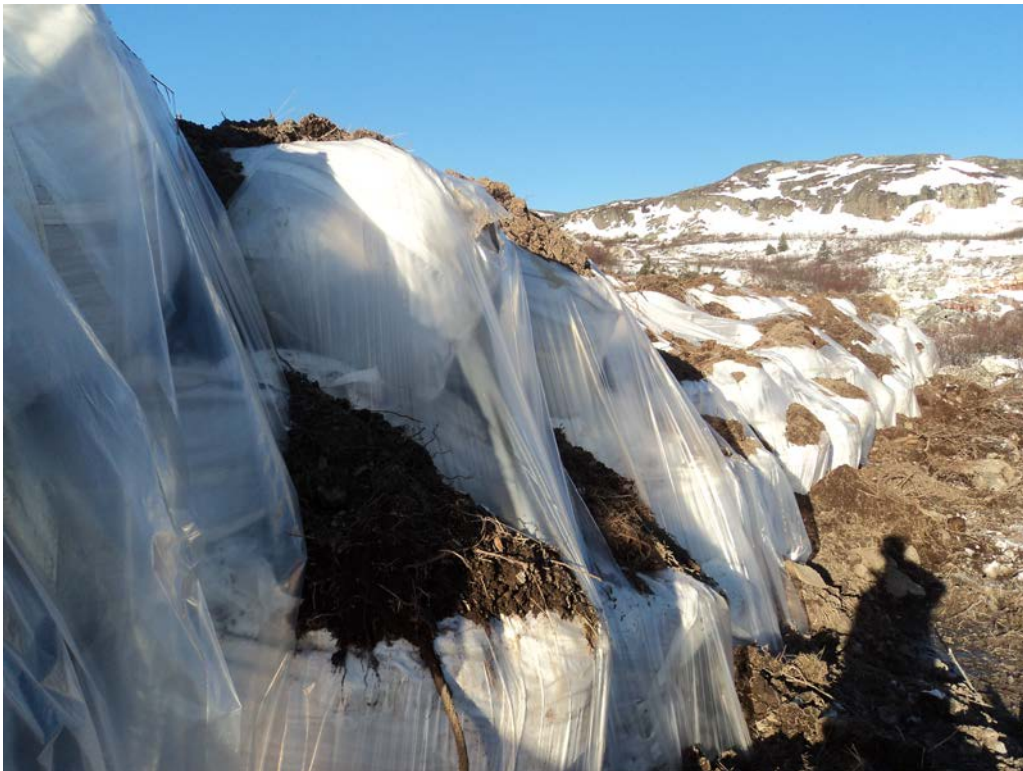
All visibly damaged bags were double-bagged and the stockpile was covered in a plastic liner. Clean backfill material was poured onto the plastic to prevent movement of the plastic liner. Boulders were then placed at the entrance to the laydown area to block access from roadway. A public notice sign was also placed at the entrance to the laydown area. Photos of the temporary storage area and signage are provided in Appendix B.

Photo 26 Bags remaining at laydown area following barge loading (bags covered in plastic).

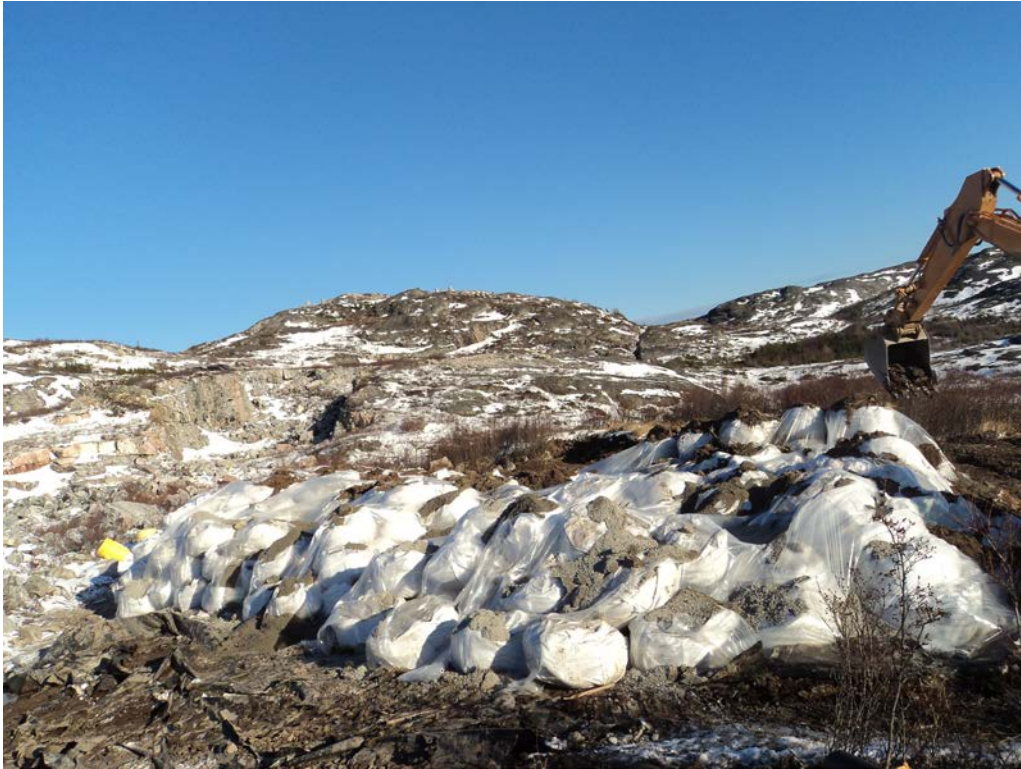
Photo 29 Bags remaining at laydown area following barge loading (bags covered in plastic).

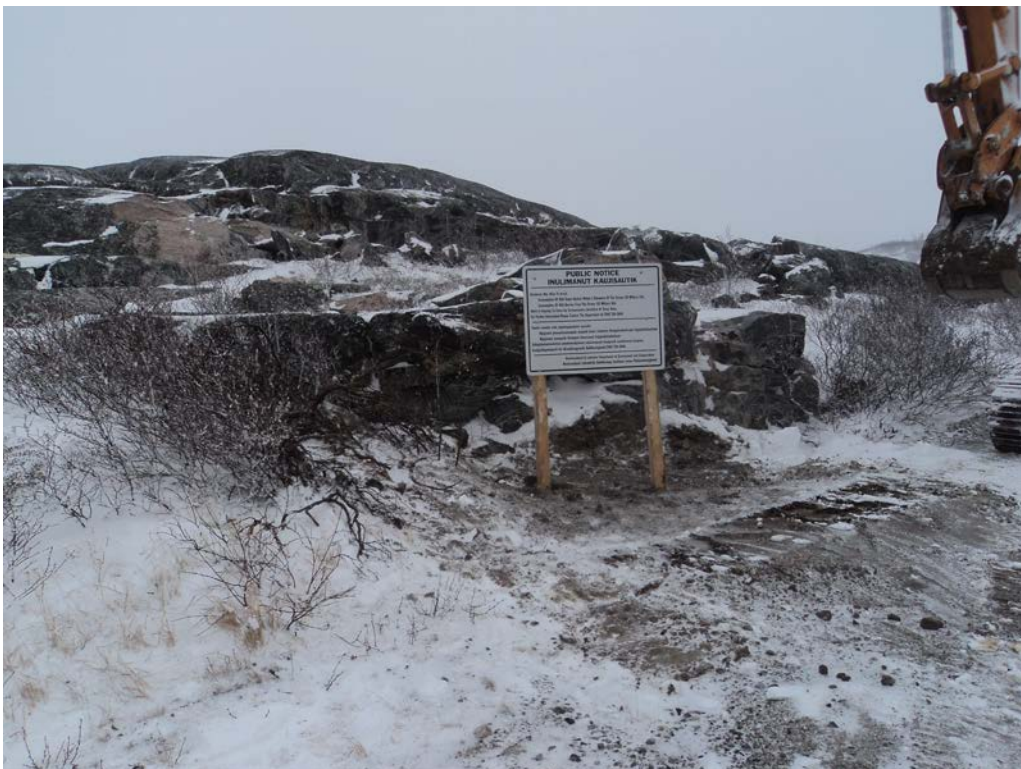
Photo 30 Public Notice sign installed at the entrance to Pit No. 1.

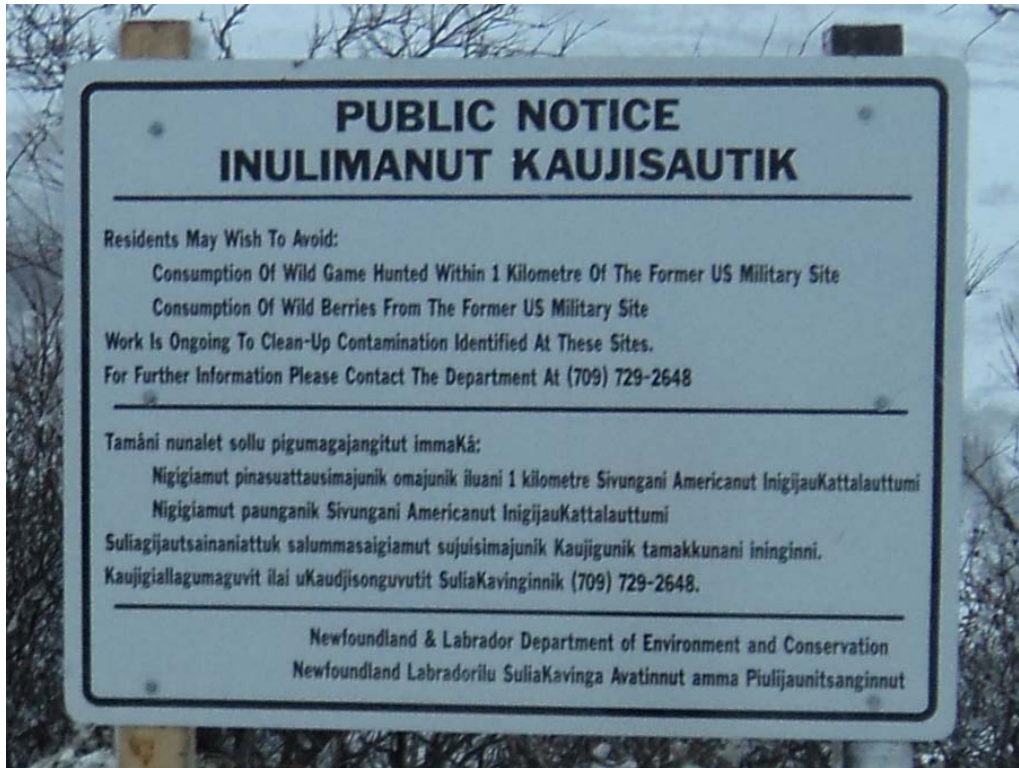
Photo 31 Public Notice sign installed at the entrance to Pit No. 1.

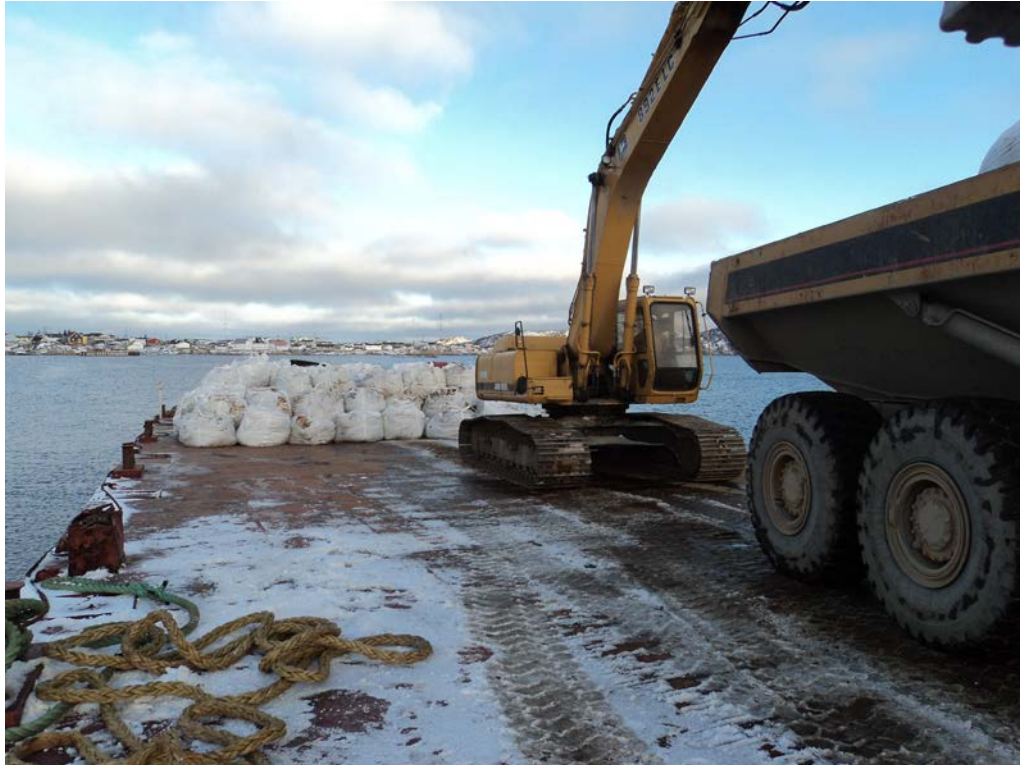
On November 8, 9 and 12, 2012, a total of 567 bags of PCB-impacted soil bags were loaded onto a 1,000 tonne capacity barge (the Kaligak) owned by NGC Nunatsiavut Marine Inc. at the American dock in Hopedale. Soil bags were inspected for damage (due to UV exposure and/or protruding metal). All damaged bags were double-bagged at the laydown area. The soil bags were then loaded into rock trucks, which were weighed using a scale system provided by RJG, then transported to the American dock to be loaded onto the barge. The barge was properly loaded for gross stability, as per the direction of the captain. The total load weighed in at 560.2 tonnes, as per the scale system in Hopedale. Once all soil bags were loaded onto the barge, they were covered in plastic and netting and strapped down with chains. RJG provided appropriate placards and shipment manifests in accordance with Transportation of Dangerous Goods (TDG) and International Maritime Dangerous Goods (IMDG) codes. The barge was transported to Port Saguenay in La Baie, Quebec (QC) using a tug (the Kaliutik) that was owned and operated by NGC Nunatsiavut Marine Inc. The barge and tug left Hopedale on November 14, 2012 and arrived at Port Saguenay on November 23, 2012.

Photo 32 Loading soil bags onto the barge on November 8, 2012.

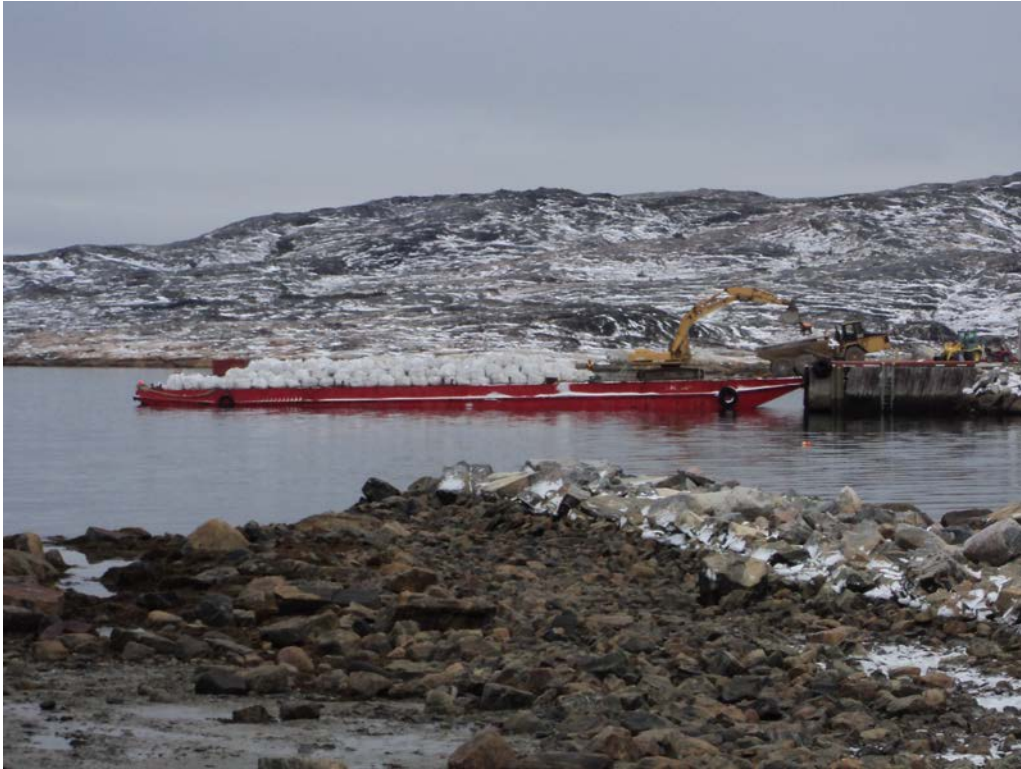
Photo 33 Loading soil bags onto the barge on November 9, 2012.

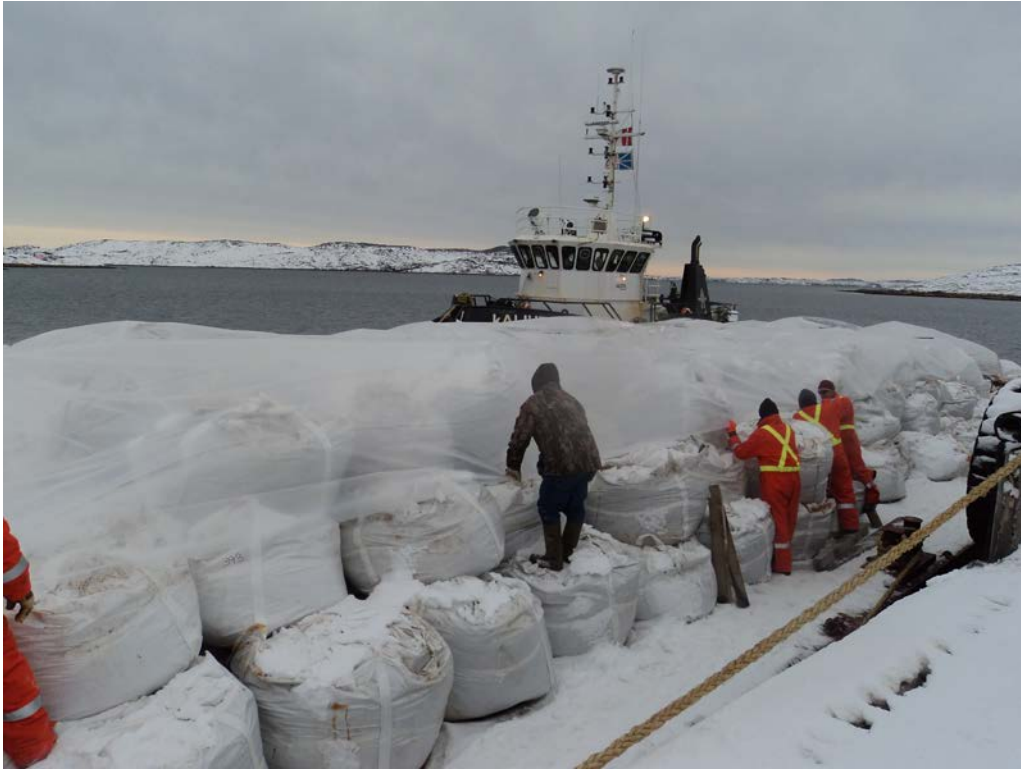
Photo 35 Installation of tarp over soil bags on barge.
