**Implementation of Remedial
Action Plan – Year 3, Former
U.S. Military Site and
Residential Subdivision,
Hopedale, Labrador**

Prepared for:
Newfoundland Department of
Environment and Conservation
4th Floor Confederation Building,
West Block
St. John's, NL A1B 4J6

Prepared by:
Aivek Stantec Limited Partnership
141 Kelsey Drive
St. John's, NL A1B 0L2
Tel: (709) 576-1458
Fax: (709) 576-2126

Final Report

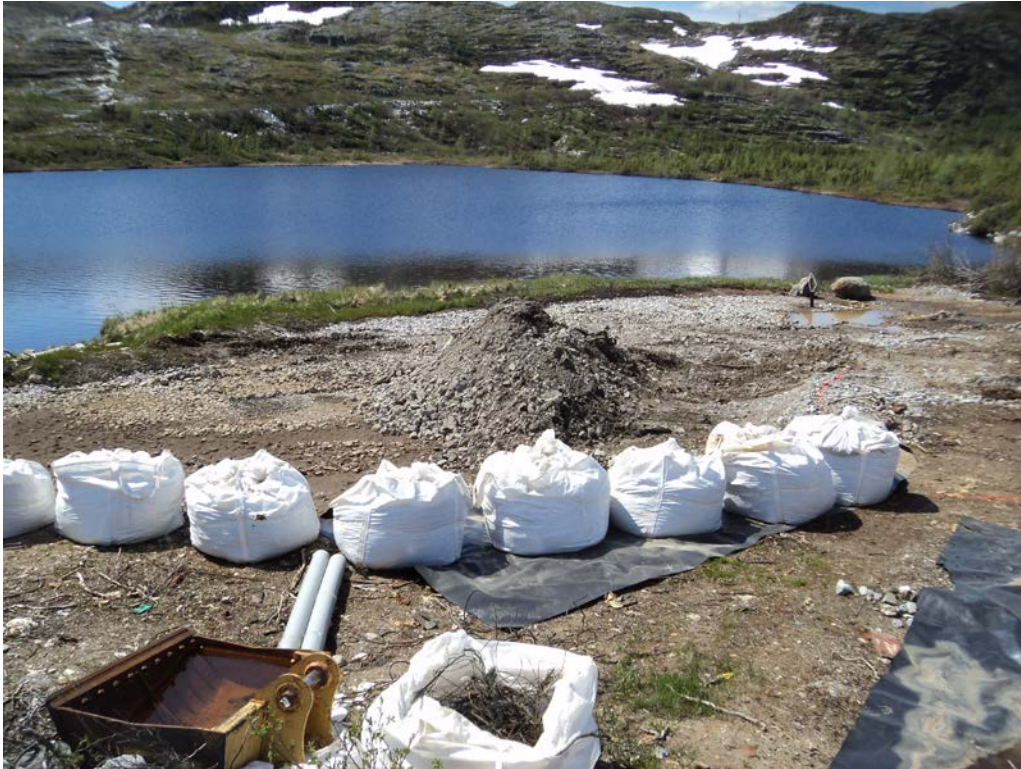
Photo 1 Old Dump Pond (ODP) – Area 2 on June 26, 2013, prior to excavation.

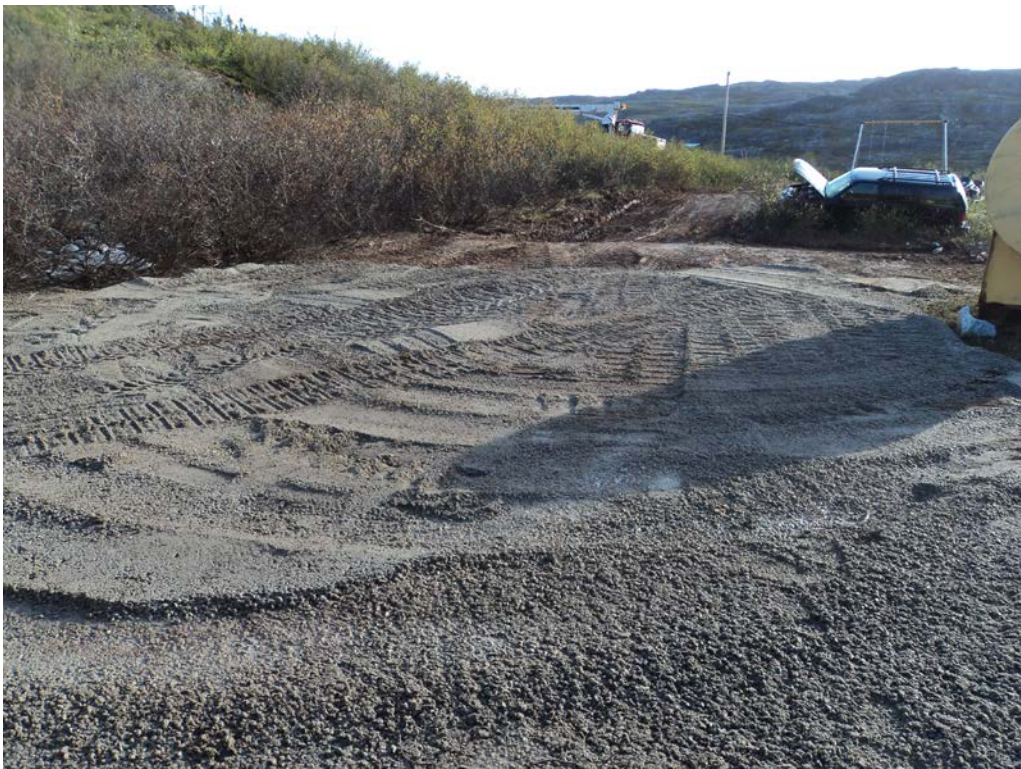
Photo 2 Laydown area prepared at Old Dump Pond.

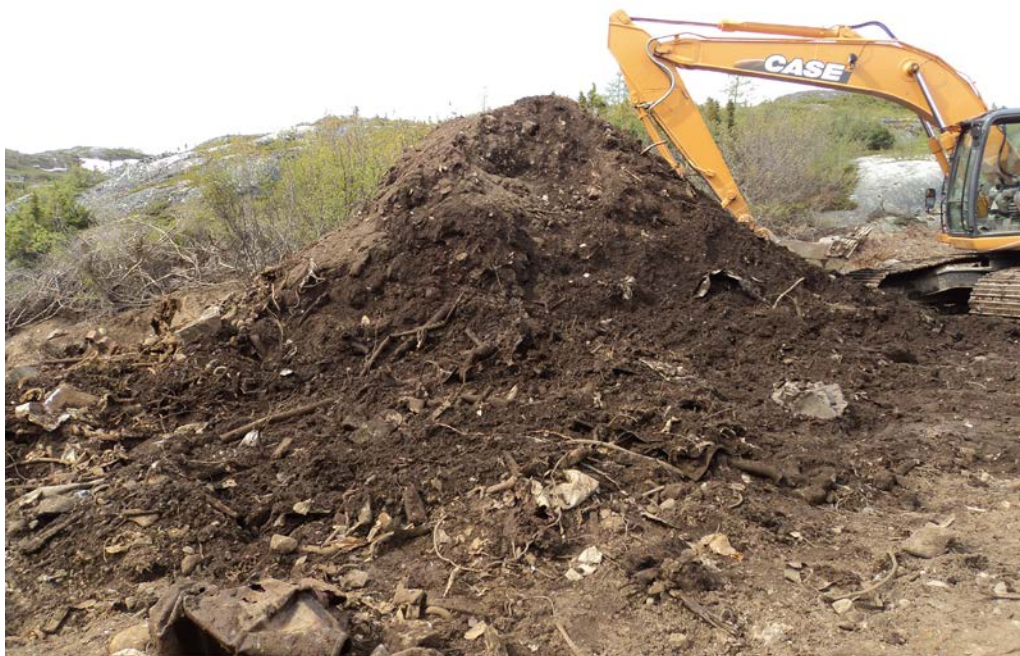
Photo 3 Soil removal at Old Dump Pond on June 29, 2013.

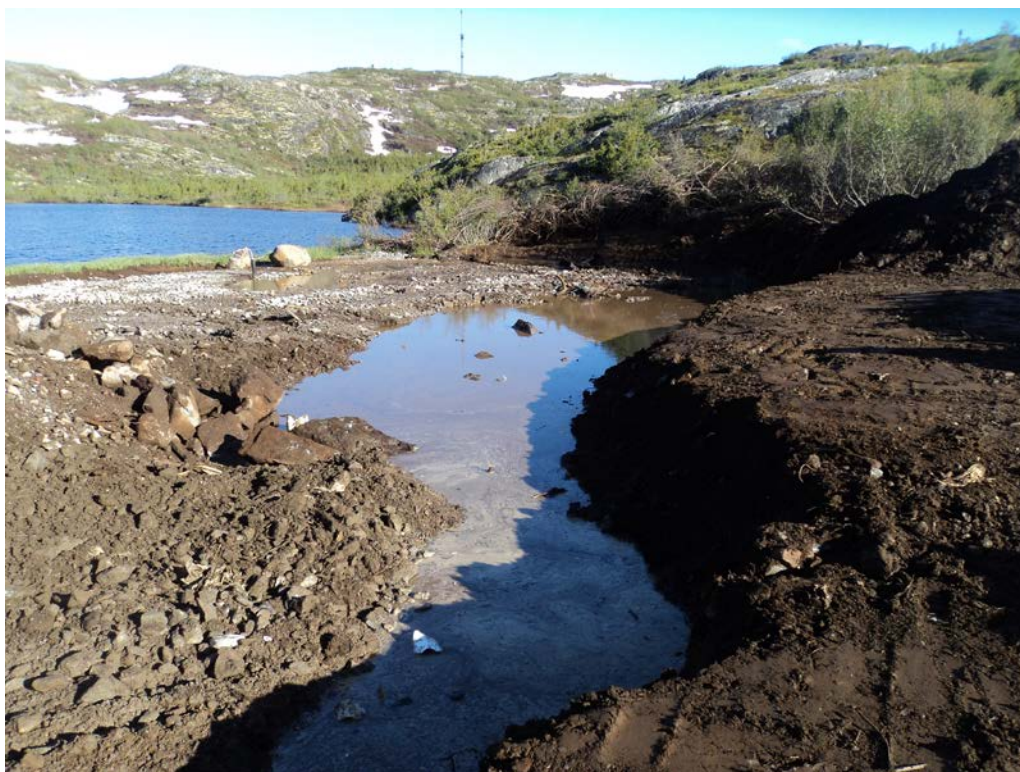
Photo 4 Old Dump Pond remedial excavation on July 2, 2013.

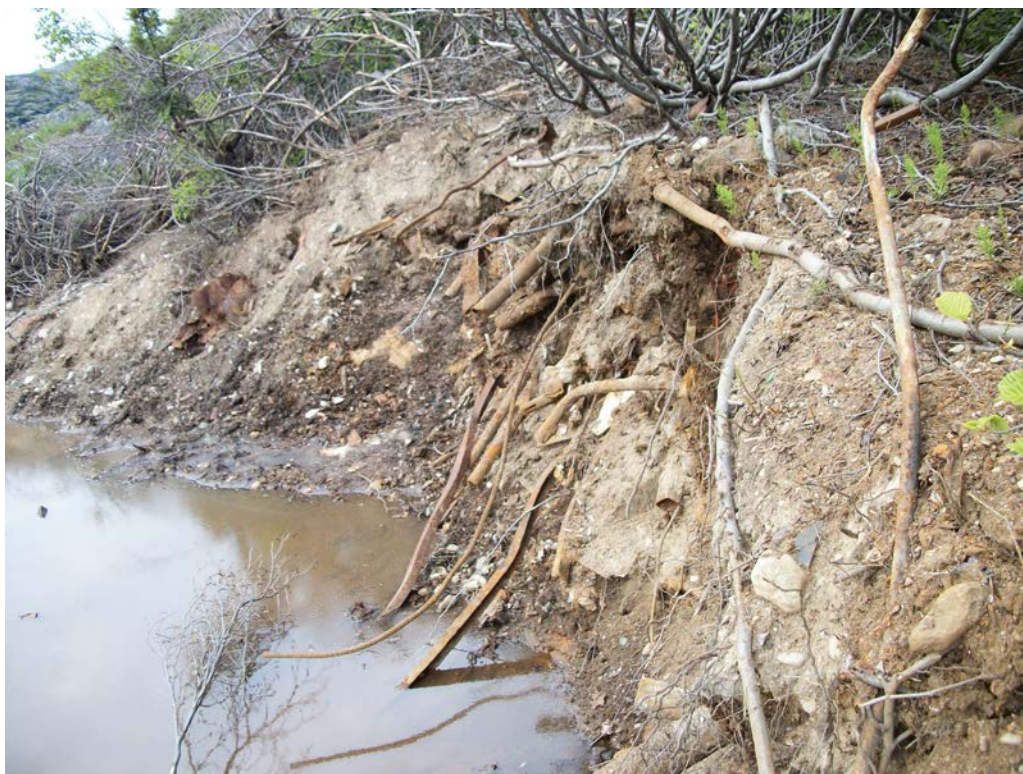
Photo 5 Buried metal observed in the vicinity of sample 13-ODP-BS4 prior to removal.

Buried metal debris was encountered in the remedial excavation at the Old Dump Pond and BMEWS areas. Metal debris consisted of empty 45 gallon drums, poles, girders, rebar, vehicle parts and other small pieces of metal. Broken glass and amber glass bottles were also encountered in the remedial excavation. None of the pieces of debris appeared to have painted surfaces. Smaller pieces of debris were placed in the bags with soil. Large pieces of metal were manually segregated from the soil. Residual soil was shaken/scraped from the metal and placed in soil bags. The metal was then stacked into piles and tied together with straps to facilitate movement. Larger pieces of metal were cut up using a metal grinder prior to being stacked. The piles of metal were placed in a temporary scrap metal stockpile next to the ODP – Area 2 remedial excavation, next to the Year 1 and Year 2 metal stockpiles.

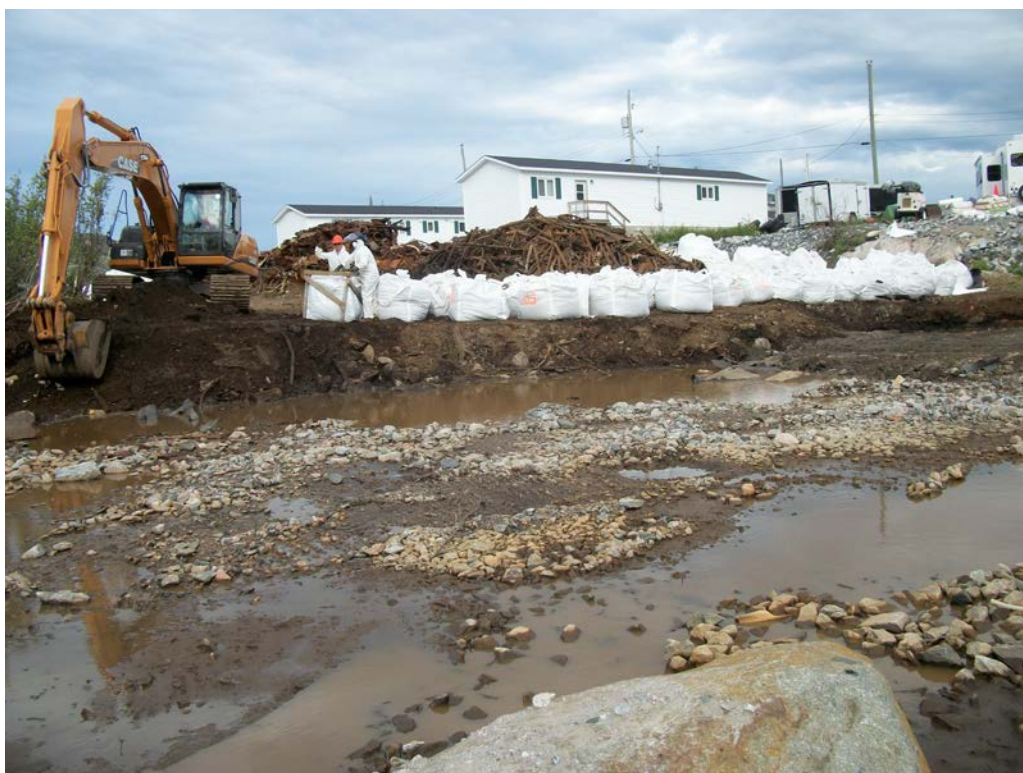
Photo 6 Old Dump Pond remedial excavation on July 11, 2013.

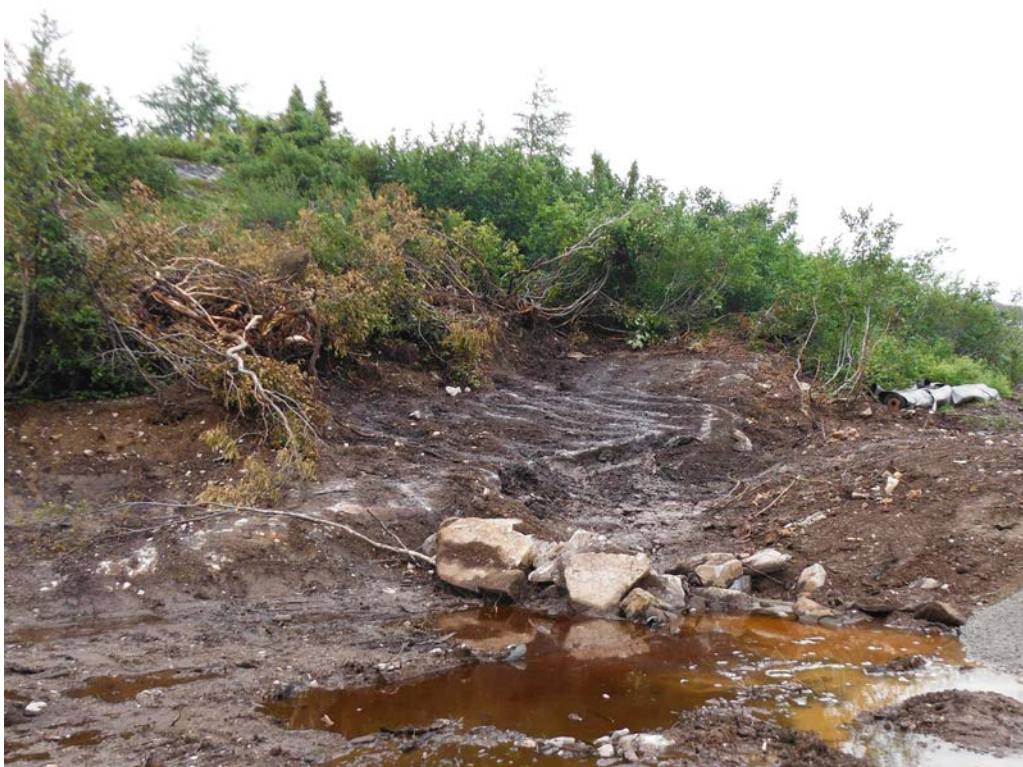
Photo 7 Remedial excavation terminated on bedrock in the vicinity of samples 13-ODP-BS16 and 13-ODP-BS17.

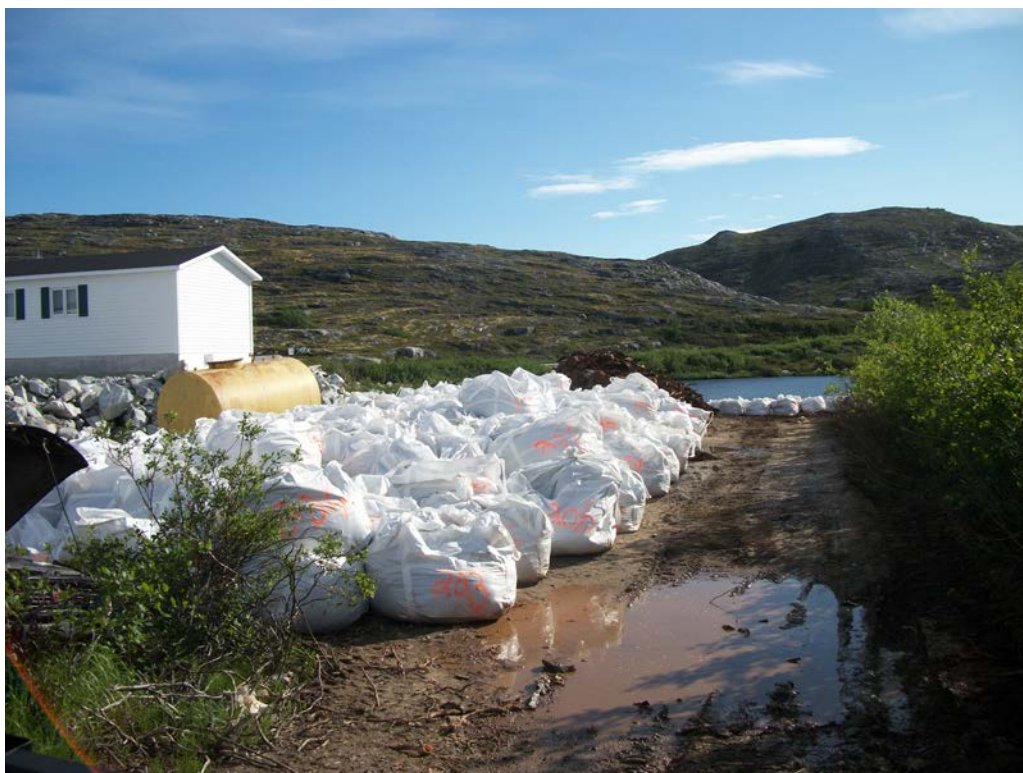
Photo 8 Laydown area in Old Dump Pond area.

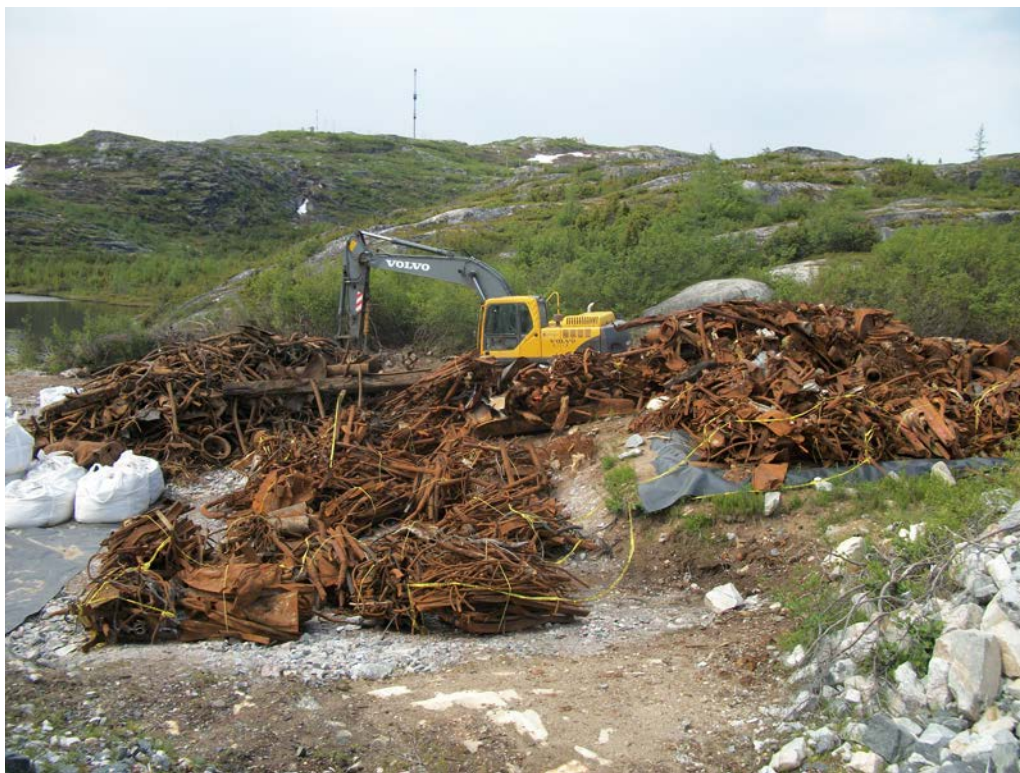
Photo 9 Metal stockpiles in Old Dump Pond area.

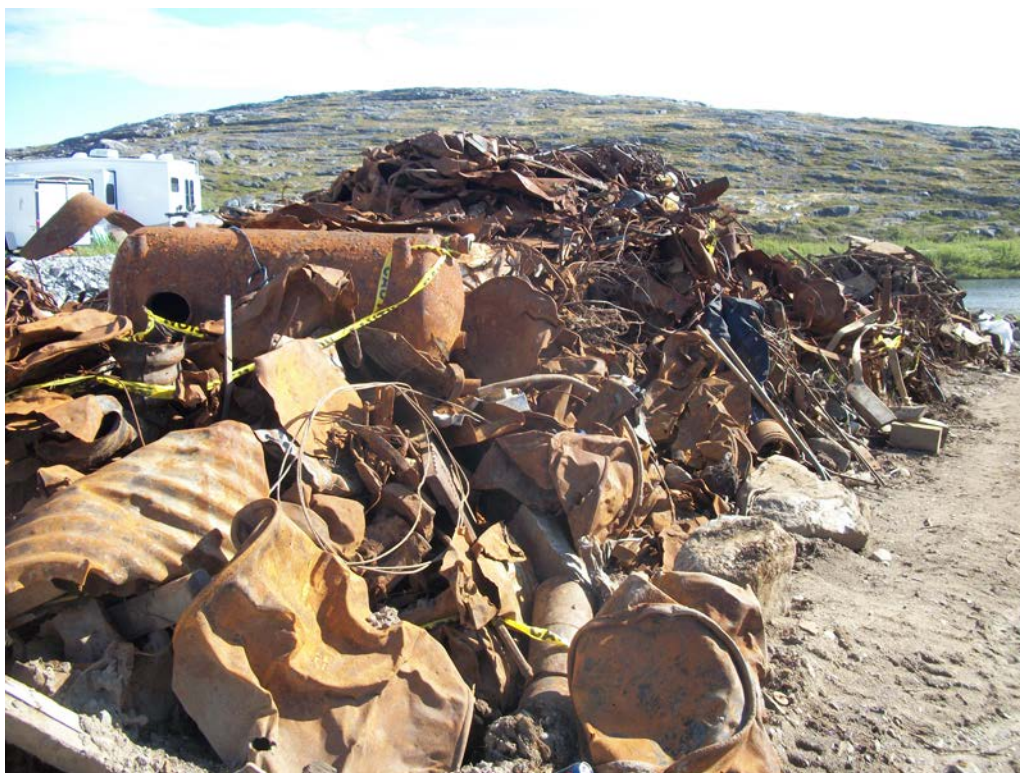
Photo 10 Metal stockpiles in Old Dump Pond area.

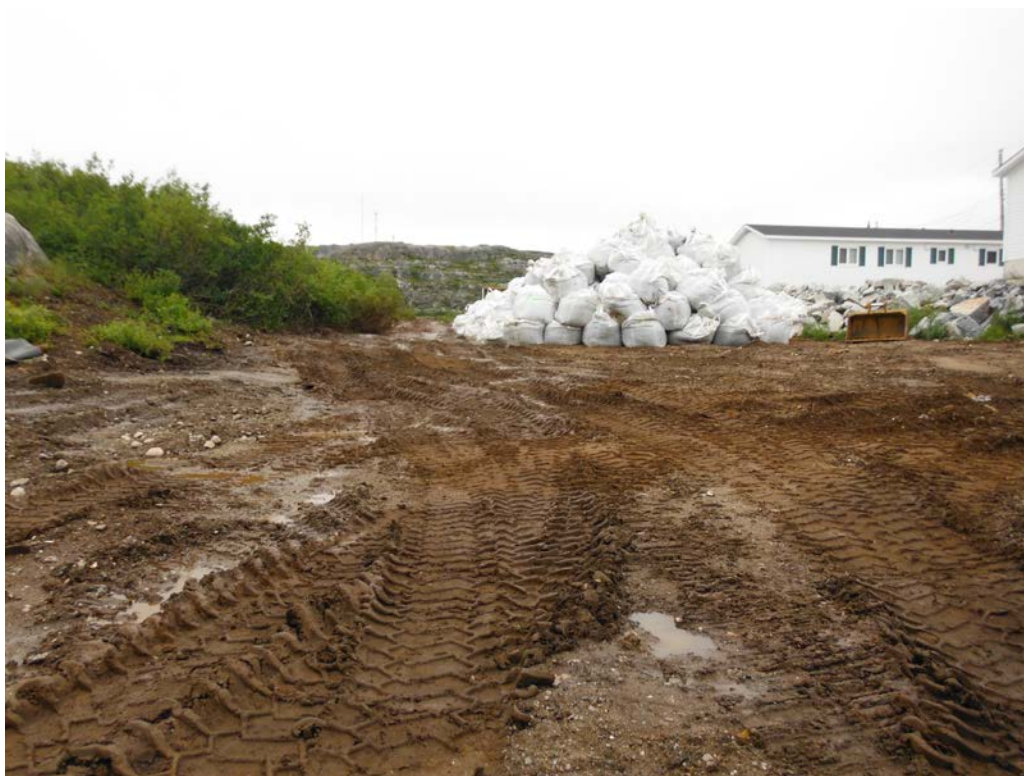
Photo 11 Metal stockpiles removed from Old Dump Pond area.

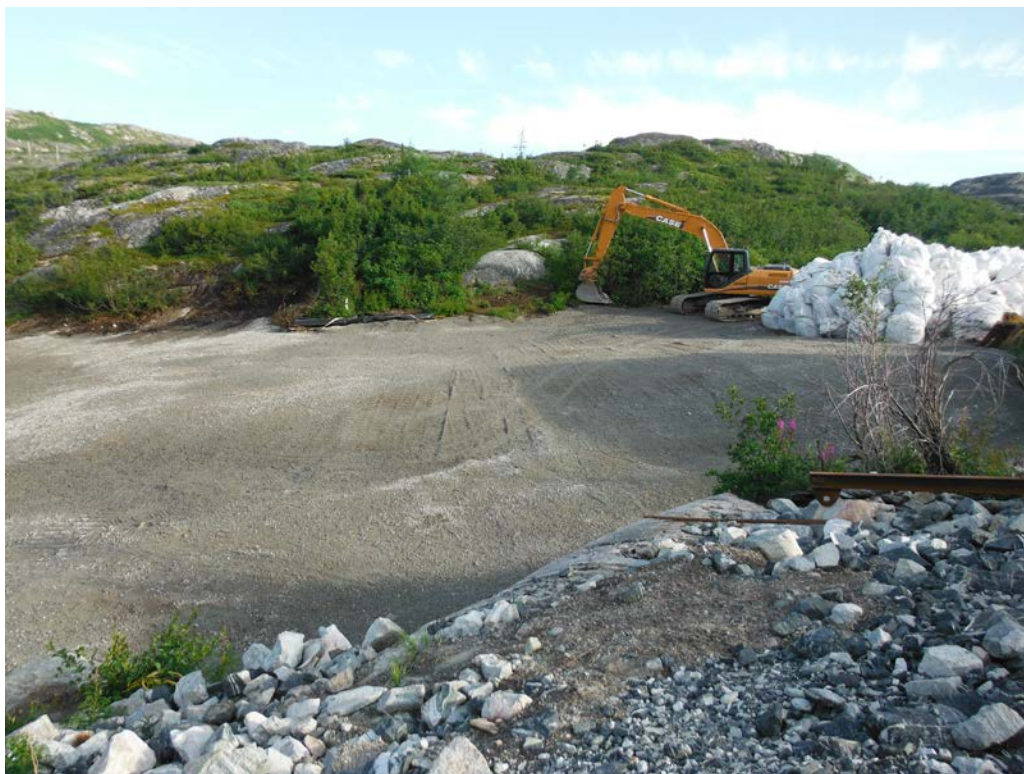
Photo 12 Surficial soil removed and area backfilled in Old Dump Pond area.

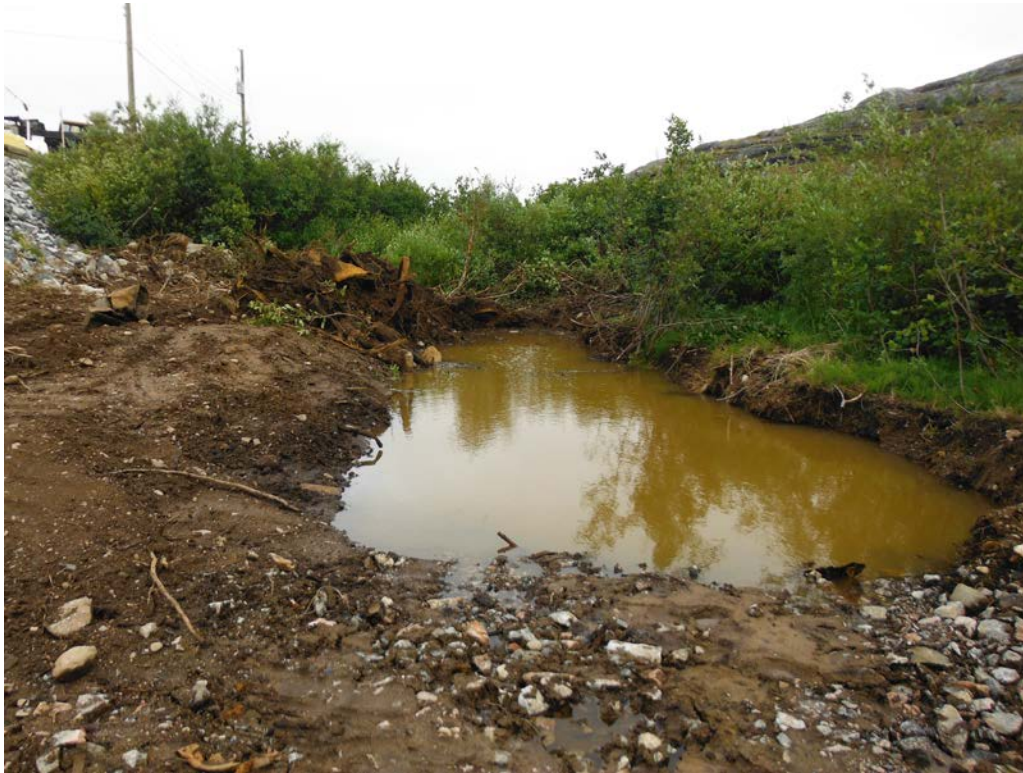
Photo 13 Additional soil removed in the vicinity of samples 13-ODP-BS18 and 13-ODP-BS19.

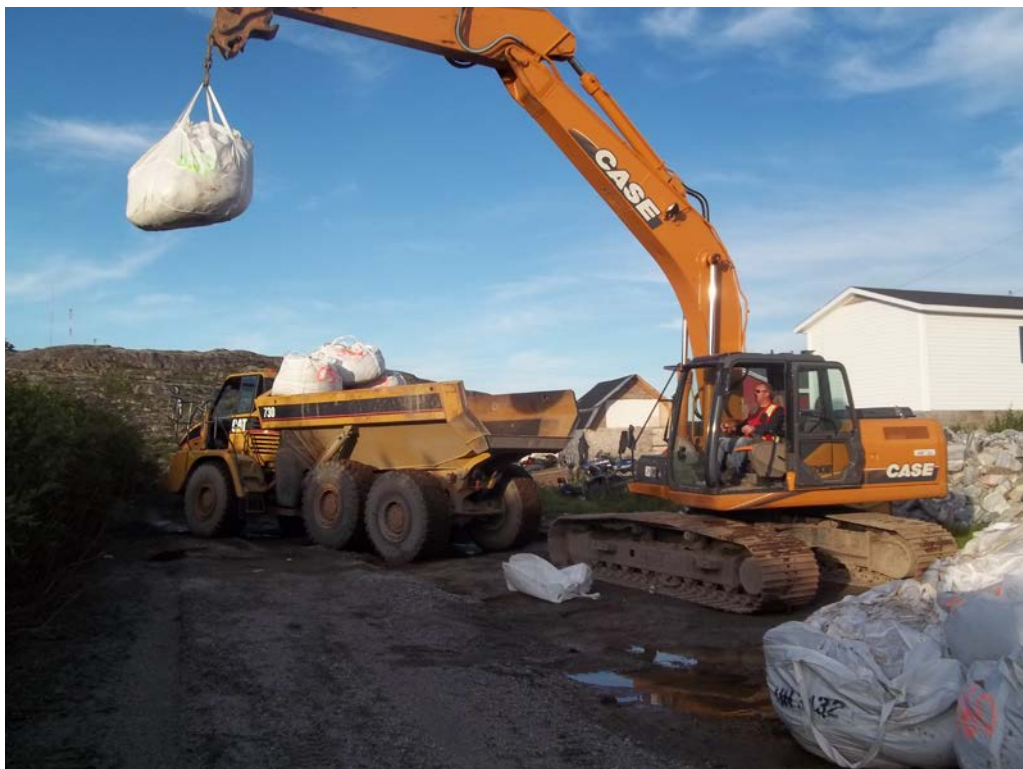
Photo 14 Moving bags from Old Dump Pond site up to the Main Laydown Area on August 14, 2013.

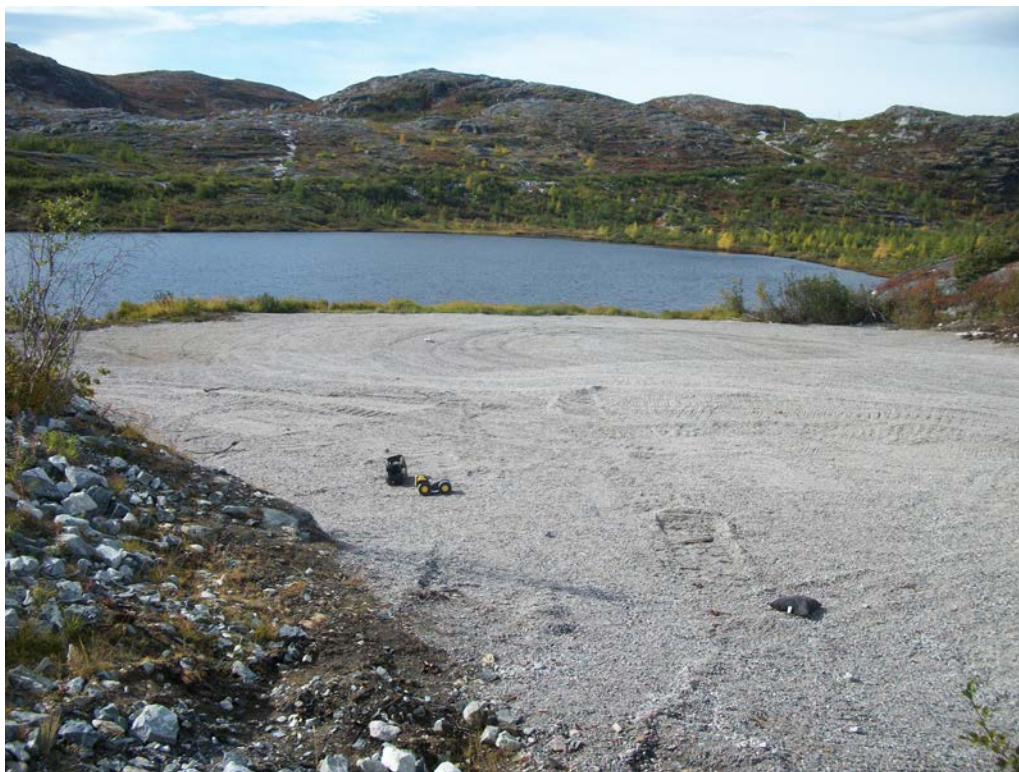
Photo 15 Old Dump Pond area backfilled.

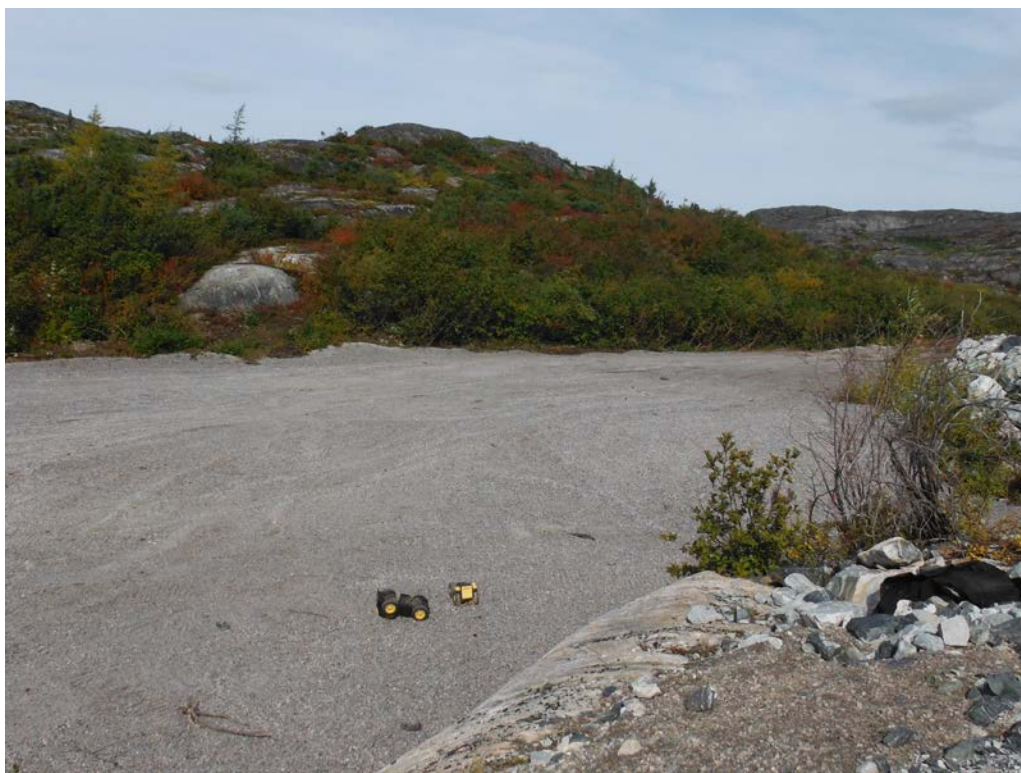
Photo 16 Old Dump Pond area backfilled.

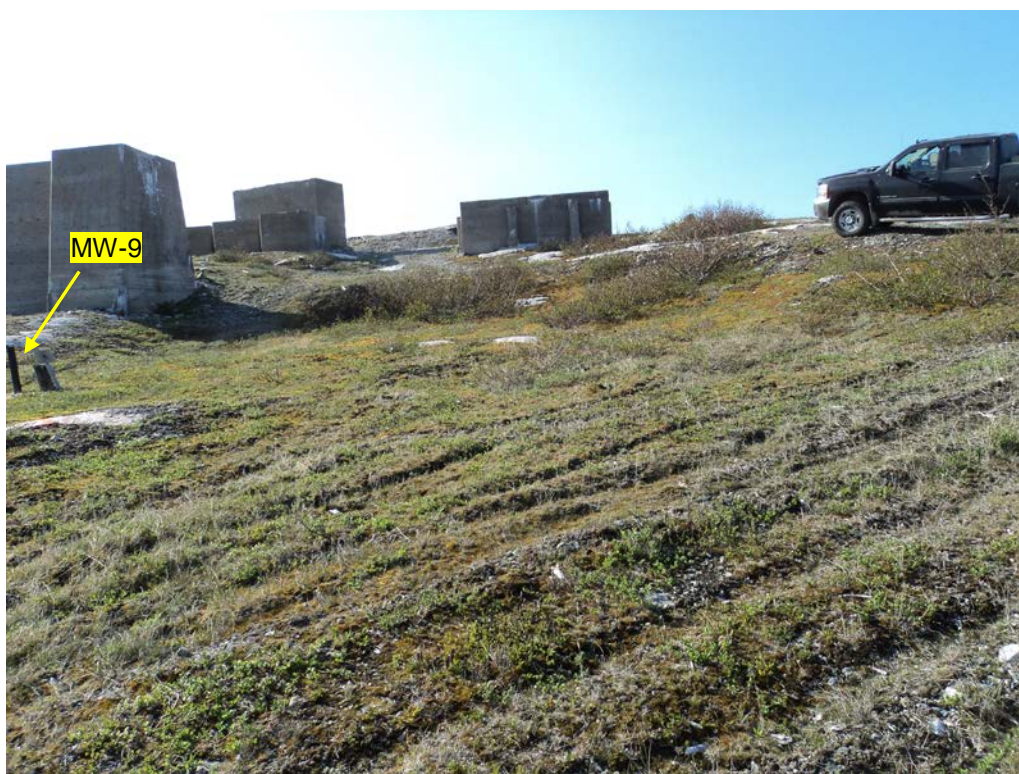
Photo 17 BMEWS area prior to excavation, looking southeast.

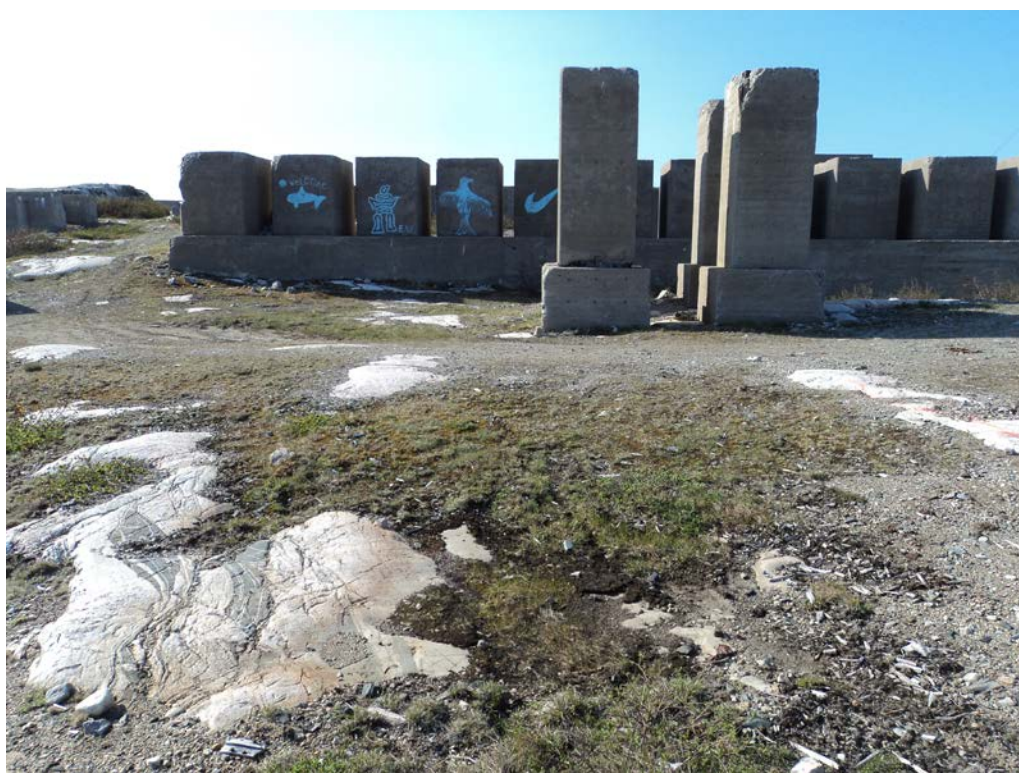
Photo 18 BMEWS area prior to excavation, looking south.

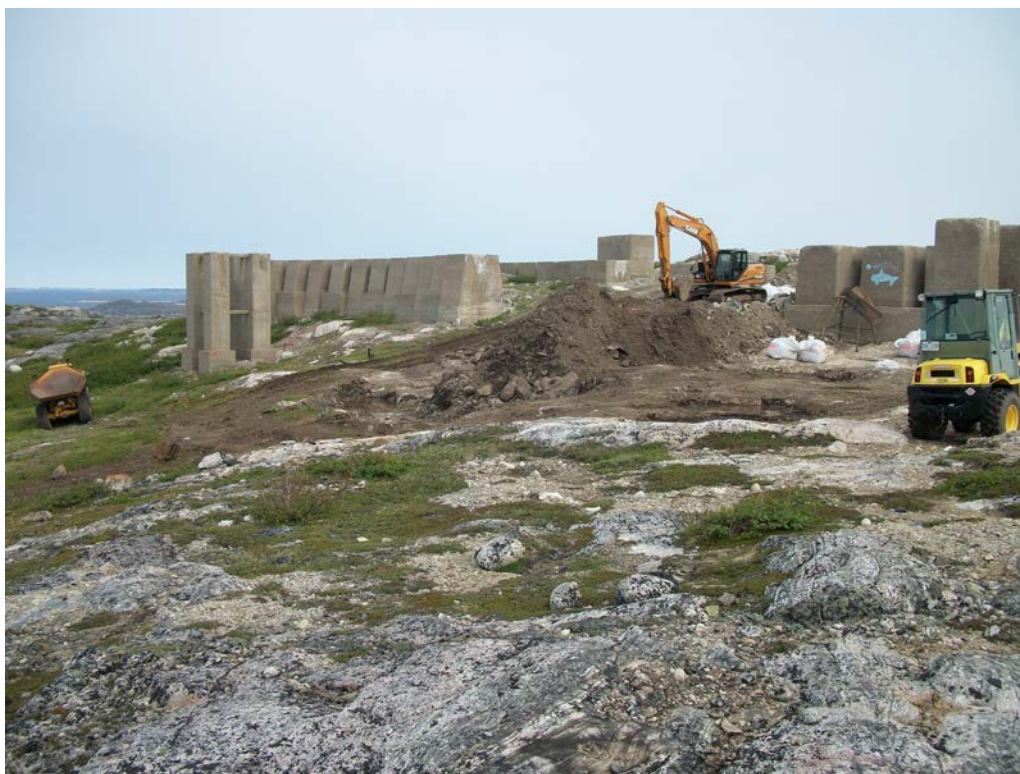
Photo 19 Remedial excavation in BMEWS area on July 10, 2013.

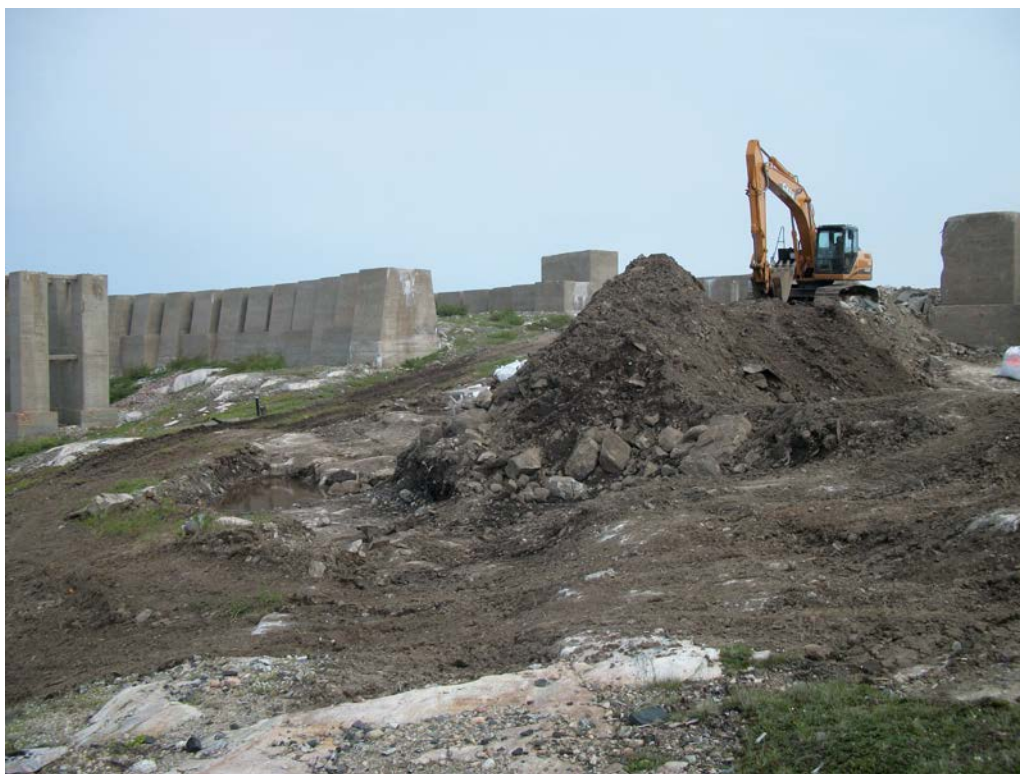
Photo 20 Remedial excavation in BMEWS area on July 10, 2013.

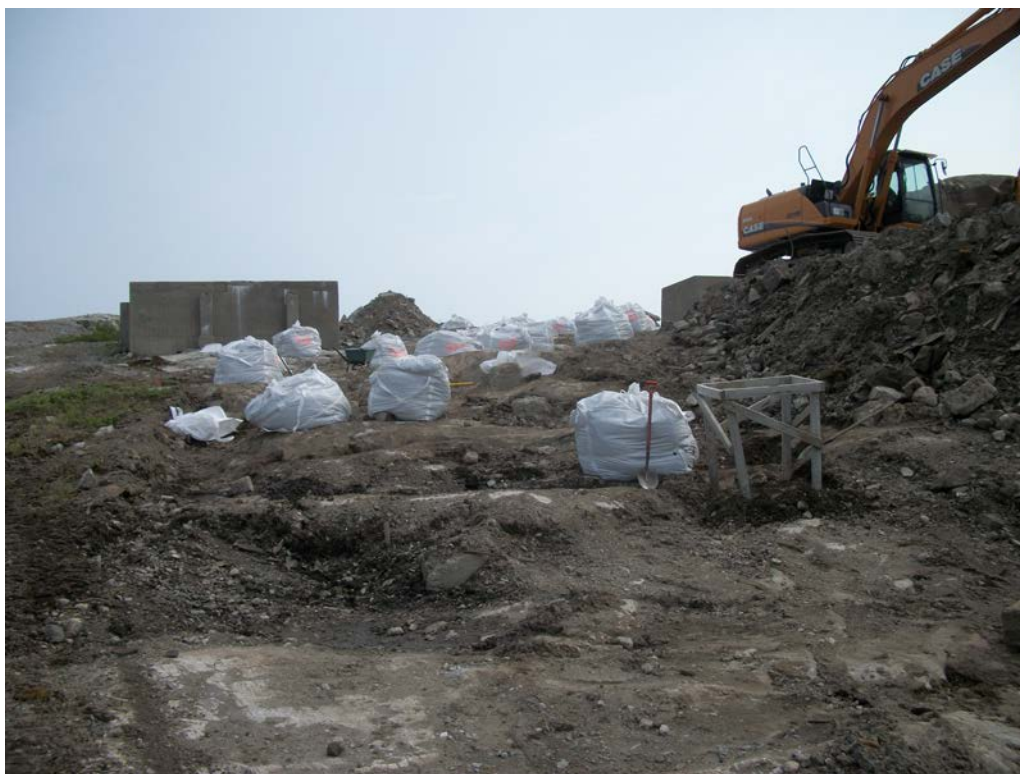
Photo 21 Remedial excavation in BMEWS area on July 10, 2013.

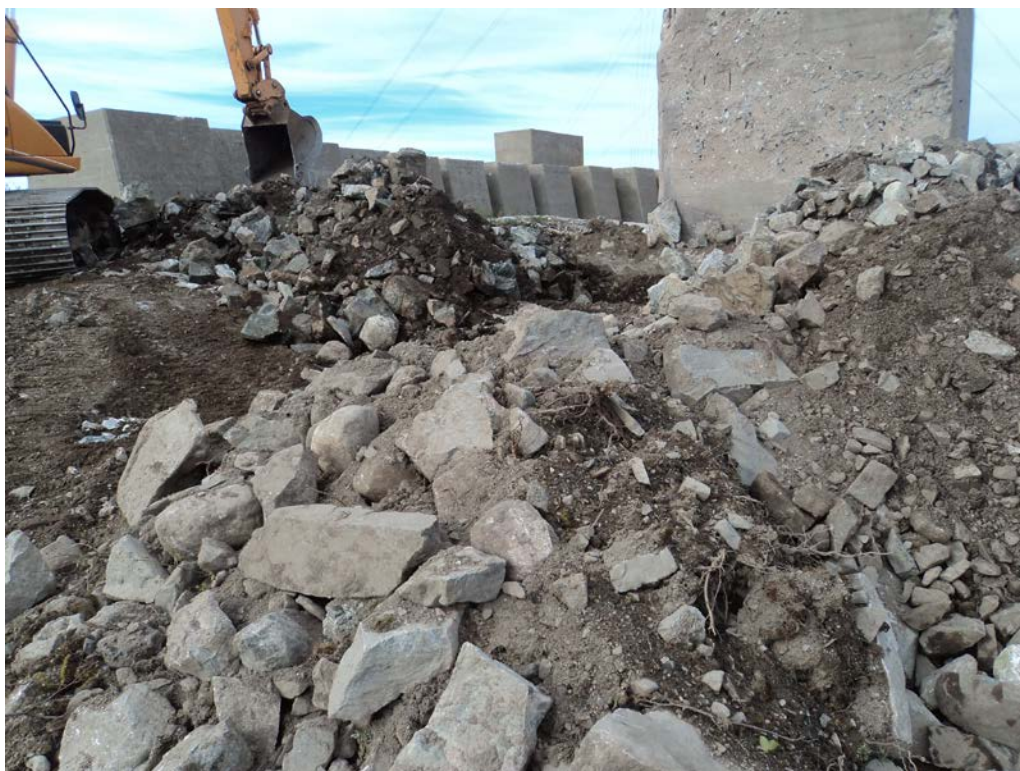
Photo 22 Boulder-sized rocks encountered in BMEWS excavation.

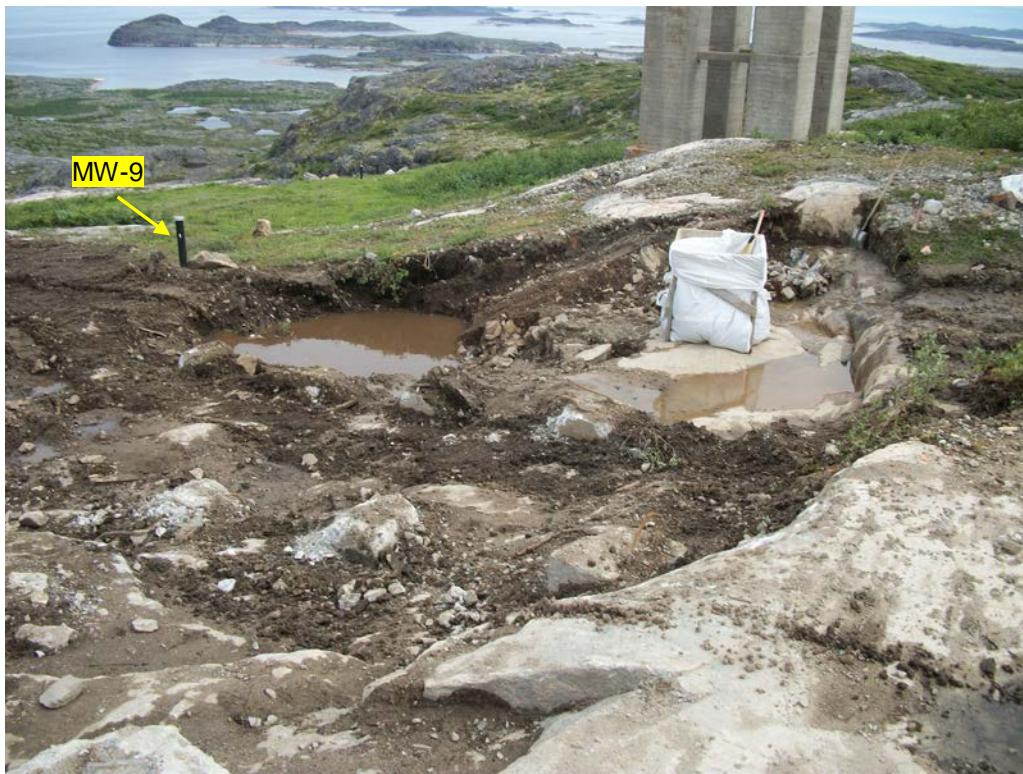
Photo 23 Soil removal in the vicinity of MW-9 on July 16, 2013.

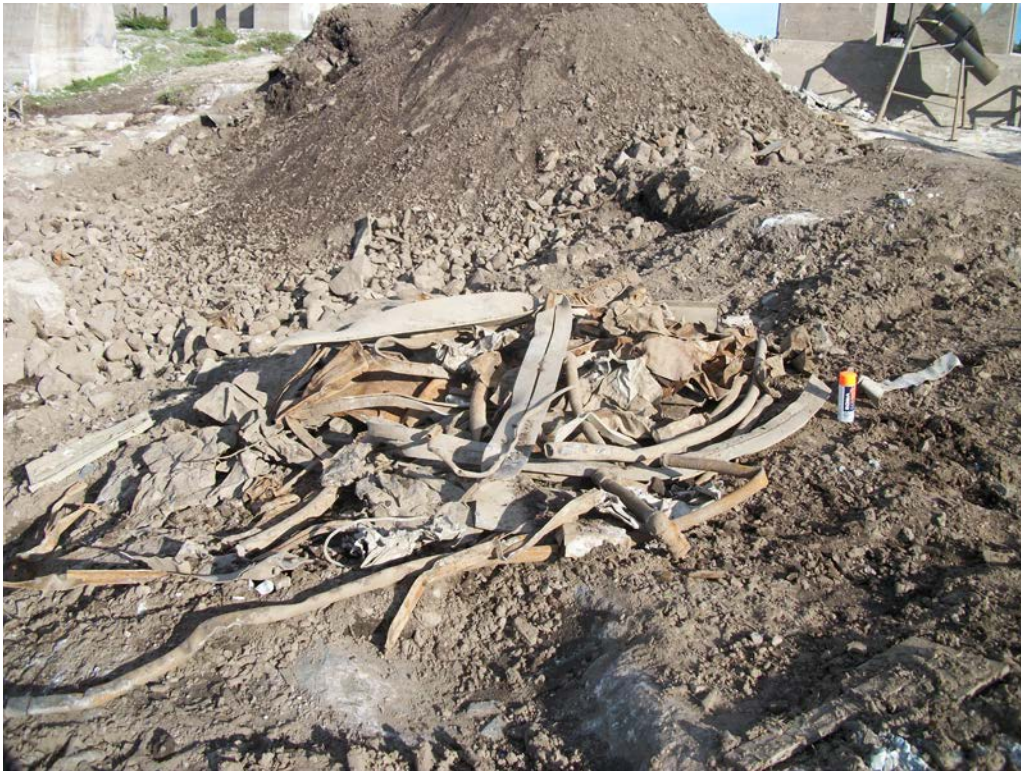
Photo 24 Buried metal encountered during excavation in the BMEWS area.

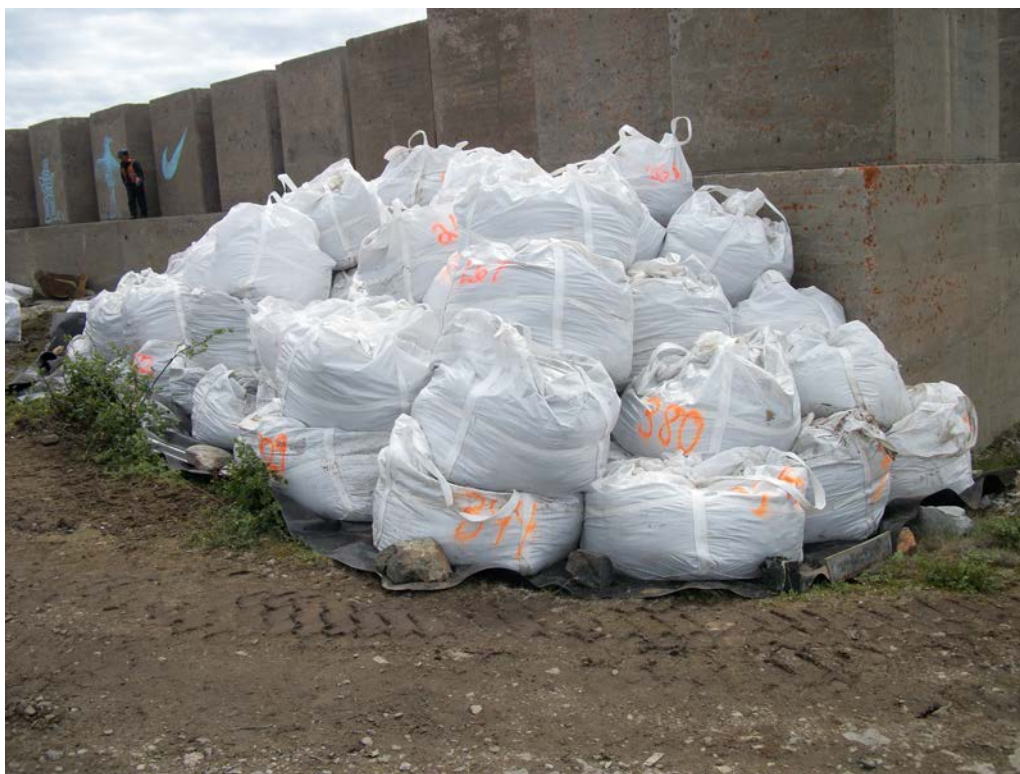
Photo 25 Laydown area in the BMEWS area.

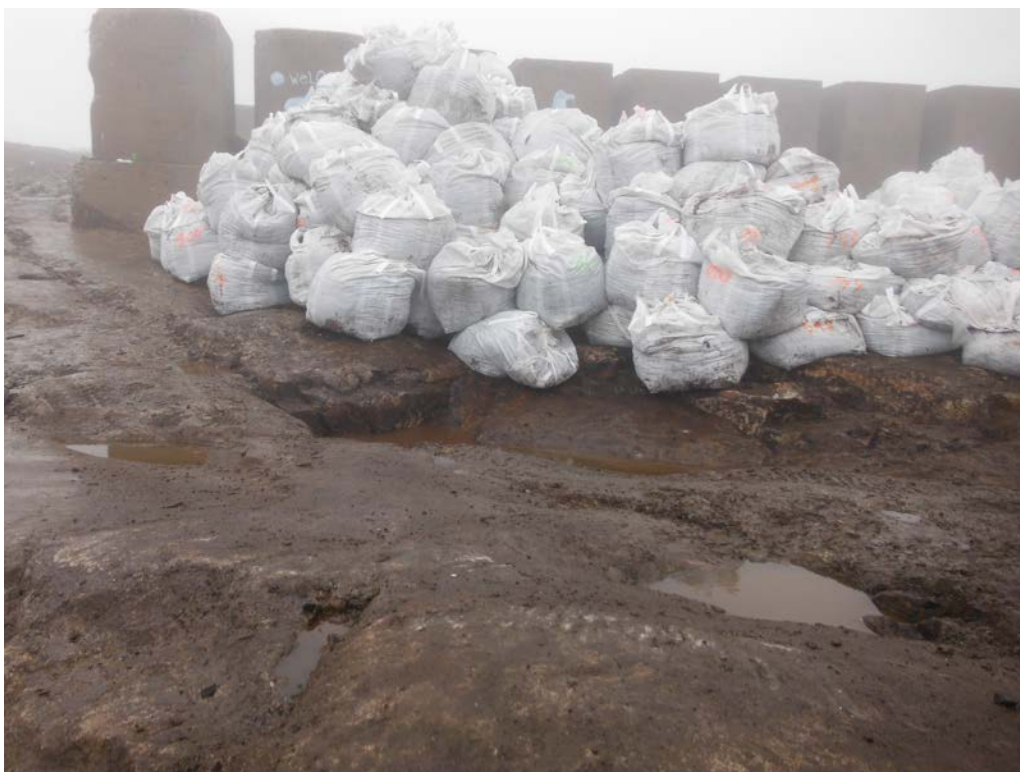
Photo 26 Soil bags temporarily stored on bedrock within the remedial excavation in the BMEWS area.

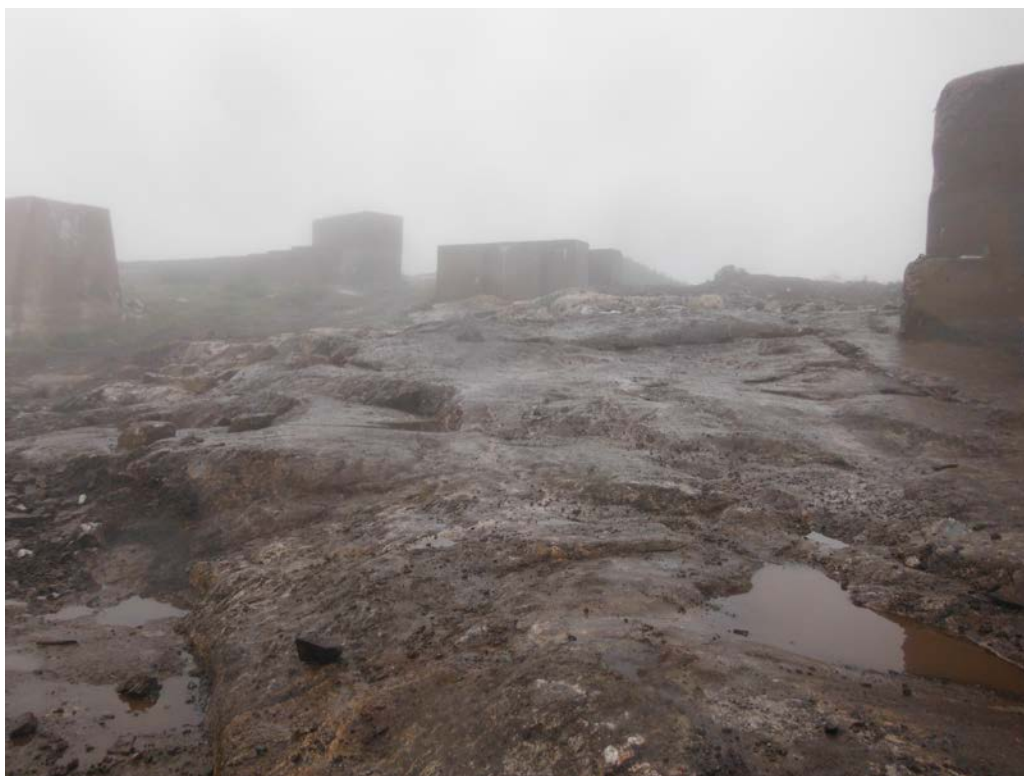
Photo 27 Central portion of BMEWS remedial excavation on August 6, 2013 (removed to bedrock).

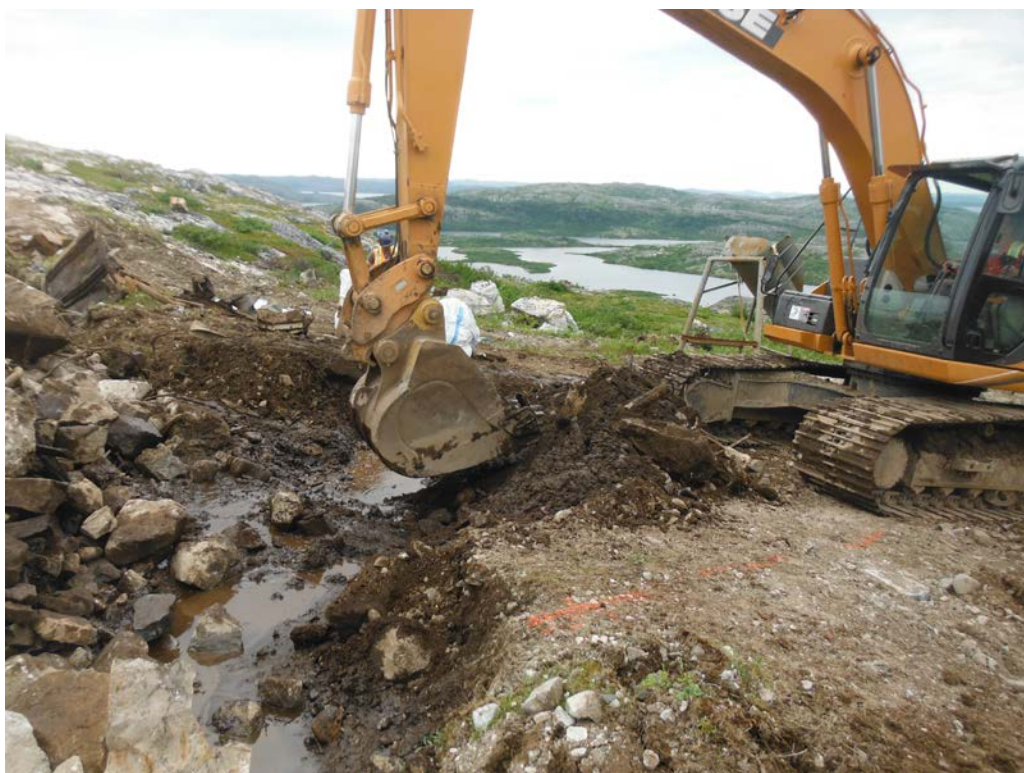
Photo 28 Removal of additional soil in the vicinity of 13-BMEWS-BS15 on August 9, 2013.
