**Implementation of Remedial
Action Plan – Year 3, Former
U.S. Military Site and
Residential Subdivision,
Hopedale, Labrador**

Prepared for:
Newfoundland Department of
Environment and Conservation
4th Floor Confederation Building,
West Block
St. John's, NL A1B 4J6

Prepared by:
Aivek Stantec Limited Partnership
141 Kelsey Drive
St. John's, NL A1B 0L2
Tel: (709) 576-1458
Fax: (709) 576-2126

Final Report

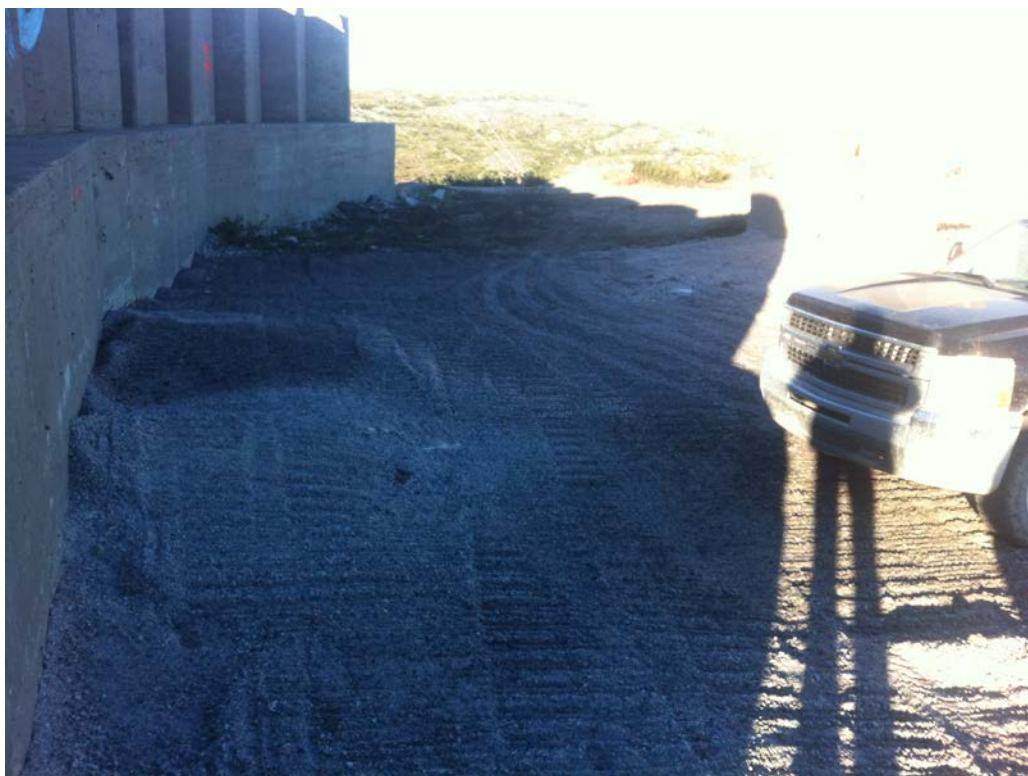
Photo 29 Surficial soil removed and area backfilled at the BMEWS laydown area.

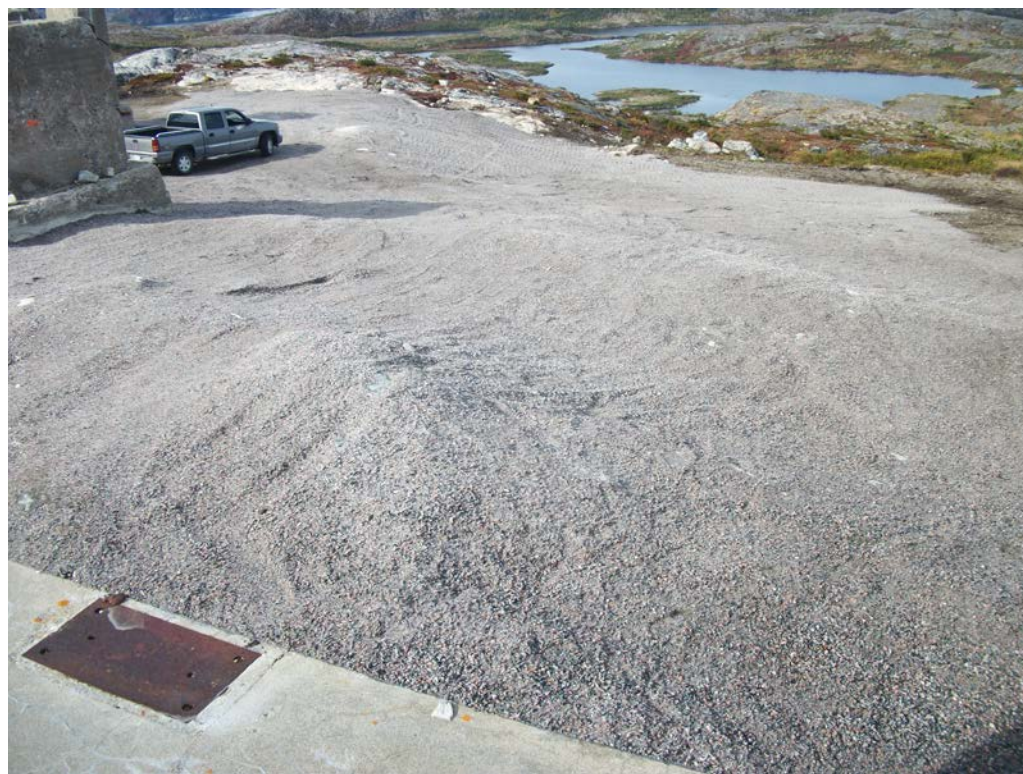
Photo 30 BMEWS area backfilled, looking northwest.

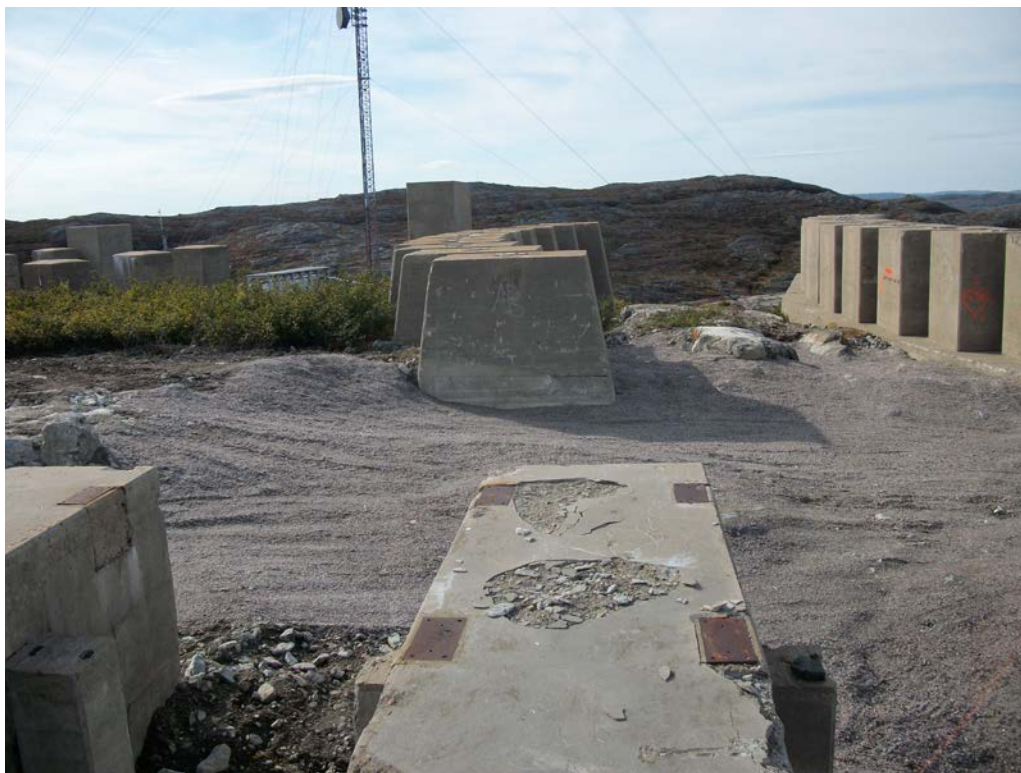
Photo 31 BMEWS area backfilled, looking west.

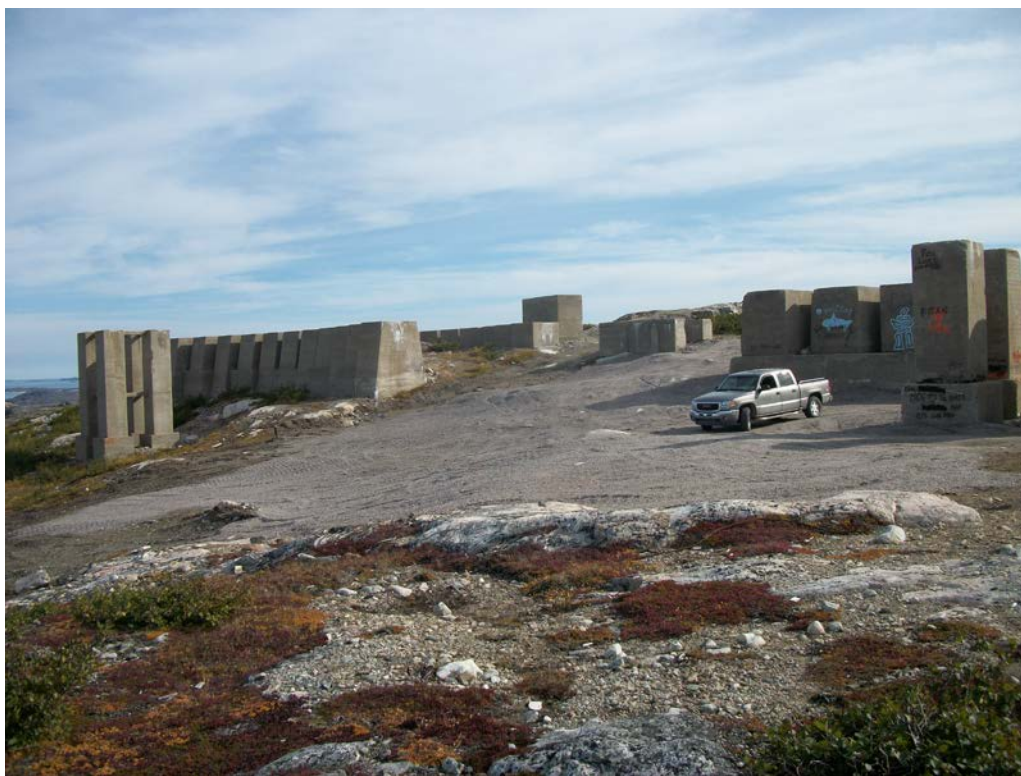
Photo 32 BMEWS area backfilled, looking southeast.

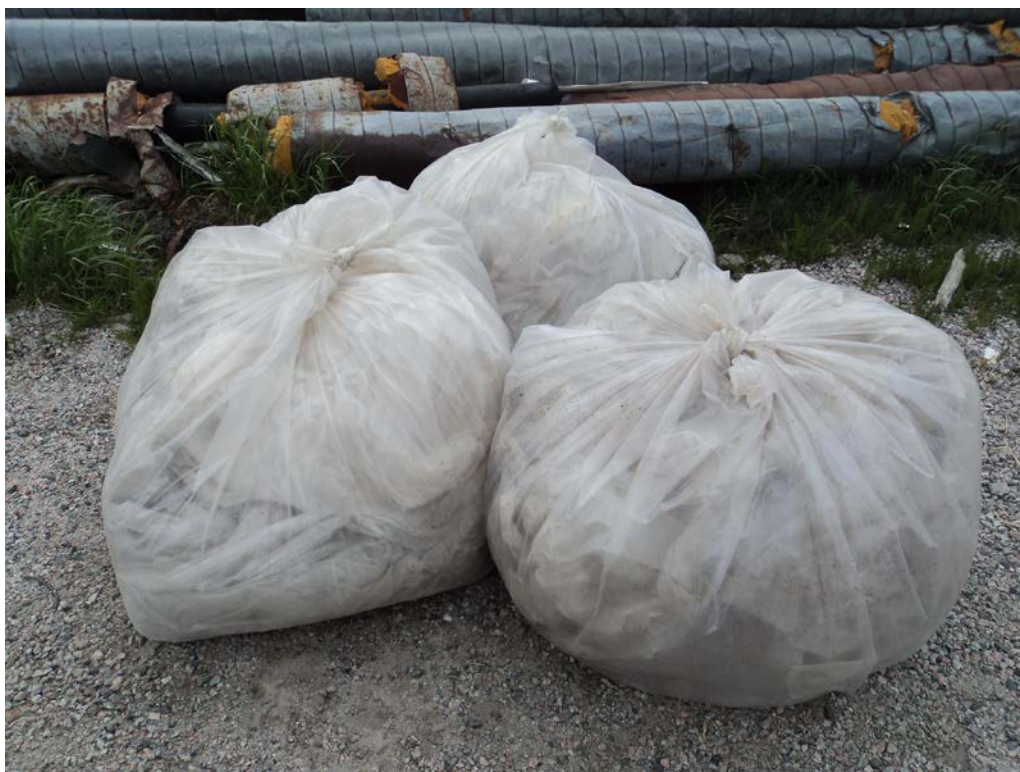
Photo 33 Plastic cover removed from Main Laydown Area and bagged.

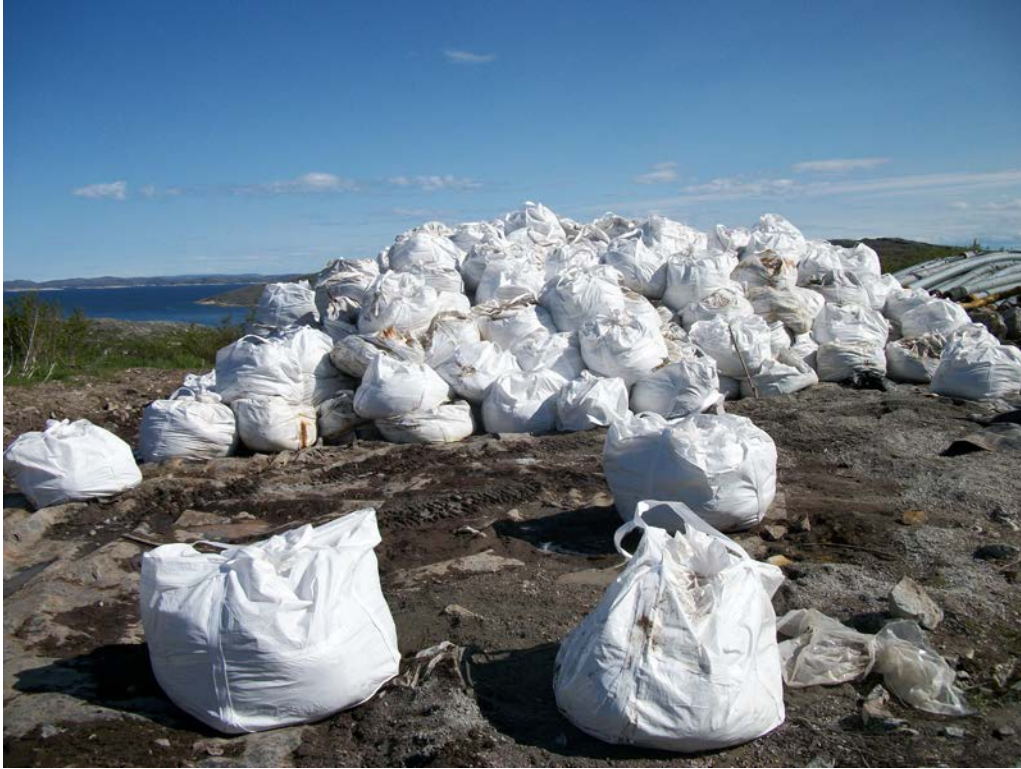
Photo 35 Main Laydown Area. Backfill material shown on bottom liner was subsequently removed and bagged.

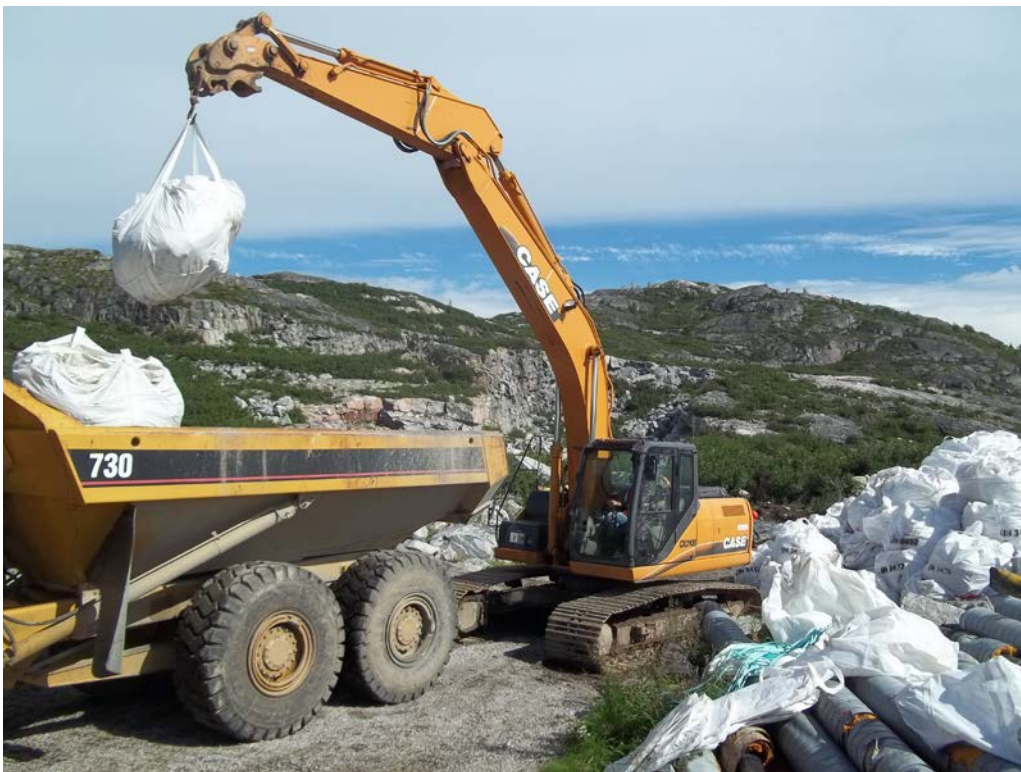
Photo 36 Loading soil bags from Main Laydown Area into Rock Truck for transportation to the barge on August 13, 2013.

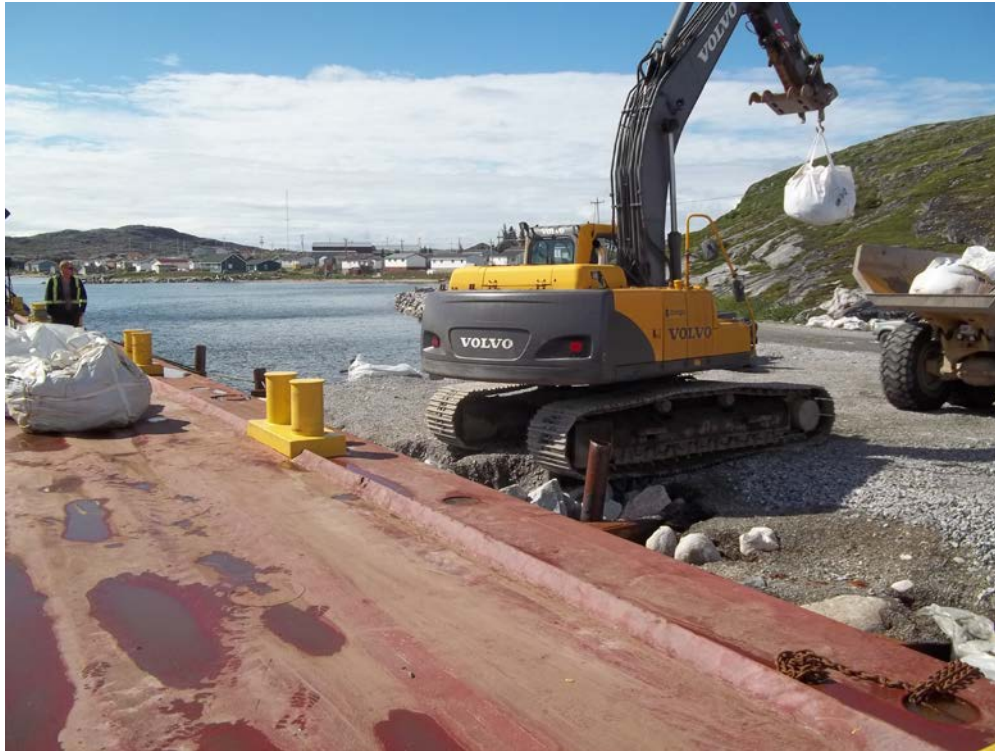
Photo 37 Loading soil bags onto barge at the polishing plant wharf on August 13, 2013.

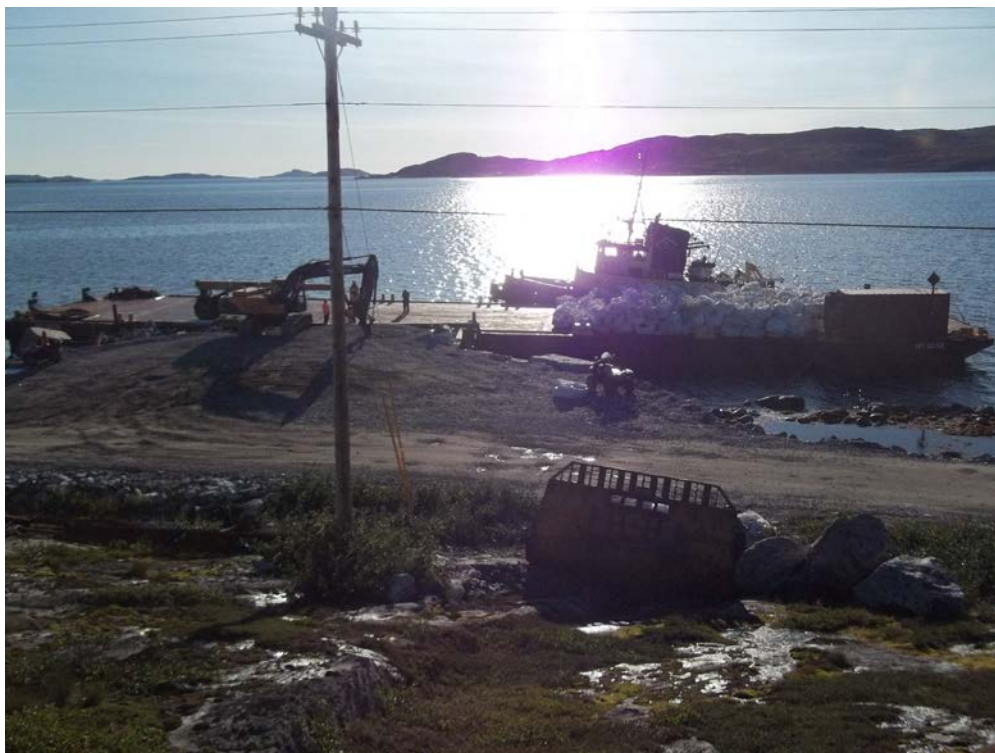
Photo 38 Loading soil bags onto the barge at the polishing plant wharf on August 14, 2013.

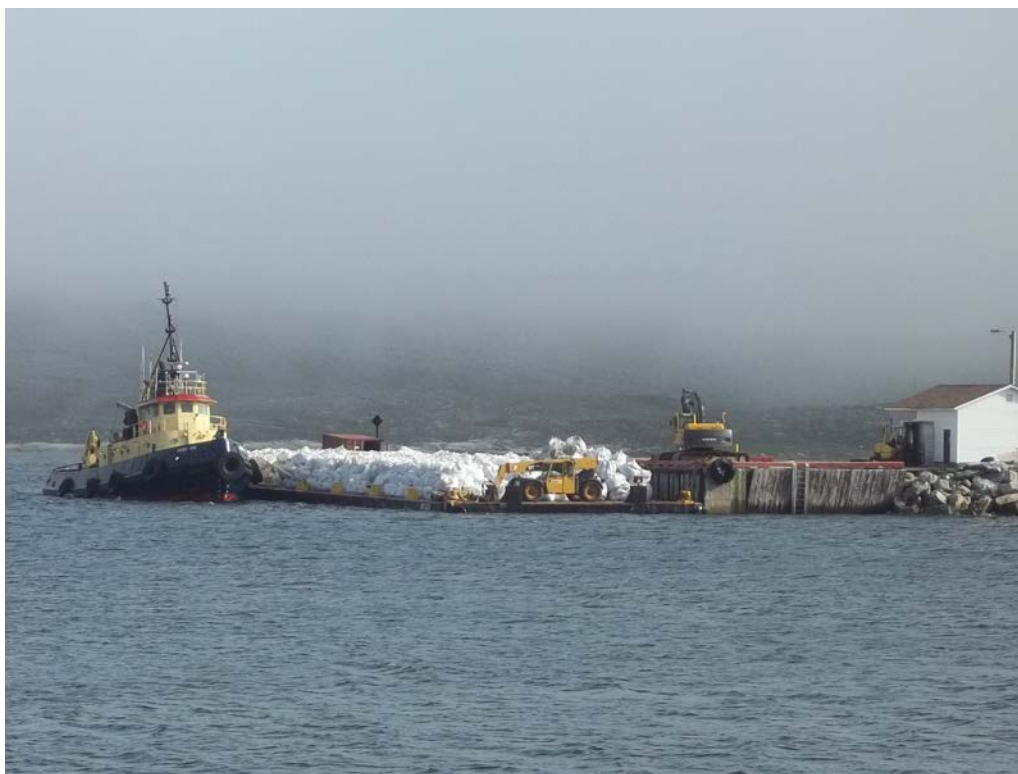
Photo 39 Loading barge at the American Dock on August 15, 2013.

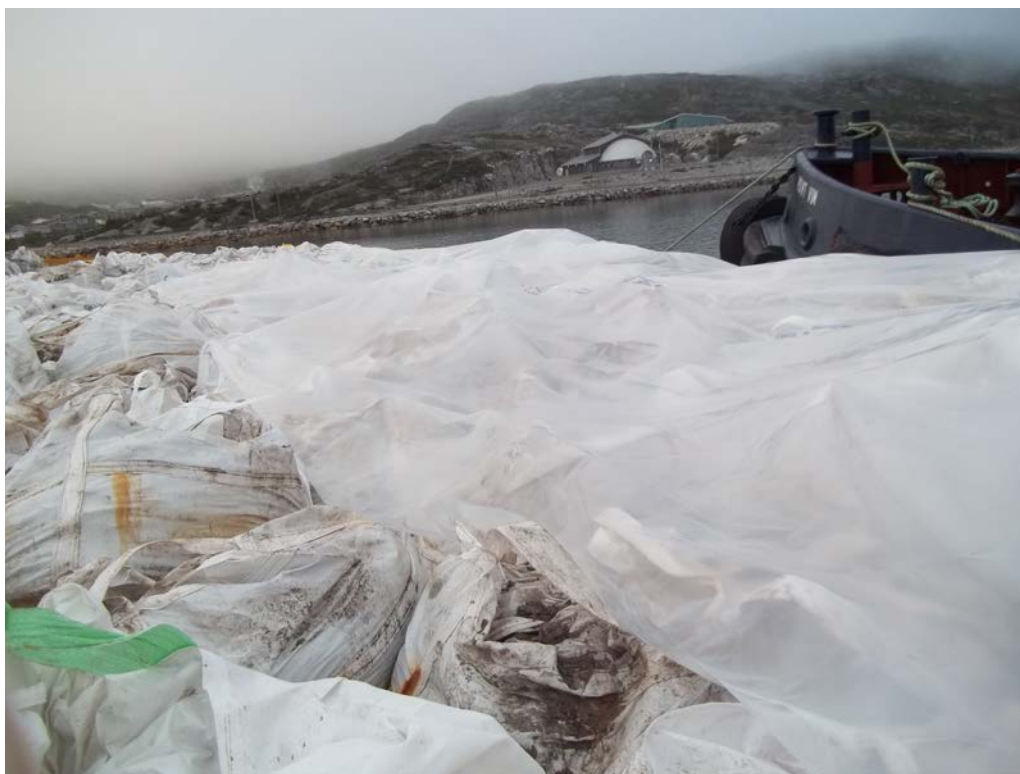
Photo 40 Covering soil bags with plastic tarp on August 15, 2013.

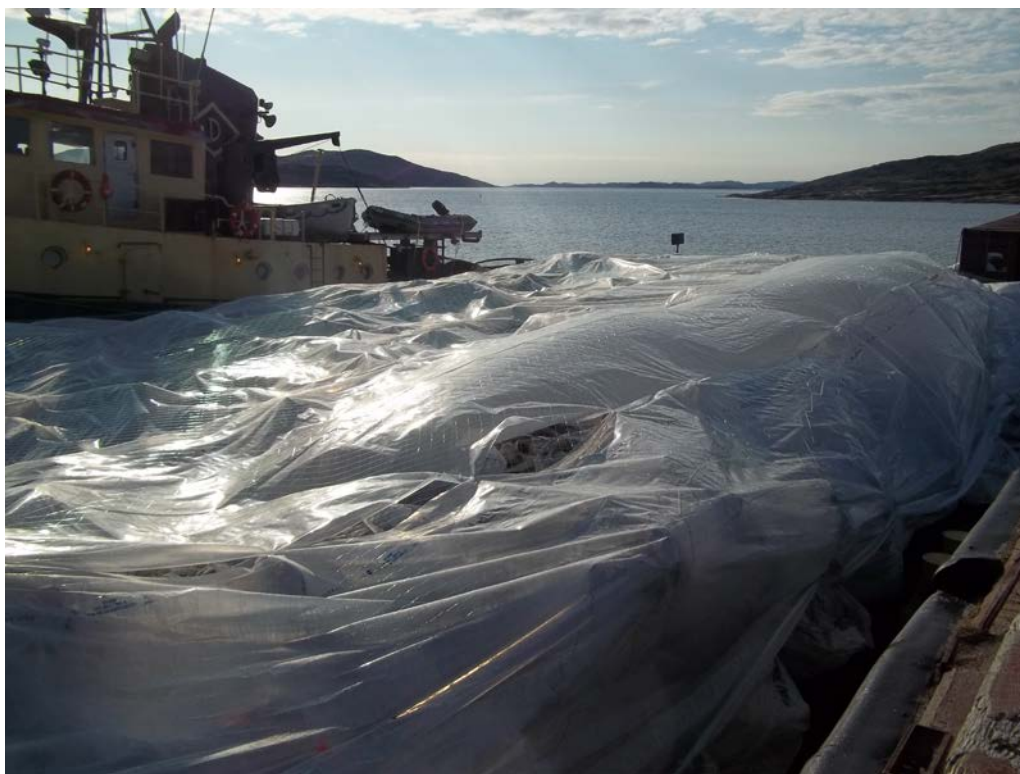
Photo 41 Bags covered with plastic liner and netting on August 16, 2013.

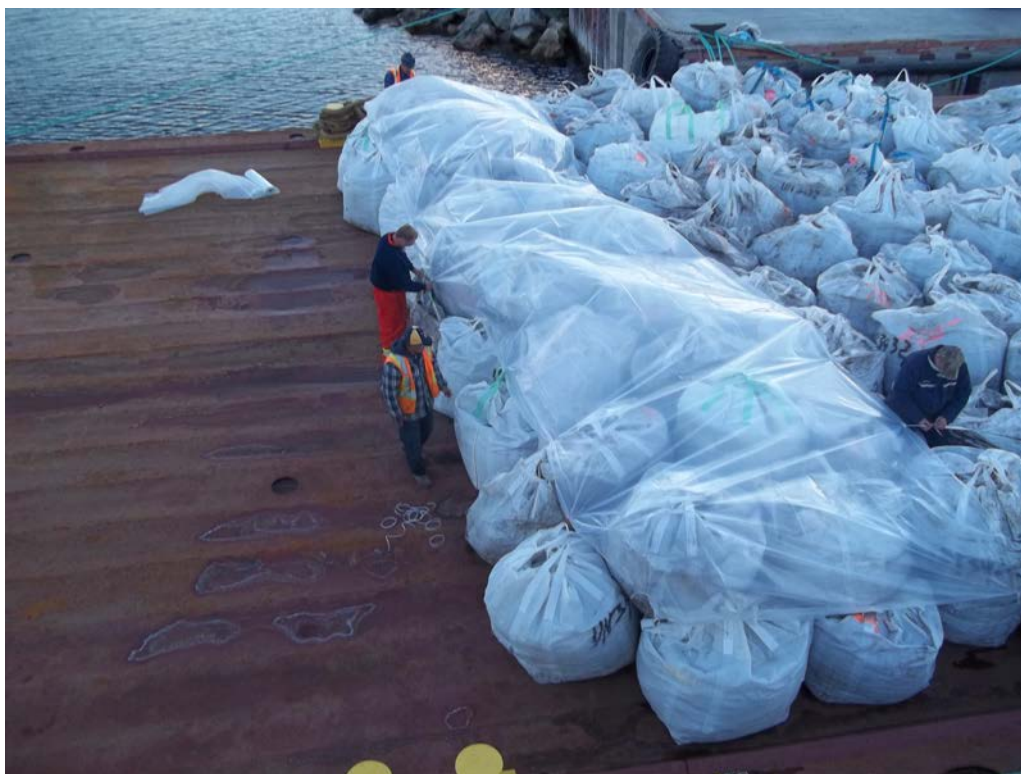
Photo 43 Loading barge on August 31, 2013.

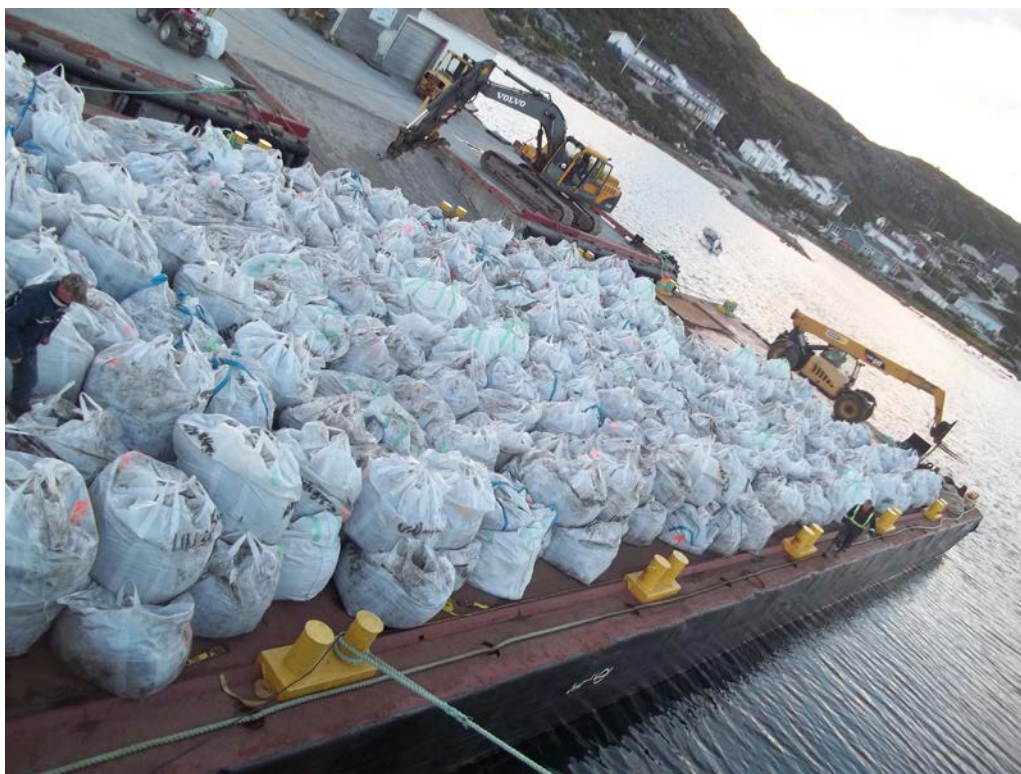
Photo 44 Loading barge on August 31, 2013.

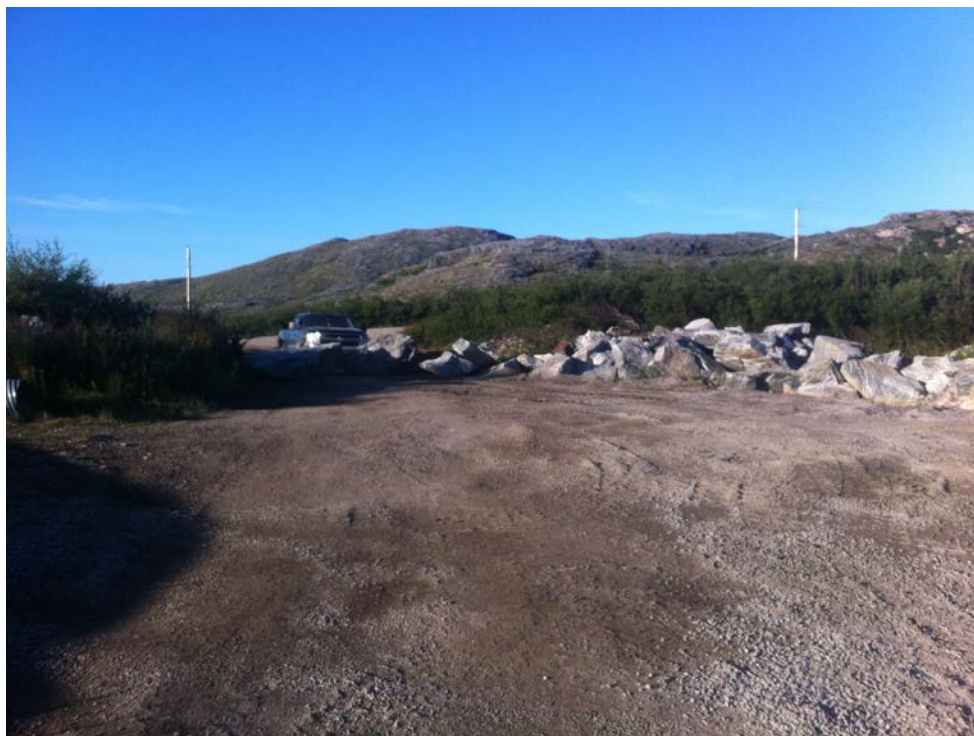
Photo 45 Main Laydown Area on September 2, 2013 following bag removal, surficial soil removal and backfilling.

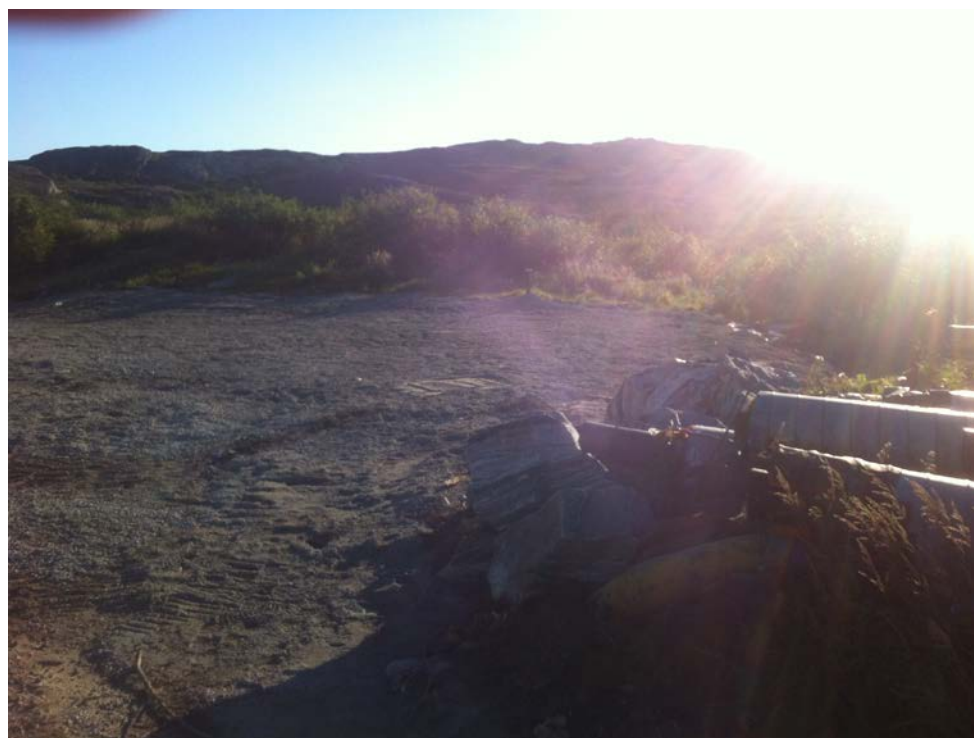
Photo 46 Main Laydown Area on September 2, 2013 following bag removal, surficial soil removal and backfilling.

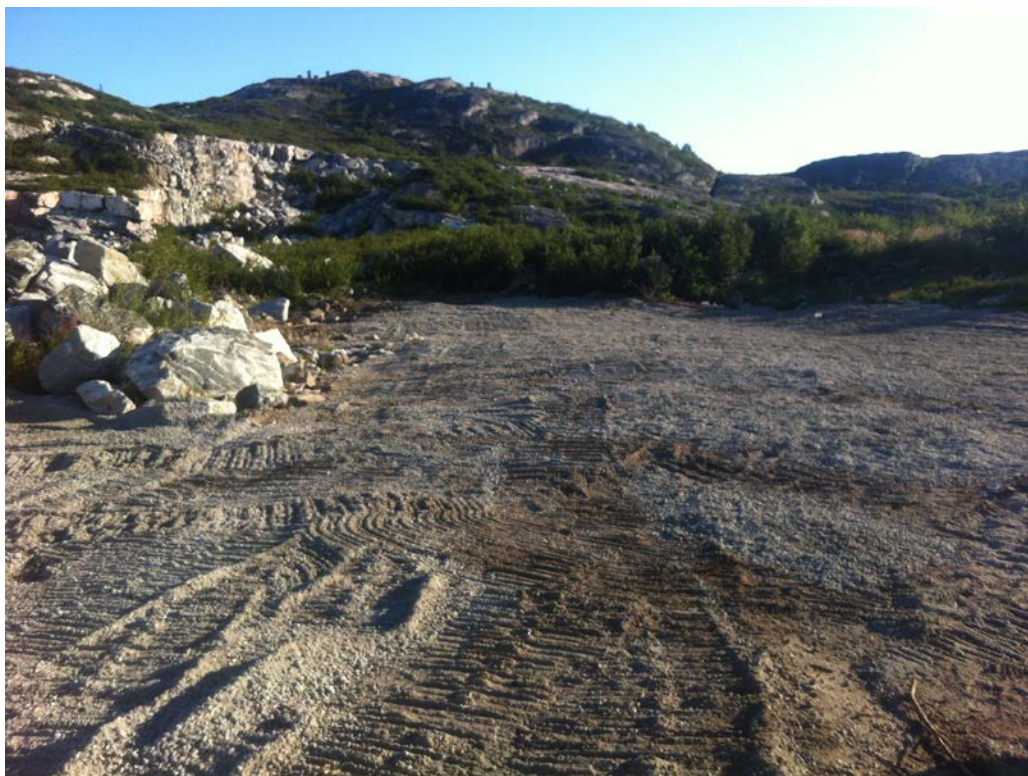
Photo 47 Main Laydown Area on September 2, 2013 following bag removal, surficial soil removal and backfilling.
