Implementation of the Remedial Action Plan - Year 4, Former U.S. Military Site, Hopedale, NL

Final Report

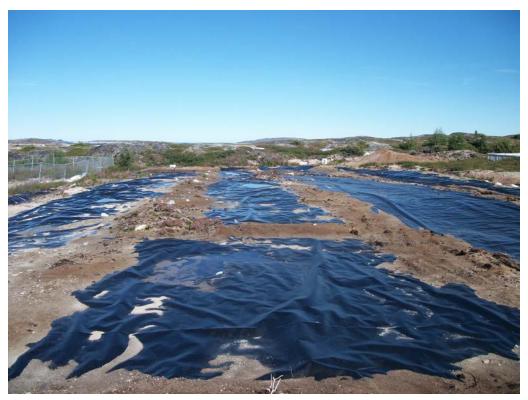
Photo 1 Biopile prior to dismantling in Year 4.

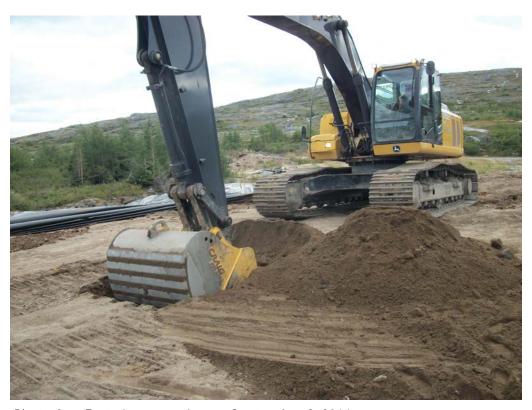
Photo 2 Test pit excavation on September 8, 2014.

On September 8, 2014, confirmatory soil sampling was carried out at the biopile to confirm that concentrations of TPH in soil were below the target concentration of 1,000 mg/kg. The HDPE cover was removed and test pits were excavated with the aid of a track-mounted excavator supplied and operated by Budgell's. Stantec personnel recorded details of subsurface conditions encountered during excavation and collected confirmatory soil samples.

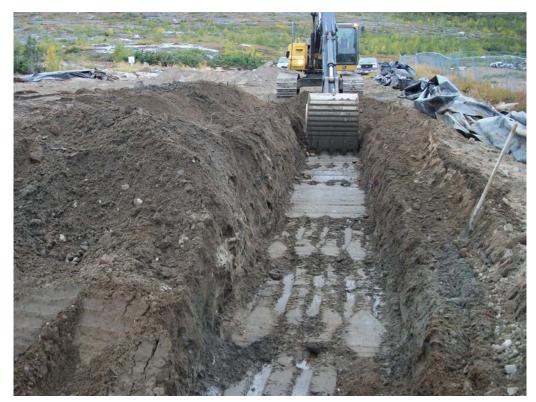
Photo 3 Removal of treated soil from the biopile.

On October 7, 2014, treated soil was removed from the temporary biopile, transported to the local landfill and stockpiled for use as cover material. Soil removal and transportation was carried out using a track mounted excavator and tandem dump trucks. A 450 mm thick layer of soil was left in place at the bottom of the biopile containment cell to minimize the risk of damage to the bottom liner. Photos taken of the biopile are provided in Appendix B.

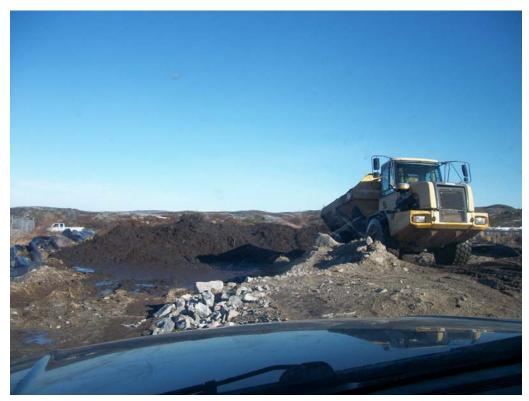
Photo 4 Placement of TPH-impacted soil in the biopile containment cell.

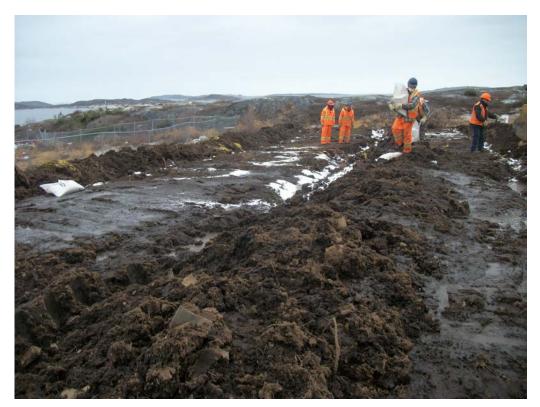
Photo 5 Addition of biopile nutrients/fertilizers.

- Biopile maintenance activities, consisting of the addition of specified nutrients and mechanical aeration were carried out following the placement of TPH-impacted soil in the biopile containment cell. A cover was placed over the biopile and was secured in place using clean sand.

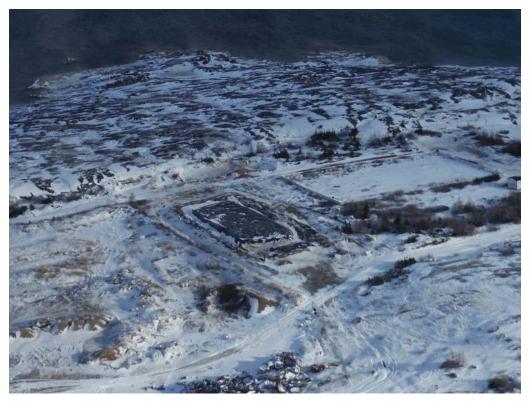
Photo 6 Aerial photo taken of the biopile on November 14, 2014.

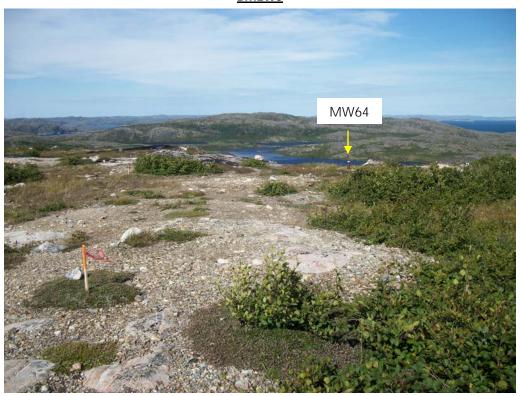
Photo 7 Southern portion of BMEWS-Area 1, looking north, prior to grubbing and soil removal.

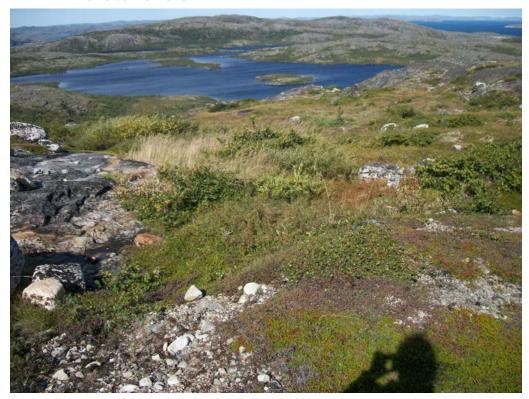
Photo 8 Norther portion of BMEWS-Area 1, looking north, prior to grubbing and soil removal.

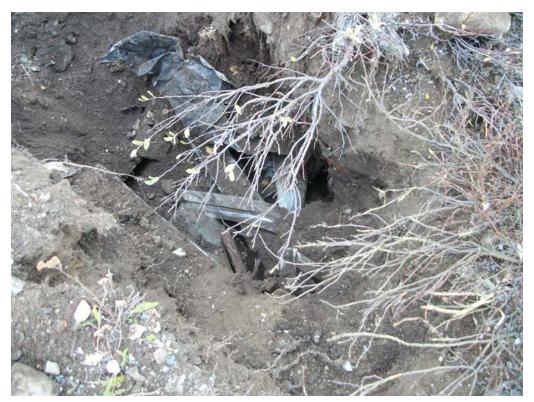
Photo 9 Metal debris at BMEWS-Area 2, prior to removal.

Metal debris was observed protruding from the ground to the east of BMEWS-Area 1 and was removed to eliminate physical hazards during site work. Metal debris consisted mainly of steel girders, large pieces of steel and vehicle parts. Metal debris encountered in the excavation was shaken/brushed to remove excess soil, and the metal debris was transported to the Laydown Area where it was stockpiled on tarps for storage until it is transported out of Hopedale for recycling during a subsequent year of the Implementation of the RAP. A cable encountered in the excavation was sampled to confirm that it did not contain PCBs. A bulk sample was collected from the cable and was submitted for PCB analysis (Cable-1). PCBs were not detected in the sample (refer to Section 3.1 for further details). Soil removed from this area (referred to as BMEWS-Area 2) contained a minor petroleum hydrocarbon odour; therefore soil removed during metal debris removal was disposed of at the biopile. Sidewall samples were collected from the limits of the excavation to determine the concentrations of TPH in soil. Concentrations of TPH were below the applicable SSTL of 1,700 mg/kg. The excavation extended to bedrock. Groundwater was not encountered at this location. The limits of the BMEWS-Area 2 excavation are shown on Drawing No. 121413099-200-EE-03 in Appendix A.

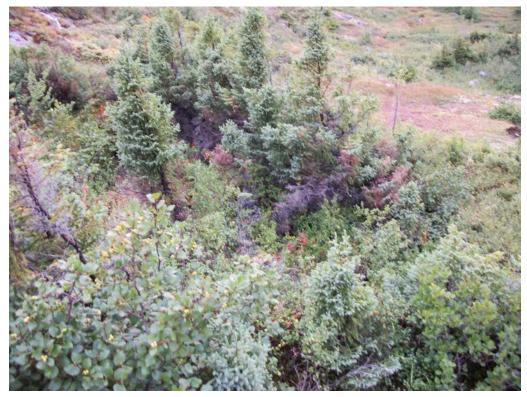
Photo 10 BMEWS-Area 3, looking northwest, prior to grubbing (note: this area was not remediated in 2014).

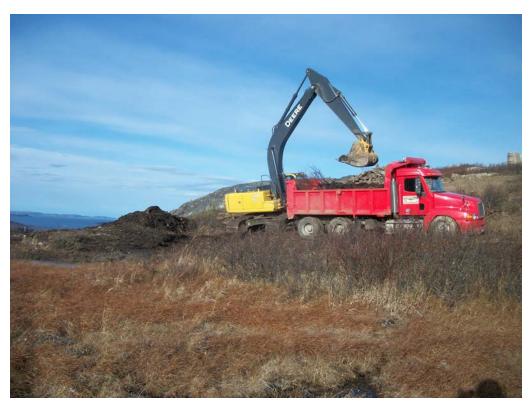
Photo 11 Soil removal at BMEWS-Area 1.

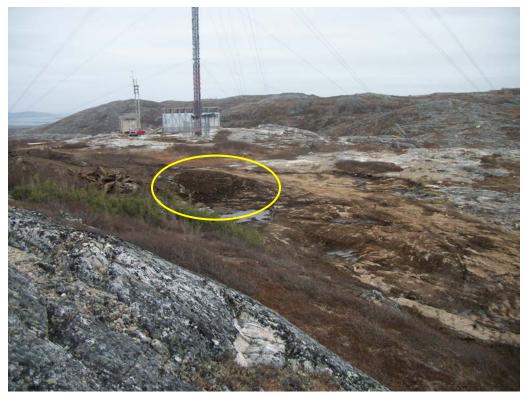
Photo 12 Upper (south) portion of BMEWS-Area 1 following soil removal, looking south. Circle shows area requiring additional soil removal.

- 1. Complete the removal of TPH-impacted soil exceeding the SSTL of 1,700 mg/kg in areas specified for remediation at BMEWS (estimated 240 tonnes) and Main Base (estimated 530 tonnes). Once clean boundaries are obtained, return the site to its original condition. This will include backfilling, levelling and/or the placement of topsoil, as necessary.

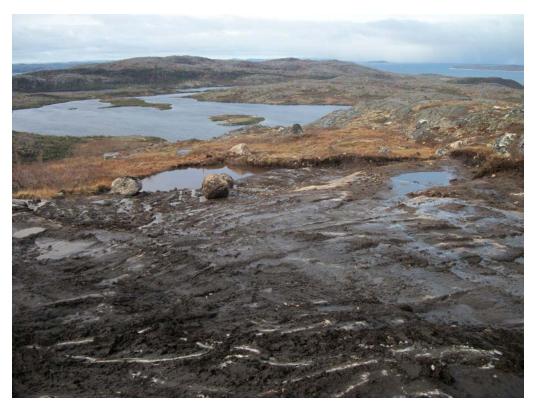
Photo13 Lower (north) portion of BMEWS-Area 1 following soil removal, looking north.

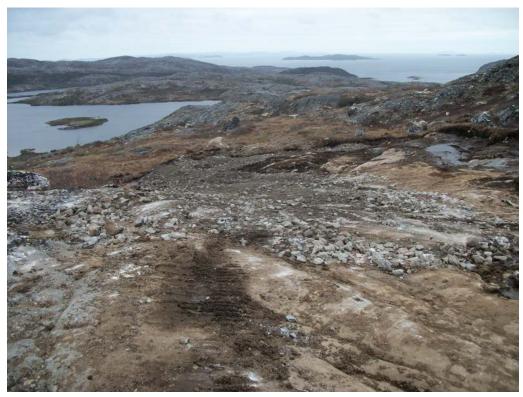
Photo 14 Lower (north) portion of BMEWS-Area 1 partially backfilled, looking north.

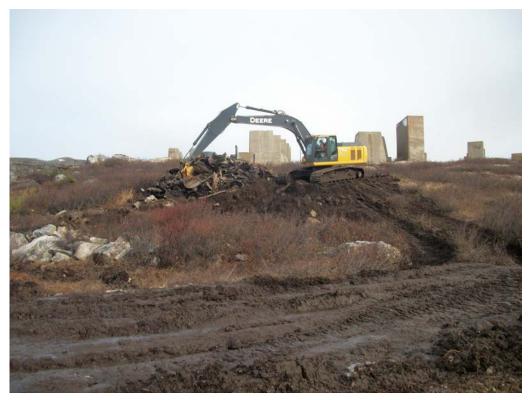
Photo 15 Removal of metal at BMEWS-Area 2.

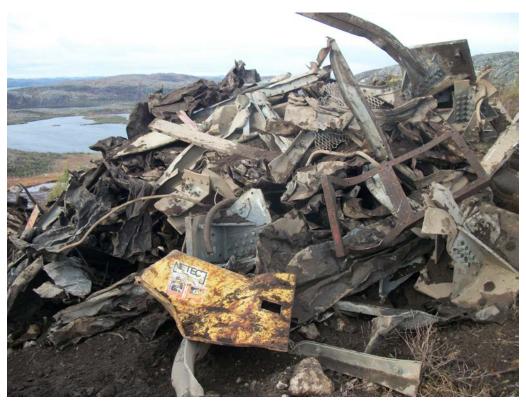
Photo 16 Metal removed from BMEWS-Area 2.

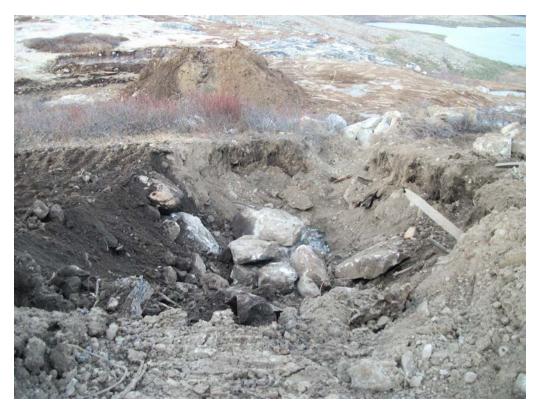
Photo 17 BMEWS-Area 2 excavation, looking west.

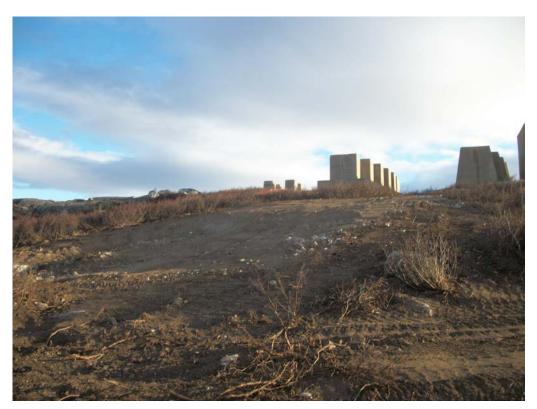
Photo 18 BMEWS-Area 2 excavation following backfilling, looking east.

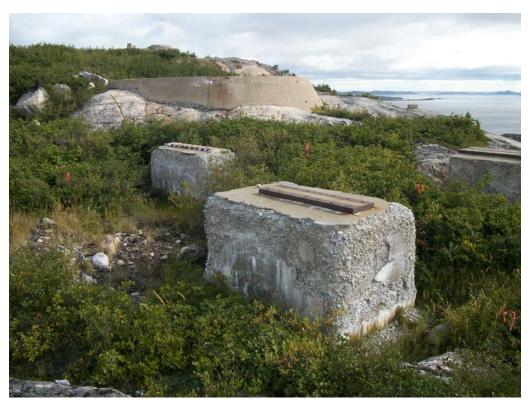
Photo 19 Main Base-Area 1, looking northwest in area of samples 22474 and 22475, prior to grubbing and soil removal.

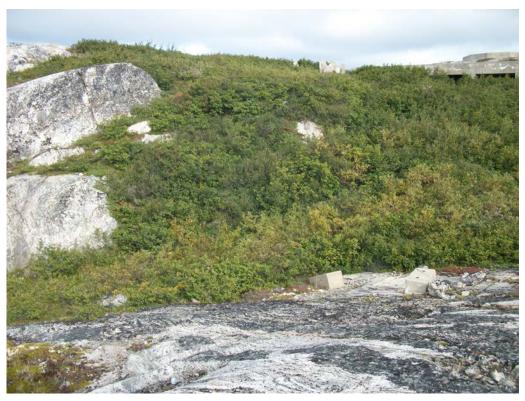
Photo 20 Main Base-Area 1, looking north, prior to grubbing and soil removal.

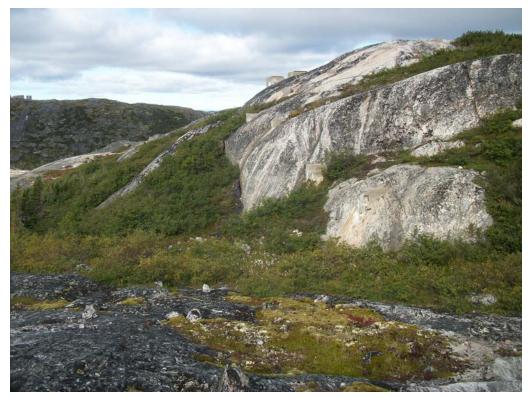
Photo 21 Main Base-Area 1, looking west, prior to grubbing and soil removal.

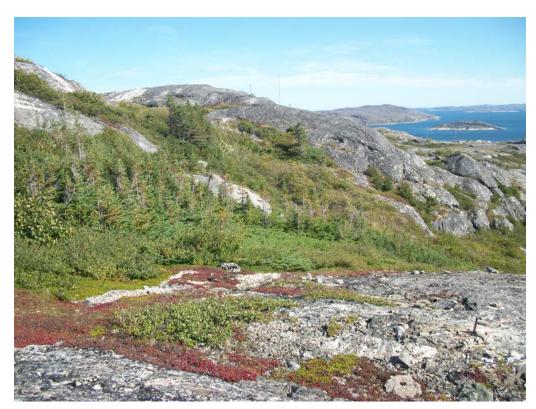
Photo 22 Main Base-Area 1, looking east, prior to grubbing and soil removal.

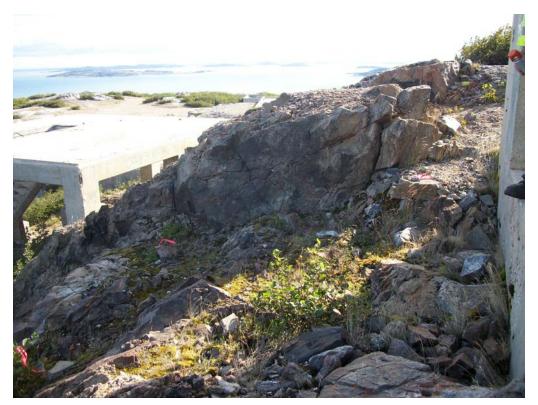
Photo 23 Main Base-Area 5, looking west, prior to grubbing (note: area not remediated in 2014).

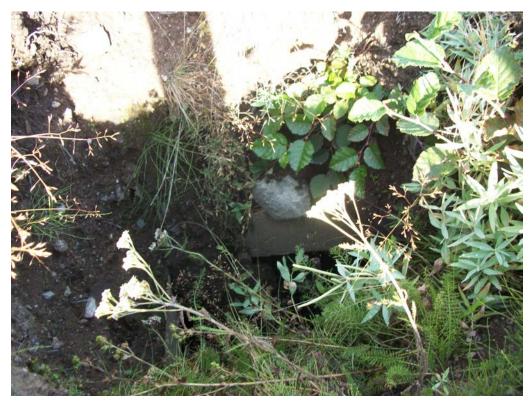
Photo 24 Concrete opening of septic tank (note: area not remediated in 2014).

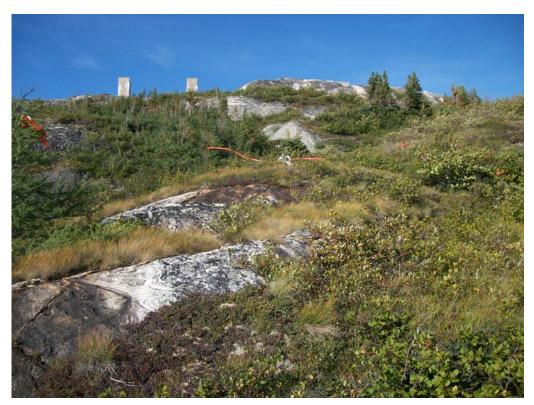
Photo 25 Main Base-Area 7, looking north, prior to grubbing and soil removal.

Orange flagging tape marks boundary between PCB and TPH remedial excavations.

Six (6) confirmatory soil samples were initially collected from the presumed limits of the Main Base-Area 7 remedial excavation (14-MB-BS701 to 14-MB-BS705). The concentrations of TPH in samples 14-MB-BS701 (14,000 mg/kg), 14-MB-BS702 (42,000 mg/kg), 14-MB-BS703 (6,600 mg/kg) and 14-MB-BS705 (6,800 mg/kg) exceeded the SSTL of 1,700 mg/kg, therefore additional soil removal was recommended in these areas. This work was not carried out during Year 4 of the Implementation of the RAP. The extent of TPH impacts in soil in this area has not been fully delineated.

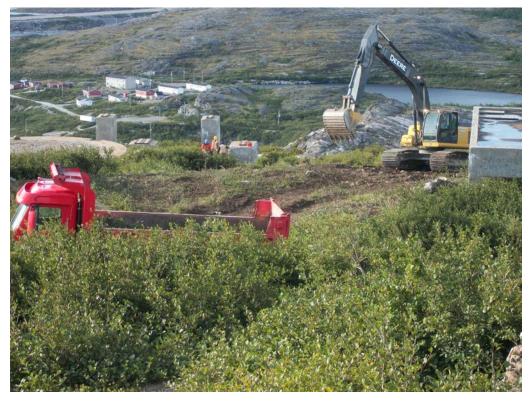
Photo 26 Grubbing at Main Base-Area 1.

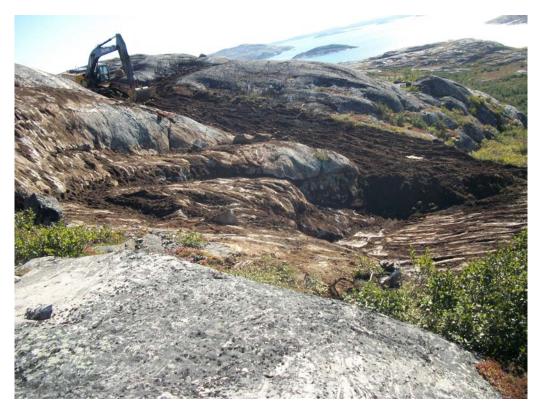
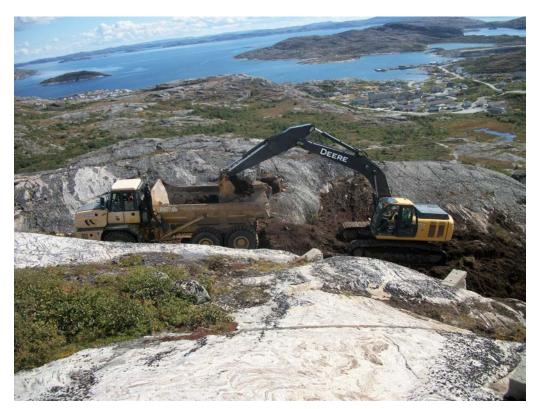
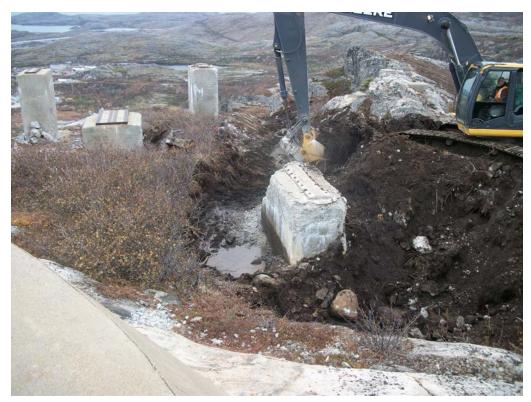
Photo 27 PCB-impacted soil removal at Main Base-Area 1.

Photo 28 PCB-impacted soil removal at Main Base-Area 1.

Photo 29 PCB-impacted soil removal at Main Base-Area 1.

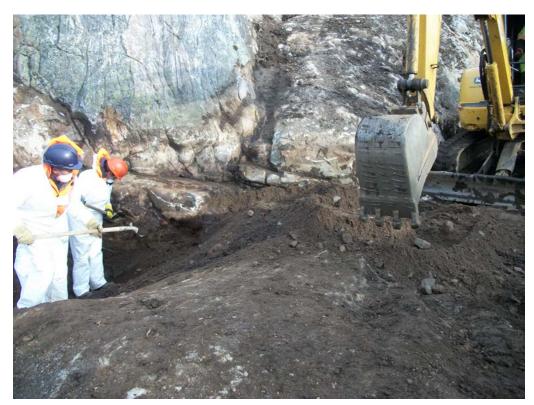
Photo 30 Removal of PCB-impacted soil and tar-like material in the vicinity of former sample 22488 at Main Base-Area 1.

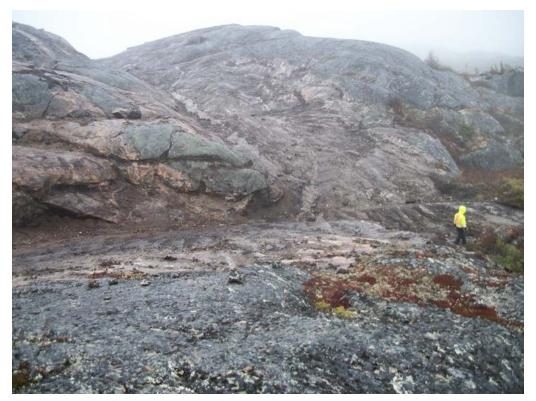
Photo 31 Main Base-Area 1 following the removal of PCB-impacted soil, looking east.

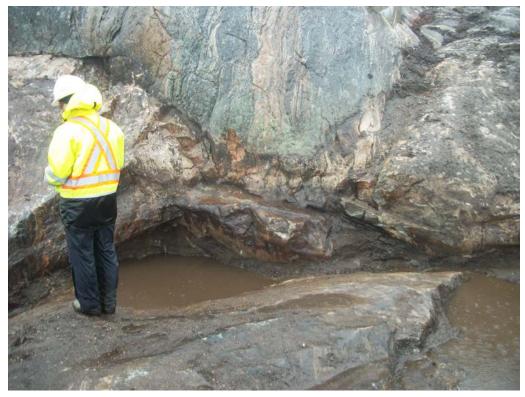
Photo 32 Main Base-Area 1 following the removal of PCB-impacted soil and tar-like material in the vicinity of former sample 22488.

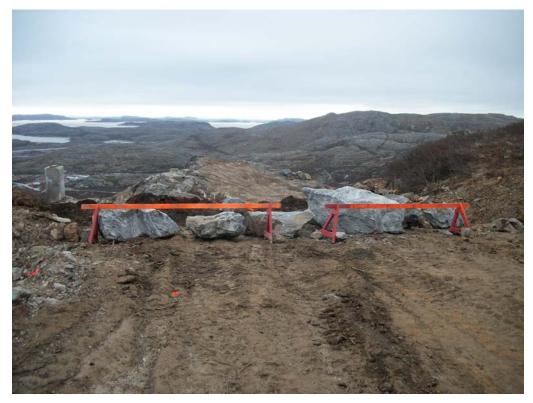
Photo 33 Boulders and barricades placed along the northeast limits of the Main Base-Area 1 excavation.

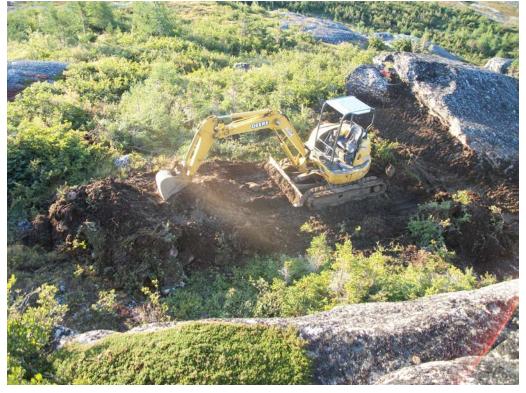
Photo 34 TPH-impacted soil removal at Main Base-Area 7.

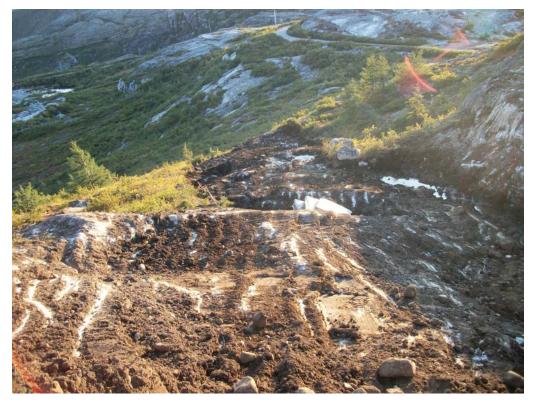
Photo 35 TPH-impacted soil removal at Main Base-Area 7 (note: remaining soil on bedrock was manually removed using shovels).

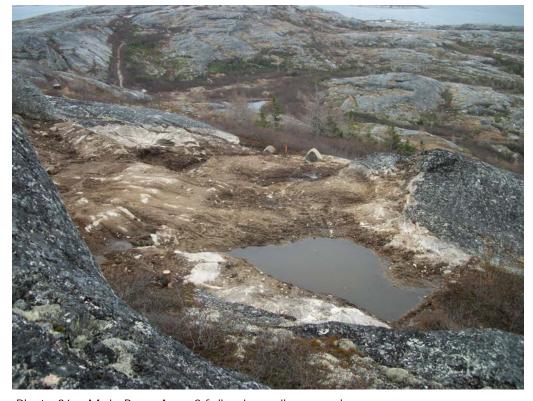
Photo 36 Main Base-Area 8 following soil removal.

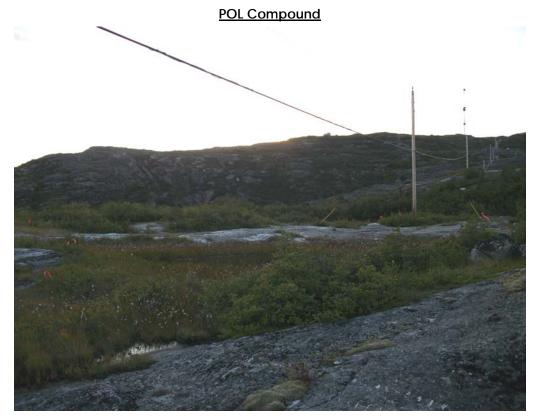
Photo 37 POL-Area 1, looking northwest, prior to grubbing and soil removal.

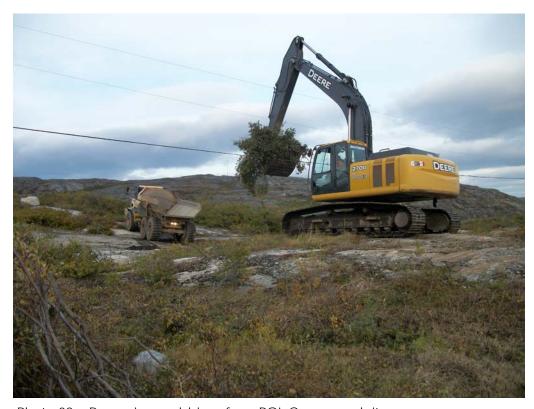
Photo 38 Removing grubbings from POL Compound site.

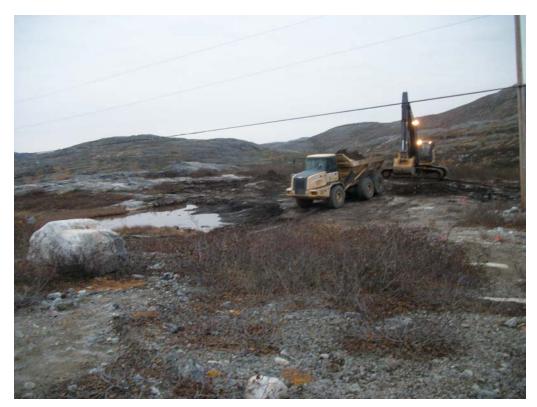
Photo 39 TPH-impacted soil removal at the POL Compound.

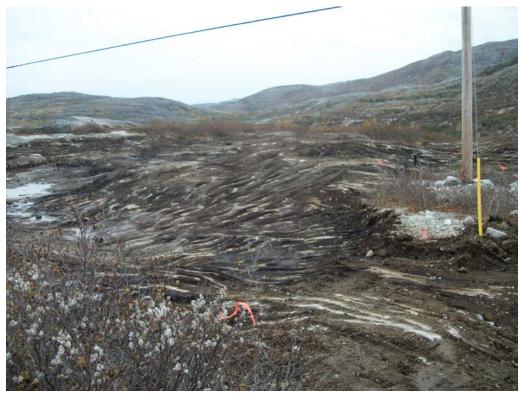
Photo 40 TPH-impacted soil removal at POL Compound (note: remaining soil on bedrock was manually removed using shovels).

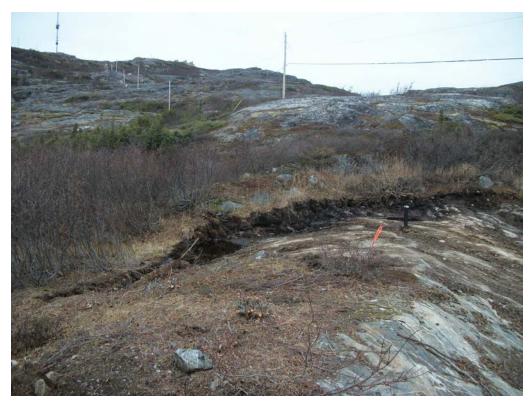
Photo 41 POL-Area 1 during soil removal, looking north in the vicinity of MW-21.

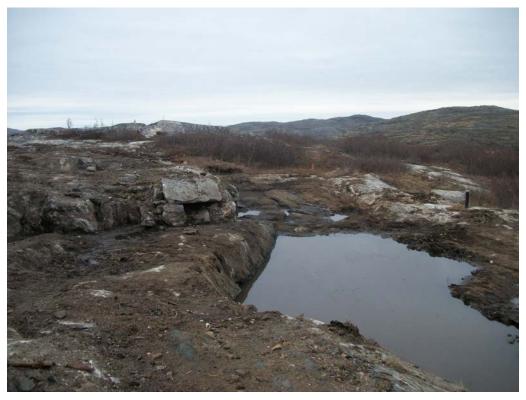
Photo 42 POL-Area 1 during soil removal, looking south in the vicinity of MW-22.

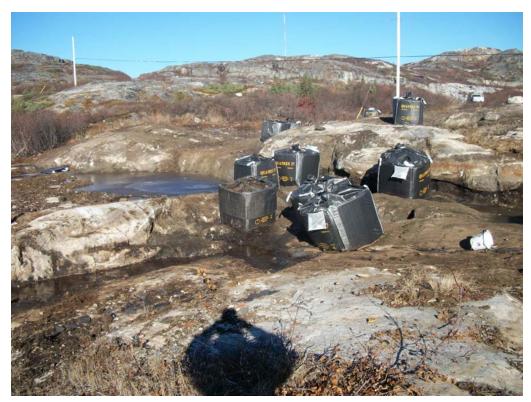
Photo 43 Bags containing soil that was removed manually removed from bedrock.

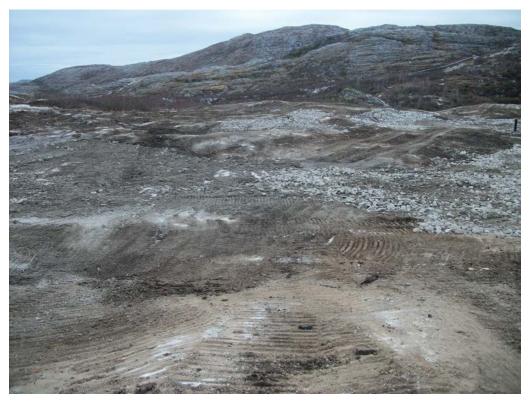
Photo 44 POL-Area 1, looking southwest, following soil removal and backfilling.

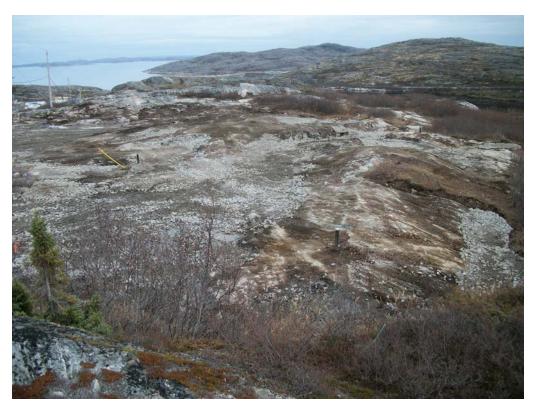
Photo 45 POL-Area 1, looking southeast, following soil removal and backfilling.

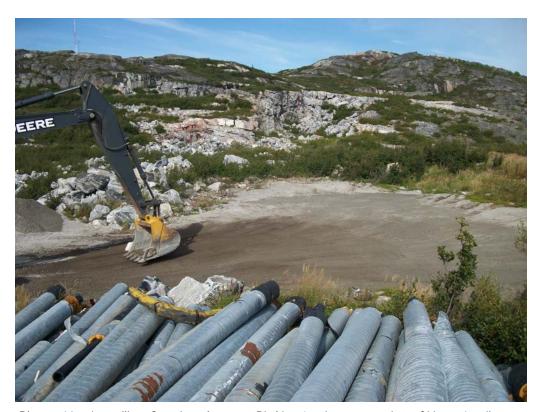
Photo 46 Levelling Staging Area at Pit No. 1 prior to receipt of Year 4 soil.

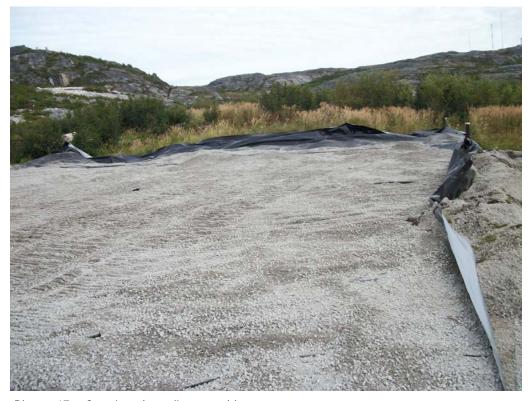
Photo 47 Staging Area liner and berm.

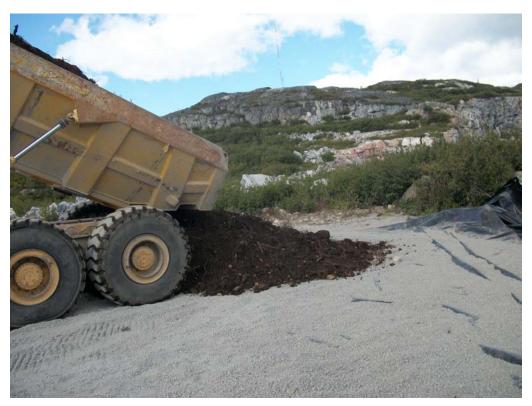
Photo 48 PCB-impacted soil in the Staging Area.

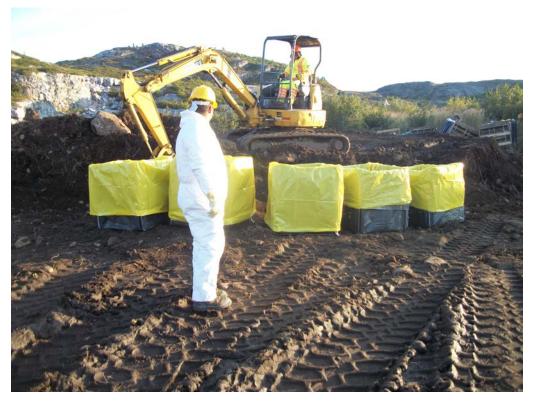
Photo 49 Loading PCB-impacted soil into enviro-bags at the Staging Area.

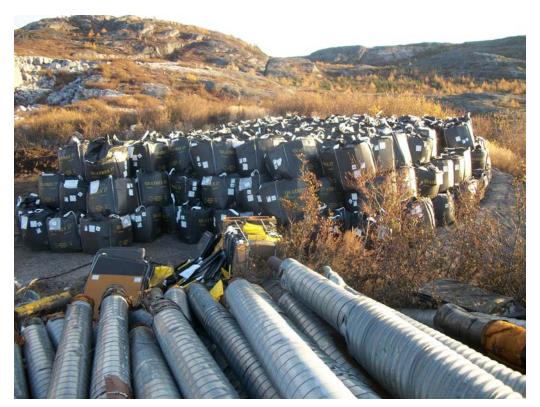
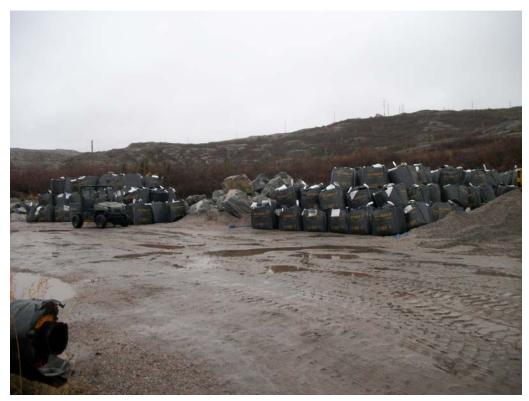
Photo 50 PCB-impacted soil bags.

Photo 51 PCB-impacted soil bags.

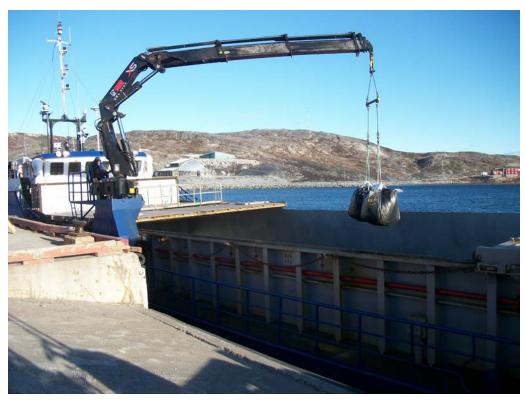
Photo 53 Loading soil bags.

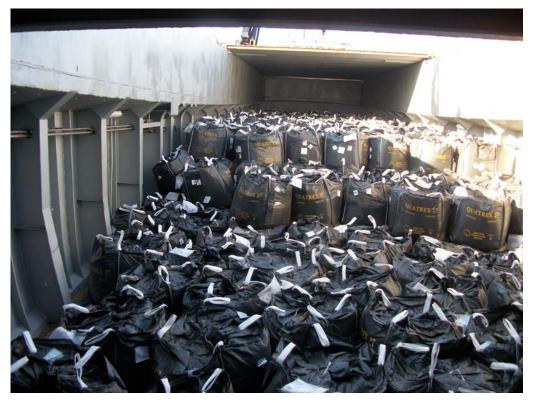
Photo 55 PCB-impacted soil bags in the ship's cargo hold.

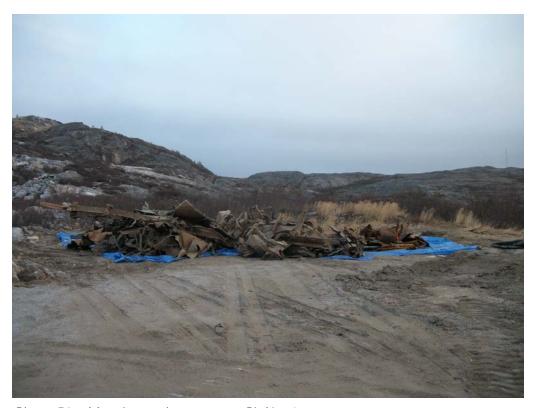
Photo 56 Metal stored on tarps at Pit No. 1.

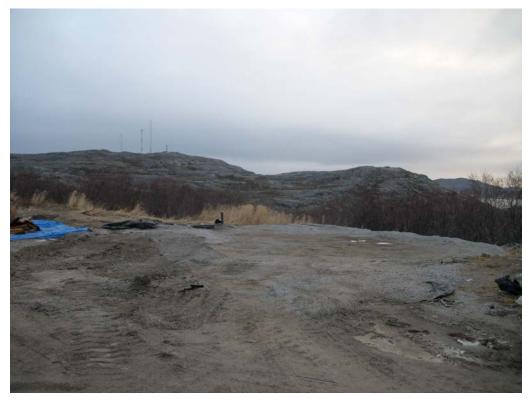
Photo 57 Former bag storage area.

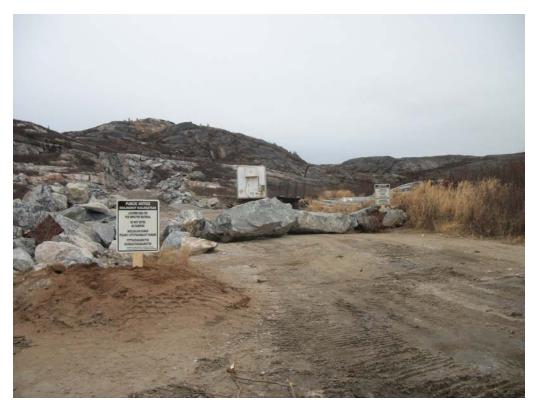
Photo 58 Signs installed at the entrance to the Laydown/Staging Area at Pit No. 1 and boulders blocking access.
