**CLOSURE PLAN
UPPER TRINITY SOUTH (NEW HARBOUR)
WASTE DISPOSAL SITE**

**March 2011
AMEC Project No. TF1112731**

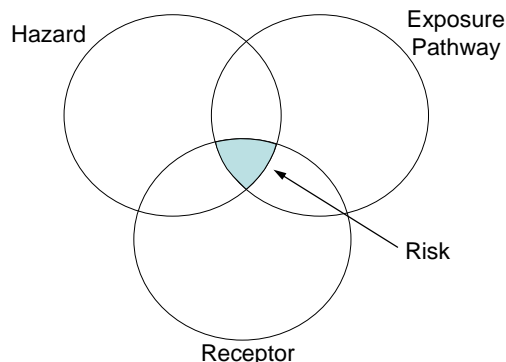
For a risk to exist at a site, three components must be present to contribute a risk to human health and the environment. As indicated in the diagram to the right, these are:

- An elevated chemical concentration (hazard).
- A receptor to come in contact with the chemical.
- An exposure pathway to facilitate contact between the receptor and the chemical.

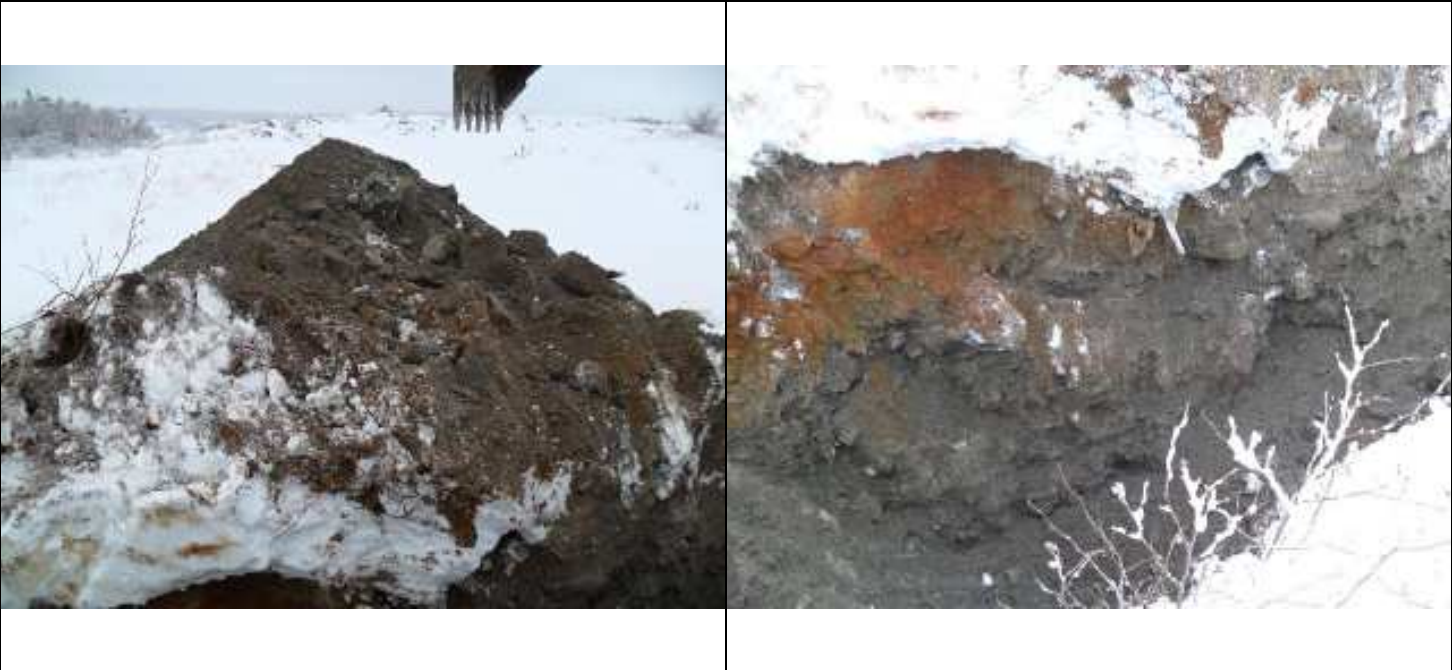
Depth (m) From - To	Description	Sample ID.	Sample Depth (m)	Sample Type
0.0 – 0.4	FILL – Trace organic debris, SAND and GRAVEL, dry to moist, loose, brown.	N/A	N/A	N/A
0.4 – 3.1	GLACIAL TILL - SAND and GRAVEL, trace fines, cobbles and small boulders, moist, dense, grey.	N/A	N/A	N/A
3.1	Test Pit terminated at 3.1 m.			
Estimated Cobbles (%) 10 - 15	Estimated Boulders (%) 5 - 10	Estimated Max Diameter (m) 0.3		
Start Time: 8:15 am	End Time: 8:40 am

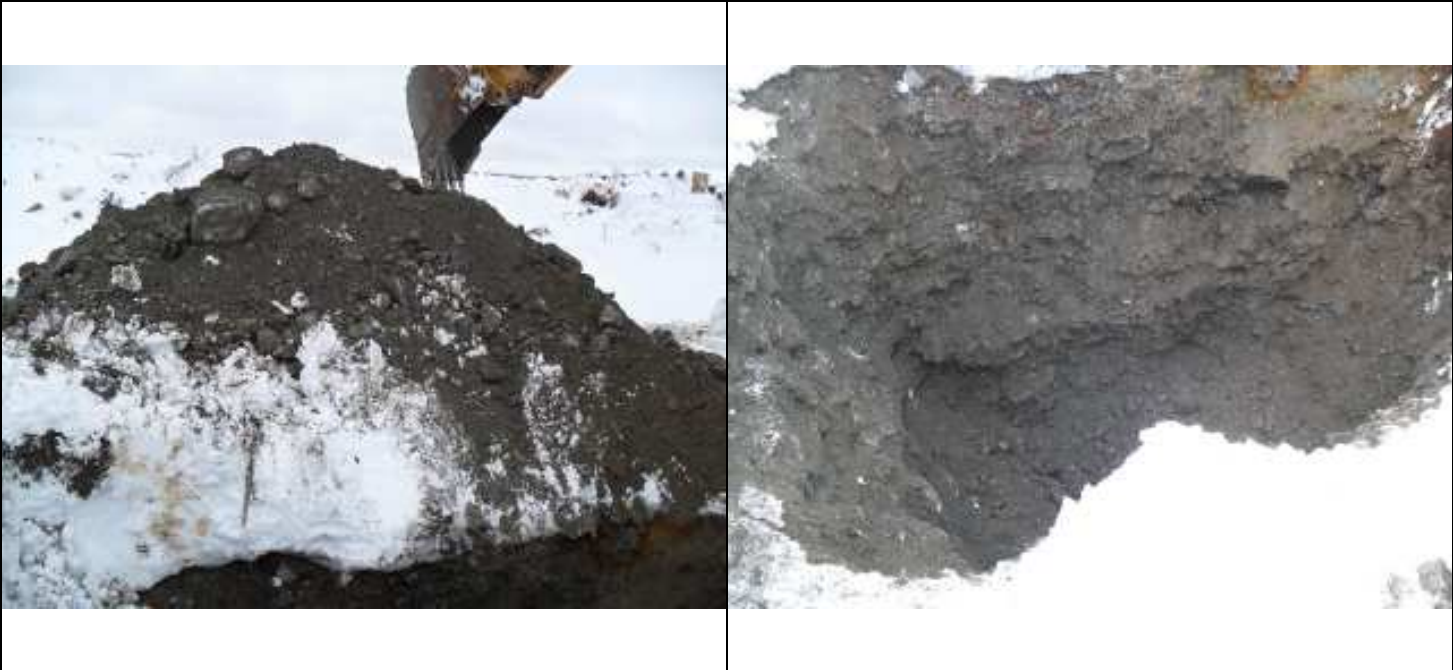
Depth (m) From - To	Description	Sample ID.	Sample Depth (m)	Sample Type
0.0 – 0.1	FILL – silty SAND and GRAVEL, moist, loose, brown.	N/A	N/A	N/A
0.1 – 5.2	GLACIAL TILL - SAND and GRAVEL, trace fines, cobbles and large boulders, moist, dense, grey.	N/A	N/A	N/A
5.2	Test Pit terminated at 5.2 m.			
Estimated Cobbles (%) 10 - 15	Estimated Boulders (%) 5 - 10	Estimated Max Diameter (m) 0.3		
Start Time: 10:00 am	End Time: 10:30 am

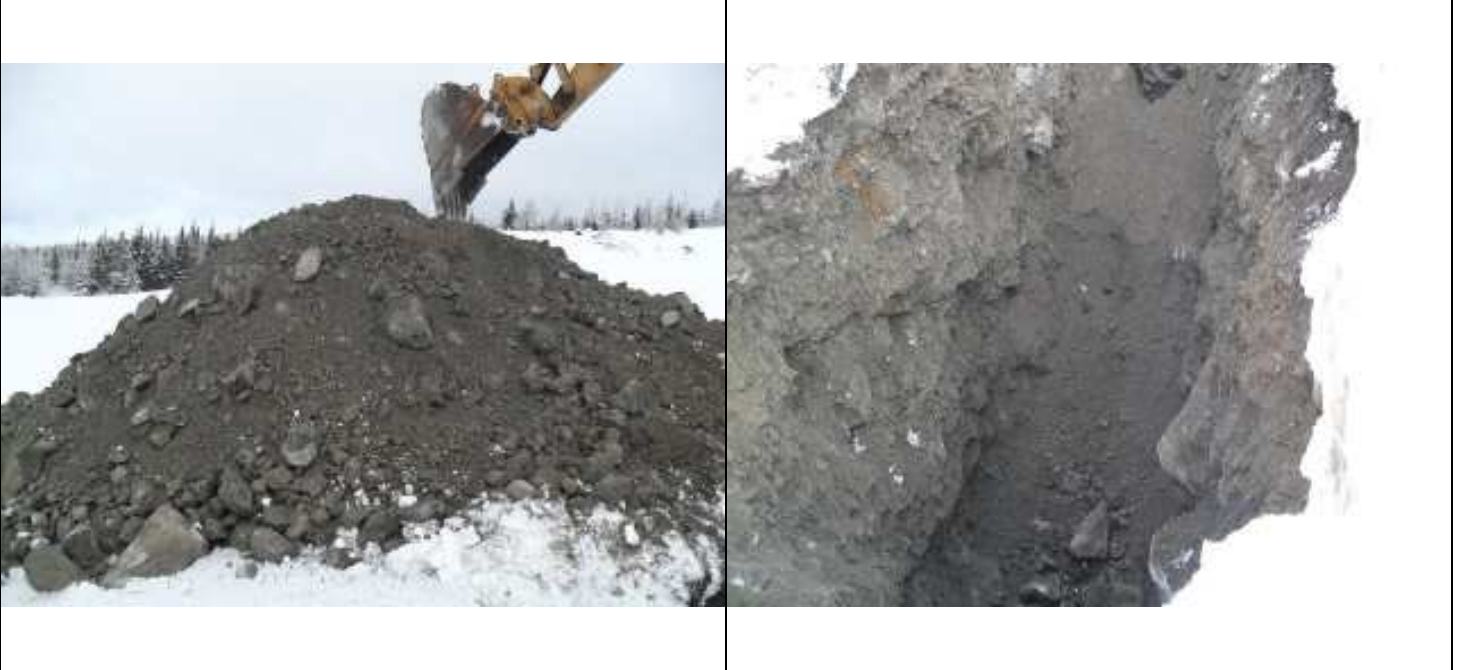
Depth (m) From - To	Description	Sample ID.	Sample Depth (m)	Sample Type
0.0 – 5.1	GLACIAL TILL - SAND and GRAVEL, trace fines, cobbles and large boulders, moist, dense, grey.	N/A	N/A	N/A
5.1	Test Pit terminated at 5.1 m.			
Estimated Cobbles (%) 10 - 15		Estimated Boulders (%) 5 - 10		Estimated Max Diameter (m) 0.3
Start Time: 10:50 am		End Time: 11:20 am

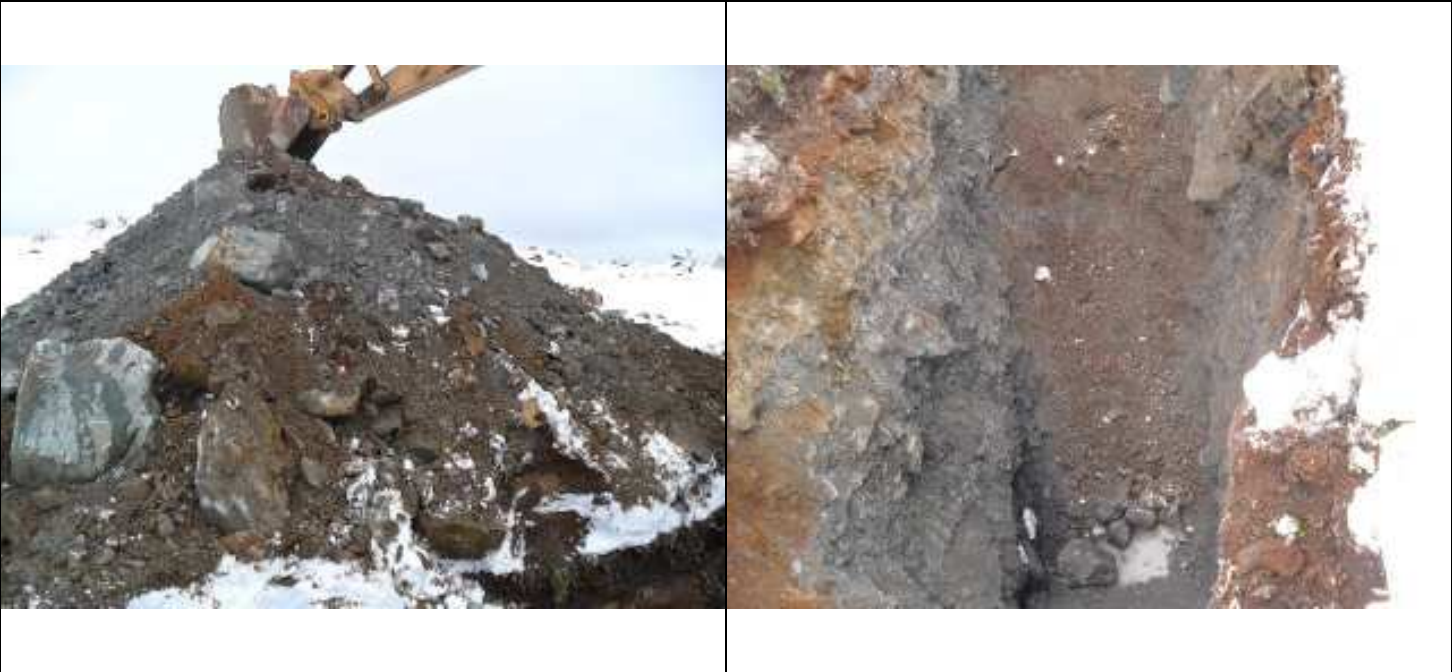
Depth (m) From - To	Description	Sample ID.	Sample Depth (m)	Sample Type
0.0 – 0.4	FILL – organic debris, silty SAND and GRAVEL, moist, loose, brown.	N/A	N/A	N/A
0.4 – 5.1	GLACIAL TILL - SAND and GRAVEL, trace fines, cobbles and boulders, moist, dense, grey.	N/A	N/A	N/A
5.1	Test Pit terminated at 5.1 m.			
Estimated Cobbles (%) 10 - 15	Estimated Boulders (%) 5 - 10	Estimated Max Diameter (m) 0.3		
Start Time: 11:45 am	End Time: 12:15 pm

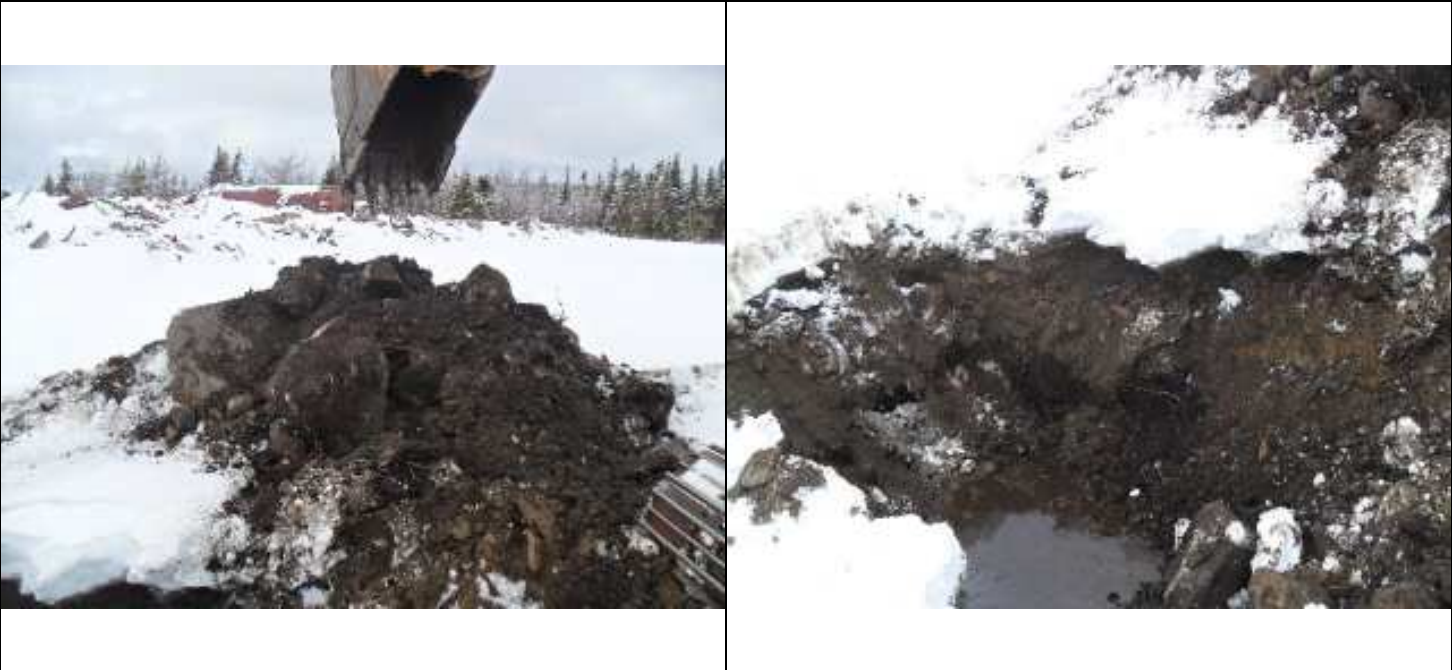
Depth (m) From - To	Description	Sample ID.	Sample Depth (m)	Sample Type
0.0 – 1.5	FILL – rootlets and organic debris, trace sand and gravel, boulders, moist to wet, loose, brown / black, strong odour.	N/A	N/A	N/A
1.5	Test Pit terminated at 1.5 m.			
Estimated Cobbles (%) 10 - 15	Estimated Boulders (%) 5 - 10	Estimated Max Diameter (m) 0.5		
Start Time: 1:00 pm	End Time: 1:25 pm

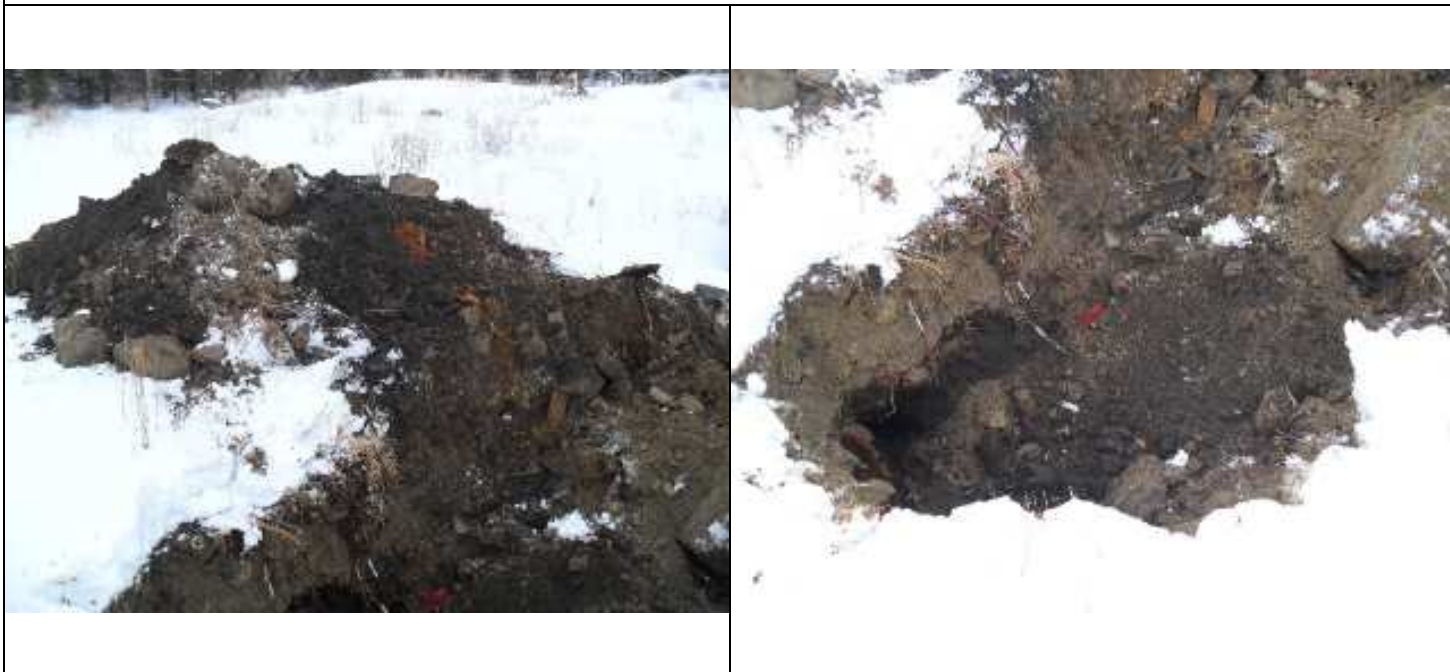
Depth (m) From - To	Description	Sample ID.	Sample Depth (m)	Sample Type
0.0 – 2.0	FILL – garbage, moist, loose, brown / black.	N/A	N/A	N/A
2.0	Test Pit terminated at 2.0 m.			
Estimated Cobbles (%) 10 - 15	Estimated Boulders (%) 5 - 10	Estimated Max Diameter (m) 0.3		
Start Time: 1:40 pm	End Time: 1:55 pm

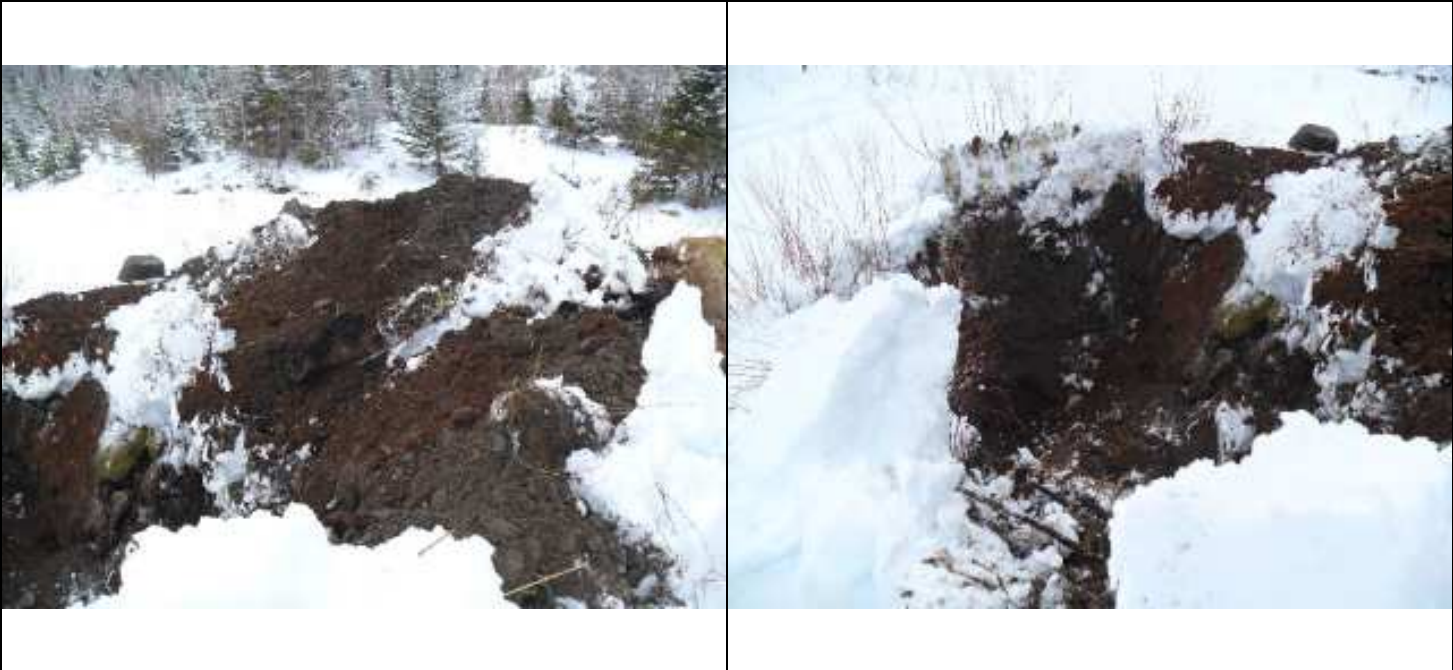
Depth (m) From - To	Description	Sample ID.	Sample Depth (m)	Sample Type
0.0 – 1.0	FILL – silty SAND and GRAVEL, trace organics, moist, loose, brown.	N/A	N/A	N/A
1.0 – 2.0	FILL – garbage, moist, loose, brown / black.	N/A	N/A	N/A
2.0	Test Pit terminated at 2.0 m.			
Estimated Cobbles (%) 10 - 15		Estimated Boulders (%) 5 - 10		Estimated Max Diameter (m) 0.3
Start Time: 2:15 pm		End Time: 2:30 pm

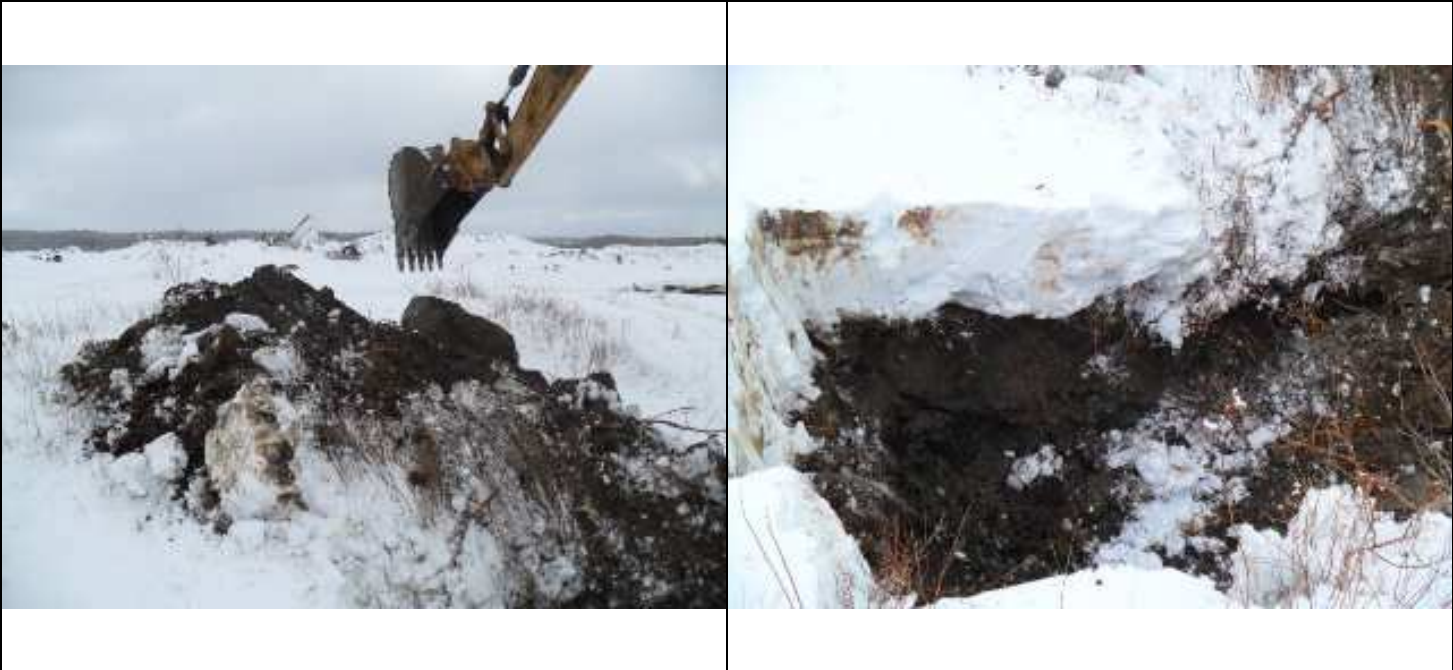
Depth (m) From - To	Description	Sample ID.	Sample Depth (m)	Sample Type
0.0 – 1.0	FILL – trace organics, silty SAND and GRAVEL, moist, loose, boulders, brown / black.	N/A	N/A	N/A
1.0	Test Pit terminated at 1.0 m.			
Estimated Cobbles (%) 10 - 15	Estimated Boulders (%) 5 - 10	Estimated Max Diameter (m) 0.3		
Start Time: 2:50 pm	End Time: 3:15 pm

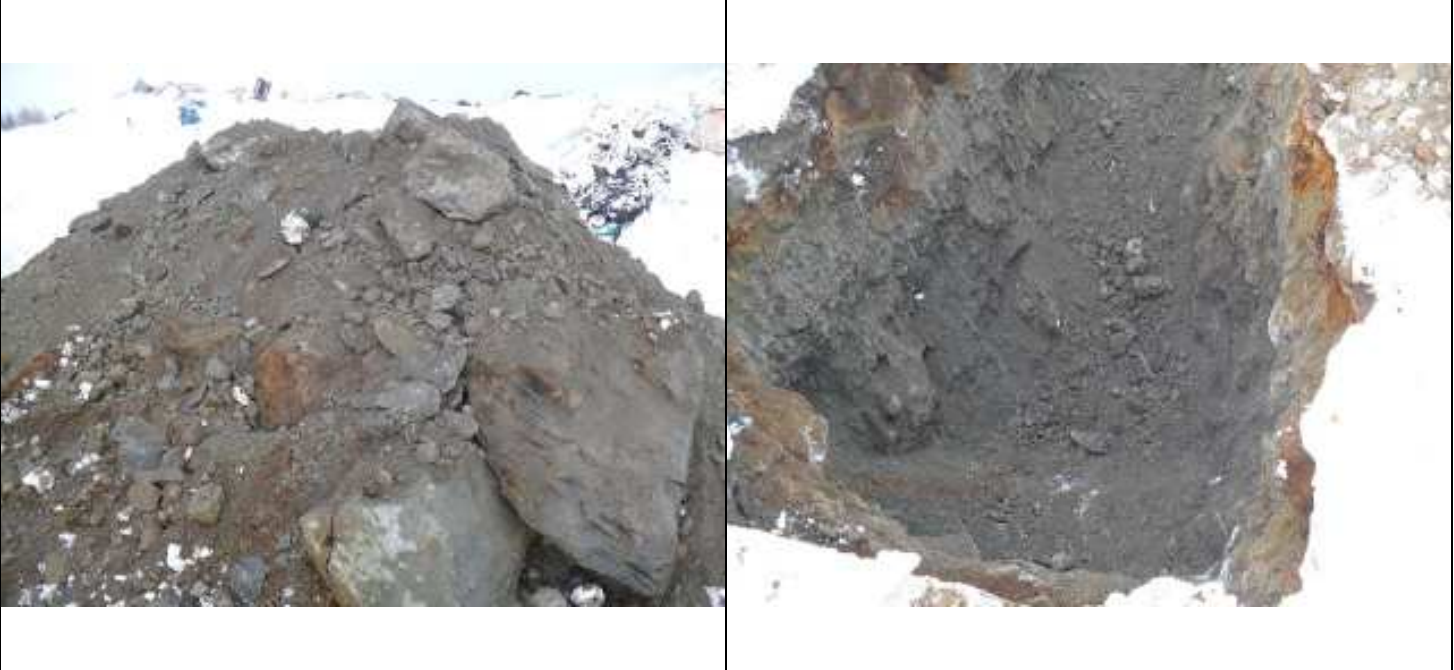
Depth (m) From - To	Description	Sample ID.	Sample Depth (m)	Sample Type
0.0 – 0.2	FILL – silty SAND and GRAVEL, moist, loose, cobbles, brown.	N/A	N/A	N/A
0.2 – 4.5	GLACIAL TILL - SAND and GRAVEL, trace fines, cobbles and large boulders, moist, dense, grey.	N/A	N/A	N/A
4.5	Test Pit terminated at 4.5 m.			
Estimated Cobbles (%) 10 - 15	Estimated Boulders (%) 5 - 10	Estimated Max Diameter (m) 0.3		
Start Time: 3:45 pm	End Time: 4:15 pm

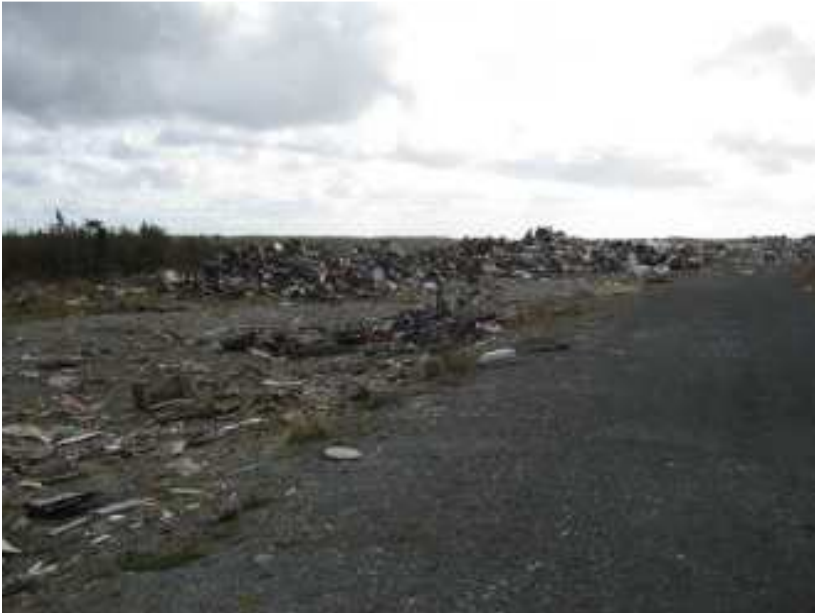
Photo 1 – Exposed waste on north of site.

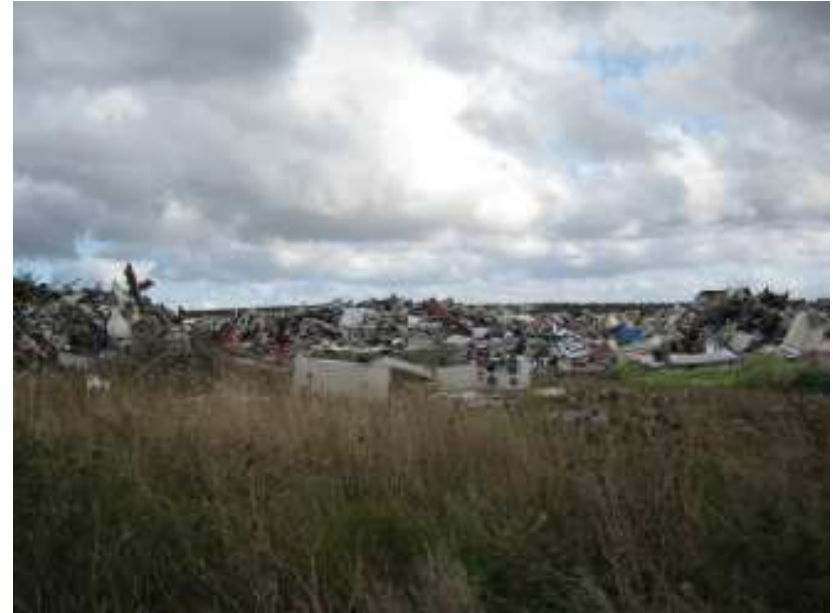
Photo 2 – Exposed waste on north of site looking west.

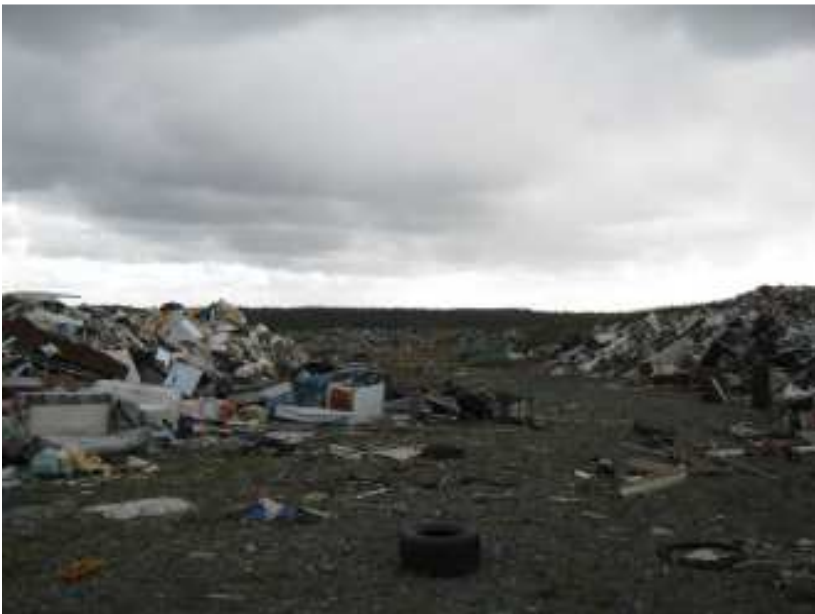
Photo 3 – Potential fill between waste piles, consolidate waste in excavation.

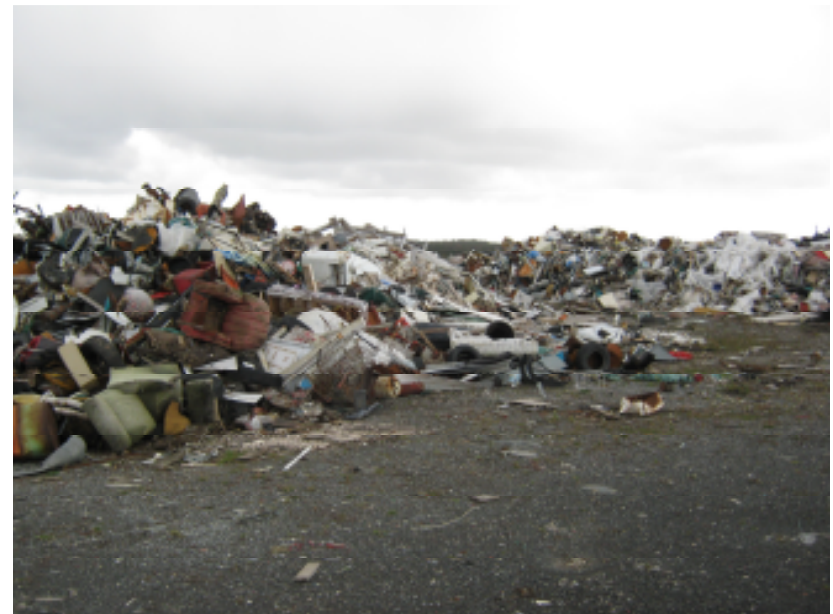
Photo 4 – Exposed waste on top section of site.

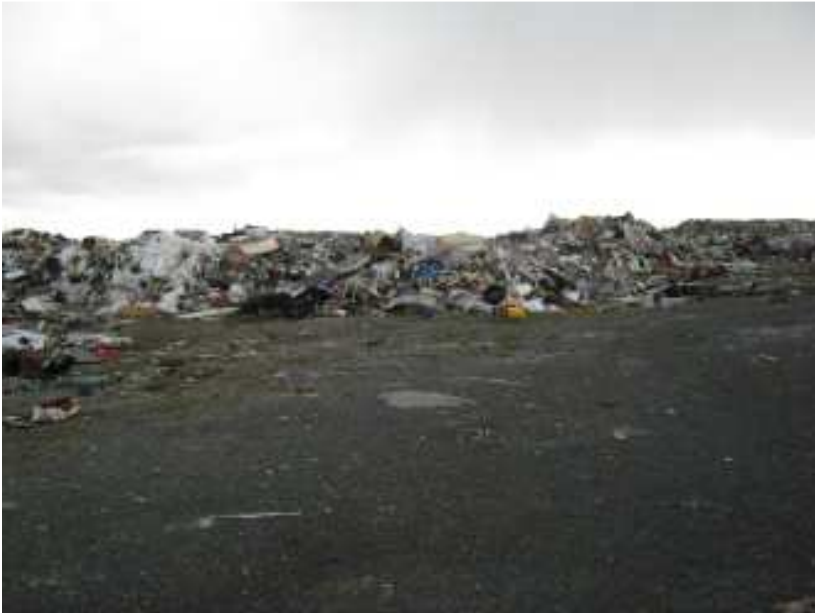
Photo 5 – Exposed waste in west section.

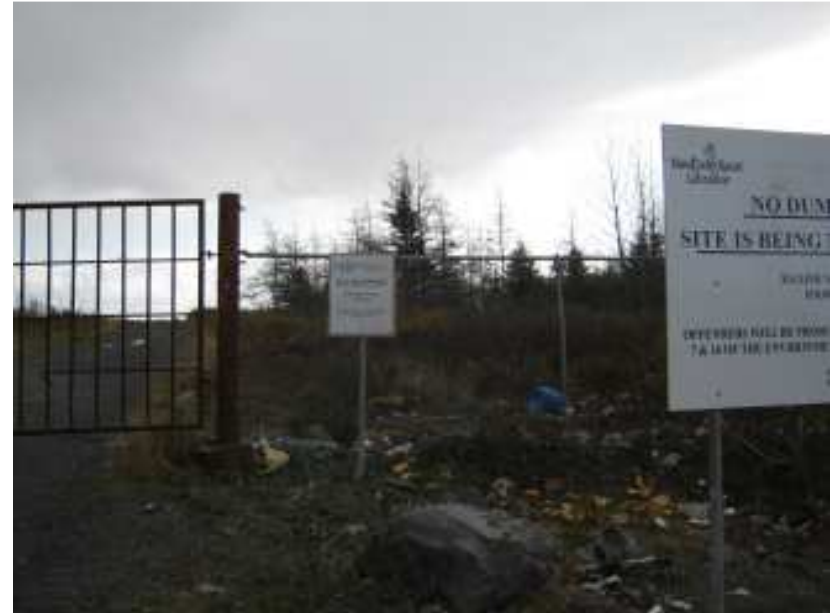
Photo 6 – Current gate and chain link fencing.

The infrastructure remaining on site from the waste site operation and subsequent work includes a gate and chain link fence along the access road, monitoring wells installed as part of the groundwater monitoring program and ditching and a settling pond constructed as part of the leachate control program. The condition of the gate and chain link fence appears acceptable for future use and will remain in operation throughout the year one closure plan. This infrastructure shall be removed during the final phase of construction in year three.

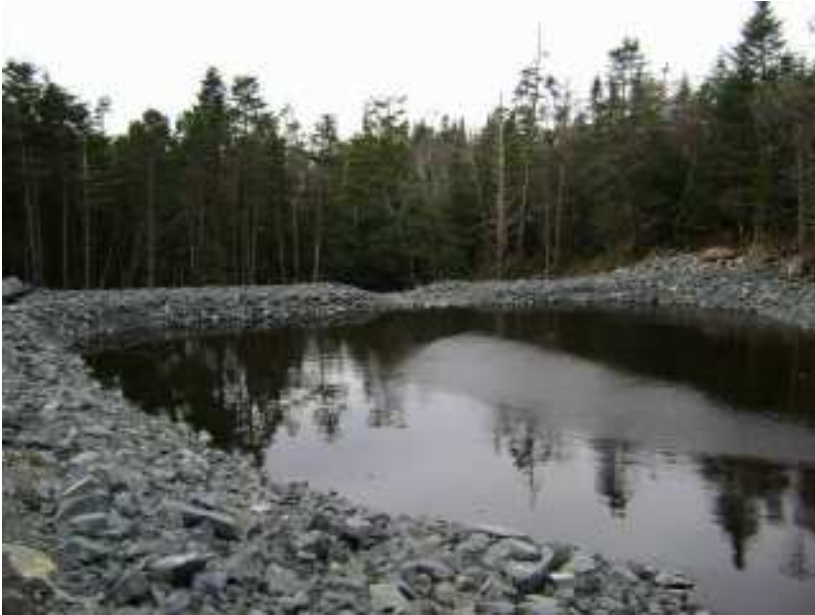
Photo 9 – Collection pond.

The monitoring of the existing sediment pond has been conducted on an annual basis and it is proposed to continue. During this inspection, the ditches and sediment pond shall be visually inspected for any deterioration or faults in the system. Any maintenance which is required from the inspection shall be assessed on a case by case basis.

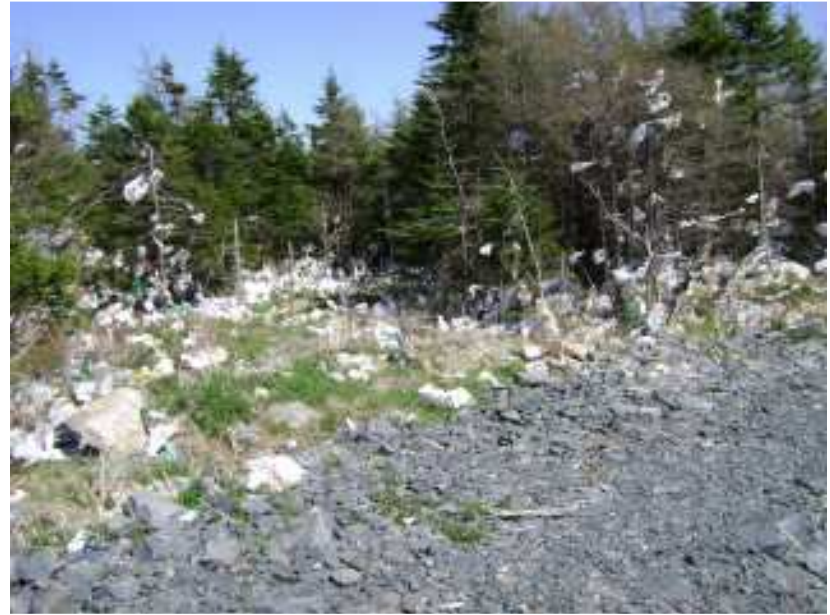
Photo 10 – Windblown debris along access road to collection pond.
