COMPLETION REPORT

Maintenance of Interim Soil Cover for Upper Trinity South (New Harbour) Waste Disposal Site New Harbour, NL

May 2013

AMEC Project No. TF1212734

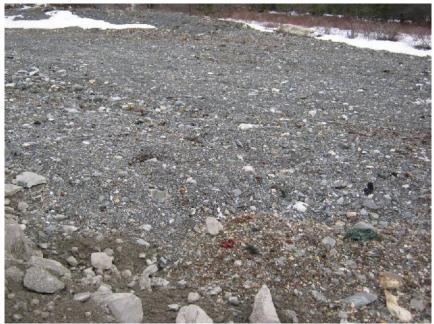
Photo 1 – Boulder section prior to fill placement.

The sawdust section required some cover material. Approximately 1000 m³ of fill was used in this area to cover the section. The metals, boulder, and access sections required approximately 2000 m³ of fill. The Phase II site inspection identified areas of minimal surface litter and sink holes. Imported fill was placed and compacted over these areas.

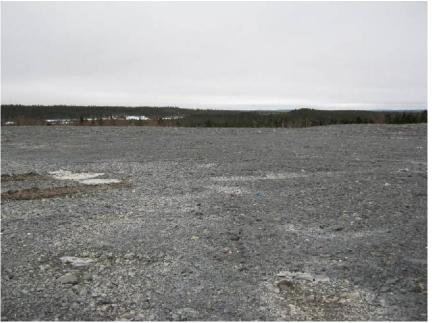
Photo 3 – Buried waste section from Phase I prior to fill placement.

The buried waste area, required additional fill over the surface. The additional fill was placed and graded to create a crown through the center of the site. The crown was graded at 3.28% on both sides to prevent surface ponding in this section. A total of 8500 m³ of fill was placed and compacted over the buried waste area.

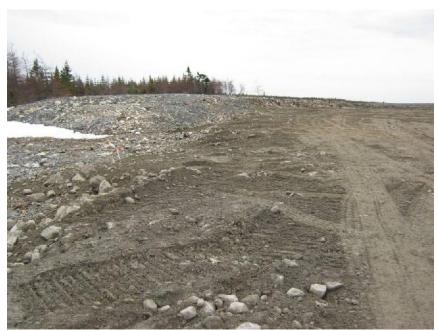
Photo 2 – Site access road and metals section during construction.

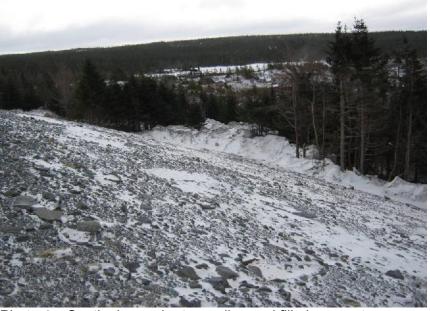
Photo 4 – South slope prior to grading and fill placement.

Prior to placing cover on the slopes, the contractor had to snow clear the slopes. From AMEC's initial inspection the slope remained in good condition from Phase I activities, with minimal evidence of erosion, disturbance, and settlement. Phase II included additional grading and approximately 2500 m³ fill placement on the slope to further increase the stability.

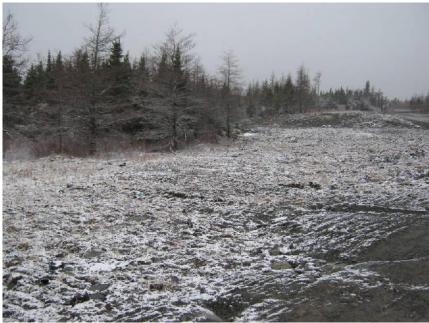
Photo 5 – West side of access road looking north prior to construction.

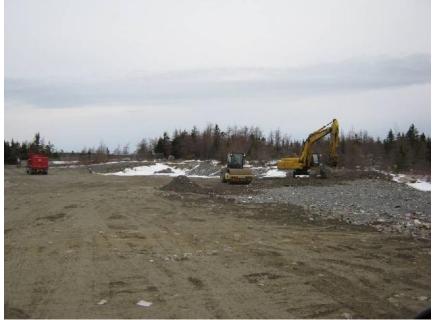
Photo 6 – Boulder section during fill placement.

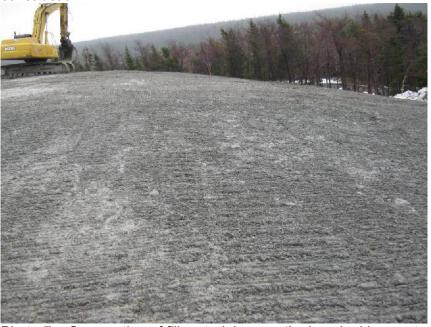
Photo 7 – Compaction of fill material on south slope looking east.

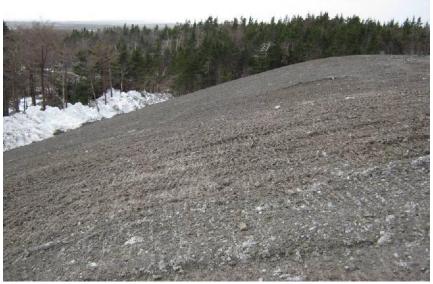
Photo 8 – South slope looking west

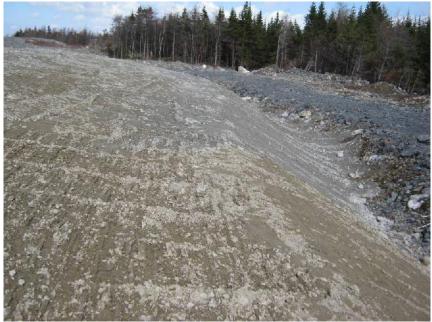
Photo 9 – East slope and ditch looking north.

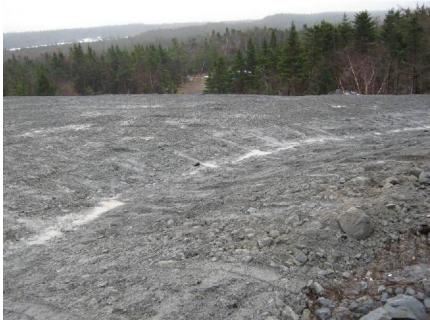
Photo 10 – Ditching between sawdust and buried waste sections.

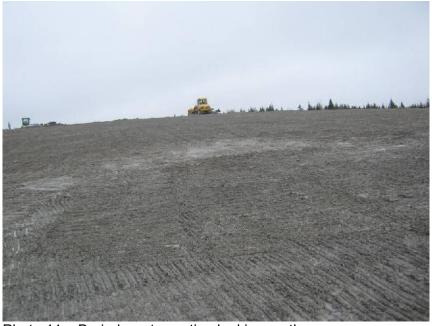
Photo 11 – Buried waste section looking north.

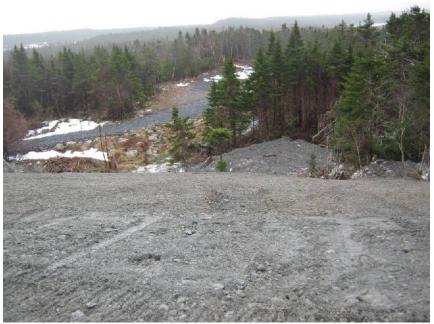
Photo 12 – Southeast corner slope looking south.

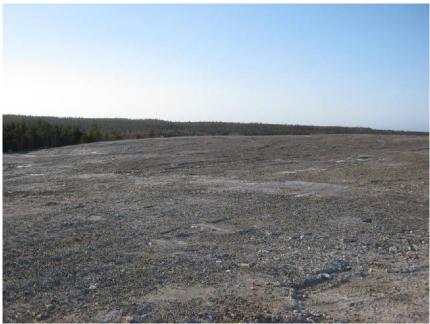
Photo 13 – Buried waste section looking southwest.

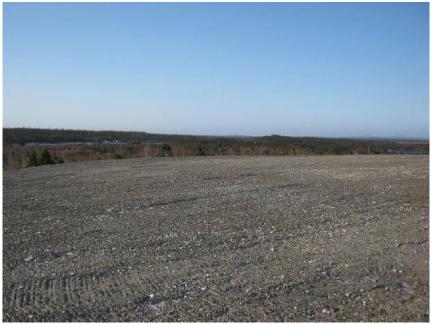
Photo 15 – Buried waste section looking southwest.

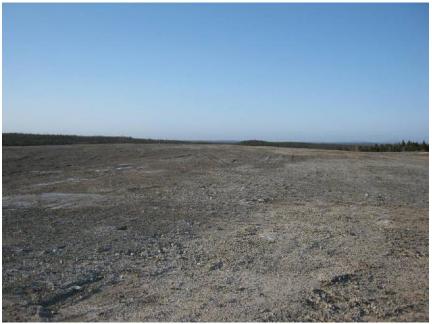
Photo 14 – Buried waste section looking west.

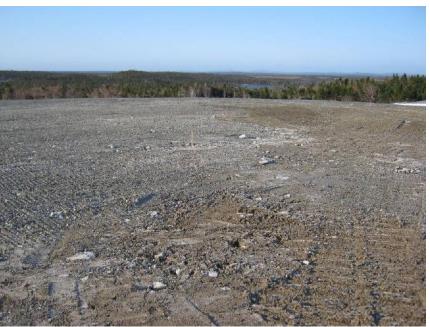
Photo 16 – Buried waste section during construction looking south.

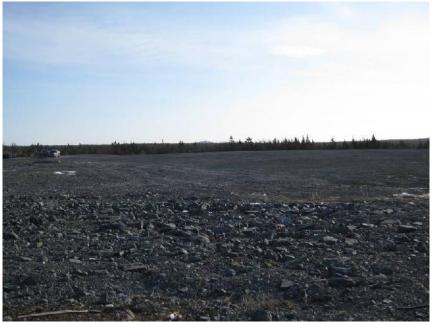
Photo 17 – Sawdust section during construction, final grade on buried waste section looking northeast.

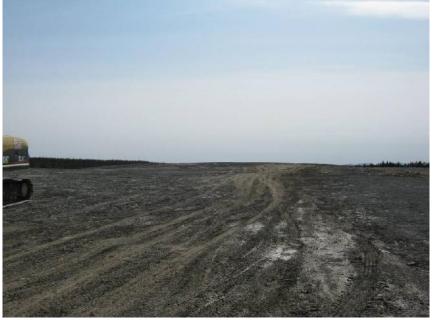
Photo 19 – Final grade on buried waste section looking south.

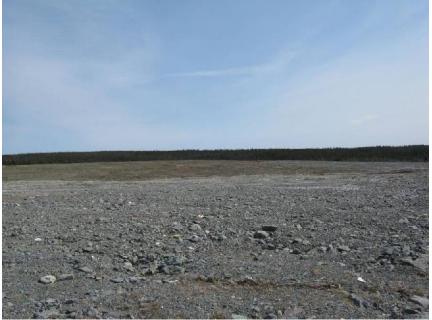
Photo 18 – Final grade on buried waste section looking east.

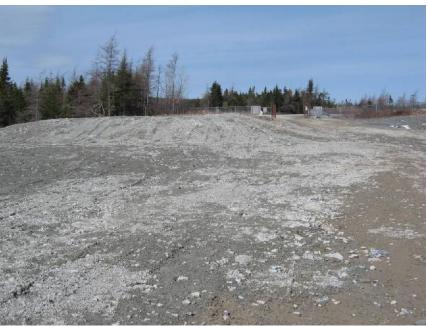
Photo 20 – Final cover on site access section looking north.
