Appendix 5a

Site Drawings

– East Generator Site

PROJECT TITLE: PHASE III ENVIRONMENTAL SITE ASSESSMENT, HUMAN HEALTH AND ECOLOGICAL RISK ASSESSMENTS, REMEDIAL ACTION PLAN FOR THE FORMER U.S. MILITARY FACILITY OF NORTHWEST POINT, NL

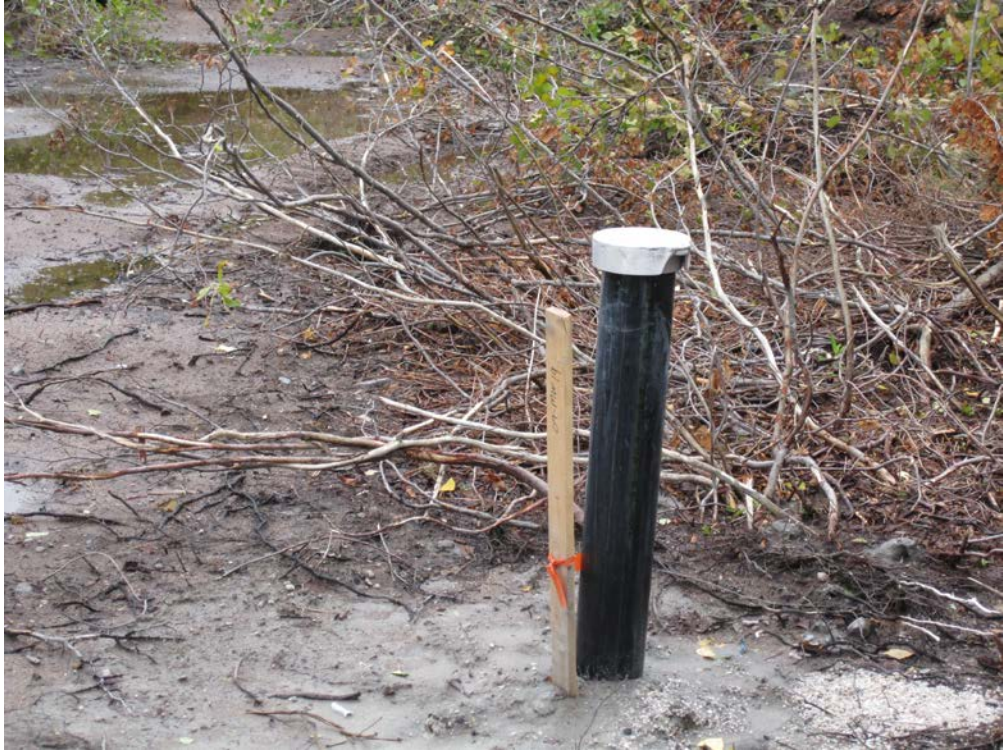
Photo 1 View of 09-MW19

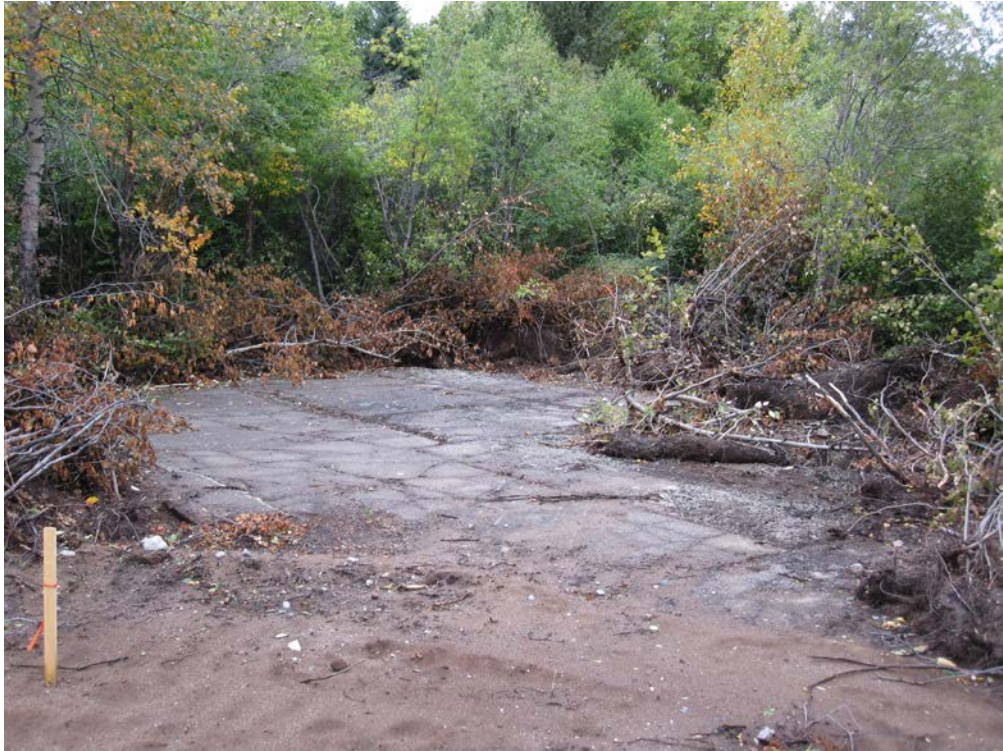
Photo 2 View of 09-TP35

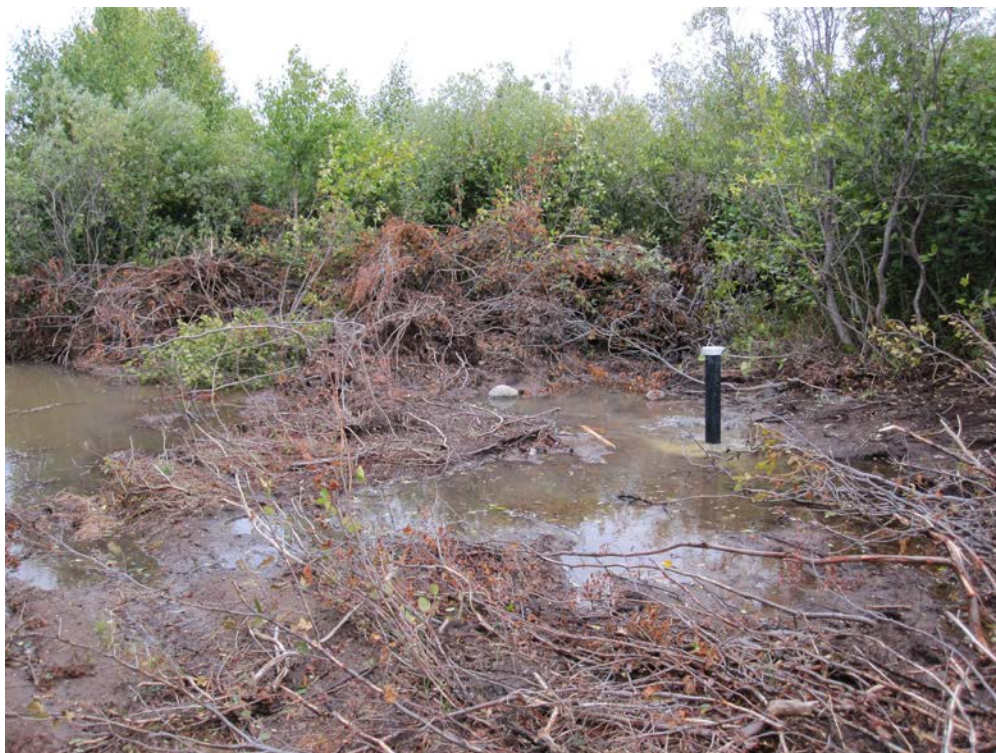
Photo 3 View of 09-MW18

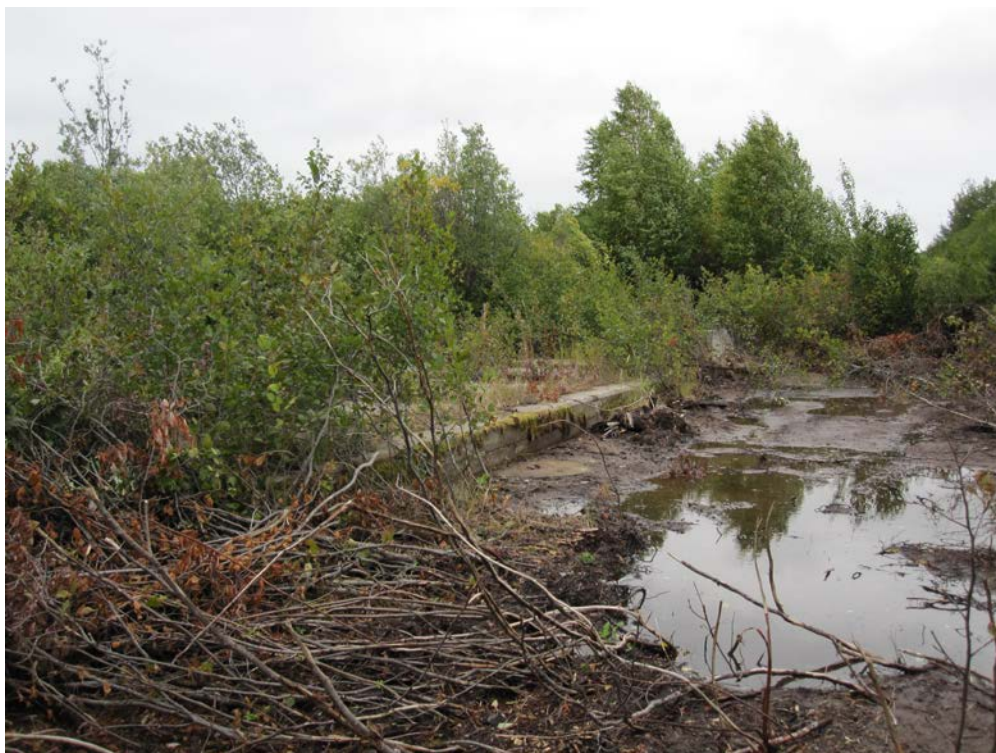
Photo 4 View of concrete pad at the site
