Joyce Lake Direct Shipping Iron Ore Project
 - Fish and Fish Habitat Baseline Study -

Joyce Lake Direct Shipping Iron Ore Project

- Fish and Fish Habitat Baseline Study -

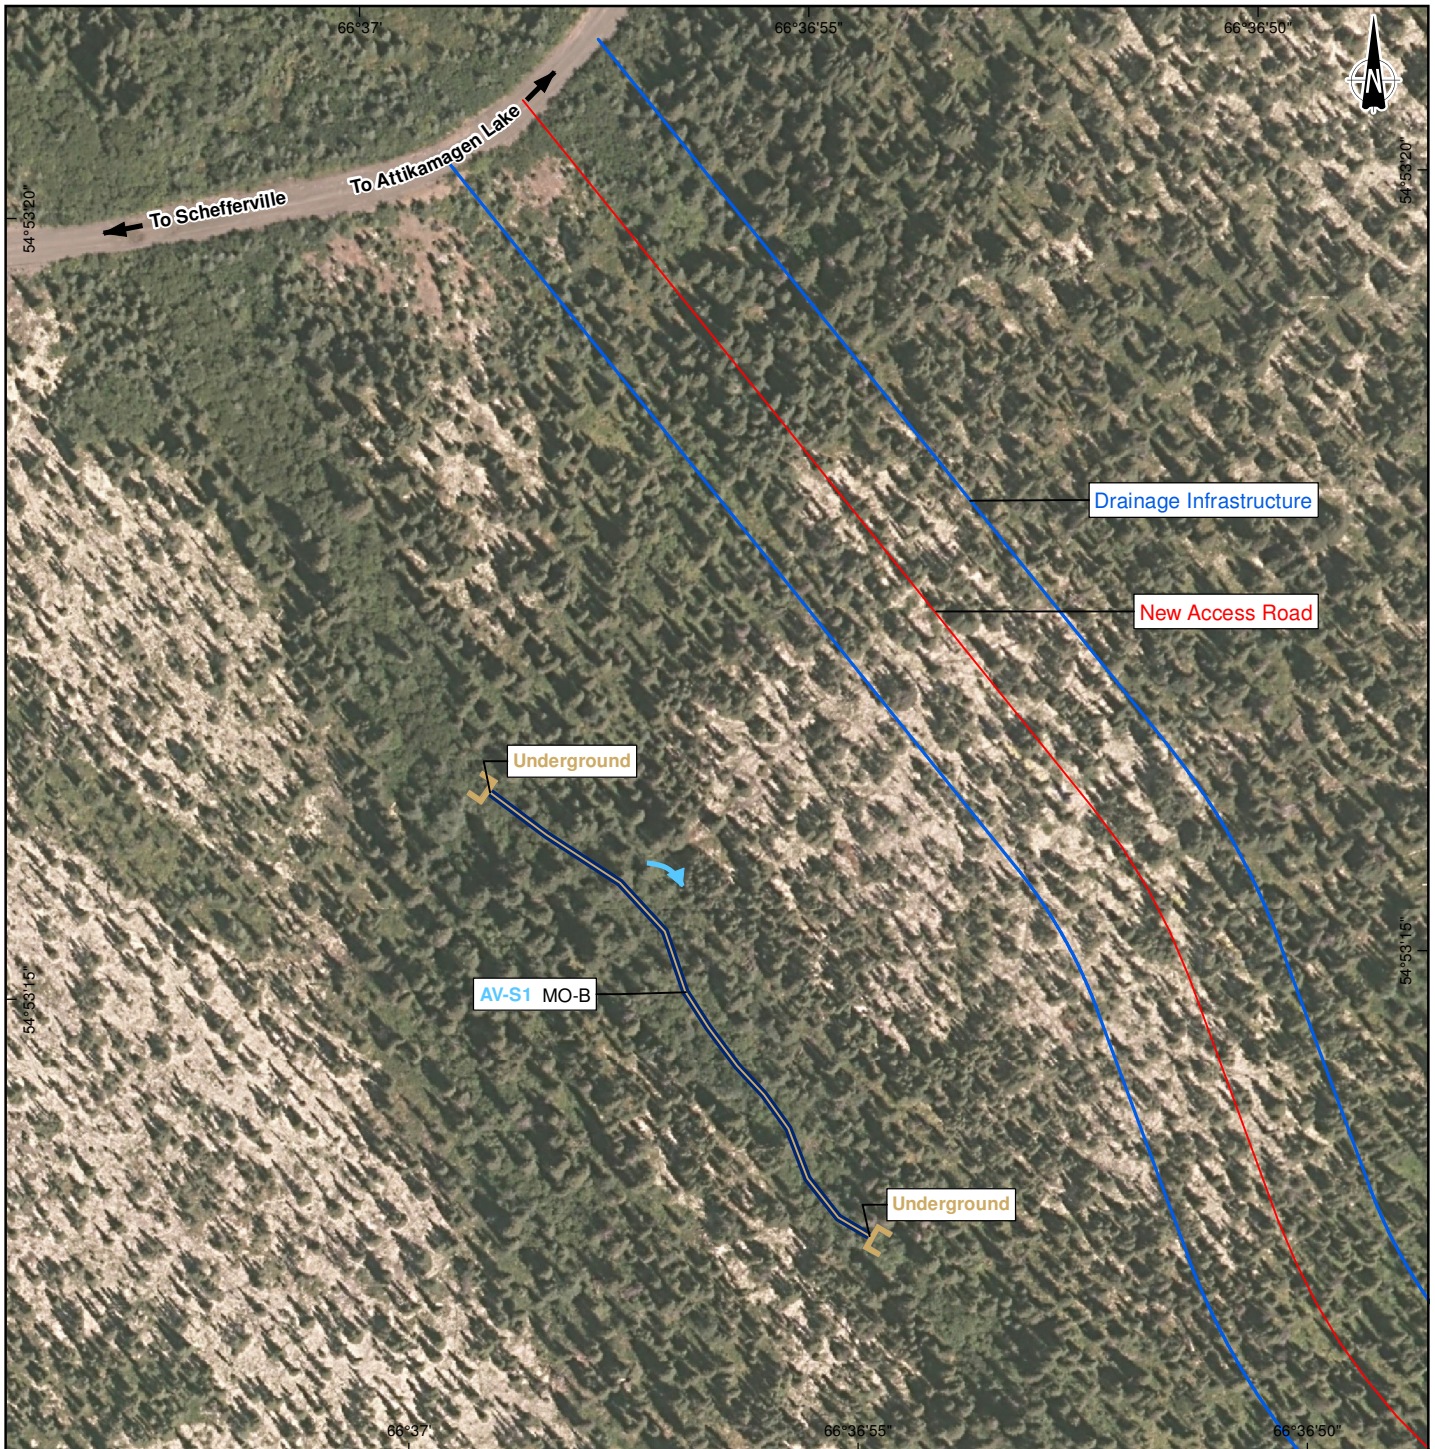
Figure 26

Stream Crossing CR01

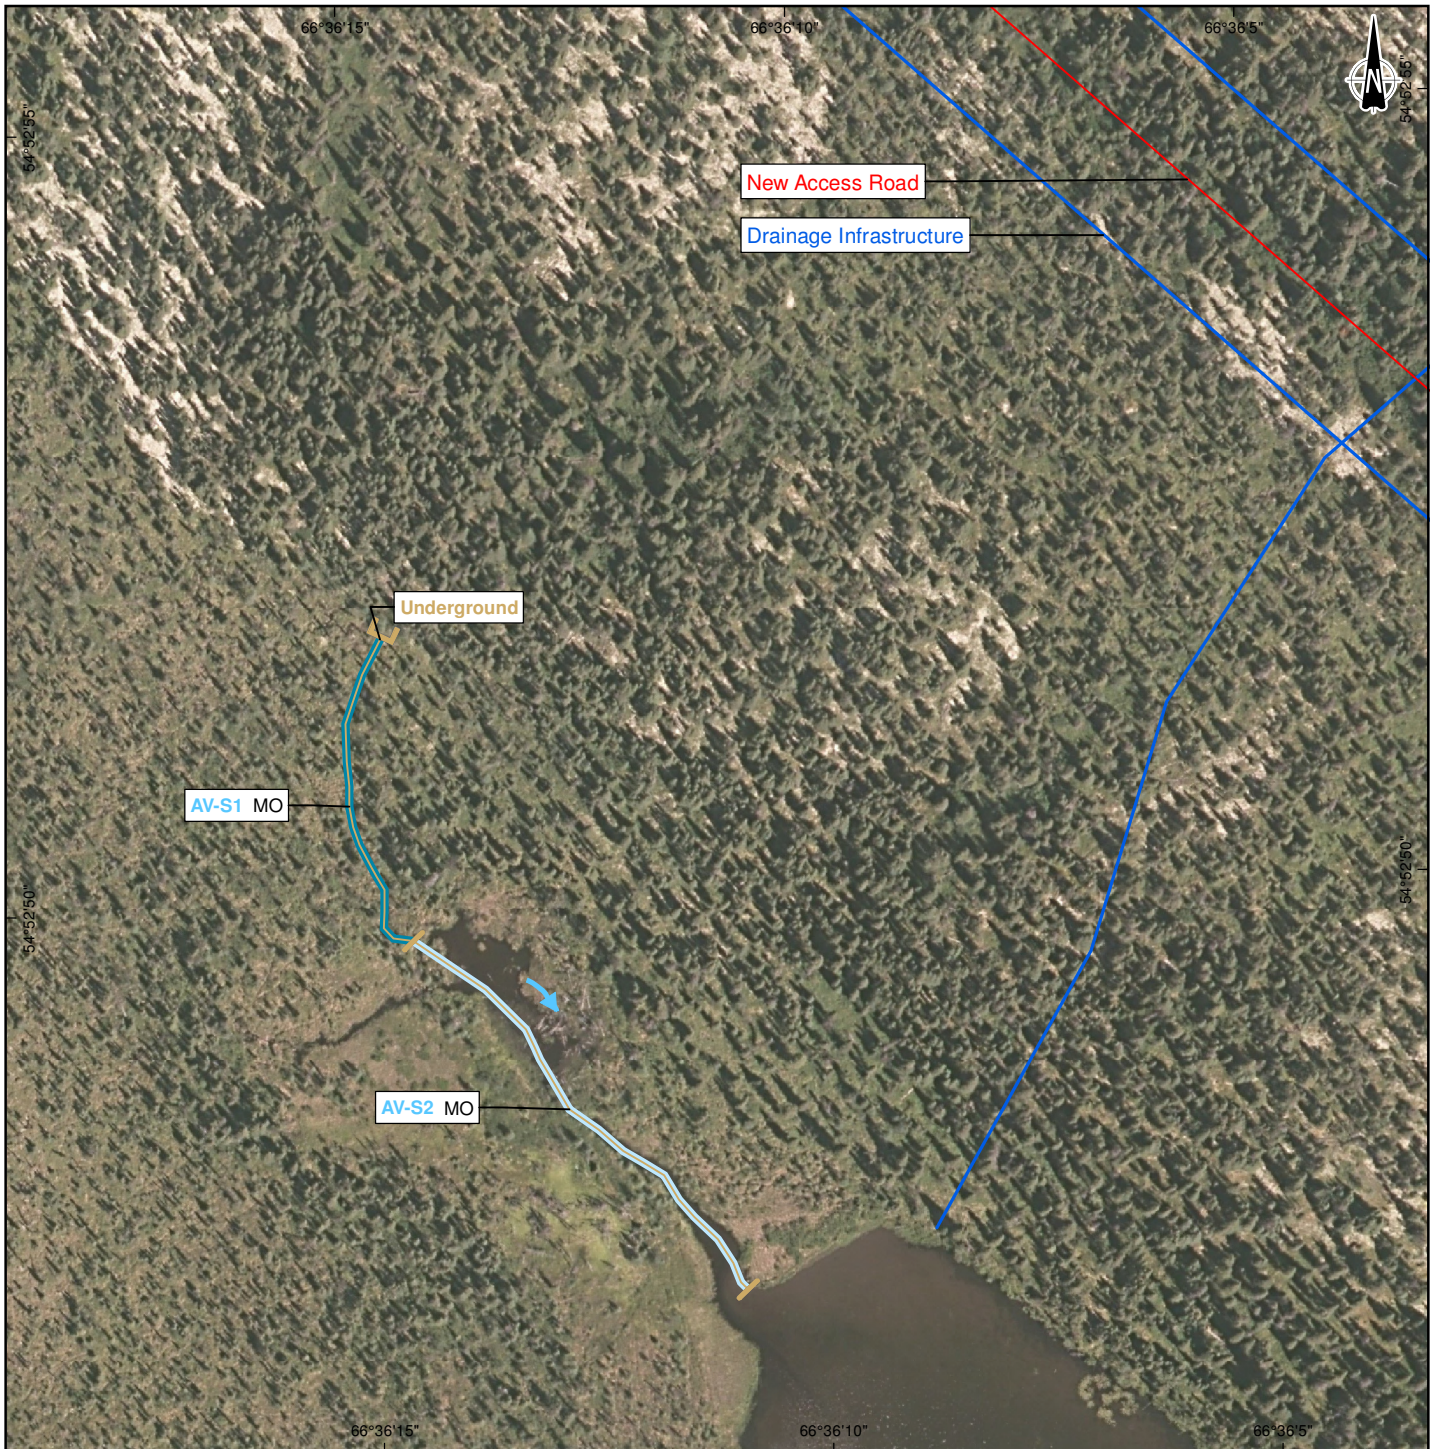
Figure 27

Stream Crossing CR02

flow velocity was 0.2 m/s. Muck was the only substrate constituent and aquatic vegetation was found on 30 % of the stream bed.

No fish sampling was conducted in this stream. However, it discharges into a series of lakes that connect to Petitsikapau Lake. Downstream, these lakes discharge through CR20 where a beaver dam was determined to act as barrier to fish passage. Northern pike was found in CR20 and CR03 which are located a few kilometres downstream. Other than this fish barrier found, it remains possible that CR02 is used by fish.

During the field work, the water conductivity was 43.9 $\mu\text{S}/\text{cm}$ and the pH was 6.96 (Table 8).

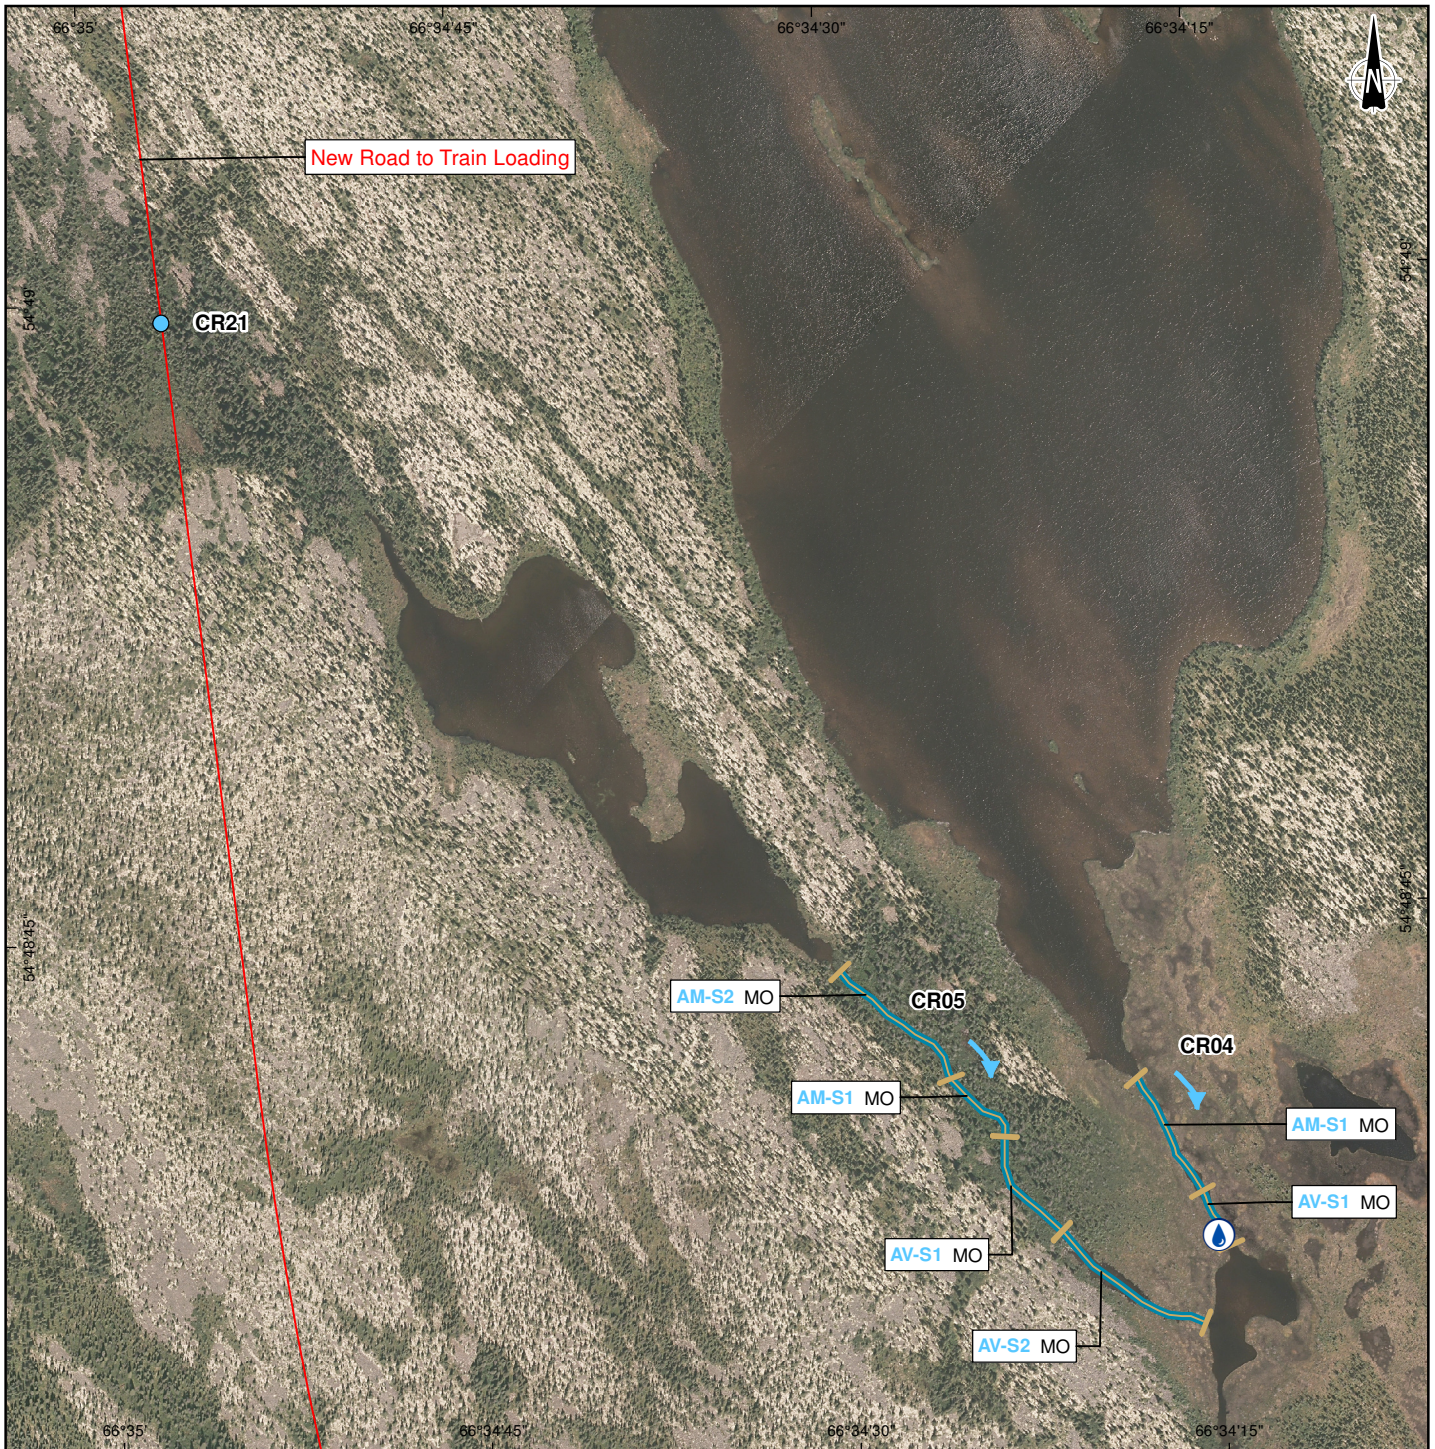
Figure 29

Stream Crossings CR04, CR05 and CR21

CR04 and CR05 no longer exist as the access road layout was changed. The crossing is found upstream in the area of CR21 (Figure 29).

During the field campaign in the summer of 2012, no stream was found at CR21, but a few pockets of water were observed. These seem to be part of some wetlands but not connected to each others. Therefore, CR21 is not considered as a fish habitat. Photo 51 in Appendix D presents the area where the road is planned and the small pockets of water.

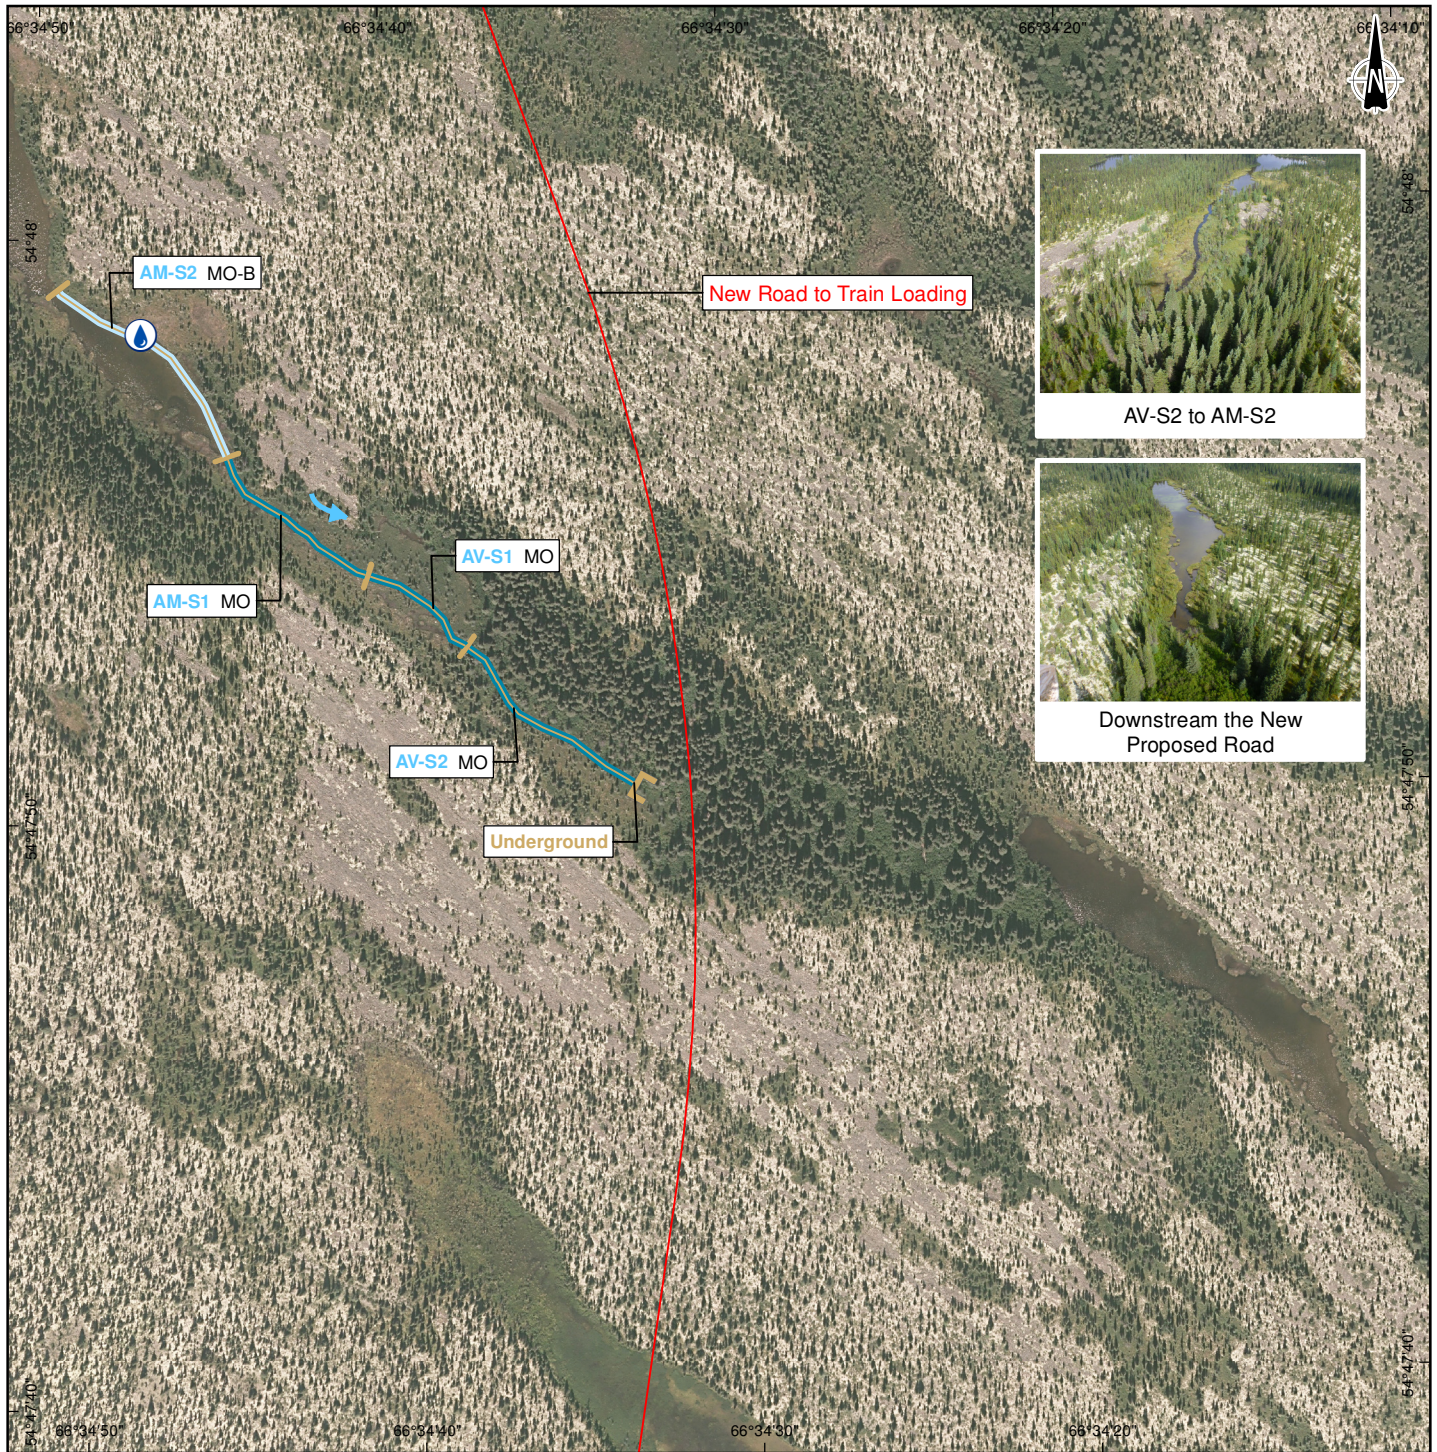
Figure 30

Stream Crossing CR07

CR07 was characterized along approximately 415 m and the lowermost segment stopped when the stream becomes underground (Figure 30; Appendix H). The road crosses just a few metres downstream where the water disappears in the ground. It is assumed that CR07 connects to the small pond located to the south but there was no evidence of a stream bed in between and the connection is potentially underground down to the pond.

AV-S2 is the lowermost part of CR07 that was characterized in 2012 and begins where the water flows through the ground (Photo 54, Appendix D). The habitats found in this segment are flat/run with flow velocities of 0.1 to 0.2 m/s. The stream is narrow with a mean width of 1.0 m. The mean water depths were around 0.28 m. The substrate is composed of muck and aquatic vegetation was also found (10 % of the stream bed surface area).

The next two segments upstream are flat habitat type of 1.5 and 2.0 m wide (Photos 53 and 55, Appendix D). No water depths or flow velocities are available for this part of the stream. The substrate was composed of muck and no aquatic vegetation was found.

The uppermost part that was characterized is a 10-m wide pond with a substrate composed of muck (90 %) and boulders (10 %; Photo 56, Appendix D). Aquatic vegetation was present on 10 % of the stream bed surface area.

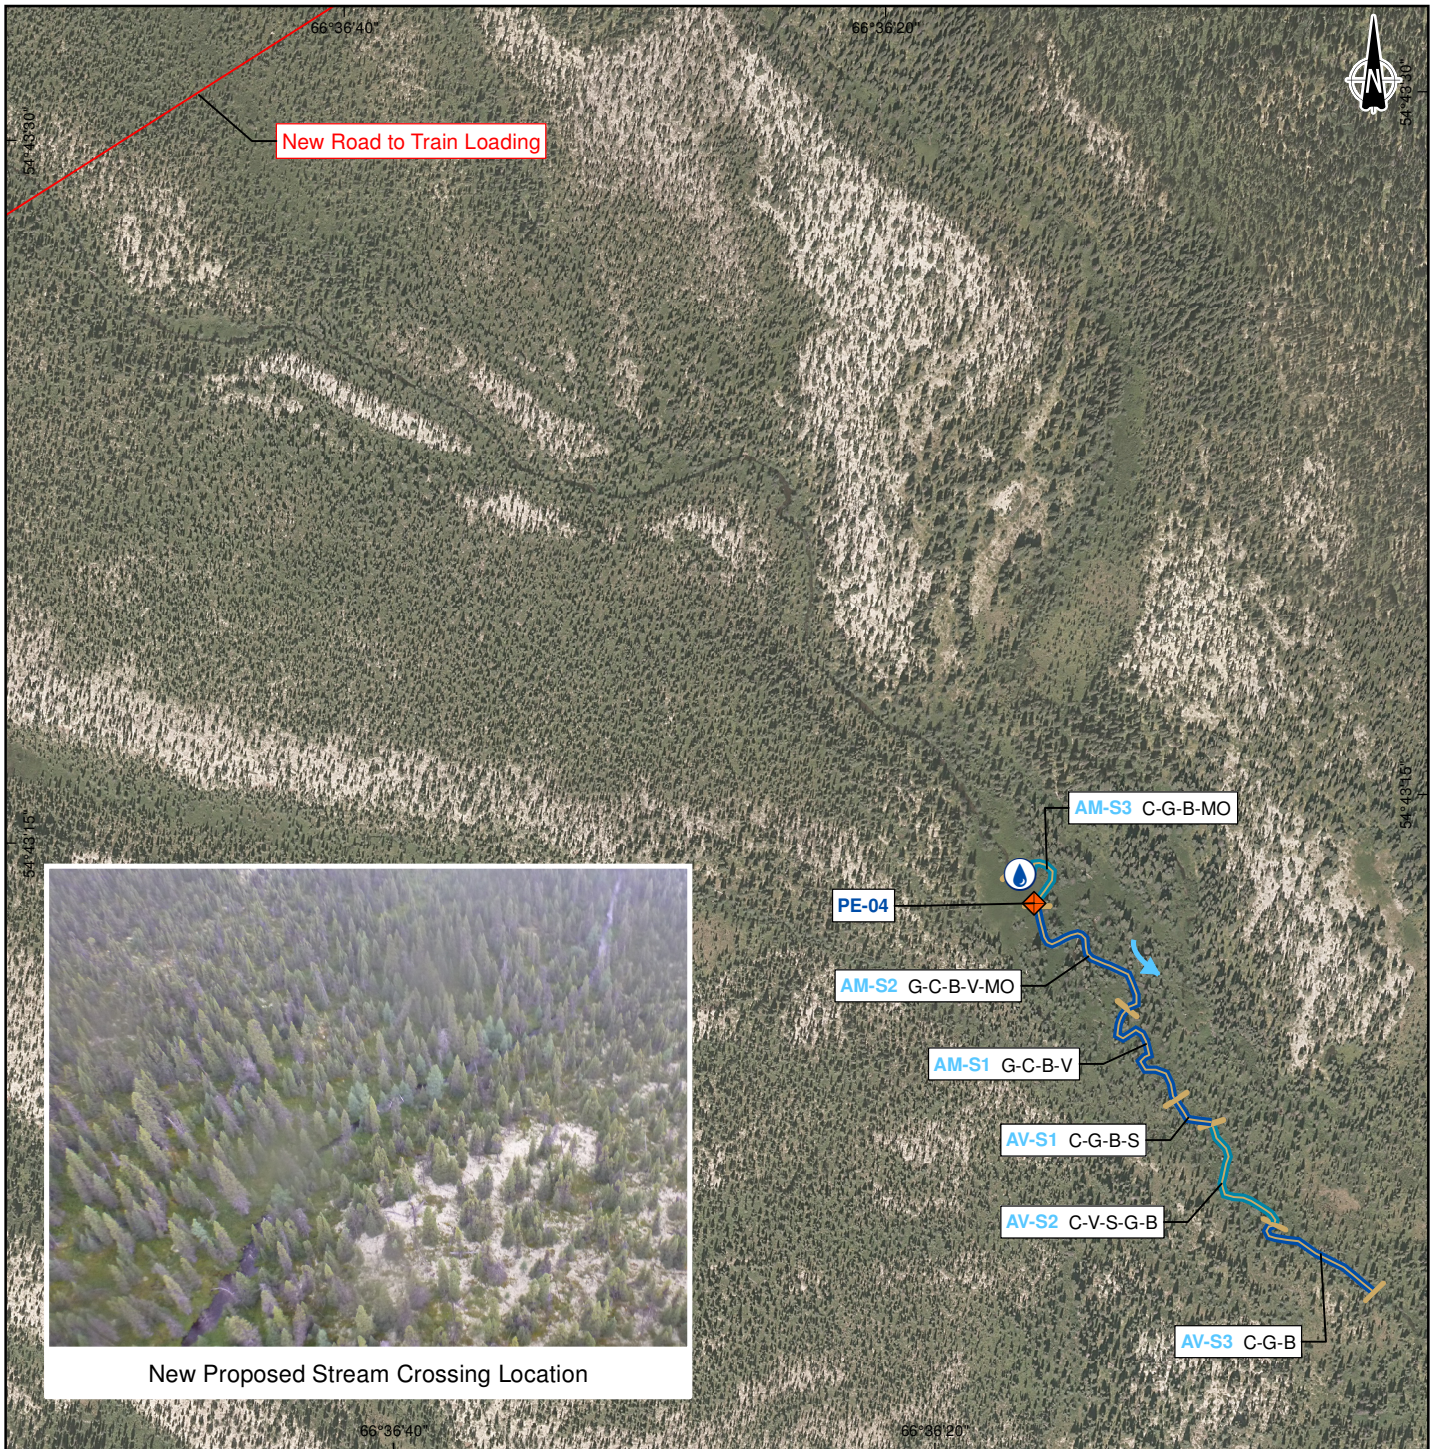
Figure 32

Stream Crossing CR12

Stream crossing CR12 is now located approximately 900 m upstream from where the field work was conducted in August 2012 (Figure 32). However, the proposed crossing is located in the area that was characterized from the helicopter and no barrier to fish passage and suitable spawning habitats were observed.

The section of the stream characterized is a meandering channel in a relatively open area (shrubby vegetation) while the area of the revised crossing is more linear and located in mature forest. Besides the surrounding vegetation and linearity, the revised crossing shares some common characteristics with the section characterized in the summer of 2012 (Figure 32; Appendix H).

AV-S3 is the lowermost segment characterized in 2012 (Photo 67, Appendix D). The mean width was 2.0 m and the water depth ranged from 0.20 to 0.55 m during field work on August 2 (Figure 32; Appendix H). The type of habitat is rapid with some sections of flat/riffle. The flow velocities ranged from 0.1 to 1.5 m/s. The substrate was composed of cobble (60 %), rubble (25 %) and boulders (15 %). AV-S2 presents flat and run/riffle types of habitat (Photo 66, Appendix D). The water depth and flow velocities ranged from 0.18 to 0.54 m and 0.0 to 0.6 m/s. The substrate is mainly composed of cobble and gravel. AV-S1 presents a variety of types of habitat, where run/pool is dominant (Photo 65, Appendix D). The water depth and flow velocities are quite similar to what is found downstream, and substrate is predominantly cobble and rubble.

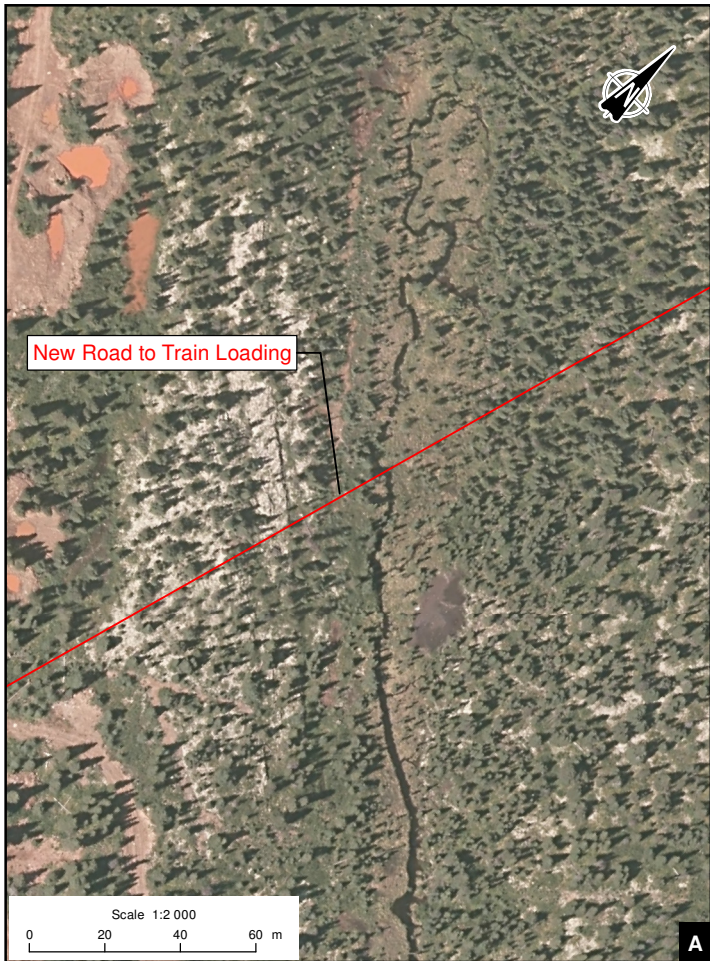
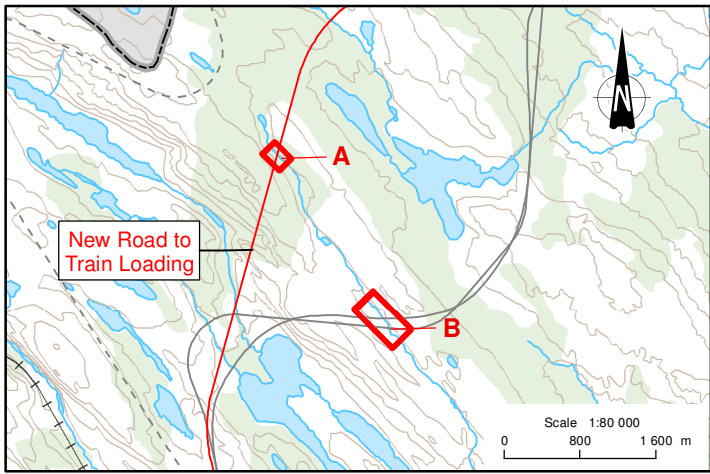
Figure 33

Stream Crossing CR14

CR14 was characterized far downstream from where the revised haulage road crosses the stream (Figure 33). This stream is approximately 3.7 km long and discharges into Astray Lake. It does not connect to any other waterbody. The stream is meandering through herbaceous vegetation (mostly sedges), shrubs (willows, sweet gale; Photos 71 to 74, Appendix D). Black spruce and larch is the most

CR14 was characterized over approximately 490 m (Appendix H). This section is quite narrow with mean widths ranging from 1.0 to 2.0 m and water depths between 0.29 and 1.2 m. The type of habitat is predominantly flat with flow velocities generally between 0.2 and 0.5 m/s. Only the lowermost part (AV-S3) showed a higher flow velocity (1.3 m/s), and rapids and cascades were found in this segment. The substrate was composed of organic material, mostly muck with woody debris and fallen trees. The aquatic vegetation, predominantly bur-reed, was dense and covered 80 to 95 % of the stream bed. During field work, dissolved oxygen was 8.78 mg/L, pH was 6.31 and conductivity was 20.9 μ S/cm (Table 8).
