## **APPENDIX 1 REGISTRATION FORMAT**

**(i) Name of the Undertaking:** Improvement of Atlantic Salmon passage at a waterfall on Middle Barchois Brook

#### **Upper Waterfall on Middle Barachois Brook, Bay St. George.**

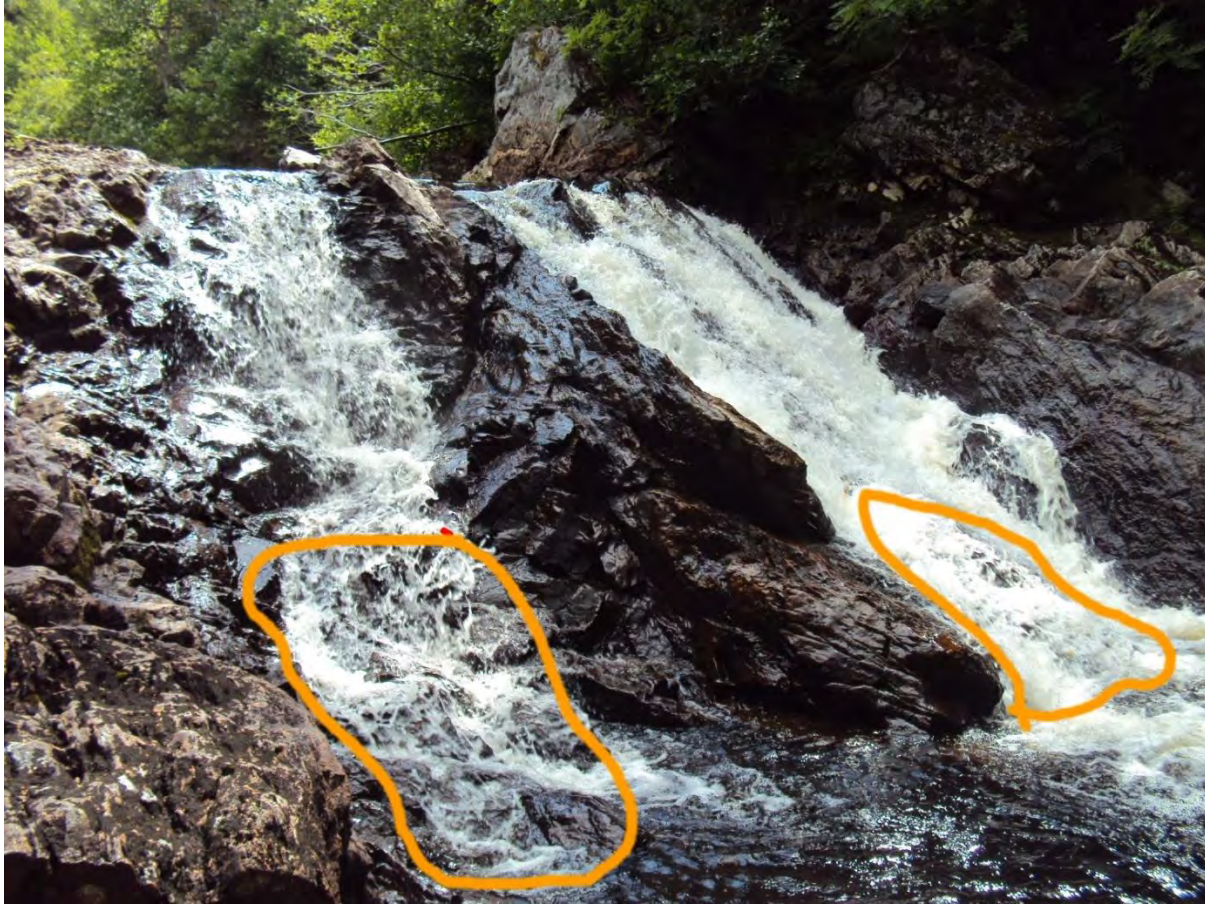
**Photo 1:** Waterfall is about 3m high at a slope of about  $70^\circ$  ( $30^\circ$  off vertical). At the low water level when the photo was taken the waterfall had 2 channels. The left channel (looking upstream) is about 0.5m wide at the top; whereas the channel to the right is about 2m wide and contains most of the river flow at this water level. Note, the rocky slope and rock out cropping at the base of channels would prevent salmon from surmounting the waterfall at this water level. It is proposed that rocks be removed within areas enclosed by the orange borders.

The major undertakings include removing a small amount of rock (~ 0.5m<sup>3</sup>) at the base of both the right and left side of the waterfall to improve channels for salmon to surmount the waterfall (see Photo 1). Additionally, we will place two large concrete blocks (6'x2'x2') in a constriction in the brook at the end of pool below the waterfall to raise the water level in the pool and reduce the height of the waterfall that salmon have to jump to surmount the waterfall (see Photos 4 & 5).

The rock at the base of the waterfall would be removed using a manually operated jack hammer and if necessary, using expansion grout. Explosives will not be used. The broken rock will be pushed into the pool below the waterfall. The pool is sufficiently deep that this rock will not interfere with salmon jumping the waterfall or affect water flow below the waterfall.

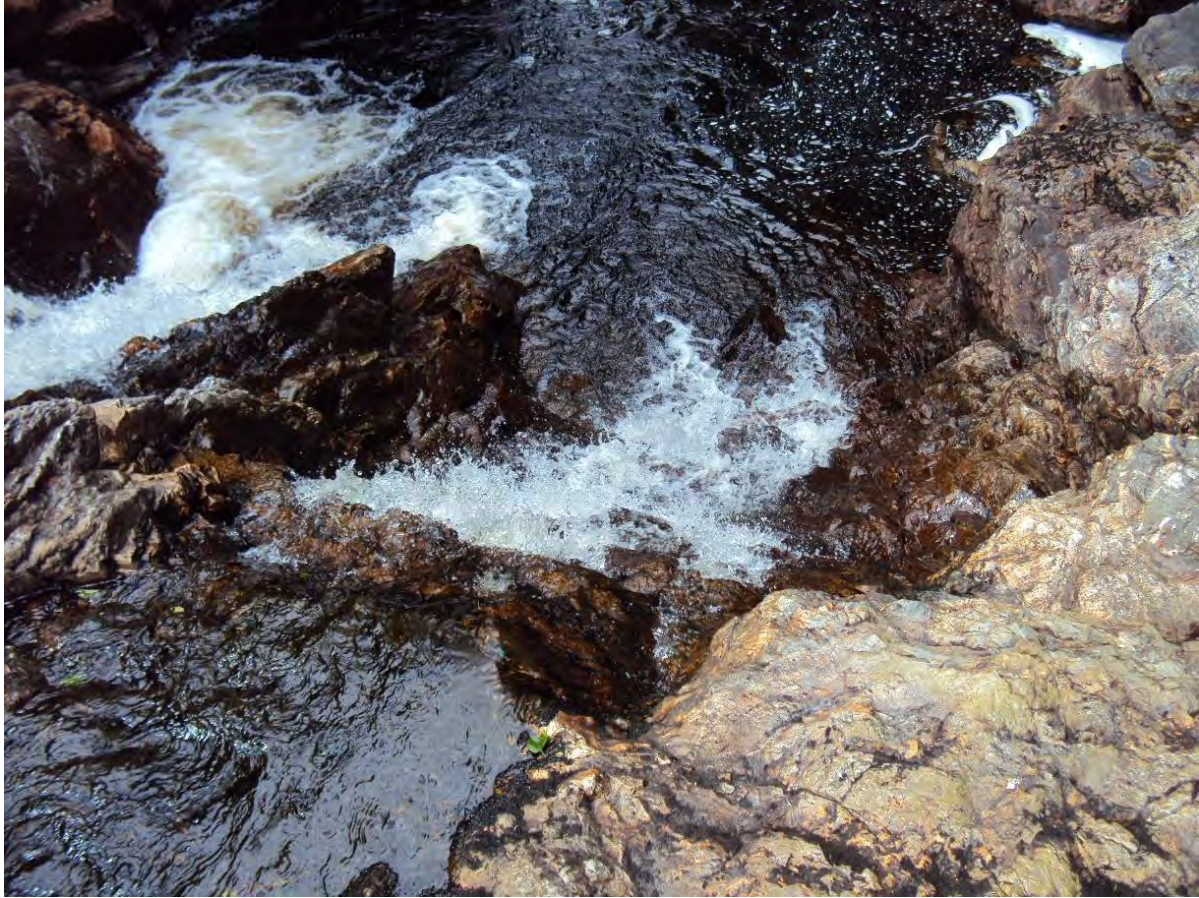
**Photo 2:** This photo shows the top of the left (looking upstream) channel of the waterfall. The width of the wetted area is approx. 0.5m. Note the rocks on both the left and right channels at the base of the waterfall. These rocks would impede salmon from jumping the waterfall.

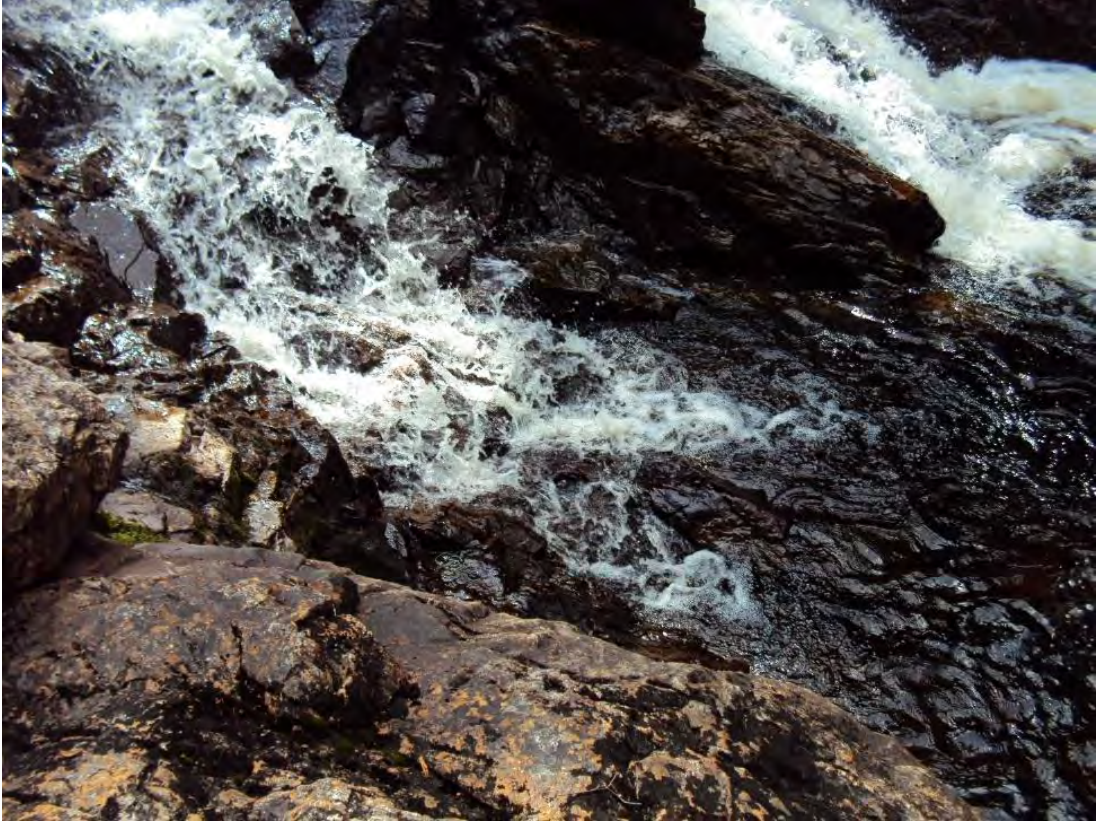
**Photo 3:** Photo of rocks at base of the left and right channels of the waterfall.

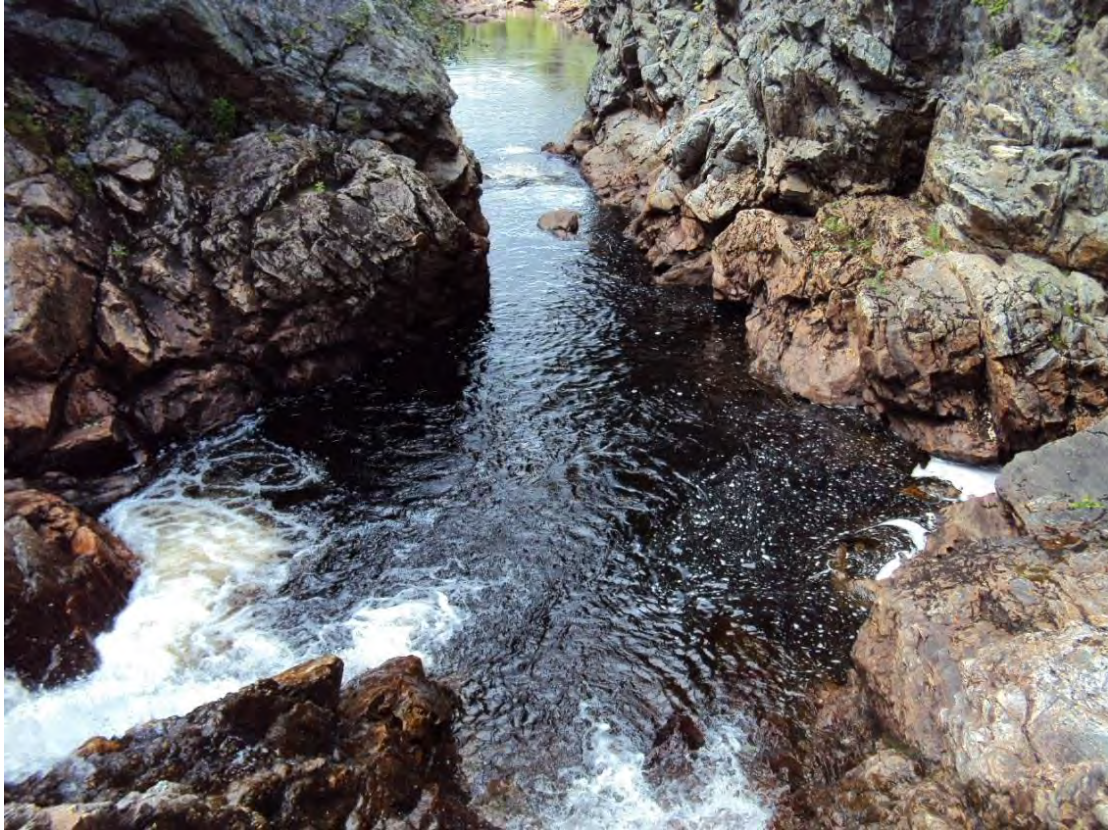
**Photo 4:** Pool at base of waterfall. Pool is approx. 8m long and 6m wide. The constriction at the lower end of pool is about 2.5m wide. Note rocks in the center of the constriction. This constriction and rocks result in higher water levels in pool during high flows as indicated by the staining of rock walls of pool approximately 1.0-1.5m above water level.

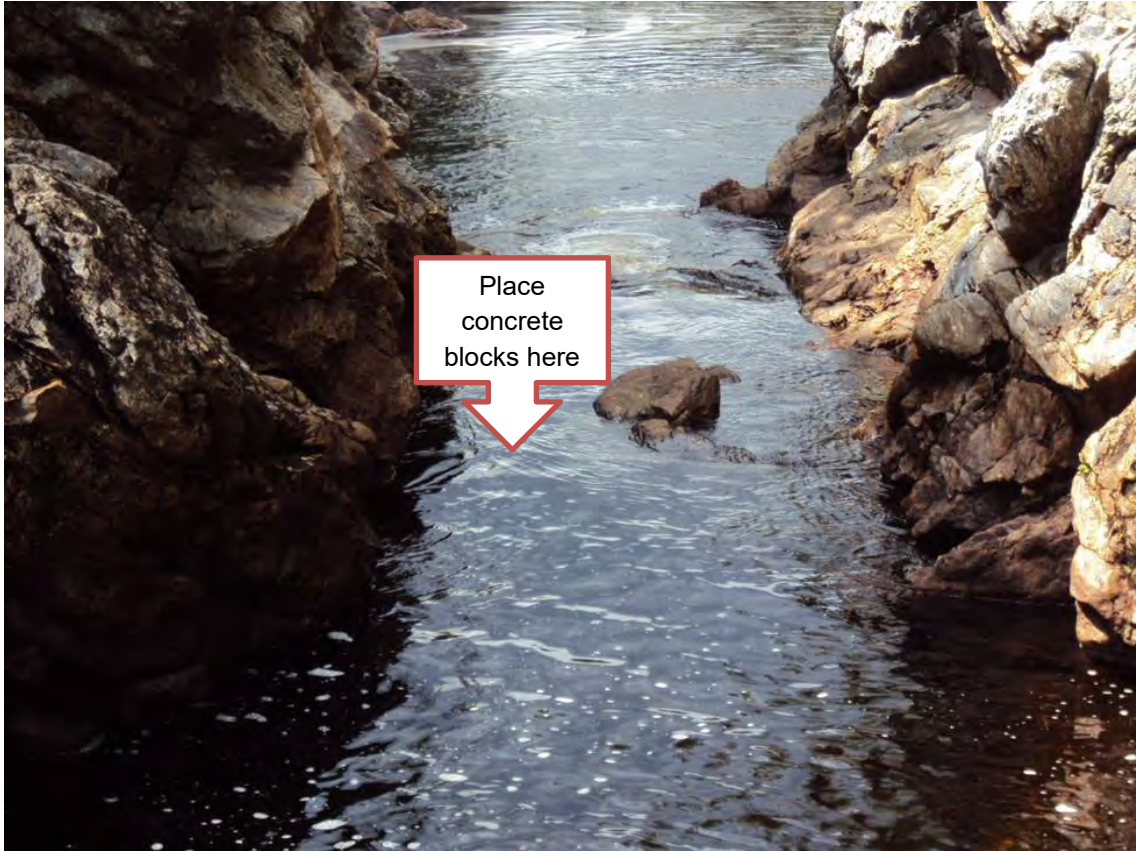
**Photo 5:** Location to place concrete blocks at downstream end of pool to increase water level in pool.

Two to four large concrete blocks (6'x2'x2') will be strategically lowered into the water at the constriction at the downstream end of the pool by an excavator. There is an eye bolt in each of the concrete blocks assist in lowering and positioning. If for some reason the

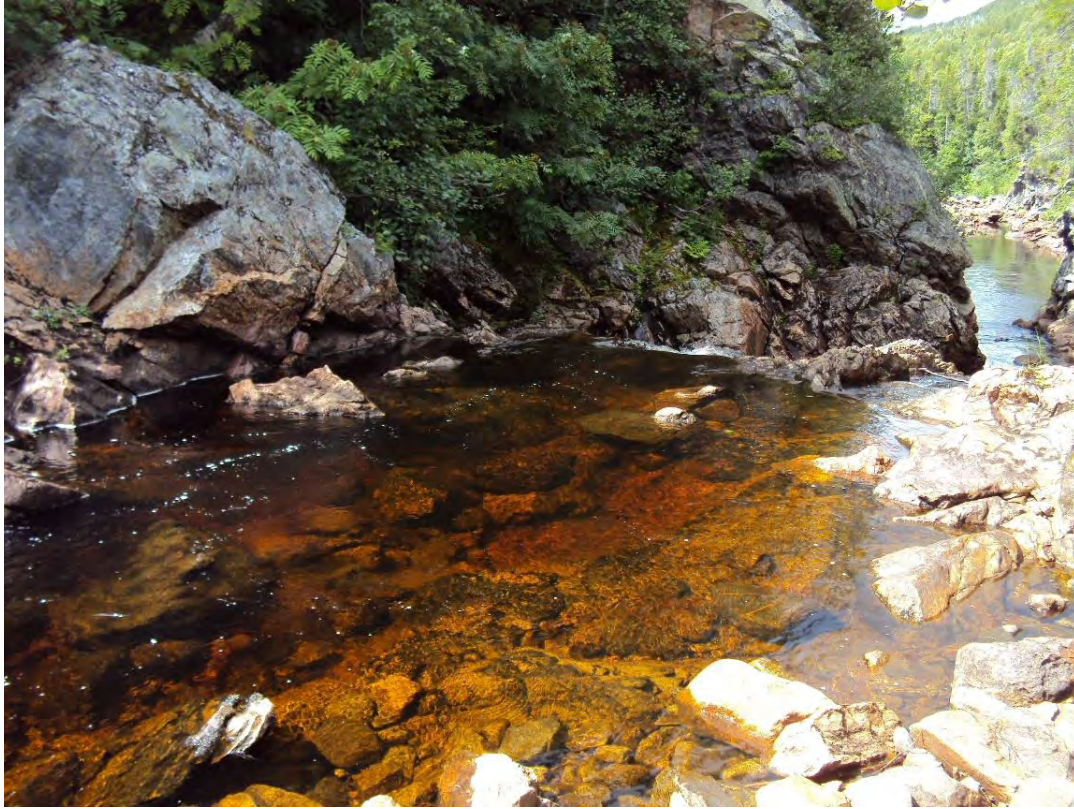
**Photo 6:** Pool at top of waterfall, approx. 5m wide and 0.3m deep. Rocks in pool may interfere with salmon after they jump the waterfall at higher discharge.

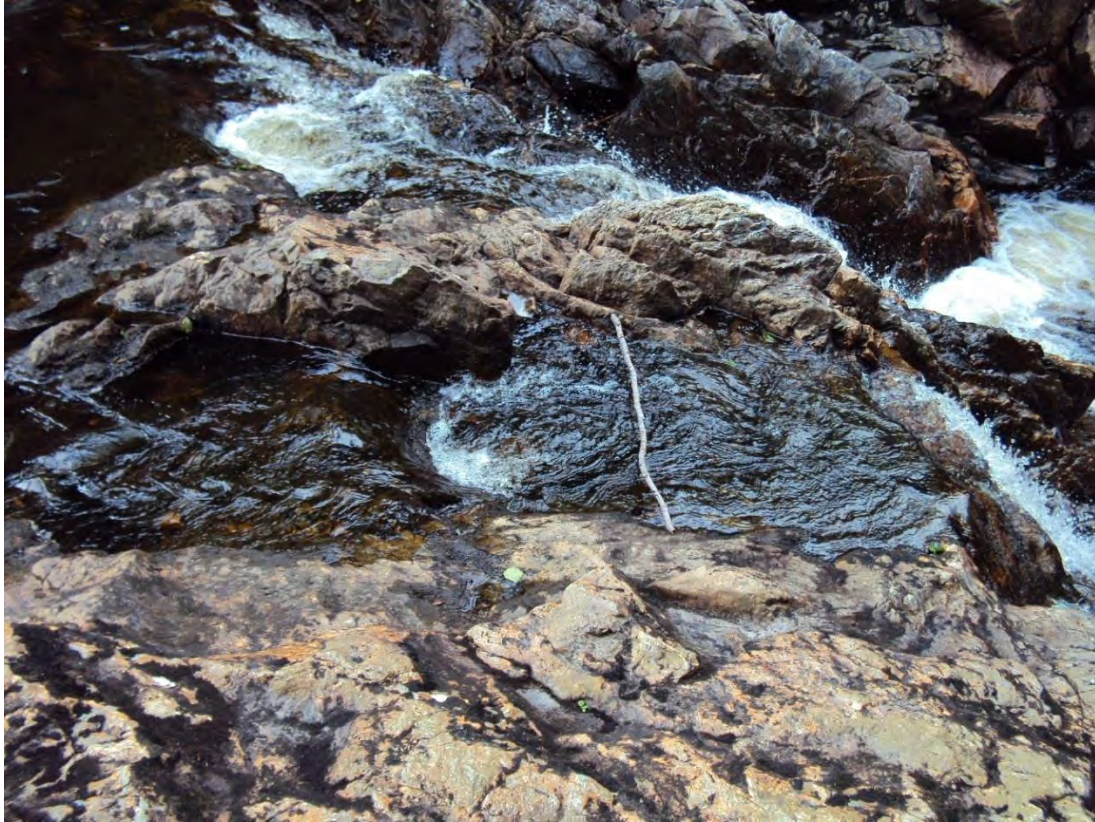
**Photo 7:** Crest of waterfall. The stick across left (looking upstream) channel is about 0.5m in length. Flow in channel would be greater at higher river discharge.

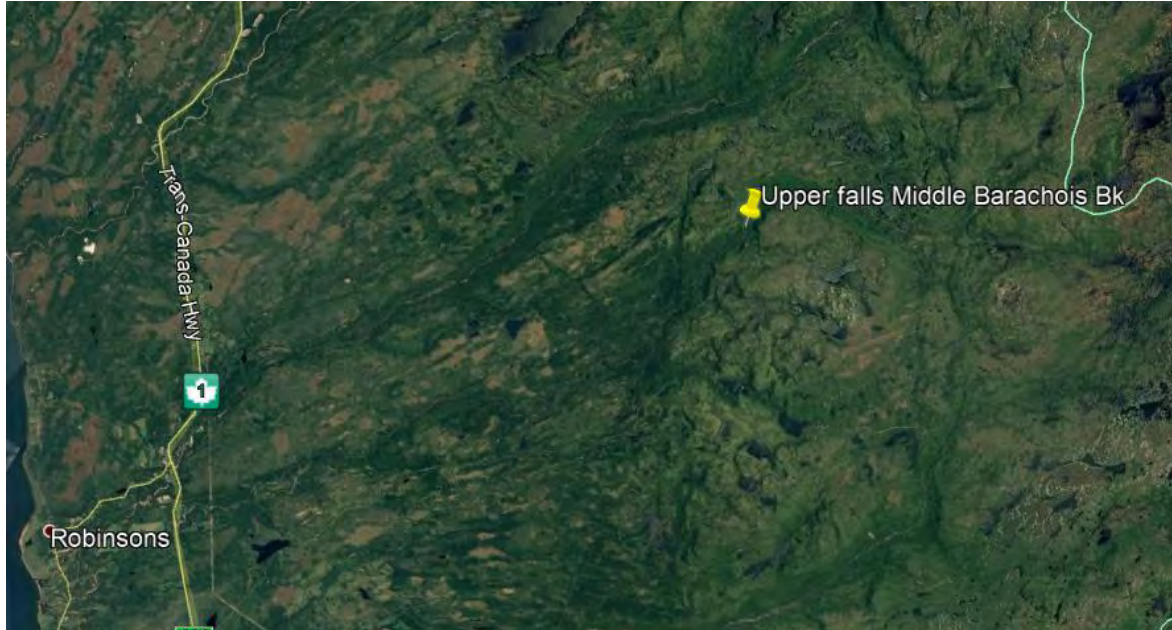
**Map 1:** Location of Middle Brook upper waterfall, approximately 27 km in a straight line from estuary.

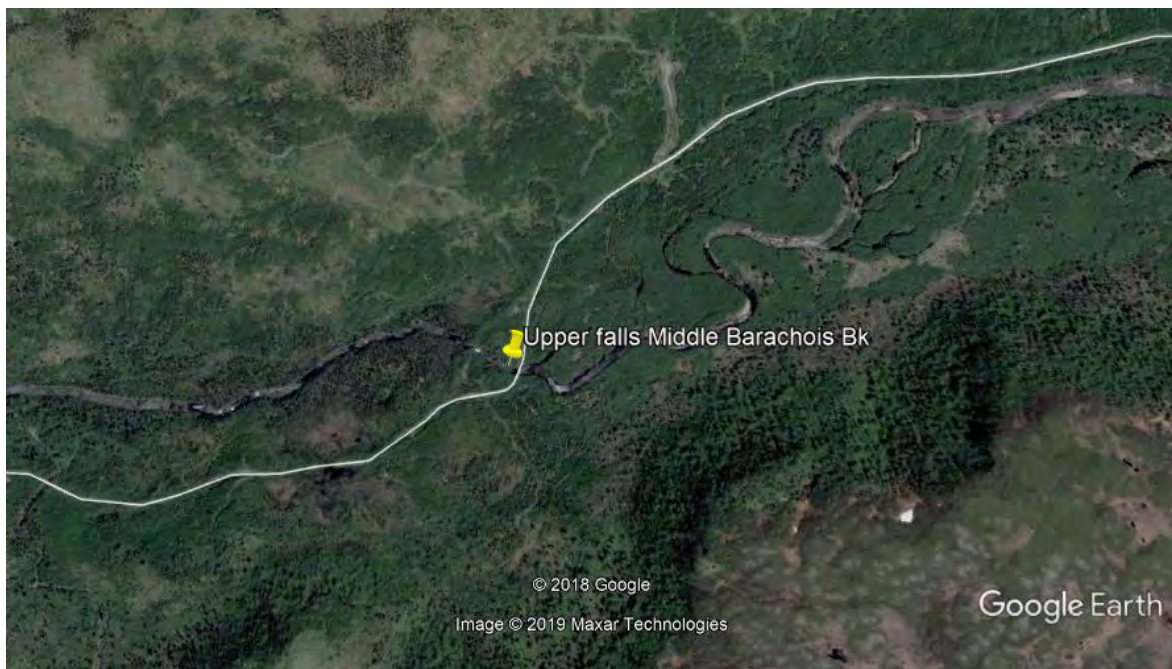
**Map 2:** Location of upper waterfall, Middle Barchois Bk, ~ 80m below bridge on camp 180 resource road.

For an excavator to access the site, two culverts on the Camp 180 Resource Road will have to be replaced. The excavator will access the constriction on the north side of the Brook from Camp 180 Resource Road via an old road previous constructed to the constriction. This old road is about 3m wide and about 100m long. The access road is on solid ground and partially over-grown with alders, which the excavator can drive over (see site plan). No soil will have to be removed and no gravel will have to be added. The concrete blocks (owned by a contractor) are on the side of Camp 180 Resource Road about 100m from the proposed access road.

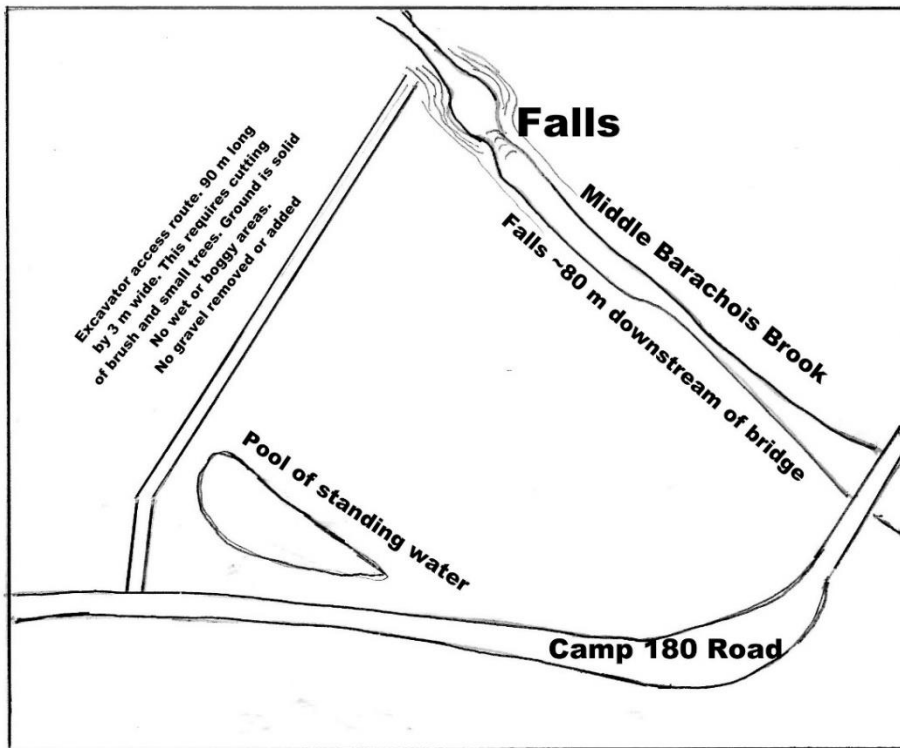
Map 3: Site plan

**Site Plan for remedial work  
Middle Barachois falls**
