**Decommissioning of the Long
Lake Water Control Structure
Environmental Registration**

Final Report

September, 2023

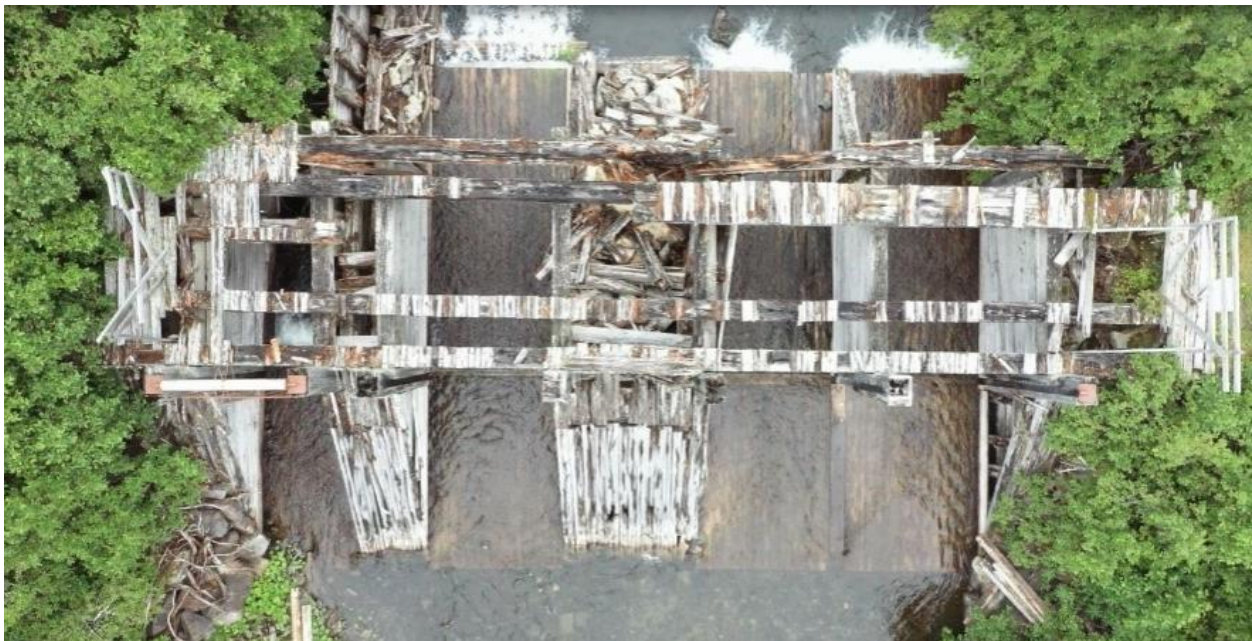
Figure 2.2 Long Lake WCS – Top View

The WCS is constructed of wood timber and rock cribbing and measures approximately 9.35 m wide and 13.2 m long and consists of four openings (Figures 2.2-2.4). There are three large openings (2.5 m wide) where stop logs were placed to control the water level in the lake. The fourth opening (1.80 m wide) was a former fishway and contains a metal control valve, gate, and curved channel along the edge of the right-hand bank, when facing downstream. The base of the WCS consists of a degraded wooden deck which lies on top of a rock-filled base.

The fish passage assessment conducted indicated that the Long Lake WCS is a complete barrier to brook trout and a partial barrier to ouananiche (Stantec 2023 draft in preparation). For the fish passage assessment, it was assumed that fish passage is not currently possible through the fourth opening as it is blocked with rocks or debris. Within each of the three openings there is a lip connecting the upstream and downstream portions of the deck, which has degraded over time and currently has 1 to 2.5 cm gaps in the wood, allowing water to be entrained. It is anticipated that these gaps can allow small fish to fall through the deck during up and down steam migration, and become trapped in the rock base of the WCS, potentially leading to fish mortality.

At the time of the ground assessment, water depth varied from 0.04 to 0.06 m at the downstream end of the opening and water velocities were 0.118 to 0.766 m/s. At the time of the survey, the deck of the WCS is perched relative to the downstream water surface by approximately 0.54 m. Based on the ordinary high water mark it appears that the deck is likely perched relative to the water's surface during the majority of the year. In addition, the third opening has a "step" at the downstream end of the deck which may further inhibit fish passage during low flow conditions (Figure 2.3). There is a pool at the base of the WCS, which at the time of the survey was 0.43 to 0.77 m in depth.

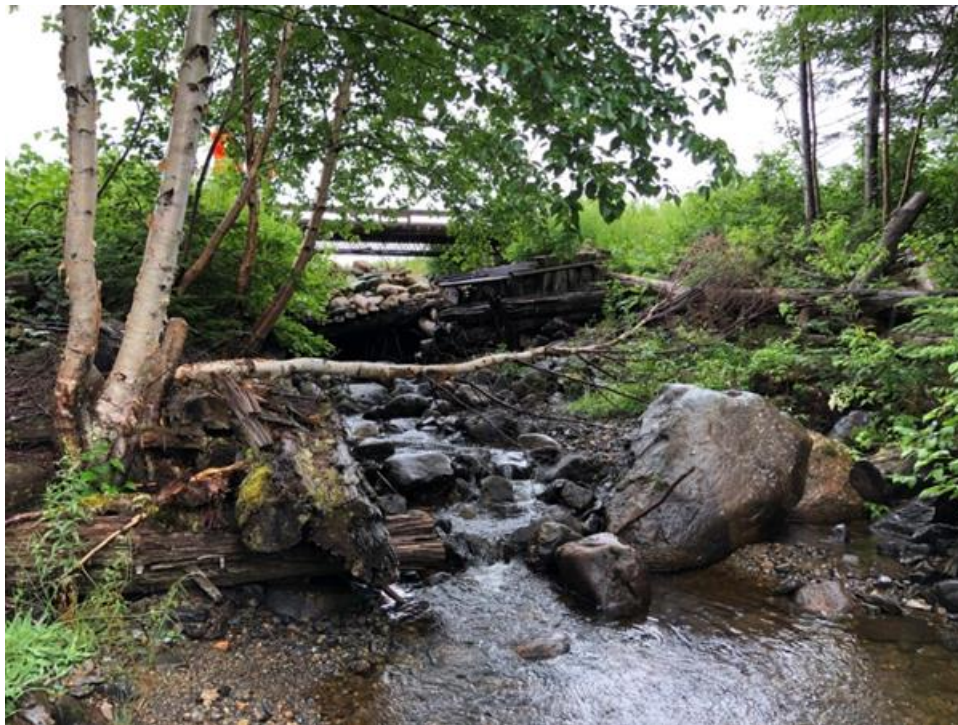
Figure 2.7 Shoulder Blade Lake WCS Facing Upstream

Shoulder Blade Lake is a small (2.06 km²) headwater lake which is located in the Noel Paul sub-watershed which is part of the Exploits Watershed. A contingency opportunity at Shoulder Blade Lake appears to consist of an abandoned WCS which is located at the outlet of the lake (Figure 2.7). The structure is approximately 5 m wide and may have functioned as a splash dam.

Currently, water flows through the outlet, under the bridge, and falls onto boulders which have slumped on top of the washed out WCS. The water trickles between the boulders and logs of the WCS and onto the stream bed below (Figure 2.8). The WCS at Shoulder Blade Lake is likely to be a full barrier to fish passage. There is insufficient consolidated flow to facilitate fish passage as the flow is dissipated through the boulders on top of the WCS.

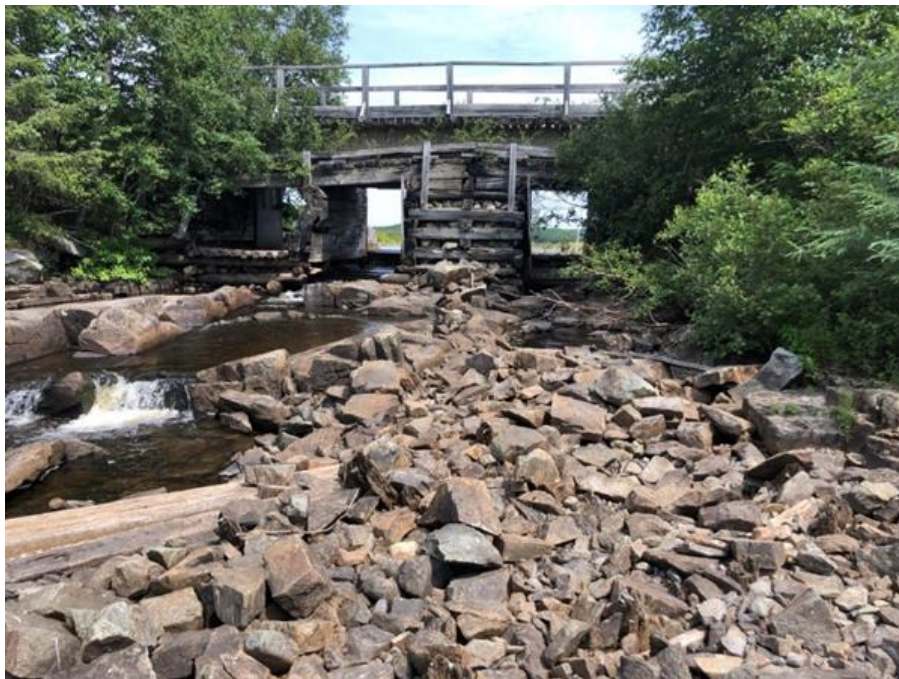
Figure 2.9 Mary Anne Brook WCS Facing Upstream

The opportunity at Mary Anne Lake consists of an abandoned WCS which is located at the outlet of Mary Anne Lake (Figure 2.9-2.10). Mary Anne Lake is a large lake (15.3 km²) located in the Badger Brook sub-watershed which is within the Exploits Watershed. The WCS is located under a concrete span multiuse trail bridge that was replaced in the recent past (Figure 2.9).

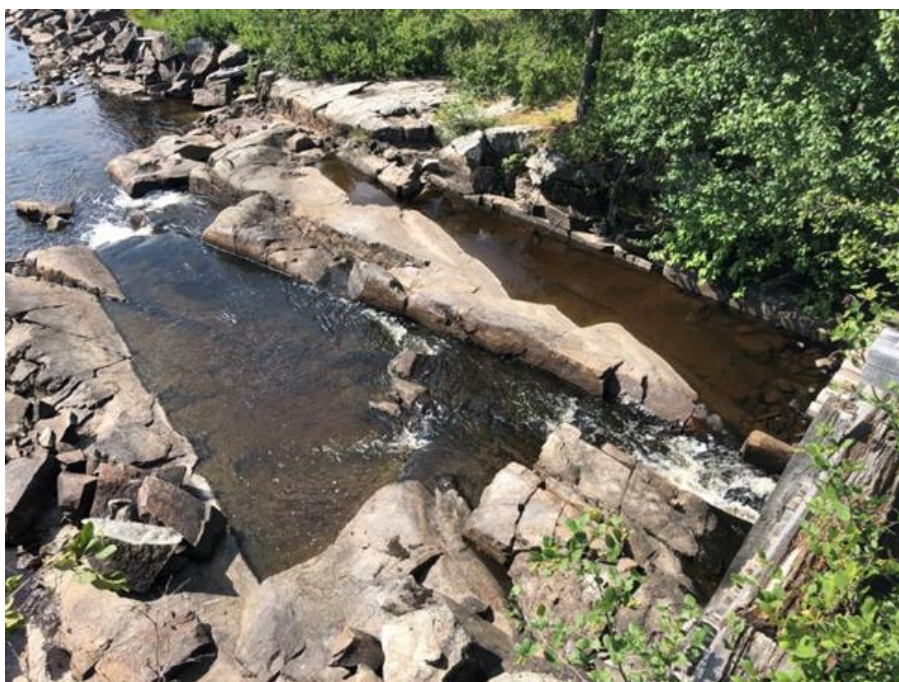
Figure 2.10 Bedrock Sill Downstream of Mary Anne Brook WCS Facing Downstream

The WCS is constructed on top of a natural bedrock sill which contains a number of natural drops and pools (Figure 2.10). The structure is approximately 13 m wide and ranges in length from 7.45 to 9.62 m and consists of three large openings. Water flows through the openings at different rates due to the degradation of the WCS structure. This structure likely represents a partial barrier to brook trout, Atlantic salmon and ouananiche passage during low flow periods of the year and potentially during high flow periods.
