Environmental Assessment Registration

**Project: Remediation of the Former Burgeo Rifle Range,
Burgeo, Newfoundland and Labrador**

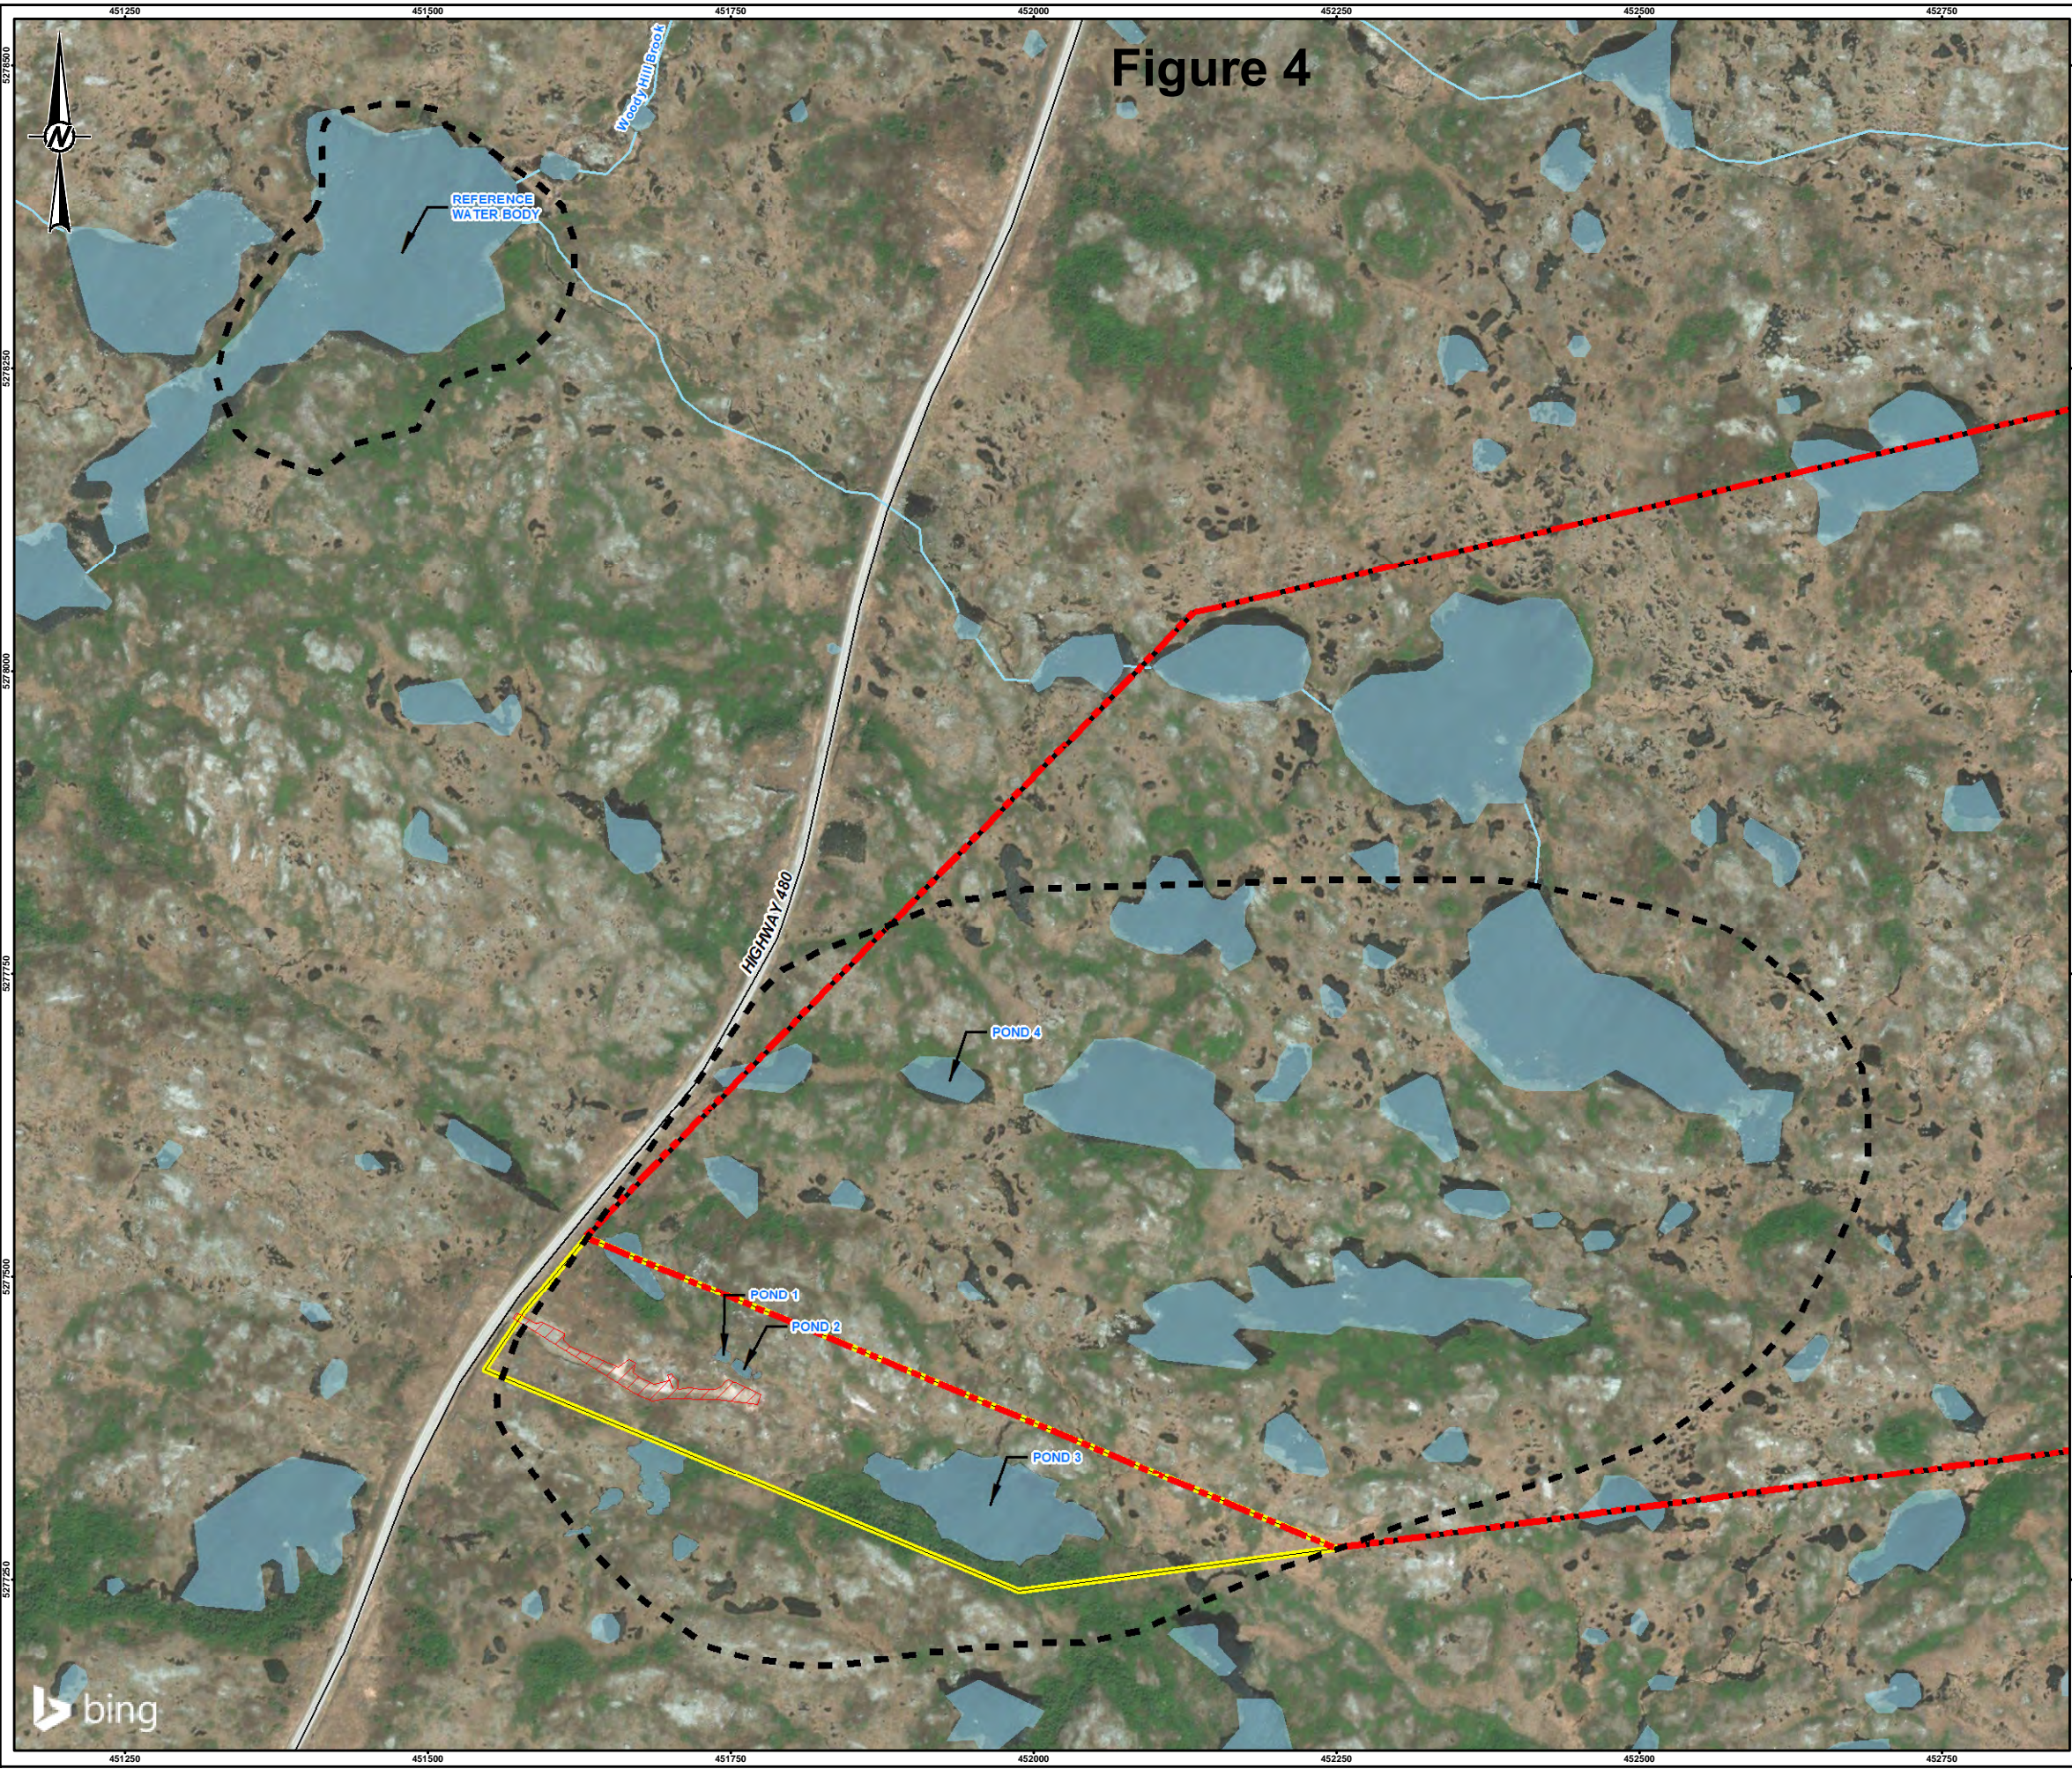
Figure 4

The site does not have any built infrastructure other than a gravel access road off Highway 480 ([Figure 4](#) ["Disturbed Area"], Annex A). Materials on-site are related to firing activities, such as wooden stakes, stands, and targets (debris to be removed). The project does not include construction of any physical features (e.g., buildings, roads).

A habitat assessment was completed at and around the site (WSP, 2023a) (see "Ecological Study Area" on [Figure 4](#), Annex A).

A habitat assessment was completed at and around the site (WSP, 2023a) (see “Ecological Study Area” on [Figure 4](#), Annex A).

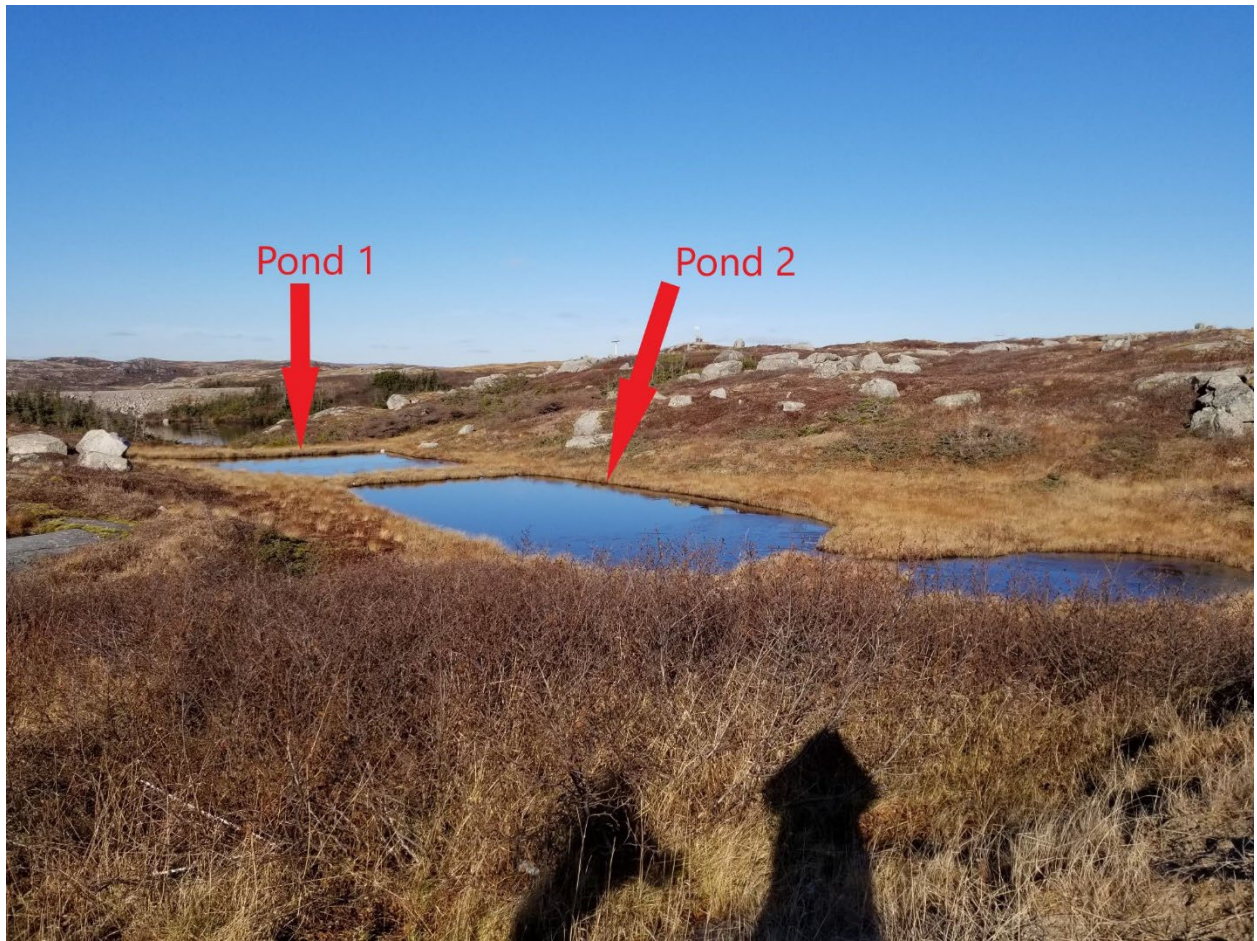
View of Pond 1 and Pond 2, facing northwest.

- Sediment dredging and off-site disposal: Two ponds (ponds 1 and 2; [Figure 3](#), Annex A; [photos](#), Annex B) containing impacted sediment are proposed to be excavated using heavy machinery, where accessible, or hydraulic dredging using hydraulic vacuuming. The method used to remove the sediment from ponds 1 and 2 will be determined by the contractor and approved by DND. The sediment would then be loaded into trucks for transport and disposal at engineered landfills licensed to accept the impacted material. The depth of the impacted sediment extends to approximately 0.6 meters below the bottom of the ponds. The approximate total area of the impacted ponds is 300 m². As such, sediment quantities have been estimated to be 180 m³. Any water from impacted sediment during sediment dewatering will be considered impacted water and treated on-site (see next bullet).

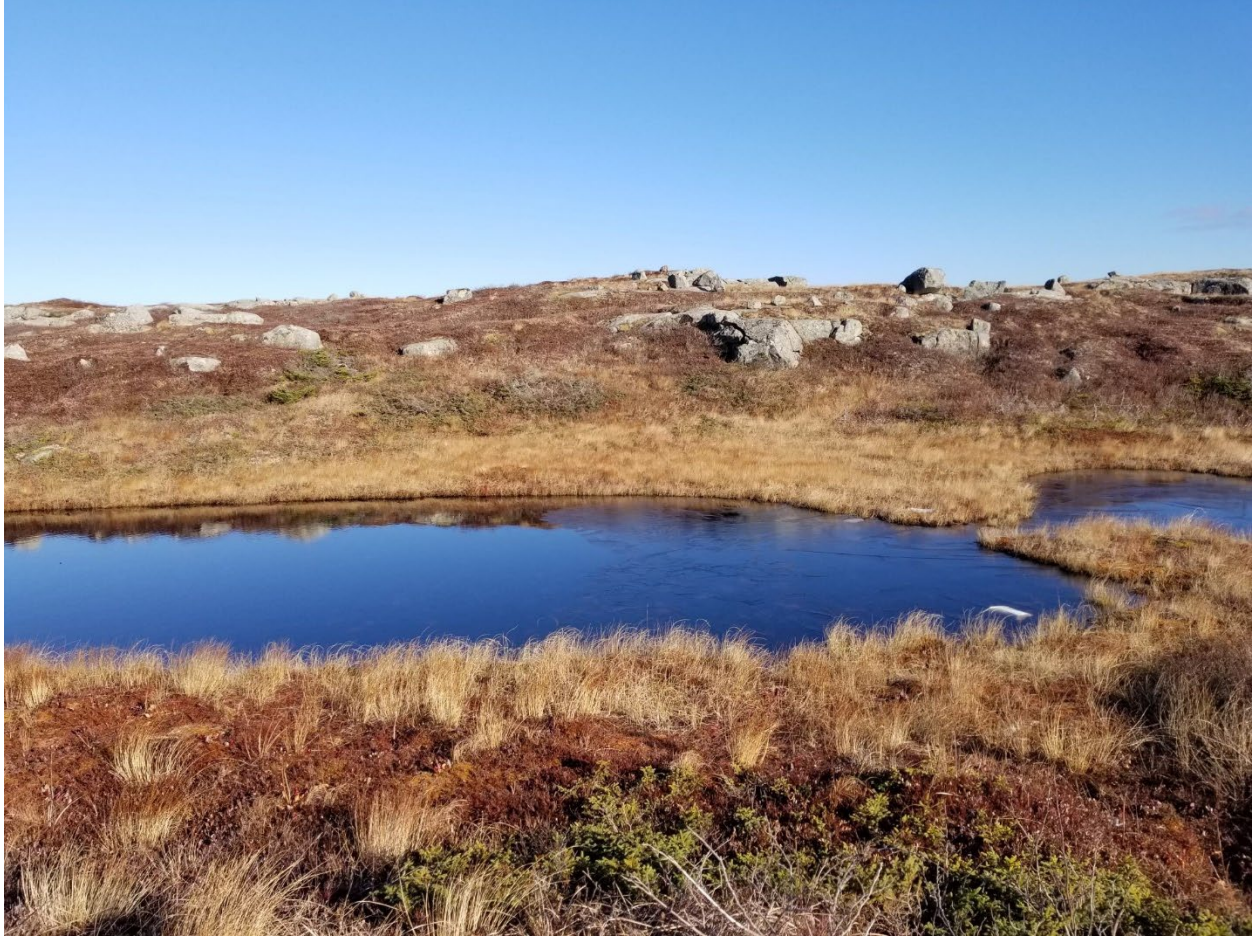
View of Pond 2, facing north-northeast.

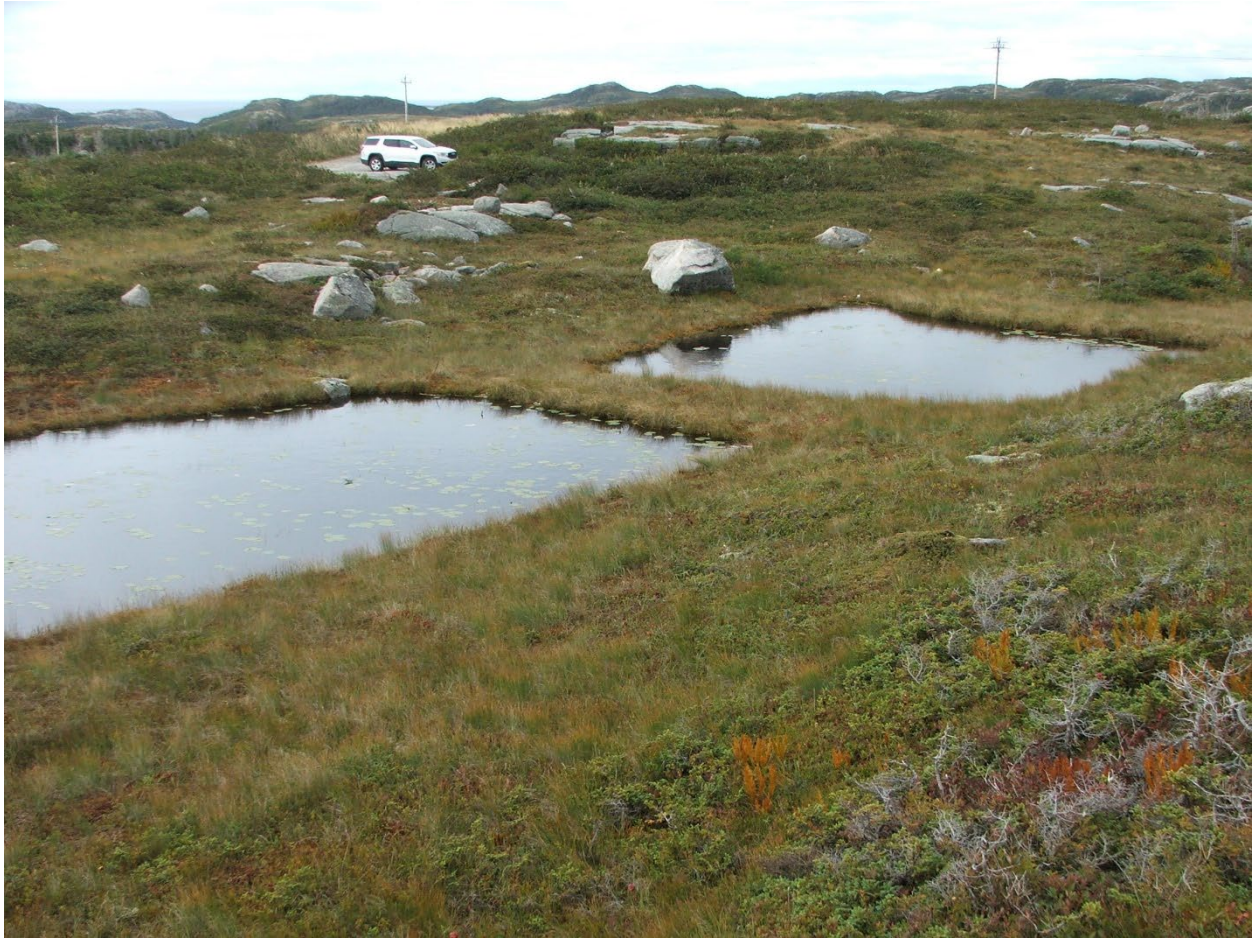
View of pond 1 (right) and partial pond 2 (left), facing west.

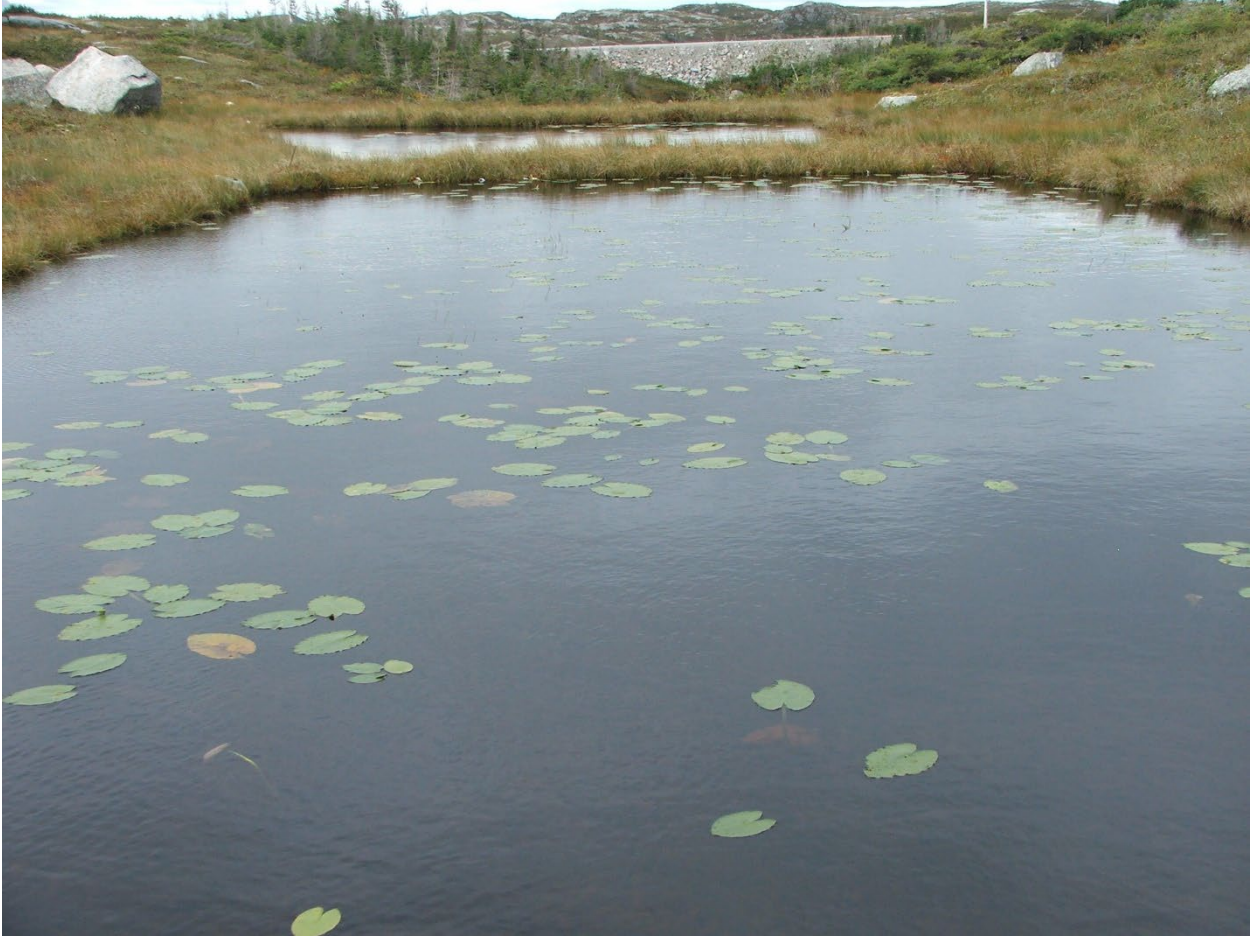
View of pond 1 (background) and partial pond 2 (foreground), facing northwest.

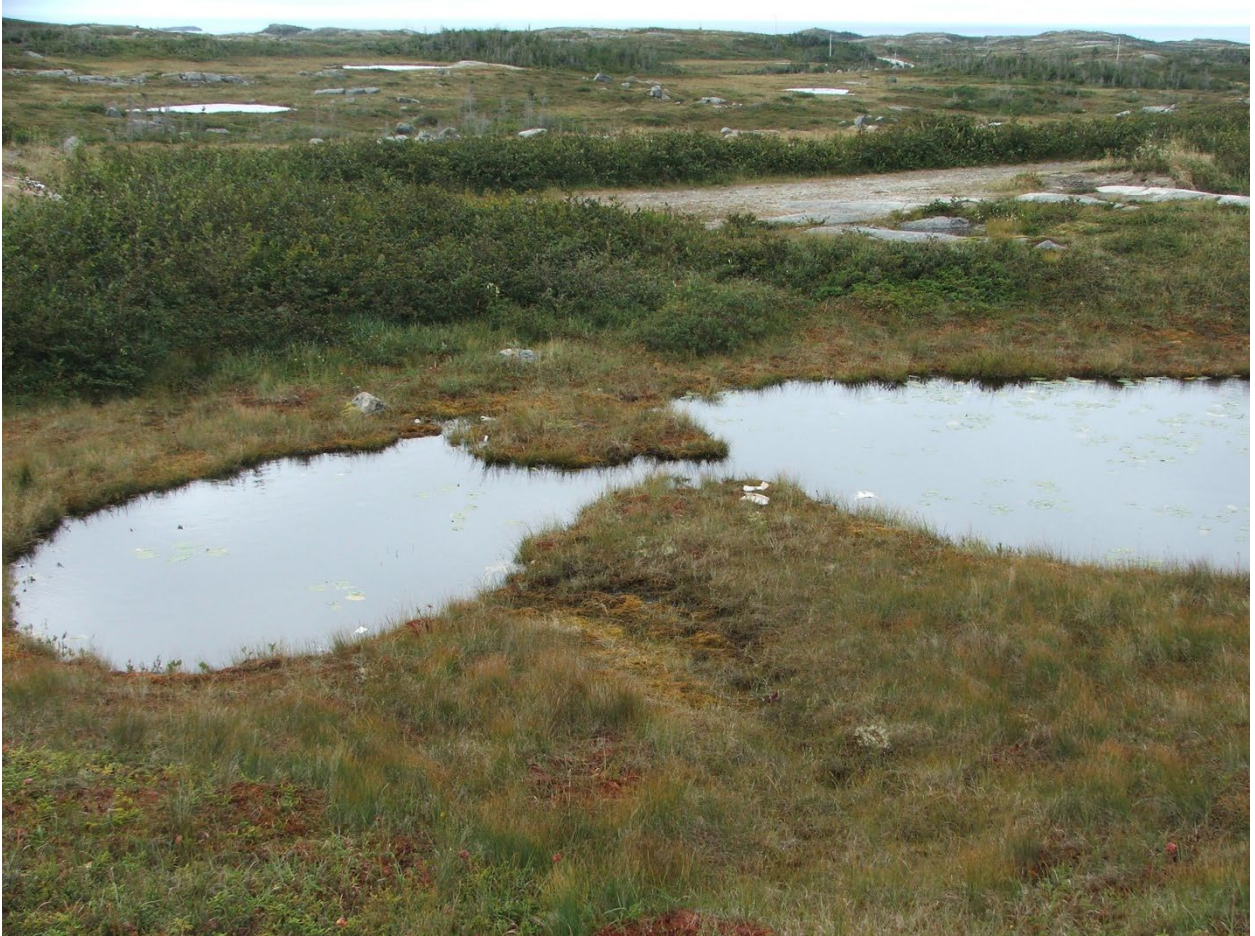
View of partial pond 2, facing southwest.
