# Remedial and Risk Management Strategy

*Former Burgeo Rifle Range, Burgeo, NL*

*DND Project # N.002180.02*

November 2023

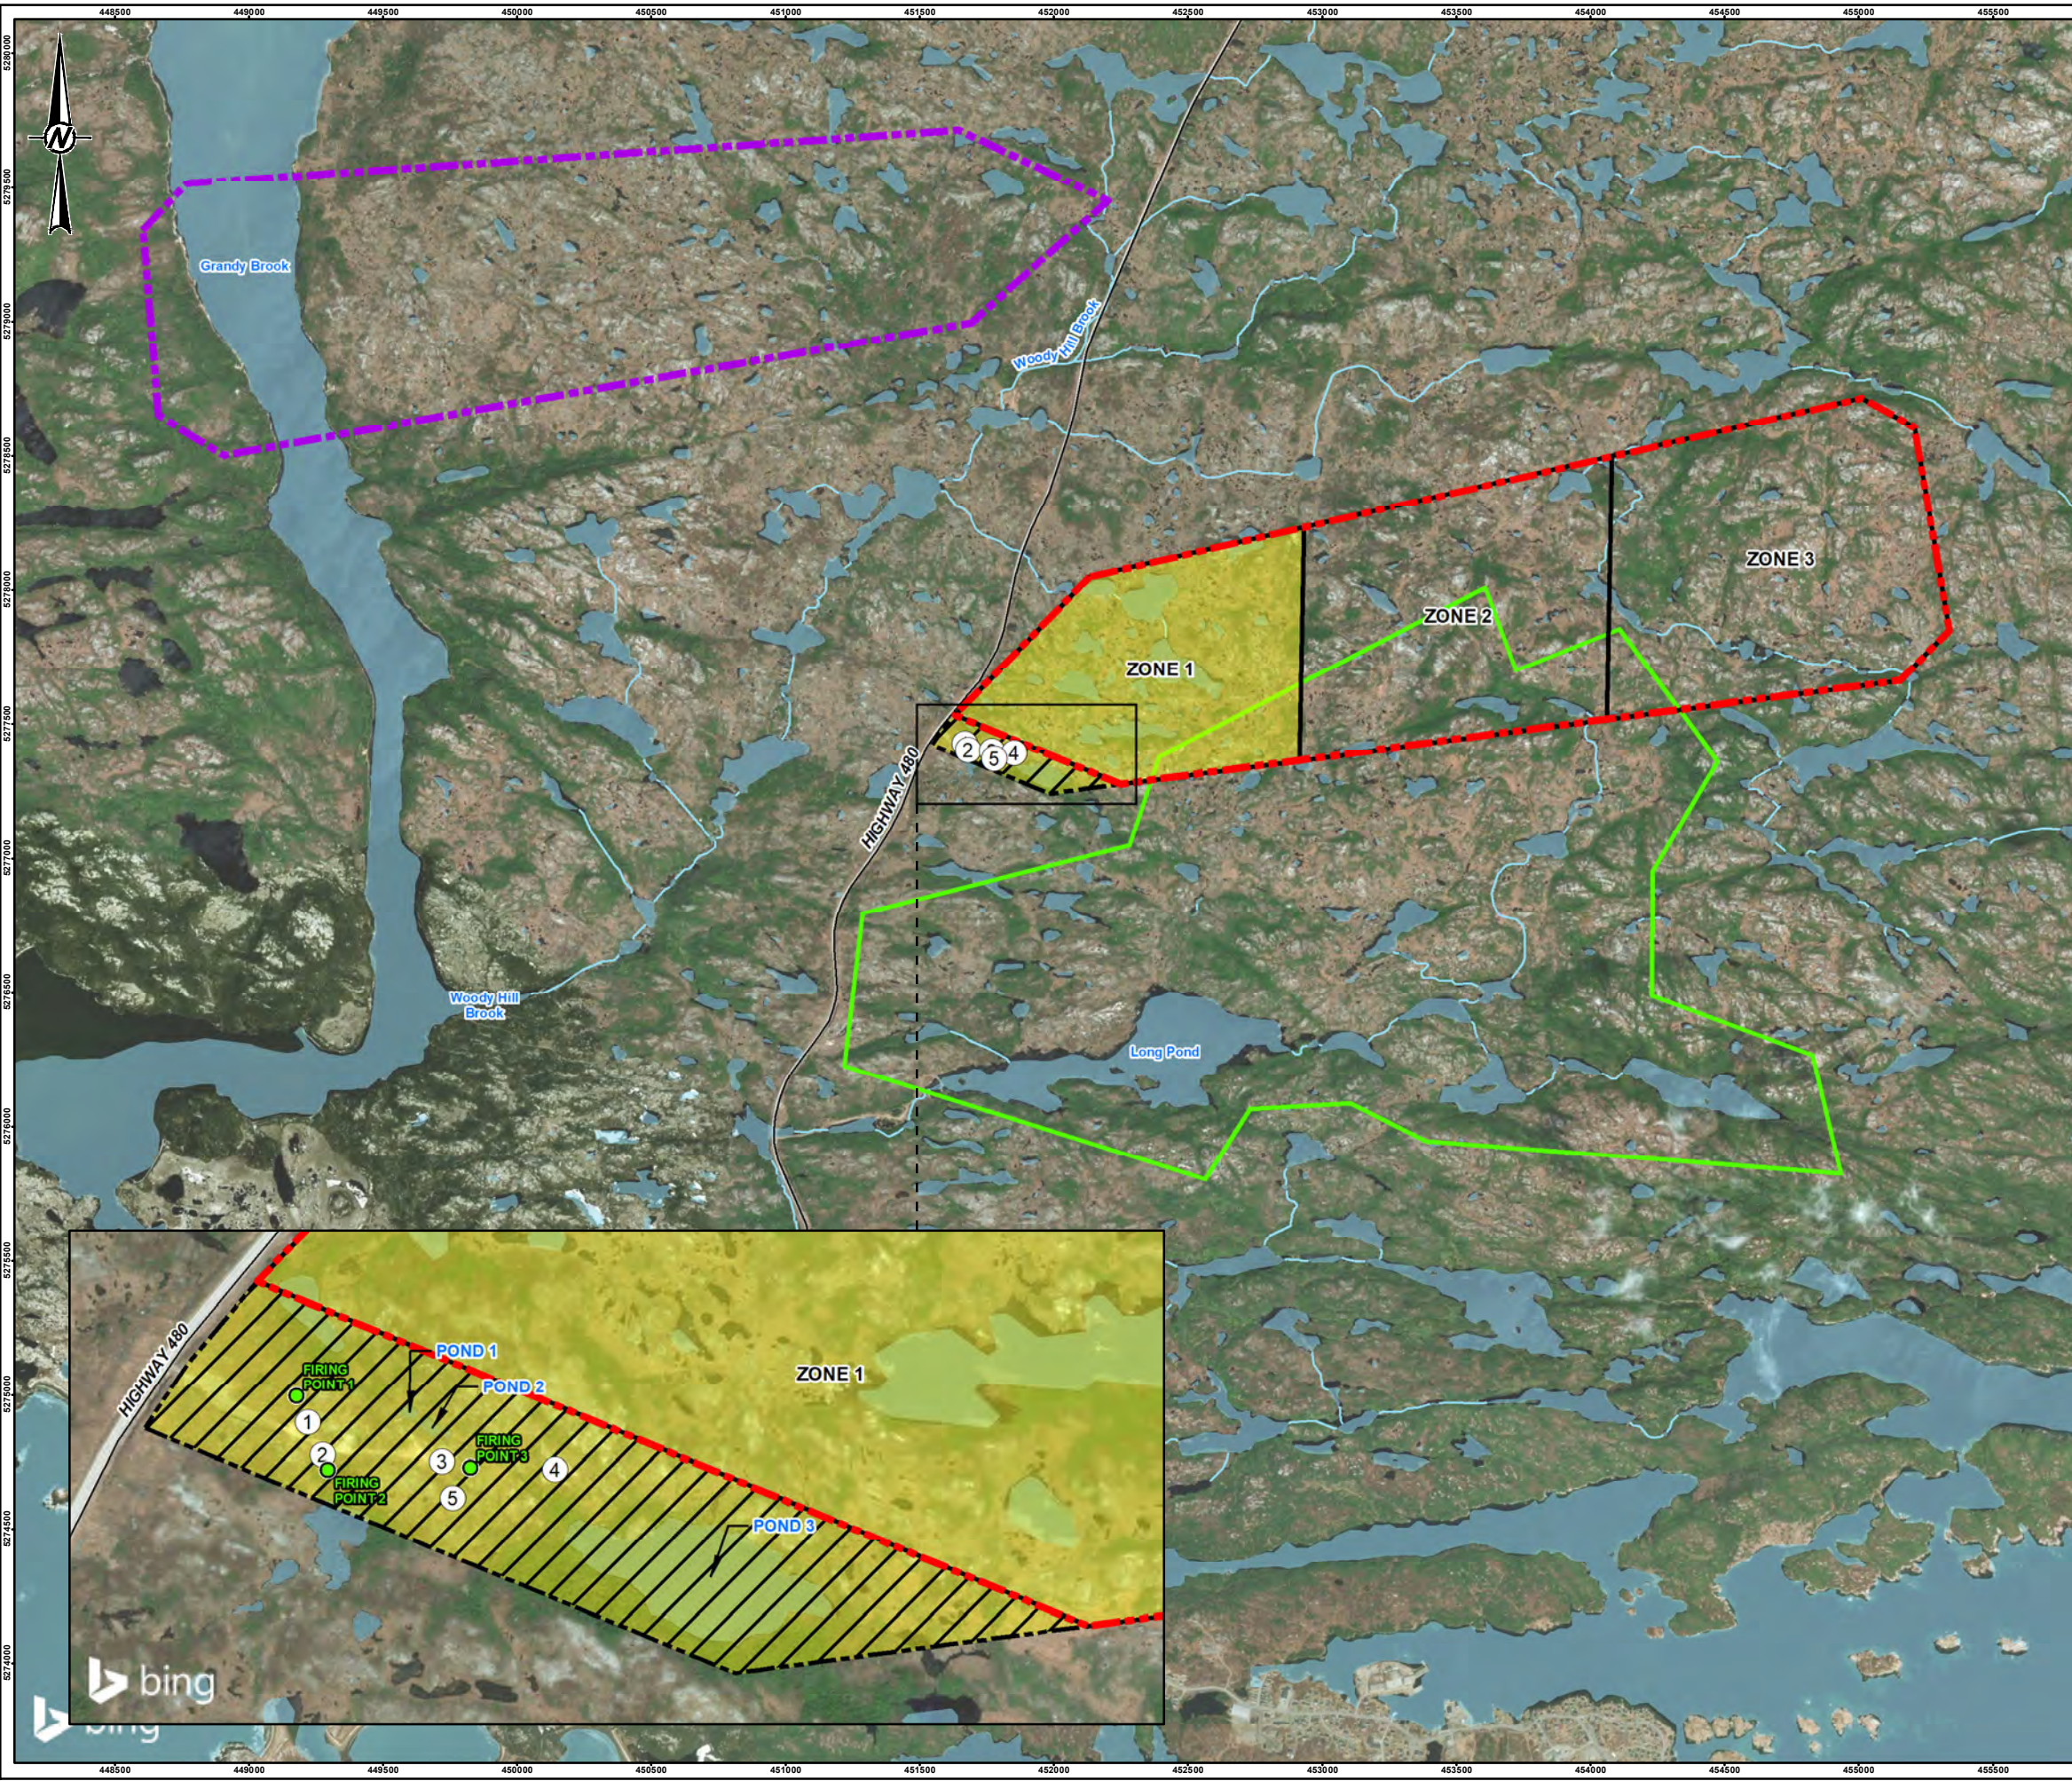
FIGURE 1

Figure 1: Site Plan

The treated surface water must meet the NL DWQ and HC GCDWQ, prior to discharge back to an adjacent surface water body. Pond 3, located on Figure 1, would be an acceptable receiving water body. It is noted that only the chemical, health-based guidelines are required to be met for discharge. This includes a guideline of 0.005 mg/L of lead.

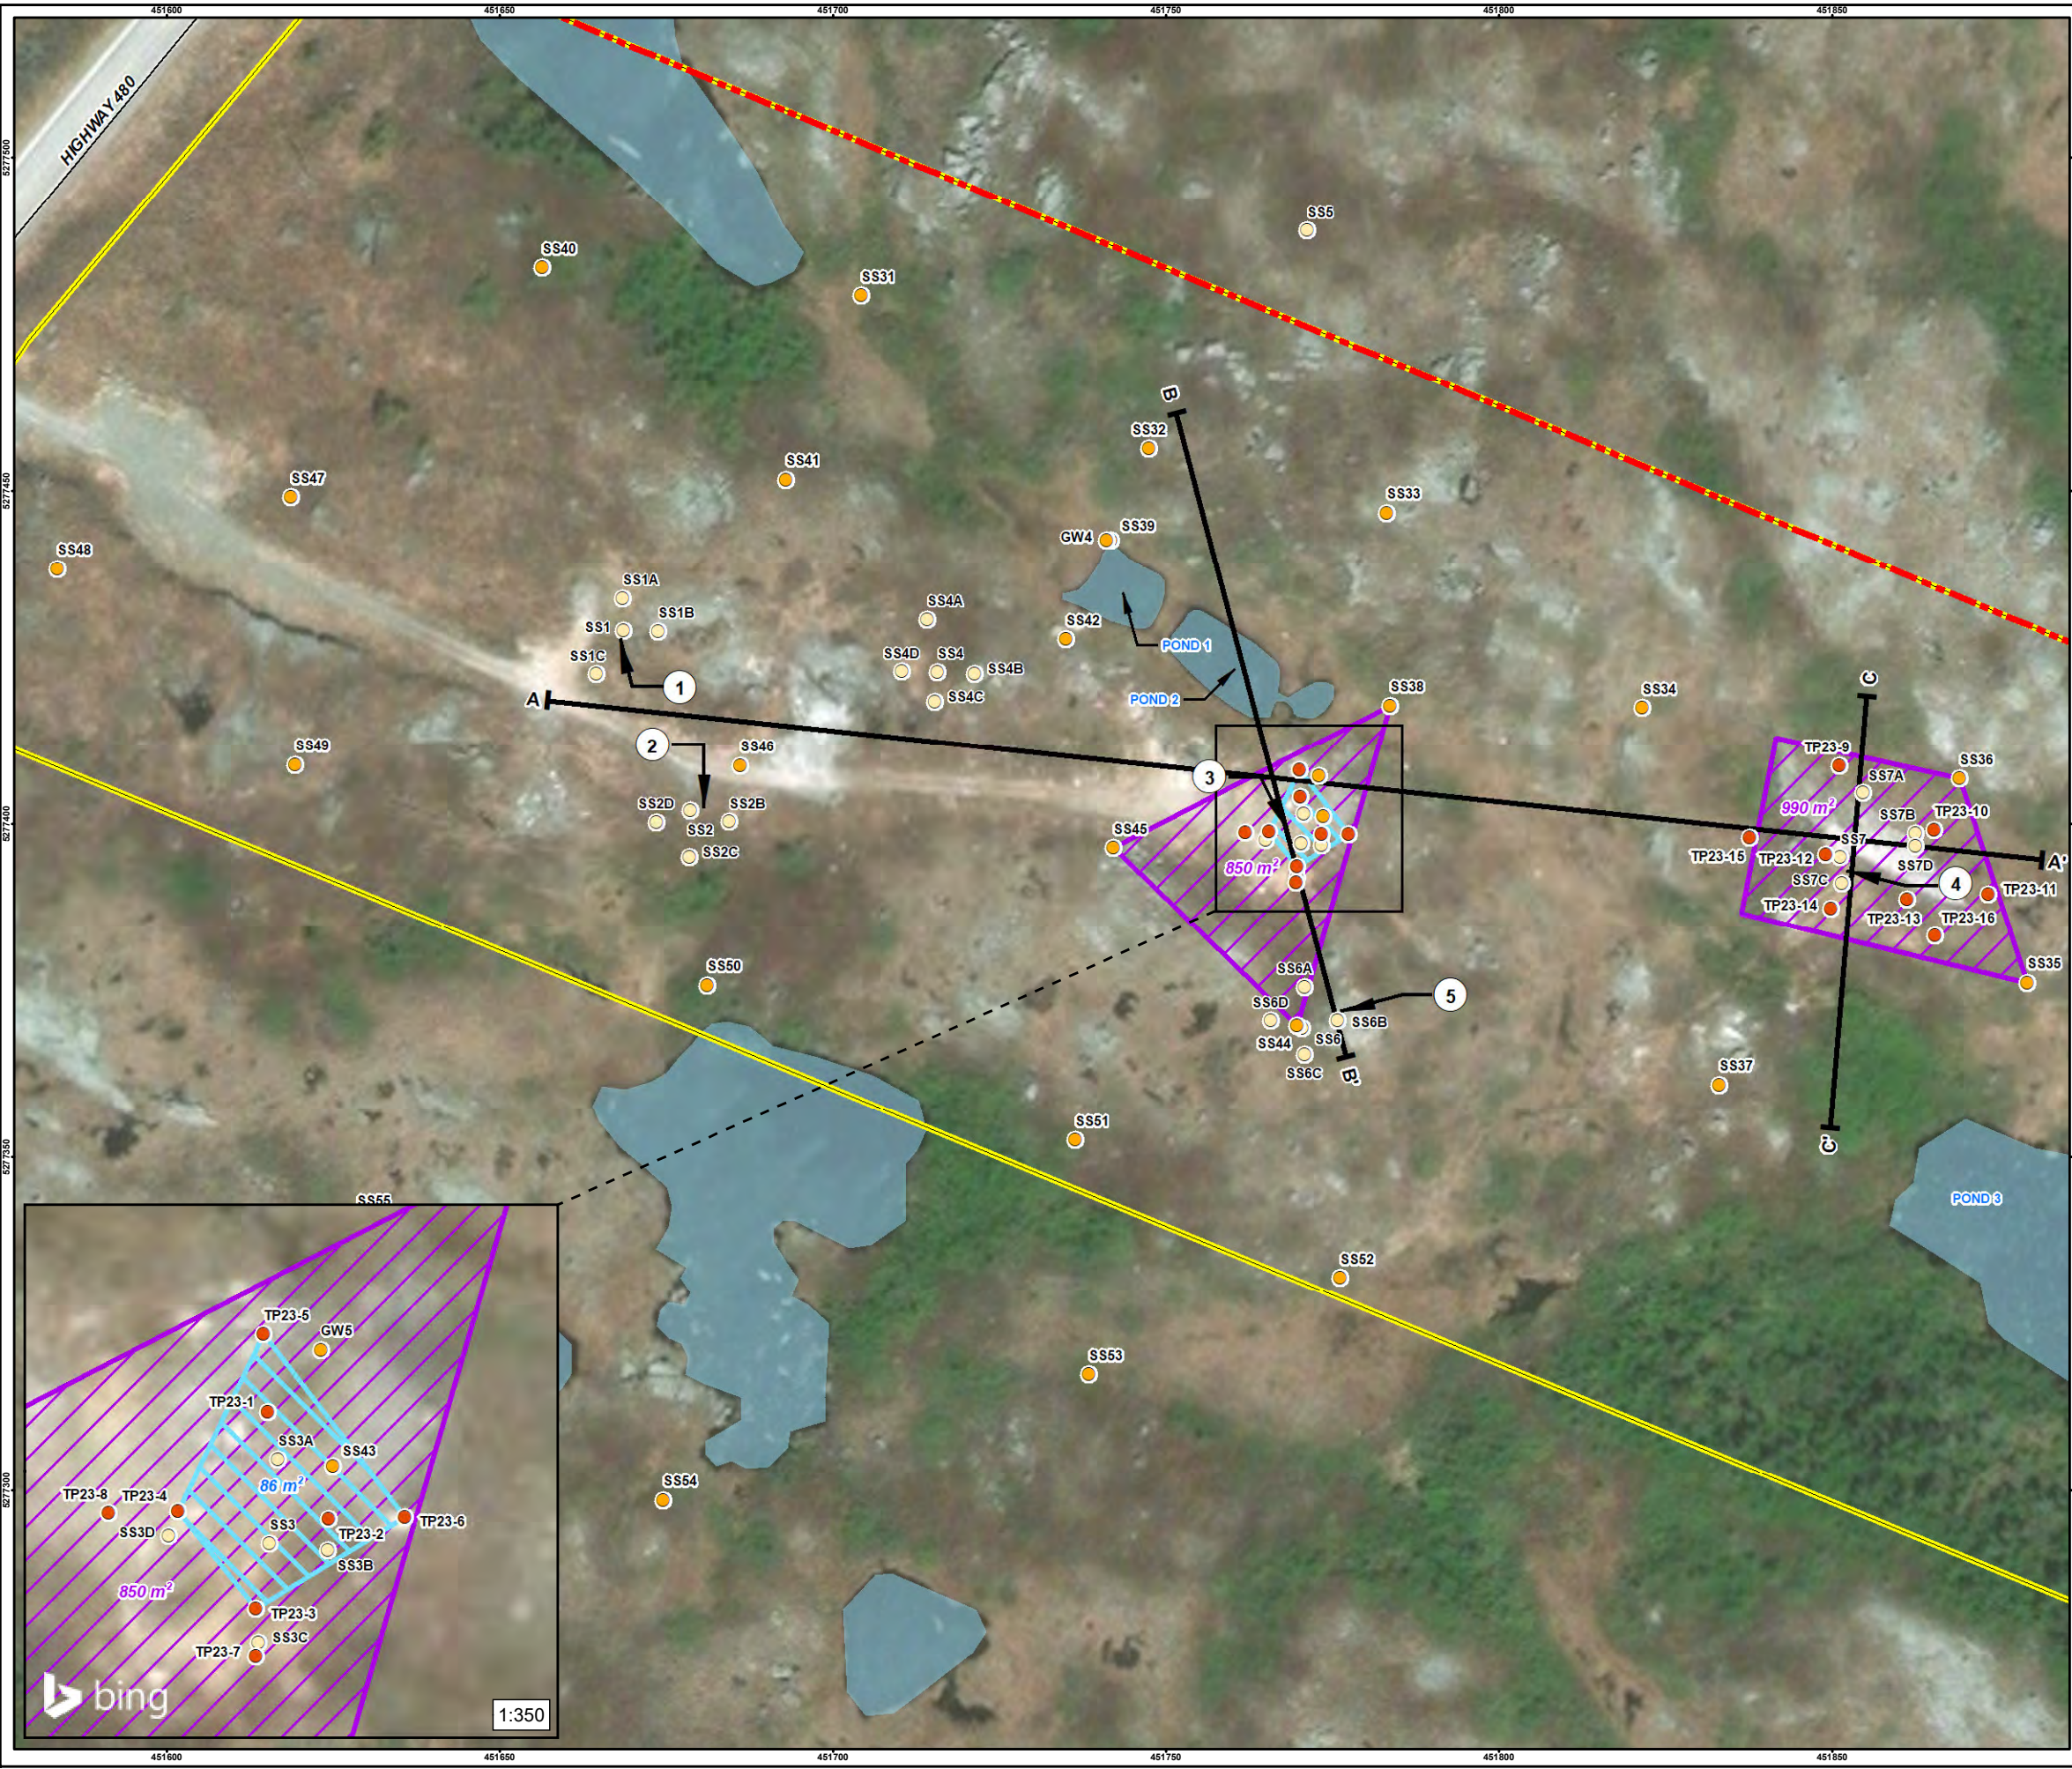
Figure 2: Location 1 – Zone 1 – Firing Area – Delineation of Contaminated Soil

The horizontal extent of impacted soil to be removed can be found on Figure 2. Cross-sections (with estimated depth) of impacted soil to be removed can be found on Figures 3A and 3B. Approximately 680 m<sup>3</sup> of impacted soil is to be removed.

Contaminated soil excavated from the area shown in blue on Figures 2, 3A, and 3B must be treated as hazardous waste due to leachable lead, as discussed in Section 3.0. This soil should be disposed of at a licenced hazardous waste treatment facility. The estimated volume of hazardous soil is 30 m<sup>3</sup>.

Contaminated soil excavated from the areas shown in purple on Figures 2, 3A, and 3B is not considered to be hazardous waste due to acceptable concentrations of leachable lead and can be disposed of accordingly. The estimated volume of non-hazardous contaminated soil is 650 m<sup>3</sup>.

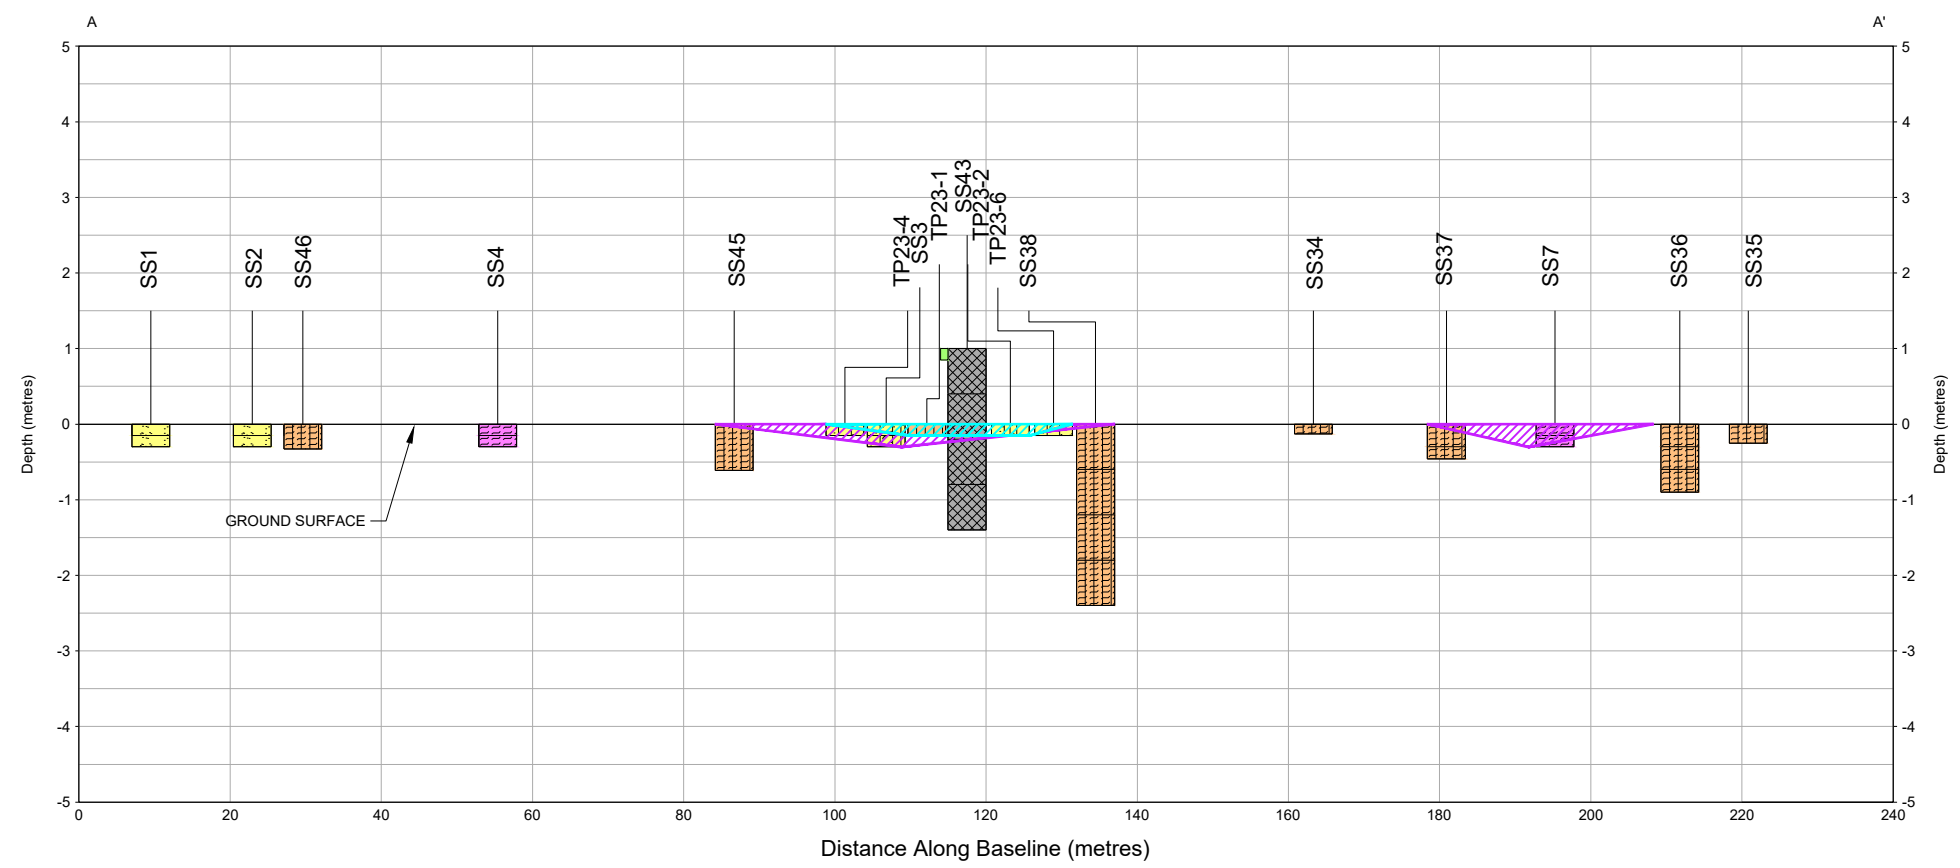
Figure 3A: Cross section A-A’

EXTENT OF NON-HAZARDOUS SOIL IMPACTS

EXTENT OF HAZARDOUS SOIL IMPACTS

Based on the above results, the total area of hazardous material on site is 86 m<sup>2</sup>; the area of non-hazardous material is 1,840 m<sup>2</sup>. Based on the depth of observed impacts (Figures 3a and 3b), the estimated volume of hazardous soil is 30 m<sup>3</sup>, and volume of non-hazardous soil is 650 m<sup>3</sup>. The volume of hazardous material was calculated conservatively, in accordance with previous reports. No leachable metals samples were collected beyond 0.15 mbgs depth, but it is assumed that impacts extend to the depth of bedrock previously observed in this area. The exact volume of hazardous material should be confirmed in the field during the remediation program.

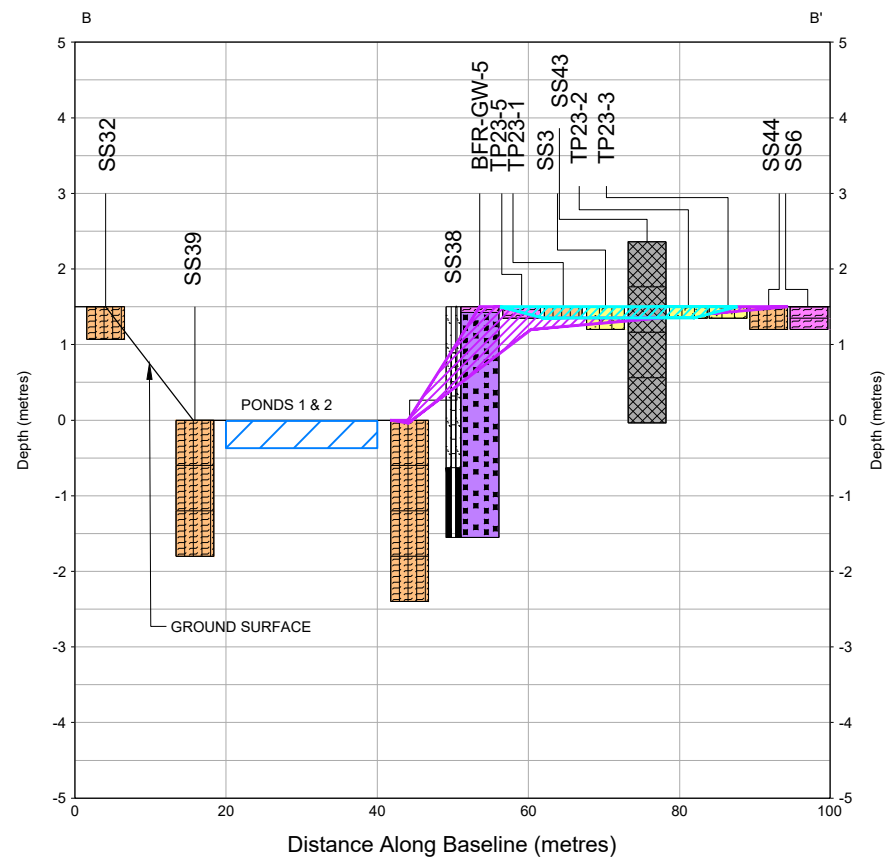
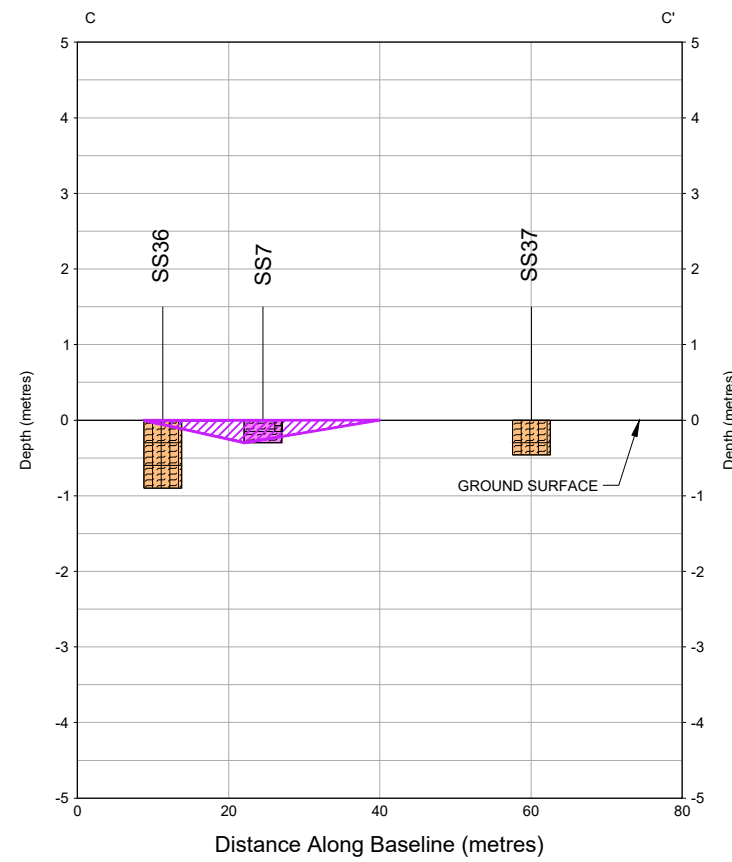
Figure 3B: Cross Section B’B’ and C-C’

- LEGEND**
- DIORITE
  - SAND
  - SILTY SAND
  - ORGANIC SILT
  - TOPSOIL
  - FILL
  - EXTENT OF NON-HAZARDOUS SOIL IMPACTS
  - EXTENT OF HAZARDOUS SOIL IMPACTS

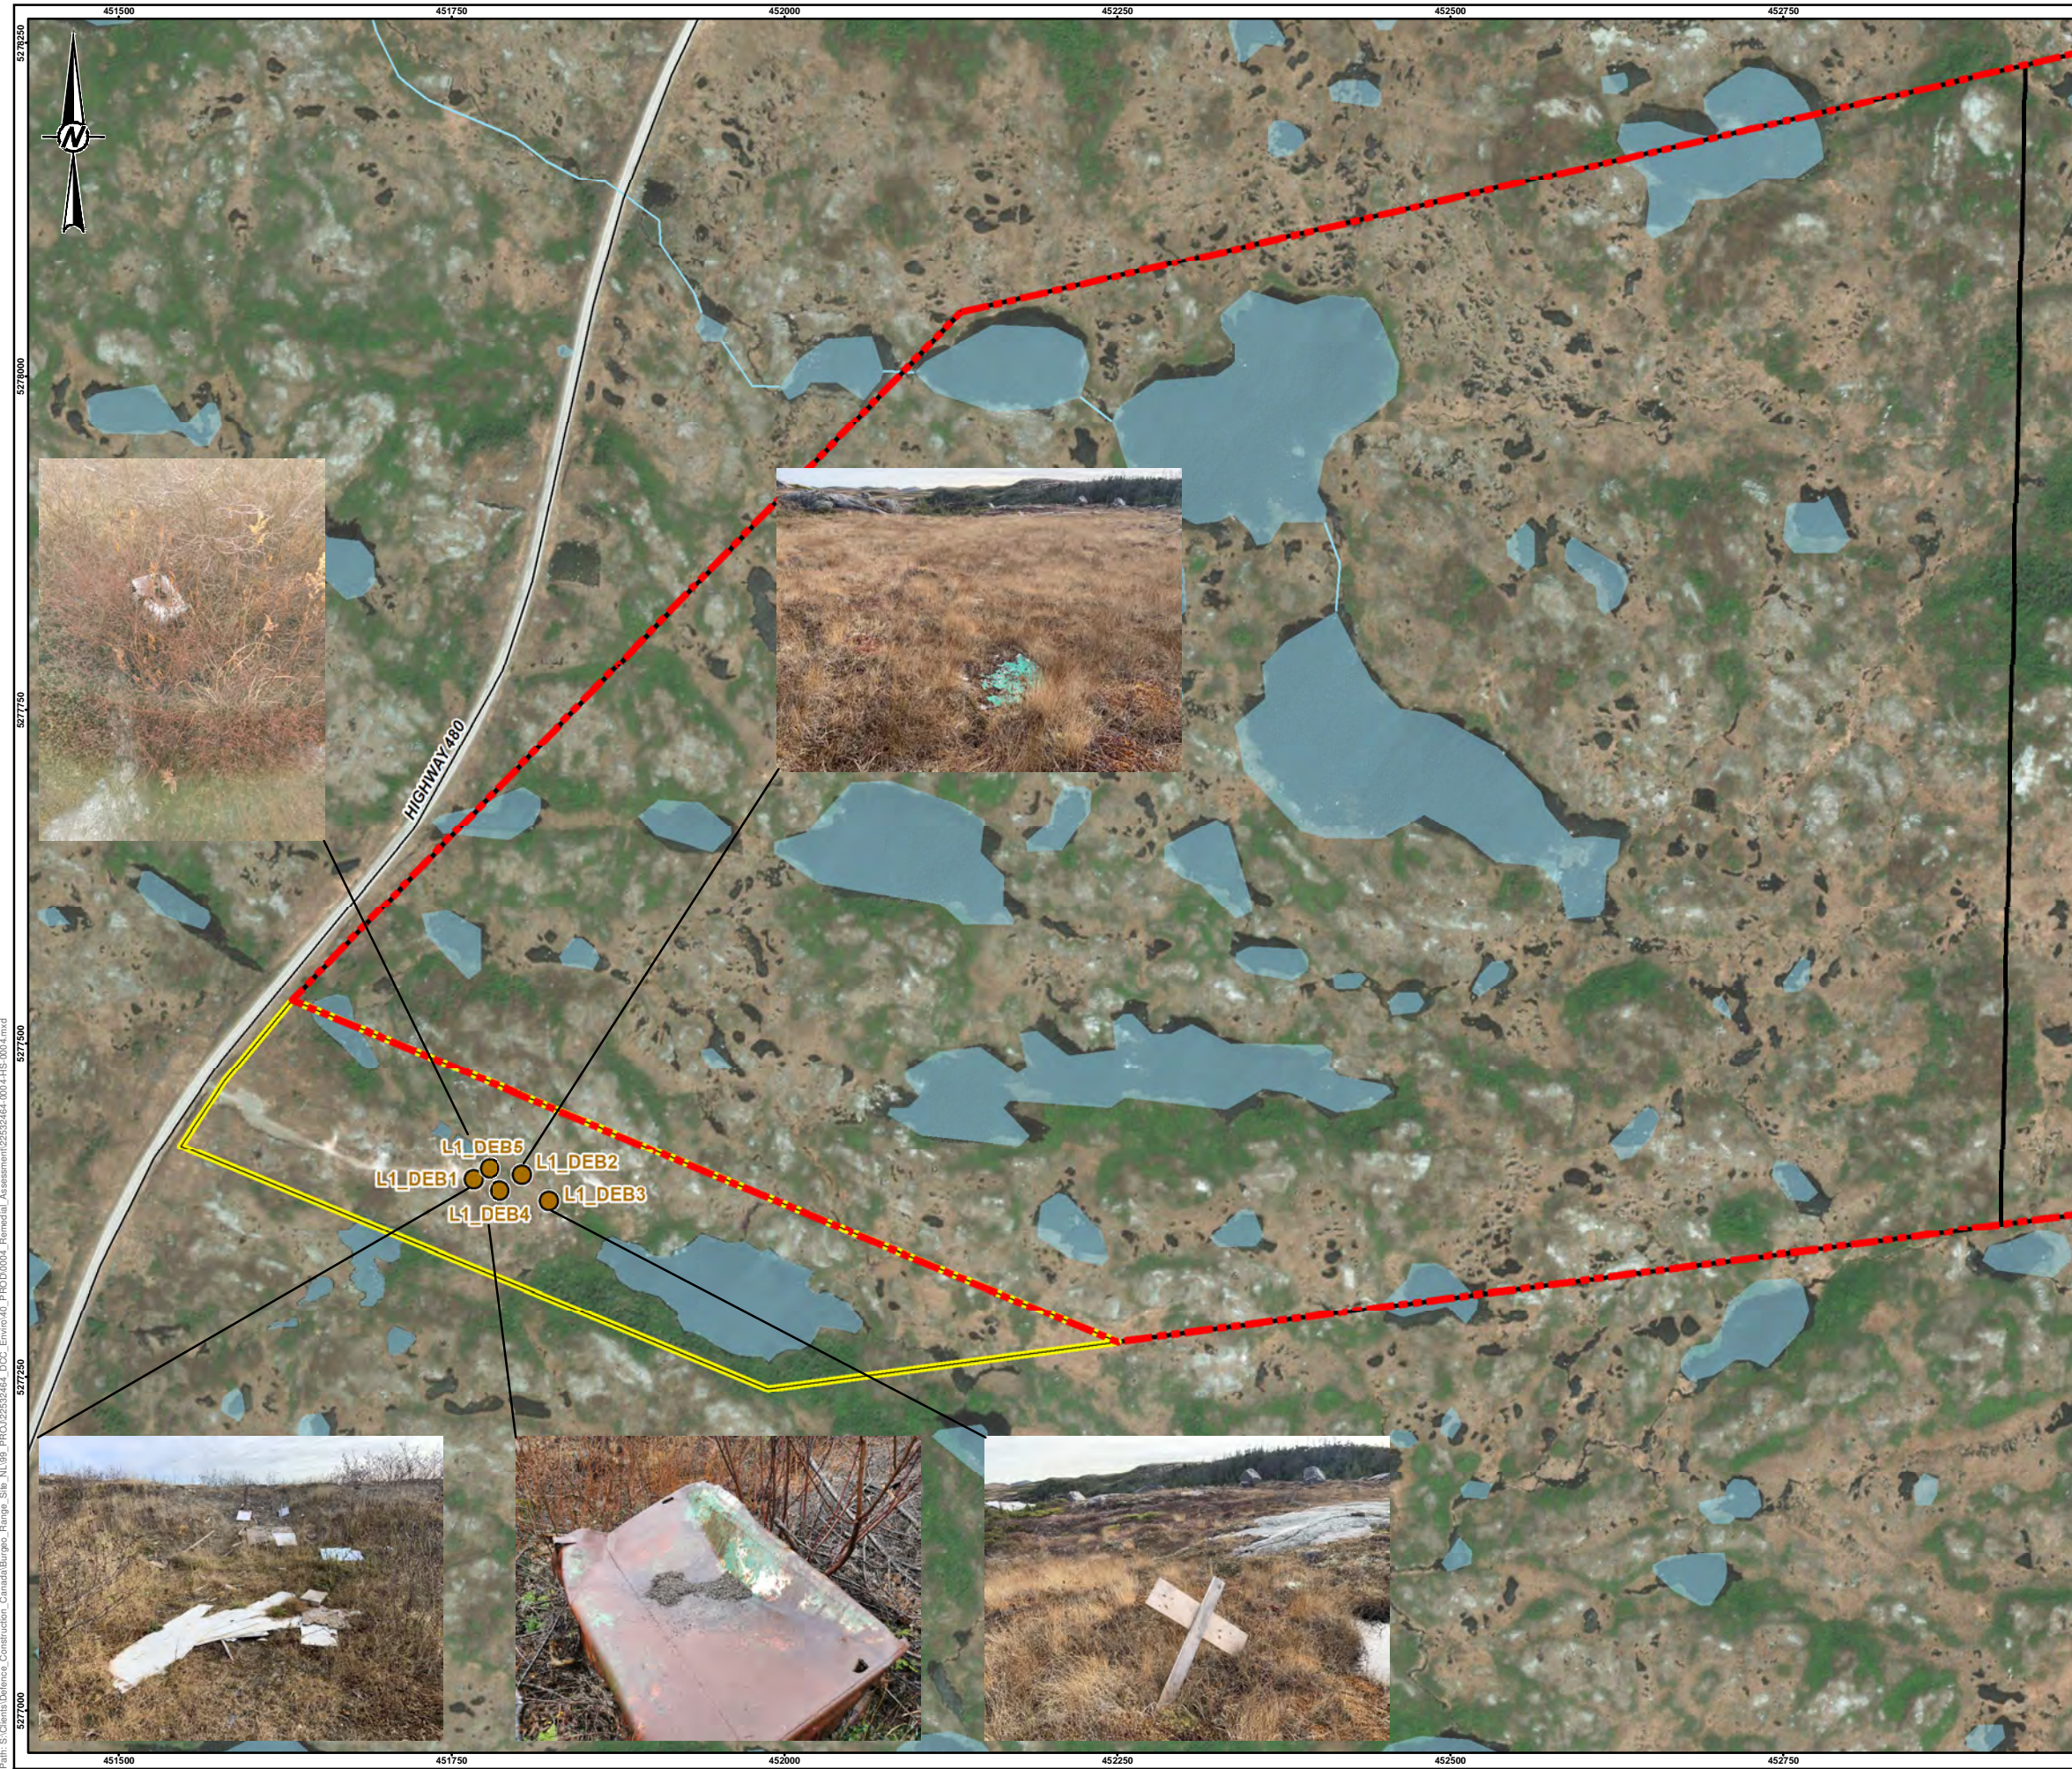
PROJECT NO. 22532464 CONTROL 0004 REV. 0 FIGURE 4

Figure 4: Location 1 – Debris Locations

Debris ID	Description	Approximate Quantity
L1_DEB_1	General refuse found at firing backstop. Includes household waste, targets, spent shotgun shells, spent rifle cartridges, and spent ammunition.	~1m <sup>3</sup>
L1_DEB_2	Plastic target behind backstop. Includes spent shotgun shells.	~1m <sup>3</sup>
L1_DEB_3	Wooden stakes and cardboard target.	~1m <sup>3</sup>
L1_DEB_4	Rusted tank used as target. Includes spent ammunition, spent rifle cartridges and spent ammunition.	~1m <sup>3</sup>
L1_DEB_5	Rusted Kitchen sink used as target. Includes spent ammunition.	<1m <sup>3</sup>

Eighteen debris items were observed as part of the Golder 2022 Report on Steps 5 to 7 of the FACS. No changes to the debris inventory were noted during the WSP 2023 investigation. Debris at Location 1 amounts to approximately 5 m<sup>3</sup> of debris, including, but not limited to general refuse found at firing backstop, consisting of household waste, wooden stakes, cardboard and plastic targets, rusted material used as a target, spent shotgun shells, spent rifle cartridges, and spent ammunition. Debris at Location 2 amounts to approximately 13 m<sup>3</sup> of debris, including, but not limited to wooden stakes and gun stands, cardboard, plastic and wooden (plywood) targets, spent shotgun shells, spent rifle cartridges, and spent ammunition.

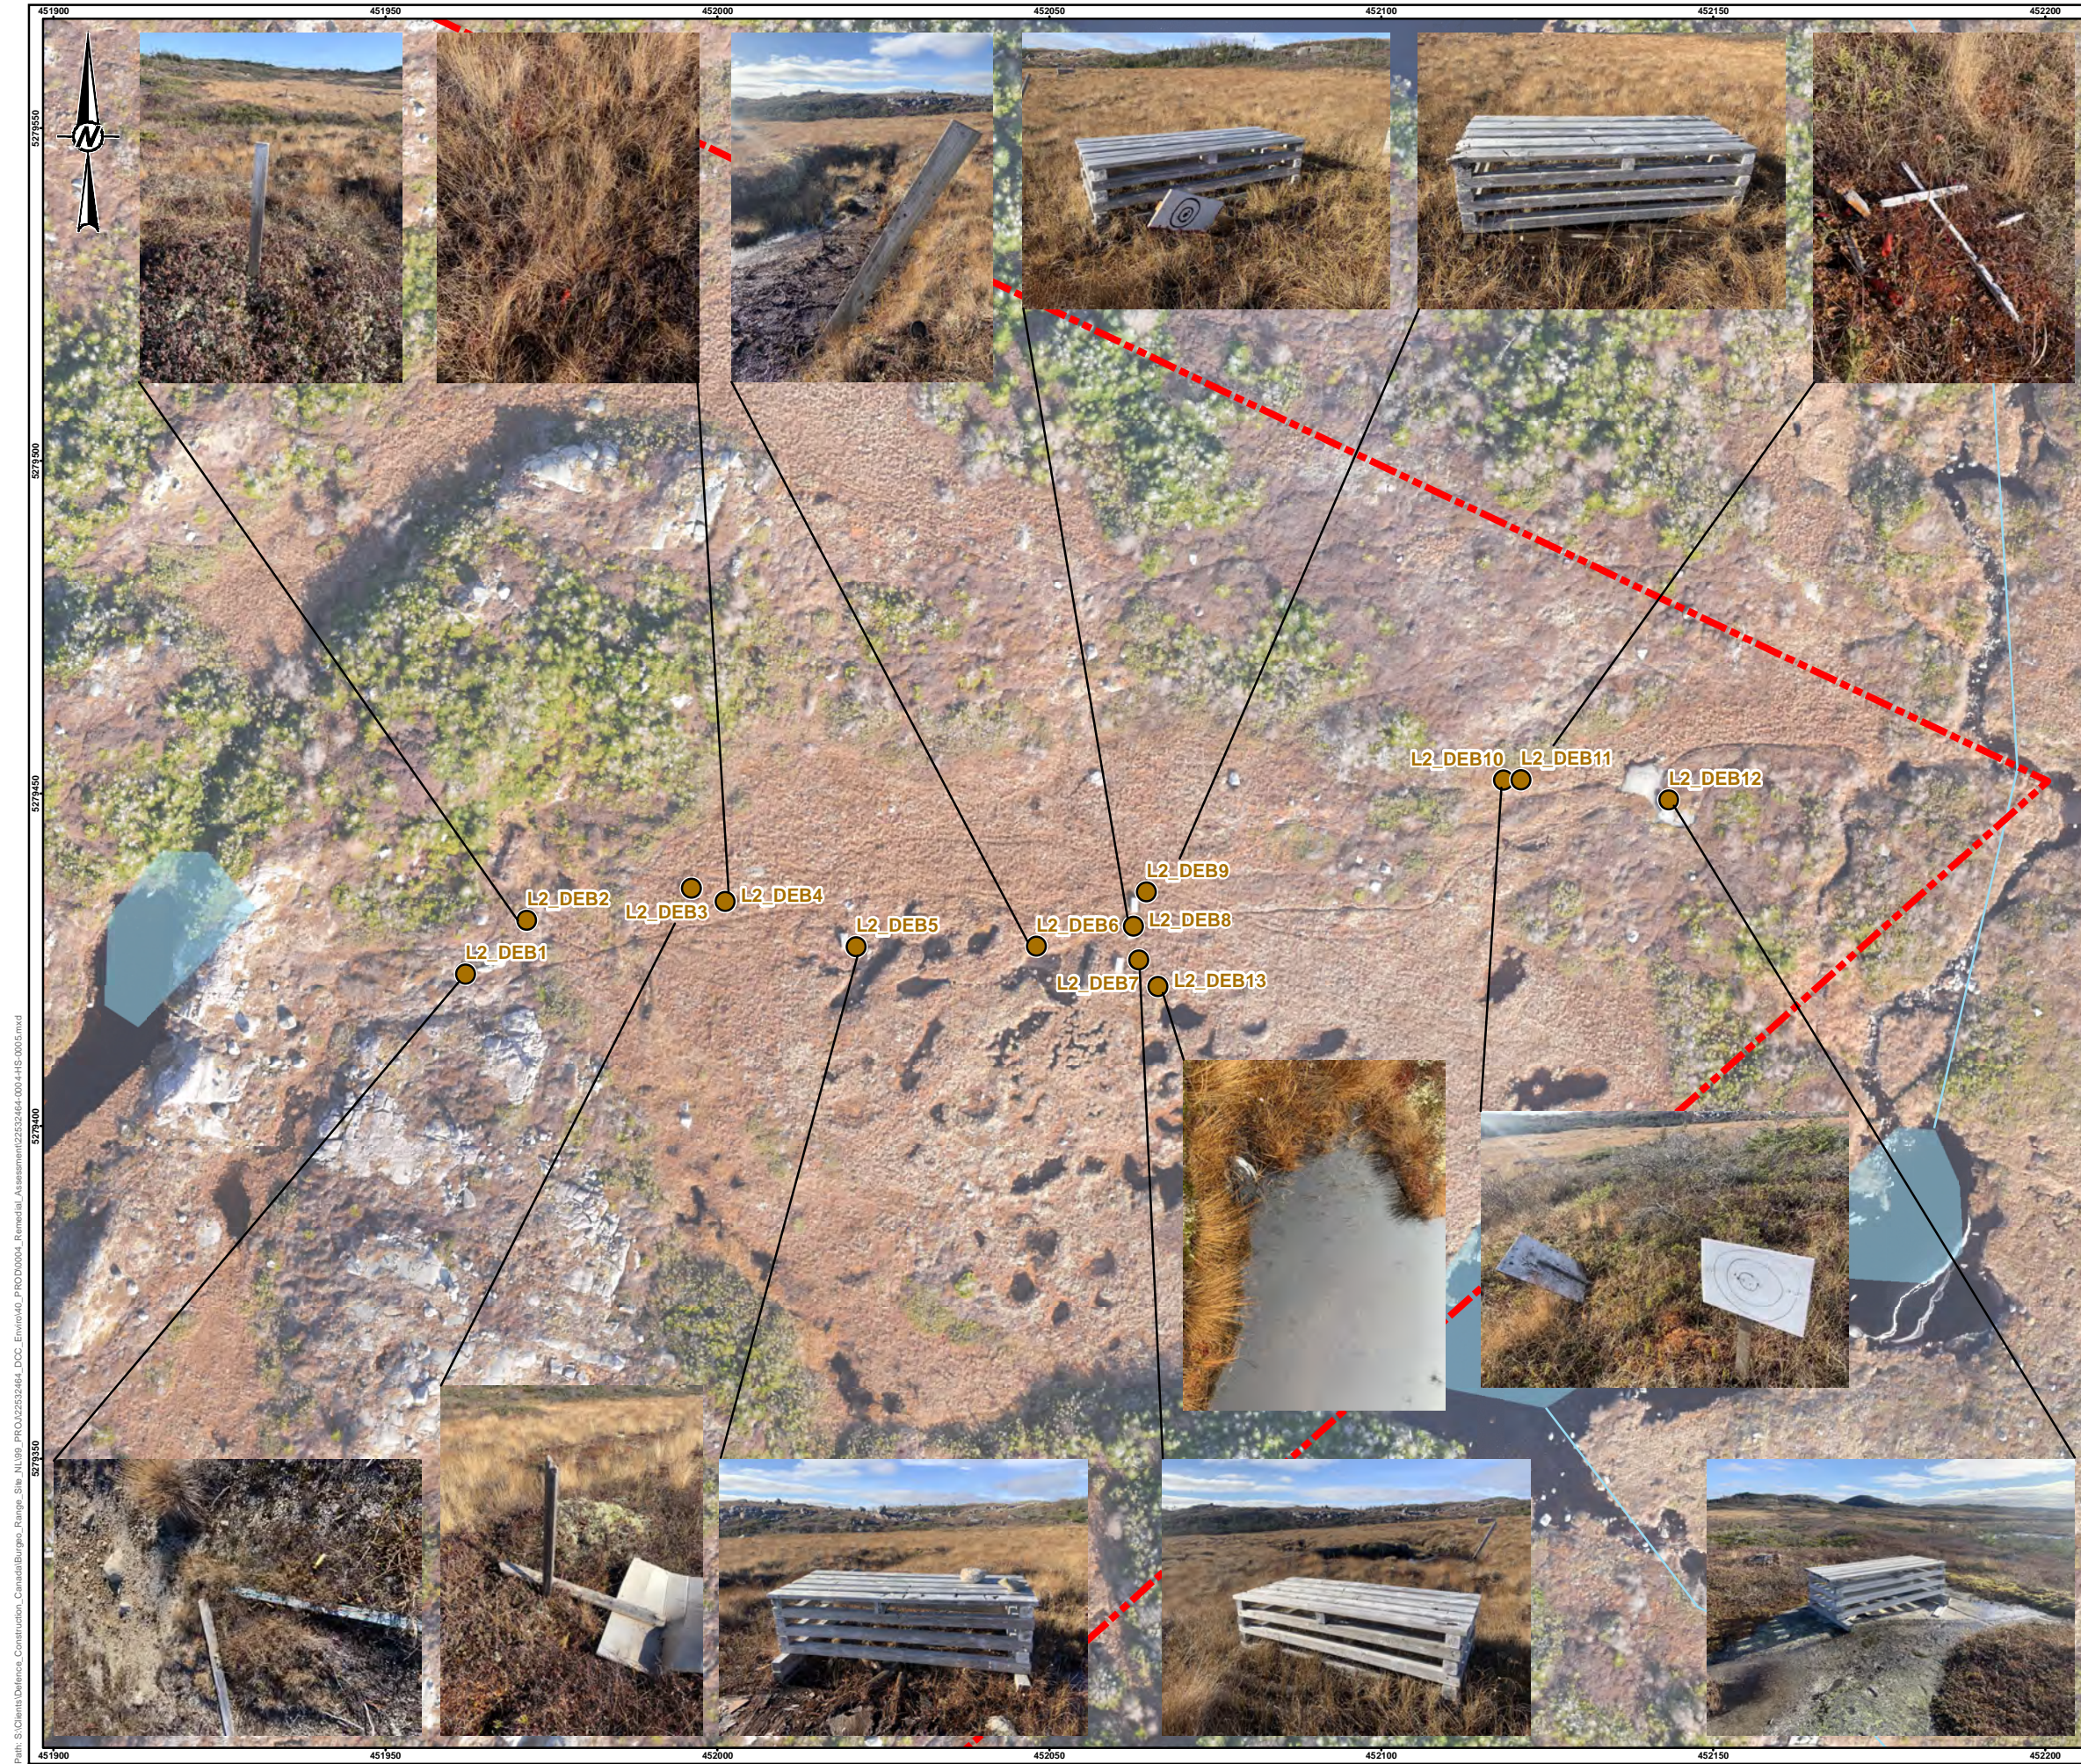
Figure 5: Location 2 – Debris Locations

Debris ID	Description	Approximate Quantity
L2_DEB_1	Wooden stake target and spent ammunition.	<1m <sup>3</sup>
L2_DEB_2	Wooden stakes and spent shotgun shells.	<1m <sup>3</sup>
L2_DEB_3	Wooden stakes and cardboard target.	<1m <sup>3</sup>
L2_DEB_4	Wooden target, spent rifle cartridges and spent ammunition found on pathway towards firing backstop.	<1m <sup>3</sup>
L2_DEB_5	Wooden gun stand, plywood targets and spent rifle cartridges	~1m <sup>3</sup>
L2_DEB_6	Wooden plank target	<1m <sup>3</sup>
L2_DEB_7	Wooden gun stand, plywood targets and spent rifle cartridges	~1m <sup>3</sup>
L2_DEB_8	Wooden gun stand, composite target, spent rifle cartridges and spent ammunition	~1m <sup>3</sup>
L2_DEB_9	Wooden gun stand, plywood targets and spent rifle cartridges	~1m <sup>3</sup>
L2_DEB_10	Wooden stakes with plastic targets and spent ammunition	<1m <sup>3</sup>
L2_DEB_11	Wooden stakes and spent shotgun shells.	<1m <sup>3</sup>
