Appendix D

Western Hillside Fish and Fish Habitat Survey

SEM Report Western Hillside – Aquatic Habitat Assessment

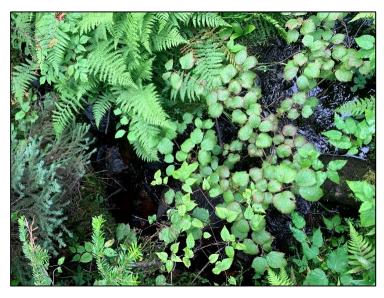
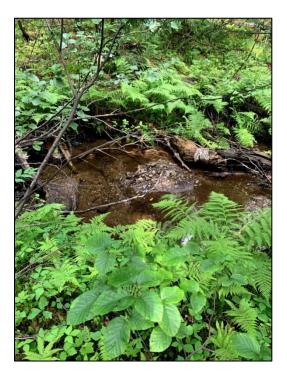
Figure 6 Representative Stream Habitat of S2. Hillside Stream

Stream 2 (S2) velocity was, on average, 0.02 m/s with an average depth of 8 cm and width of 0.5 m. The stream consisted of riffle (80%) and run/pool (20%) meso-habitat types. Substrates in S2 consisted of approximately 30% boulders / rubble / cobble and 70% fines (gravel/sand and muck). Canopy and instream cover accounted for approximately 20% coverage, while overhanging vegetation consisted of 50%. No fish were observed during the stream habitat assessment of S2. IOC's tailings beach was noted to have encroached upon the stream near the outflow location.

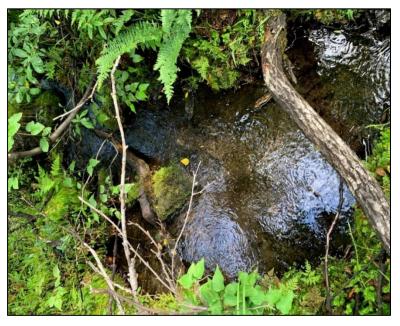
Figure 8 Representative Habitat of Spring 1 (Sp1).

Sp1 is a small stream originating from a spring. Sp1 velocity was on average 0.08 m/s with and average depth and width of 6 cm and 0.25 m, respectively. The stream consisted of 85% riffle and run with the remaining 15% being pool and steady meso-habitat types. Substrates consisted mainly of gravels/sand (50%) with muck/gravel/sand representing 45% and the remaining 5% consisted of rubbles. Most cover types were overhanging alder and fern (70%). The entire reach of Sp1 was found to be 88 m. Some spot

electrofishing was conducted in S1 and no fish were observed or captured from the efforts.

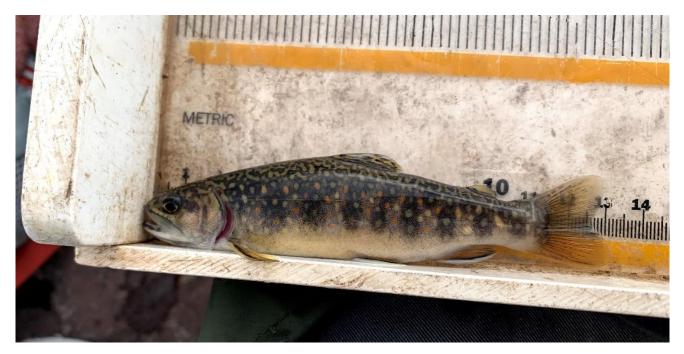
Figure 9 Brook Trout Captured from Hillside Stream August 10, 2021.

Hillside stream was the only stream habitat that exhibited fish presence. Spot electrofishing effort spanned approximately 650 m of the length of the stream for a total effort of 756 seconds. Fishing effort on the stream resulted in the capture of four brook trout (*Salvelinus fontinalis*) ranging from 51 mm (young-

of-the-year (YOY)) to 139 mm (1+ age class) (Figure 5). Fish capture efforts were poor due to relatively low flow and shallow water depths. At least an additional ten YOY and five 1+/2+ brook trout were observed during the stream habitat assessment. The presence of multiple age classes suggests a healthy population of brook trout in Hillside Stream with successful recruitment. Completed field electrofishing form and fish data collection form can be found in Appendix C. FP1, FP2, FP3, S1, S2 and Sp1 did not exhibit fish populations.

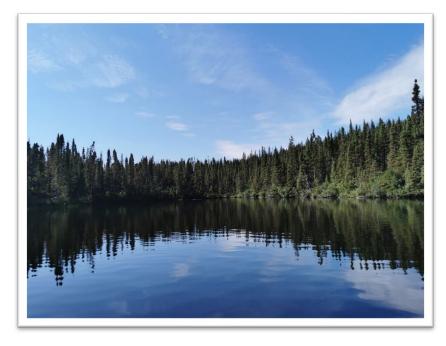
Figure 3.1 Hillside Pond, August 2022.

Hillside Pond is situated approximately 1.3 km northeast of the IOC Mine Engineering Building (MEB). Access to the pond was gained from behind the MEB along decommissioned exploration trails via ATV and trailer to mobilize equipment. The pond sits near the top of the watershed in a south to north orientation draining into Hillside Stream which terminates at Wabush Lake. There is one small inlet to Hillside Pond which occurs along the northwestern shoreline of the pond near the narrowest portion of the pond. The inlet stream is approximately 1.6 km in length and was preliminarily examined by field personnel (200 m upstream from confluence). Field personnel noted the inlet stream is relatively shallow (<10 cm) with intermittent and braided flow. There is small unnamed pond that drains from the top of the watershed into the inlet stream and eventually into Hillside Pond. A spring was also noted along the shoreline of the pond adjacent to the inlet. The pond has multiple water sources including a combination of groundwater, surface water and runoff from the headwaters. The shoreline of Hillside Pond is dominated by boulders and rubble with some sections of sand and muck. The pond is long, narrow with steep slopes (narrow littoral zone) and deep. Along the southern shoreline and near the outflow of the pond emergent and submerged aquatic vegetation were noted. The majority of the surrounding forest species consisted of black spruce (Picea mariana), with riparian vegetation consisting of mainly eastern larch (Larix laricina) and green alder (Alnus viridis) with some other herbs and shrubs interspersed throughout (Canada burnet, leatherleaf and Kalmia spp.) (Figure 3.1).

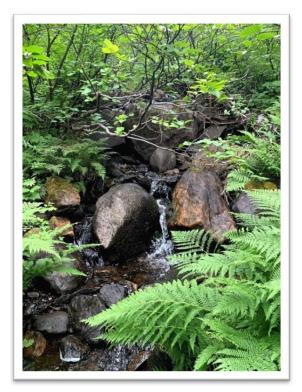
Figure 4.2 Representative Section of Hillside Stream.

The main substrate types were primarily rubble (30.8%), with some boulder (22.5%), cobble (22.5%) and gravel (12.5%). Small amounts of sand, muck/clay and bedrock were also present (7.5, 2.5 and 1.7%, respectively; Table 4.2). Mean overhanging cover was predominant (54.2%) with some instream cover (15.9%), and smaller proportions of canopy cover (12.5%). Some areas of eroding banks were observed in section 3 (10%), while undercut banks were noted in section 5 (10%), Table 4.3.
