**Desktop Environmental
Review, Former U.S. Military
Facility, Hopedale, NL**

File No: 121414998

Final Report

April 29, 2019

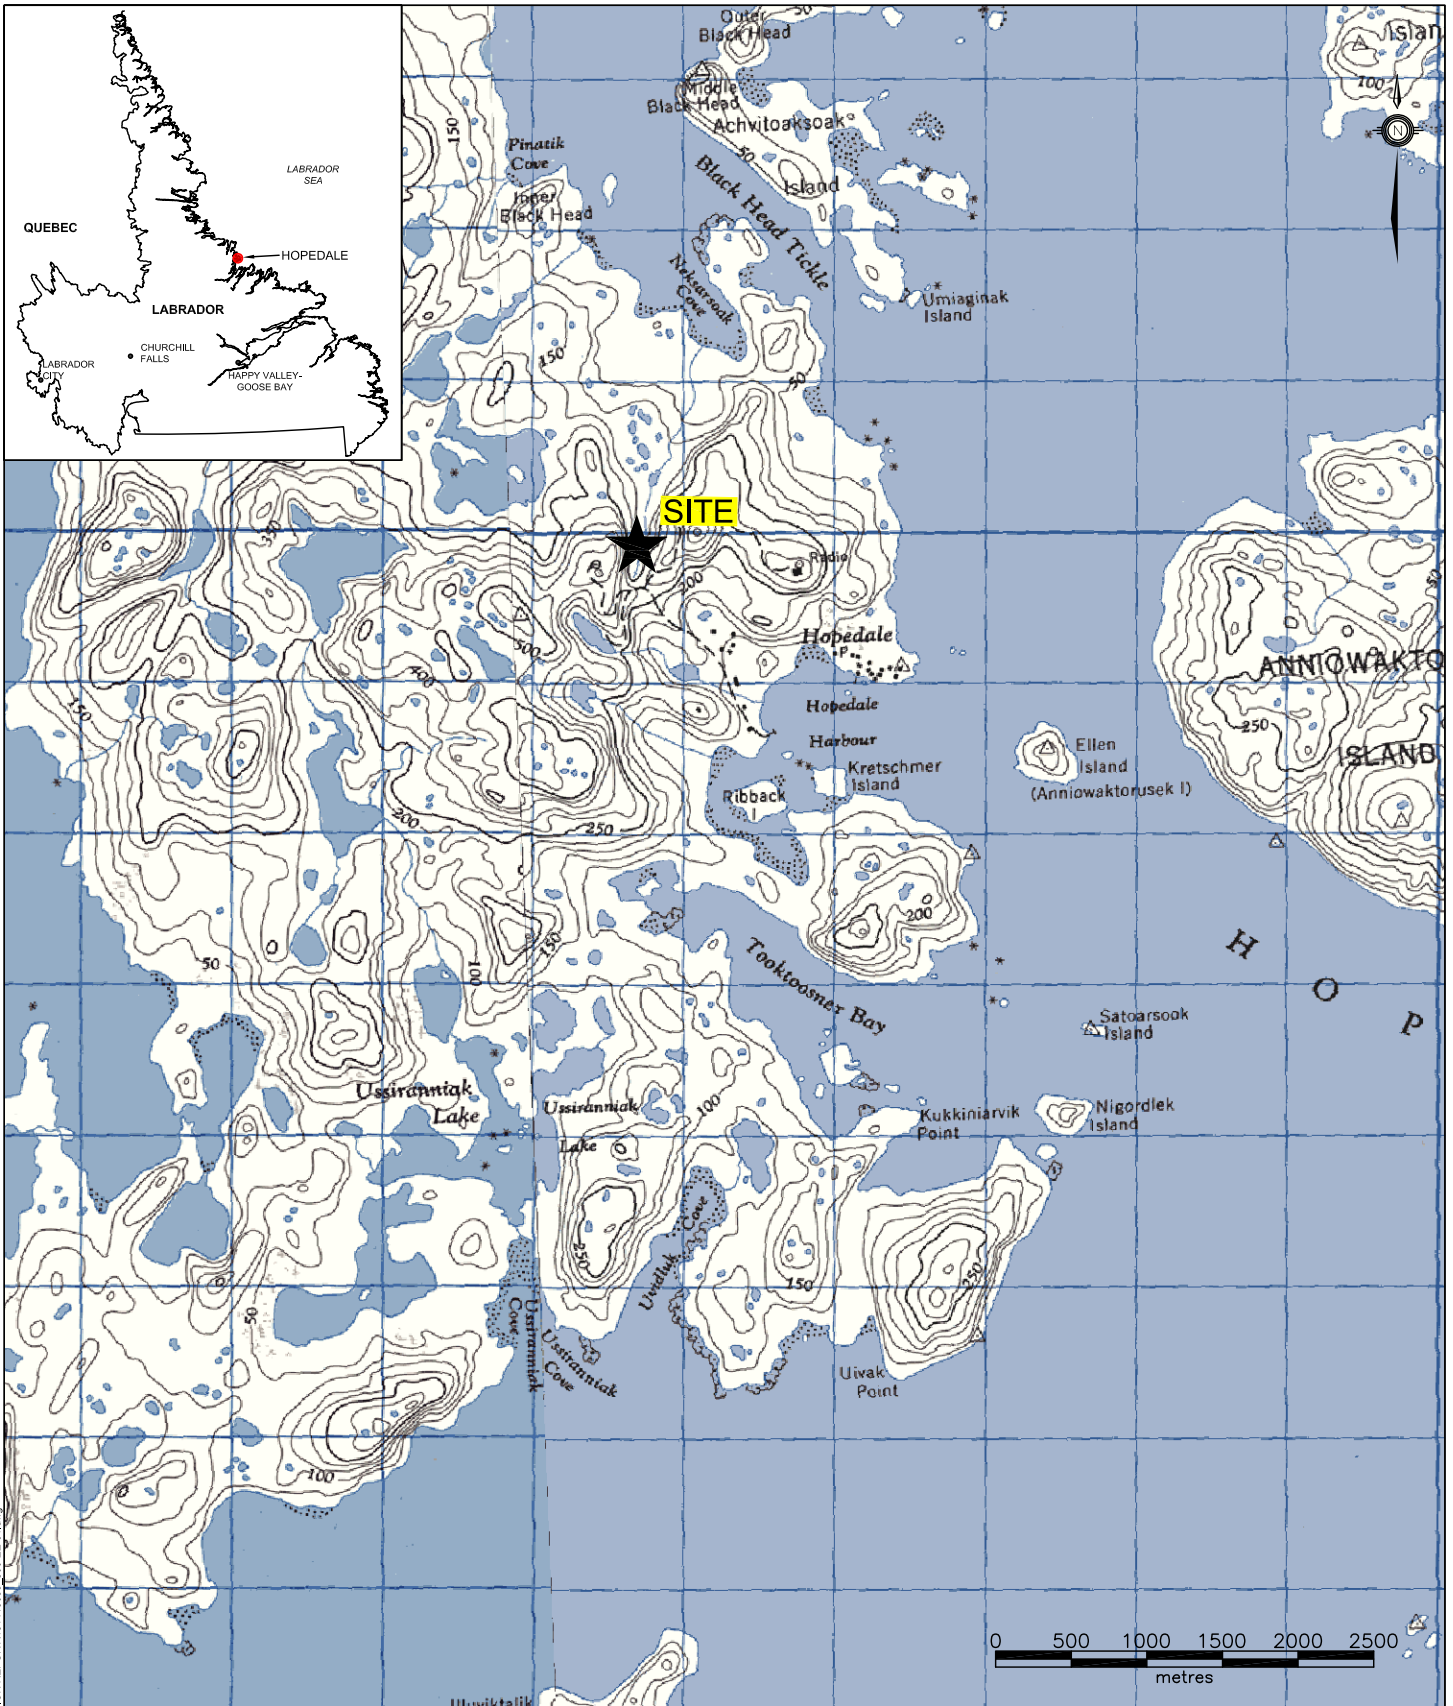
CLIENT:	NEWFOUNDLAND AND LABRADOR DEPARTMENT OF MUNICIPAL AFFAIRS AND ENVIRONMENT		
	SCALE:	DATE:	REV. No.
PROJECT TITLE:	1:50,000	MAR. 15, 2017	0
	IMPLEMENTATION OF REMEDIAL ACTION PLAN - YEAR 6, FORMER U.S. MILITARY SITE, HOPEDALE, NL		
DRAWING TITLE:	DRAWN BY:	EDITED BY:	CHECKED BY:
	N.M.	-	
	DRAWING No:	CAD FILE:	
	121413099-800-EE-01	121413099_800-EE-01.DWG	
DRAWING TITLE:

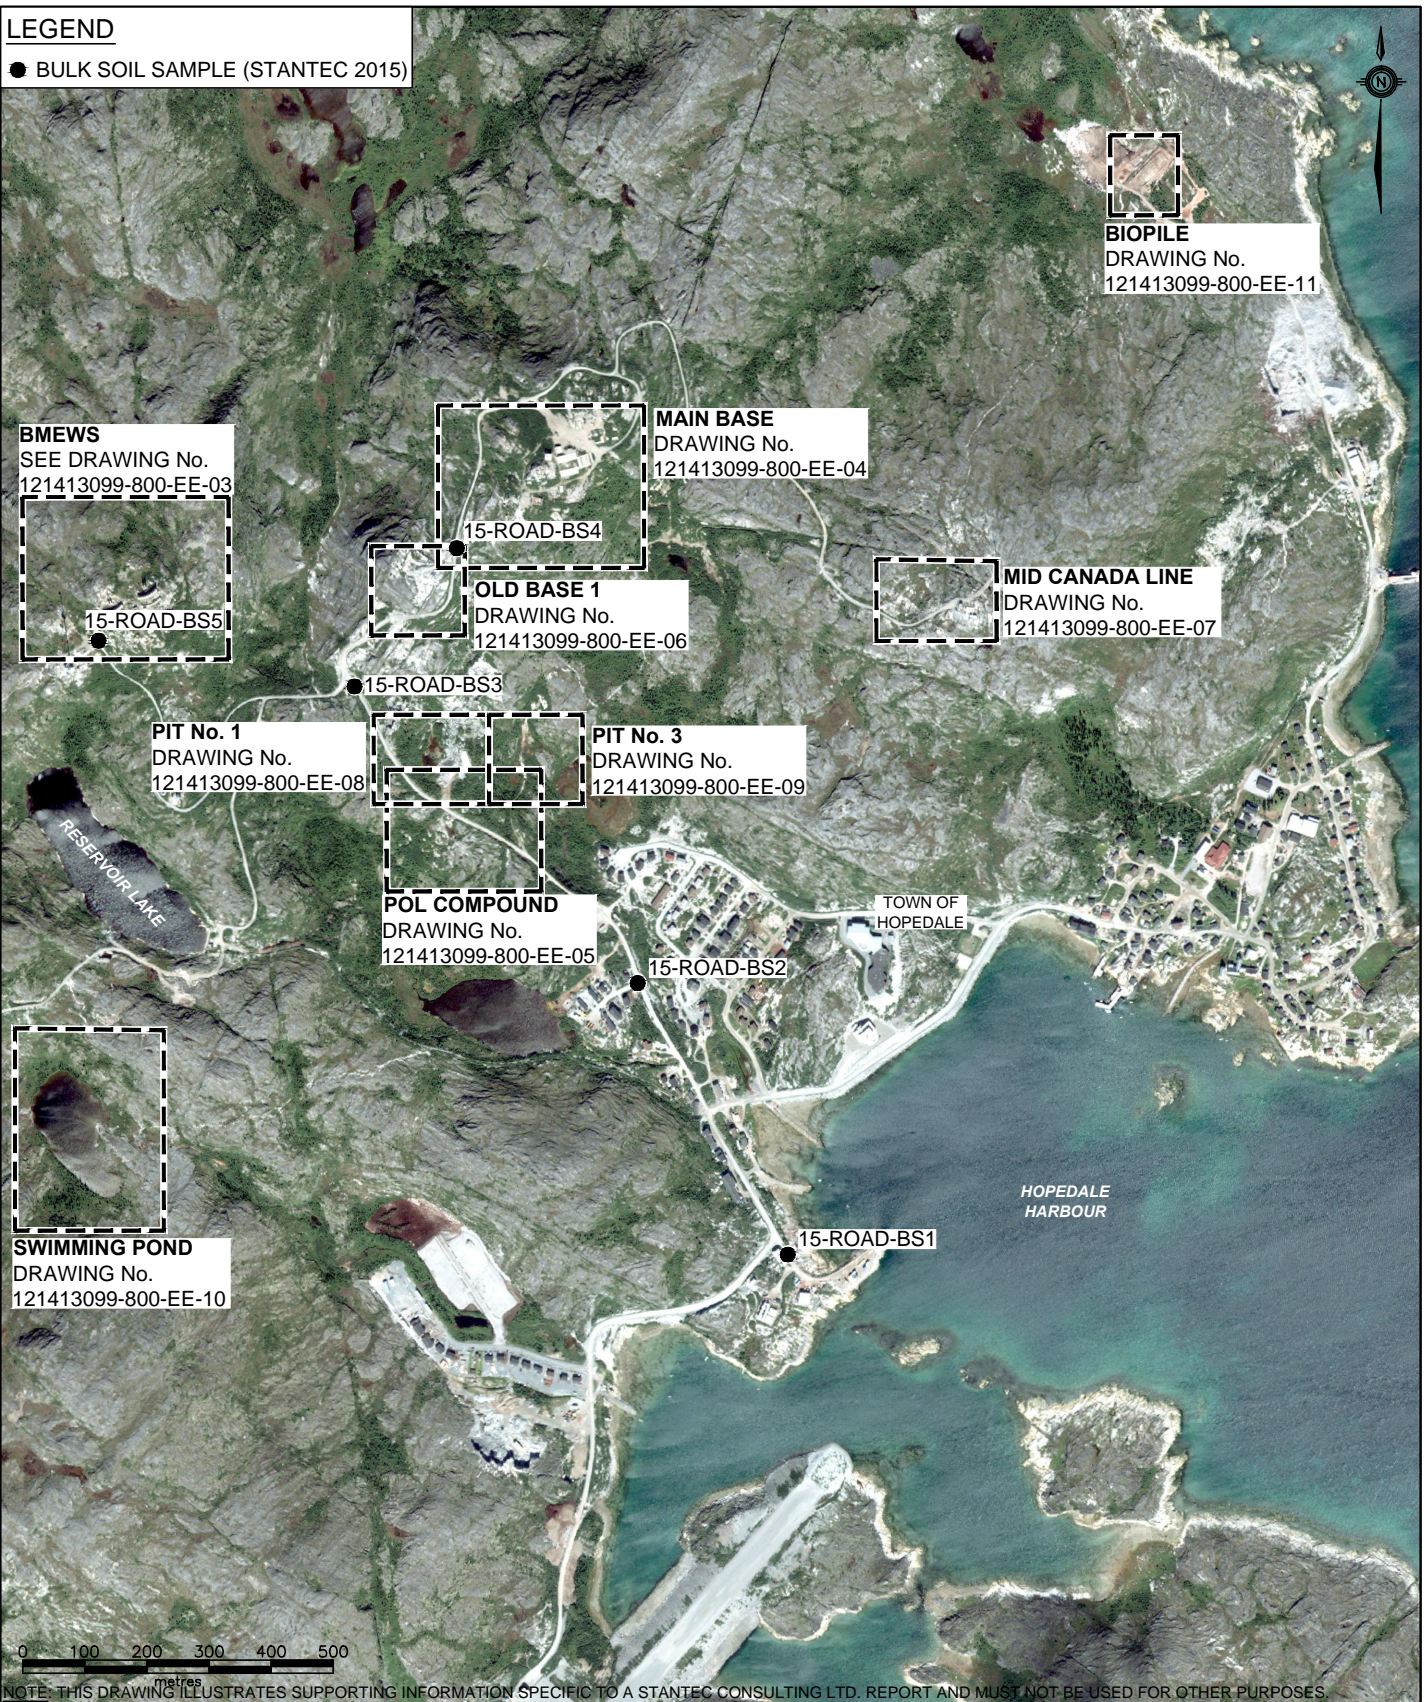
CLIENT: NEWFOUNDLAND AND LABRADOR DEPARTMENT OF MUNICIPAL AFFAIRS AND ENVIRONMENT		SCALE: 1:12,000	DATE: MAR. 15, 2017	REV. No. 0
PROJECT TITLE: IMPLEMENTATION OF REMEDIAL ACTION PLAN - YEAR 6, FORMER U.S. MILITARY SITE, HOPEDALE, NL		DRAWN BY: N.M.	EDITED BY: -	CHECKED BY: P.B.
DRAWING TITLE: SITE PLAN		DRAWING No. 121413099-800-EE-02	CAD FILE: 121413099_800-EE-02.DWG

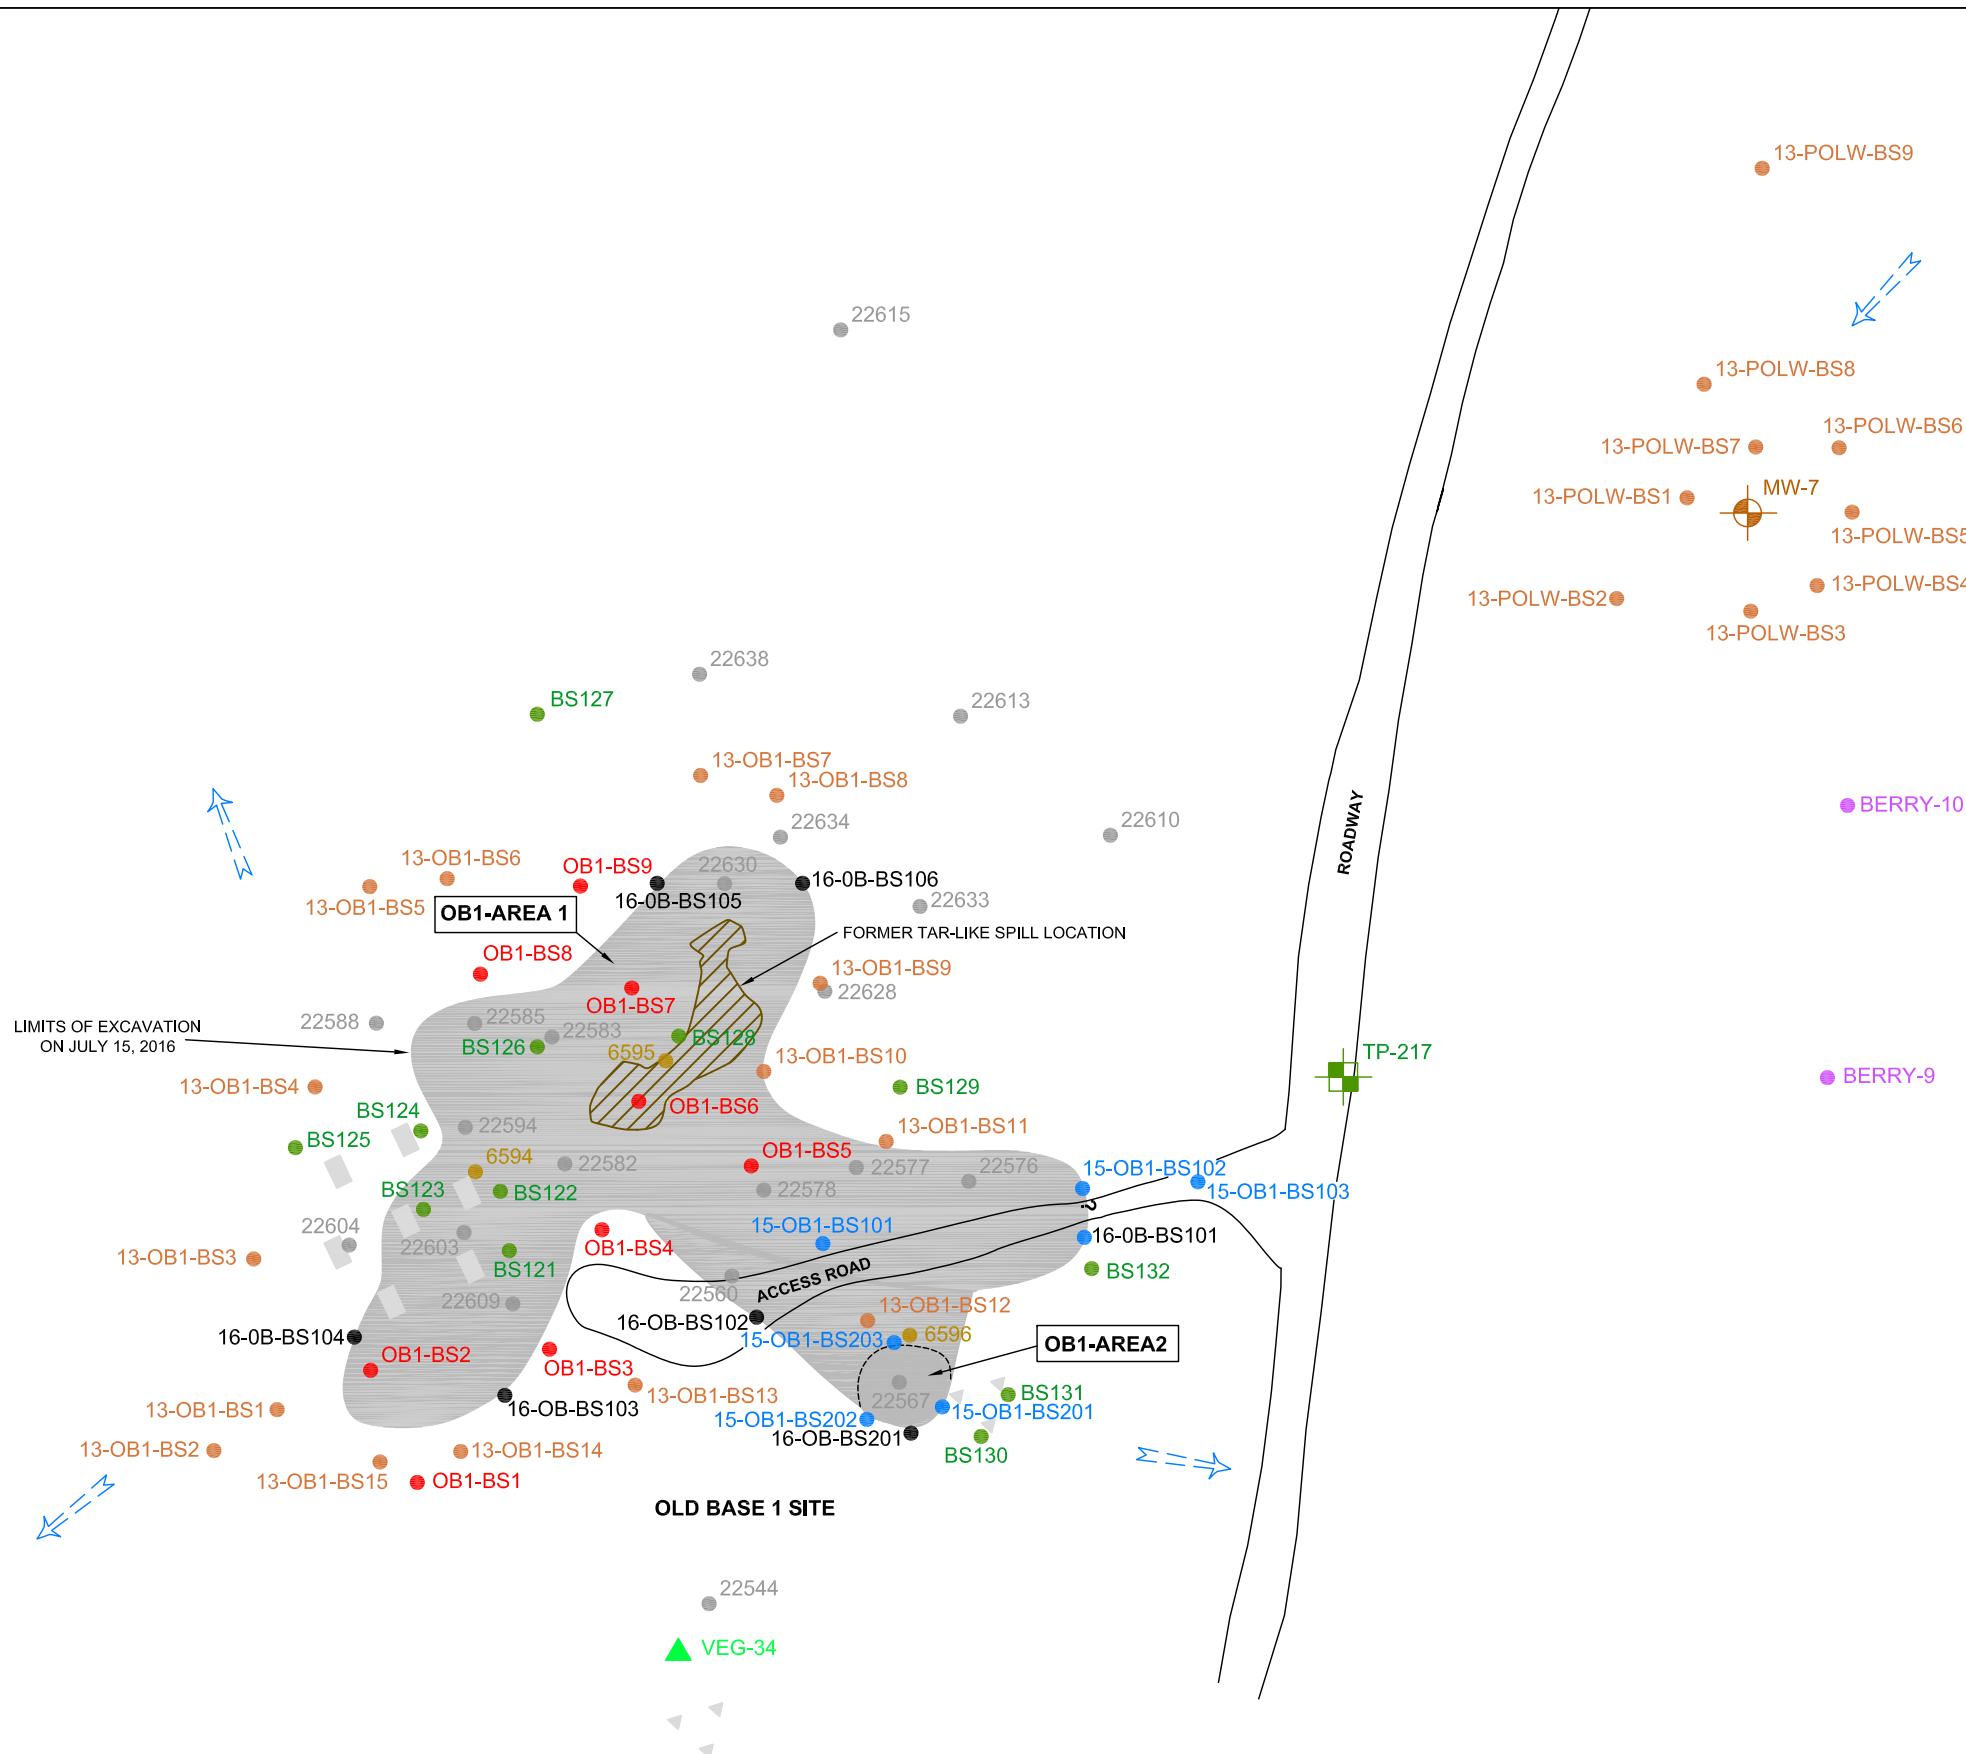
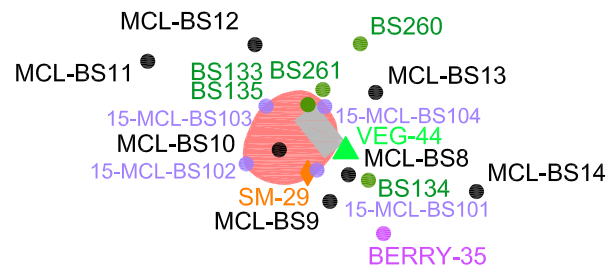
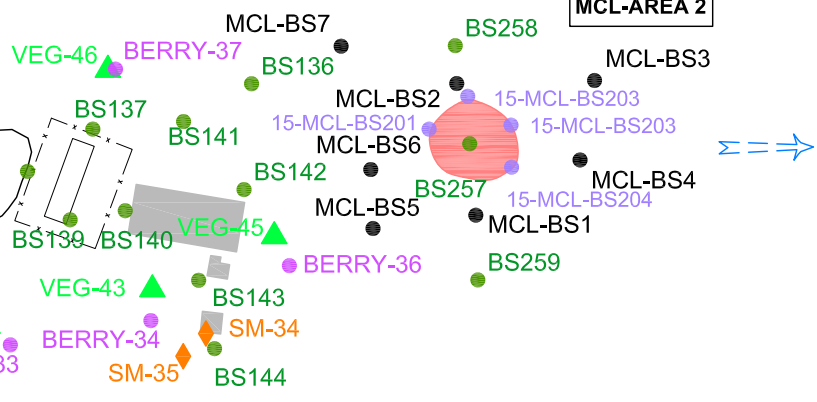
FILE NAME: T:\JOBS\121413099\YEAR 6 REMEDIATION REPORT\121413099_800-EE-07.dwg

- BULK SOIL SAMPLE (STANTEC 2015)
- BULK SOIL SAMPLE (STANTEC 2010)
- BULK SOIL SAMPLE (STANTEC 2009)
- BERRY SAMPLE (STANTEC 2009)
- ▲ VEGETATION SAMPLE (STANTEC 2009)
- ◆ SMALL MAMMALS (STANTEC 2009)
- ? — UNKNOWN EXTENT OF IMPACTS
- CONCRETE FOUNDATION
- ⇄ INFERRED GROUNDWATER FLOW DIRECTION
- ESTIMATED AREA OF METALS-IMPACTED SOIL EXCEEDING SSTLs REQUIRING REMOVAL

The Mid-Canada Line site is located approximately 700 m southeast of the Main Base on top of a hill as shown on Drawing No. 121413099-800-EE-02 in Appendix A. The site formerly included a Mid-Canada Line antenna and small buildings. The concrete foundations from the former antenna and buildings currently remain at the site. The site also included two fenced antennae and a communications trailer. Terrain in the vicinity of the Mid-Canada Line site was moderately sloped and surface drainage (apparent groundwater flow direction) appears to be to in all directions, including to the west towards Pit No. 2. Vegetation at the site was limited and consists of patches of grasses and some low bushes. Bedrock and boulder outcroppings are common at the site.

3. Complete the removal of metals-impacted soil exceeding the ecological SSTLs of 1.3 mg/kg for cadmium, 20 mg/kg for chromium and 75 mg/kg for lead at the Mid-Canada Line (estimated 17 tonnes) as per Table 5.1. Once clean boundaries are obtained, return the Site to its original condition. This will include backfilling, levelling and/or the placement of topsoil, as necessary. Refer to Drawing No. 121413099-800-EE-07 in Appendix A.
