The Flood of January 1983 in Central Newfoundland

THE FLOOD OF JANUARY 1983

IN CENTRAL NEWFOUNDLAND

Prepared Jointly By

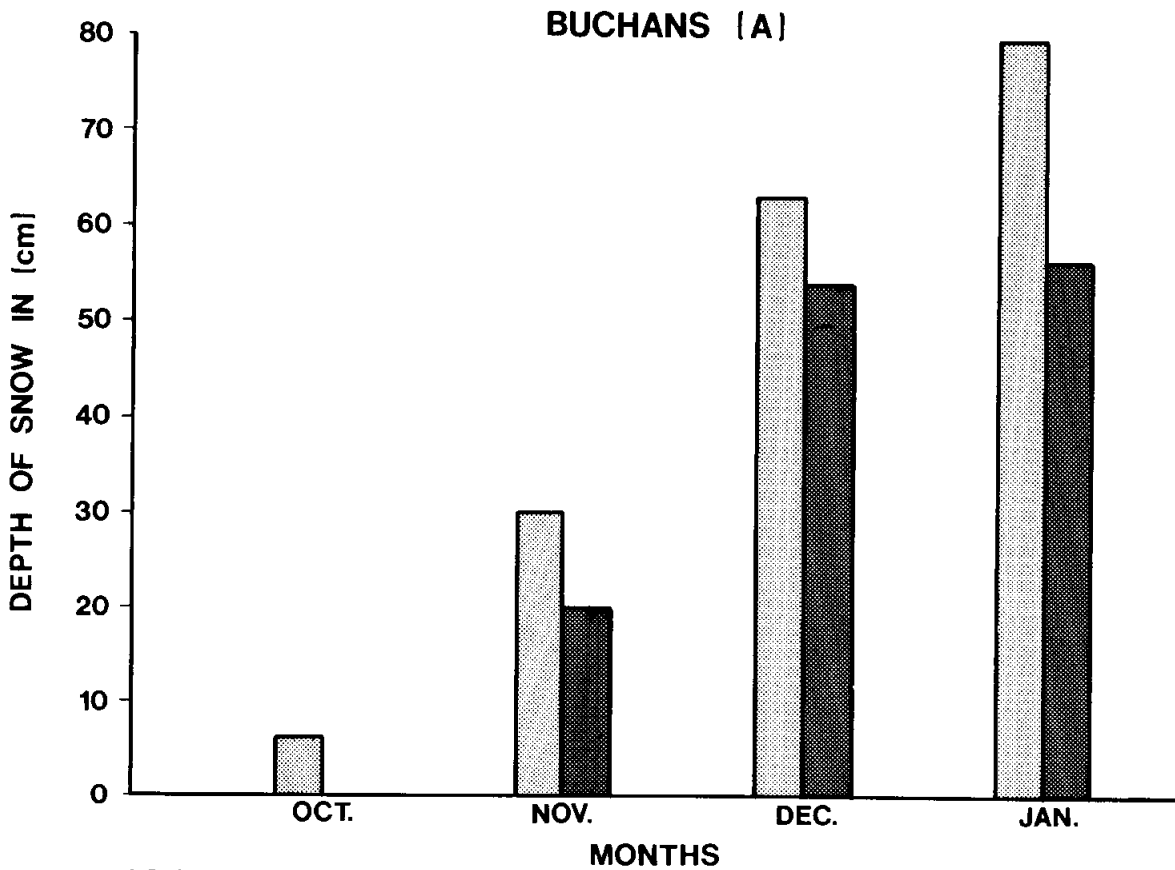
Figure 3.1 Comparison of 1982/83 Snowfall with Long Term Average Snowfall

NOTE: NO SNOWFALL FOR OCT. 1982

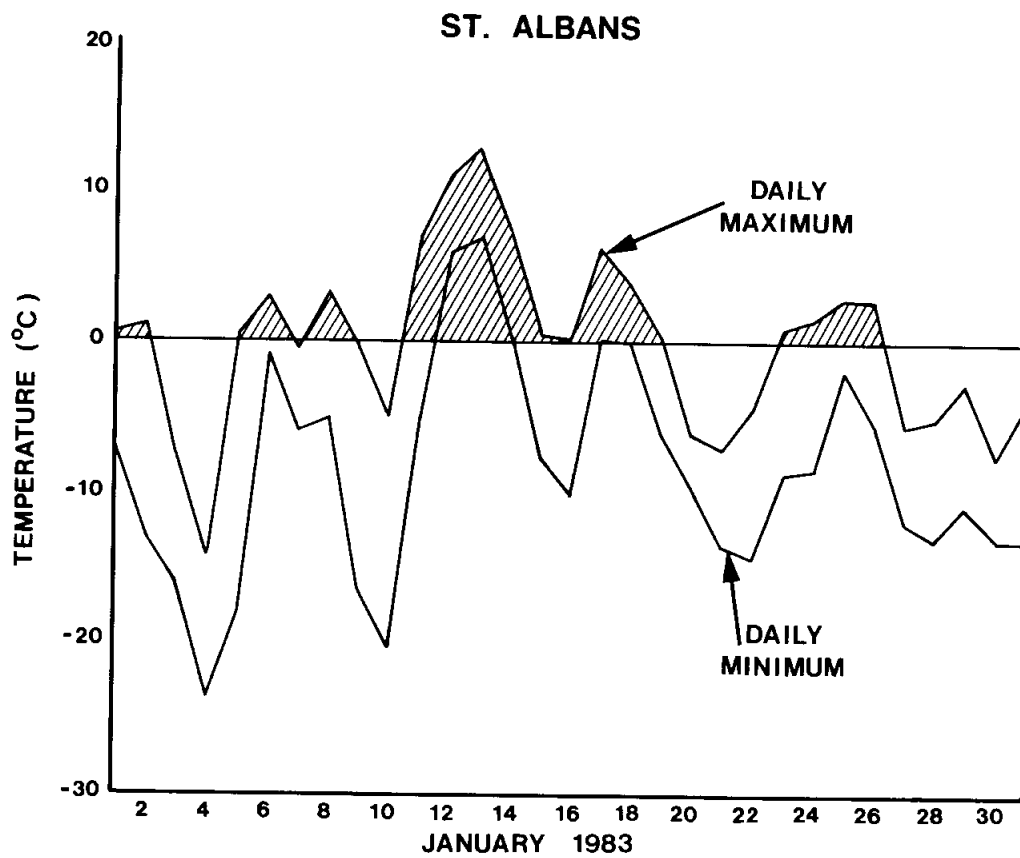
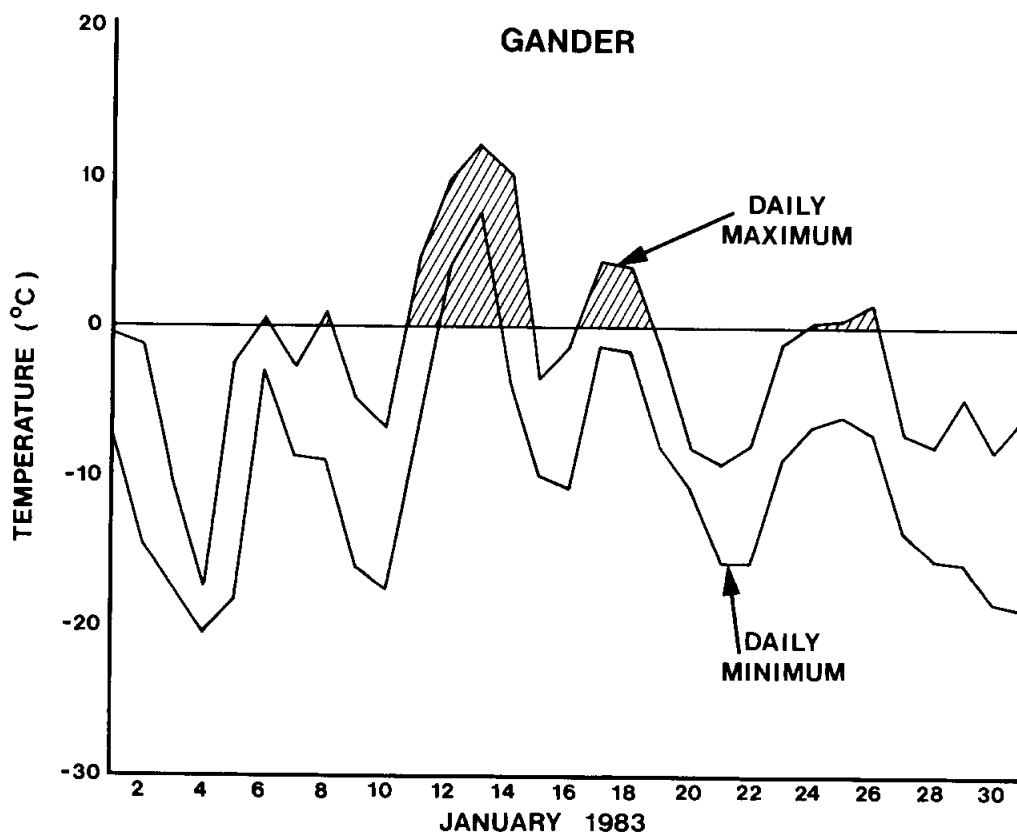
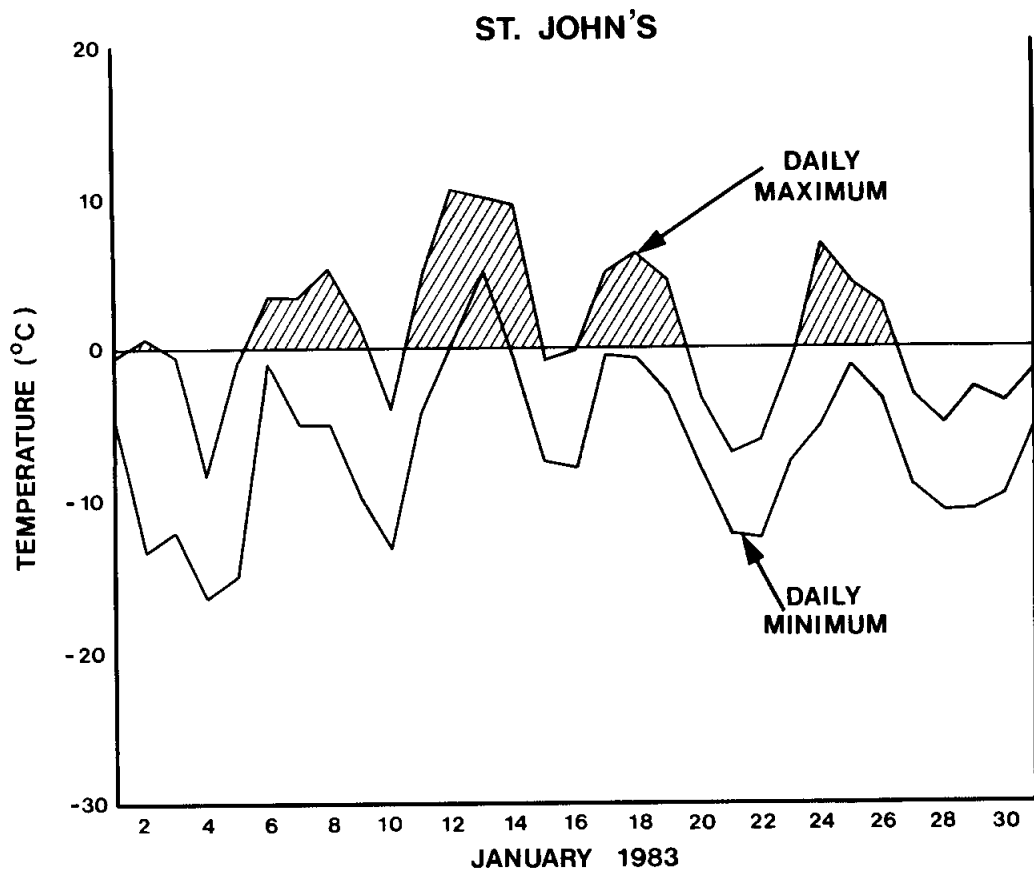
For comparative purposes, the daily maximum and minimum temperatures at selected meteorological stations are shown on Figures 3.5a to 3.5e. These data show that the highest temperatures for the month occurred between January 10 and 15, and were centered on the 12th and 13th. For the entire Island, the greatest daily maxima ranged between 5°C and 15°C during that period. Concurrently, a low pressure system approaching the Island from the south, simultaneously brought very mild air and copious amounts of rain. Because of these two conditions, the rate of snowmelt was very high.

Figure 3.5a Daily Extremes of Temperature at St. Albans Meteorological Station

Figure 3.5b Daily Extremes of Temperature at Gander Meteorological Station

Figure 3.5c Daily Extremes of Temperature at St. John's Meteorological Station

Figure 3.5d Daily Extremes of Temperature at Port Aux Basques Meteorological Station

Figure 3.5e Daily Extremes of Temperature at Daniels Harbour Meteorological Station

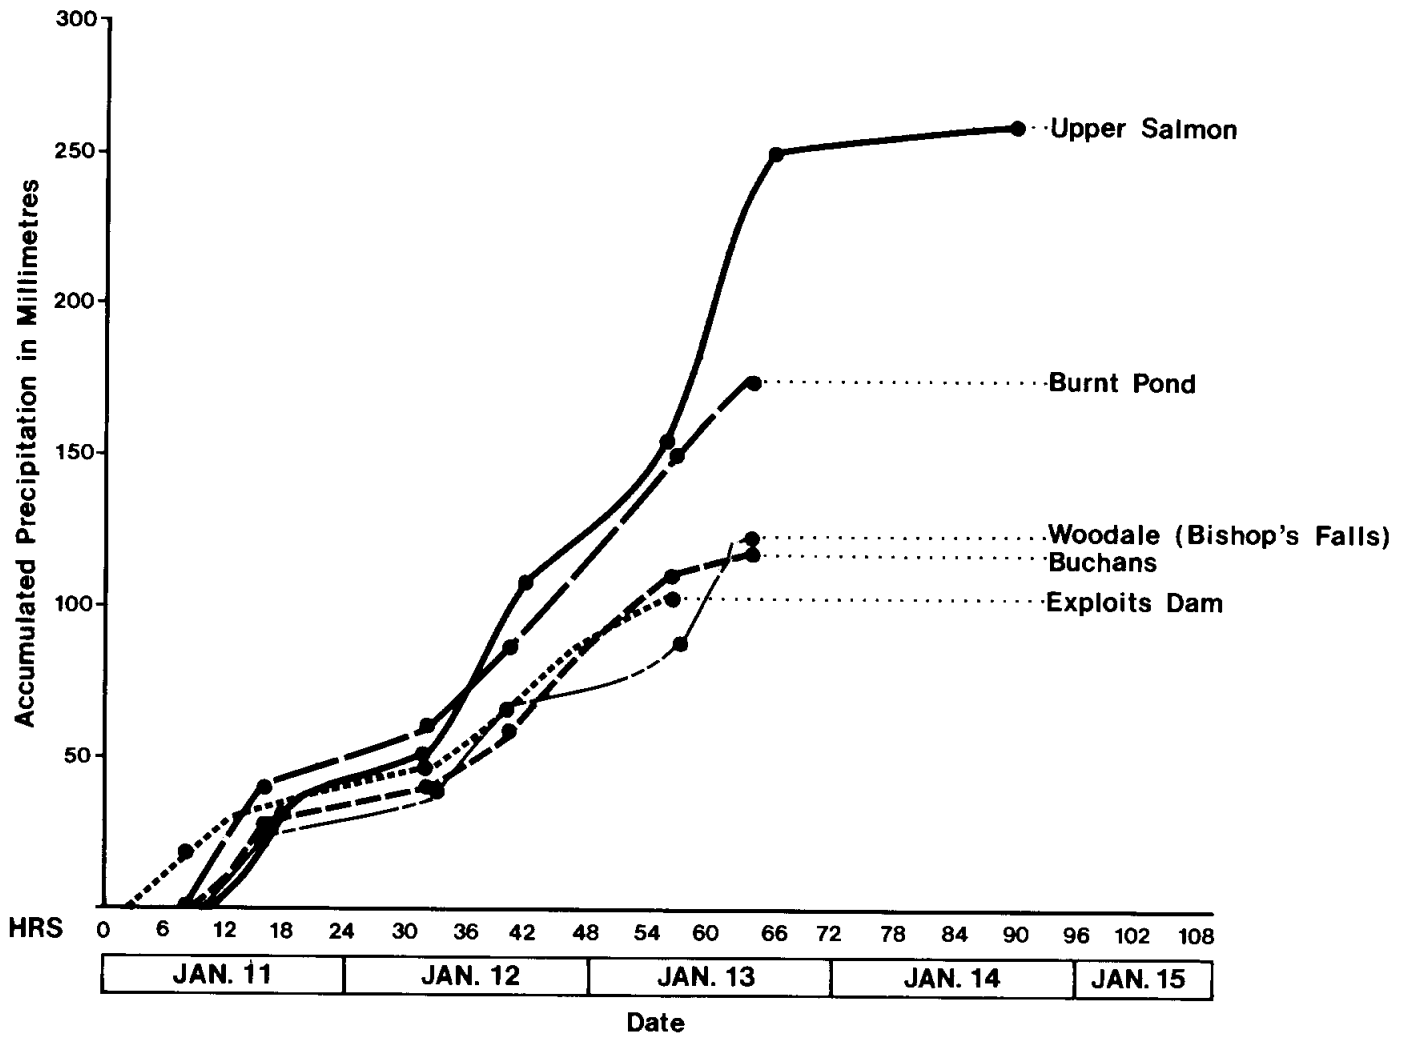
Figure 3.10 Mass Curves of Rainfall

The areal distribution of total rainfall for the storm is shown on Figure 3.9. The temporal distribution of rainfall at locations in the Exploits Basin and vicinity, equipped with ordinary rain gauges, is displayed as mass curves on Figure 3.10. Accumulated 6 hourly precipitation amounts are shown in Table 3.2 for selected AES synoptic stations. This information shows that precipitation totals in excess of 100 mm occurred in some watersheds. Also, in excess of 250 mm fell in the vicinity of St. Albans.

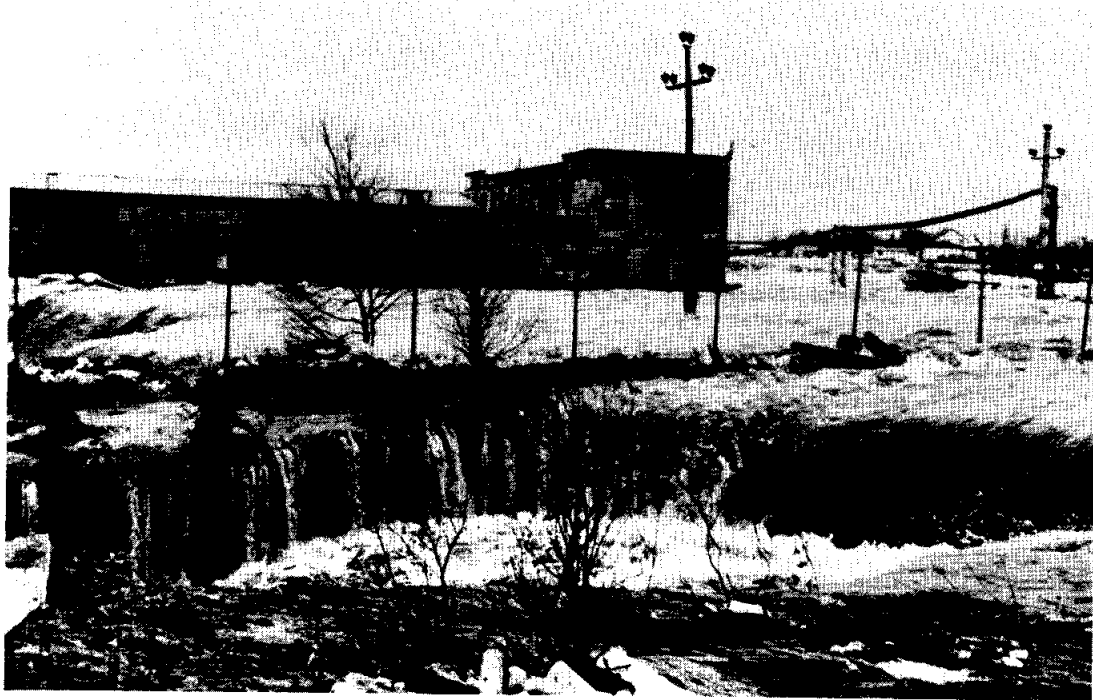
Photograph 7.2 - Old Greenwood Mill at Bishop's Falls prior to collapse - midday on January 14, 1983

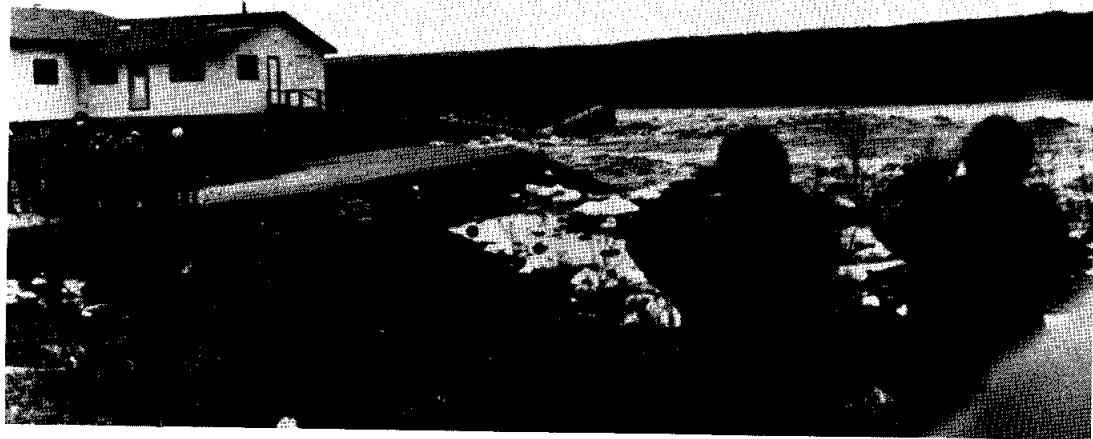
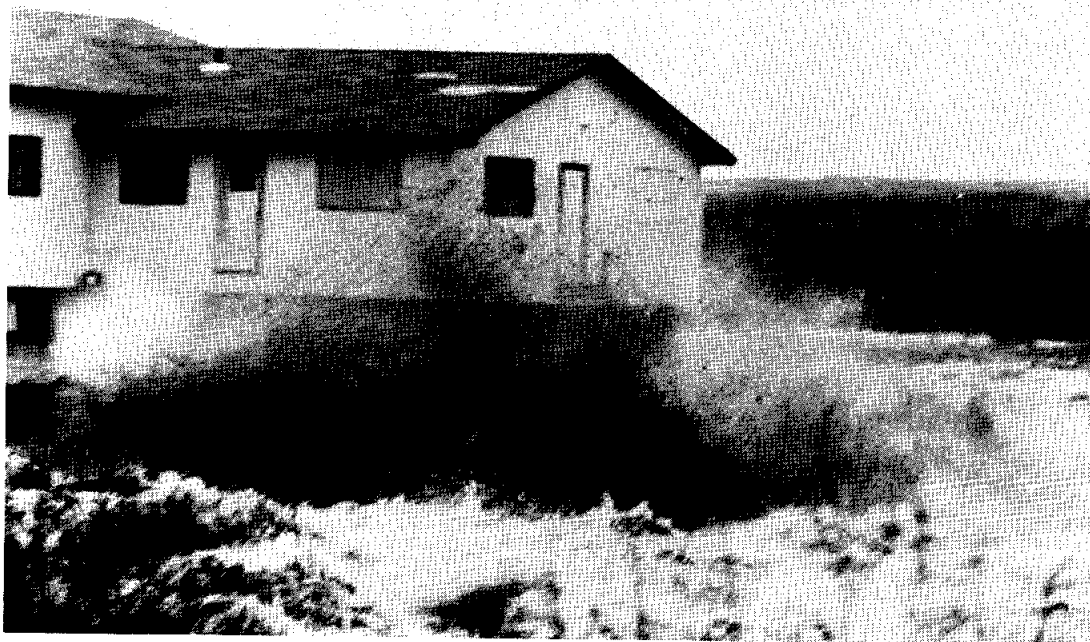
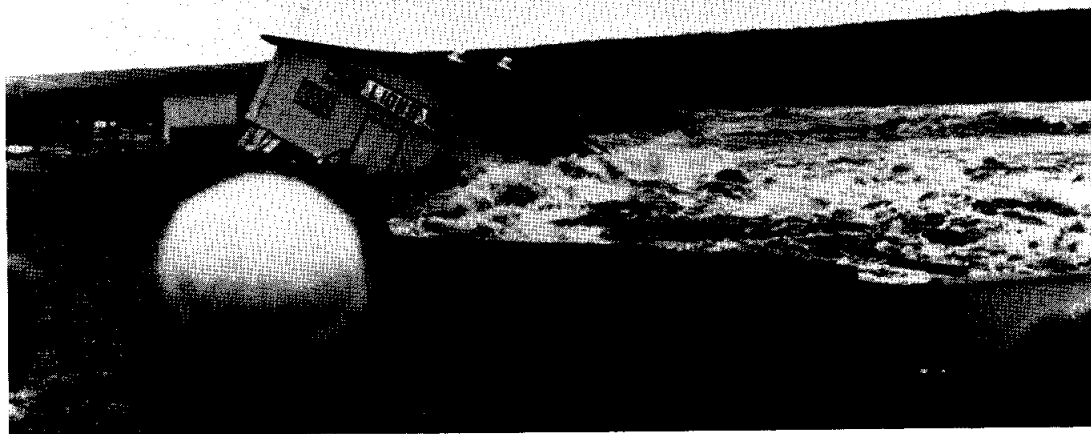
- About 180 families were evacuated from western and eastern sections of the Town over a period of 24 hours.
- Three homes, the Lions Club (see Photographs 7.6 to 7.9) and the Senior Citizens Club were washed away by the flood water.
- The Fall View Municipal Park (see Photograph 7.6), along with two historic 60 ton railway cars (from the famous Newfie Bullet) disappeared in the flood waters.
- The power plant, old groundwood mill building, and transmission lines were extensively damaged. The hydro plant provided 12% of the Abitibi-Price power requirement in addition to providing some power to the community of Botwood.

Photograph 7.6 - Bishop's Falls' Lions Club located near the
Municipal Park - early afternoon on January 14, 1983

Photograph 7.7 - Bishop's Falls' Lions Club just prior to its loss
- January 14, 1983

Photograph 7.8 - Lions Club at Bishop's Falls being destroyed -
January 14, 1983

Photograph 7.9 - Lions Club at Bishop's Falls being destroyed
- January 14, 1983

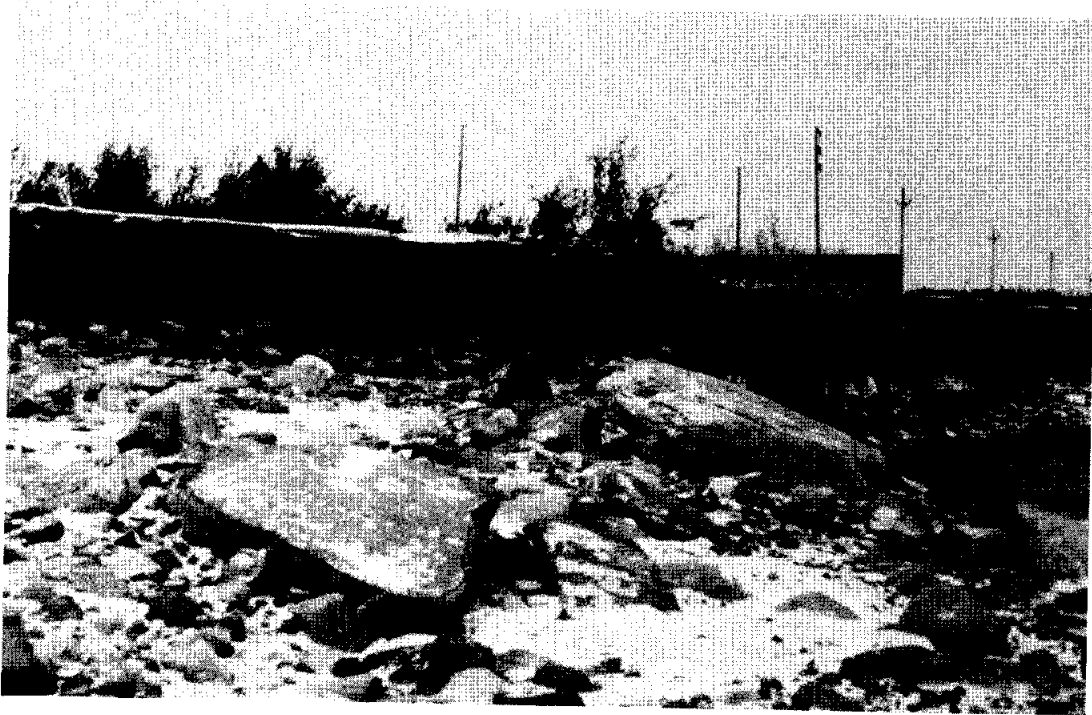
Photograph 7.10 - Downstream End of Bank Erosion, Bishop's Falls -
January 14, 1983

Repair and construction of sewerage and drainage systems and damage to water supplies within the Exploits Basin amounted to \$495,319 primarily in the Bishop's Falls area. Additionally, \$473,448 was required for stabilization of heavily eroded river banks within the Basin. Outside the Basin, \$2,381 was required for repairs to the Morrisville water supply.

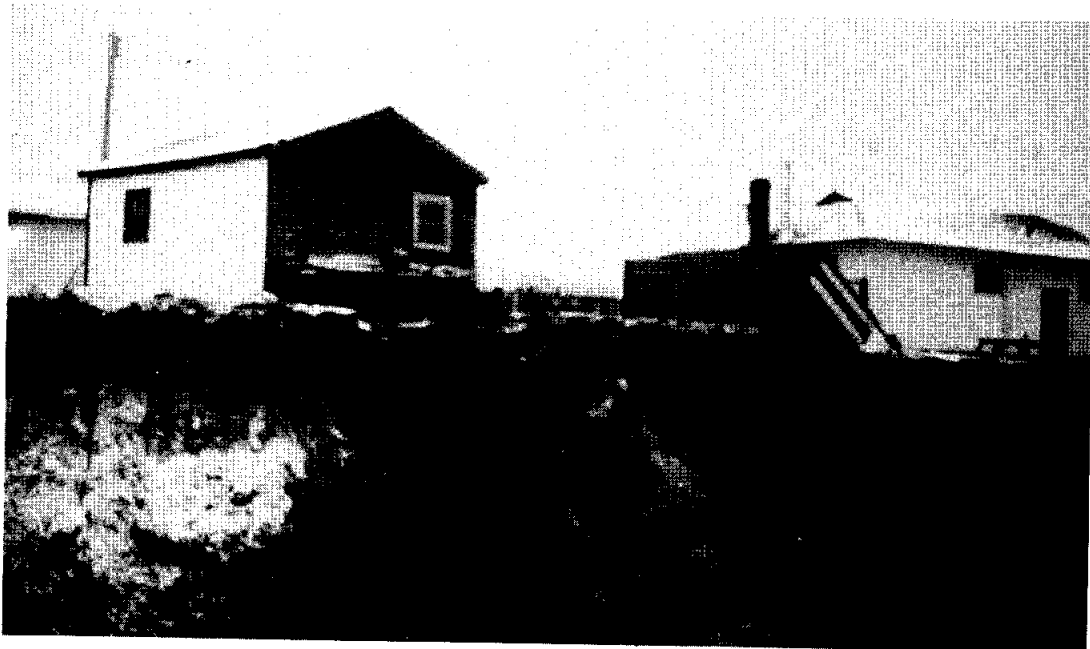
Photograph 7.11 - Eroded Bank along New River Channel

Note: Remnants of Earth Filled Section of
Abitibi-Price Dam.
