53113.00 ● Final Report ● June 2018

Solving today's problems with tomorrow in mind RE: Flood Risk Mapping Study: Waterford River Area Final Report

CBCL has completed a flood risk assessment of the Waterford River area for the 1:20 and 1:100 AEP flood events. The analysis includes a complete set of flood zone maps for current and future development conditions within the drainage catchment, as well as climate change considerations including sea level rise. Fully developed and calibrated hydraulic and hydrologic models of the study area using HEC-HMS and HEC-RAS computational software support the flood risk assessment.

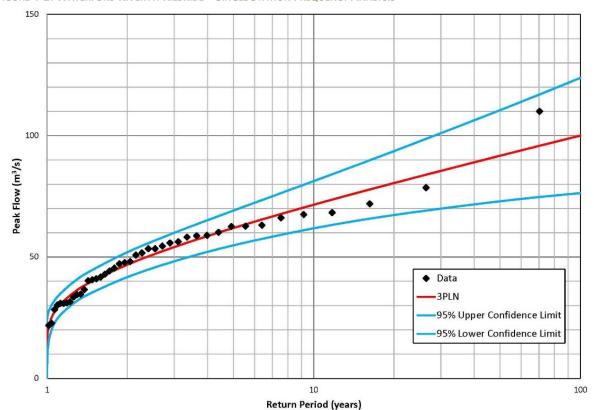
FIGURE 4-1: WATERFORD RIVER AT KILBRIDE - SINGLE STATION FREQUENCY ANALYSIS

Several statistical distributions were examined, including Gumbel, Generalized Extreme Value (GEV), Lognormal, 3-Parameter Lognormal and Log Pearson Type III. Appendix E contains the results of the statistical analysis. The most appropriate distribution was selected based on visual goodness-of-fit and statistical test Figure 4-1 illustrates the selected distribution, along with the 95% confidence interval. The resulting AEP flow estimates are listed in Table 4-1.

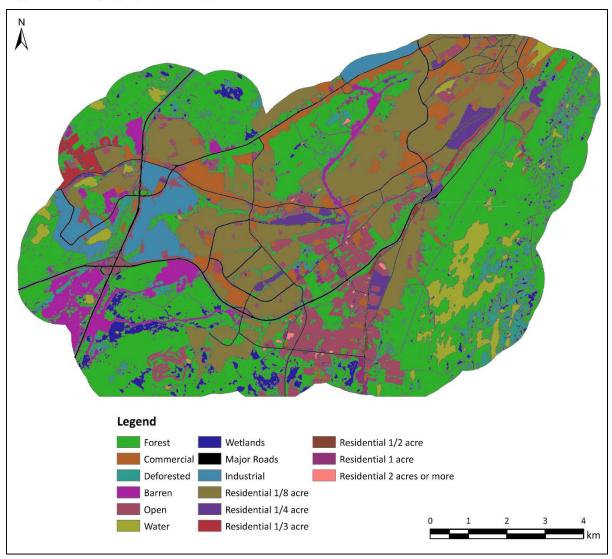
FIGURE 4-4: LAND CLASSIFICATION ANALYSIS

Runoff curve numbers (CN) are determined through a combination of land use, antecedent runoff condition and soil type. Typical values of CN range between 30 and 100. A large value for CN represents impervious areas.

ARC III was assumed for the selection of curve numbers for this study.

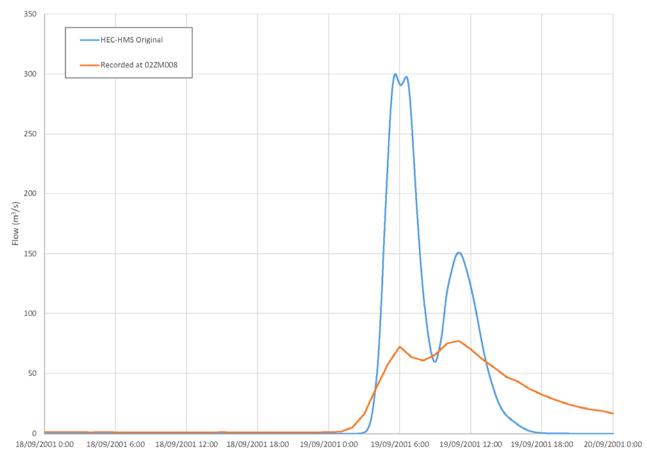
FIGURE 4-6: CALIBRATION TO HURRICANE GABRIELLE AT O2ZM008

The Waterford River at Kilbride gauge (02ZM008) was used to calibrate the HEC-HMS model. Rainfall data recorded at the Ruby Line rain gauge during Hurricane Gabrielle (September 2001) in 5 minute increments was obtained from the City of St. John's. Hourly flow data recorded at the 02ZM008 gauge was obtained from EC for the same time period. The rain data was simulated in the HEC-HMS model and the model results were compared to the recorded flow data by plotting both hydrographs on the same graph (Figure 4-6).

The comparison illustrated that the peak flows simulated by HEC-HMS were higher than the observed gauge flows but the modeled limbs of the hydrograph were much lower than was recorded. Attempts were made to increase the modeled hydrograph limbs by applying a baseflow in the model and running the preceding and following days. However, these efforts did not have a significant impact on the rising and falling hydrograph limbs. The runoff curve numbers were adjusted in an effort to decrease the peak of the model hydrograph to correspond with the recorded peak flow. A decrease of approximately 29% in the subbasin curve numbers, and correspondingly the subbasin lag times, resulted in a simulated peak flow that closely matches the measured peak,

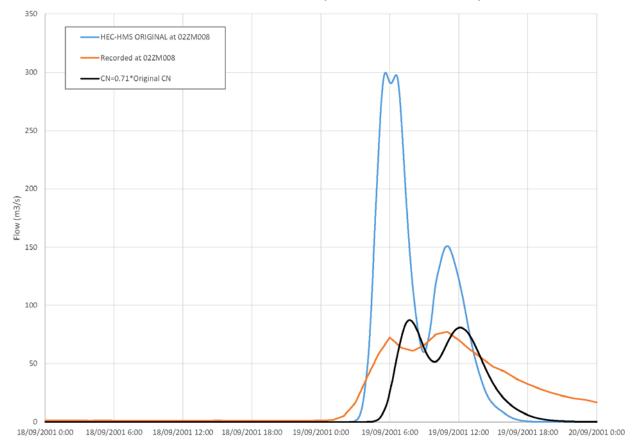
FIGURE 4-7: CALIBRATION TO HURRICANE GABRIELLE AT 02ZM008 (WITH SIMULATED HYDROGRAPH)

as illustrated in Figure 4-7. Since the main objective of the hydrologic models is to determine peak flows for the 1:20 and 1:100 AEP it was decided that by matching the peaks of the simulated and recorded hydrographs the model was considered calibrated.

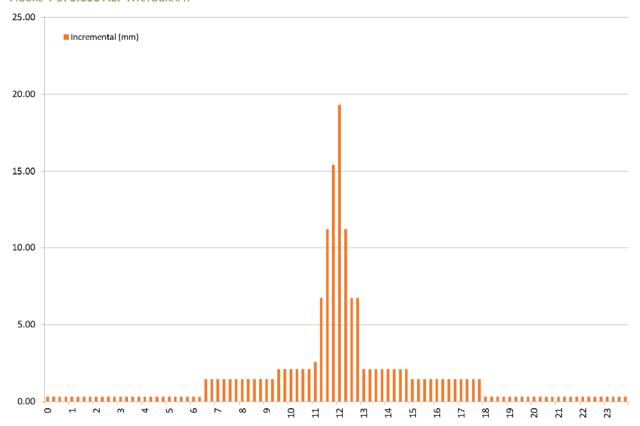
FIGURE 4-9: 1:100 AEP HYETOGRAPH

The alternating block method was used to estimate a synthetic hyetograph shape. This method incorporates the precipitation for various durations for a particular return period rainfall event into a single hyetograph. The maximum incremental precipitation is placed at the centre of the storm and the remaining incremental precipitation values are arranged in descending order alternating right and left of the centre. The hyetographs created for the 1:20 and 1:100 AEP return periods include the precipitation amounts for the 15 and 30-minute, and 1, 2, 6, 12 and 24-hour duration. Figures 4-9 and 4-10 illustrate the 1:20 and 1:100 AEP hyetographs.

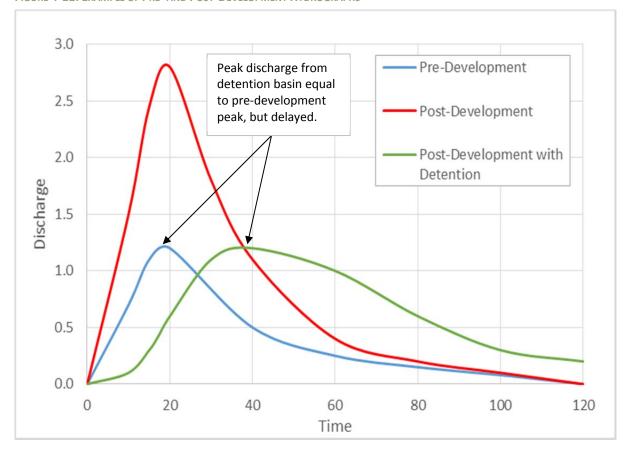
FIGURE 4-11: EXAMPLE OF PRE- AND POST-DEVELOPMENT HYDROGRAPHS

Future developments within Mount Pearl and St. John's will have detention basins. The outlet hydrograph from a detention basin is such that the peak post-development flow is "flattened" to match the peak pre-development flow and, therefore, is delayed and stretched over a longer time period compared to the pre-development hydrograph (an illustration of this is presented in Figure 4-11). The delayed hydrograph peak may in fact increase the peak of the downstream subbasin(s) if the timing of the delayed peak coincides with the downstream subbasin peak. Therefore, keeping the curve numbers of future developable land the same as the current CNs is not technically representative of future developed conditions, since the peak of the hydrograph will not be delayed and stretched, as it would be if a detention basin were modeled. Without modeling future

developable lands with detention basins, the effect of detention on the main tributaries cannot be simulated. This analysis would require detention basin design for each parcel of land available for development. Such an analysis is outside the scope of this study.

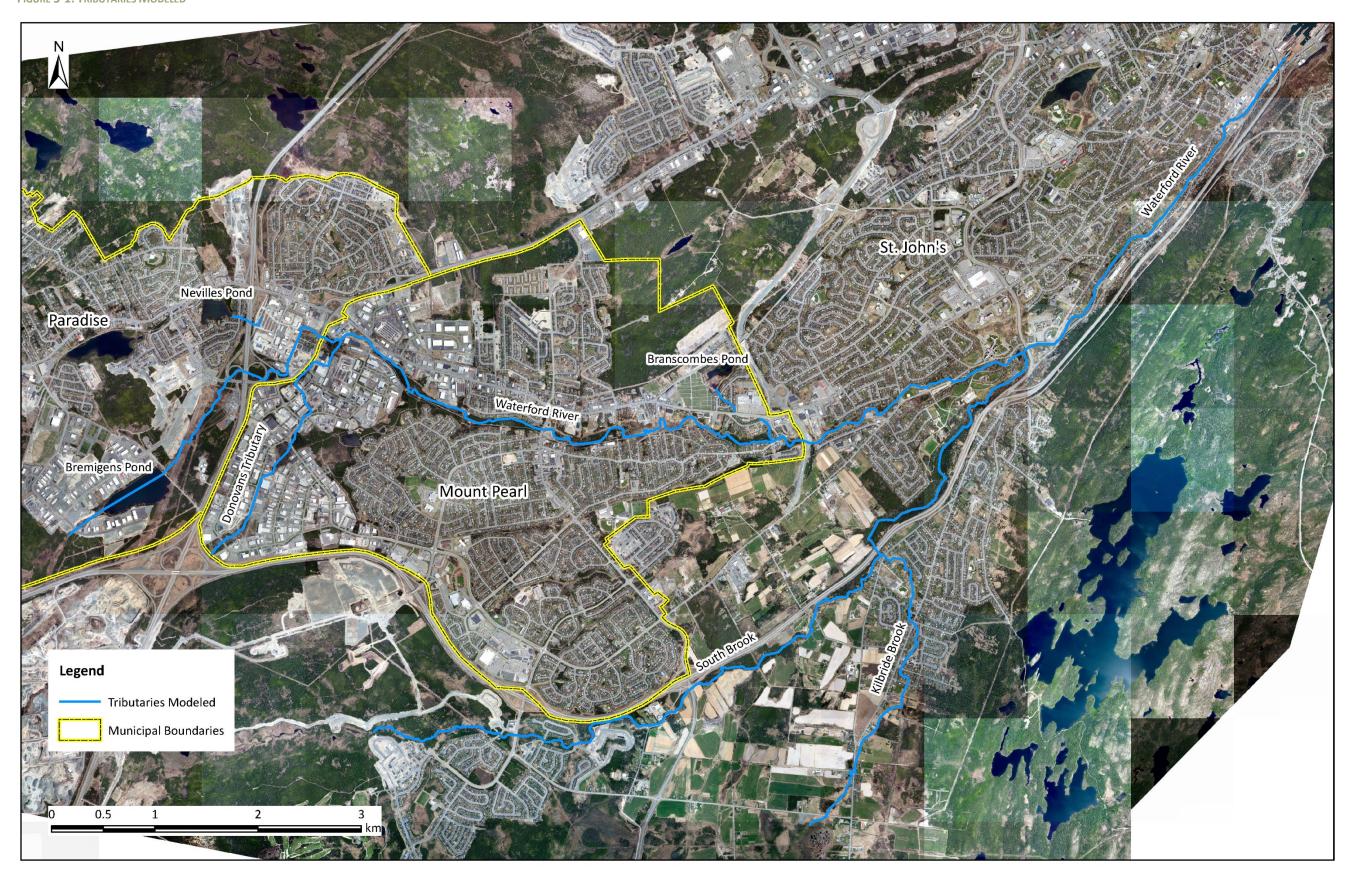
FIGURE 5-1: TRIBUTARIES MODELED

These tributaries are identified on Figure 5-1. Branscombe's Pond tributary is shown as a broken line, because the stream enters the storm sewer system at the intersection of Topsail Road and the west entrance to Mount Pearl Square and exists at the south side of Topsail Road, between Dunns Road and Greenwood Crescent. HEC-RAS is an open channel flow model, and although it has the ability to simulate flow through culverts and bridges, it is not capable of modeling flow through piped networks. Therefore, the section of piped storm sewer is not included in the hydraulic model. The Nevilles Pond tributary is also shown as a broken line through St. Anne's Industrial Park. However, from field visits, it appears that the stream is carried through one continuous culvert spanning the industrial park; therefore, the entire reach is modeled in HEC-RAS for the Nevilles Pond tributary.

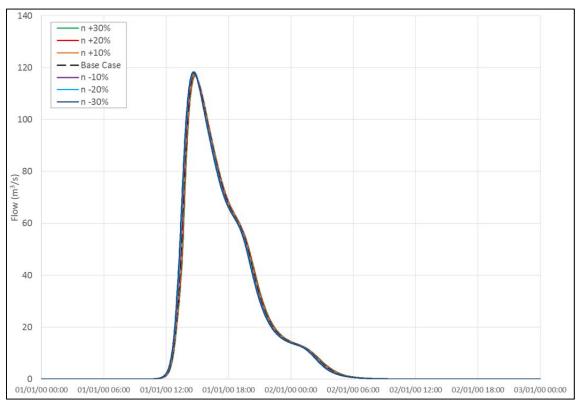
FIGURE 5-3: MANNING'S N SENSITIVITY ANALYSIS

Changing the Manning's n values has little impact on the resulting flows; an increase of 30% in Manning's n decreases the flow by only 1%. Figure 5-3 presents the hydrologic models sensitivity to changing Manning's n.

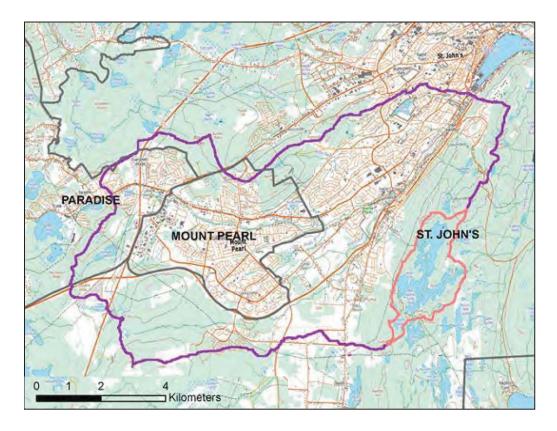
$$Q = \frac{(P - I_a)^2}{P - I_a + S}$$

This document describes the procedures followed in generating a land cover map in support of a flood risk study carried out for the Waterford River drainage basin. The location of the study area and preliminary watershed boundary is presented in Figure 1.

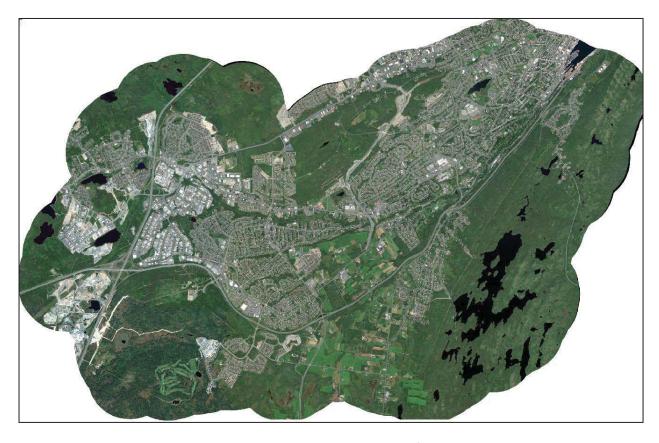
Figure 2. Satellite ortho-mosaic of AOI

Pansharpening is a data fusion technique used to combine the high spatial resolution of a panchromatic channel with the high spectral resolution offered by multiple spectral bands. While this level of processing is useful for visual image interpretation, the altering of original image values during the pansharpening process can negatively affect automated algorithms used for classification. It is therefore

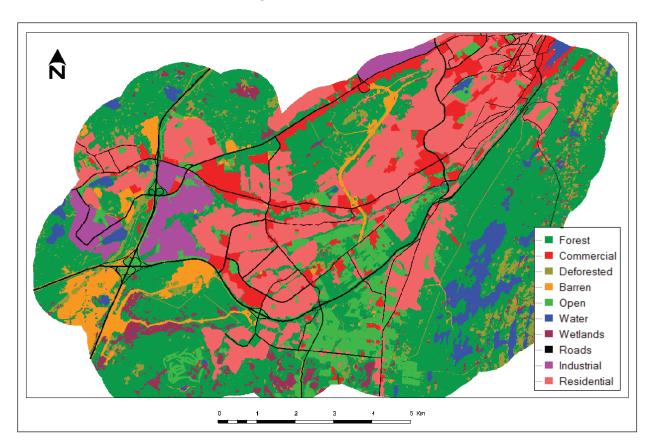
Figure 3. Final land cover map

The final land cover map for the Waterford River watershed is presented in Figure 3. The result of the accuracy assessment is shown in Table 4. Reference data and classified map agree well with an overall classification accuracy of 94.95%. The corresponding 95%-confidence limits are 91.90% and 98.00%, respectively. As the samples for accuracy assessment were selected at random, the variation of sample sizes across the different land cover categories reflects their occurrence and distribution in the AOI.

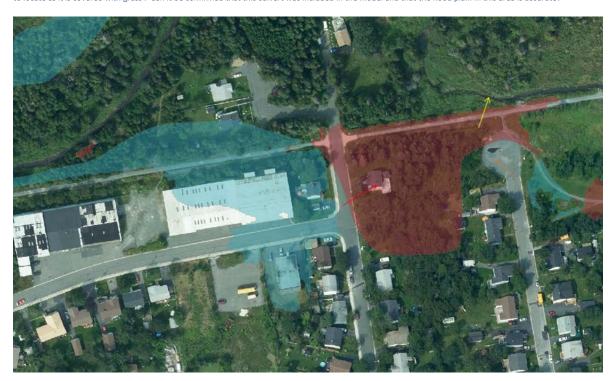
In the image below, the area in red is being removed from the 1:20 year flood zone and the area in blue is added as the 1:20 climate change flood zone. Attached are photos from Tropical Storm Chantal from August 1, 2007 showing the house at 16 Winston Avenue (red arrow) and from the end of Birch Avenue looking north west towards the T'Railway (orange arrow - the end of Birch Avenue has been paved since this photo was taken, so there may be changes there). The yellow arrow shows the approximate location of a culvert crossing under the T'Railway (yellow arrow – photos attached). This is difficult to locate as it is covered with grass. Can it be confirmed that this culvert was included in the model and that the flood plain in this area is accurate?
