Intensive Survey of Bonne Bay Big Pond and Bonne Bay Little Pond

September 2014

Government of Newfoundland & Labrador
Department of Environment and Conservation
Water Resources Management Division
St. John's, NL, A1B 4J6 Canada

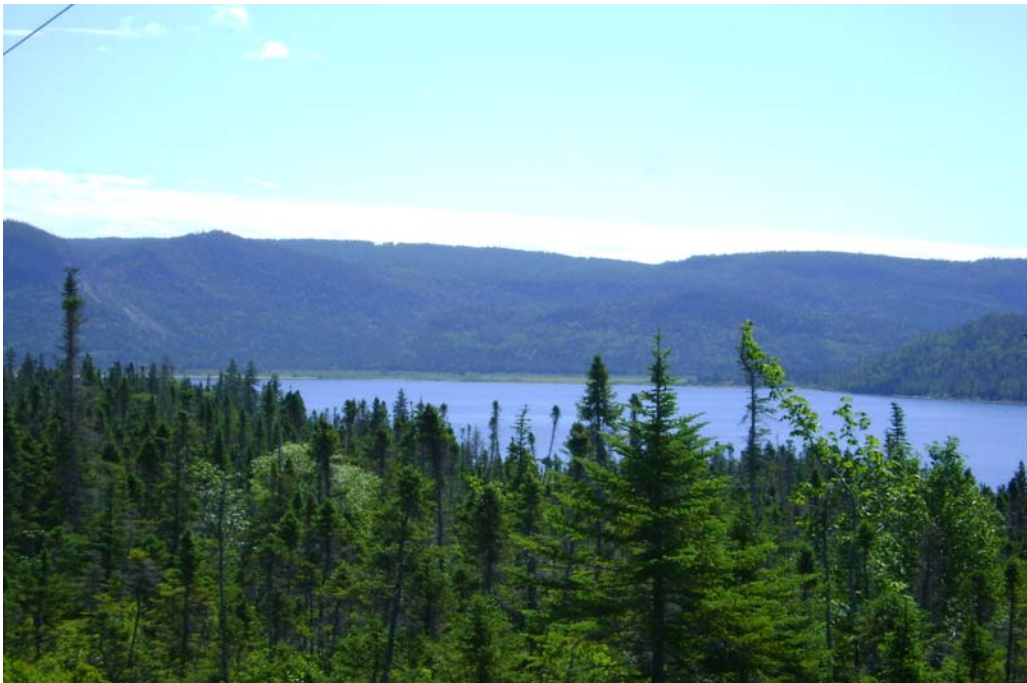
Figure 3: Bonne Bay Little Pond

Bonne Bay Little Pond is surrounded by steep sided heavily wooded hills (figure 3) and is approximately 4.7 km long with width ranging from approximately 300 m to 900m (Figure 4). It is oriented in a west-north-west to east-south-east direction with the Lomond River flowing in on the east-south-east end and out on the west-south-west end. Apart from the Lomond River there are numerous smaller tributaries flowing into Bonne Bay Little Pond around its perimeter.

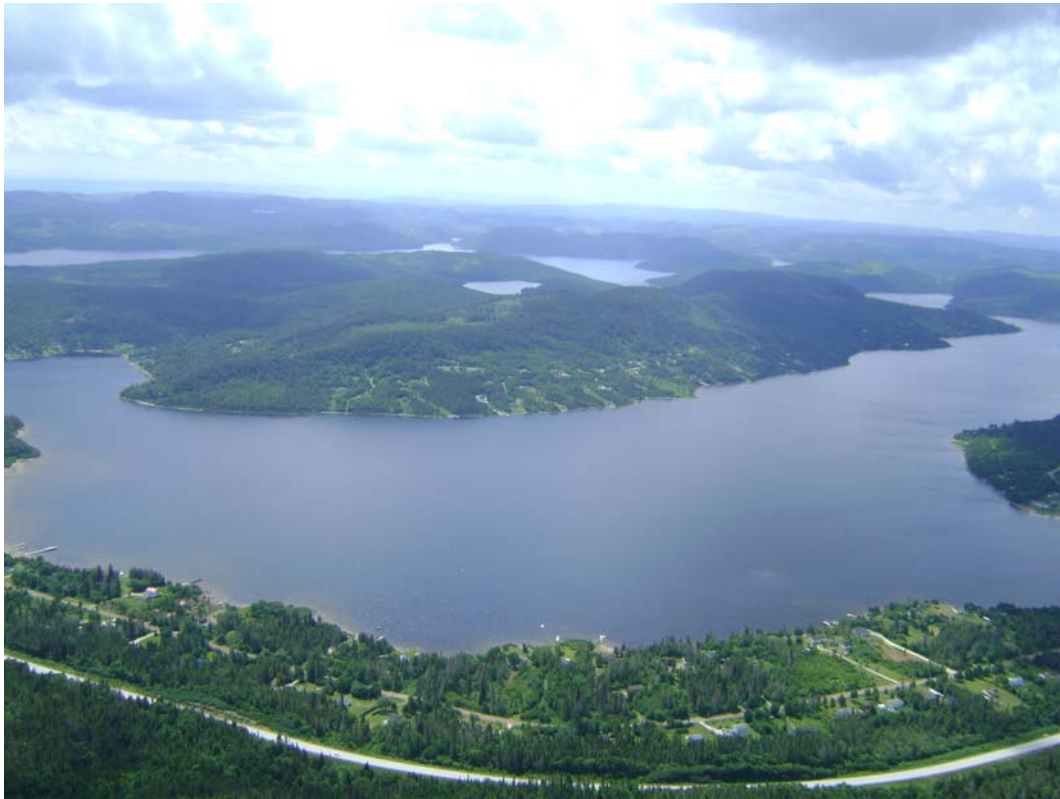
Figure 5: Bonne Bay Big Pond

Bonne Bay Big Pond is a highly irregularly shaped pond made up of numerous bays and irregular shaped lobes. It ranges in a north-south direction for approximately 9 km and east-west for approximately 6 km. From figure 5 it can be seen that the pond is surrounded by heavily wooded rolling hills.

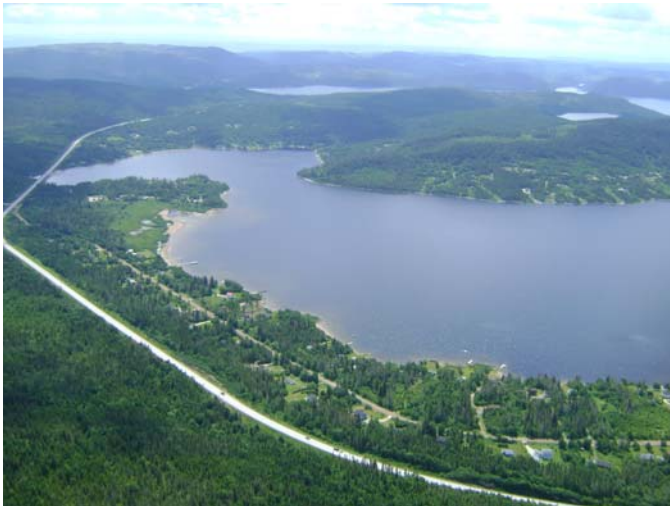
Figure 7: Cottage Development at Bonne Bay Big Pond

Cottage development in the watershed area is concentrated along the northern shore of Bonne Bay Little Pond and along the eastern shores of Bonne Bay Big Pond. There are approximately 520 cottages in the Lomond River watershed (Land Management Division, 2011). Figure 7 shows an area of significant cottage development along the eastern side of Bonne Bay Big Pond. Most of the cottages are used sporadically throughout the year with heavier use during the late spring to early fall period. However, there is a growing

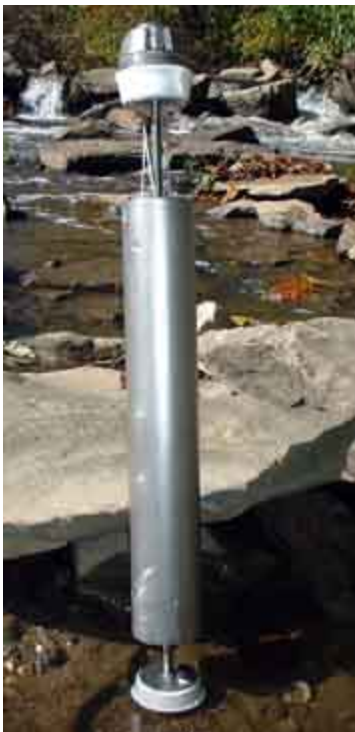
Figure 10: Kemmerer Sampler

A Kemmerer water sampler is a device that makes it possible to obtain a sample of water from a pond, river or lake at a specified depth down in the water column. The sampler is essentially a metal tube with stoppers on each end that can be held open when the sampler is lowered by a line to a desired depth. These same stoppers can then be triggered to close the ends of the tube when a metal cylinder called a messenger is dropped down the line holding the Kemmerer sampler. After the stoppers close the ends of the tube, the sampler is retrieved with the desired sample of water being uncontaminated by water from other depths. Once the sampler is retrieved the sample water inside is transferred to an appropriate sample bottle for storage and transportation to the laboratory for analysis.

In addition to profiling the water quality at regular depth intervals with the YSI multi-parameter probe, four sites were selected for collecting samples below the thermocline. The samples at depth were collected to show any differences in water quality above and below the thermocline. Samples below the thermocline were collected using a Kemmerer sampler similar to the one shown in figure 10. In this case a stainless steel version of the Kemmerer sampler was used. If one was available, it would have been more appropriate to use a Teflon version to avoid any trace metal contamination of the sample.

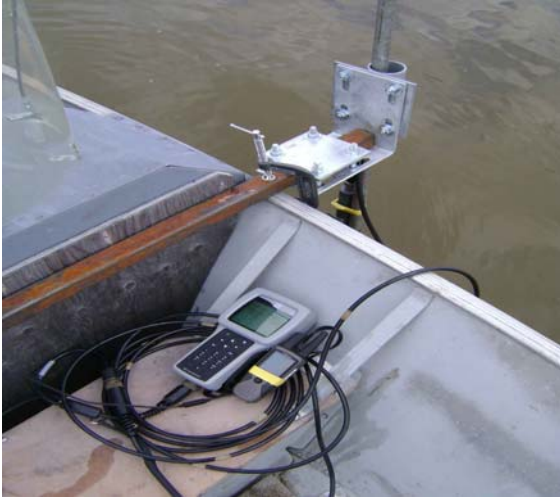
Figure 11: GPS Enabled Multi-parameter Probe Deployed from Side of Boat

plotted on a map to assess spatial variability in the parameters. A photo of the deployed sonde is shown in figure 11.

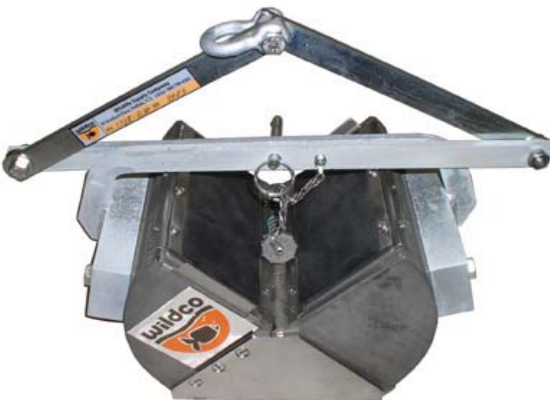
Sediment samples were taken using a mini Ponar sampler similar to the one shown in figure 12. This sampler is lowered over the side of the boat suspended on a rope until it reaches the bottom. The Ponar grab consists of a pair of weighted, tapered jaws which are held open by a catch bar. It is triggered upon impact with the sediment and the tension on the catch bar is reduced allowing the jaws to close. The upper portion of the jaws is covered with a mesh screen which allows water to flow freely during descent, consequently reducing the shock wave that precedes the sampler. Upon recovery, the mesh can be removed to allow access to the sediment for sub-sampling purposes. The Ponar grab is suitable for collecting fine-grained to coarse material.

Figure 12: Mini Ponar Sampler

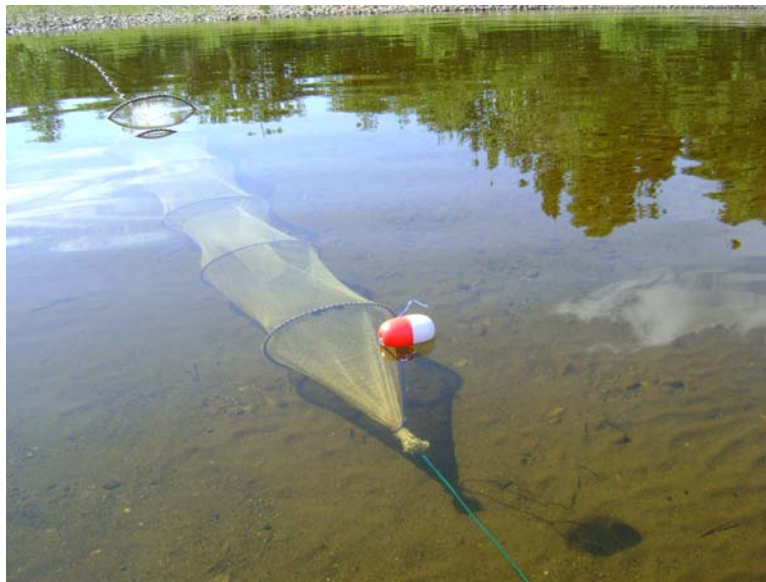
Figure 14: Fyke Net Deployed at Bonne Bay Little Pond

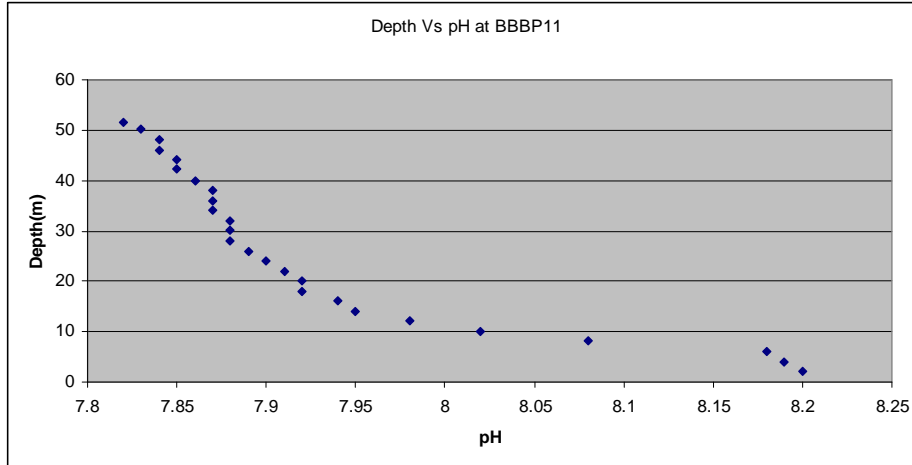
For all the depth profiling sites both oxygen and pH consistently vary with depth and the corresponding temperature gradient. Figure 17 shows a graph for depth versus pH for sample site BBBP11. It appears that pH is directly proportional to temperature and decreases with depth in a manner very similar to temperature. Oxygen is inversely proportional to temperature and increases with depth as can be seen in figure 18, which shows depth versus oxygen for site BBBP8.

Figure 17: Depth(m) Vs pH for Site BBBP11

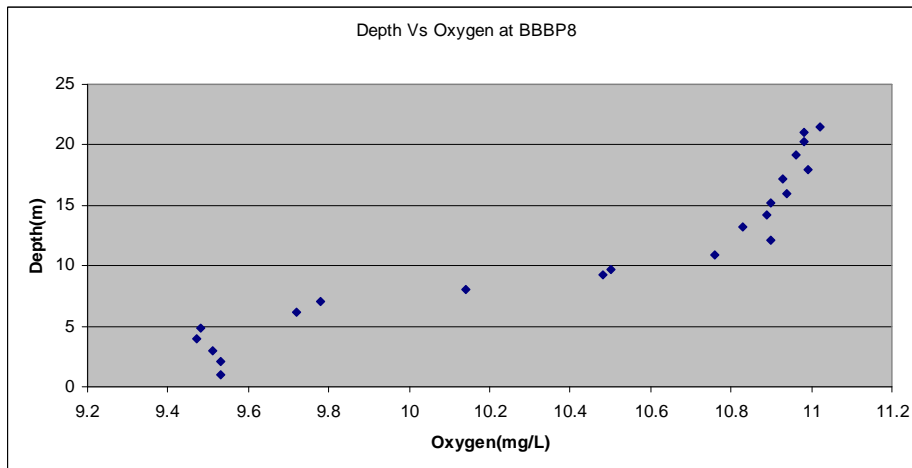
Figure 18: Depth(m) Vs Oxygen(mg/L) for Site BBBP8
