**Real Time Water Quality Monthly Report
Come by Chance River
June 2007—July 2007**

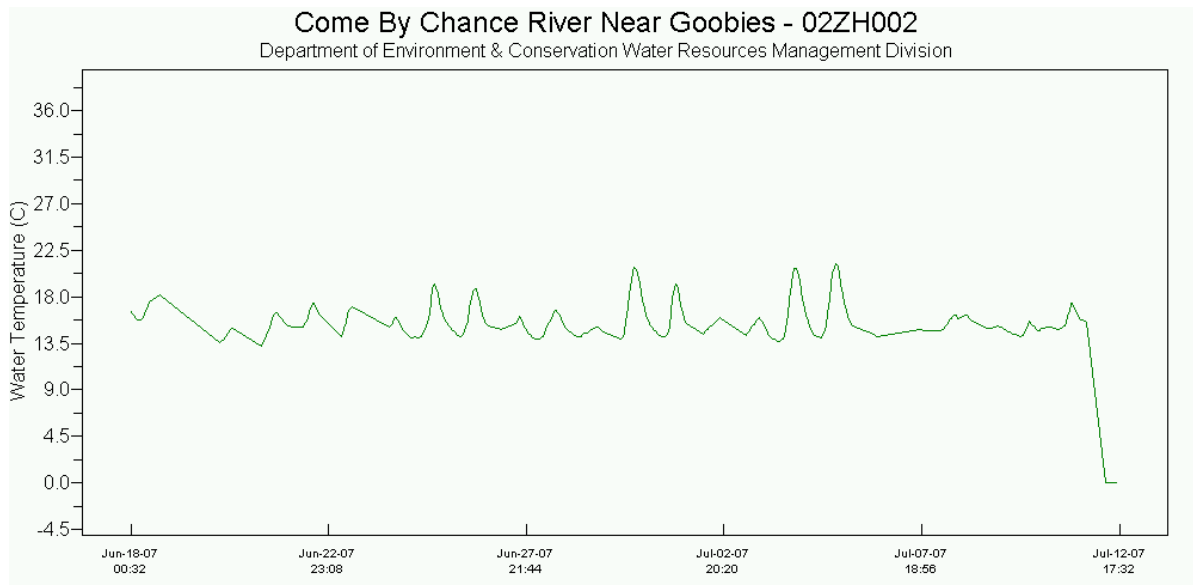
Figure 1

- This monthly report interprets the data from the Come by Chance River RTWQ station for the period of June 11th, 2007 – July 12th, 2007. Only the data that was obtained via satellite was used for the graphs in this report. The period between June 11th and June 18th is not included.
- The water temperature (**Figure 1**) readings for Come by Chance River remained fairly consistent over the deployment period. Values were as expected at this time of the year with a temperature range of 13.2– 22.54°C.

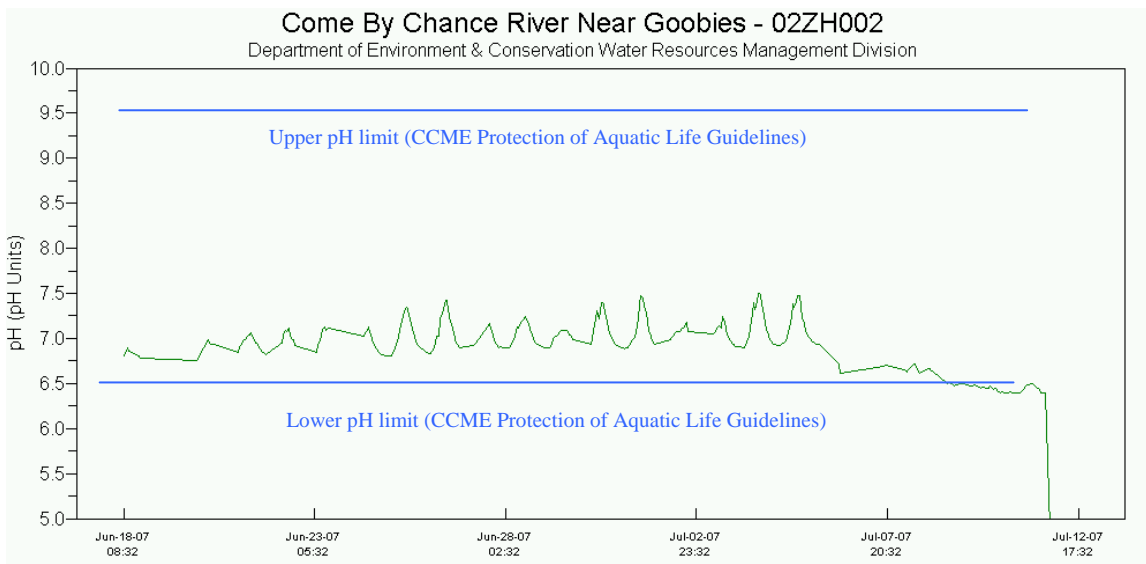
Figure 3

- The pH values (**Figure 3**) for Come by Chance River remained consistent throughout the deployment period. The pH values ranged from 6.39 – 7.5 with the majority of values falling within the recommended range (6.5 – 9.0) for the CCME Protection of Aquatic Life guidelines.

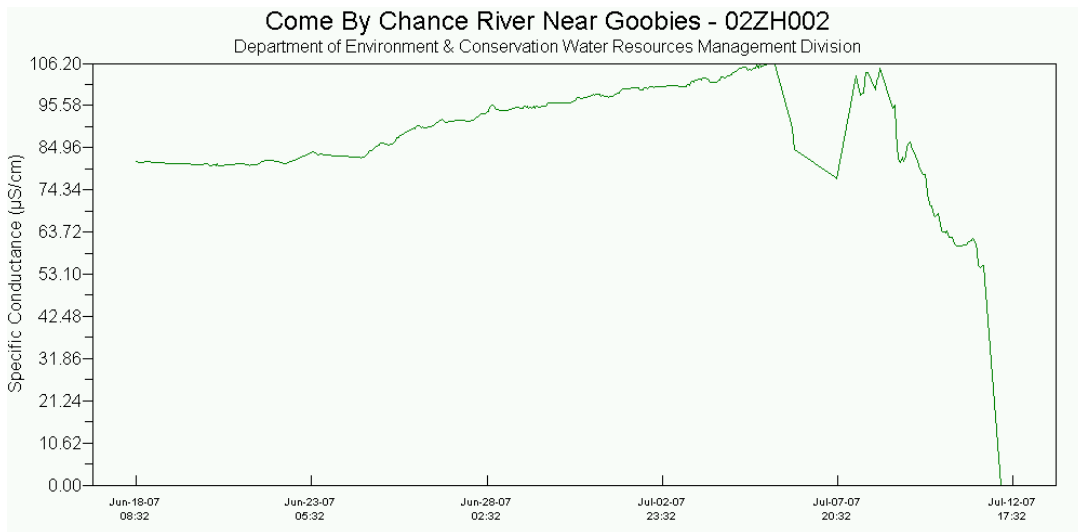
Figure 4

- The specific conductivity values (**Figure 4**) remained fairly consistent throughout the deployment period with a gradual increase to a maximum of 106.2 $\mu\text{S}/\text{cm}$. There was sharp decline in conductivity values prior to removal of the Datasonde, which was likely a result of increased flow due to increased precipitation. Values ranged from 54.7– 106.2 $\mu\text{S}/\text{cm}$.

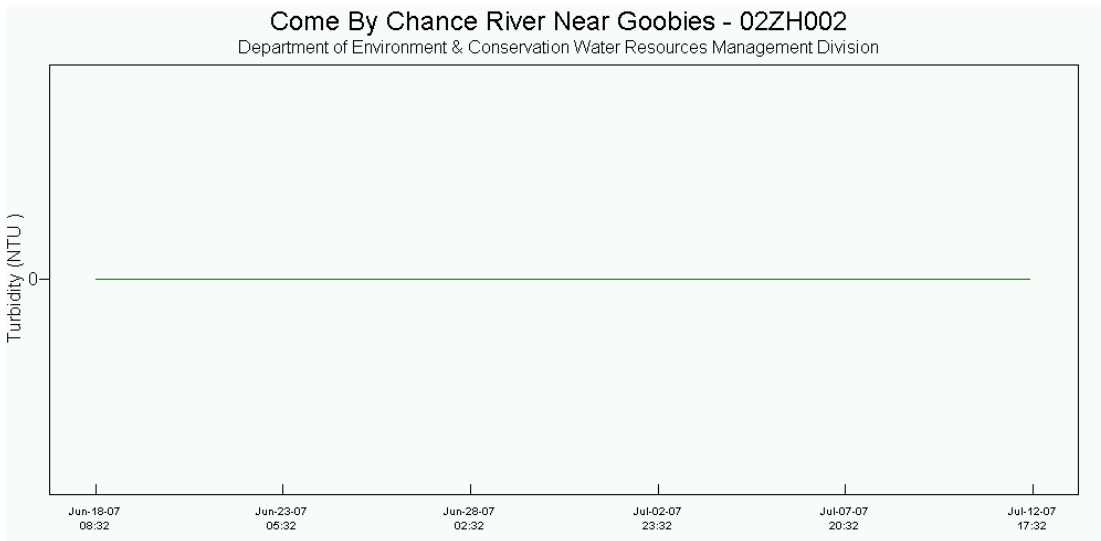
Figure 5

- . The turbidity values (**Figure 5**) remained at 0 NTU throughout the deployment period.

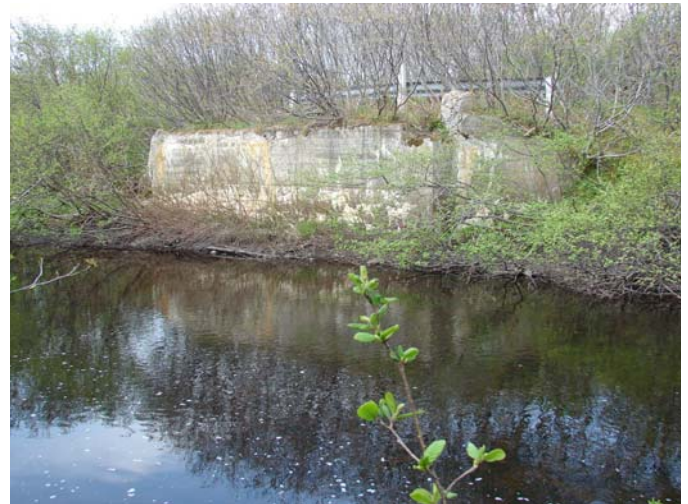
Site location – Datasonde is placed roughly midstream

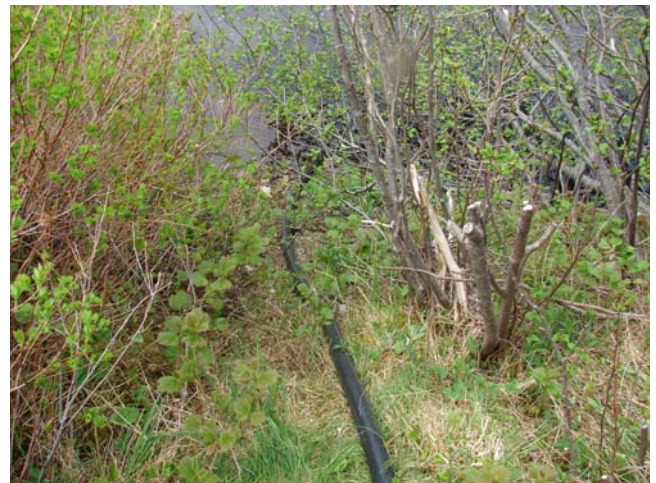
Image of conduit running down bank to Datasonde
