# Real-Time Water Quality Deployment Report

# MEMP at Great Pond

October 31, 2014 to November 24, 2014

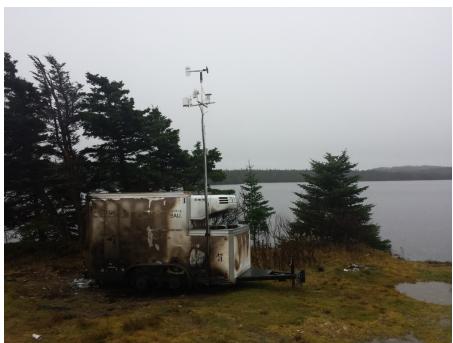
Figure 1

• Below are photos of the MEMP after the trailer was looted and burned.
