Real-Time Water Quality Deployment Report

Long Harbour Annual Report

2018

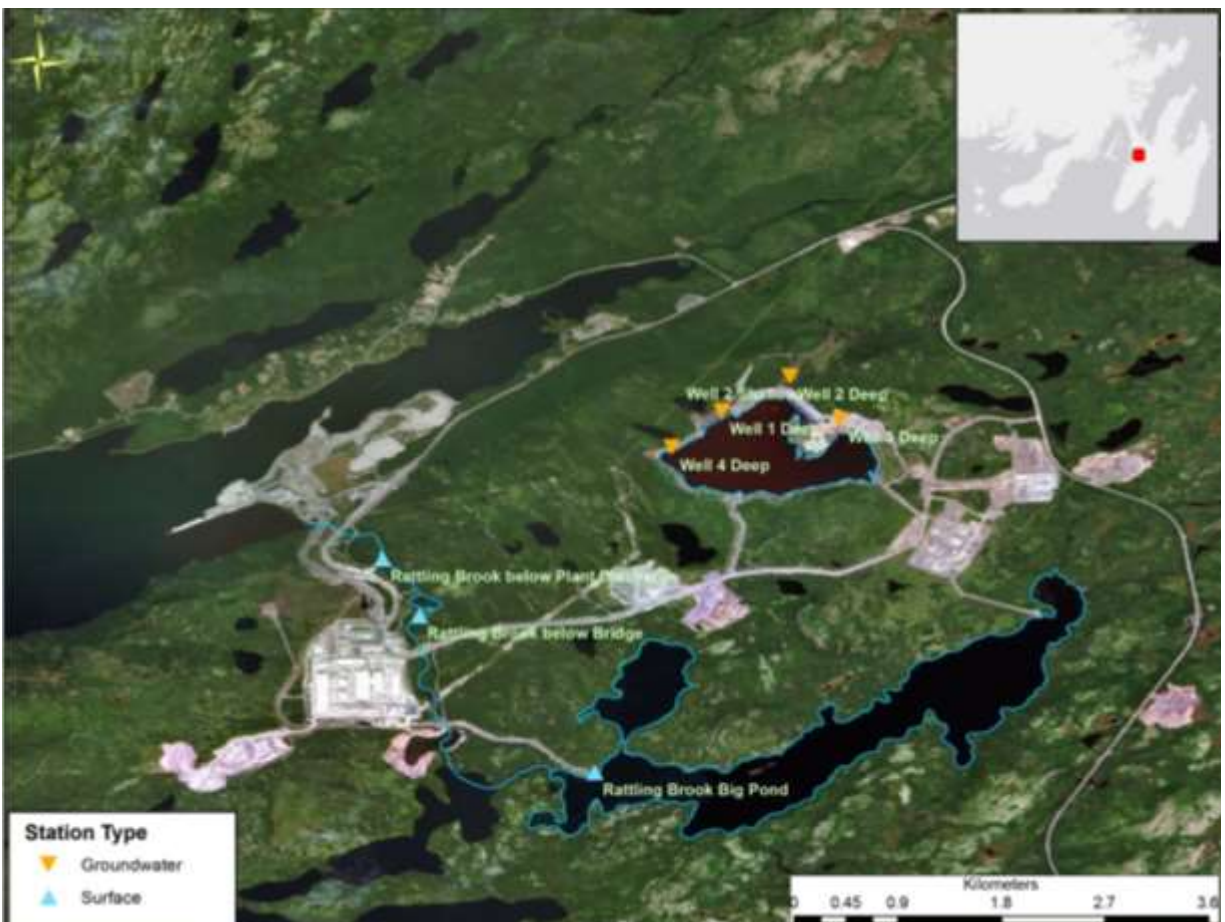
Photo 1: Real-time water quality monitoring stations in Long Harbour, Newfoundland

Surface and groundwater monitoring stations are depicted in Photo 1 below (green triangles are surface water monitoring stations on Rattling Brook and blue arrows are groundwater monitoring stations around the RSA).

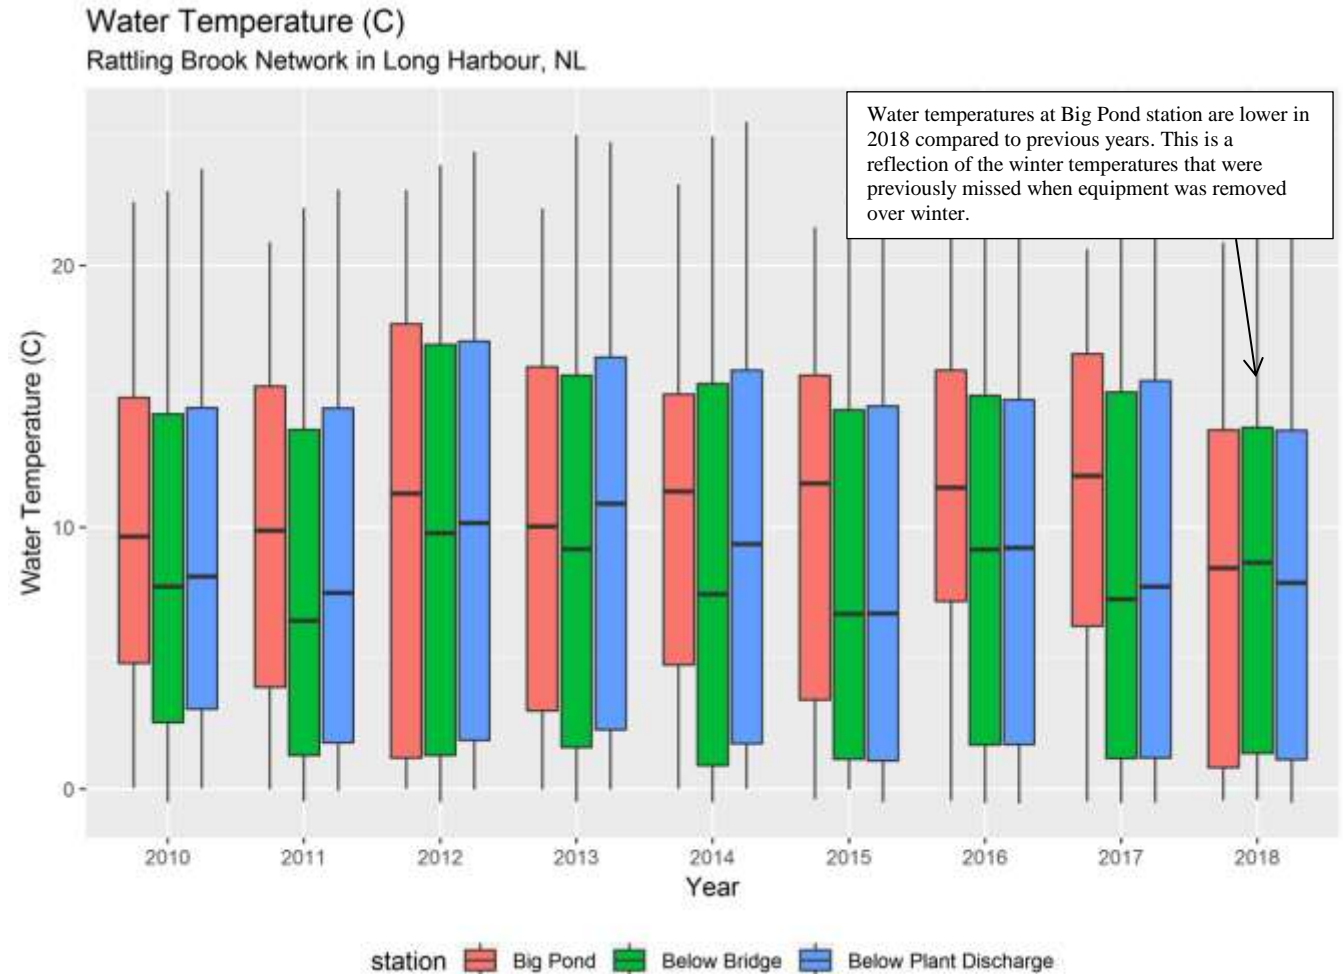
Figure 2: Boxplots of water temperature at Rattling Brook from 2010 to 2018

Winter water temperatures were recorded at Big Pond station in 2018, unlike previous years. Figure 2 clearly illustrates the considerable change that resulted from this change in procedure – the red boxplot indicates a notable decline in median value while temperatures at the two river stations are similar to previous years.

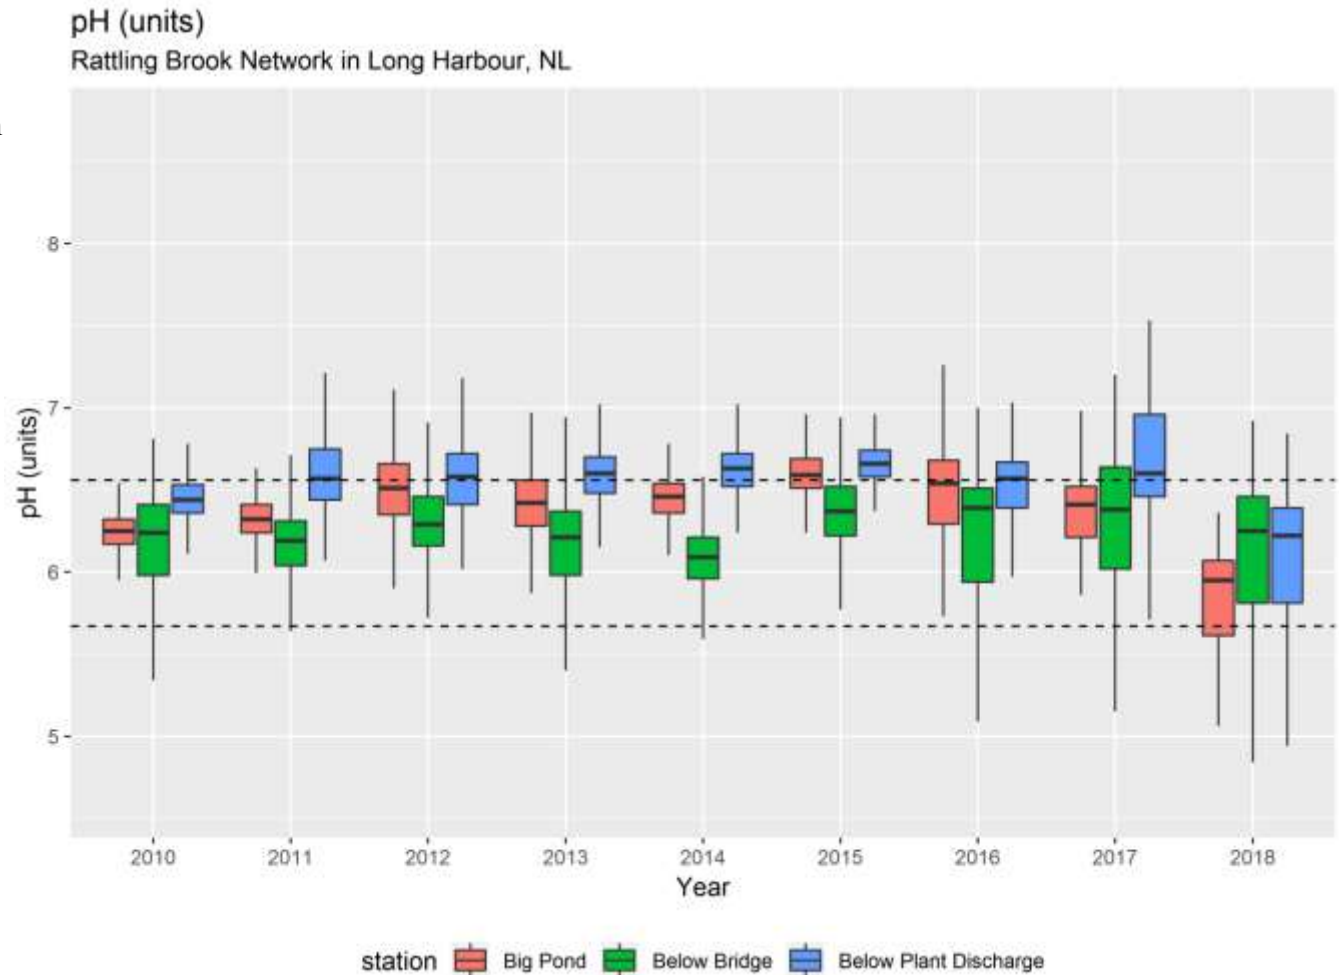
Figure 4: Boxplots of pH at Rattling Brook from 2010 to 2018

Figure 4 illustrates the change in pH values from year to year. A general upward trend appears at each station over time; however, 2018 exhibited a decline at each station from 2017 to 2018.

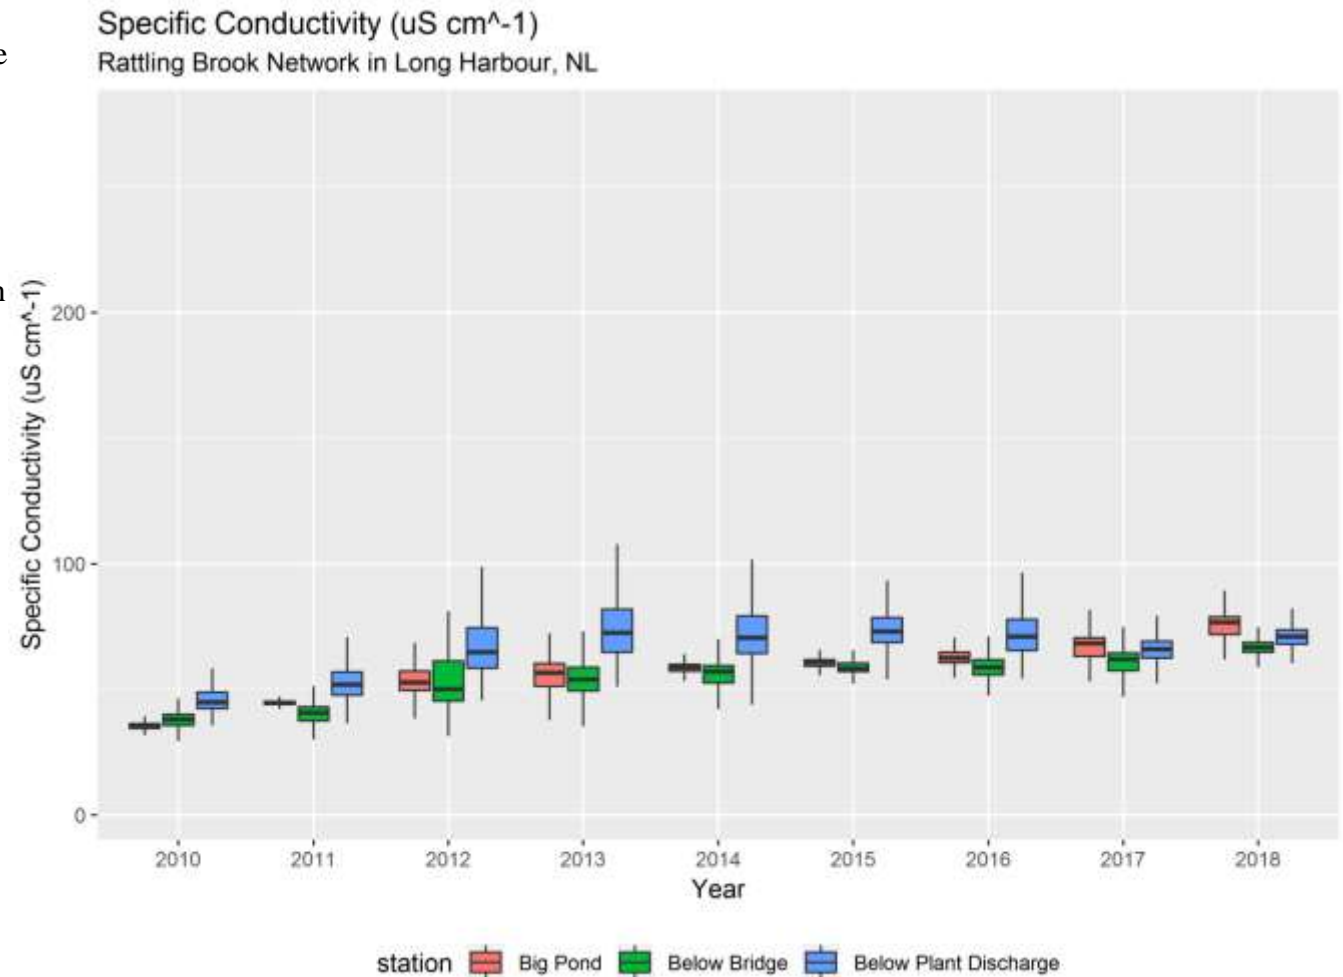
Figure 6: Boxplots of specific conductivity at Rattling Brook from 2010 to 2018

Increases in specific conductivity at each station continued into 2018. It is also notable that variability continued to decline from 2016 into 2018 (Figure 6).

The reduction in variability indicates that movement of dissolved solids into the river system is beginning to stabilize. Specific conductivity values could begin to decline in the future.

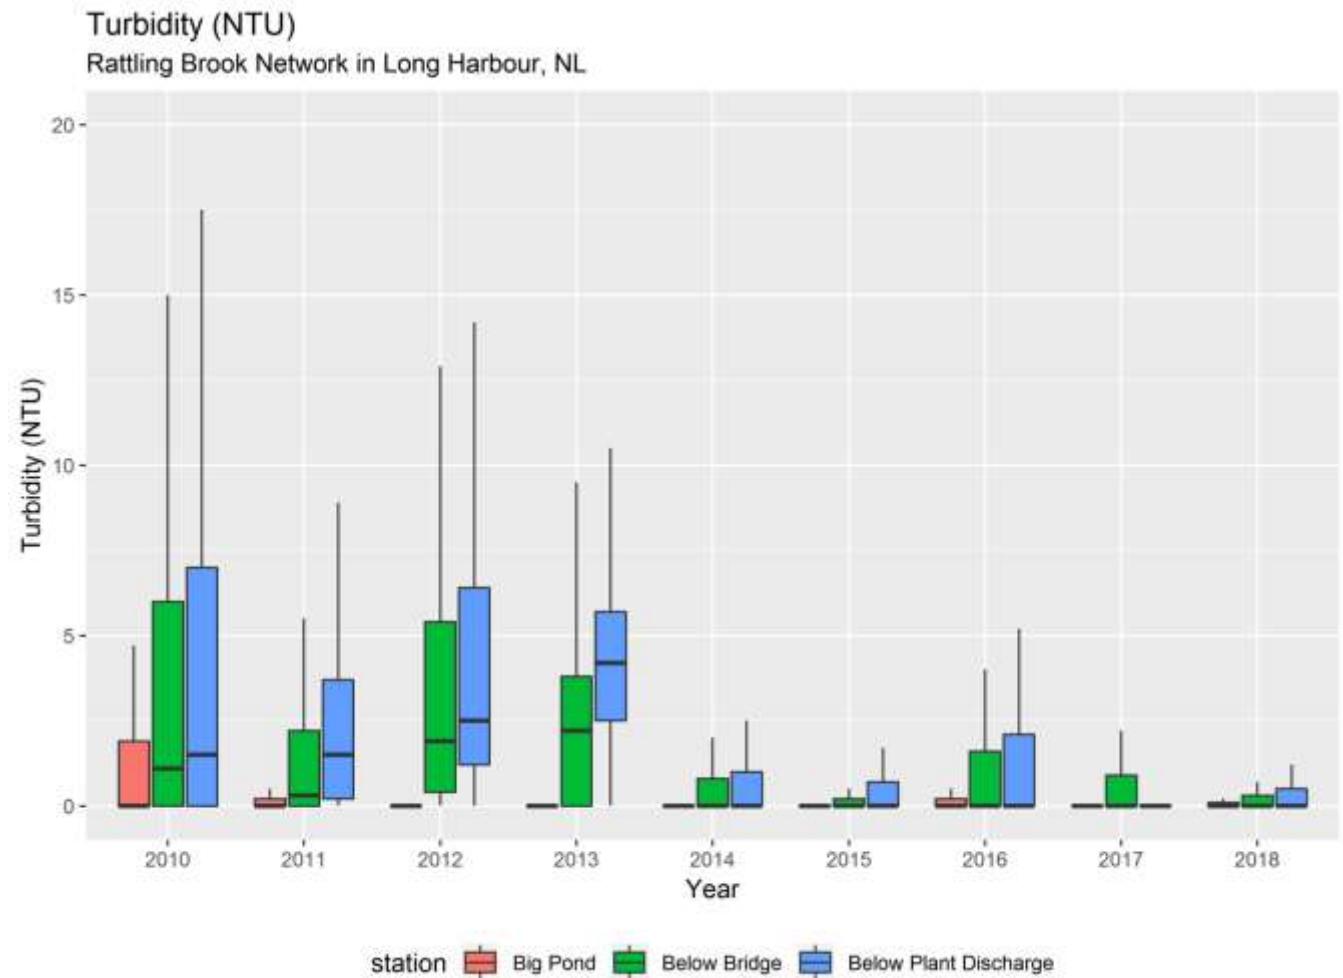
Figure 10: Boxplots of Turbidity at Rattling Brook from 2010 to 2018

As shown in Figure 10, turbidity levels in 2018 are similar to those observed in 2017 although a declining trend is ongoing at Bridge station since 2016.

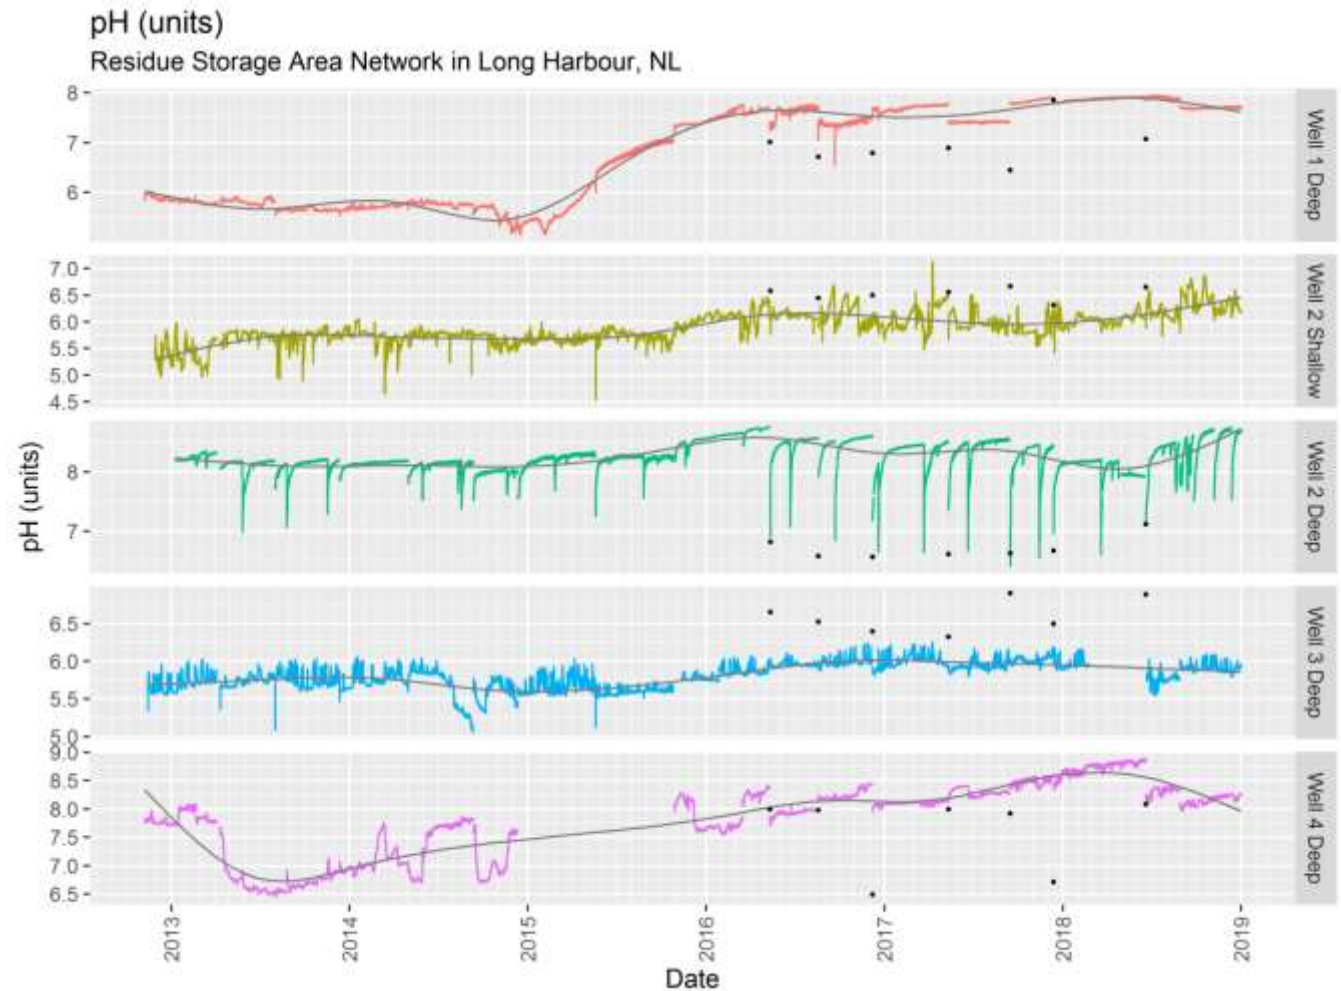
Figure 13: pH at the Residue Storage Area from 2012 to 2018

Long term trends are difficult to extrapolate from Figure 13, but the gray trend lines show potentially rising pH at wells 1 Deep, 2 Deep, 2 Shallow, and 4 Deep. Grab samples support this and show a rising tendency at wells 1 Deep, 2 Shallow, and 2 Deep. This will be closely monitored.

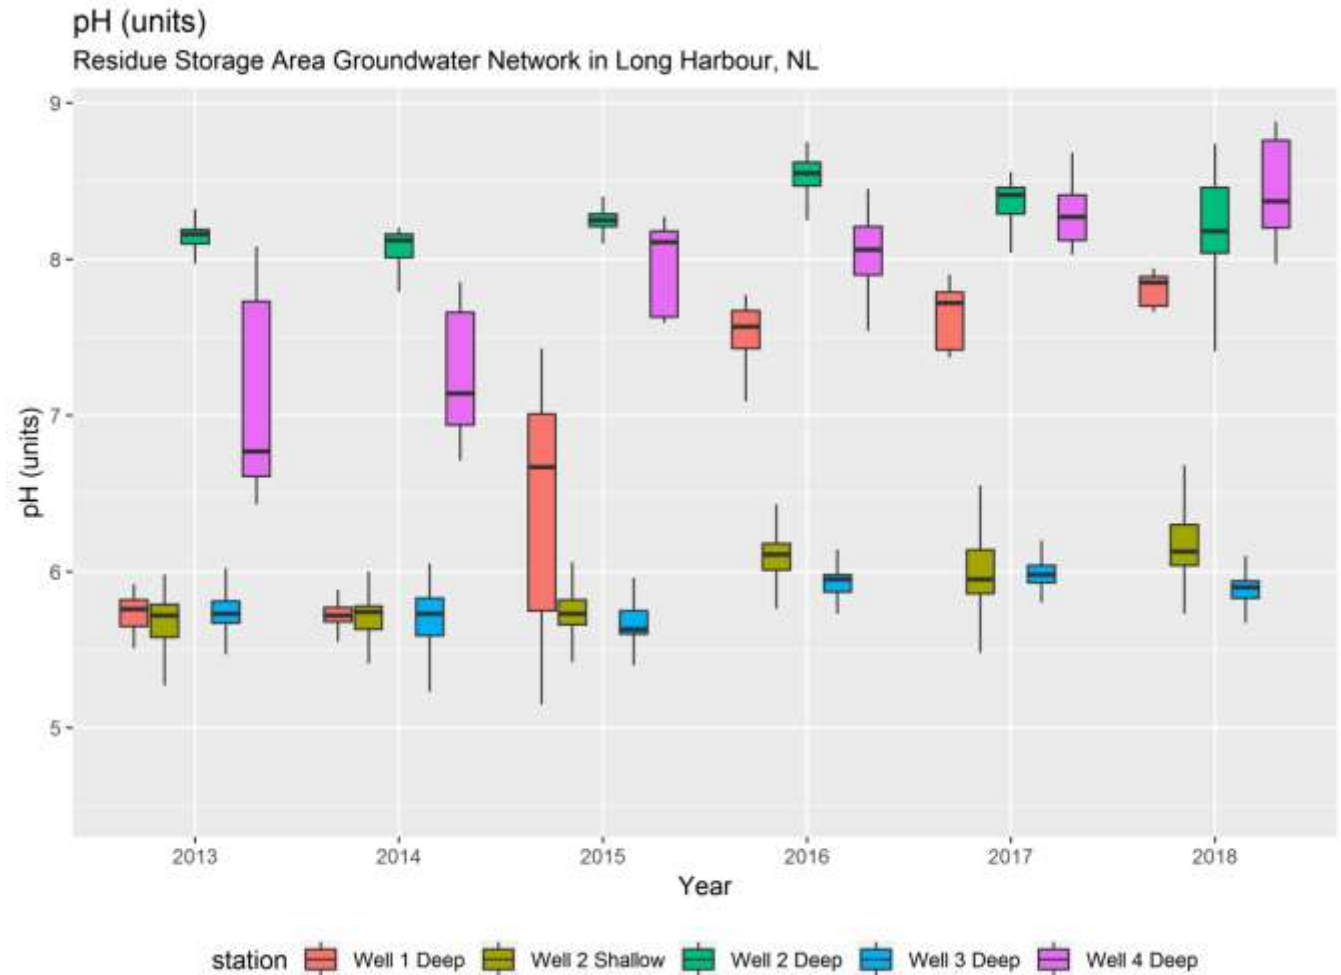
Figure 14: Boxplots of pH at the Residue Storage Area from 2013 to 2018

Increasing pH values are most obvious at wells 1 Deep and 4 Deep and, to a lesser degree, 2 Shallow and 2 Deep, according to Figure 14.

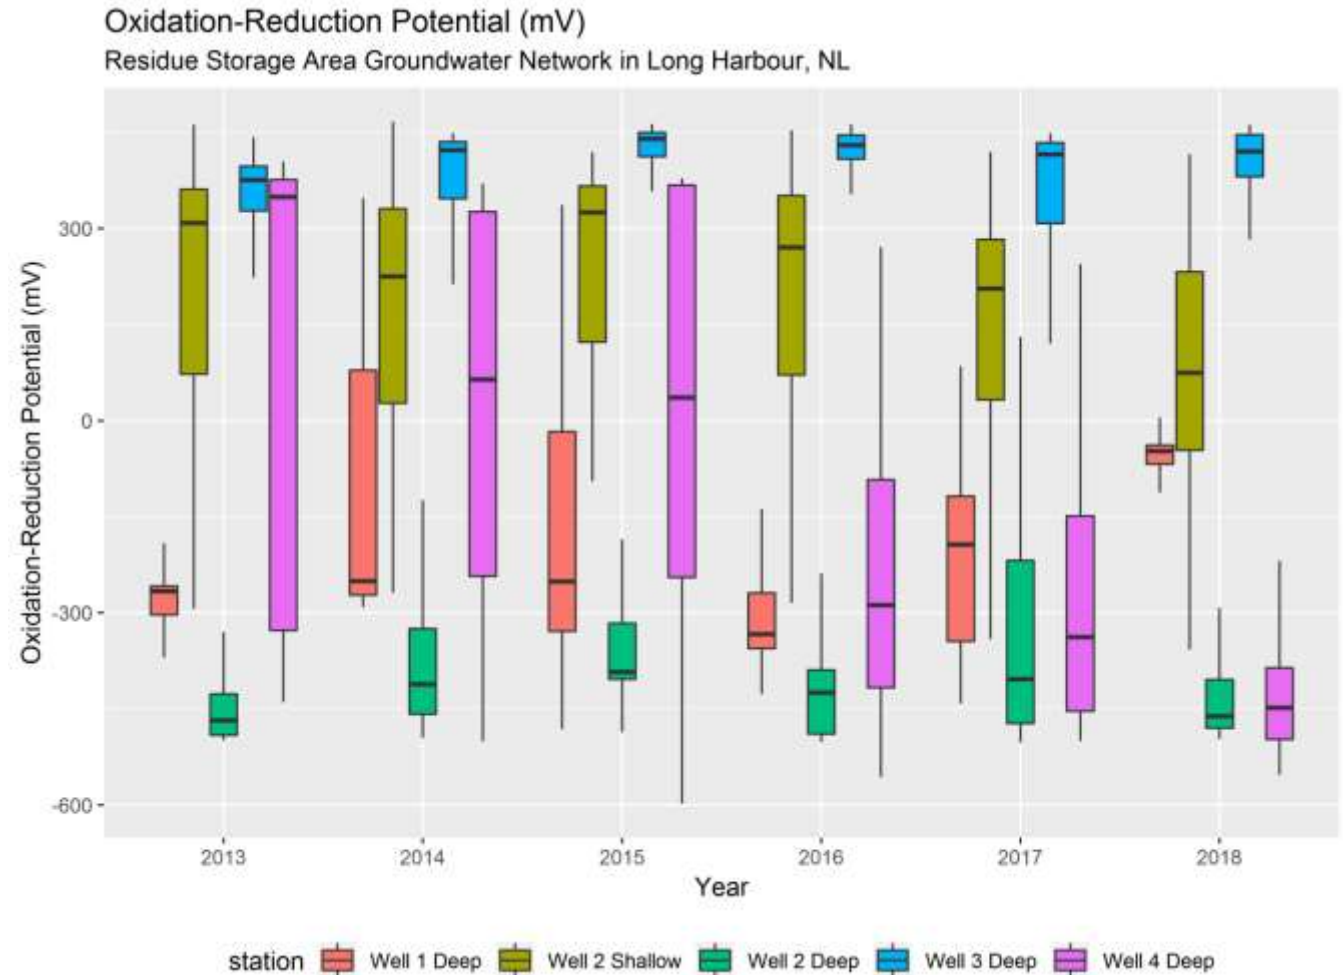
Figure 18: Boxplots of Oxidation-Reduction Potential at the Residue Storage Area from 2013 to 2018

Year-over-year tendency in ORP values are most clearly shown in Figure 18. Wells 1 Deep, 2 Shallow, and 4 Deep can be seen to change to a much larger degree than wells 3 Deep and 2 Deep.

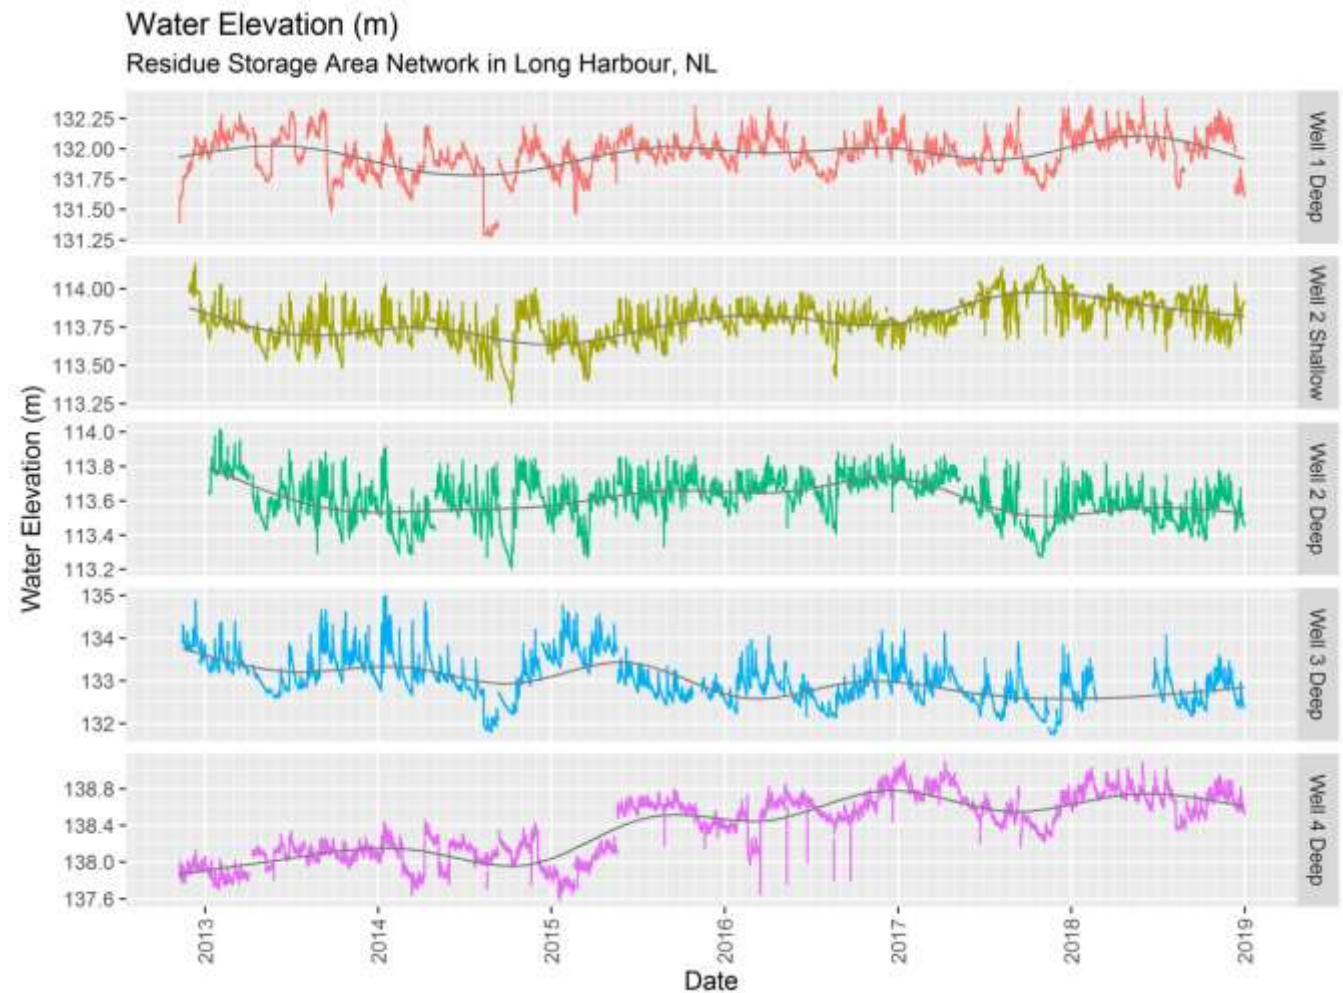
Figure 19: Water elevation at the Residue Storage Area from 2012 to 2018

The local height of the aquifer surrounding each well is closely indicated by the water level in each well. These values are not expected to change a great deal over the long term, barring unforeseen circumstances or major changes to water level in nearby water bodies.

Periodic variation is commonplace as illustrated by Figure 19 but levels in 2018 were close to previous years as shown in Table 10
