Real-Time Water Quality

Deployment Report

Vale Nickel Project

Annual Report 2010

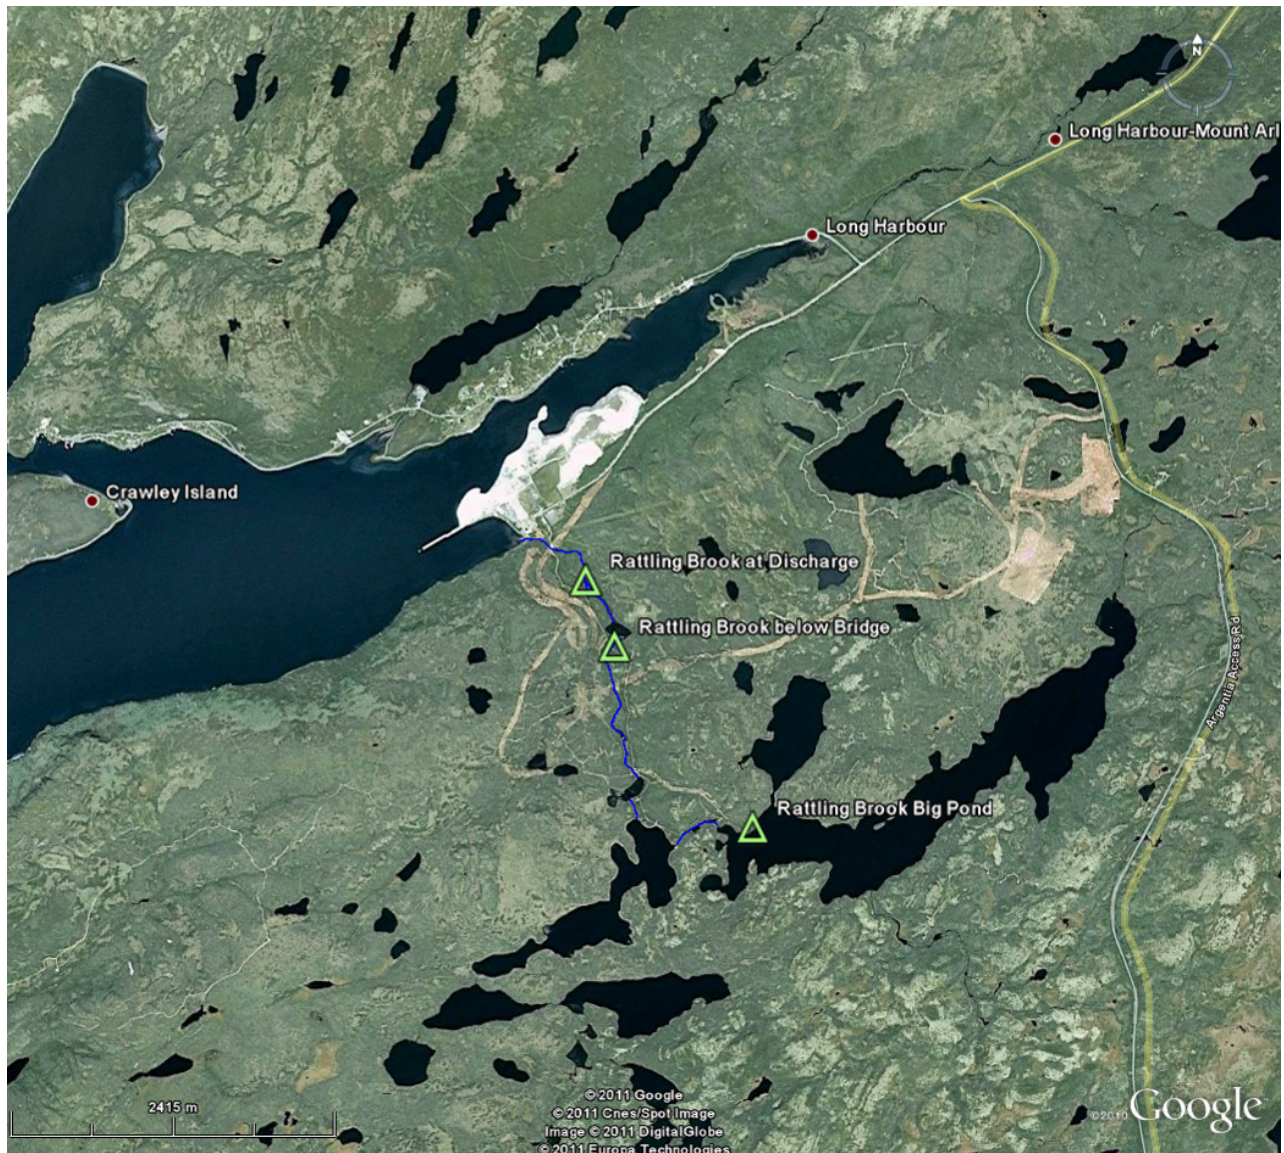
Figure 1: Rattling Brook Water Quality Network

Shown in Figure 1, the network comprises of three stations (green triangles). Big Pond station is situated in the upper reaches of the Rattling Brook river system and provides a background picture of water quality without impact by construction efforts. As water progresses through the river system, Bridge station (the oldest in the network) is reached, followed by Discharge station.

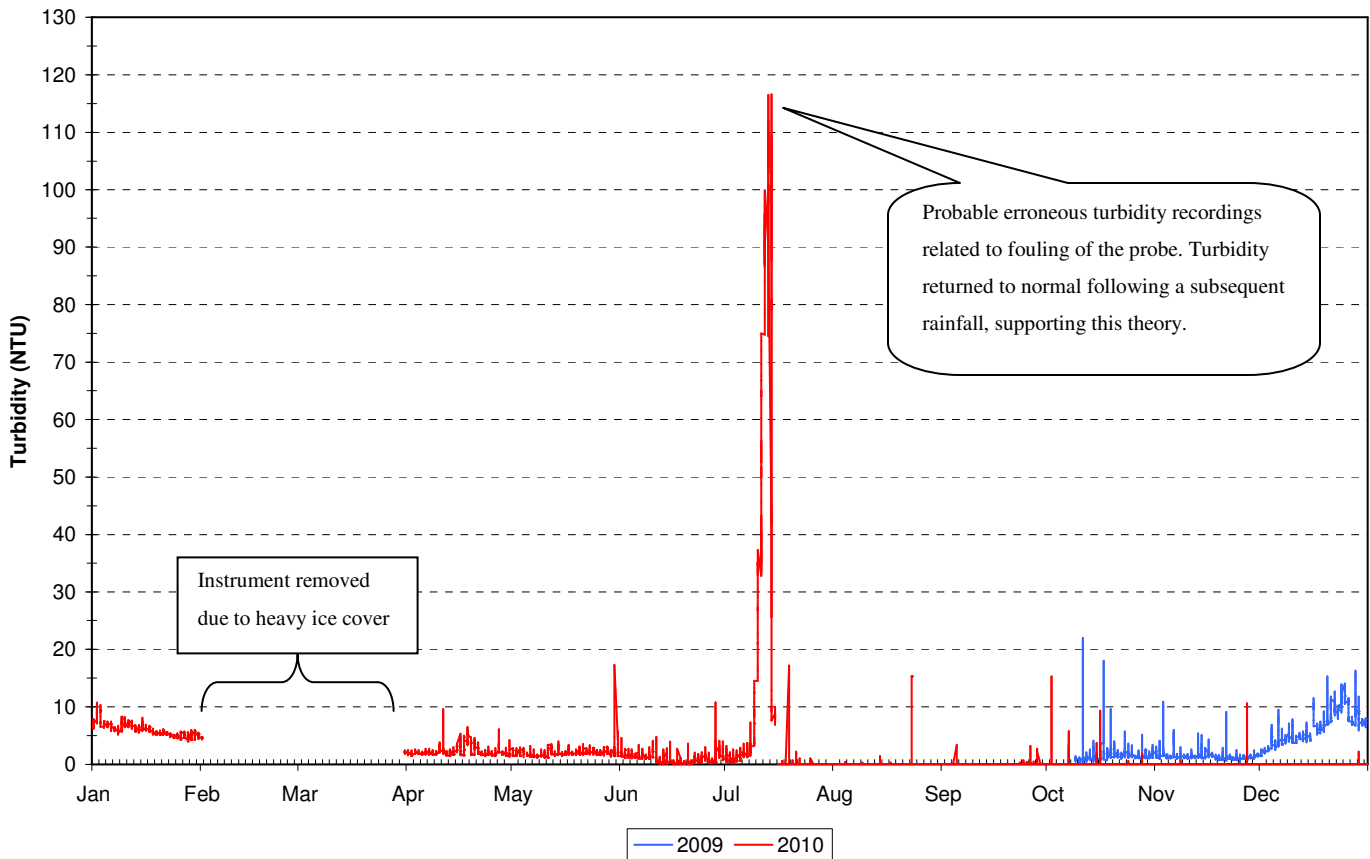
Figure 6: Turbidity at Rattling Brook Big Pond, 2009 – 2010

Very little was recorded in terms of turbidity in 2010. By far, most values were free of turbidity since the calculated median is 0.0 NTU (90% CI: 0.0 – 0.0 NTU). A range of 0.0 to 116.6 NTU was observed. Occasional spikes are recorded during precipitation events, but the probable cause in most instances is sediment stirred up by wave action or chance blockage by drifting debris.

In July, the annual maximum was encountered. It has been determined that this plateau (indicated in Figure 6) is probably related to biofouling of the sensor as opposed to as true readings since turbidity drops abruptly following a rainfall event indicating wave action and water influx may have cleared the sensor.

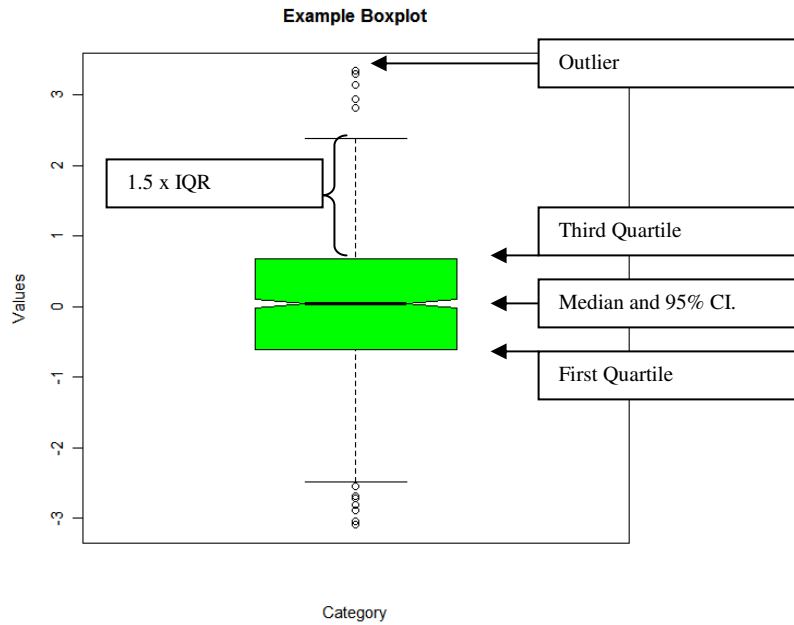
Figure 7: Anatomy of a Boxplot

A series of boxplots are included for each parameter. A boxplot is useful for illustrating the range of values encountered and presenting the skew of a distribution through the relative placement of first, second (median) and third quartiles. Outliers, or extreme values, are expressed as individual hollow circles once they are outside 1.5 times the interquartile range (IQR). See Figure 7 for details.

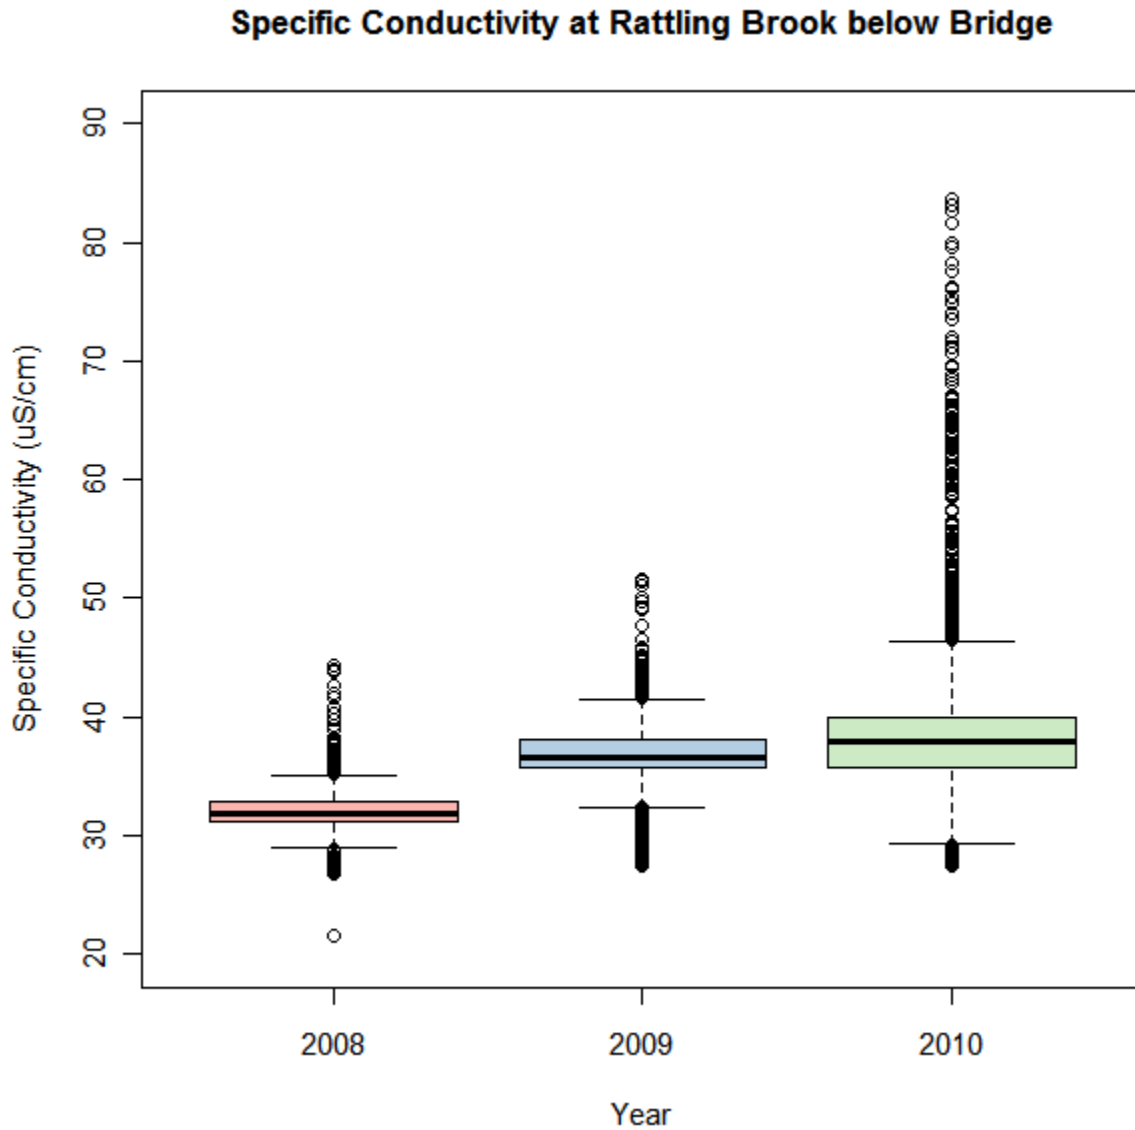
Figure 13: Boxplots of Specific Conductivity for 2008 – 2010 at Rattling Brook below Bridge

In 2010, conductivity was found to range from 27.4 to 83.6 $\mu\text{S}/\text{cm}$ with a median of 35.6 $\mu\text{S}/\text{cm}$ (90% CI: 35.6 – 35.6 $\mu\text{S}/\text{cm}$). As shown in the boxplots depicted in Figure 12, it is notable that values identified as

outliers are increasingly elevated compared to prior years. This highlights the importance of protecting Rattling Brook from silt-laden runoff.

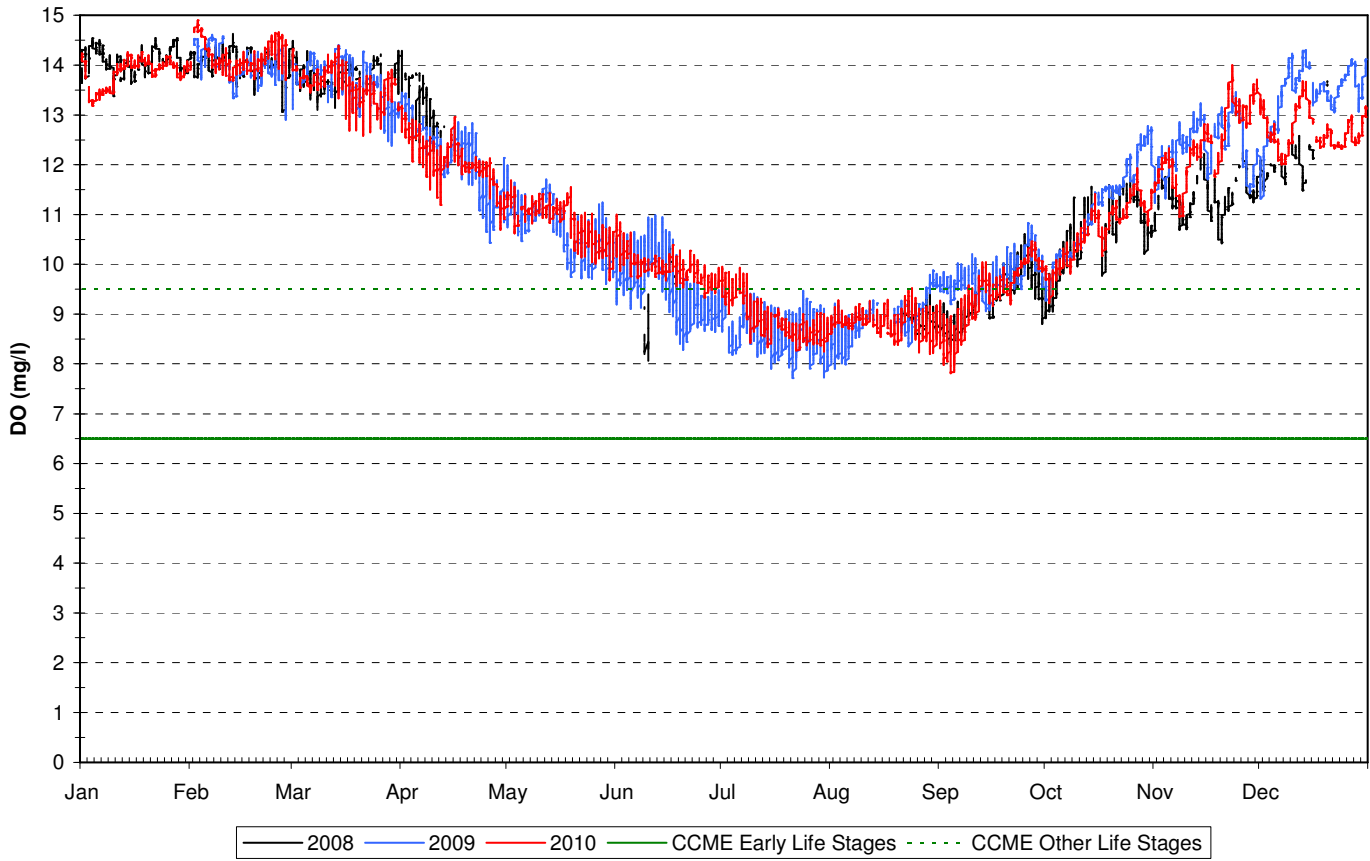
Figure 14: Dissolved Oxygen at Rattling Brook below Bridge, 2008– 2010

DO concentration values are highly consistent in a year-to-year comparison. Throughout most of 2010, DO coincided very well with previous years (Figure 15), except for some variability during the winter months of November through January (Figure 14).

In 2010, the recorded values ranged from 7.81 to 14.9 mg/l with a median value of 10.69 mg/l (90% CI: 10.62 – 10.76 mg/l). At no time did the DO concentrations decline below the CCME guideline for the protection of early life stage cold water biota (lower dashed green line in Figure 14).

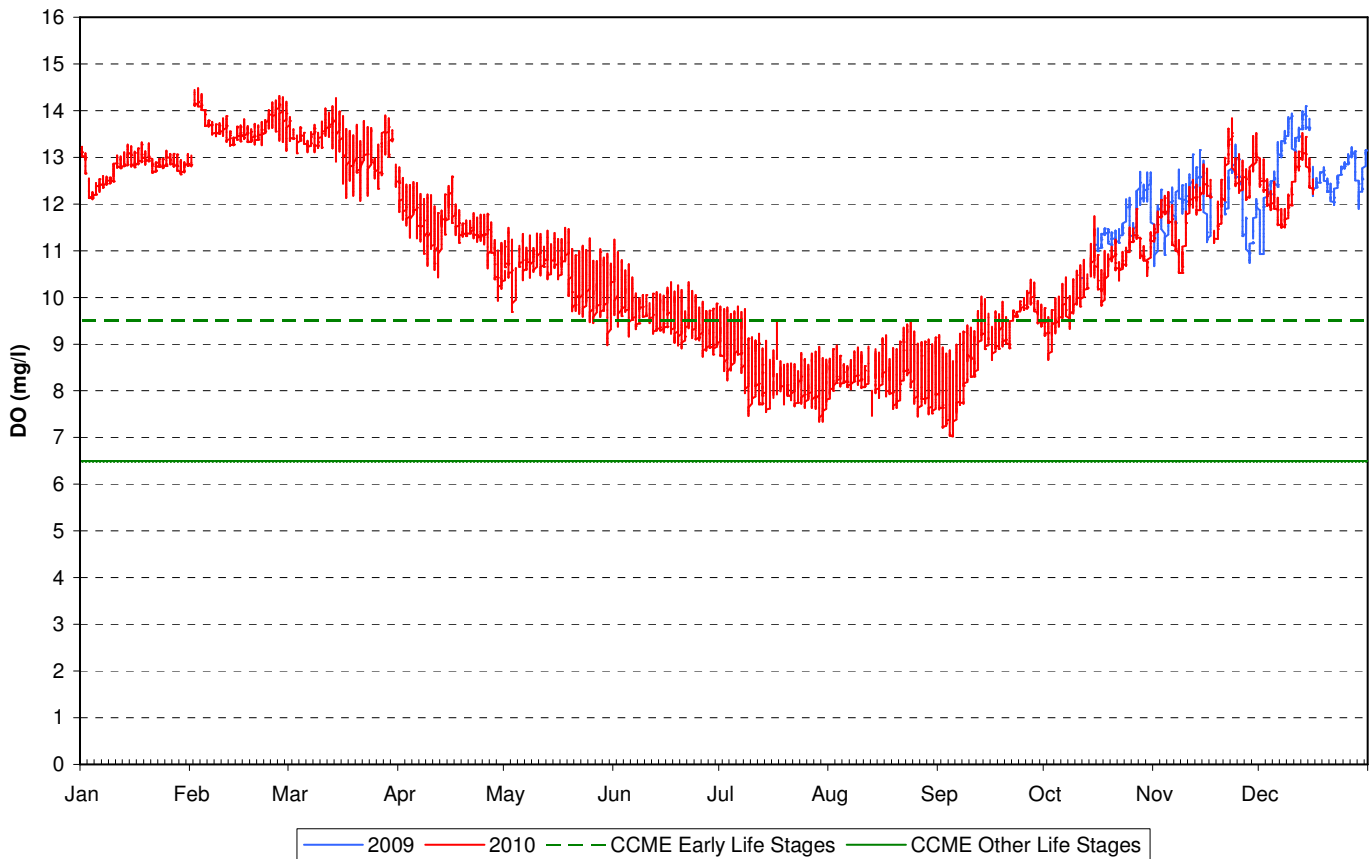
Figure 21: Dissolved Oxygen at Rattling Brook below Plant Discharge, 2009 – 2010

The trend for dissolved oxygen in 2010 was as expected with the highest values recorded in the cold winter months of February and early March. Concentrations began to decline as water temperatures increase from mid-March to July. For the concurrent 2009 and 2010 values, there does not appear to be any meaningful difference.

Values were found to range from 7.02 to 14.48 mg/l with a median value of 10.94 mg/l (90% CI: 94.0 – 94.2 mg/l). All values were found to be above the CCME Guideline for Other Life Stage cold water biota.

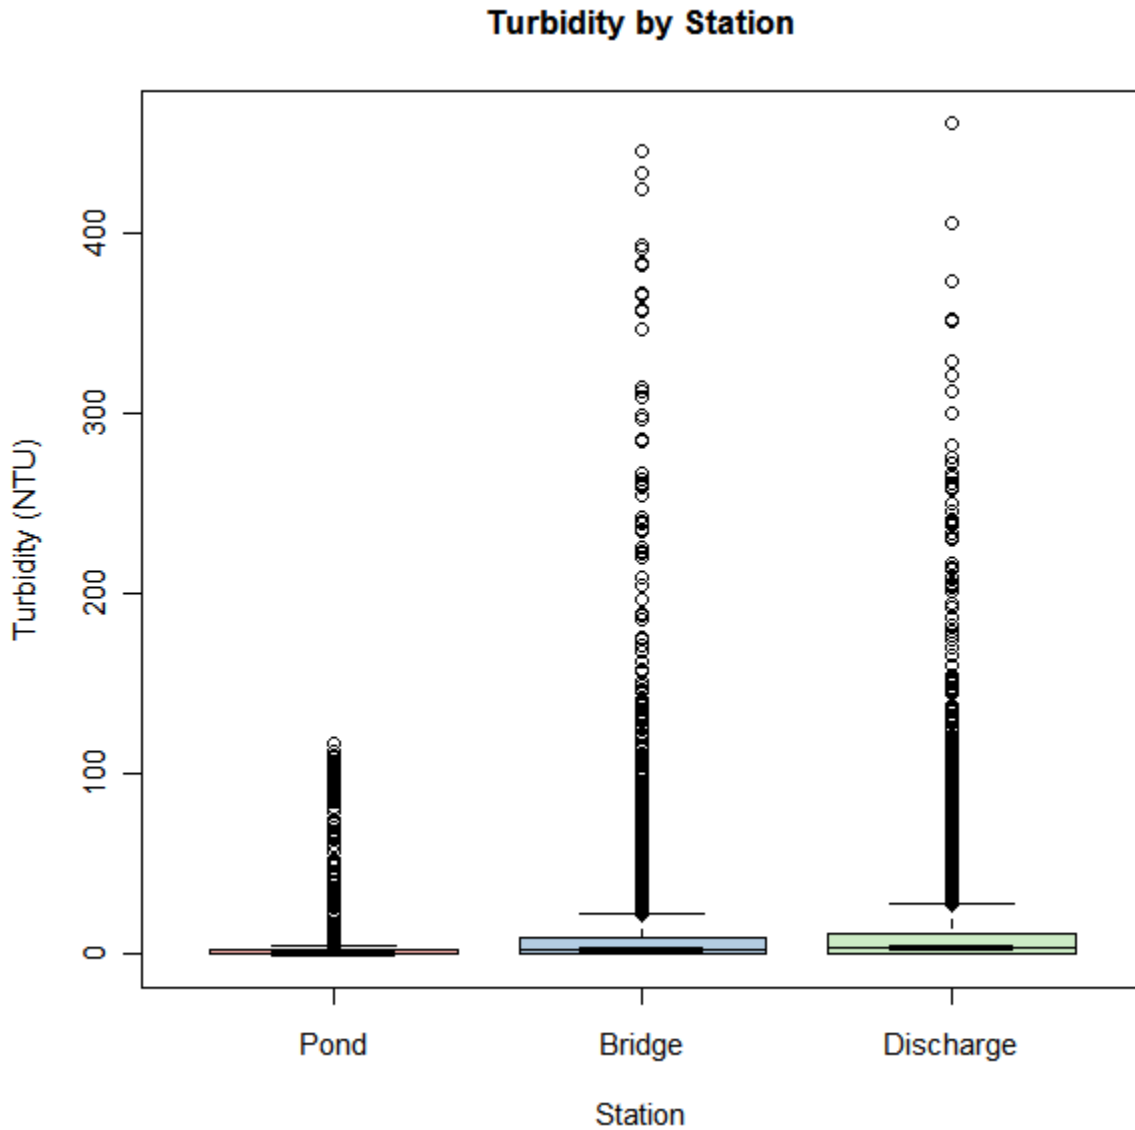
Figure 32: Boxplots of Turbidity for Pond, Bridge and Discharge Stations in 2010

Outlier values are common in turbidity as Figure 32 shows. Turbidity tends to be quite flashy and transient because of the fast flowing water commonly occurring during turbidity events – the particulate matter is normally flushed through the system quickly.

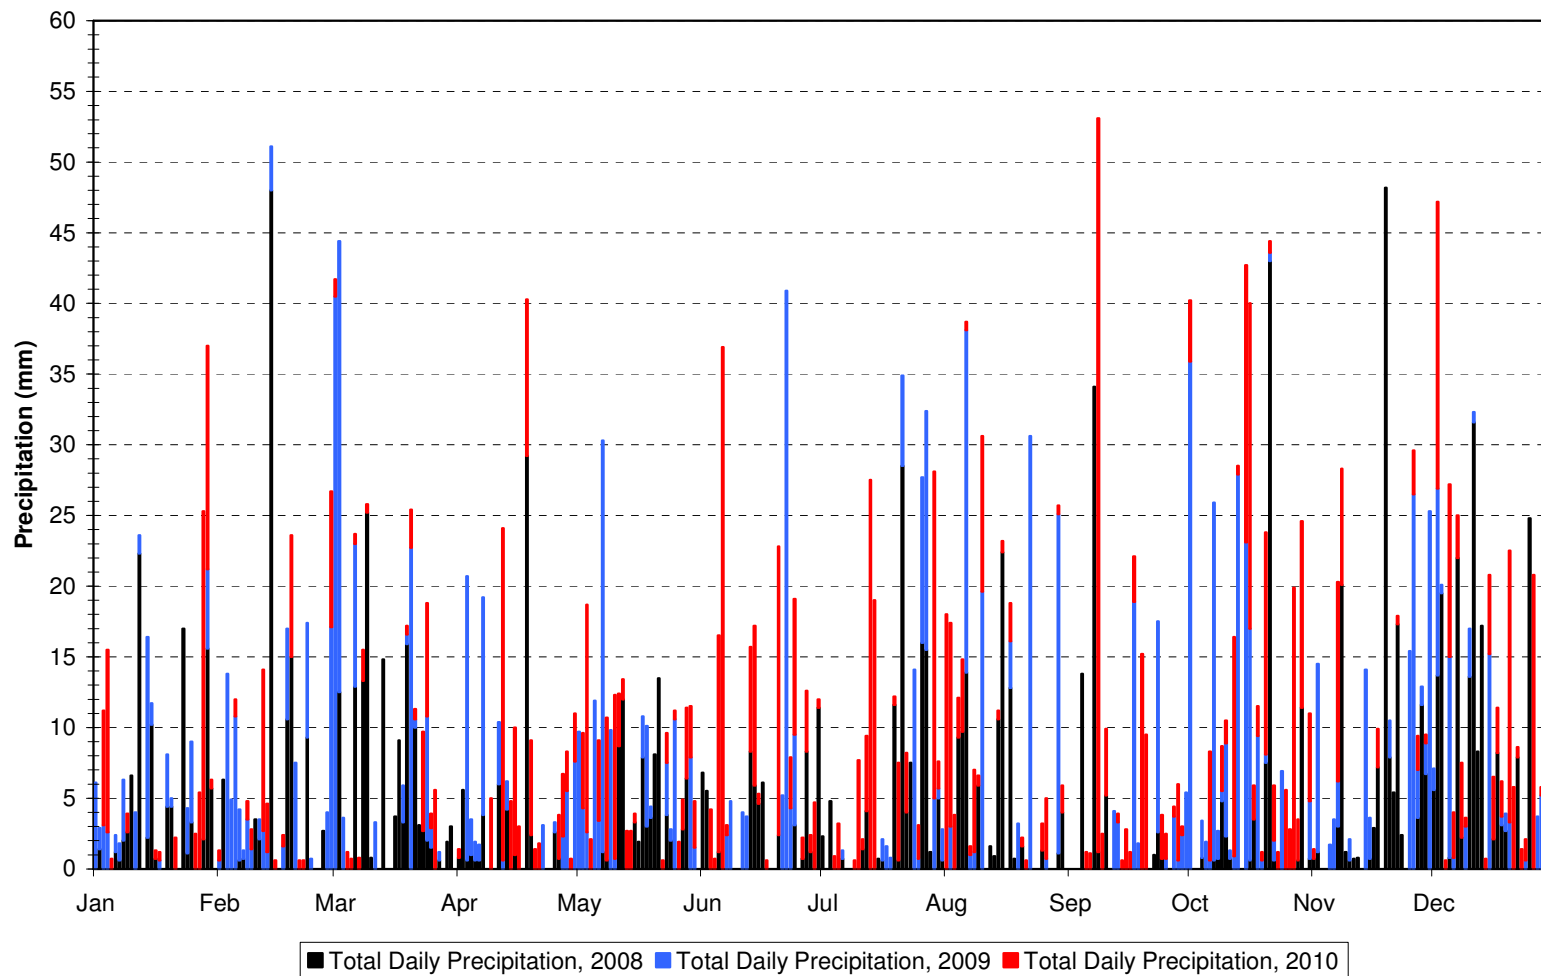
Figure 34: Total Daily Precipitation at the Argentia Weather Station for 2008, 2009 and 2010

Total Daily Precipitation at Argentia Weather Station
