Real-Time Water Quality

Deployment Report

Vale Nickel Project

Annual Report 2011

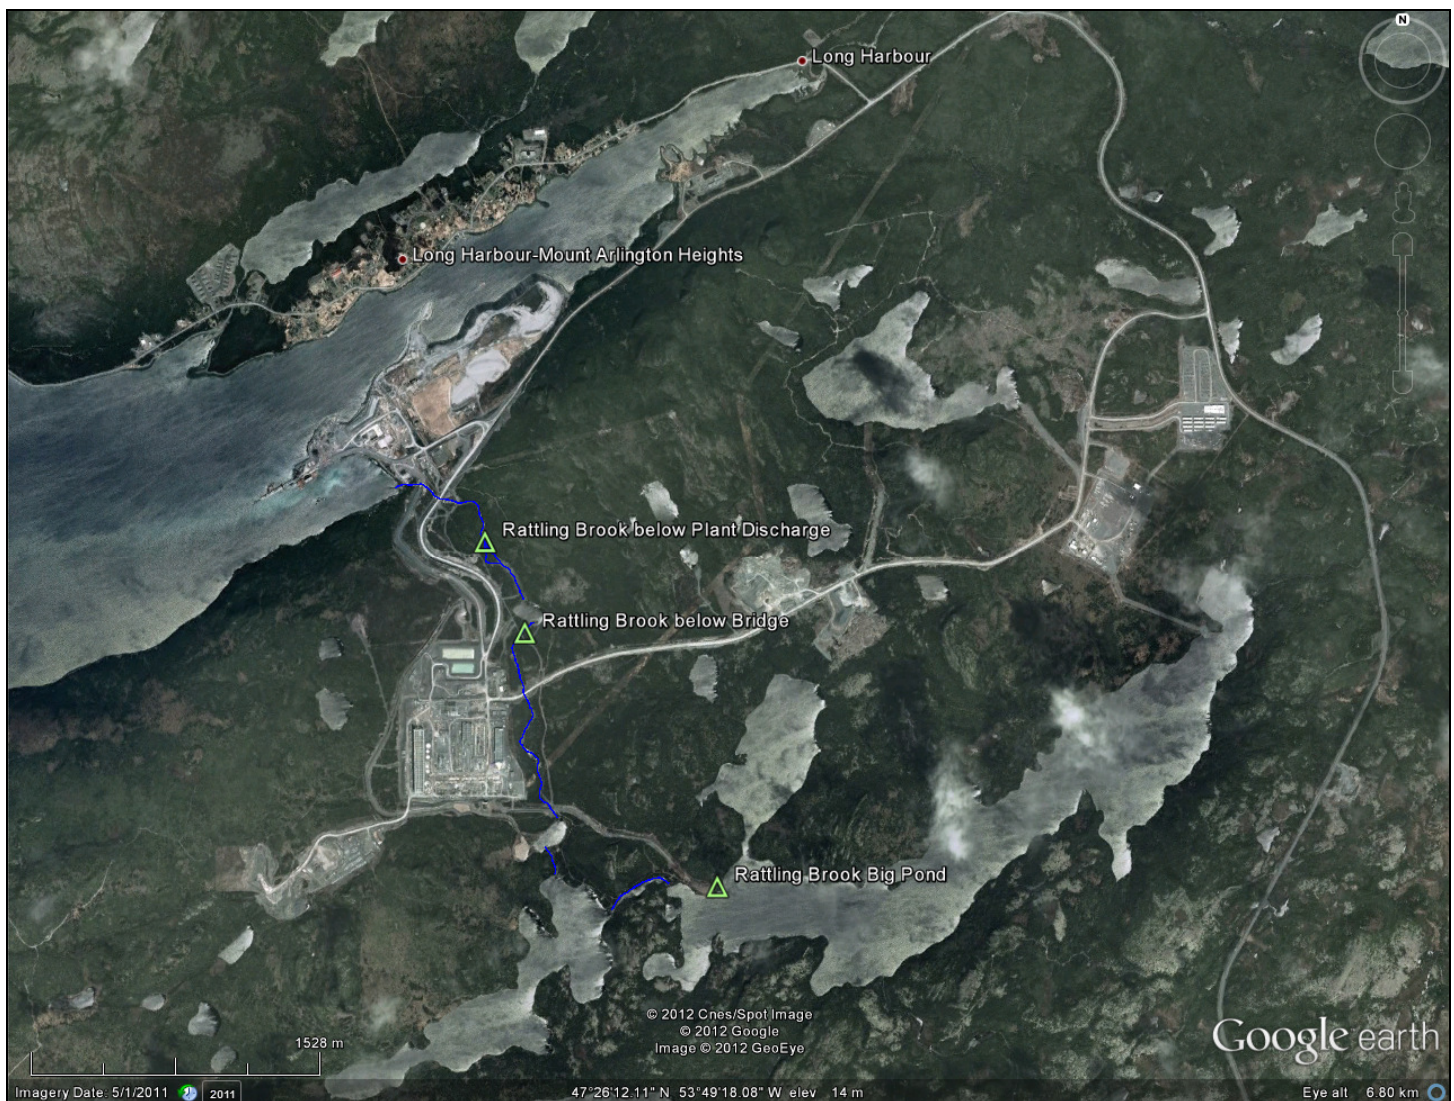
Figure 1: Rattling Brook Water Quality Network

Continuous water quality monitoring has been underway on Rattling Brook for five years since the deployment of Bridge station in 2006. At present, three surface water quality stations provide water quality data in near-real time at Big Pond station, Bridge station, and Plant Discharge station (Figure 1).

Big Pond was established in the fall of 2009 with the aim of maintaining a record of baseline water quality in the Rattling Brook network. Bridge station, established in late 2006, was established as a baseline monitoring

site prior to any work by Vale in the area. Lastly, Plant Discharge station was commissioned in 2009 to capture the discharge of overland runoff and stormwater from the construction of the Hydromet plant site.

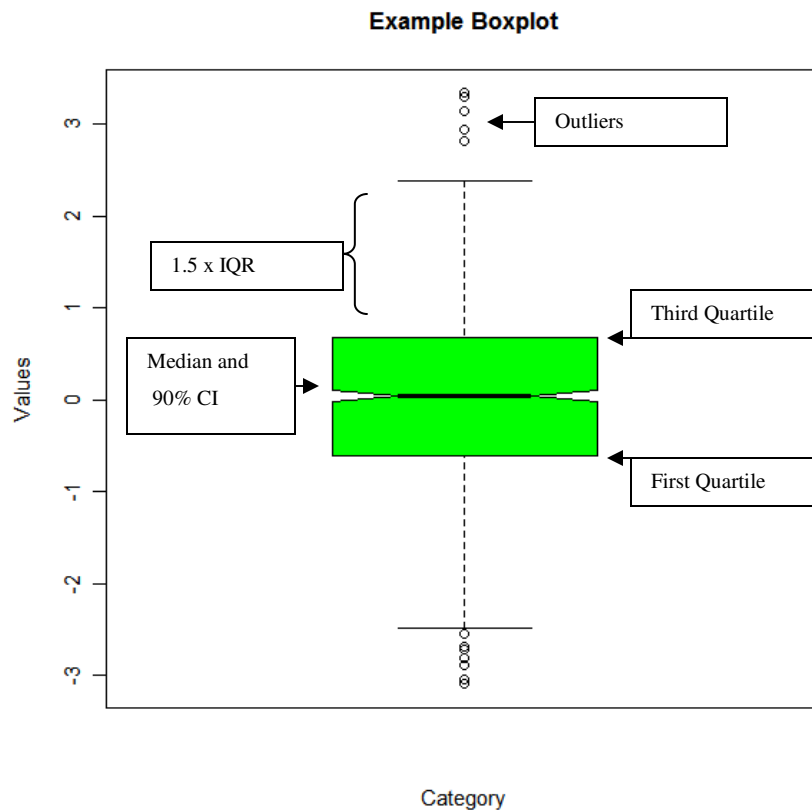
Figure 2: Anatomy of a Boxplot

This section makes extensive use of the boxplot as shown in Figure 2. A boxplot is useful for illustrating the range of values encountered and presenting the skew of a distribution through the relative placement of first, second (median) and third quantiles. Outliers, or extreme values, are expressed as individual hollow circles once they are outside 1.5 times the interquartile range (IQR). See Figure 2 for details.

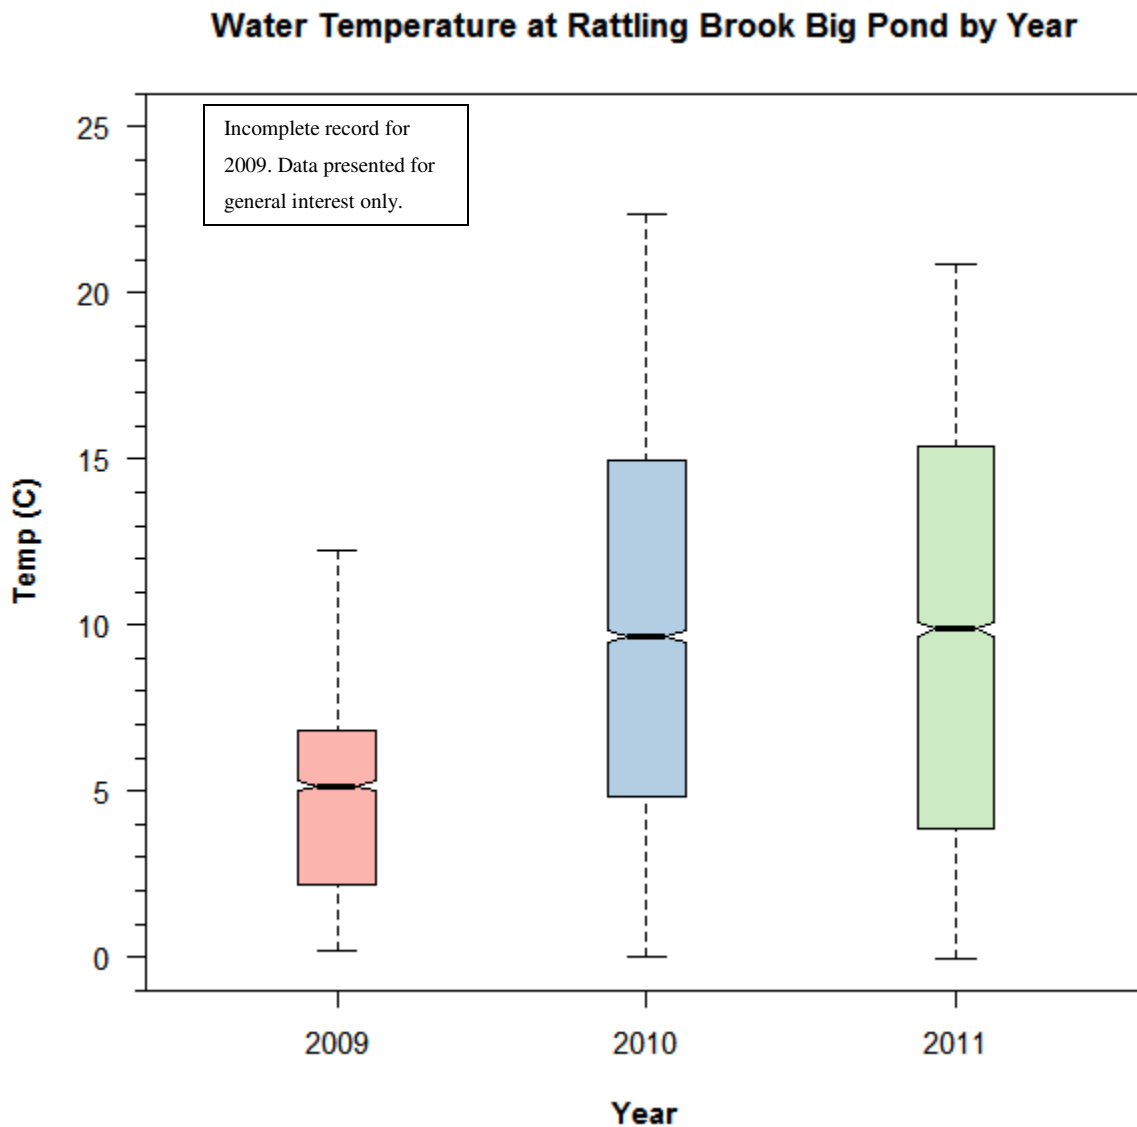
Figure 4: Boxplots of Water Temperature at Rattling Brook Big Pond, 2009 – 2011

Water temperatures are comparable between 2010 and 2011. Since the station was commissioned in October 2009, warm summer temperature values were missed, skewing the distribution towards lower values.

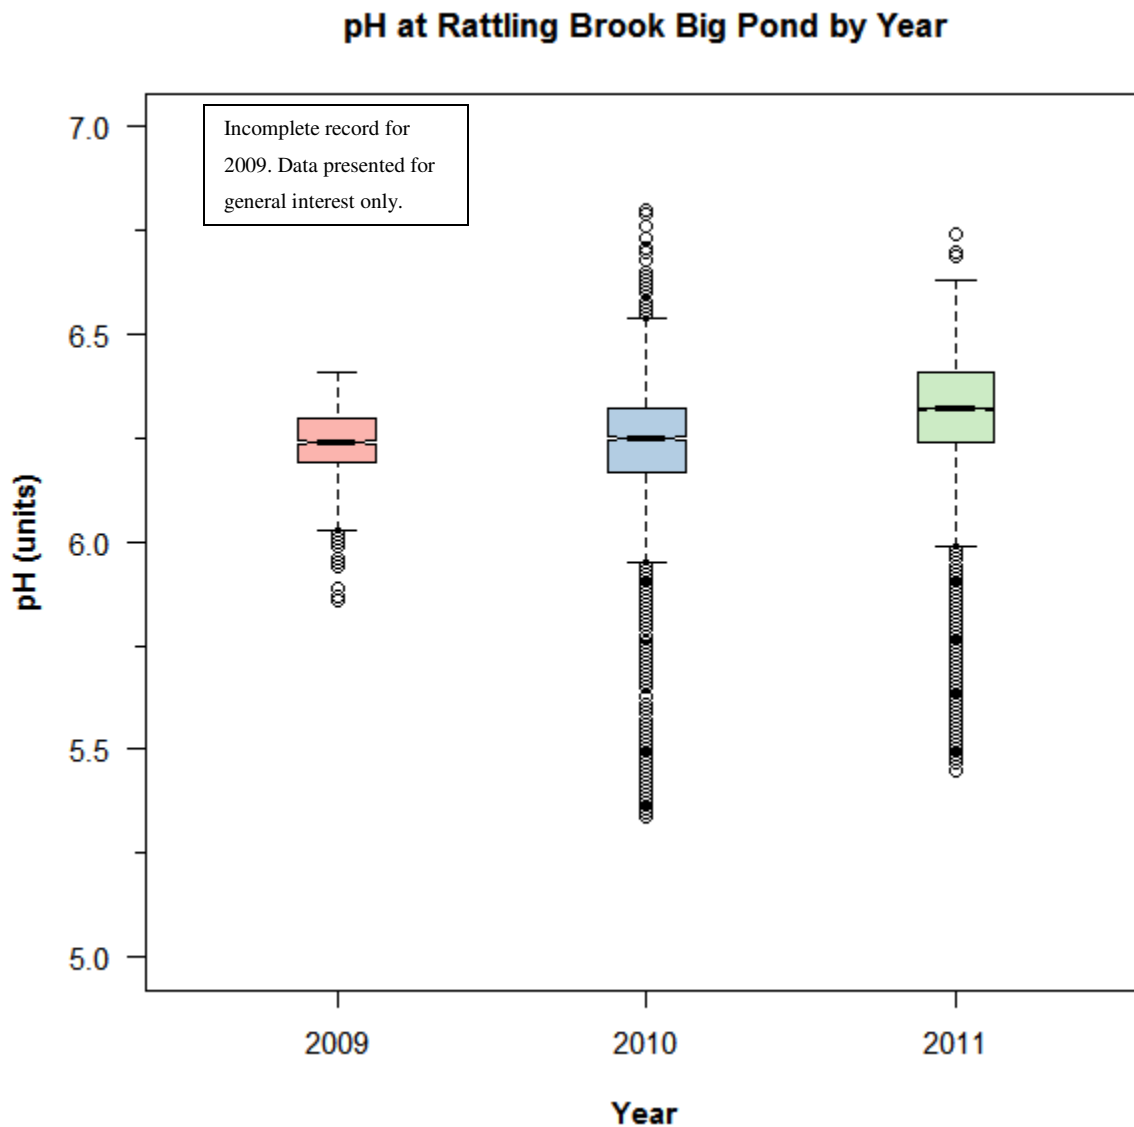
Figure 6: Boxplots of pH at Rattling Brook Big Pond, 2009 – 2011

Observing Figure 6 indicates that the median pH value in 2011 is higher than it was in 2010. Indeed, the median value calculated in 2010 was 6.25 versus 6.32 in 2011. This may be due to many factors including natural variation or some construction efforts in the area around Big Pond station. In 2011 some earth works were completed in the development of a water intake structure. Disturbance of the land in the area could result in the mobilization of soil solids that could affect pH.

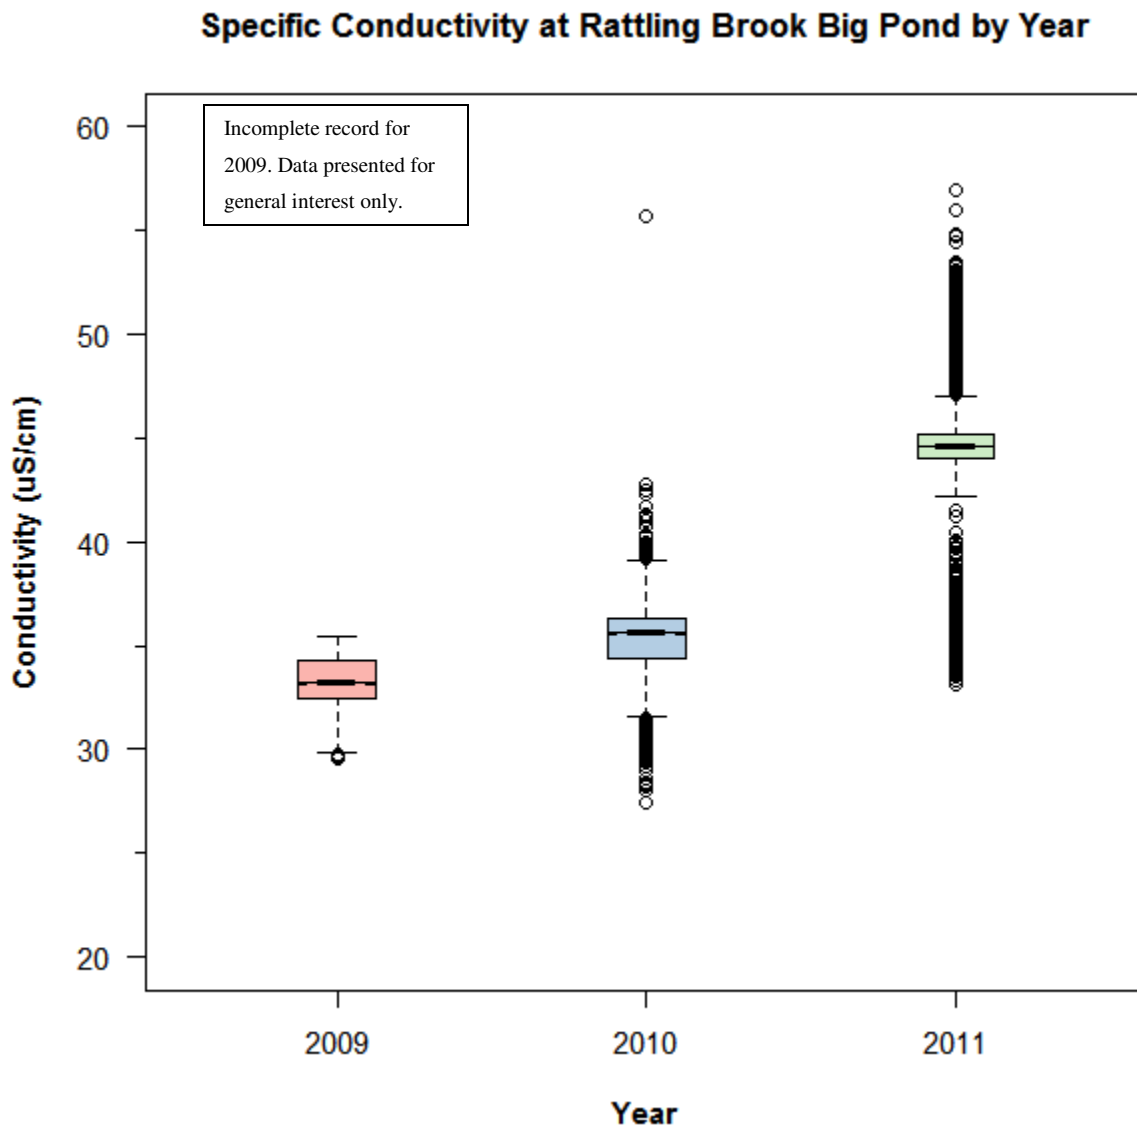
Figure 8: Boxplots of Specific Conductivity at Rattling Brook Big Pond, 2009 – 2011

A significant difference is observed in the range of conductivity from 2010 to 2011. In 2010, a median value of 35.6 $\mu\text{S}/\text{cm}$ was calculated compared to 44.6 $\mu\text{S}/\text{cm}$ in 2011.

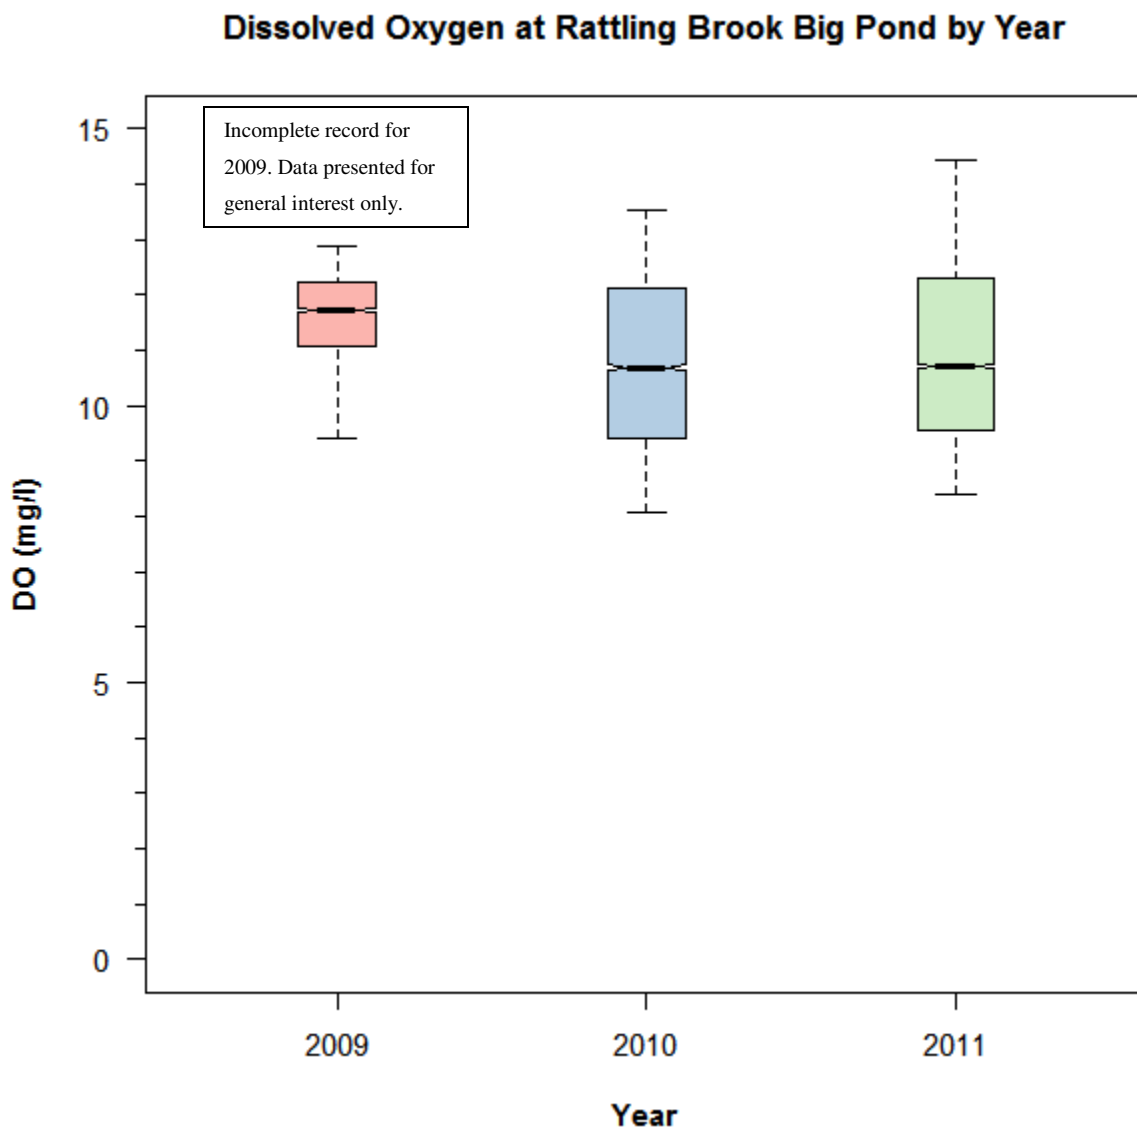
Figure 10: Boxplots of Dissolved Oxygen at Rattling Brook Big Pond, 2009 – 2011

A slight difference between 2010 and 2011 DO values is expected because of the cooler summer temperatures in 2011. In 2010, the median DO value was calculated as 10.69 mg/l versus 10.71 mg/l.

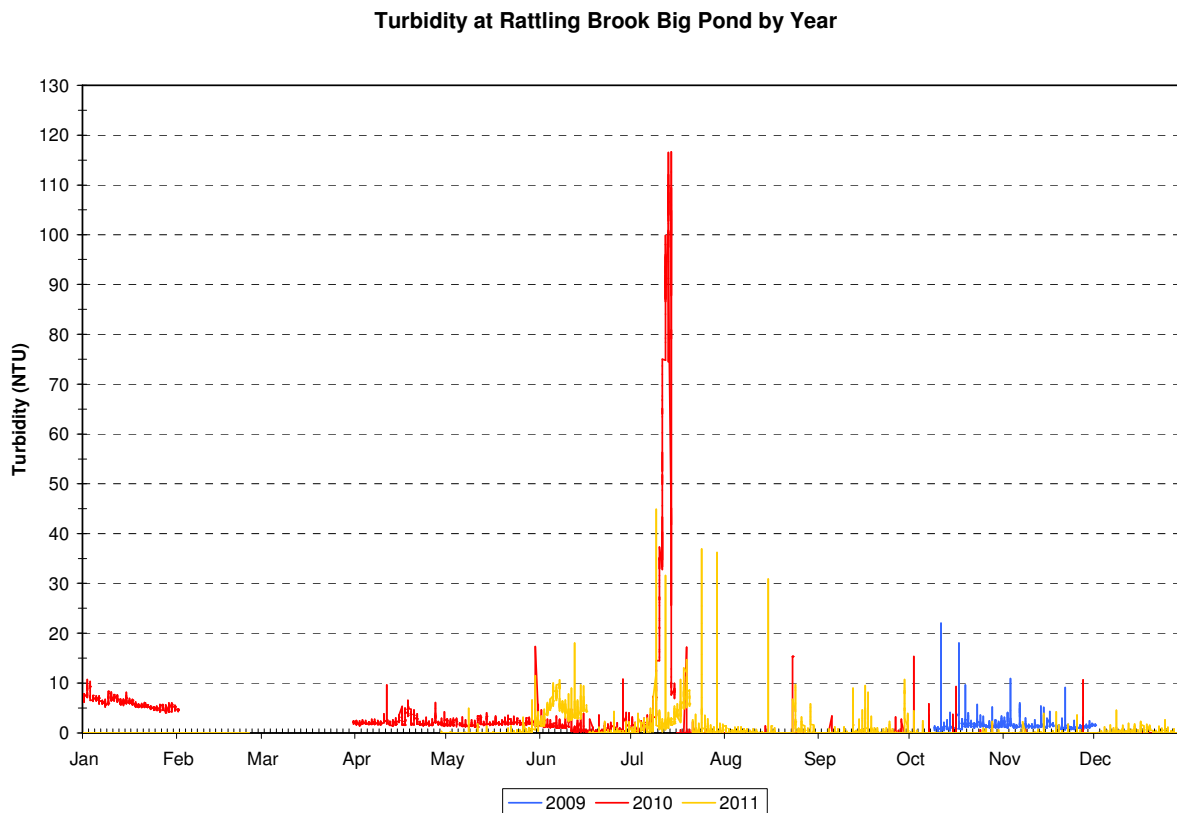
Figure 11: Turbidity at Rattling Brook Big Pond, 2009 – 2011

Turbidity values in 2011 ranged from 0.0 NTU to 44.9 NTU with a median value of 0.0 NTU (90% CI: 0.0 NTU – 0.0 NTU). This clearly indicates that greater than 505 of all recordings in this report year showed an absence of measurable turbidity.

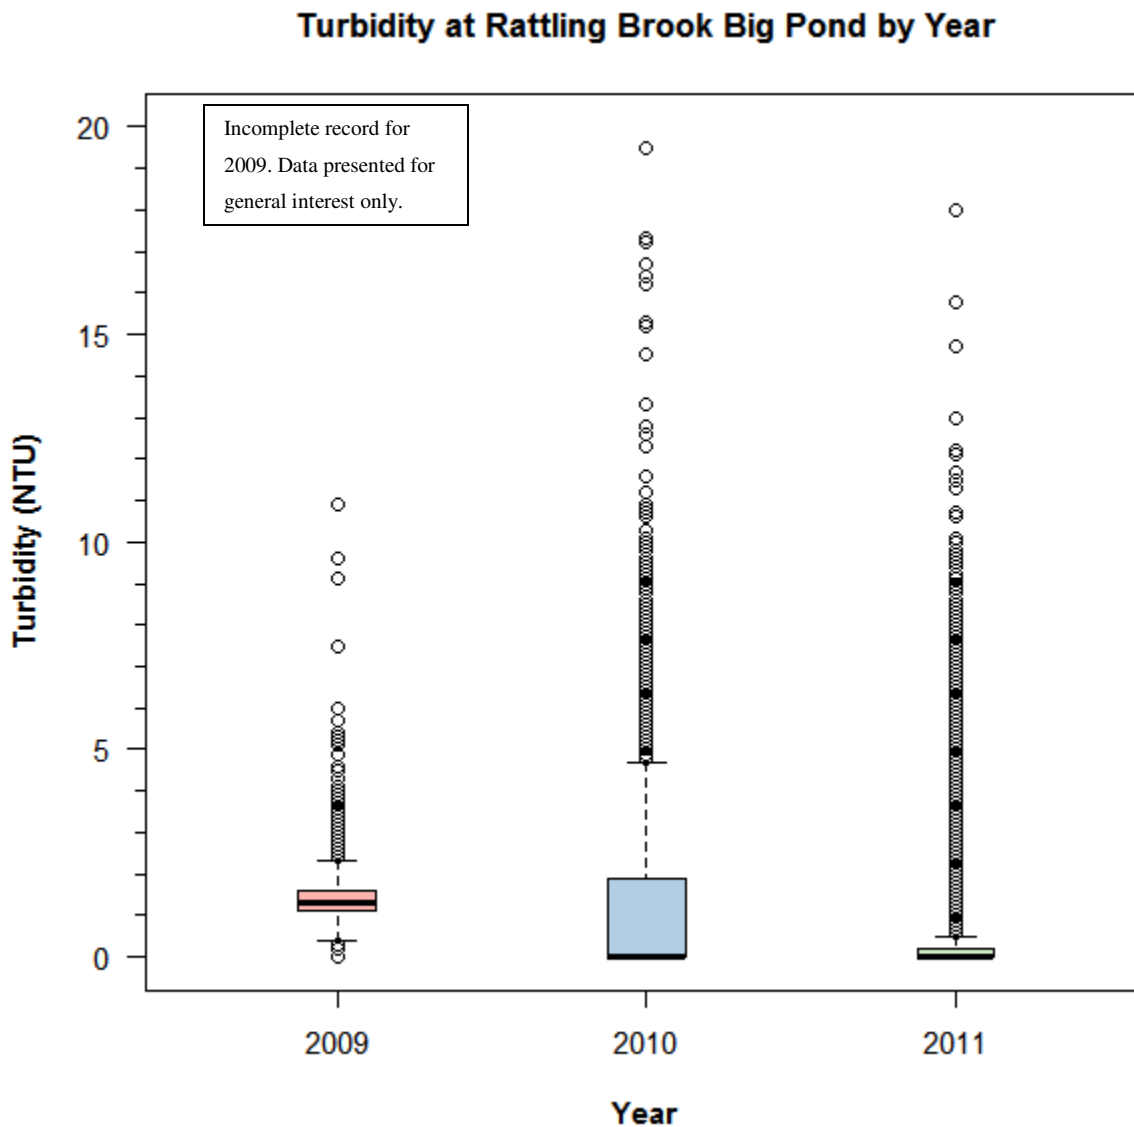
Figure 12: Boxplots of Turbidity at Rattling Brook Big Pond, 2009 – 2011

It is clear from the figure above that upper-range turbidity values have decreased substantially from 2010. While median values from both years were found to be 0.0 NTU, the third quartile of turbidity values in 2010 was 1.9 NTU versus 0.2 NTU in 2011.

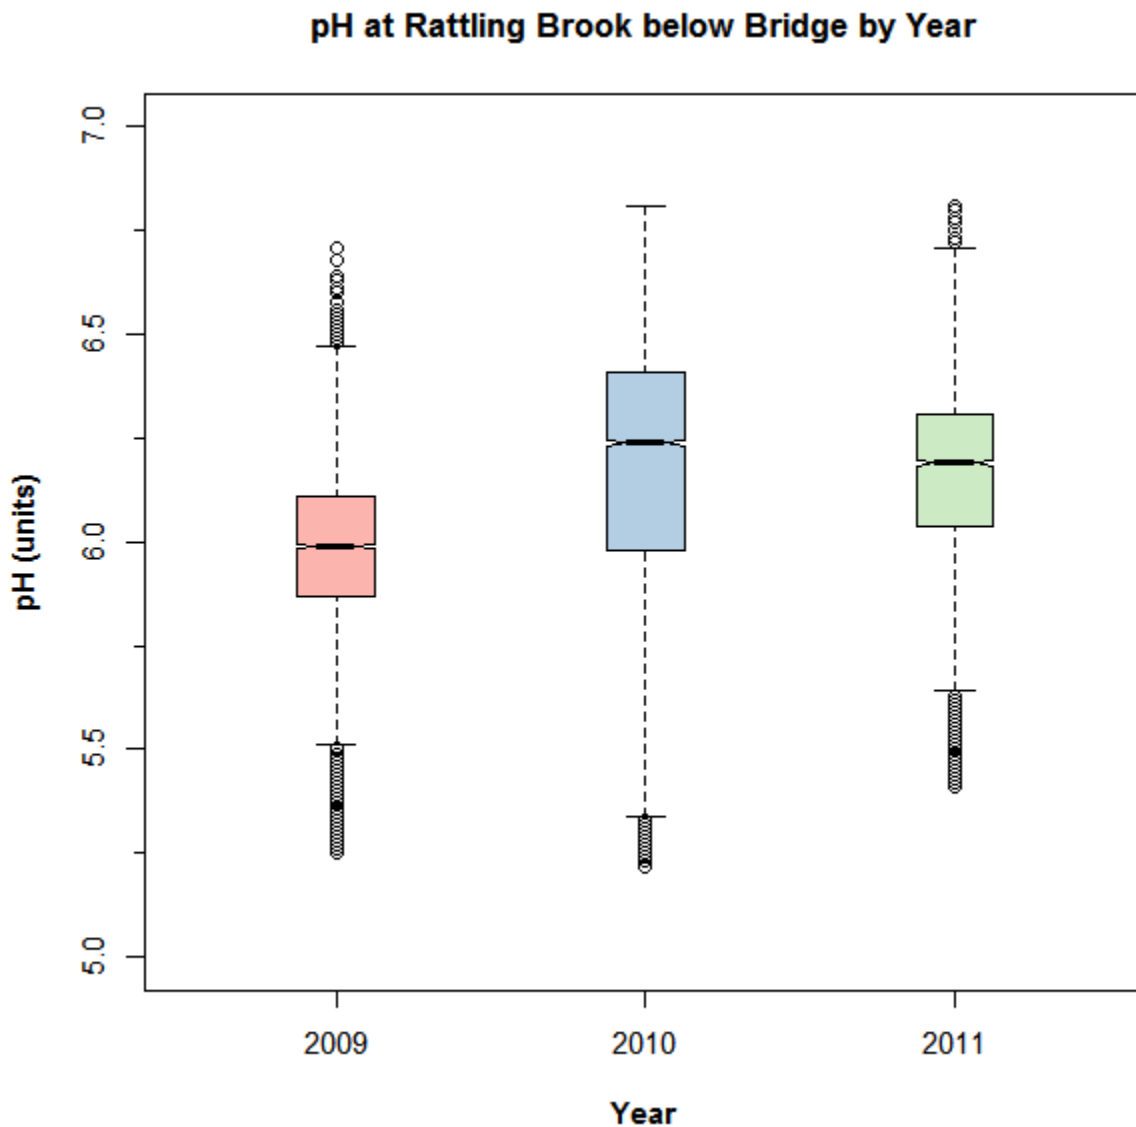
Figure 16: Boxplots of pH at Rattling Brook below Bridge, 2009 – 2011

The median pH value in 2011 was higher than in 2009, but lower than 2010. Further, the tendency of pH values to be somewhat spread out from the median in 2010 has been reduced to a more defined distribution in 2011. In 2010, a median pH value of 6.24 was calculated versus 6.19 in 2011.

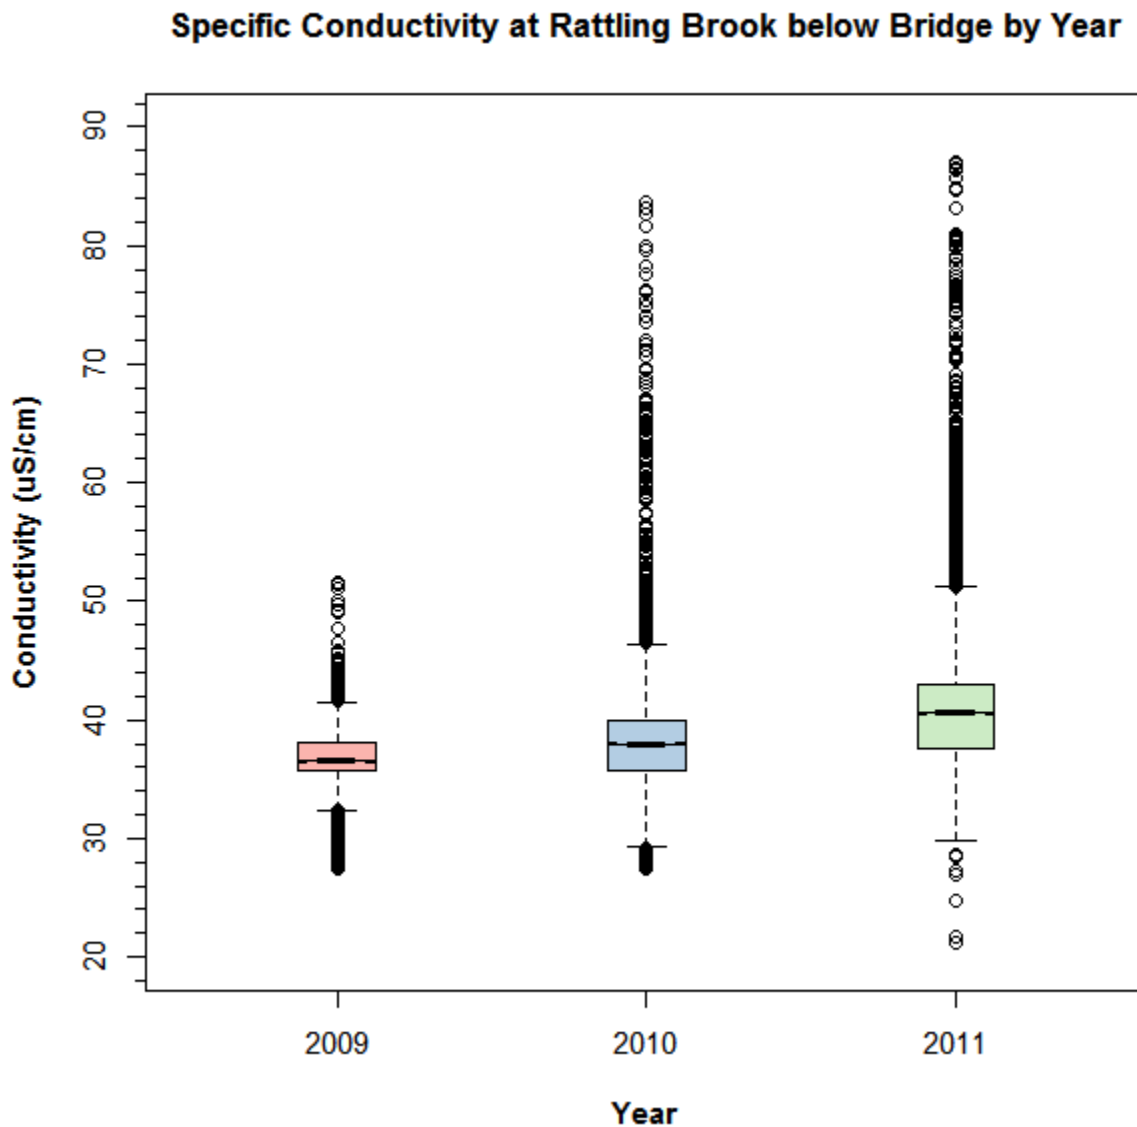
Figure 18: Boxplots of Specific Conductivity at Rattling Brook below Bridge, 2009 – 2011

Specific conductivity values increased once again since 2009. With large earth movement, tree removal and traffic through the area, the mobilization of previously bound sediments and soil elements, in addition to runoff from the construction site, this is expected to occur.

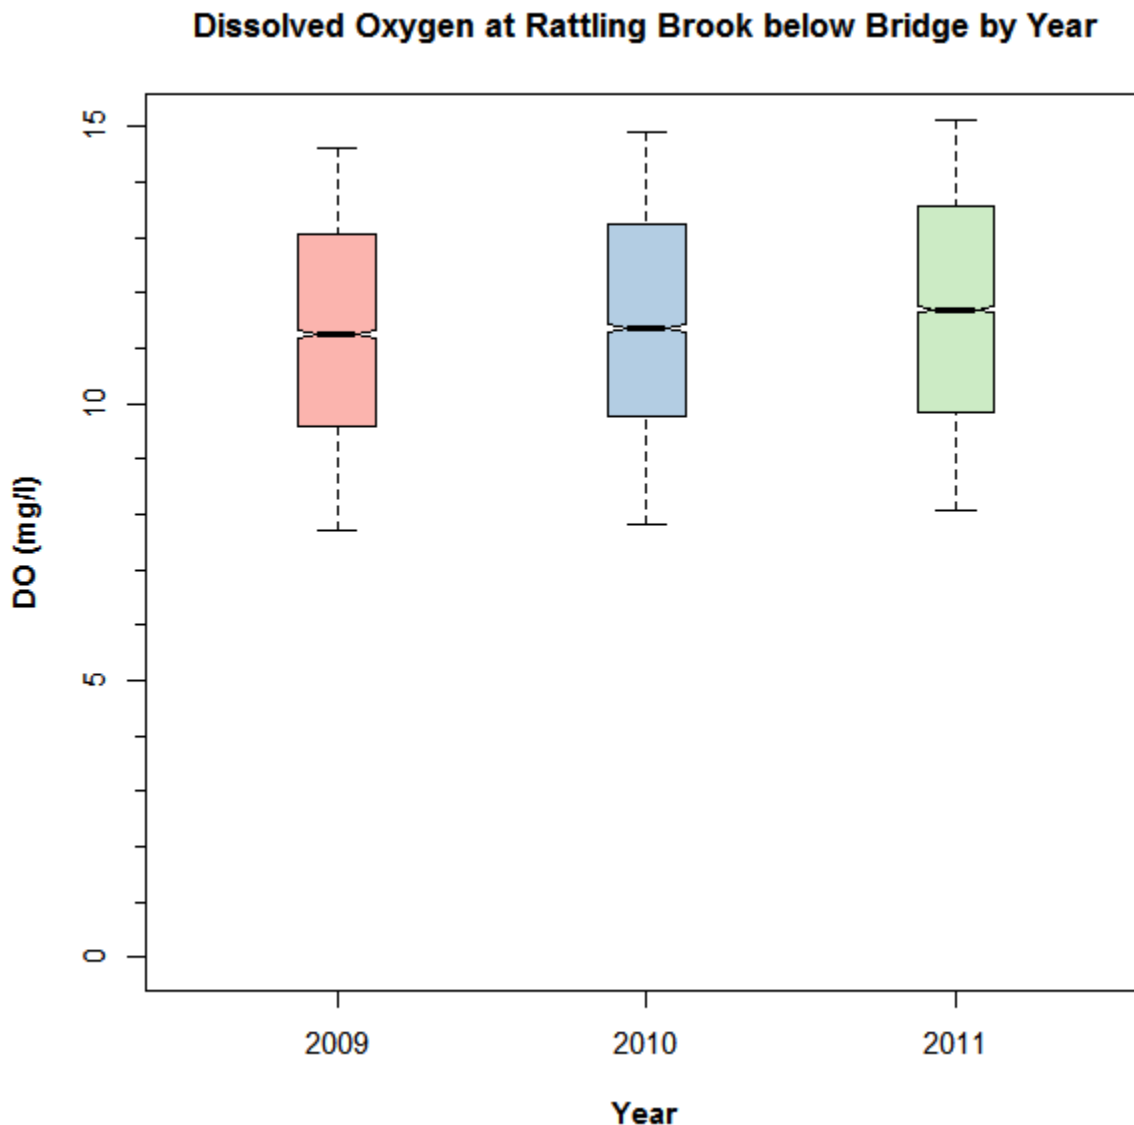
Figure 20: Boxplots of Water Temperature at Rattling Brook below Bridge, 2009 – 2011

Dissolved oxygen concentrations tend to follow the same range from year-to-year at below Bridge station. In 2010, however, the median DO concentration was found to be 11.36* mg/l versus 11.70 mg/l in 2011 due to the lower summer water temperatures.

* This value has been revised since the initial publication of the 2010 Annual Report. In 2010, the median DO concentration was reported as 10.69 mg/l (90% CI: 10.62 mg/l – 10.76 mg/l).

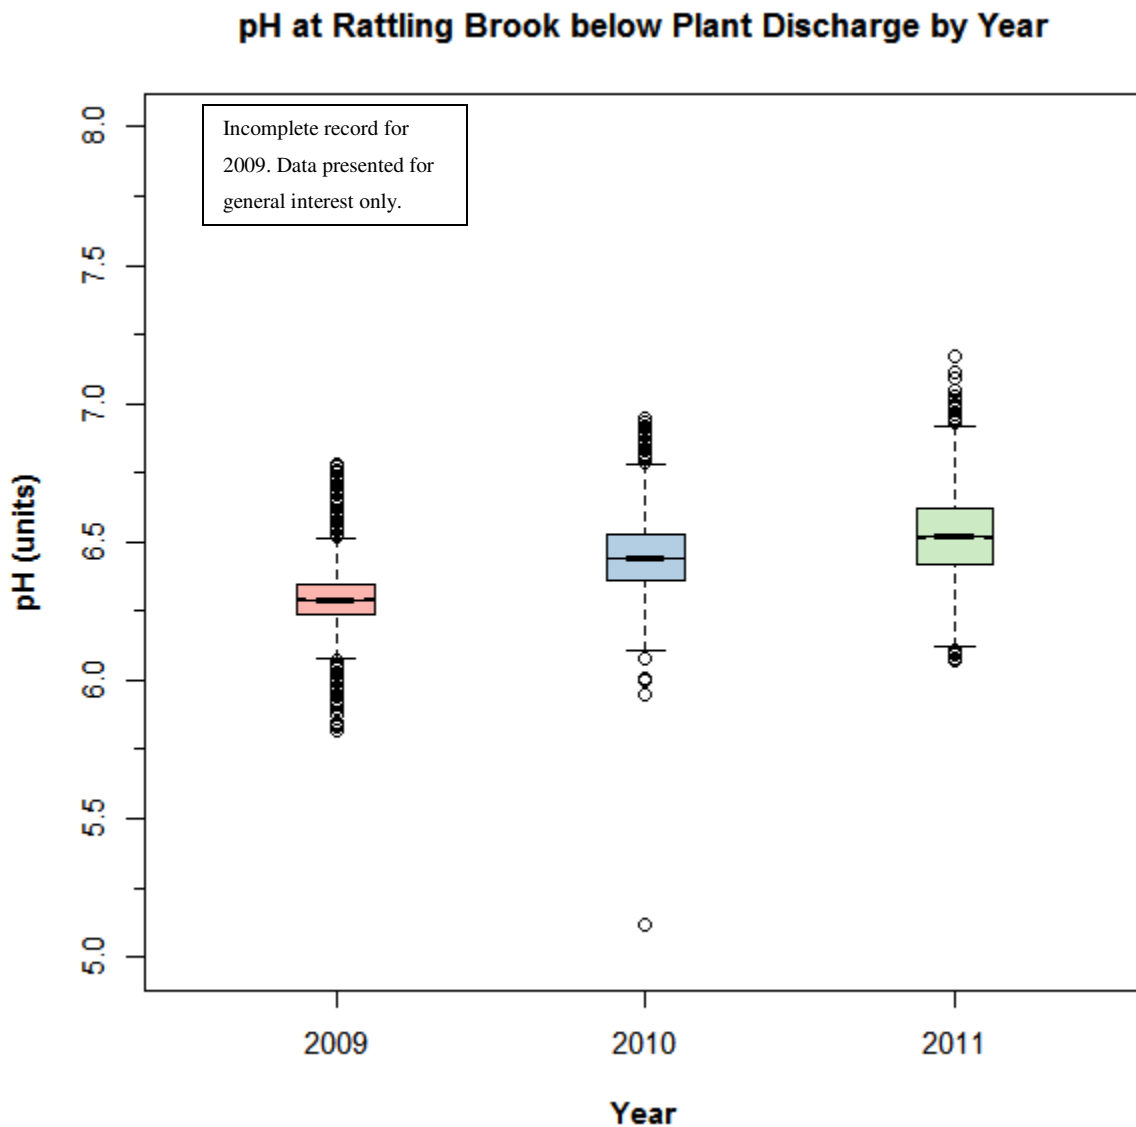
Figure 26: Boxplots of pH at Rattling Brook below Plant Discharge, 2009 – 2011

Only a partial record for pH exists in 2009 so no conclusions should be drawn regarding trends from 2009 onward. However, a slight upward trend does appear to exist moving from 2010 to 2011 – this will be monitored in the future.

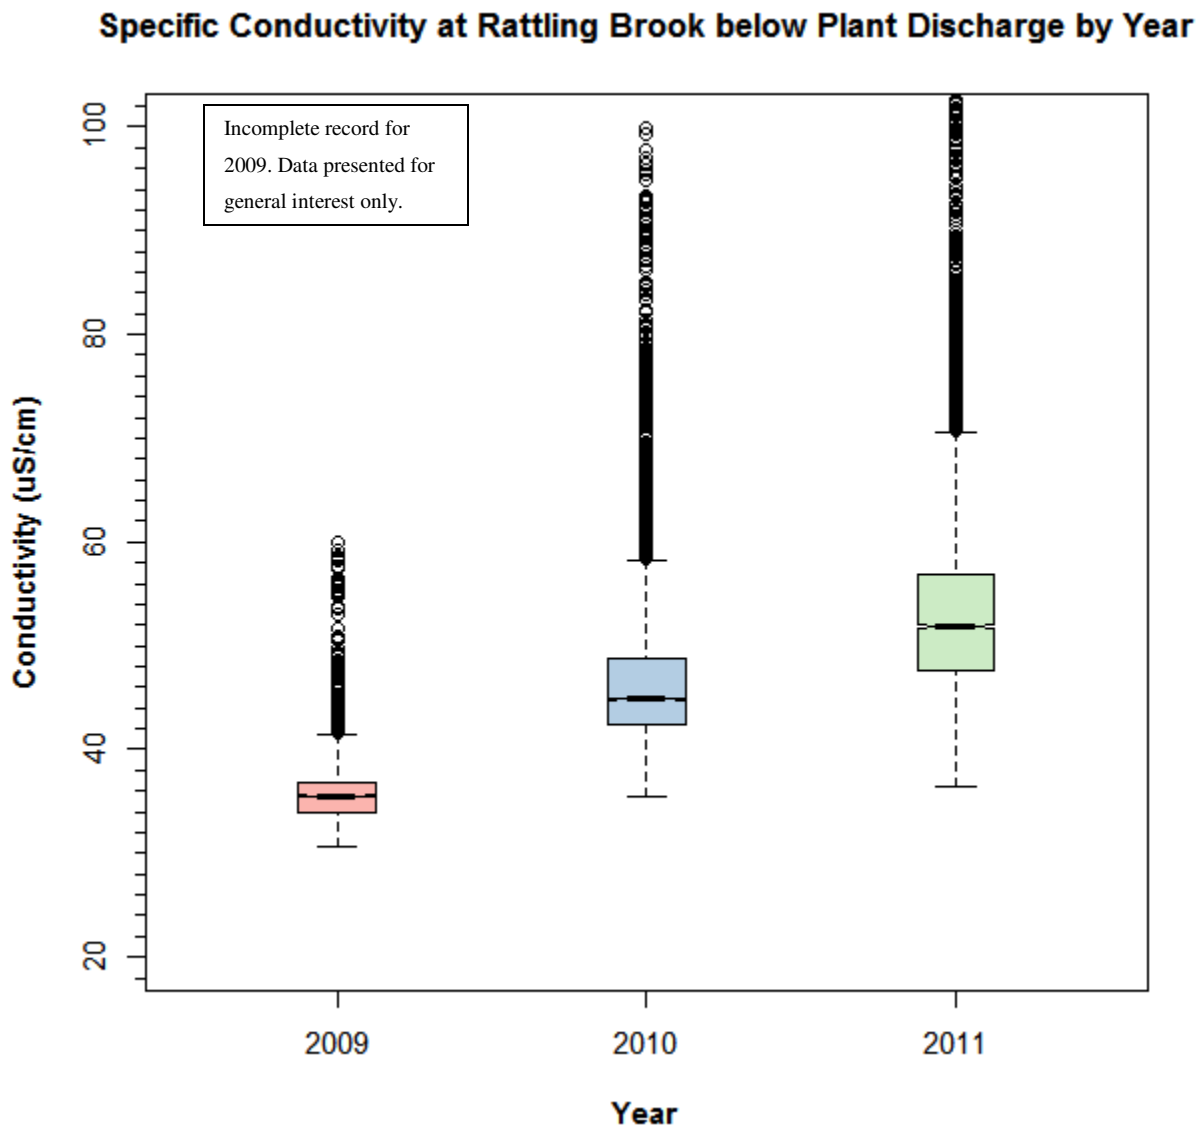
Figure 28: Boxplots of Specific Conductivity at Rattling Brook below Plant Discharge, 2009 – 2011

From 2010 to 2011 there was a notable increase in conductivity. This increase can be attributed to the intense ground work and construction in the area, resulting in increased runoff into the river. With the addition of functional settling ponds and runoff management, conductivity should be reduced over time.

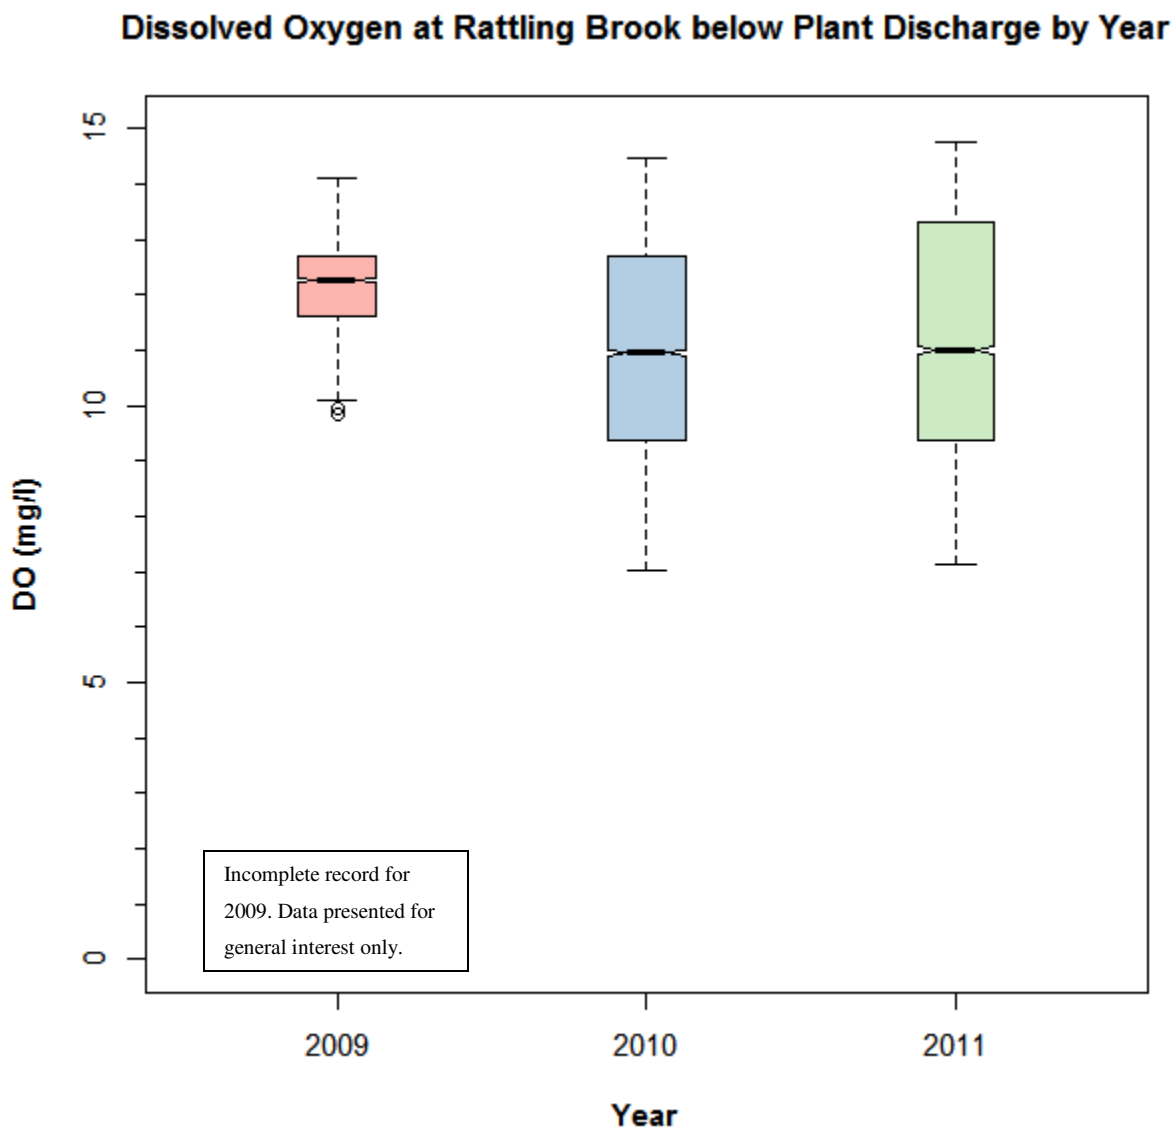
Figure 30: Boxplots of Dissolved Oxygen at Rattling Brook below Plant Discharge, 2009 – 2011

The median concentration of dissolved oxygen did not show great change from 2010 to 2011 – only an increase in the upper spread of values due to the cool summer (lower temperature, higher DO values).

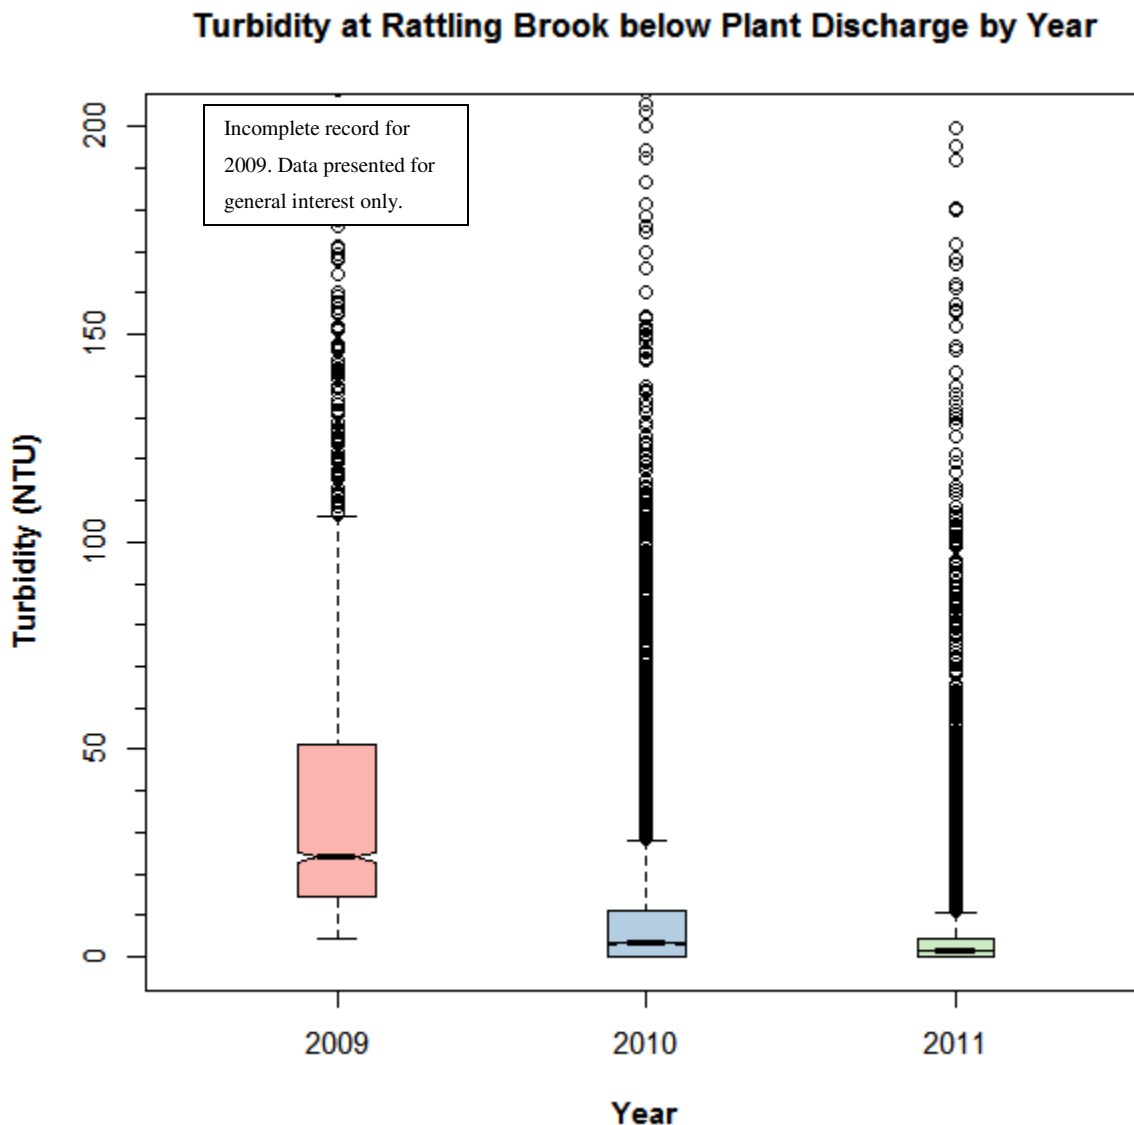
Figure 32: Boxplots of Turbidity at Rattling Brook below Plant Discharge, 2009 – 2011

A decline in turbidity from 2010 to 2011 is clear from Figure 32. The incorporation of stronger runoff management policies and sedimentation ponds appear to have assisted a great deal at this particular station. A further reduction in turbidity is expected as time goes on but will be monitored closely.
