# Real-Time Water Quality Report

## Waterford River at Kilbride

Deployment Period  
September 6, 2016 to October 18, 2016

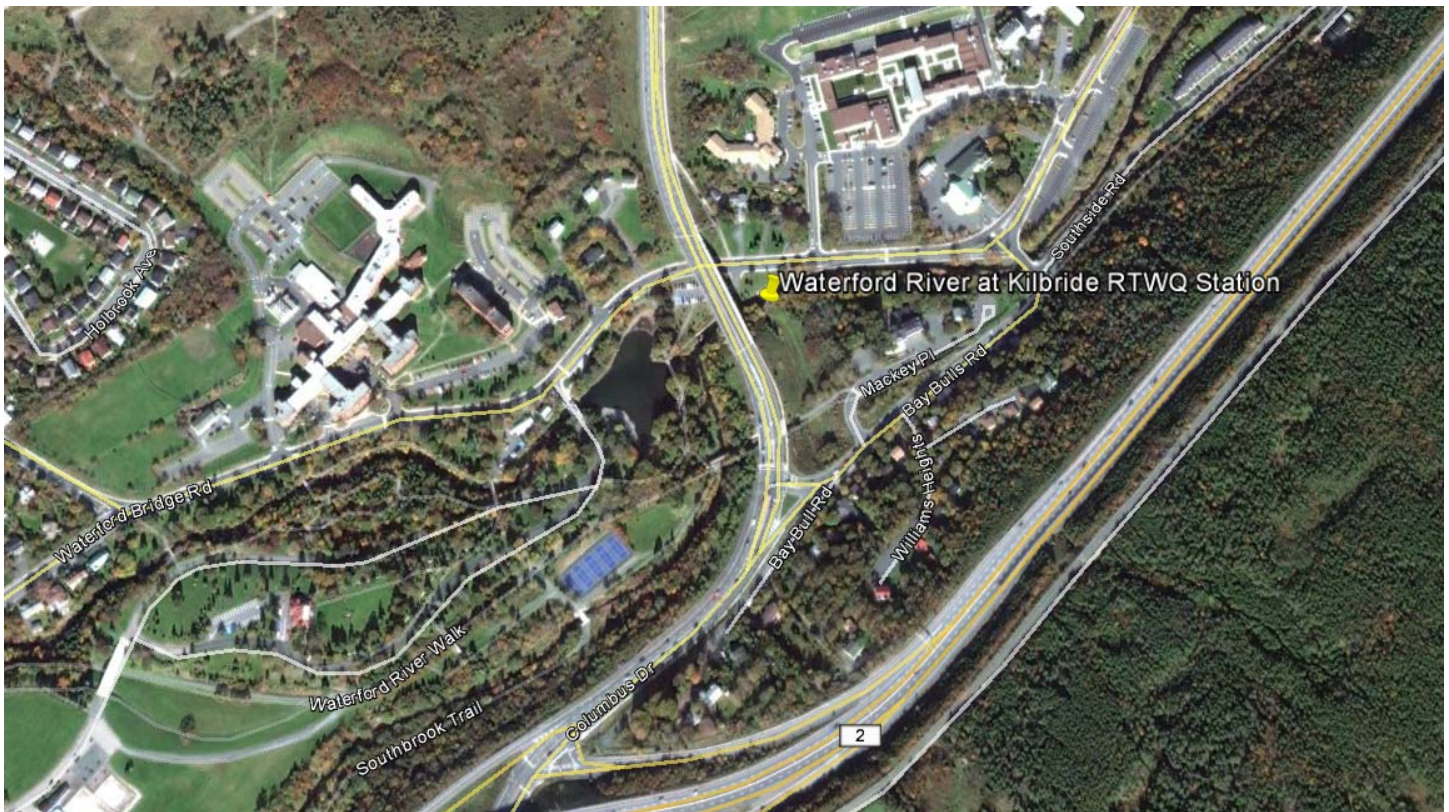
Figure 1: Waterford River at Kilbride Real-Time Water Quality and Quantity Station.

The Water Resources Management Division (WRMD), in partnership with Water Survey of Canada - Environment and Climate Change Canada (WSC-ECCC), maintain a real-time water quality and water quantity monitoring station on Waterford River at Kilbride.

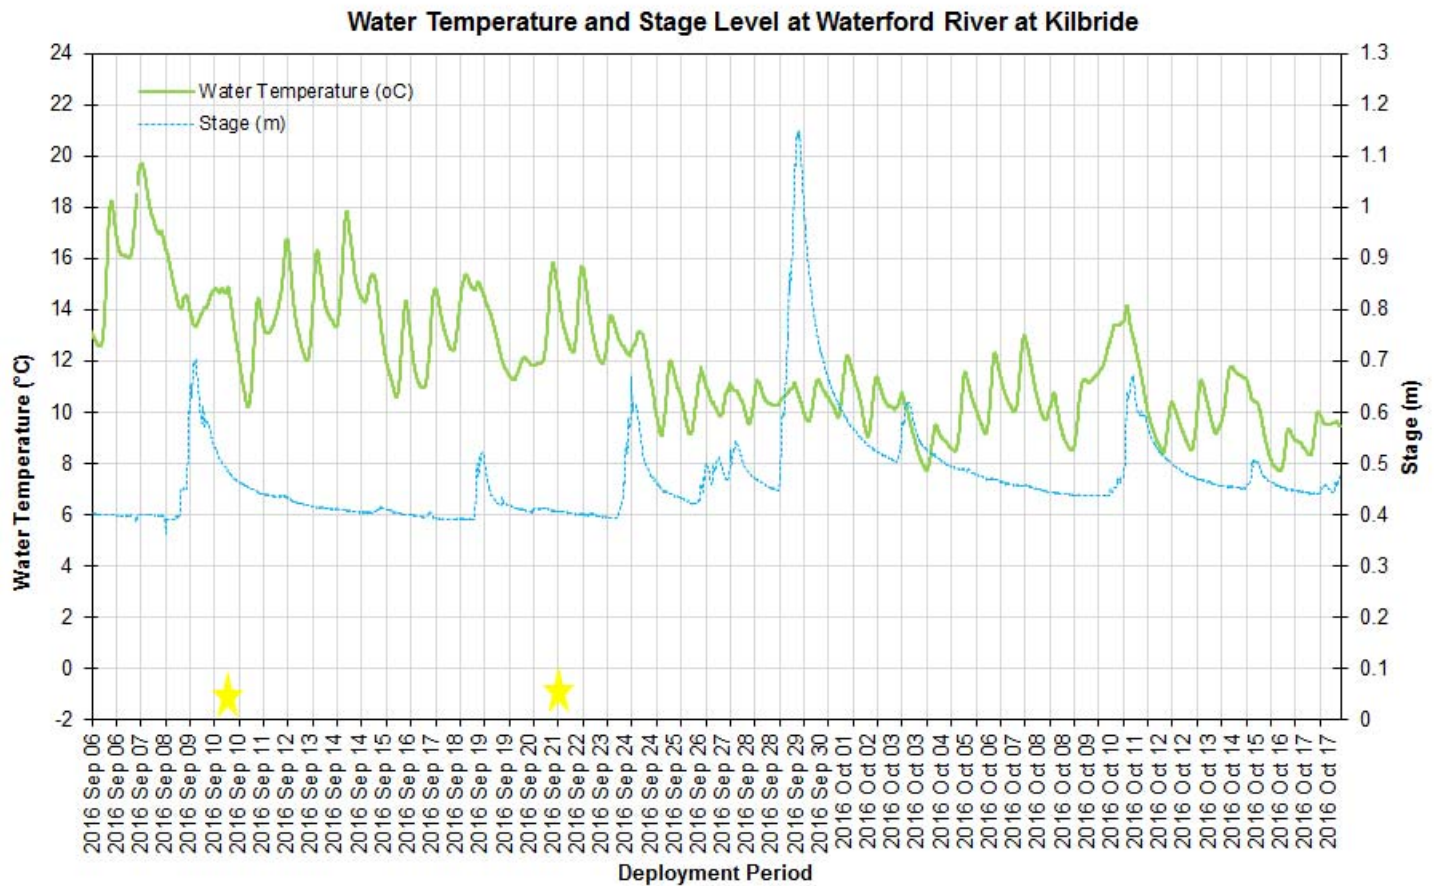
Water temperature ranged from 7.70°C to 19.71°C during this deployment period (Figure 2).

The water temperature at this station displays diurnal variations although slightly elongated due to the depth of water at this station. Deeper streams are influenced more subtly by natural diurnal variations in air temperatures (Appendix I).

Over the duration of the deployment period the water temperature gradually decreases as the air temperatures decrease with the cooler temperatures approaching. During high stage events there is a slight increase in the water temperatures for a short period of time until the temperatures start to dip again. This is evident after a peak in stage on September 9<sup>th</sup> there is a subsequent peak in water temperature and then a dip to a lower temperature as the stage stabilizes again.

Figure 2: Water temperature (°C) and Stage (m) values at Waterford River at Kilbride

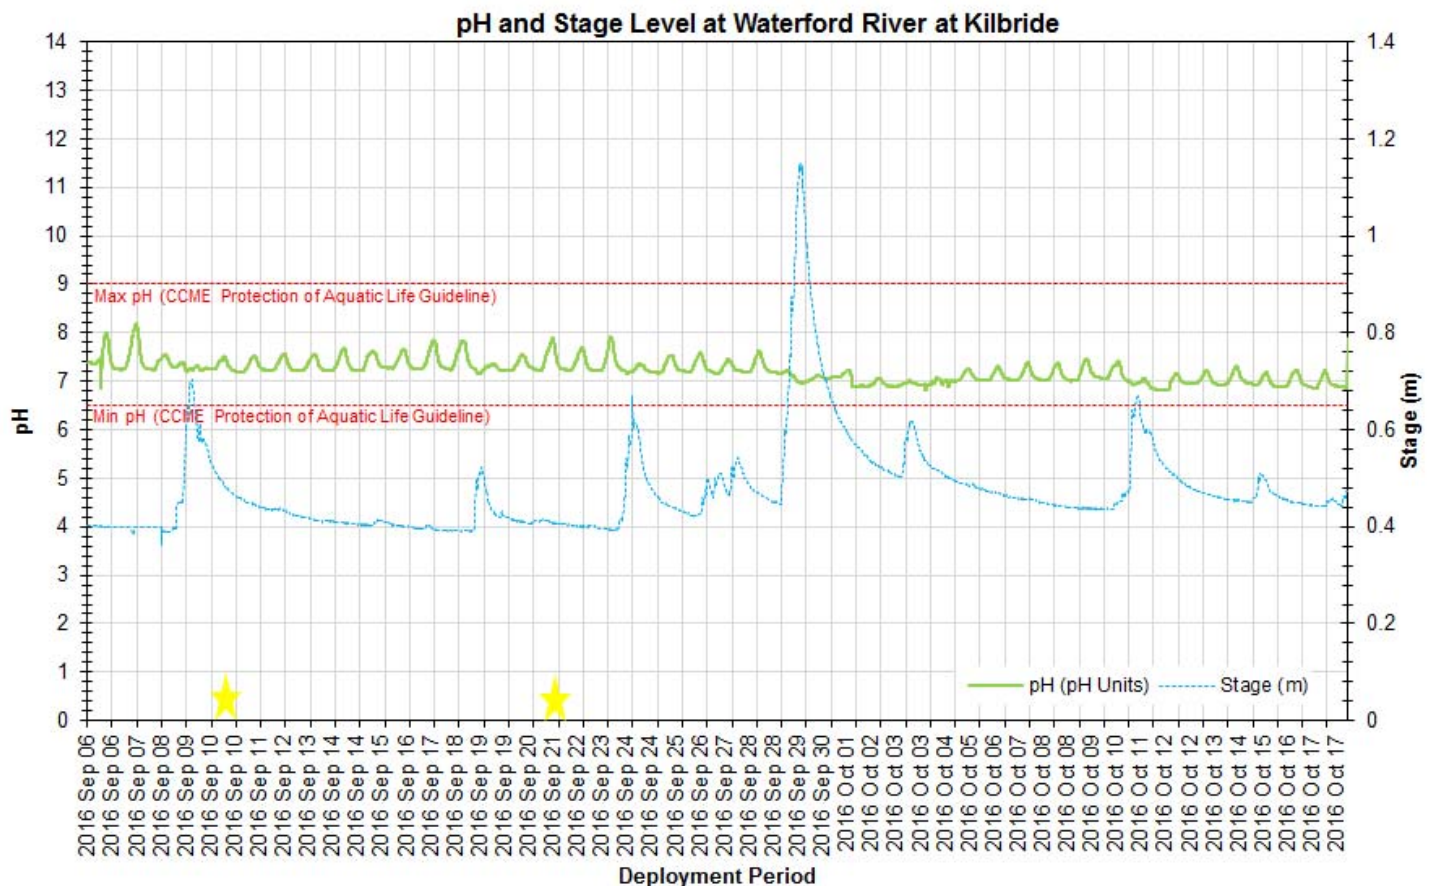
Throughout the deployment period, pH values ranged between 6.81 pH units and 8.18 pH units (Figure 3).

On September 9<sup>th</sup> there is an evident dip in pH, this dip continues into the early hours of September 10<sup>th</sup>. The morning of September 10<sup>th</sup> was the first sighting of dead fish in the river. September 21<sup>st</sup> was the second fish kill while there is no substantial change in pH that day, there is a dip in pH on September 19<sup>th</sup> and 20<sup>th</sup>. It is not clear if these changes in pH are related to the cause of the fish kills.

The pH levels are reasonably consistent and remained within the guidelines indicated on the graph; however during and after high stage levels the pH data decreases slightly for short period of times and is a natural occurrence. In this stream the CCME guideline provides a basis by which to judge the overall health of the brook. pH levels did not indicate that there were any immediate issues with water quality in Waterford River during this deployment. The median pH level was 7.23 pH units.

Figure 3: pH (pH units) and stage level (m) values at Waterford River at Kilbride

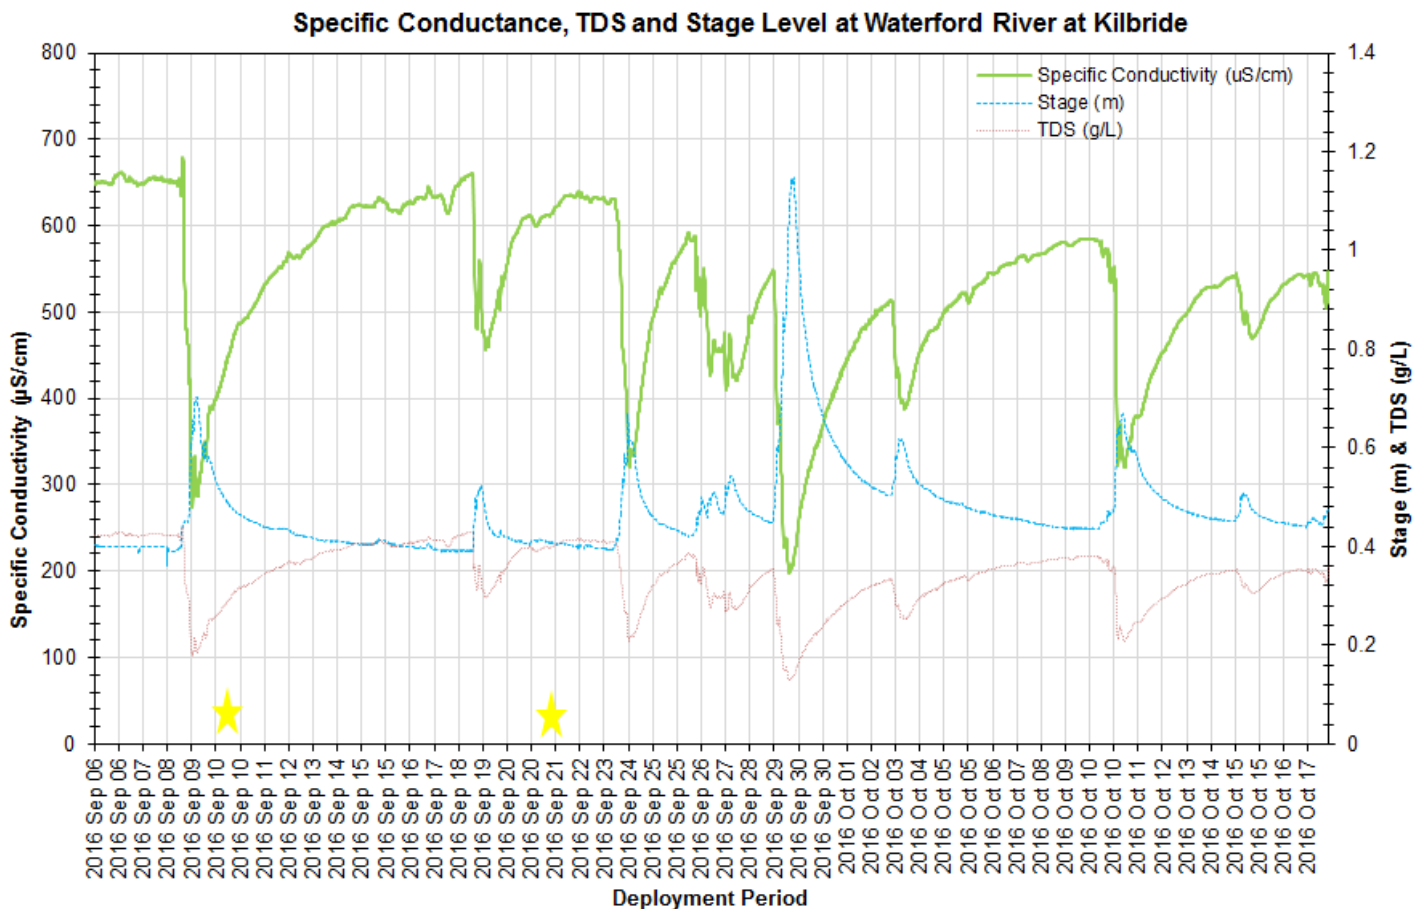
The conductivity levels were within 197.0  $\mu\text{S}/\text{cm}$  and 679.0  $\mu\text{S}/\text{cm}$  during this deployment period. TDS (a calculated value) ranged from 0.1280 g/L to 0.4410 g/L (Figure 4).

The relationship between conductivity and stage level is inversed. When stage levels rise, the specific conductance levels drop in response, as the increased amount of water in the river system dilutes the solids that are present (as noted on Figure 4).

On September 9<sup>th</sup> there is a dip in specific conductivity indicating an increase in water passing through the brook during and around this timeframe. It was later determined after the first fish kill that there had been a water main break in a tributary that leads into Waterford River. It is possible that the water main break contributed to the stage level on this day, however there was also substantial precipitation on September 9<sup>th</sup> as well.

**Figure 4: Specific conductivity ( $\mu\text{S}/\text{cm}$ ), TDS (g/L) and stage (m) values at Waterford River at Kilbride.**

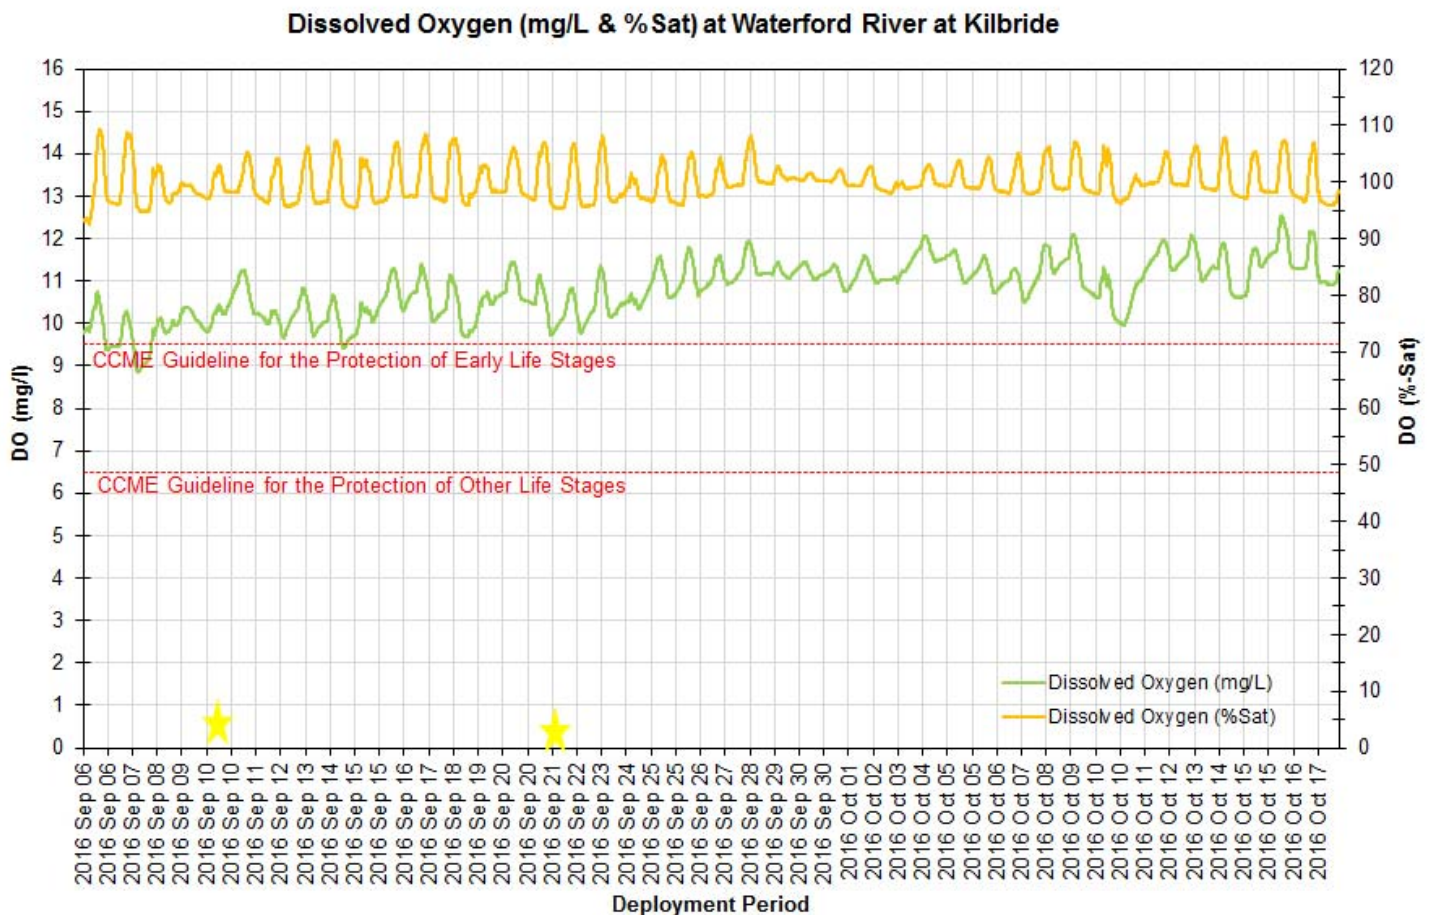
During the deployment the dissolved oxygen concentration levels ranged within a minimum of 8.86 mg/L to a maximum of 12.55 mg/L. The percent saturation levels for dissolved oxygen ranged within 92.3% Saturation to 109.3% Saturation (Figure 5).

On September 9<sup>th</sup> there was a slight change in dissolved oxygen concentration where it dipped to a lower amount before returning to the natural diurnal pattern. On September 21<sup>st</sup> there was no significant change in the DO. The dissolved oxygen data did not indicate any problems with the water quality which may have resulted in a fish kill.

Dissolved oxygen concentration remained above the Guideline for the Protection of Early Life Stages (9.5mg/L) for the majority of the deployment period. It is not unusual to see the dissolved oxygen concentration in the brook dip during warmer water temperatures. As the fall season continues with the decrease in water temperature, there will be a gradual increase of the dissolved oxygen present in the brook. The reduction in aquatic flora and fauna growth will increase the amount of dissolved oxygen present in the brook as the dissolved oxygen is not being used. This is a natural occurrence.

**Figure 5: Dissolved Oxygen (mg/L & Percent Saturation) values at Waterford River at Kilbride.**

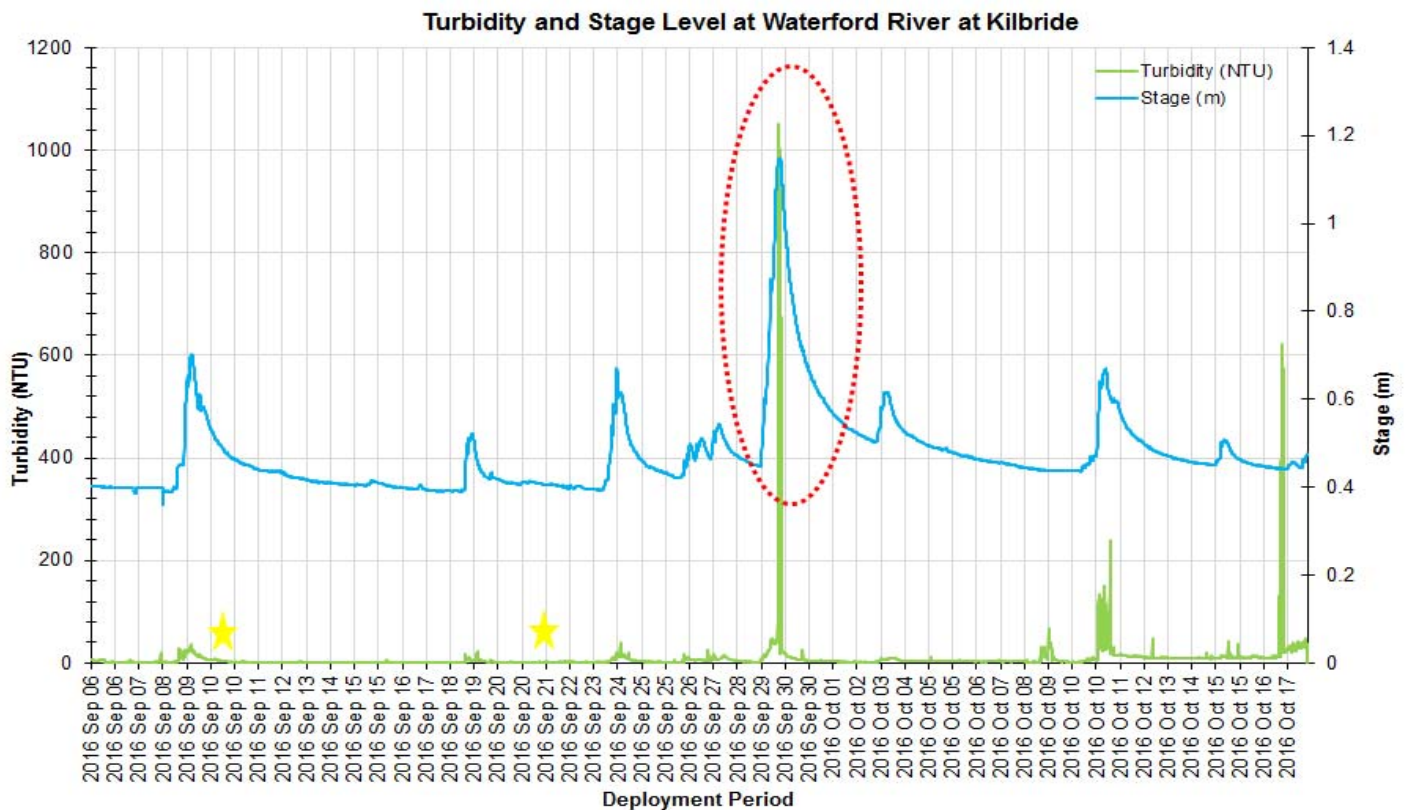
Turbidity levels during the deployment ranged within 0.6 NTU and 1050.0 NTU (Figure 6). The deployment data had a median of 2.8 NTU.

The higher turbidity events throughout the deployment period correlate with increases in stage potentially from precipitation. Precipitation can increase the presence of suspended material in water. The turbidity data does return to lower levels after the high peaks. The highest turbidity value of 1050.0 NTU was recorded during a high stage event. The turbidity data did return to a lower value as the stage level decreased. Turbidity levels can change quickly at Waterford River. This site has a significant streamflow rate which can flush the turbid water or sediments from the brook. As this brook is in the heart of the City of St. John's the turbidity values can be heavily influenced by its surroundings.

The next highest turbidity event was captured on October 17<sup>th</sup>, 2016. There is no corresponding stage increase or precipitation during the time frame therefore it is unclear what may have caused the turbidity to increase to that level. There was some debris around the protective casing when the instrument was removed for cleaning and calibration. Turbidity is slightly elevated during the first observed fish kill on September 10<sup>th</sup>, 2016, however there was no significant turbidity changes on the second fish kill. With turbidity at those lower levels it is not likely that turbidity could have played a part in the first fish kill.

Figure 6: Turbidity (NTU) and stage level (m) values at Waterford River at Kilbride.

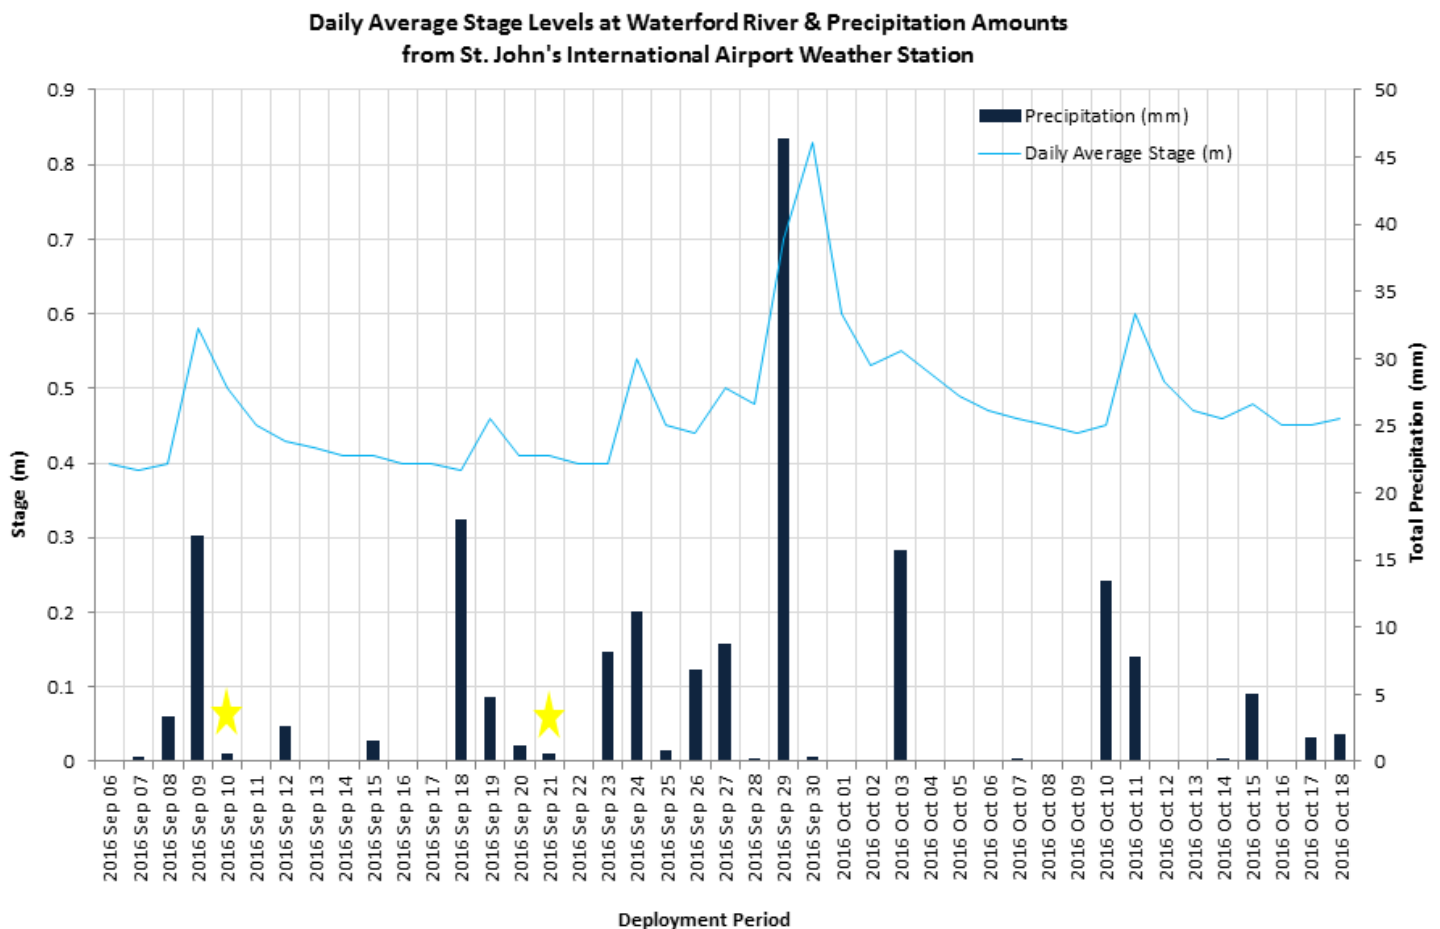
Stage is important to display as it provides an estimation of water level at the station and can explain some of the events that are occurring with other parameters (i.e. Specific Conductivity, DO, turbidity). Stage will increase during rainfall events (Figure 7) and during any surrounding snow or ice melt as runoff will collect in the brooks. However, direct snowfall will not cause them to rise significantly.

During the deployment period, the stage values ranged from 0.361m to 1.149m. The larger peaks in stage do correspond with substantial rainfall events as noted on Figure 7. Precipitation data was obtained from Environment Canada's St. John's Airport weather station. Precipitation ranges for the deployment period were a minimum of 0.0 mm and a maximum of 46.4 mm on September 29<sup>th</sup>, 2016.

The stars indicate the observed fish kills that occurred during this deployment. Both fish kills occurred after a day or two of rainfall and subsequent high stage levels. It was determined that the first fish kill was a result of a water main break in the brook.

**Figure 7: Daily average stage values at Waterford River at Kilbride and daily total precipitation from St. John's Airport Weather Station.**

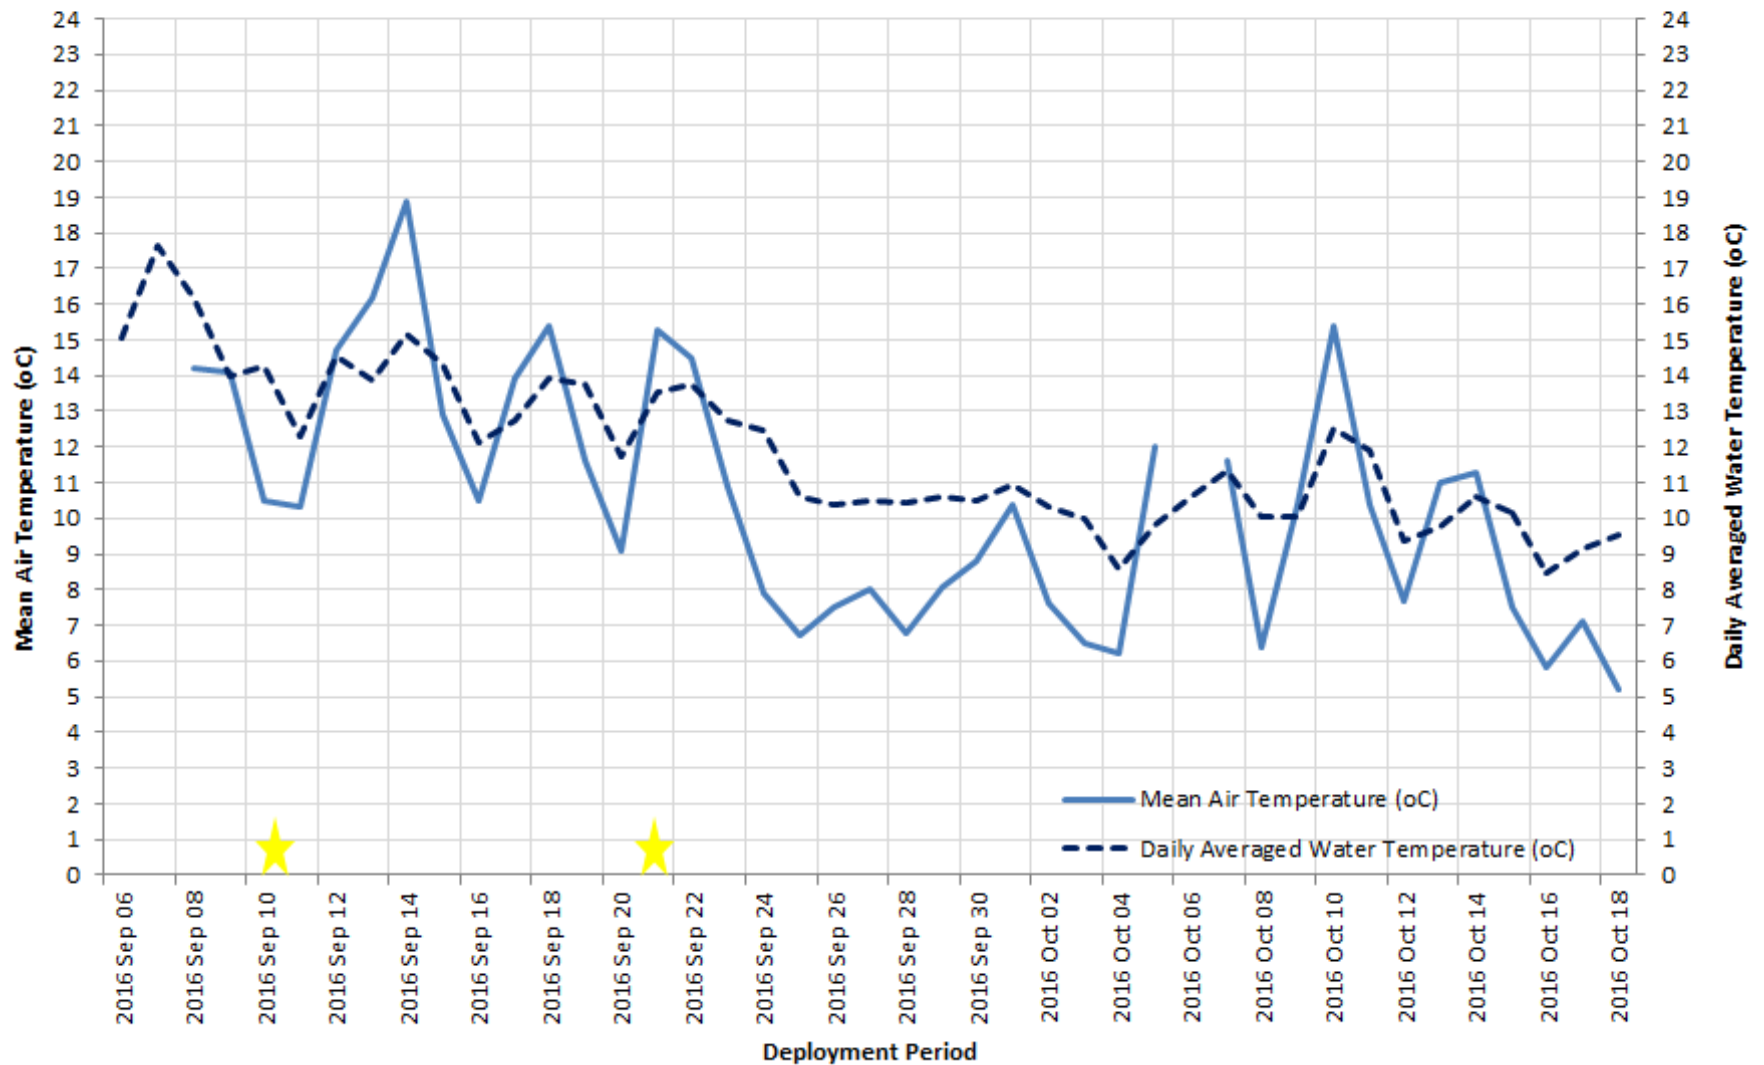
### Daily Averaged Water Temperatures (oC) at Waterford River and Mean Air Temperatures (oC) recorded at St. John's Airport Weather Station
