# Waterford River @ Kilbride

**NF02ZM0009**

May 2010

**Real Time Water Quality Monthly Report**  
**Waterford River - St. John's NL**  
**May 2010**

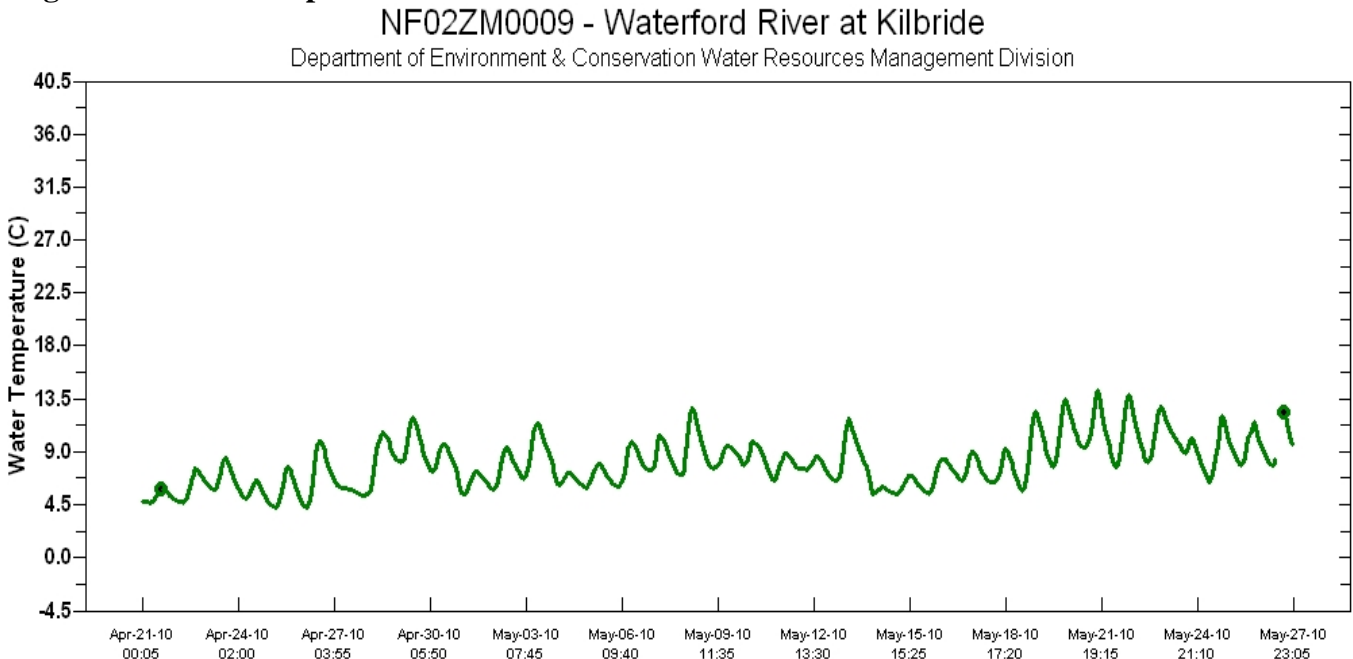
**Figure 1: Water Temperature**

- **Water temperatures** were fairly constant during this deployment showing an increasing trend in response to seasonally warmer air temperatures, as seen in **Figure 1** below. Water temperatures ranged between 3.78 and 13.68°C during this deployment.

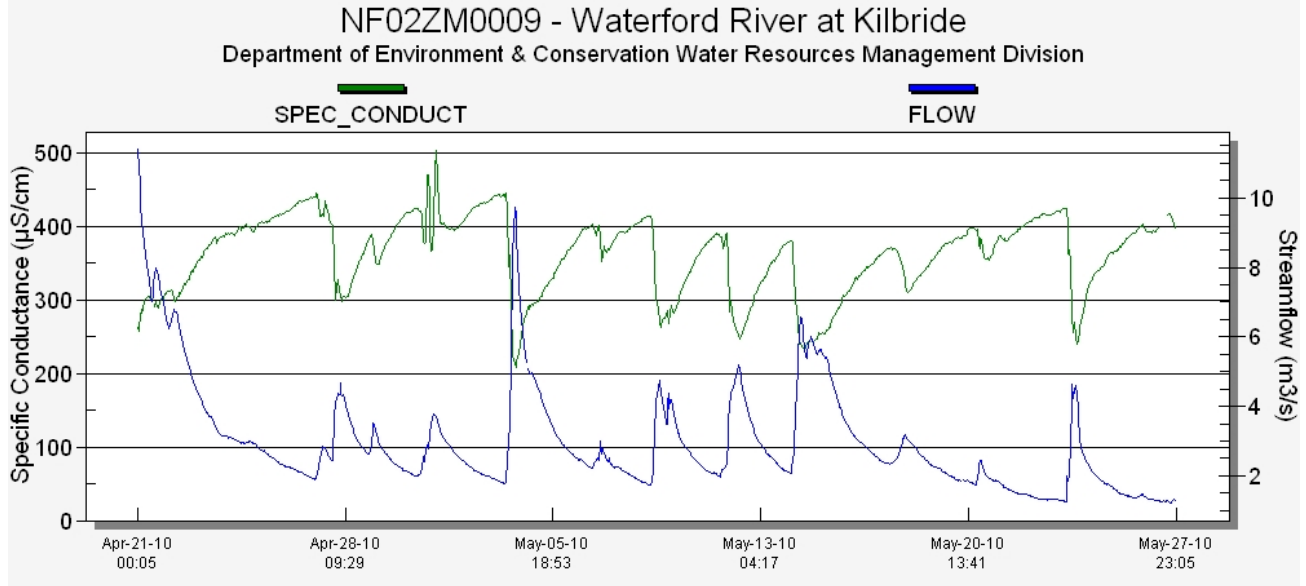
**Figure 3: Specific Conductance**

- **Specific conductivity** levels typically share an inverse relationship with stage height and flow, showing decreasing levels as stage height and flow increase due to precipitation. This is caused by the dilution effect increased water level and flow usually has on conductivity. Conversely, specific conductivity levels typically increase as flow decreases. Specific conductivity values are shown in green and flow is shown in blue in **Figure 3** below. The exception to this occurs during the winter months when road salting operations are in effect, and increased run-off and flow may increase specific conductivity levels. Specific conductivity values ranged between 208-503  $\mu\text{S}/\text{cm}$  during this deployment.
