Waterford River @ Kilbride

NF02ZM0009

February 2011

**Real Time Water Quality Monthly Report
Waterford River - St. John's NL
February 2011**

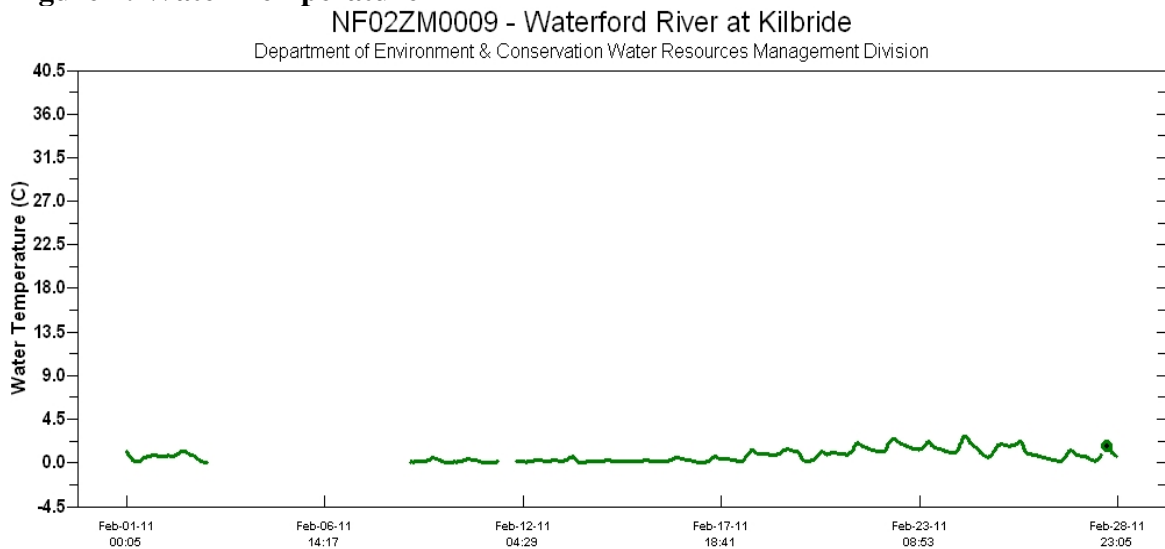
Figure 1: Water Temperature

- **Water temperatures** were fairly constant during this deployment, ranging between -0.43 and 2.25°C, which is within the expected temperature range for this time of year. There was no ice cover on Waterford River at the time of instrument deployment and removal, though water temperatures frequently hovered near the freezing point. Water temperature data is shown in **Figure 1** below. The gap in the graph represents the period from February 3 – 9 when the data logger was not receiving water quality information from the sonde.
