# **Real-Time Water Quality Report**

# **Outer Cove Brook Network**

Deployment Period April 9 to May 3, 2013

Government of Newfoundland & Labrador Department of Environment and Conservation Water Resources Management Division

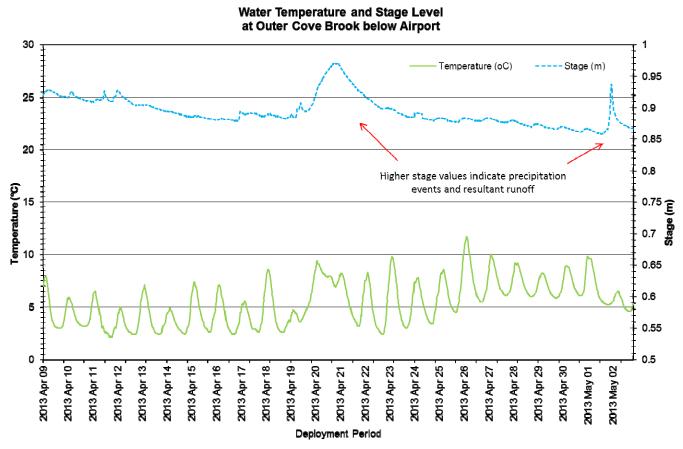
- Water temperature ranged from 2.10°C to 11.70°C during this deployment period (Figure 2).
- Water temperatures rise from just above freezing to above 10°C, as expected during the spring months, with a further increase in temperatures noted during the last week of the deployment. This is consistent with ambient air temperatures over this time period.
- Water temperatures display diurnal variations, typical of shallow streams and ponds which are highly influenced by natural diurnal variations in ambient air temperatures.
- Water temperature is a very important parameter and it has the ability to influence other parameters that are measured by the water quality instrument.

Figure 2: Quarter-hourly water temperature (°C) and stage level (m) values at Outer Cove Brook below Airport for the deployment period April 9, 2013 to May 3, 2013.

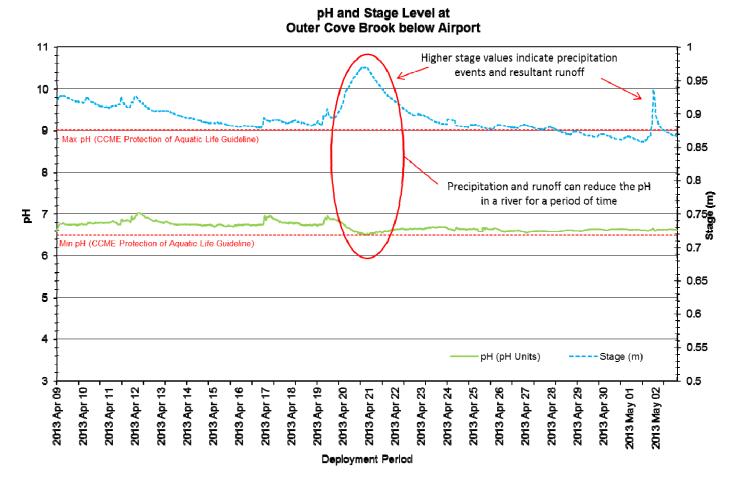
- Throughout this deployment period pH values ranged between 6.49 pH units and 7.02 pH units (Figure 3). The maximum value of 7.02 pH units is higher than the 2012 maximum value at this station of 6.96 pH units.
- During the deployment, the pH values at this station hover just above the minimum CCME Guideline for the Protection of Aquatic Life (between 6.5 and 9 pH units). There is a notable drop in pH on April 21, related to a precipitation event (Figure 3). This is a natural occurrence between rainfall and pH levels. The pH stays low after this precipitation event, compared to the beginning of the deployment period.
- The CCME guideline provides a basis by which to judge the overall health of the brook. Naturally, all streams and brooks are different. In the case of Outer Cove Brook below Airport, pH is within the normal range for stream water in St. John's.

Figure 3: Quarter-hourly pH (pH units) and stage level (m) values at Outer Cove Brook below Airport for the deployment period April 9, 2013 to May 3, 2013.

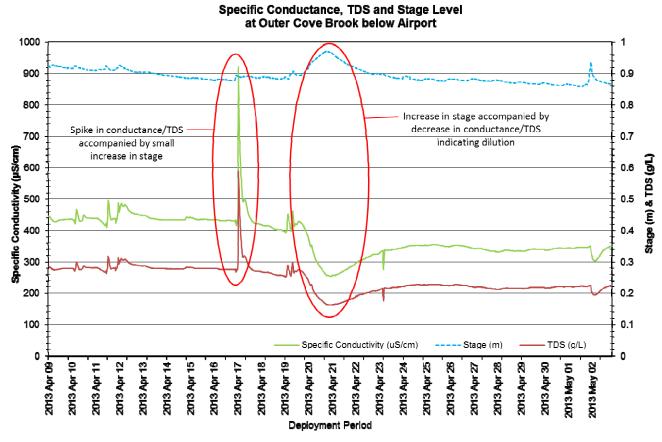
- The conductivity levels were within 252 μS/cm and 922 μS/cm during this deployment period. TDS ranged from 0.1620 g/L to 0.5900 g/L.
- Generally, rainfall events, such as that which occurred on April 21 (see Figure 4), can have the effect of diluting and lowering conductance levels. When stage levels rise, the specific conductance levels drop in correlation as the increased amount of water in the river system dilutes the solids present there, thus generally decreasing the specific conductivity readings.

- There is a significant spike in conductivity and TDS on April 17<sup>th</sup>, accompanied by a small increase in stage. This indicates some input or disturbance in the river at this time which may have led to resuspension of solids and salts. This river has been under investigation by Environment Canada, and this spike may result from disturbance due to sampling upstream or near the station, or due to ATV usage upstream as users frequently drive through the river.

Figure 4: Quarter-hourly specific conductivity ( $\mu$ S/cm), TDS (g/L) and stage (m) values at Outer Cove Brook below Airport for the deployment period April 9, 2013 to May 3, 2013.

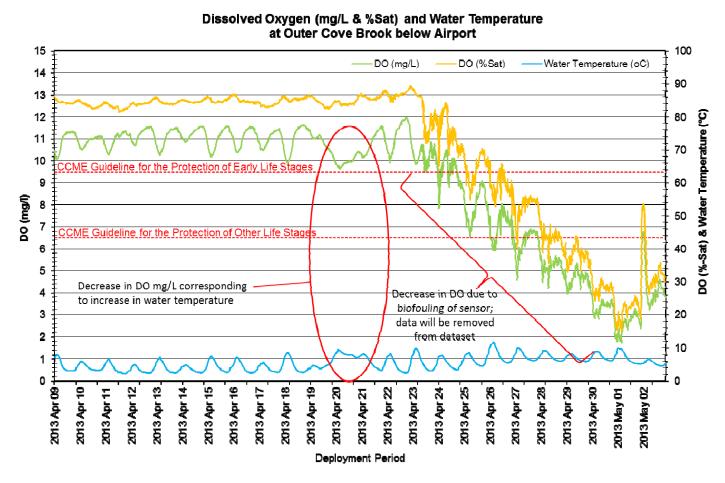
- The DO mg/L values are above the minimum DO CCME guideline for early life stages for the majority of the deployment until April 24<sup>th</sup> (see Figure 5). After this, the DO readings gradually decline. This is likely due to biofouling of the sensor as there is a large amount of 'furry slime' present in the river and around the probes. The data from April 24-May 3 will be removed from the dataset.

- Dissolved Oxygen percent saturation remains relatively constant throughout the deployment period until April 24<sup>th</sup>. Dissolved oxygen mg/L content fluctuates with the water temperature changes. Small decreases in dissolved oxygen values are inversely related to increases in water temperature as warmer water can hold less oxygen.

Figure 5: Quarter-hourly dissolved oxygen (mg/L & % sat) and water temperature (°C) values at Outer Cove Brook below Airport for the deployment period April 9, 2013 to May 3, 2013.

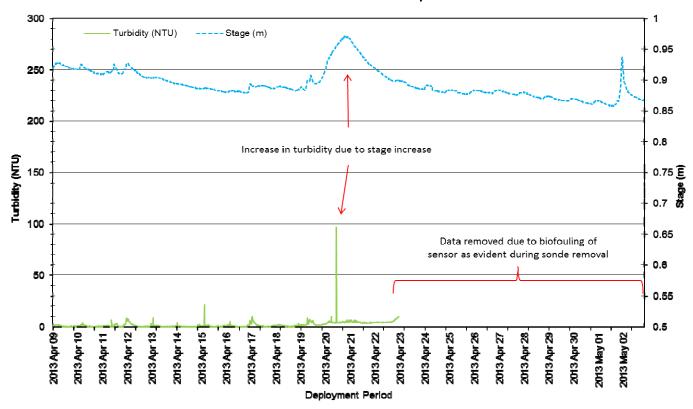
- The turbidity sensor can read a turbidity value between 0 NTU and 3000 NTU. If a reading hits 3000NTU it is identified as an error reading and thus is not a true turbidity value. From April 23 until the end of deployment, turbidity values increased constantly, maxing out at 3000 NTU, indicating complete blockage of the turbidity sensor or a sensor issue. Values at the end of this deployment period had reached 3000, and thus this data was removed as it was incorrect. Biofouling was evident on the sonde during removal.

- The turbidity readings from April 9 to April 23 ranged within 0.0 NTU to 96.8 NTU. Data from April 23 to removal on May 3 were excluded as there was an issue with the sensor.

- Several precipitation events and corresponding stage increases led to fluctuating turbidity values (see Figure 6) as sediment and debris were resuspended into the water column.

- This sensor received a 'poor' performance ranking at removal due to the large amount of biofouling occurring around the sensors and on the casing. The substance which fouled the sensors was a thick, whitish-brown 'furry slime', which coated all the equipment in the water as well as the river bed and surrounding vegetation.

Figure 6: Quarter-hourly turbidity (NTU) and stage level (m) values at Outer Cove Brook below Airport for the deployment period April 9, 2013 to May 3, 2013.

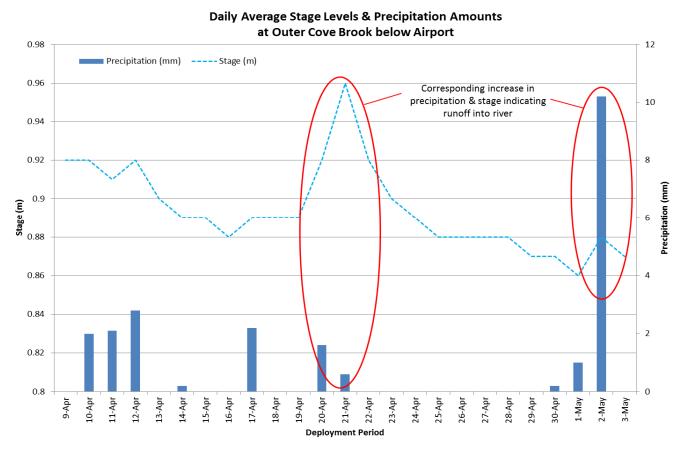
- Stage values are based on a vertical reference that is unique to each station. As a result, absolute values of stage are not comparable between stations, but relative changes in stage are.
- Stage provides an estimation of water level at the station and can explain some of the changes that are occurring with other parameters (i.e. Specific Conductivity, DO, turbidity). Stage increases during precipitation events (Figure 7) due to increased runoff from the surrounding area.
- Precipitation data was obtained from Environment Canada's St. John's Airport weather station and supplemented with data from 'The Weather Network' when EC data was unavailable.
- During the deployment period, the stage ranged from 0.86m to 0.97m.

Figure 7: Daily average stage values (m) at Outer Cove Brook below Airport and daily total precipitation values (mm) from Environment Canada's St. John's Airport Station for the deployment period April 9, 2013 to May 3, 2013.

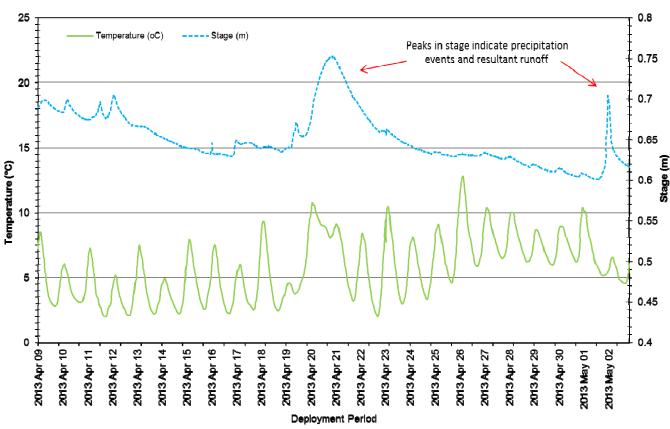
- Water temperature ranged from 2.01°C to 12.81°C during this deployment period (Figure 8).
- Water temperatures rise from just above freezing to above 10°C, as expected during the spring months, with a further increase in temperatures noted during the last week of the deployment. This is consistent with ambient air temperatures over this time period.
- Water temperatures display diurnal variations, typical of shallow streams and ponds which are highly influenced by natural diurnal variations in ambient air temperatures.
- Water temperature is a very important parameter and it has the ability to influence other parameters that are measured by the water quality instrument.

Figure 8: Quarter-hourly water temperature (°C) and stage level (m) values at Outer Cove Brook at Clovelly Golf Course for the deployment period April 9, 2013 to May 3, 2013.

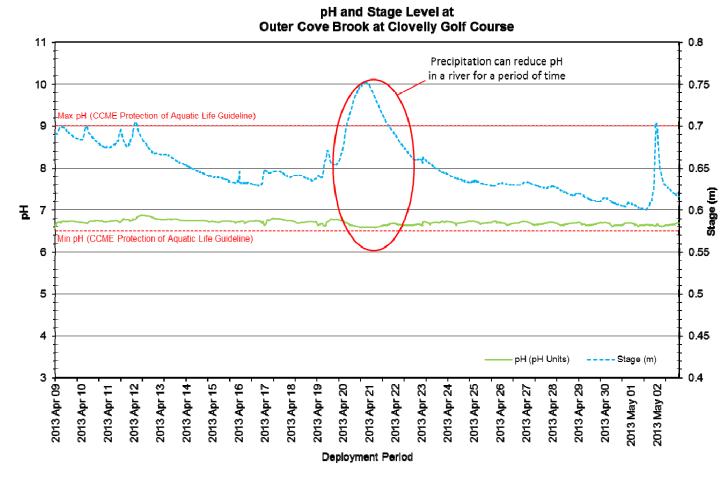
- Throughout this deployment period pH values ranged betwen 6.56 pH units and 6.88 pH units (Figure 9).
- During the deployment, the pH values at this station hover around the minimum CCME Guideline for the Protection of Aquatic Life (between 6.5 and 9 pH units) but never go below 6.50 pH units.
- There is a notable drop in pH on April 21, related to a precipitation event. This is a natural occurrence between rainfall and pH levels.
- The CCME guideline provides a basis by which to judge the overall health of the brook. Naturally, all streams and brooks are different. In the case of Outer Cove Brook at Clovelly Golf Course, pH is within the normal range for stream water in St. John's.

Figure 9: Quarter-hourly pH (pH units) and stage level (m) values at Outer Cove Brook at Clovelly Golf Course for the deployment period April 9, 2013 to May 3, 2013.

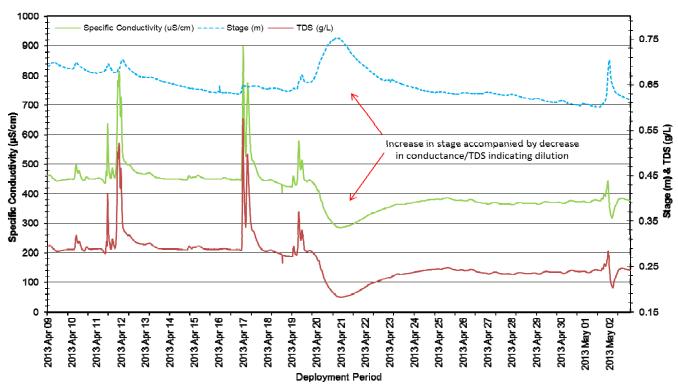
- Generally, rainfall events, such as that which occurred on April 21 (see Figure 10), can have the effect of diluting and lowering conductance levels. When stage levels rise, the specific conductance levels drop in correlation as the increased amount of water in the river system dilutes the solids present there, thus generally decreasing the specific conductivity readings.

- There is a significant spike in conductivity and TDS on April 17<sup>th</sup>, accompanied by a small increase in stage. This increase was also evident at this time at the below airport station. This indicates some input or disturbance in the river at this time which may have led to resuspension of solids and salts. This river has been under investigation by Environment Canada, and this spike may result from disturbance due to sampling upstream or near the station. Other possible causes of the river disturbance include construction occurring upstream and ATV usage cutting through the river.

Figure 10: Quarter-hourly specific conductivity (uS/cm), TDS (g/L) and stage (m) values at Outer Cove Brook at Clovelly Golf Course for the deployment period April 9, 2013 to May 3, 2013.

- It is evident from the conductivity data (Figure 10) that there is an influence upstream of this station which is causing spikes in TDS and conductance values. This may be related to construction upstream of this station near Torbay Road, or some other disturbance of the river causing resuspension of solids present in the water.

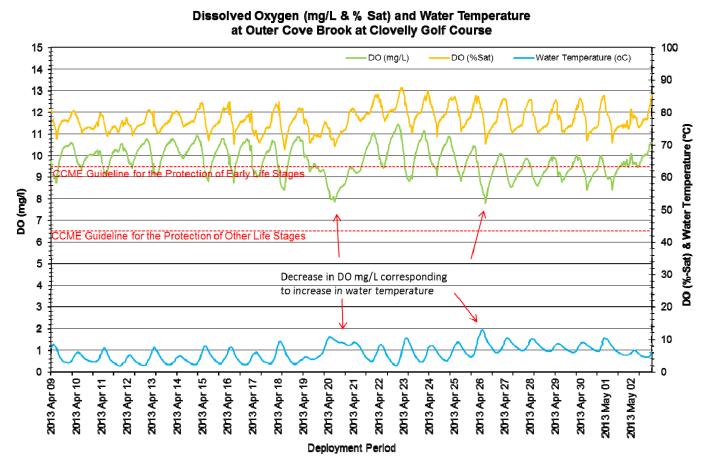
- The Dissolved Oxygen % Sat levels within this deployment period were within 68.6% Sat–87.6% Sat. Dissolved Oxygen (mg/L) measured 7.79 mg/L to 11.47 mg/L. The DO mg/L values are above the minimum DO CCME guideline for early life stages for the majority of the deployment, but dip below this threshold on several occasions, notably April 20th and 26<sup>th</sup> (see Figure 11). This coincides with peaks in water temperatures during this period.

- Dissolved Oxygen percent saturation remains relatively constant throughout the deployment period, with diurnal fluctuations. Dissolved oxygen mg/L content fluctuates with the water temperature changes. Decreases in dissolved oxygen values are inversely related to increases in water temperature as warmer water can hold less oxygen.

Figure 11: Quarter-hourly dissolved oxygen (mg/L & % sat) and water temperature (°C) values at Outer Cove Brook at Clovelly Golf Course for the deployment period April 9, 2013 to May 3, 2013.

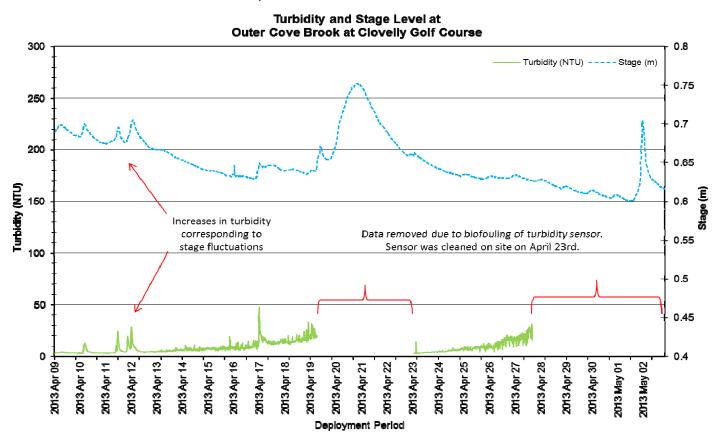
- The turbidity readings during this deployment, for data that was not removed due to biofouling ranged within 2.5 NTU to 47.7 NTU (Figure 12).
- This sensor was cleaned on April 23 when a constant climb in turbidity indicated biofouling of the sensor. Once the thin layer of brown slime was cleaned from the sensor, turbidity dropped down, indicating the sensor had been fouled. The 'poor' sensor reading at removal indicates that biofouling is an interfering factor at this location.

Figure 12: Quarter-hourly turbidity (NTU) and stage level (m) values at Outer Cove Brook at Clovelly Golf Course for the deployment period April 9, 2013 to May 3, 2013.

- High turbidity values at removal and a 'poor' sensor ranking are explained by the presence of a thin layer of brownish slime coating the sensors. To prove the presence of biofouling at this site, the sensor was cleaned on April 23<sup>rd</sup> after a steady climb in turbidity values, and resulted in a drop in turbidity values, before biofouling again built up on the probes.

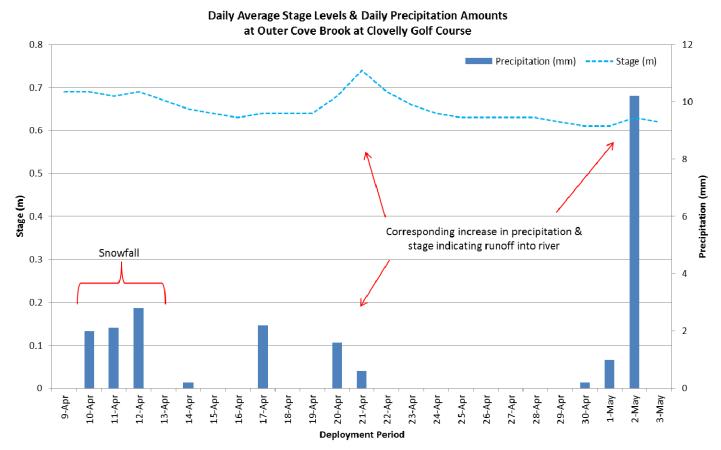
- Stage values are based on a vertical reference that is unique to each station. As a result, absolute values of stage are not comparable between stations, but relative changes in stage are.
- Stage provides an estimation of water level at the station and can explain some of the events that
  are occurring with other parameters (i.e. Specific Conductivity, DO, turbidity). Stage increases
  during precipitation events due to increased runoff from the surrounding area (see Figure 13).
- Precipitation data was obtained from Environment Canada's St. John's Airport weather station and supplemented with data from 'The Weather Network' when EC data was unavailable.
- During the deployment period, the stage values ranged from 0.60m to 0.75m.

Figure 13: Daily average stage values (m) at Outer Cove Brook below Airport and daily total precipitation values (mm) from Environment Canada's St. John's Airport Station for the deployment period March 6 to April 9, 2013.

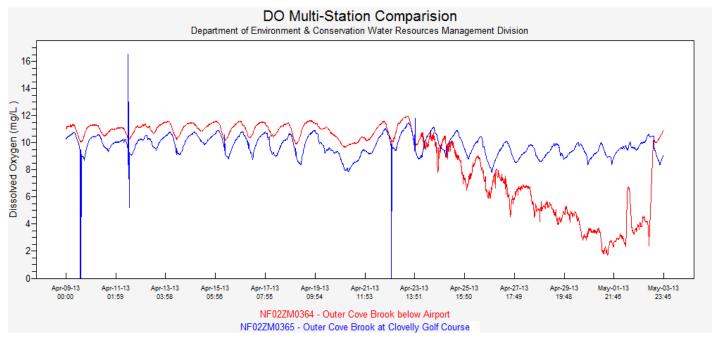
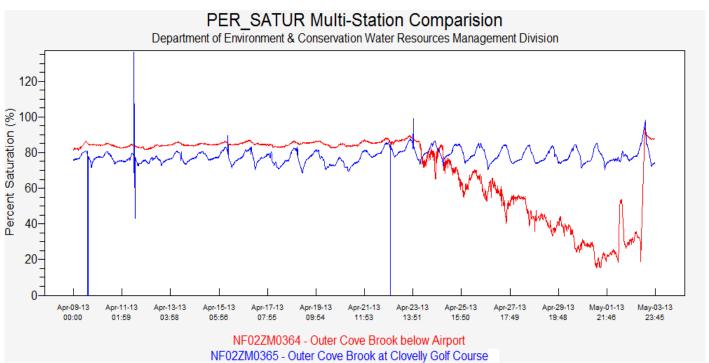
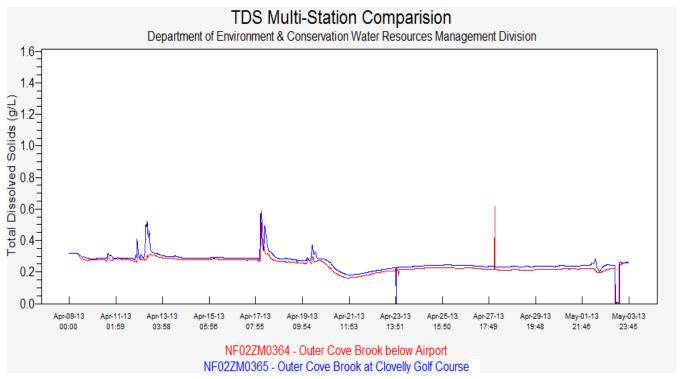
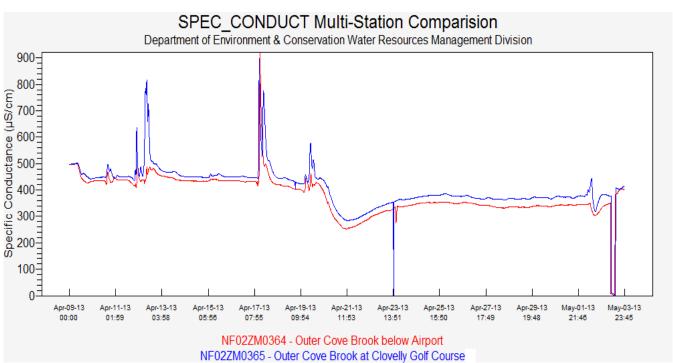
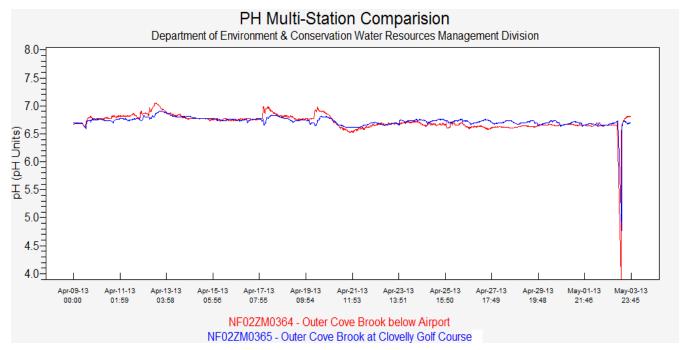
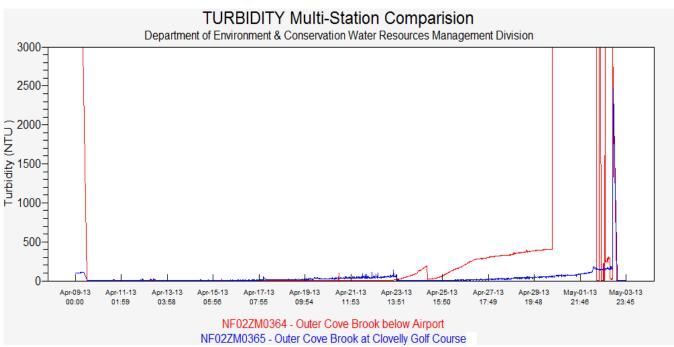
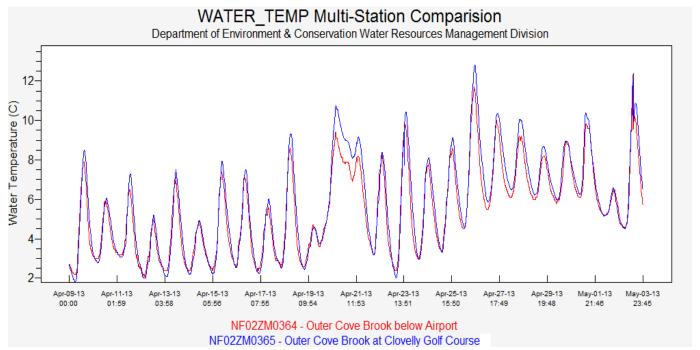
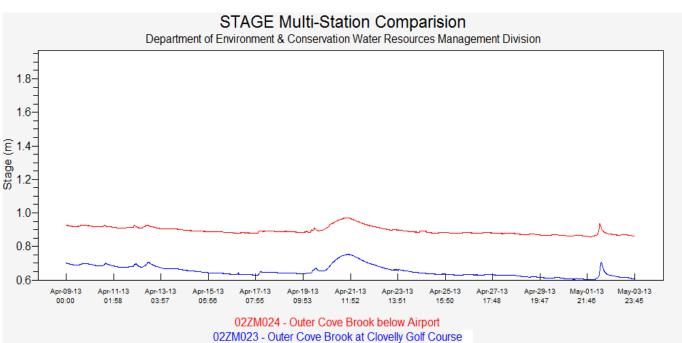
# Appendix Parameter Station Comparison Graphs

During this deployment period, the median water temperature at the upstream station (below Airport) of 5.35°C was very similar to that of the downstream station (at Clovelly Golf Course) of 5.60°C. The median pH values for both were also comparable with below Airport's median at 6.67 and Clovelly Golf Course reading 6.70, and thus no significant change in pH from the upstream to the downstream station. The specific conductivity medians were similar at both stations with 353 uS/cm reported below the airport and 382.5 uS/cm reported at the golf course. These values are approximately 200 uS/cm lower than during the previous deployment period. It should be noted that when conductance and TDS data from both stations are analyzed together, there are spikes in both parameters on April 12<sup>th</sup>, 19<sup>th</sup> and May 1<sup>st</sup> at Clovelly that do not occur at the airport station. This indicates some influence is increasing these parameters between the airport and golf course. This may be an influence of ongoing construction near Torbay Road. Dissolved oxygen at the upstream station (below Airport) had a median of 83.6%Sat during the deployment period, while the downstream station (Clovelly Golf Course) had a lower median of 77.2%Sat. This lower oxygen content at the downstream station may be due the presence of more salts in water at this station, as indicated by specific conductance values, which lowers the amount of oxygen the water can hold. A comparison of turbidity cannot be made between stations as both stations had significant biofouling or sensor issues.
