Real-Time Water Quality Report

Outer Cove Brook Network

Deployment Period
May 3 to June 4, 2013

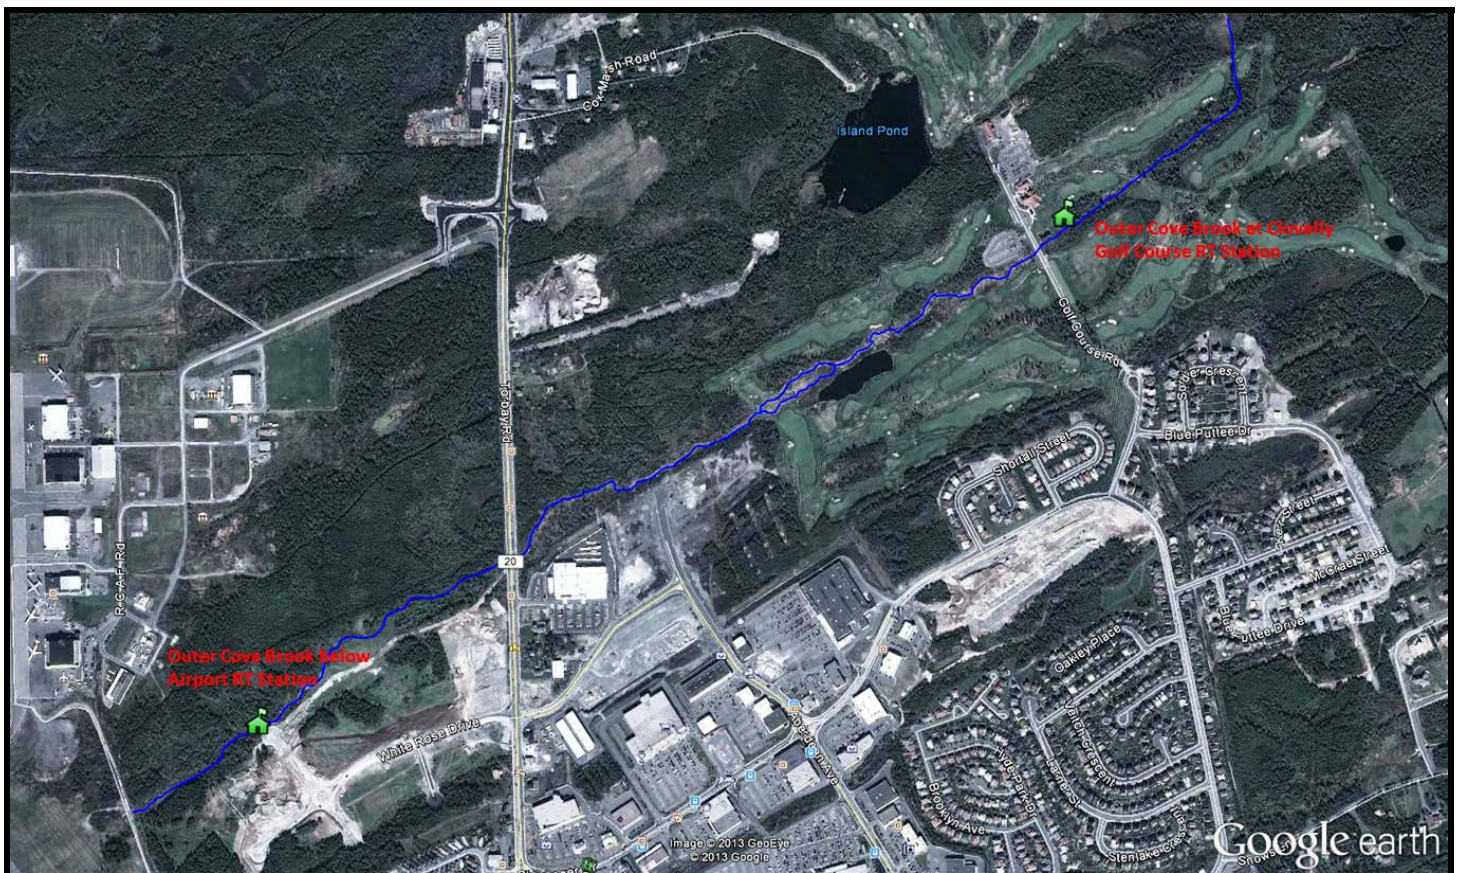
Figure 1: Outer Cove Brook Real-Time Water Quality and Quantity Stations.

- The Water Resources Management Division (WRMD), in partnership with the City of St. John's and Environment Canada, maintain two real-time water quality and water quantity monitoring stations along Outer Cove Brook.

- This deployment report discusses water quality related events occurring at the stations: Outer Cove Brook below Airport and Outer Cove Brook at Clovelly Golf Course in St. John's.

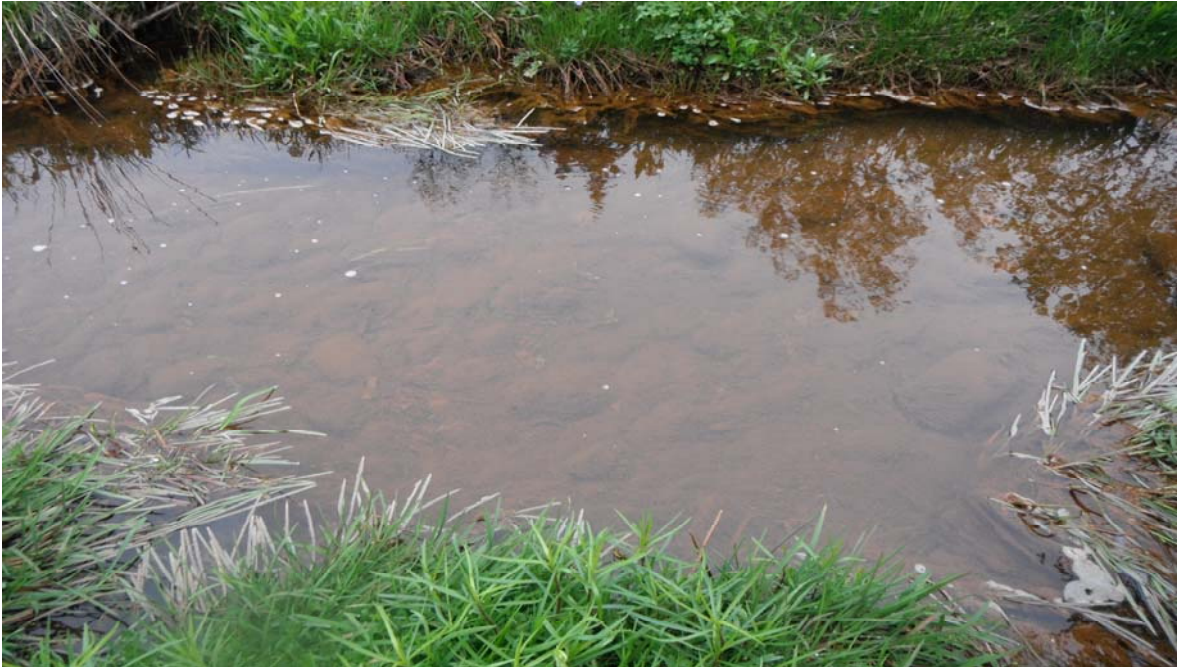
- The instrument measures dissolved oxygen (mg/L) then calculates percent saturation.
- During this deployment, DO values were inaccurate due to the presence of a large amount of brown 'slime' thickly coating the instrument (Figure 5), which led to DO values which did not reflect the actual oxygen content of the water. This caused the 'poor' sensor performance ranking upon removal, as only the QA/QC reading was an accurate reflection of the DO in the water. As this field data was inaccurate, it will be removed from the dataset for the duration of the deployment.

Figure 5: Thick brown 'slime' growth covering river bottom at deployment location.

- At removal, temperature ranked as 'good'. pH ranked as 'fair' while conductivity, dissolved oxygen and turbidity ranked as 'poor', as was to be expected after observing a constant rise in turbidity values over the month, reaching the maximum and error value of 3000#, indicative of sensor blockage. When the sonde was removed, heavy growth of a brown 'fur-like' slime substance again coated the sonde casing and the sensors, as in the previous deployment periods.

- Outer Cove Brook below Airport contains a significant amount of algae. High algal growth, biofouling, or leaf and grass debris can interfere with turbidity measurements as they block the sensor.
- Turbidity readings during this deployment period were inaccurate due to the large amount of brown 'slime' which quickly attached to the sonde casing after deployment, blocking the turbidity sensor and giving inaccurate water quality values. This biofouling is what caused the 'poor' performance ranking at removal. Methods to combat this biofouling will be investigated.

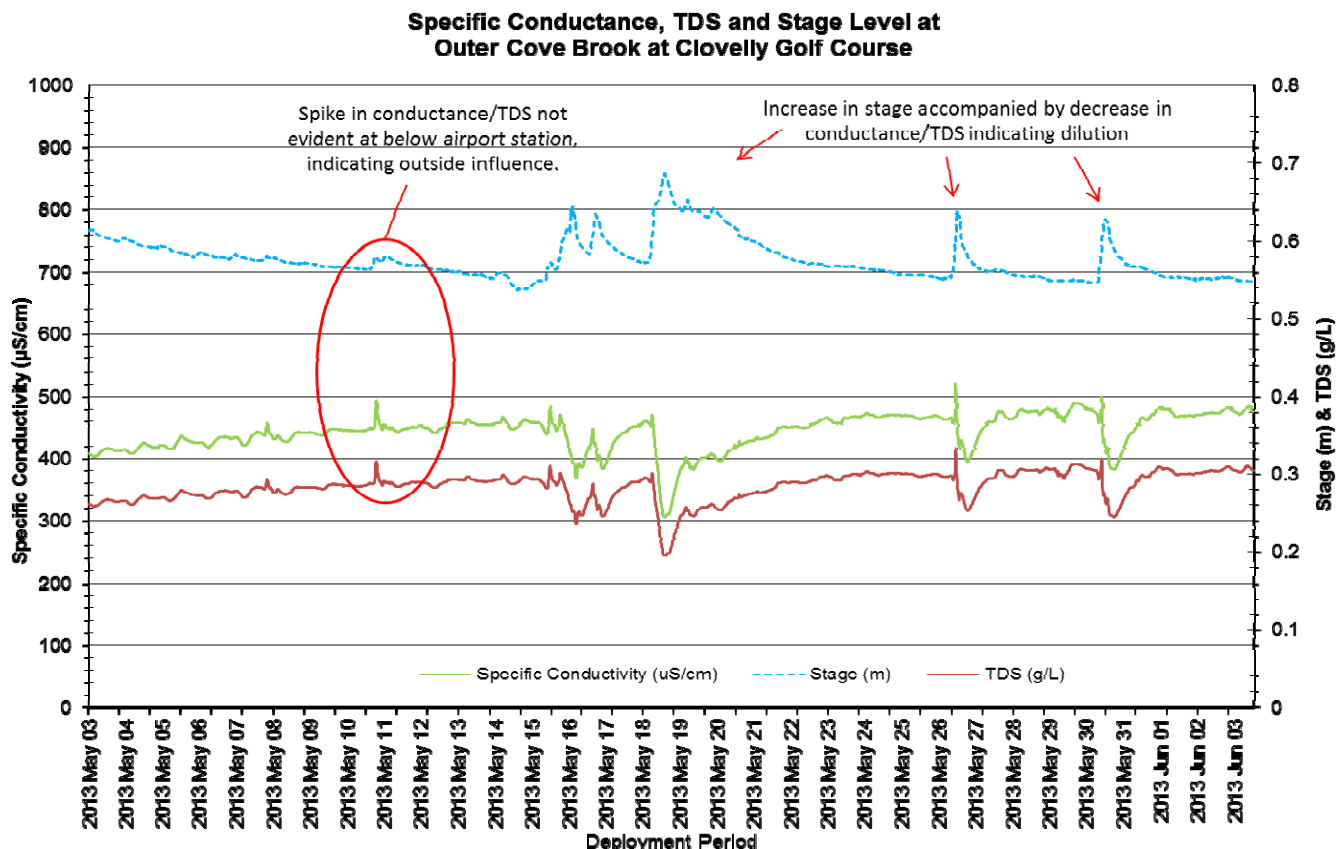
- Generally, rainfall events, such as that which occurred on May 18th (see Figure 9), can have the effect of diluting and lowering conductance levels. When stage levels rise, the specific conductance levels drop in correlation as the increased amount of water in the river system dilutes the solids present there, thus generally decreasing the specific conductivity readings.

- There is a significant spike in conductivity and TDS on May 11th, accompanied by a small increase in stage. This increase was not evident at the below airport station, indicating some possible input or disturbance in the river at this time between the two stations which may have led to resuspension of solids and salts. This river has been under investigation by Environment Canada, and this spike may result from disturbance due to sampling upstream or near the station. Other possible causes of the river disturbance include construction occurring upstream and ATV usage cutting through the river.

Figure 9: Quarter-hourly specific conductivity ($\mu\text{S}/\text{cm}$), TDS (g/L) and stage (m) values at Outer Cove Brook at Clovelly Golf Course for the deployment period May 3, 2013 to June 4, 2013.

- Total Dissolved Solids (TDS), is a parameter that the instrument calculates by an algorithm that utilizes the data from specific conductivity and water temperature to produce a TDS value and generally always mirrors specific conductivity.

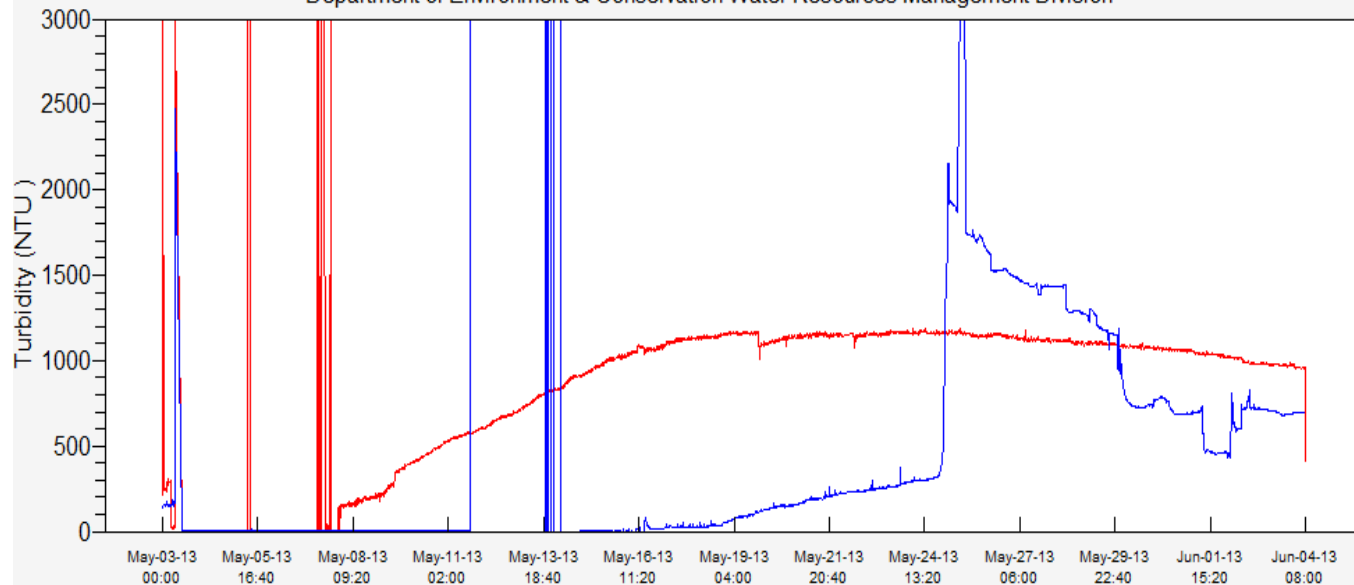
TURBIDITY Multi-Station Comparision

NF02ZM0364 - Outer Cove Brook below Airport

NF02ZM0365 - Outer Cove Brook at Clovelly Golf Course
