Real-Time Water Quality Report

Outer Cove Brook Network

Deployment Period September 4 to October 8, 2013

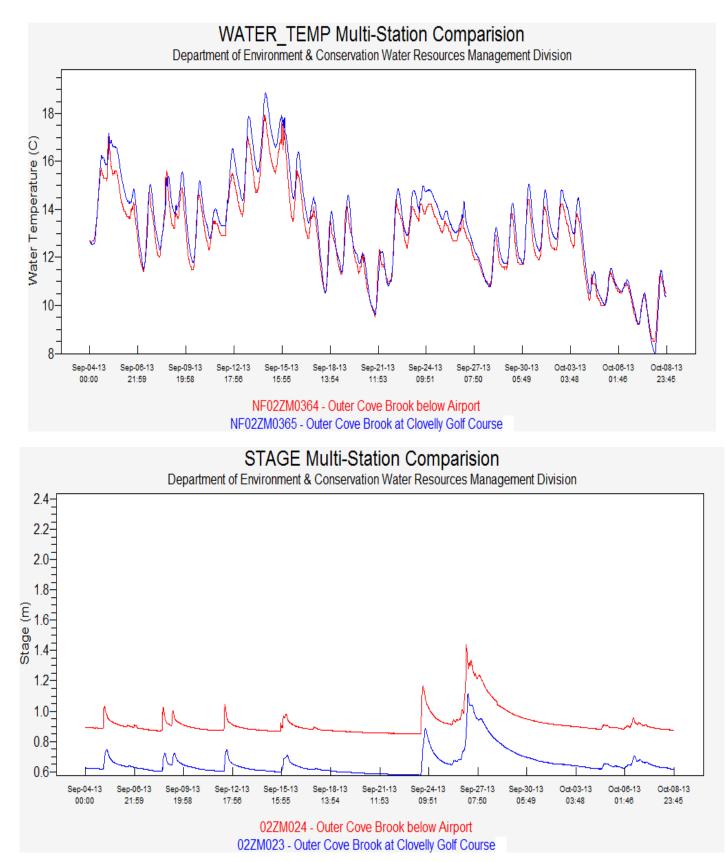
Parameter Station Comparison Graphs

NF02ZM0364 - Outer Cove Brook below Airport NF02ZM0365 - Outer Cove Brook at Clovelly Golf Course

During this deployment period, the median water temperature at the upstream station (below Airport) of 13.00°C was slightly lower than that of the downstream station (at Clovelly Golf Course) of 13.41°C. The median pH value of 6.34 below the Airport is higher than the Clovelly station median of 6.13. A comparison of the two stations pH values over the deployment period indicates that this trend was consistent over this period, and thus there is a noticeable change in pH from the upstream to the downstream station. This will be monitored during the upcoming deployment periods. The specific conductivity medians were similar at both stations with 298 uS/cm reported below the airport and 307 uS/cm reported at the golf course. Dissolved oxygen at the upstream station (below Airport) had a median of 88.7%Sat during the deployment period, while the downstream station (Clovelly Golf Course) had a lower median of 81.8%Sat. The lower oxygen levels at the downstream Clovelly station occur at night, indicating an interaction with the prolific aquatic grass growth which cannot synthesize oxygen and replenish the dissolved oxygen in the water at night. The median turbidity value below the airport was 2.7 NTU while at Clovelly Golf Course the median was 0.9 NTU. There does not appear to be any increase in turbidity from the upstream to the downstream station.
