# Real-Time Water Quality Report

## Outer Cove Brook Network

Deployment Period  
October 8 to November 6, 2013

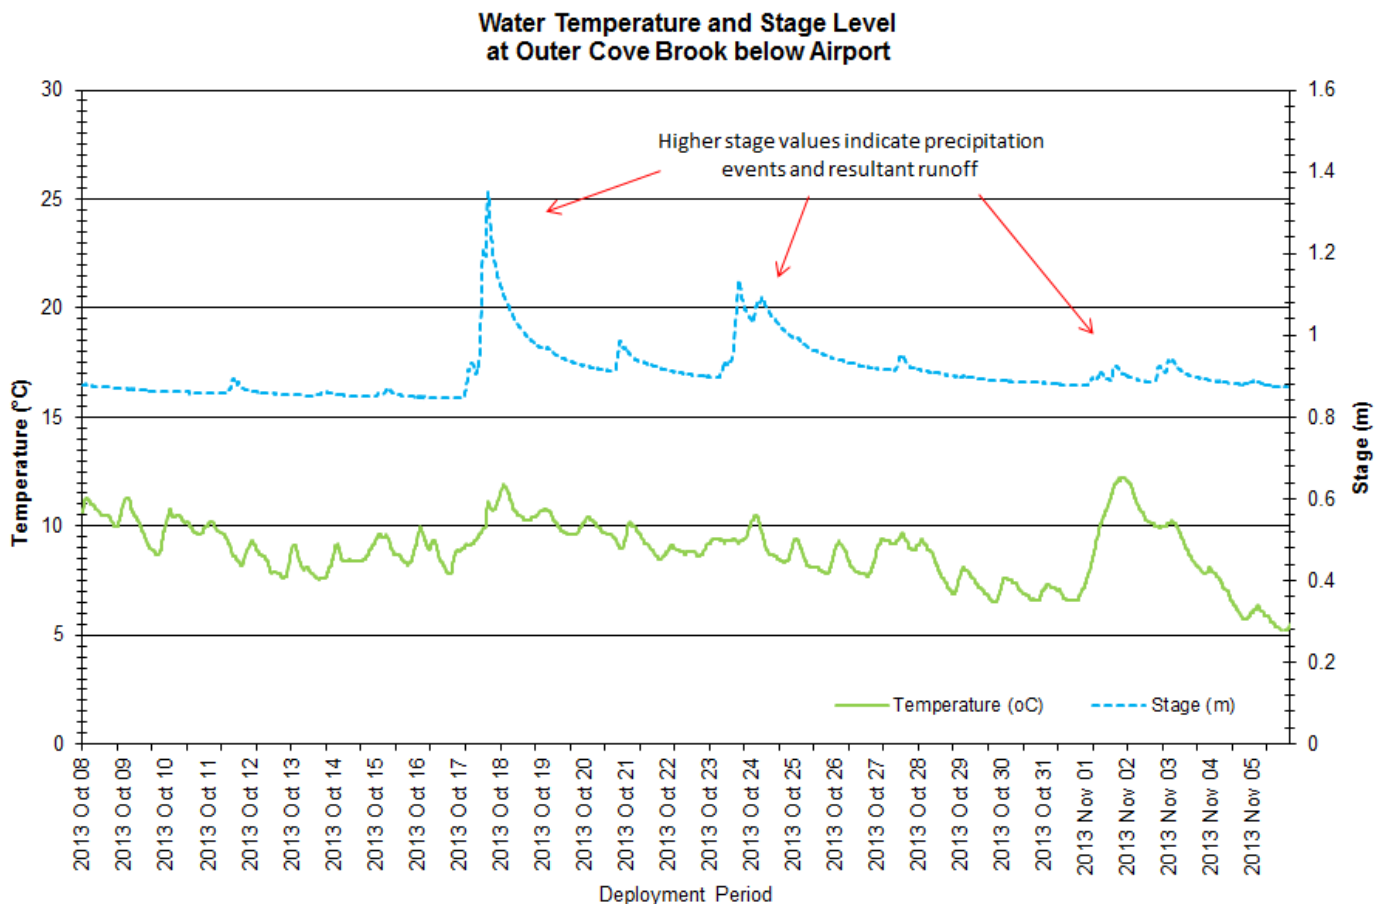
- Water temperature ranged from 5.20°C to 12.20°C during this deployment period (Figure 2).
- There are noticeable increases and decreases in the water temperature during the deployment period. This is consistent with ambient air temperatures over this time period, generally increasing during daylight hours and cooling overnight. Overall, temperature is decreasing as winter approaches.
- Water temperatures display diurnal variations, typical of shallow streams and ponds which are highly influenced by natural diurnal variations in ambient air temperatures.
- Water temperature is a very important parameter and it has the ability to influence other parameters that are measured by the water quality instrument.

**Figure 2: Quarter-hourly water temperature (°C) and stage level (m) values at Outer Cove Brook below Airport for the deployment period October 8, 2013 to November 6, 2013.**

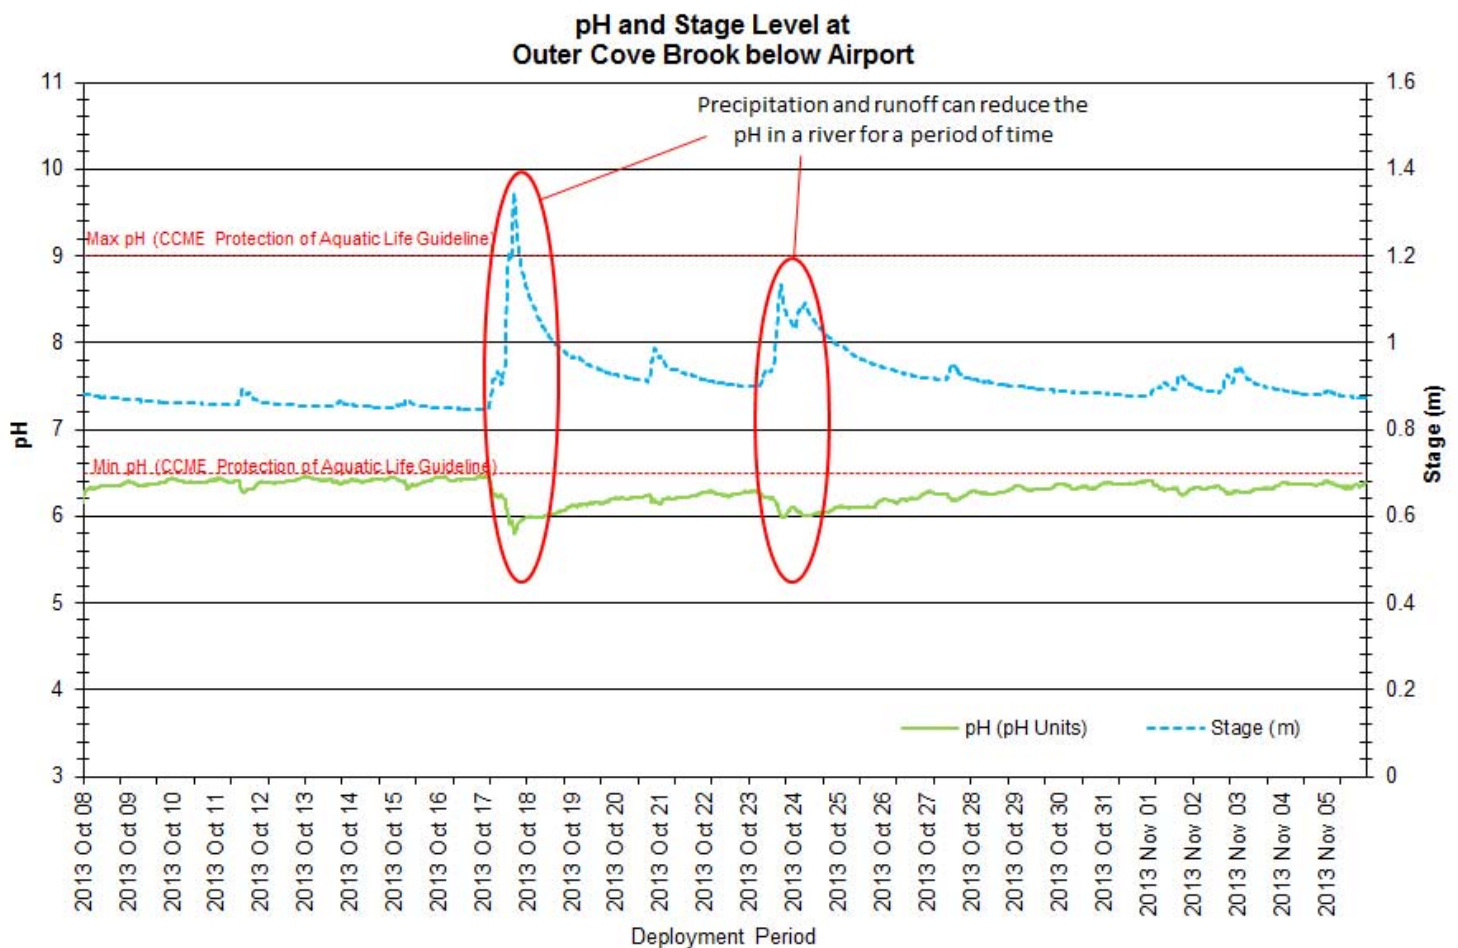
- Throughout this deployment period pH values ranged between 5.79 pH units and 6.46 pH units (Figure 3).
- During the deployment, the pH values at this station hover near the minimum CCME Guideline for the Protection of Aquatic Life (between 6.5 and 9 pH units), dropping lower after precipitation events such as those on October 17<sup>th</sup> and 23<sup>rd</sup> (Figure 3). This is a natural occurrence between rainfall and pH levels.
- The CCME guideline provides a basis by which to judge the overall health of the brook. Naturally, all streams and brooks are different. In the case of Outer Cove Brook below Airport, pH is within the normal range for stream water in St. John's.

**Figure 3: Quarter-hourly pH (pH units) and stage level (m) values at Outer Cove Brook below Airport for the deployment period October 8, 2013 to November 6, 2013.**

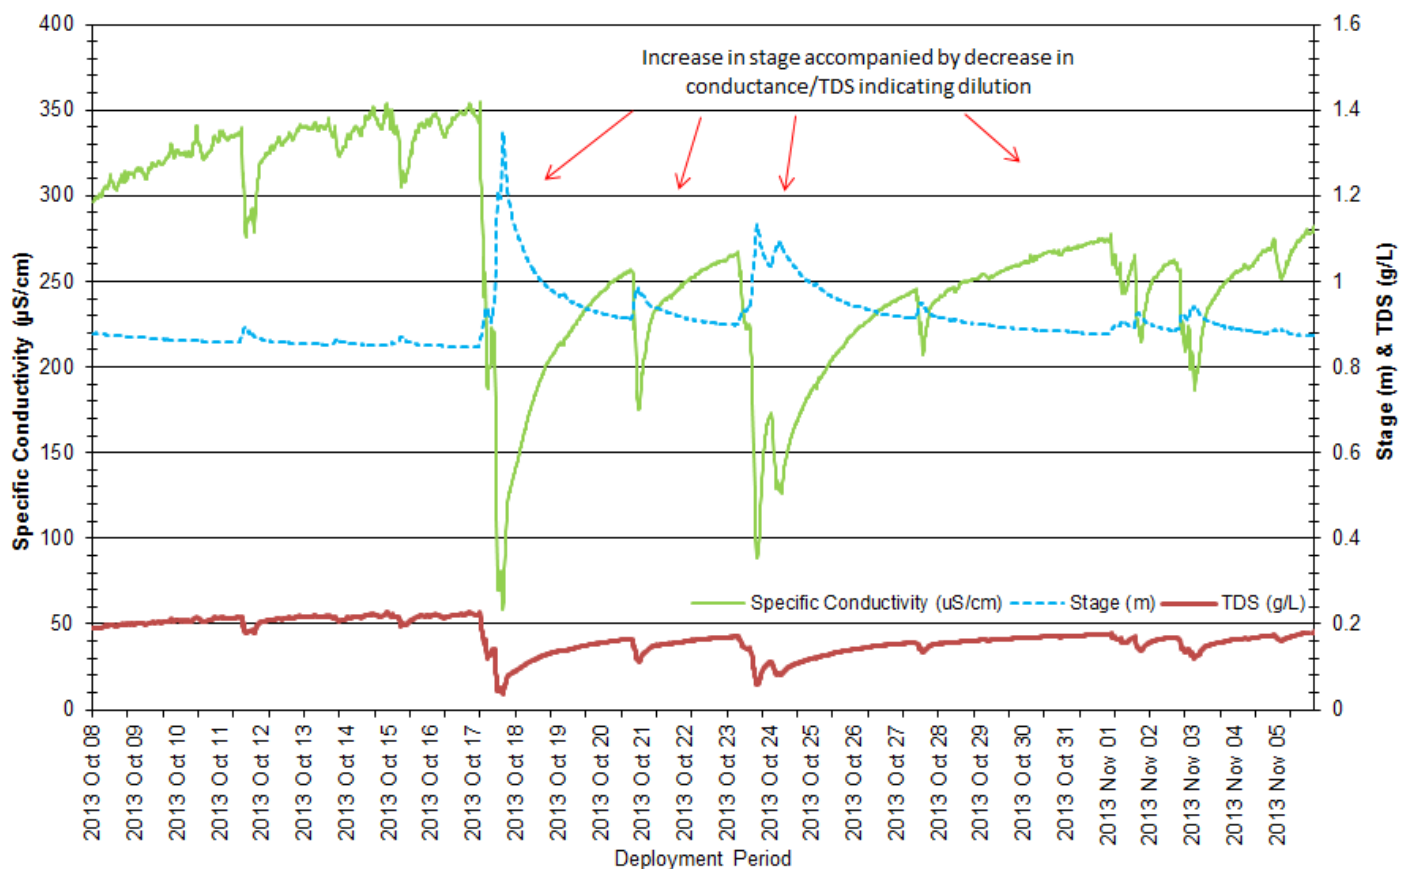
- The conductivity levels were within 58.6  $\mu\text{S}/\text{cm}$  and 355.0  $\mu\text{S}/\text{cm}$  during this deployment period. TDS ranged from 0.0375 g/L to 0.2270 g/L.
- Generally, rainfall events, such as that which occurred on October 17<sup>th</sup> and 23<sup>rd</sup> (see Figure 4), can have the effect of diluting and lowering conductance levels. When stage levels rise, the specific conductance levels drop in correlation as the increased amount of water in the river system dilutes the solids present there, thus generally decreasing the specific conductivity readings.
- Total Dissolved Solids (TDS), is a parameter that the instrument calculates by an algorithm that utilizes the data from specific conductivity and water temperature to produce a TDS value and generally always mirrors specific conductivity.

**Figure 4: Quarter-hourly specific conductivity ( $\mu\text{S}/\text{cm}$ ), TDS (g/L) and stage (m) values at Outer Cove Brook below Airport for the deployment period October 8, 2013 to November 6, 2013.**

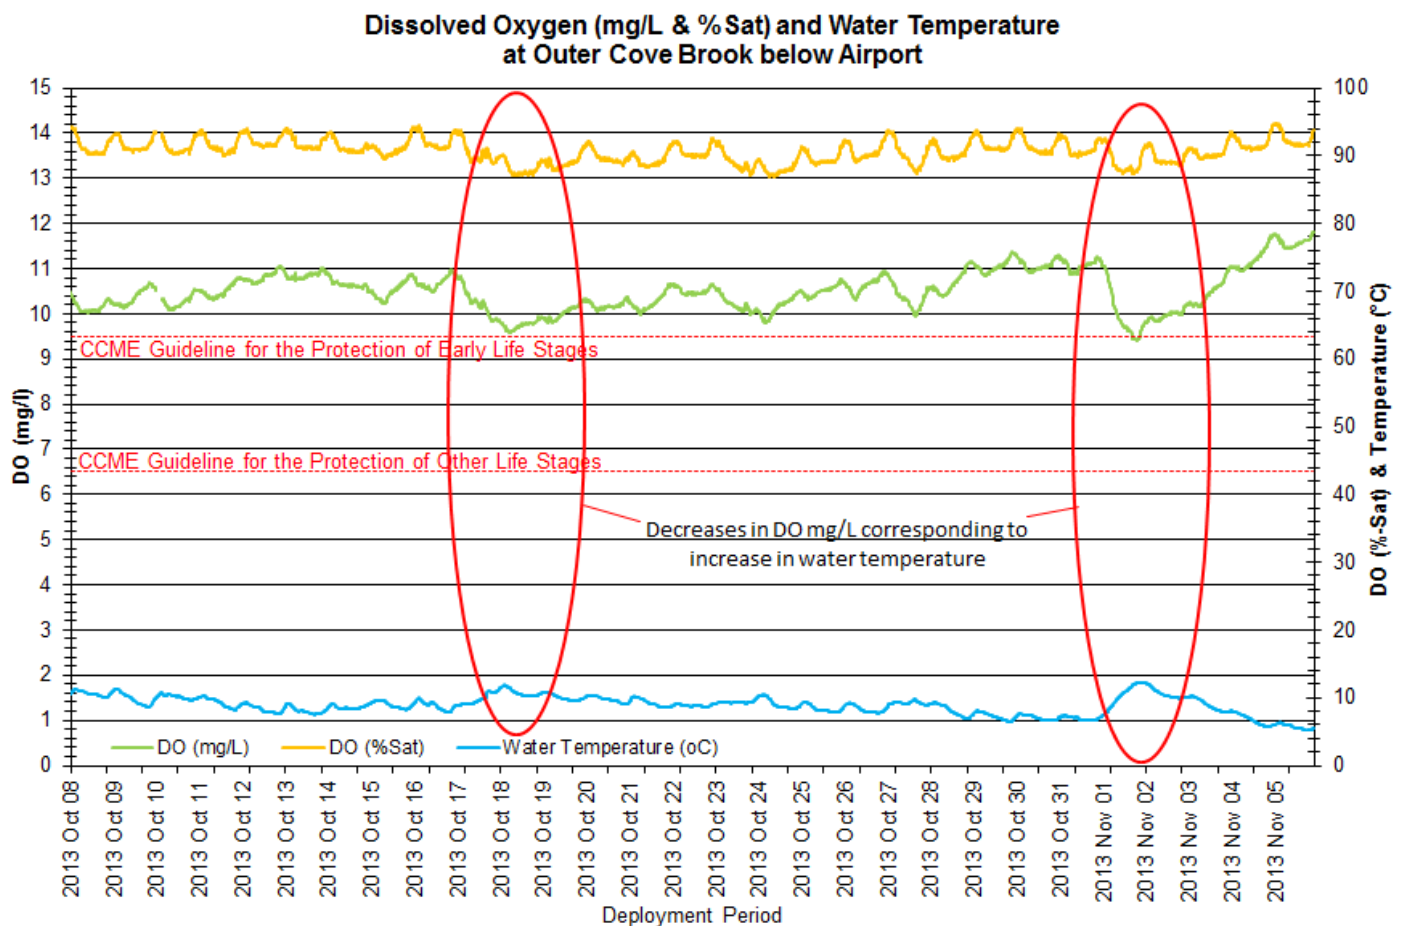
- The instrument measures dissolved oxygen (mg/L) directly then calculates percent saturation (% Sat.).
- The Dissolved Oxygen % Sat levels within this deployment period were within 86.9% Sat–94.8% Sat. Dissolved Oxygen (mg/L) measured 9.39 mg/L to 11.77 mg/L. Water temperatures were cooler during this deployment period, resulting in higher oxygen levels.

- The DO mg/L values are above the minimum DO CCME guideline for early life stages, dropping to near or below the guideline when water temperatures increase as on October 18<sup>th</sup> and November 2<sup>nd</sup> (Figure 5), and rising again when water temperatures decrease.

- Dissolved Oxygen percent saturation remains relatively constant throughout the deployment period. Dissolved oxygen mg/L content fluctuates with the water temperature changes. Small decreases in dissolved oxygen values are inversely related to increases in water temperature as warmer water can hold less oxygen.

**Figure 5: Quarter-hourly dissolved oxygen (mg/L & % sat) and water temperature (°C) values at Outer Cove Brook below Airport for the deployment period October 8, 2013 to November 6, 2013.**

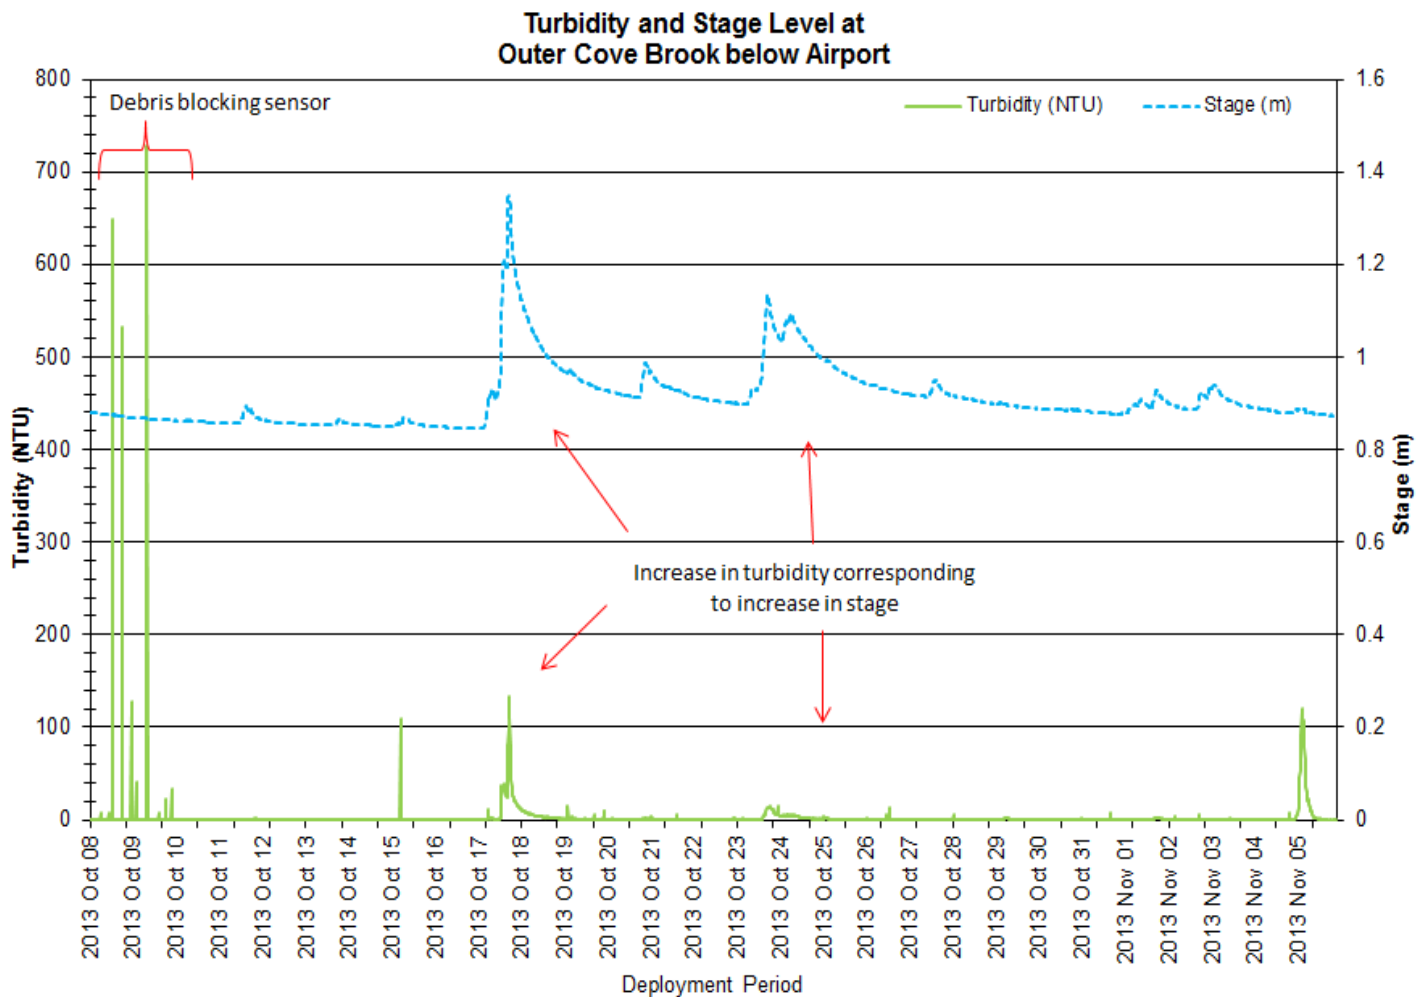
- Outer Cove Brook below Airport contains a significant amount of algae. High algal growth, biofouling, or leaf and grass debris can interfere with turbidity measurements as they block the sensor.
- The turbidity sensor can read a turbidity value between 0 NTU and 3000 NTU. If a reading hits 3000NTU it is identified as an error reading and thus is not a true turbidity value.
- The turbidity readings during this deployment ranged within 0.0 NTU to 728 NTU (Figure 6).
- Several precipitation events and corresponding stage increases led to fluctuating turbidity values (see Figure 6) as sediment and debris were resuspended into the water column. Sudden increases in turbidity for single readings may indicate debris is blocking the turbidity sensor.

**Figure 6: Quarter-hourly turbidity (NTU) and stage level (m) values at Outer Cove Brook below Airport for the deployment period October 8, 2013 to November 6, 2013.**

- The turbidity sensor may have been influenced by debris in the river October 9<sup>th</sup>, as the values increased at multiple times for single high readings at a time. This is not unusual as the river is full of leaves and grass during this time of the year.

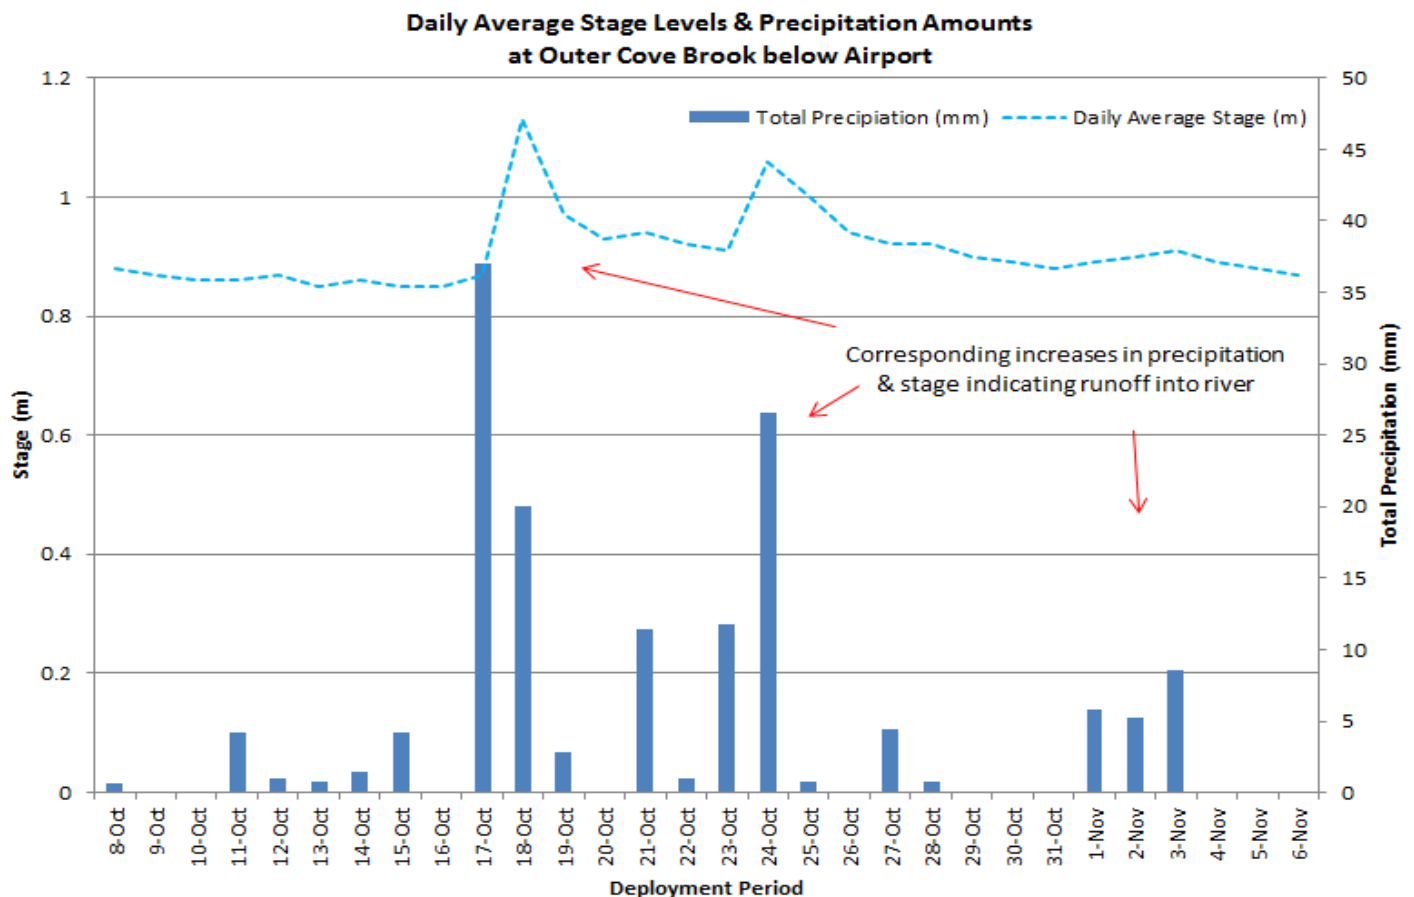
- Stage values are based on a vertical reference that is unique to each station. As a result, absolute values of stage are not comparable between stations, but relative changes in stage are.
- Stage provides an estimation of water level at the station and can explain some of the changes that are occurring with other parameters (i.e. Specific Conductivity, DO, turbidity). Stage increases during precipitation events (Figure 7) due to increased runoff from the surrounding area.
- Precipitation data was obtained from Environment Canada's St. John's Airport weather station and supplemented with data from 'The Weather Network' when EC data was unavailable.
- During the deployment period, the stage ranged from 0.85m to 1.35m, with the maximum level being reached after a significant rainfall event of 57mm over 2 days (October 17<sup>th</sup>-18<sup>th</sup>).

**Figure 7: Daily average stage values (m) at Outer Cove Brook below Airport and daily total precipitation values (mm) from Environment Canada's St. John's Airport Station for the deployment period October 8, 2013 to November 6, 2013.**

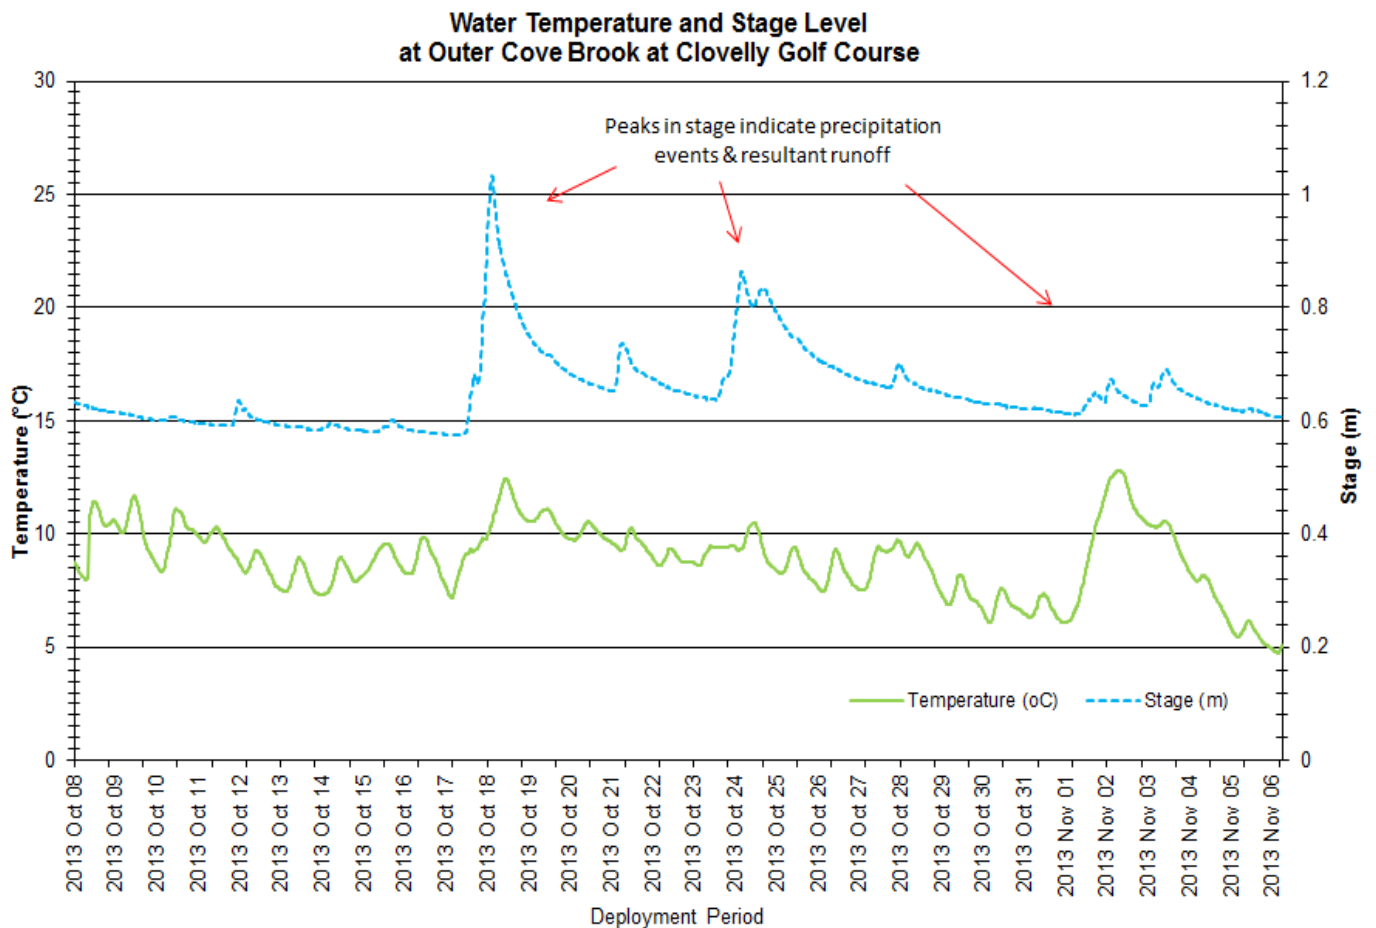
- Water temperature ranged from 4.73°C to 12.79°C during this deployment period (Figure 8). This is notably cooler than the previous deployment, and is normal as winter approaches.
- There are noticeable increases and decreases in the water temperature during the deployment period. This is consistent with ambient air temperatures over this time period, generally increasing during daylight hours and cooling overnight.
- Water temperatures display diurnal variations, typical of shallow streams and ponds which are highly influenced by natural diurnal variations in ambient air temperatures.
- Water temperature is a very important parameter and it has the ability to influence other parameters that are measured by the water quality instrument.

**Figure 8: Quarter-hourly water temperature (°C) and stage level (m) values at Outer Cove Brook at Clovelly Golf Course for the deployment period October 8, 2013 to November 6, 2013.**

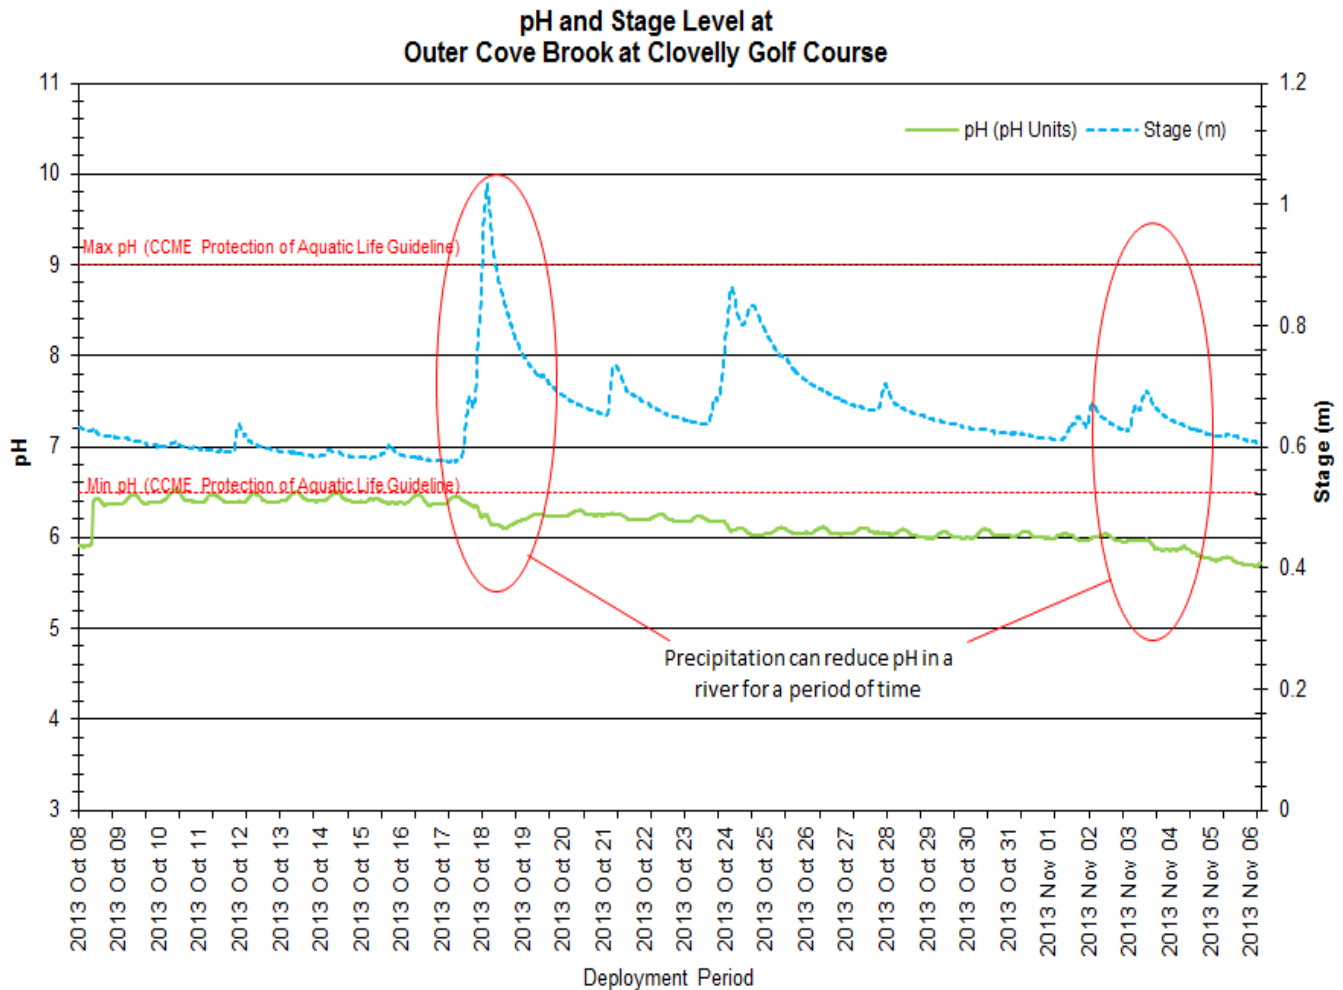
- Throughout this deployment period pH values ranged between 5.68 pH units and 6.54 pH units (Figure 9).
- During the deployment, the pH values at this station are below the minimum CCME Guideline for the Protection of Aquatic Life (between 6.5 and 9 pH units) decreasing further at times due to the addition of precipitation. There are notable drops on October 18<sup>th</sup> and November 3<sup>rd</sup>, related to precipitation events. This is a natural occurrence between rainfall and pH levels.
- The CCME guideline provides a basis by which to judge the overall health of the brook. Naturally, all streams and brooks are different. In the case of Outer Cove Brook at Clovelly Golf Course, pH is within the normal range for stream water in St. John's.

**Figure 9: Quarter-hourly pH (pH units) and stage level (m) values at Outer Cove Brook at Clovelly Golf Course for the deployment period October 8, 2013 to November 6, 2013.**

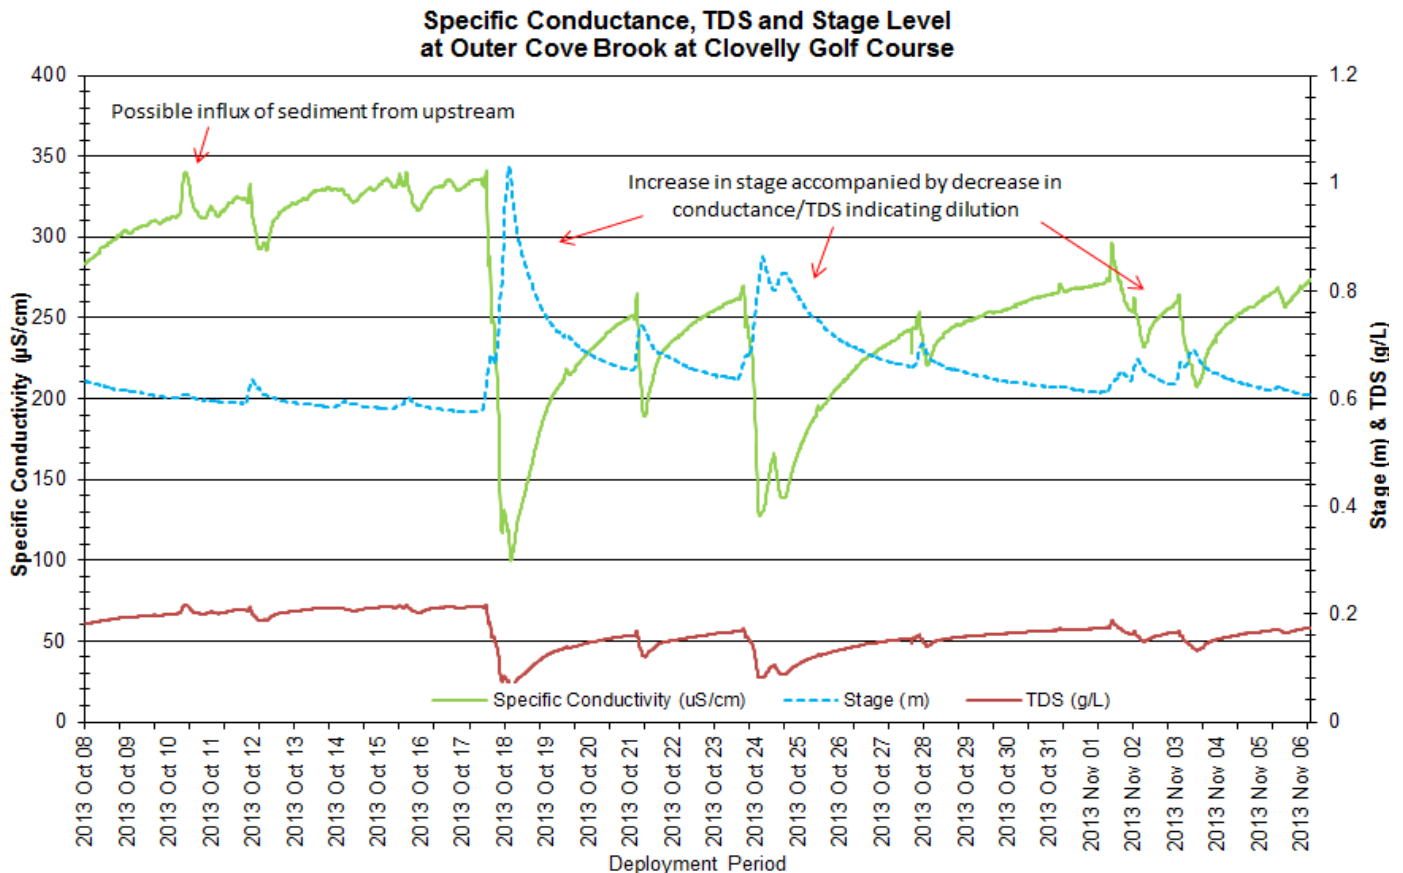
- The conductivity levels were within 100.2  $\mu\text{S}/\text{cm}$  and 341  $\mu\text{S}/\text{cm}$  during this deployment period. TDS ranged from 0.0641 g/L to 0.2180 g/L. This is notably lower than in September, likely due to the large input of freshwater from precipitation during October.

- Generally, rainfall events, such as that which occurred on October 18<sup>th</sup> (see Figure 10), can have the effect of diluting and lowering conductance levels. When stage levels rise, the specific conductance levels drop in correlation as the increased amount of water in the river system dilutes the solids present there, thus generally decreasing the specific conductivity readings.

- A spike in conductivity/TDS is noted on October 10<sup>th</sup>. There is a corresponding smaller spike at this time in the upstream station data, indicating that there may be excessive runoff of sediments into the river between the stations.

Figure 10: Quarter-hourly specific conductivity ( $\mu\text{S}/\text{cm}$ ), TDS (g/L) and stage (m) values at Outer Cove Brook at Clovelly Golf Course for the deployment period October 8, 2013 to November 6, 2013.

- An increase in conductance on October 10<sup>th</sup> may indicate the addition of sediments to the river upstream of this station. This increase did occur at the below airport station but was smaller in magnitude, indicating possible inputs having occurred between the two stations.

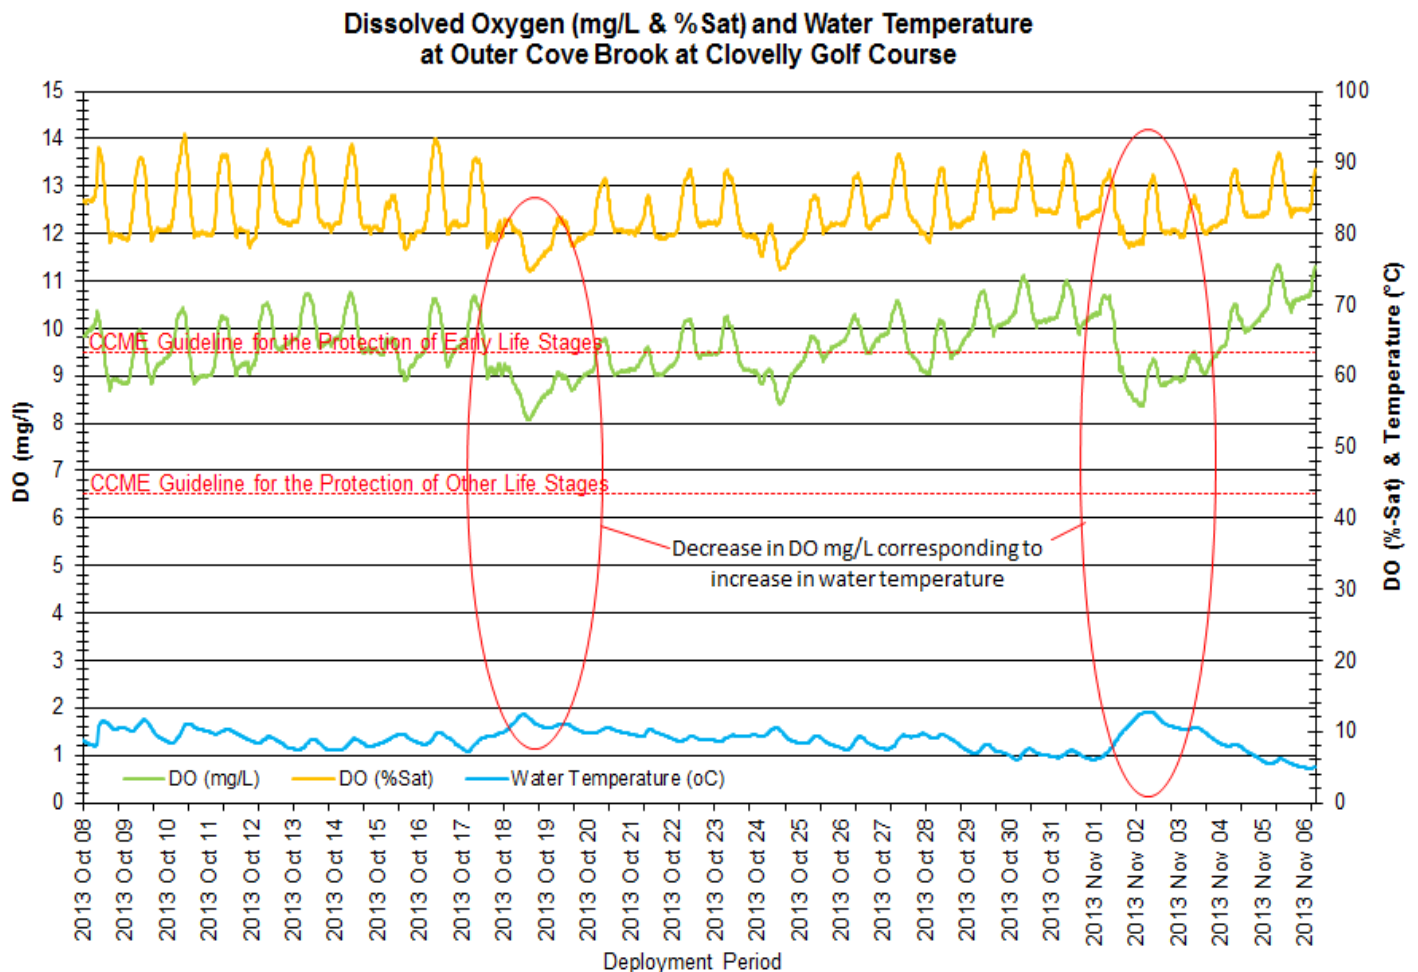
- The instrument measures dissolved oxygen (mg/L) then calculates percent saturation (% Sat).
- The Dissolved Oxygen % Sat levels within this deployment period were within 74.7% Sat–94.0% Sat. Dissolved Oxygen (mg/L) measured 8.06 mg/L to 11.34 mg/L. Water temperatures were cooler during this deployment period, resulting in higher oxygen levels.

- The DO mg/L values dip below the minimum DO CCME guideline for early life stages during warm periods during the deployment. Warm water temperatures October 18<sup>th</sup> and November 2<sup>nd</sup> led to lower oxygen (mg/L) levels in the water at this time (Figure 11).

- Dissolved Oxygen percent saturation remains relatively constant throughout the deployment period, with diurnal fluctuations. Dissolved oxygen mg/L content fluctuates with the water temperature changes. Decreases in dissolved oxygen values are inversely related to increases in water temperature as warmer water can hold less oxygen.

**Figure 11: Quarter-hourly dissolved oxygen (mg/L & % sat) and water temperature (°C) values at Outer Cove Brook at Clovelly Golf Course for the deployment period October 8, 2013 to November 6, 2013.**

- Dissolved oxygen values at this site fluctuate diurnally, increasing values during the day and decreasing values into the night, indicating a relationship between the oxygen levels and sunlight.

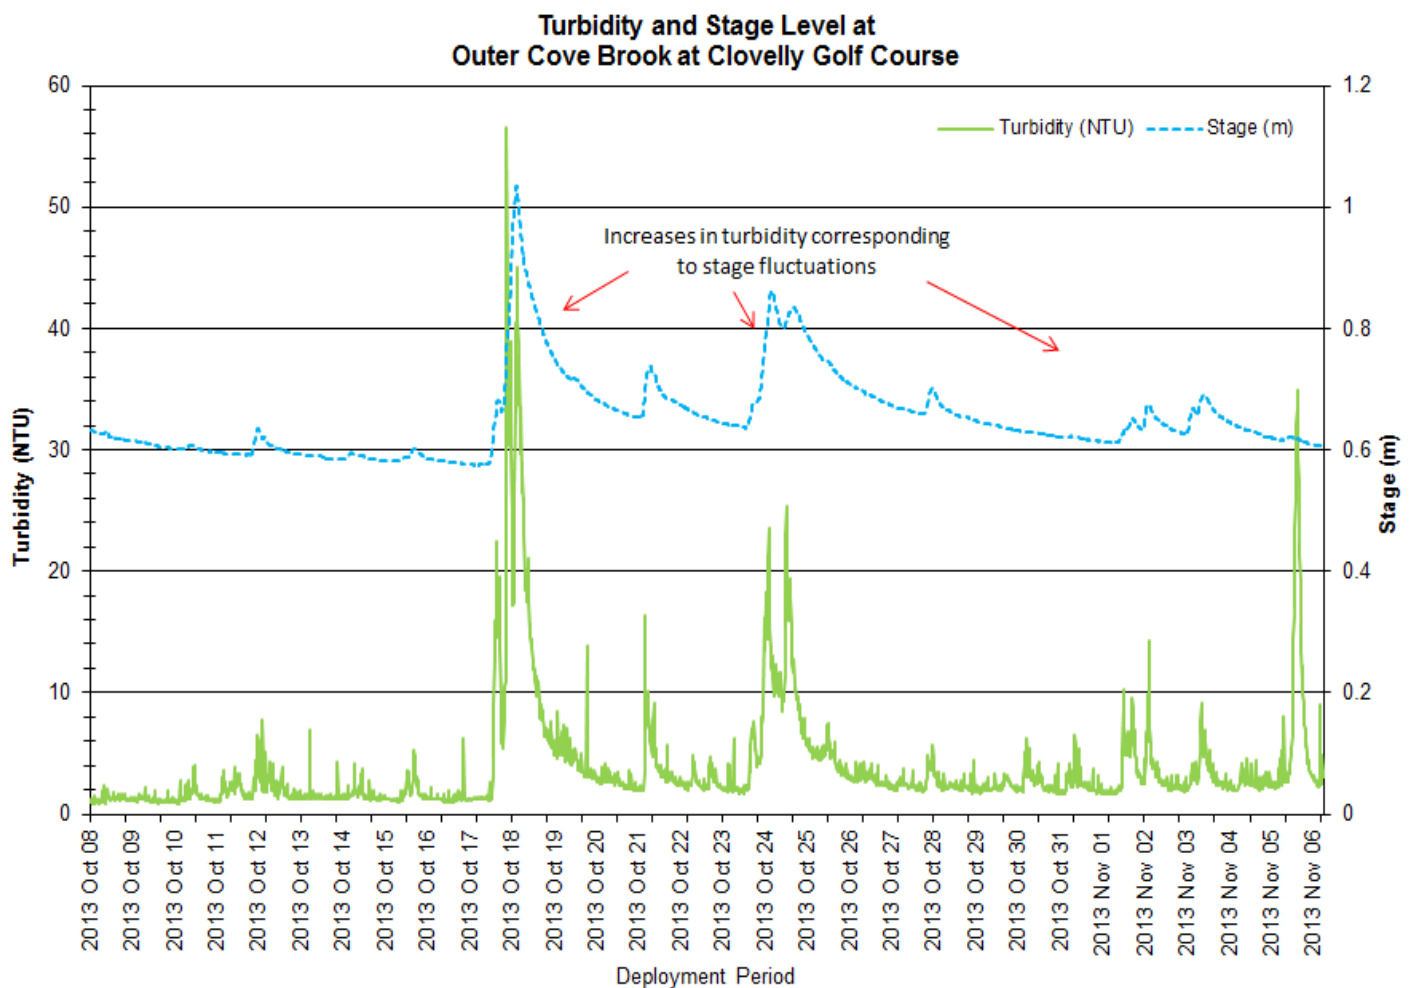
- The turbidity readings during this deployment ranged within 0.9 NTU to 56.5 NTU (Figure 12). Fluctuations in turbidity values were correlated with increases in stage and thus precipitation events. Biofouling does not appear to have been an issue during this deployment, even though the sonde was coated in fine organic material during removal.

- Several precipitation events and corresponding stage increases led to fluctuating turbidity values as sediment and debris were resuspended into the water column.

**Figure 12: Quarter-hourly turbidity (NTU) and stage level (m) values at Outer Cove Brook at Clovelly Golf Course for the deployment period October 8, 2013 to November 6, 2013.**

- During this deployment, the turbidity sensor did not suffer from biofouling as it had in previous months, even though the sonde was coated in a layer of black organic material upon removal.

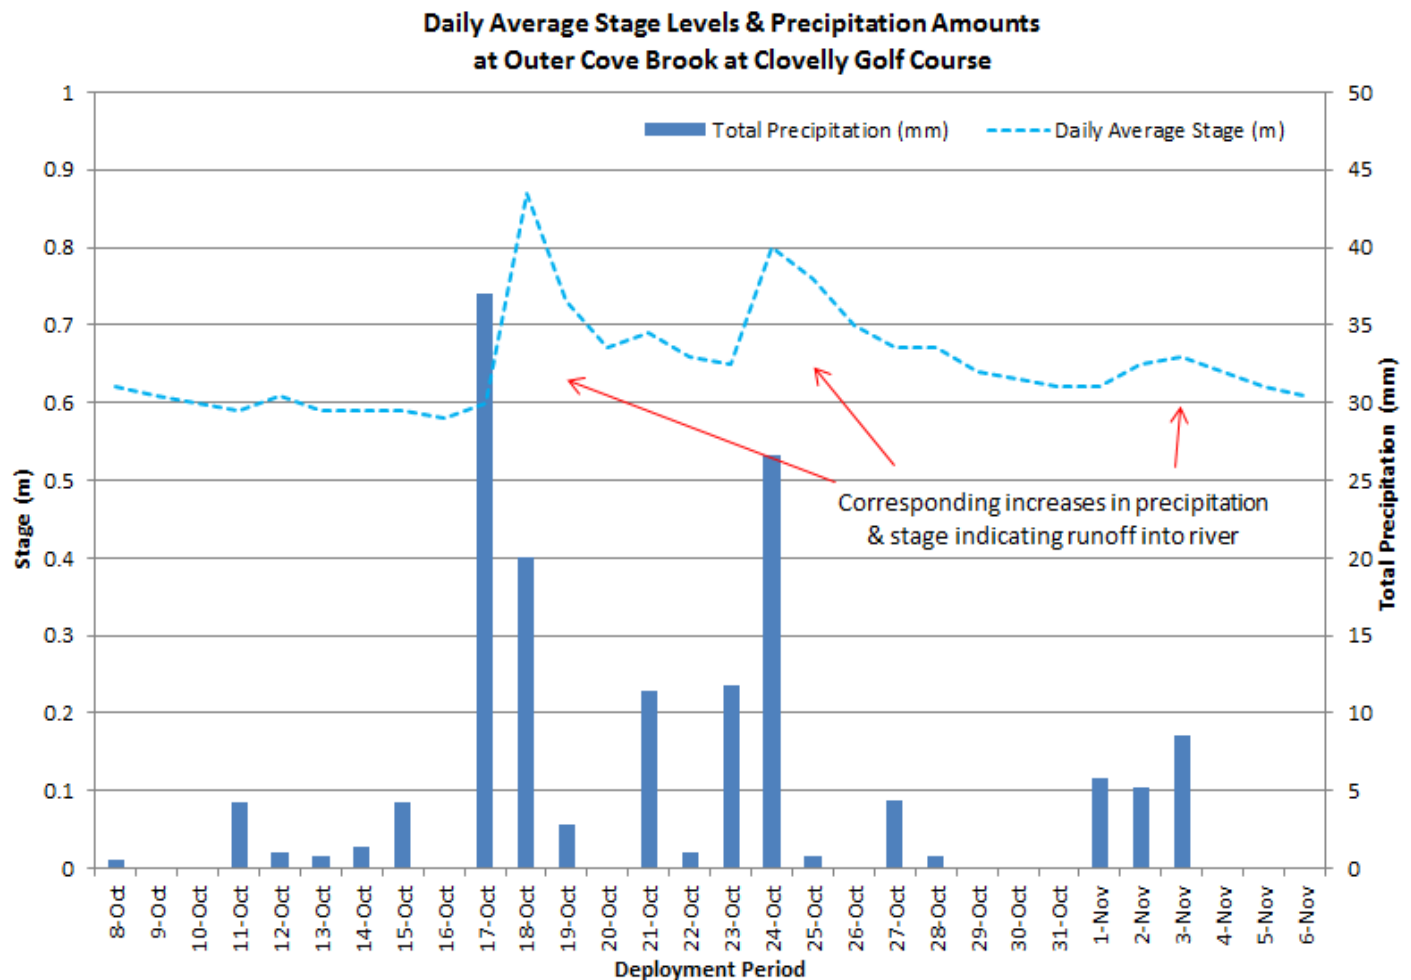
- Stage values are based on a vertical reference that is unique to each station. As a result, absolute values of stage are not comparable between stations, but relative changes in stage are.
- Stage provides an estimation of water level at the station and can explain some of the events that are occurring with other parameters (i.e. Specific Conductivity, DO, turbidity). Stage increases during precipitation events due to increased runoff from the surrounding area (see Figure 13).
- Precipitation data was obtained from Environment Canada's St. John's Airport weather station and supplemented with data from 'The Weather Network' when EC data was unavailable.
- During the deployment period, the stage values ranged from 0.58m to 1.03m, with the maximum level being reached after a significant rainfall event of 57mm over 2 days (October 17<sup>th</sup>-18<sup>th</sup>).

**Figure 13: Daily average stage values (m) at Outer Cove Brook at Clovelly Golf Course and daily total precipitation values (mm) from Environment Canada's St. John's Airport Station for the deployment period October 8, 2013 to November 6, 2013.**

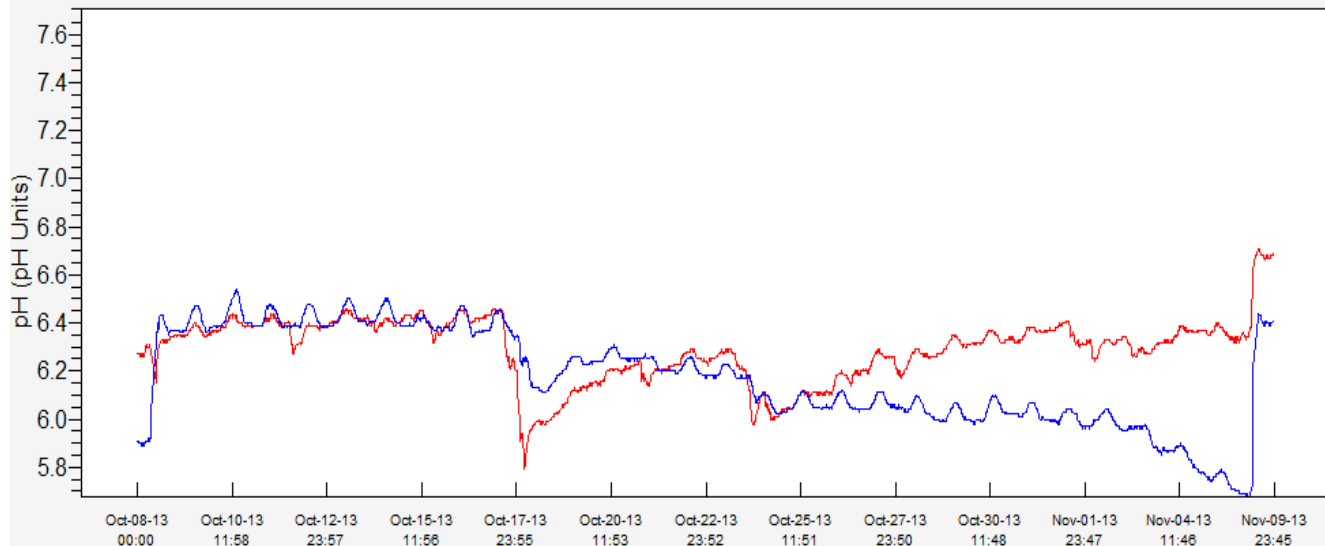
### PH Multi-Station Comparision

NF02ZM0364 - Outer Cove Brook below Airport  
NF02ZM0365 - Outer Cove Brook at Clovelly Golf Course

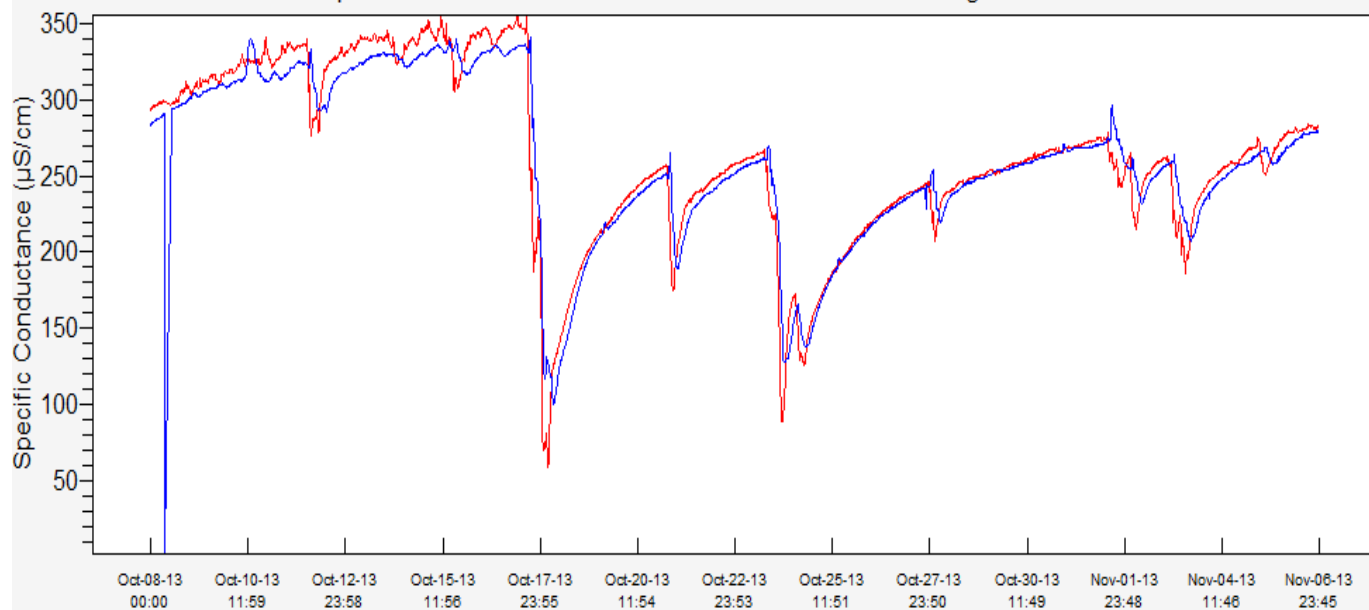
### SPEC\_CONDUCT Multi-Station Comparision

NF02ZM0364 - Outer Cove Brook below Airport  
NF02ZM0365 - Outer Cove Brook at Clovelly Golf Course

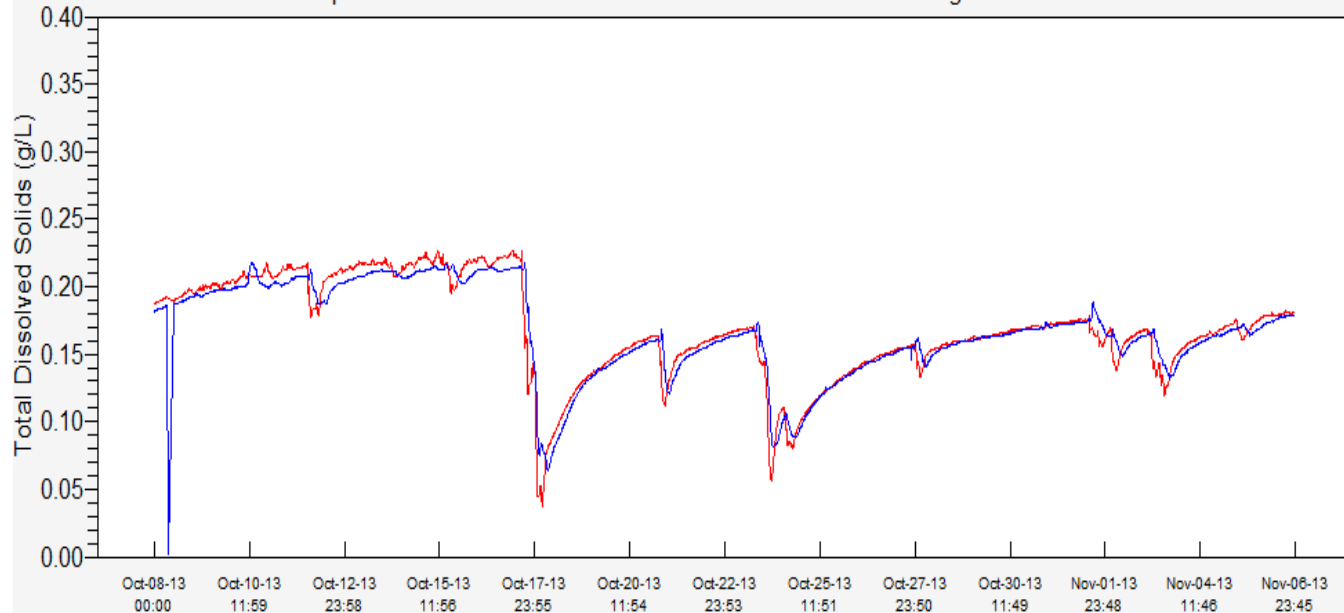
### TDS Multi-Station Comparision

NF02ZM0364 - Outer Cove Brook below Airport

NF02ZM0365 - Outer Cove Brook at Clovelly Golf Course

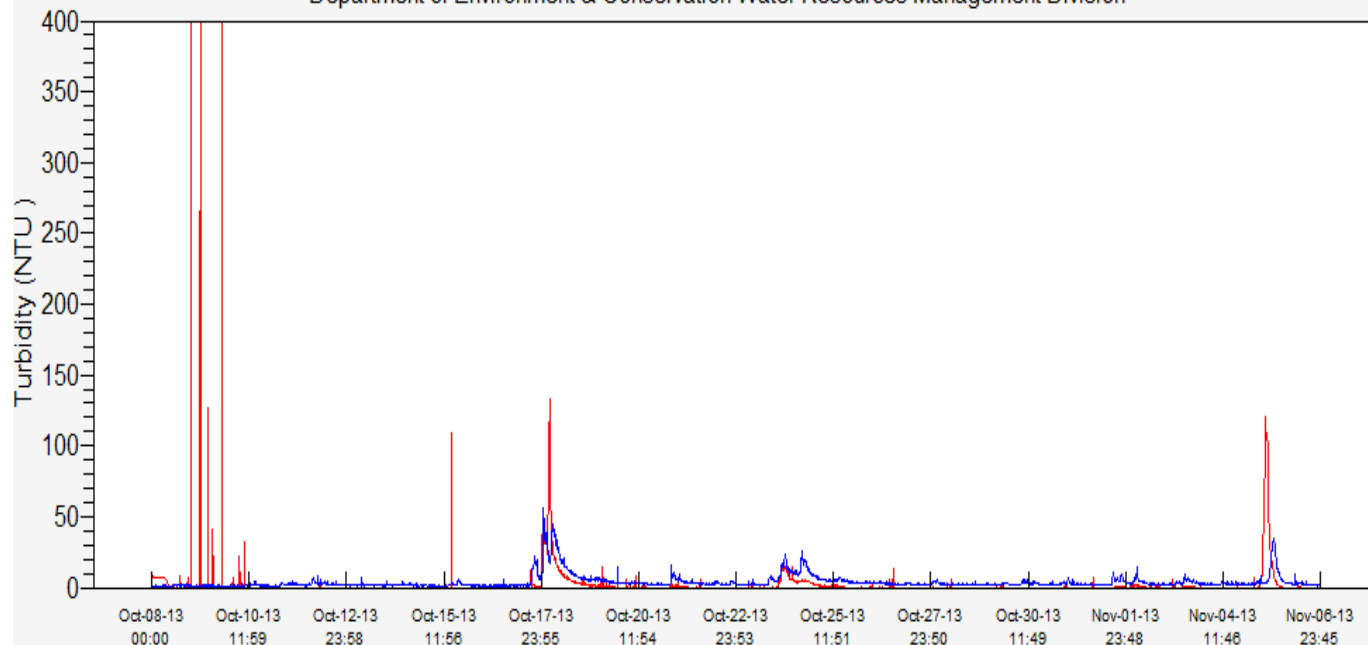
### TURBIDITY Multi-Station Comparision

NF02ZM0364 - Outer Cove Brook below Airport

NF02ZM0365 - Outer Cove Brook at Clovelly Golf Course
