# **Real-Time Water Quality Report**

# **Outer Cove Brook Network**

Deployment Period February 21, 2014 to April 8, 2014

Government of Newfoundland & Labrador Department of Environment and Conservation Water Resources Management Division

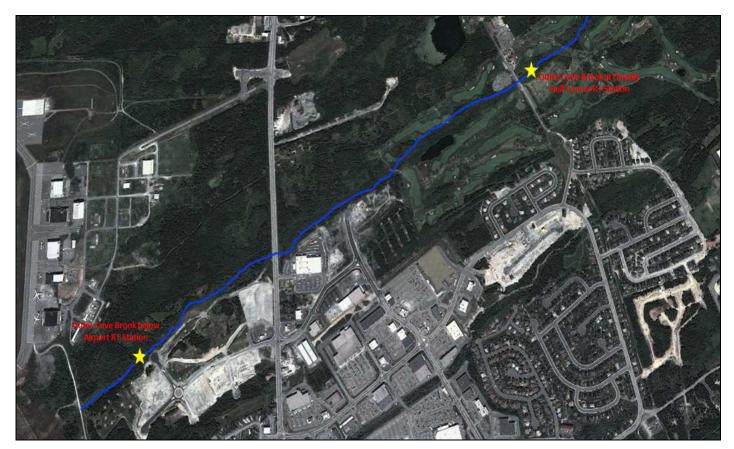
Figure 1: Outer Cove Brook Real-Time Water Quality and Quantity Stations.

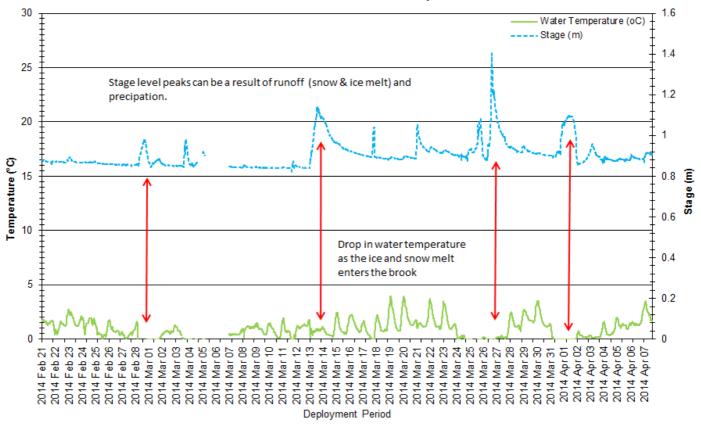
Water temperature ranged from -0.1°C to 3.90°C during this deployment period (Figure 2).

On March 1<sup>st</sup>, March 25<sup>th</sup> and April 1<sup>st</sup> 2014 there is a dip in water temperature which also corresponds with increases in stage level. It can be assumed snow melt and ice melt are flushed into the brook creating a cooler water temperature at these times.

Figure 2: Quarter-hourly water temperature (°C) and stage level (m) values at Outer Cove Brook below Airport.

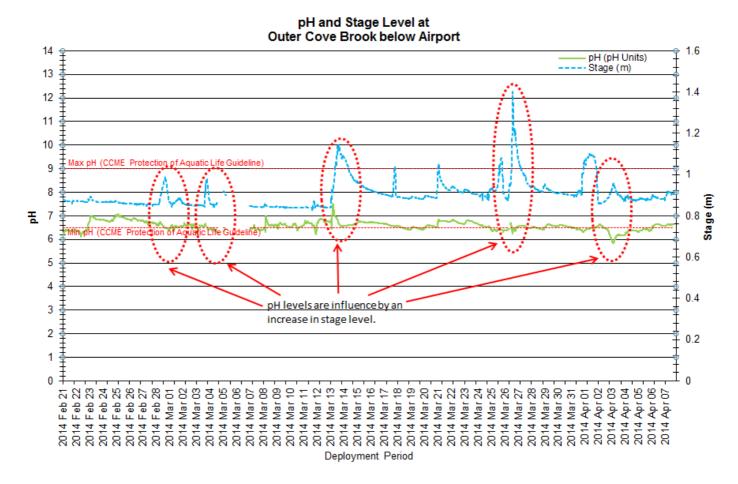
Throughout this deployment period pH values ranged between 5.84 pH units and 7.51 pH units (Figure 3).

During high stage periods the pH values drop slightly lower than the minimum pH guideline. This is evident on the graph on March 1<sup>st</sup>, March 5<sup>th</sup>, March 13<sup>th</sup>, March 26<sup>th</sup> and April 3<sup>rd</sup> (Figure 3). This is a natural occurrence between rainfall and pH levels.

Figure 3: Quarter-hourly pH (pH units) and stage level (m) values at Outer Cove Brook below Airport

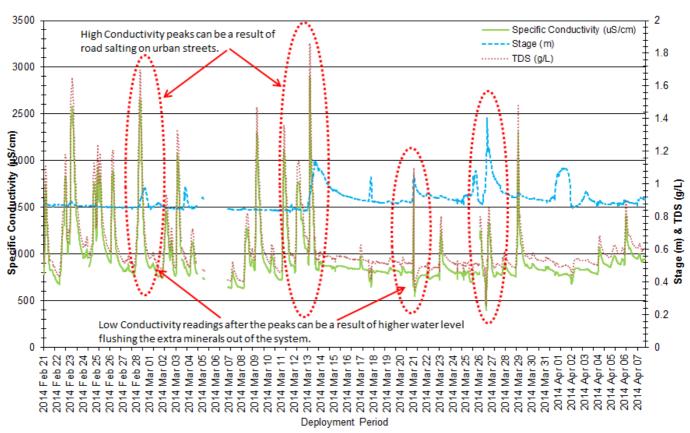
The conductivity levels were within 397.0  $\mu$ S/cm and 2912.0  $\mu$ S/cm during this deployment period. TDS ranged from 0.2540 g/L to 1.8600 g/L.

The peaks in conductivity on February 28<sup>th</sup>, March 13<sup>th</sup>, March 21<sup>st</sup> and March 26<sup>th</sup>, correspond with the higher stage levels. The presence of inorganic dissolved solids such as road salt and material are washed into the brook and increase the 'normal' levels of conductivity.

Figure 4: Quarter-hourly specific conductivity (µS/cm), TDS (g/L) and stage (m) values at Outer Cove Brook below Airport.

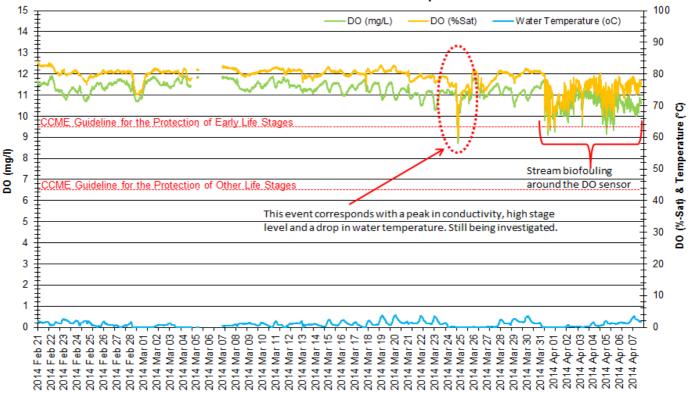
The Dissolved Oxygen % Sat levels within this deployment period were within 59.7% Sat and 83.9% Sat. Dissolved Oxygen (mg/L) measured 8.71 mg/L to 11.93 mg/L.

The DO mg/L values are above the minimum DO CCME guideline for early life stages for the majority of this deployment period (Figure 5).

A drop in dissolved oxygen on March 24<sup>th</sup> corresponds with a sharp increase in conductivity, stage level and a drop in water temperature. The decrease is likely due to the large amount of salts present in the brook, this can lower the amount of oxygen the water can hold.

The display of DO data from March 31<sup>st</sup> through to April 7<sup>th</sup> indicates fouling on the sensor (see Appendix B for pictures of the fouling).

Figure 5: Quarter-hourly dissolved oxygen (mg/L & % sat) and water temperature (°C) values at Outer Cove Brook below Airport.

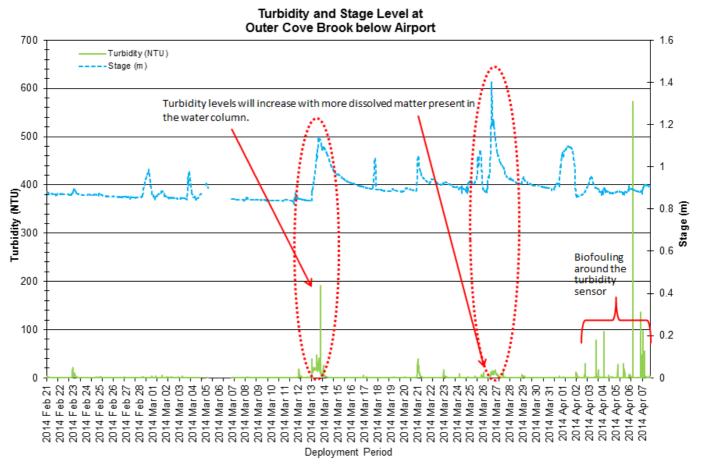
The turbidity readings during this deployment ranged within 0.0 NTU to 573.0 NTU (Figure 6).

The turbidity events evident on March 13-14<sup>th</sup> and March 27<sup>th</sup> correspond with the higher stage levels. With increase in rainfall and runoff comes an increase in sediment and material flowing into the brook and this is what is captured by the turbidity sensor.

The display of turbidity data from April 3<sup>rd</sup> through to April 7<sup>th</sup> indicates fouling on the sensor (see Appendix B for pictures of the fouling).

Figure 6: Quarter-hourly turbidity (NTU) and stage level (m) values at Outer Cove Brook below Airport.

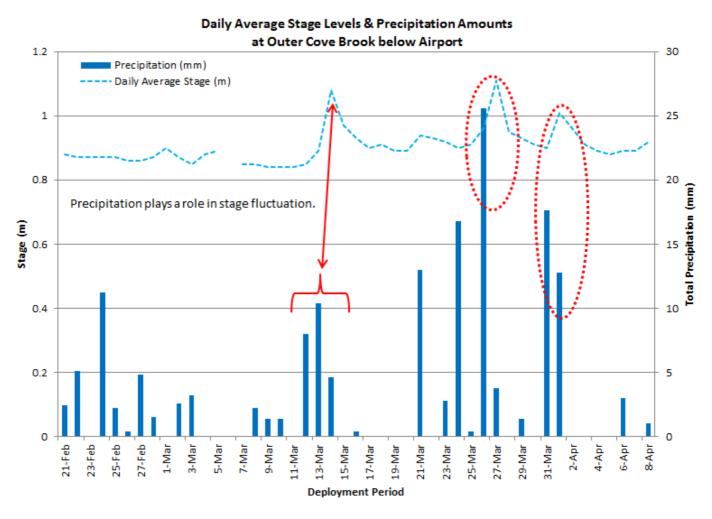
It is not unusual to see Stage vary throughout the deployment period (Figure 7). Stage is directly influenced by rainfall and subsequent runoff from the surrounding environment.

The peaks in Stage in Figure 7 were a response to the rainfall events or snowmelt events that occurred during this deployment period. Stage levels during this deployment ranged within a minimum of 0.83m and a maximum of 1.40m.

Figure 7: Daily average stage values (m) at Outer Cove Brook below Airport and daily total precipitation values (mm) from Environment Canada's St. John's Airport Station.

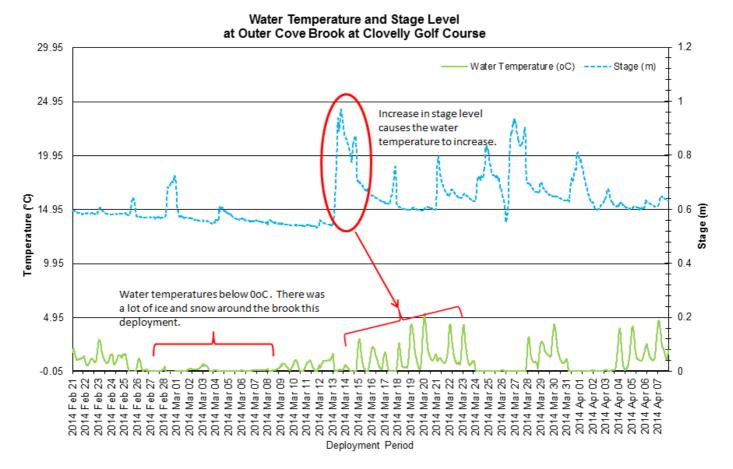
Water temperature ranged from -0.10°C to 5.31°C during this deployment period (Figure 8).

The higher water temperatures indicated on the graph also correspond with increases in stage. This can indicate that there was a rainfall or snow melt event during those particular times.

Figure 8: Quarter-hourly water temperature ( $^{\circ}$ ) and stage level (m) values at Outer Cove Brook at Clovelly Golf Course.

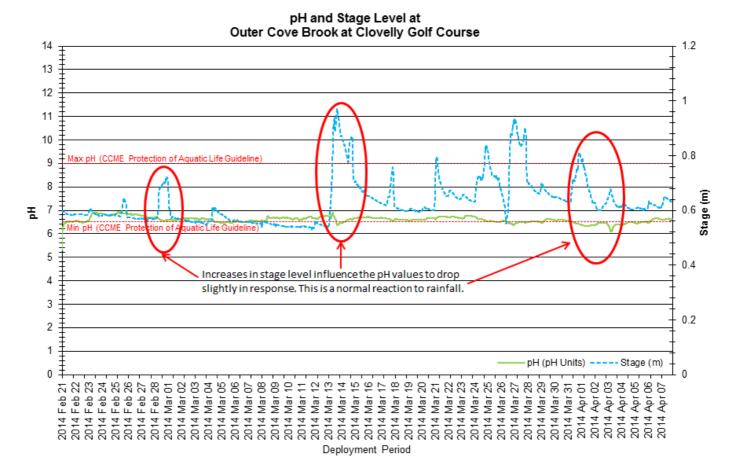
Throughout this deployment period pH values ranged between 5.34 pH units and 6.92 pH units (Figure 9).

pH levels dip below the CCME minimum guideline on February 28<sup>th</sup>, March 14<sup>th</sup> and April 3<sup>rd</sup>. These dips correspond with precipitation events on the same dates. This is a natural occurrence between rainfall and pH levels.

Figure 9: Quarter-hourly pH (pH units) and stage level (m) values at Outer Cove Brook at Clovelly Golf Course.

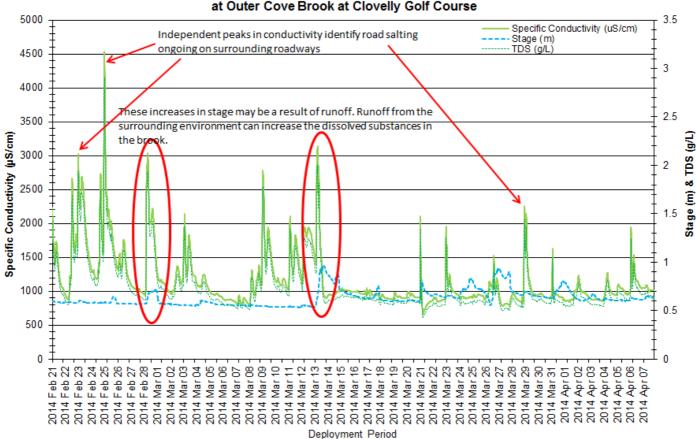
The conductivity levels were within 670  $\mu$ S/cm and 4541.0  $\mu$ S/cm during this deployment period. TDS ranged from 0.4290 g/L to 2.9100 g/L.

Road salting for safety during winter months can increase conductance levels in nearby streams, as displayed on February 23<sup>rd</sup> to February 26<sup>th</sup> and March 10<sup>th</sup>. Salt, flushed into urban streams increases the amount of dissolved substances present causing high peaks in conductivity values (Figure 10).

Higher stage level can flush the salts into the brook leading to higher conductivity levels. Data on February 28<sup>th</sup>, March 13<sup>th</sup> and March 21<sup>st</sup> (see Figure 10) display the initial peak of conductivity and then the lower levels. When stage levels rise, the specific conductance levels drop in response as the increased amount of water in the river system dilutes the solids present.

Figure 10: Quarter-hourly specific conductivity (uS/cm), TDS (g/L) and stage (m) values at Outer Cove Brook at Clovelly Golf Course.

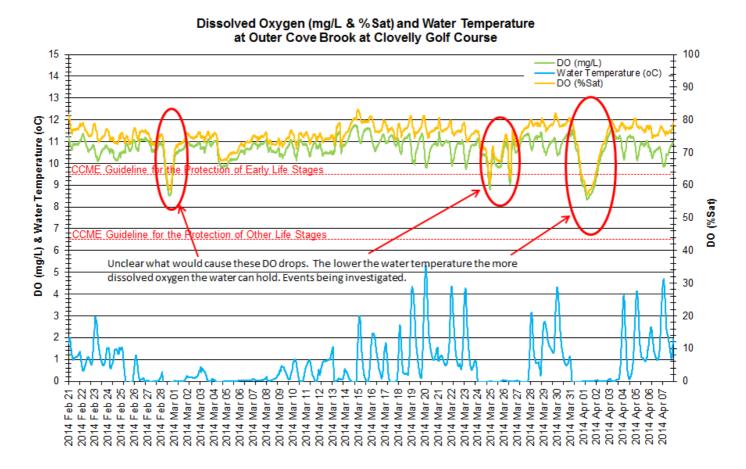
The Dissolved Oxygen % Sat levels within this deployment period were within 57.1 % Sat–83.2 % Sat. Dissolved Oxygen (mg/L) measured 8.32 mg/L to 11.77 mg/L.

For the majority of the deployment period, the DO mg/L values remain above the minimum DO CCME guideline for early life stages (Figure 11).

It is expected when water temperature drop that DO levels increase. Dissolved oxygen in water is sufficiently influenced by water temperature. Colder water holds more oxygen than warm water. Therefore it is unclear what would cause the DO to drop so significantly during February 28<sup>th</sup>, March 25<sup>th</sup> and 27<sup>th</sup>, and April 1<sup>st</sup>, when the water temperature at those times is also low. These events are still being investigated.

Figure 11: Quarter-hourly dissolved oxygen (mg/L & % sat) and water temperature ( $\mathcal{C}$ ) values at Outer Cove Brook at Clovelly Golf Course.

- As ambient air temperatures decreased it caused the water temperature to drop. Temperature directly
  affects the amount of dissolved oxygen present in the brook during those times. As noted in Figure 11 with
  a median of 10.76 mg/L of DO during the deployment period.

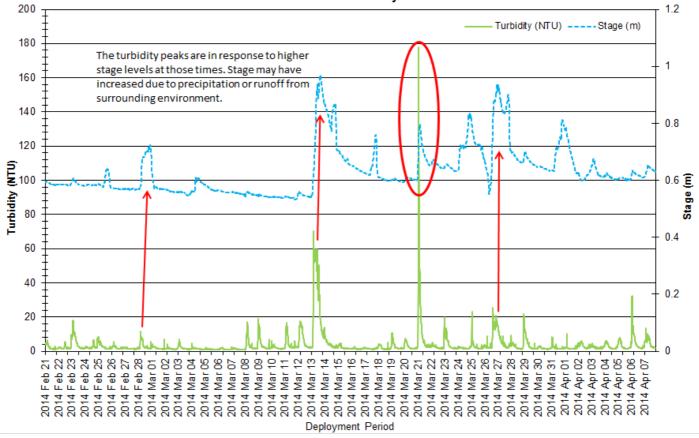
Turbidity levels during this deployment period ranged within 0.8 NTU and 177.8 NTU (Figure 12).

The turbidity events noted during this deployment period, correlated with increases in stage and in turn precipitation events. Jointly rainfall and precipitation can have the ability of increasing the presence of suspended material in water.

Figure 12: Quarter-hourly turbidity (NTU) and stage level (m) values at Outer Cove Brook at Clovelly Golf Course.

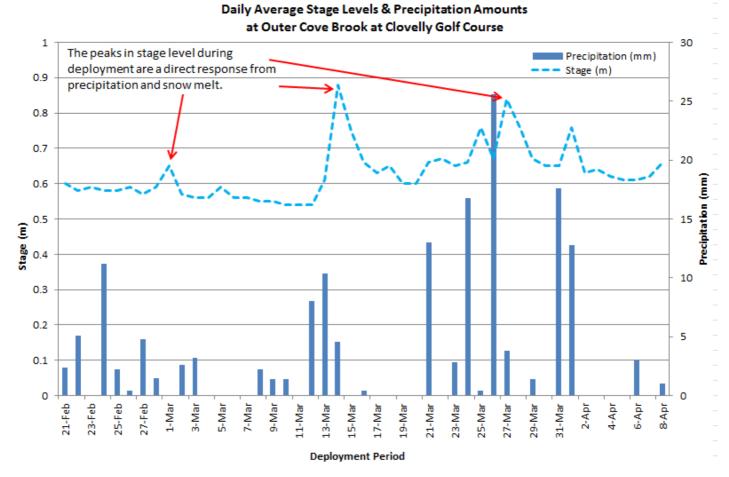
Stage will increase during rainfall events (Figure 13) and during any surrounding snow or ice melt as runoff will collect in the brooks. However, direct snowfall will not cause stage to rise significantly.

During the deployment period, the stage values ranged from 0.53m to 0.97m. The larger peaks in stage do correspond with sufficient rainfall events as noted on Figure 13.

Figure 13: Daily average stage values (m) at Outer Cove Brook at Clovelly Golf Course and daily total precipitation values (mm) from Environment Canada's St. John's Airport Station.
