Real-Time Water Quality Report

Outer Cove Brook Network

Deployment Period
June 17, 2014 to August 22, 2014

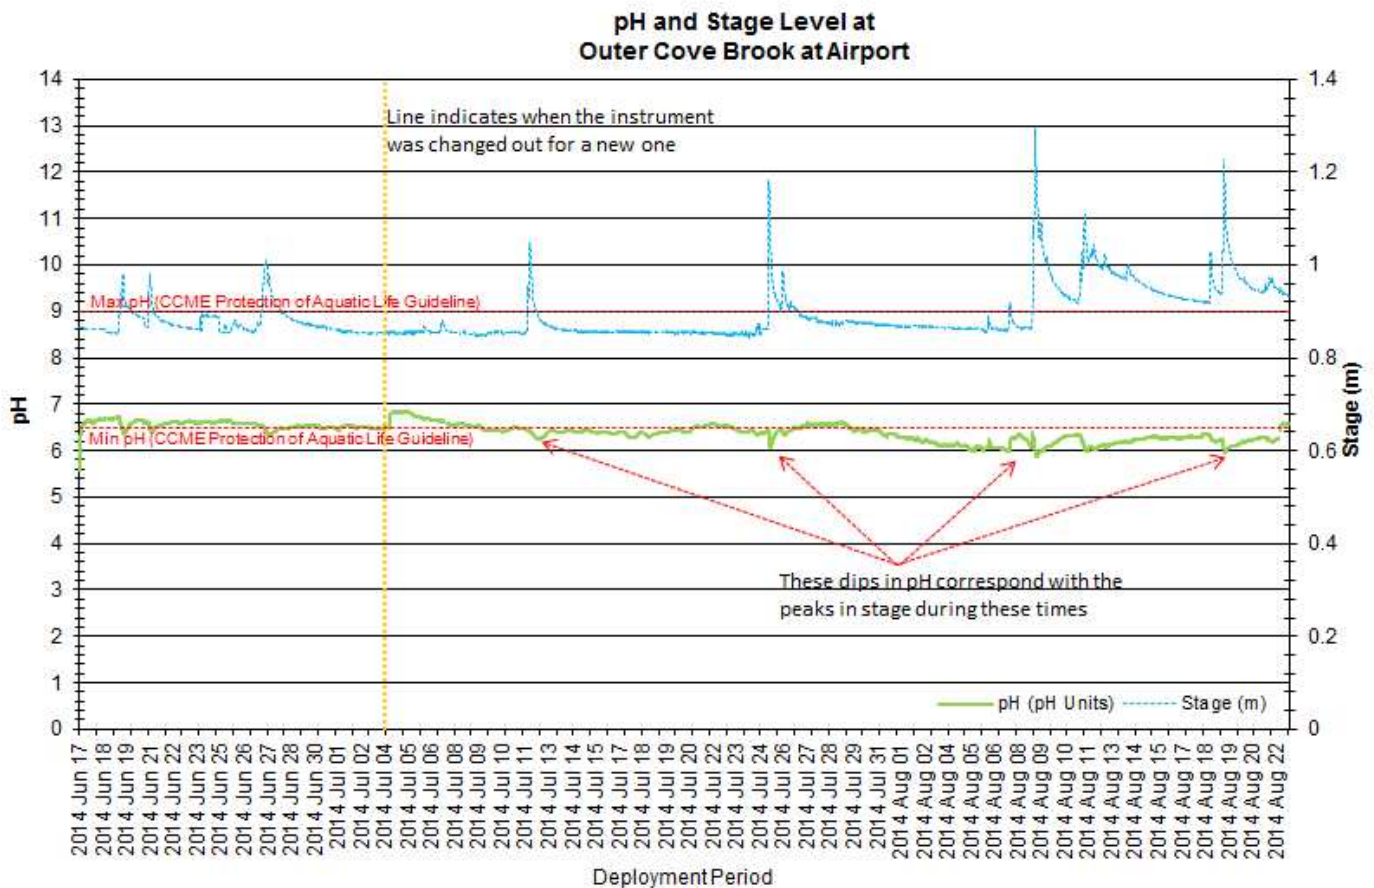
Throughout this deployment period pH values ranged between 5.57 pH units and 6.84 pH units (Figure 3).

During this deployment, the pH values at this station sat above the minimum CCME Guideline for the Protection of Aquatic Life (between 6.5 and 9 pH units) for the beginning of the deployment period, however for the remainder of the deployment period pH fluctuates around the lower guideline range.

The events on June 19th, July 13th, July 25th, August 8th and August 18th displaying the slight dips in pH levels also correspond with stage level increases. This can be explained by the natural correlation between rainfall and pH levels.

The CCME guideline provides a basis by which to judge the overall health of the brook. Naturally, all streams and brooks are different. During this deployment period the median pH level was 6.42 units, which was slightly lower than last month of 6.84 (pH units).

Figure 3: pH (pH units) and stage level (m) values at Outer Cove Brook below Airport

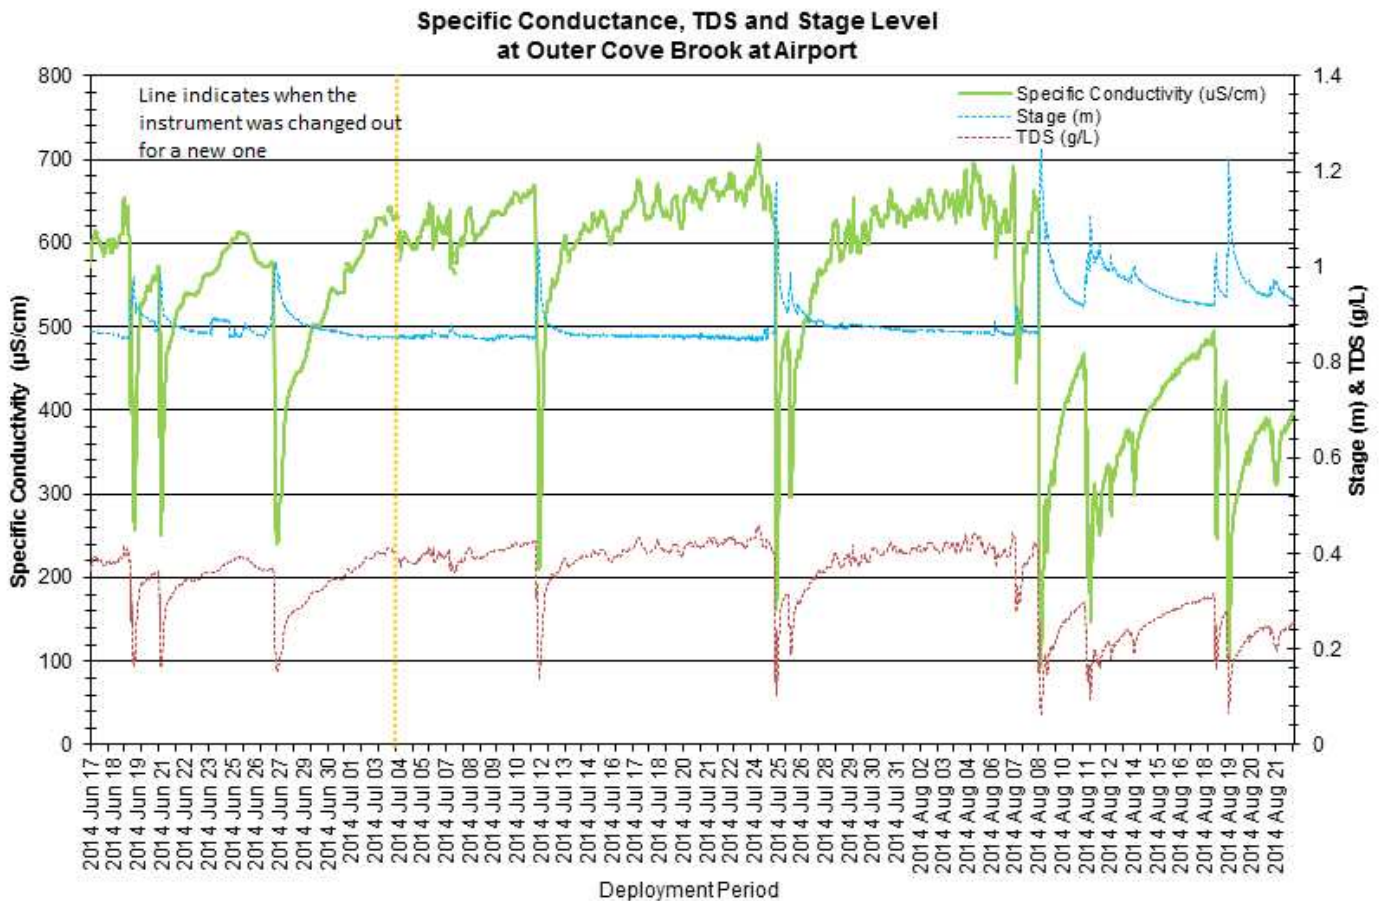
The conductivity levels were within 92.5 $\mu\text{S}/\text{cm}$ and 719.0 $\mu\text{S}/\text{cm}$ during this deployment period. TDS ranged from 0.0593 g/L to 0.4600 g/L.

When stage levels rise, the specific conductance levels drop in response as the increased amount of water in the river system dilutes the solids present. This is evident on Figure 4 as the conductivity (green) drops in concentration as the stage level (blue) increases.

Towards the end of the deployment the conductivity levels start to decline, this may be a result of higher stage levels close together from August 8th onwards. As stage increases there is a dilution of the dissolved substances present in the brook and therefore the conductivity levels decline.

Figure 4: Specific conductivity ($\mu\text{S}/\text{cm}$), TDS (g/L) and stage (m) values at Outer Cove Brook below Airport.

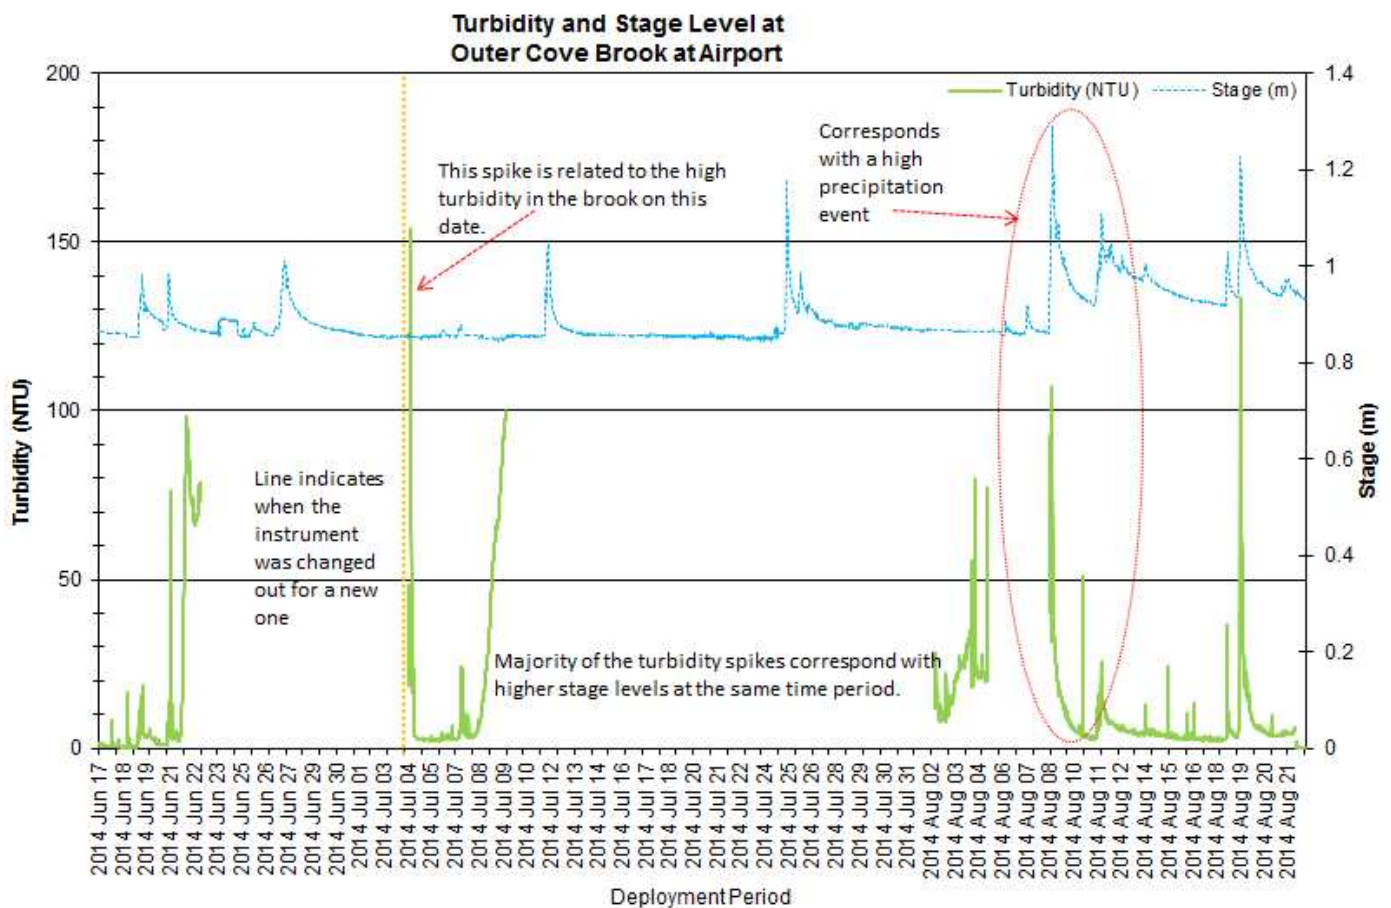
Turbidity levels during this deployment period ranged within 0.1 NTU and 153.9 NTU (Figure 6).

The turbidity events in the deployment period correlate with increases in stage potentially from precipitation (Figure 6). Precipitation can increase the presence of suspended material in water as seen on June 21st, July 27th -28th and August 10th and onward toward the end of deployment.

The event on July 4th is a result of land clearing upstream from the station (see Appendix A). During the change out of the instrument, high turbidity was evident in the brook. It was determined after following the stream the turbidity was related to the land clearing activities ongoing upstream from the station.

During this deployment period the display of data indicated fouling on the sensor so the data was removed as it could not be used in any statistical analysis.

Figure 6: Turbidity (NTU) and stage level (m) values at Outer Cove Brook below Airport.

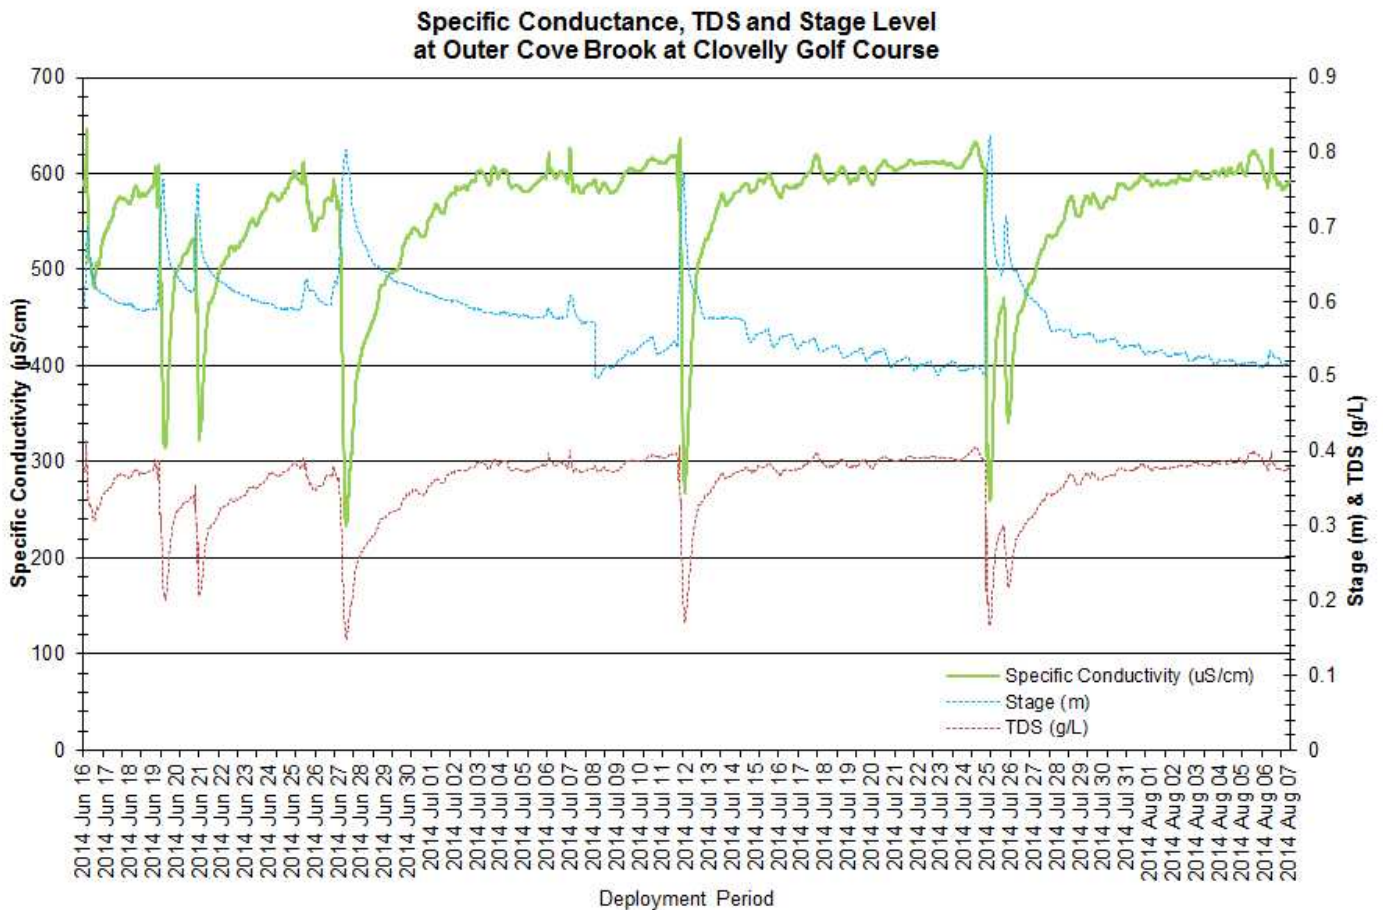
The conductivity levels were within 183.7.0 $\mu\text{S}/\text{cm}$ and 647.0 $\mu\text{S}/\text{cm}$ during this deployment period. TDS ranged from 0.1176 g/L to 0.4140 g/L.

The conductivity probe measures the dissolved particles present in a water body, when there is an increase in stage it can indicate that there was rainfall. Rainfall saturates the brook and flushes the dissolved particles from the water column diluting the conductivity levels for a short period of time. All of the dips in conductivity present on the graph (Figure 10) can be linked with a high stage level.

Figure 10: Specific conductivity ($\mu\text{S}/\text{cm}$), TDS (g/L) and stage (m) values at Outer Cove Brook at Clovelly Golf Course.

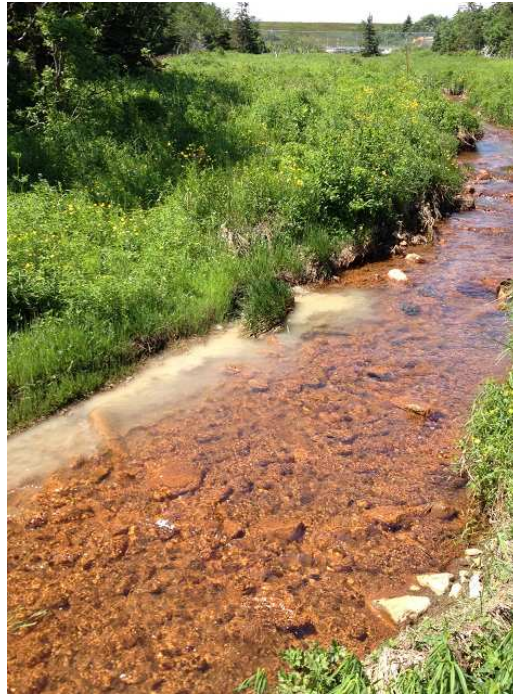
During the site visit on July 4th, it was discovered that a large amount of sediment from the construction parallel with the brook, was flowing into the brook causing the discolouration at that time (Appendix A).

Figure A5: Location of sediment runoff

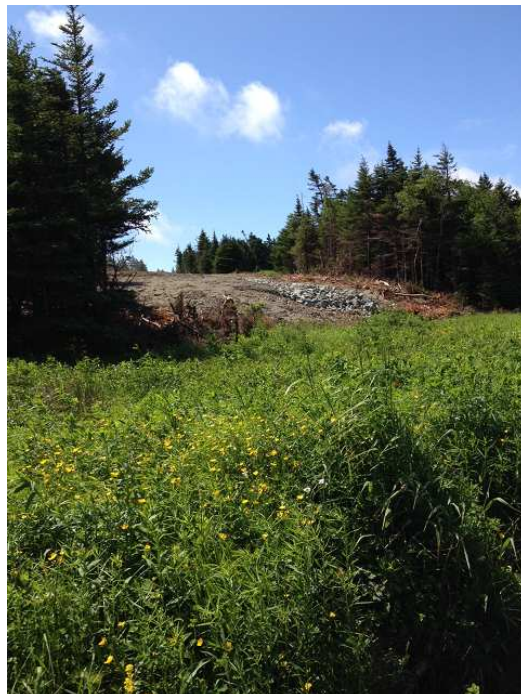
Figure A7: Land Clearing
