## **Real-Time Water Quality Report**

## **Outer Cove Brook Network**

**Deployment Period**  
**November 3, 2014 to December 3, 2014**

Outer Cove Brook, Newfoundland and Labrador

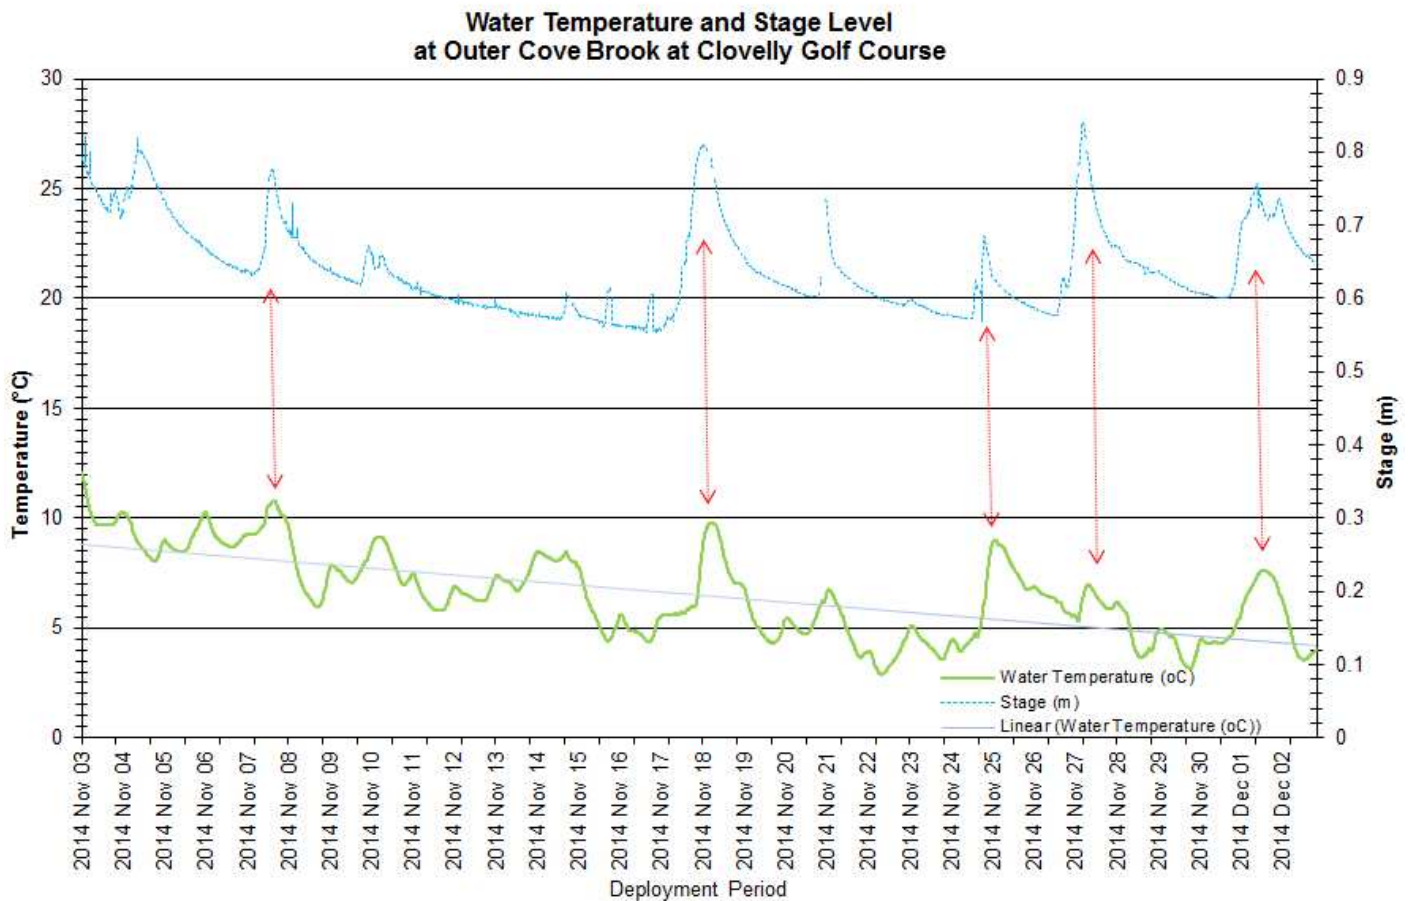
Water temperature ranged from 2.89 °C to 12.04 °C during this deployment period (Figure 8).

Water temperature in this brook displays a typical variation in pattern over the deployment period. Water temperature is generally influenced by ambient air temperature. Figure 8 indicates that stage level can also influence the water temperature for a short period of time.

It is evident on the graph that the water temperature is decreasing; trend line indicates the gradual slope of the water temperature values as the cooler temperatures start with the winter season.

**Figure 8: Water temperature (°C) and Stage (m) levels at Outer Cove Brook at Clovelly Golf Course.**

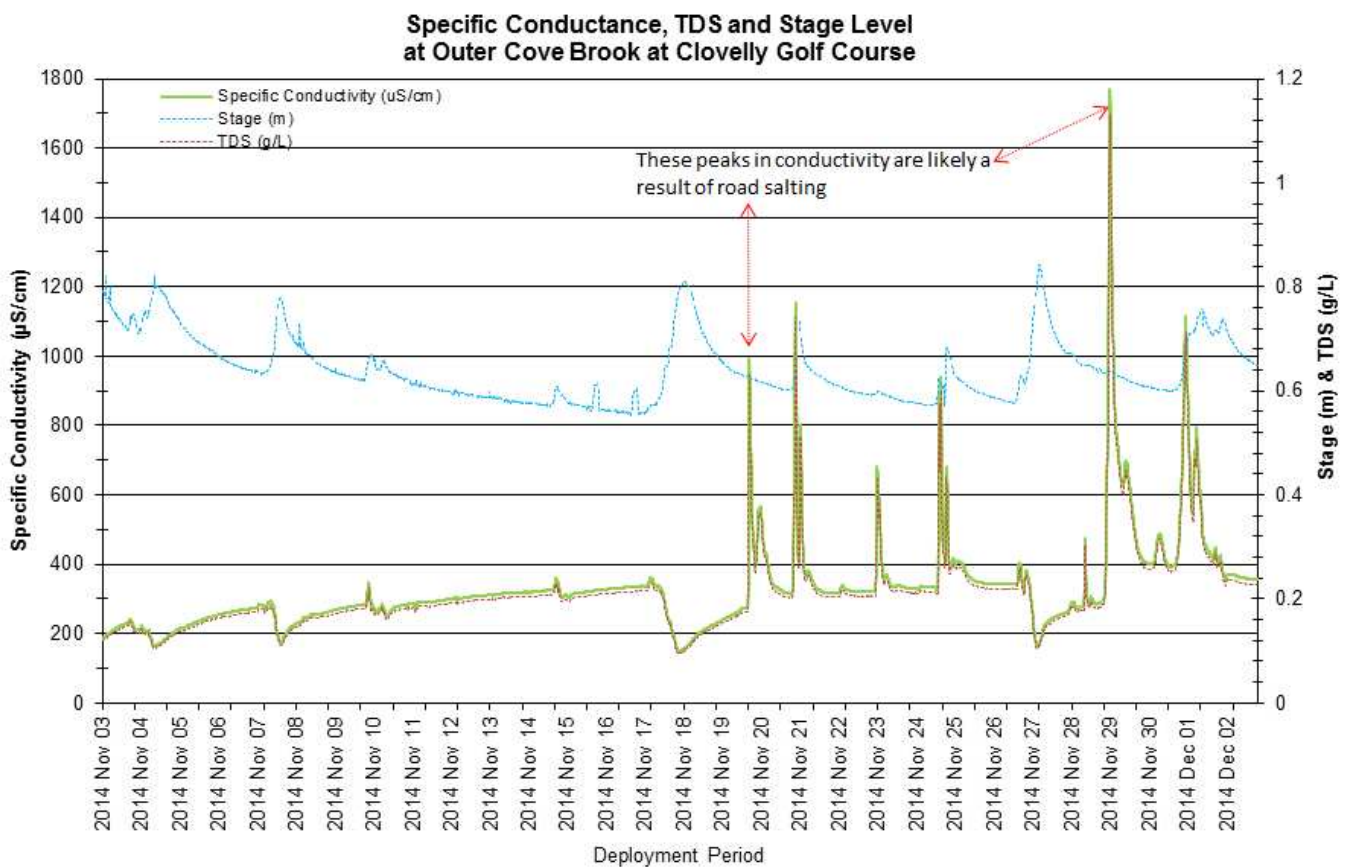
The conductivity levels were within 146.6  $\mu\text{S}/\text{cm}$  and 1769.0  $\mu\text{S}/\text{cm}$  during this deployment period. TDS ranged from 0.0938 g/L to 1.1300 g/L.

The dips in conductivity up to November 18<sup>th</sup> (see Figure 10) correspond with an increase in stage level. The conductivity probe measures the dissolved particles present in a water body, generally an increase in stage can indicate rainfall. Rainfall saturates the brook and flushes the dissolved particles from the water column diluting the conductivity levels for a short period of time.

On November 29<sup>th</sup> a high peak in conductivity was likely a result of road salting. The weather station at St. John's International airport indicated average air temperatures of -4 °C that day as well as ~3 cm in snow falls (Figure 14).

**Figure 10: Specific conductivity (uS/cm), TDS (g/L) and stage (m) values at Outer Cove Brook at Clovelly Golf Course.**

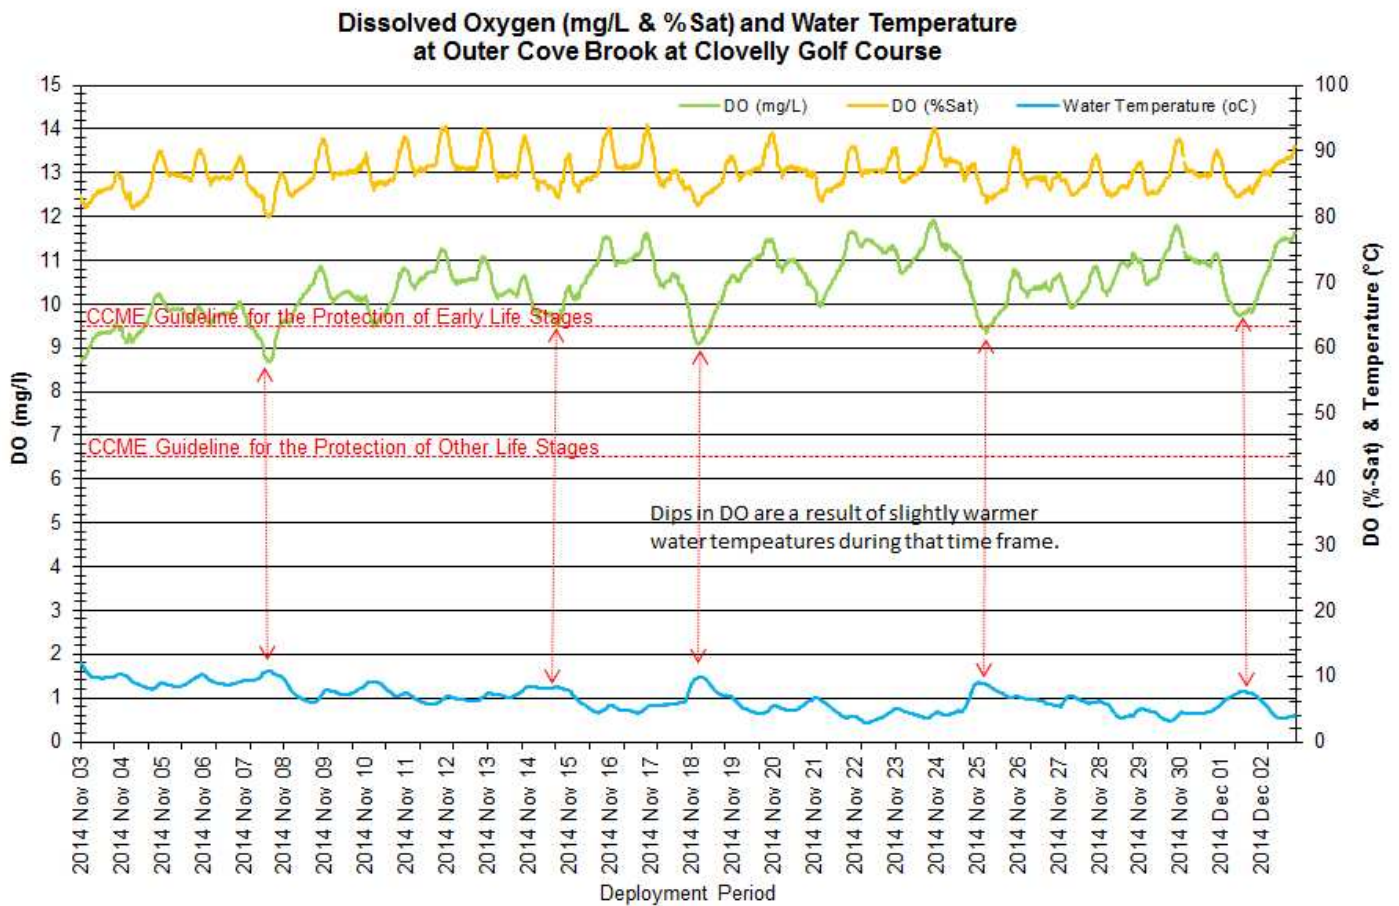
The Dissolved Oxygen %Sat levels within this deployment period were within 79.9 %Sat to 93.9 %Sat. Dissolved Oxygen (mg/L) measured 8.67 mg/L to 11.92 mg/L.

It should be noted that the cooler water temperatures increase the amount of dissolved oxygen a water body can hold. As water temperatures decrease (most likely overnight) the water dissolved oxygen levels increase.

Rainfall can also have an influence on dissolved oxygen content, the movement in the data on November 8<sup>th</sup>, November 14<sup>th</sup>, November 18<sup>th</sup>, November 25<sup>th</sup> and December 1<sup>st</sup>, is likely a result of the rainfall that occurred during that same time period (seen on Figure 13).

**Figure 11: Dissolved oxygen (mg/L & % sat) and water temperature (°C) values at Outer Cove Brook at Clovelly Golf Course.**
