Real-Time Water Quality Report

Outer Cove Brook Network

Deployment Period
January 21, 2015 to March 4, 2015

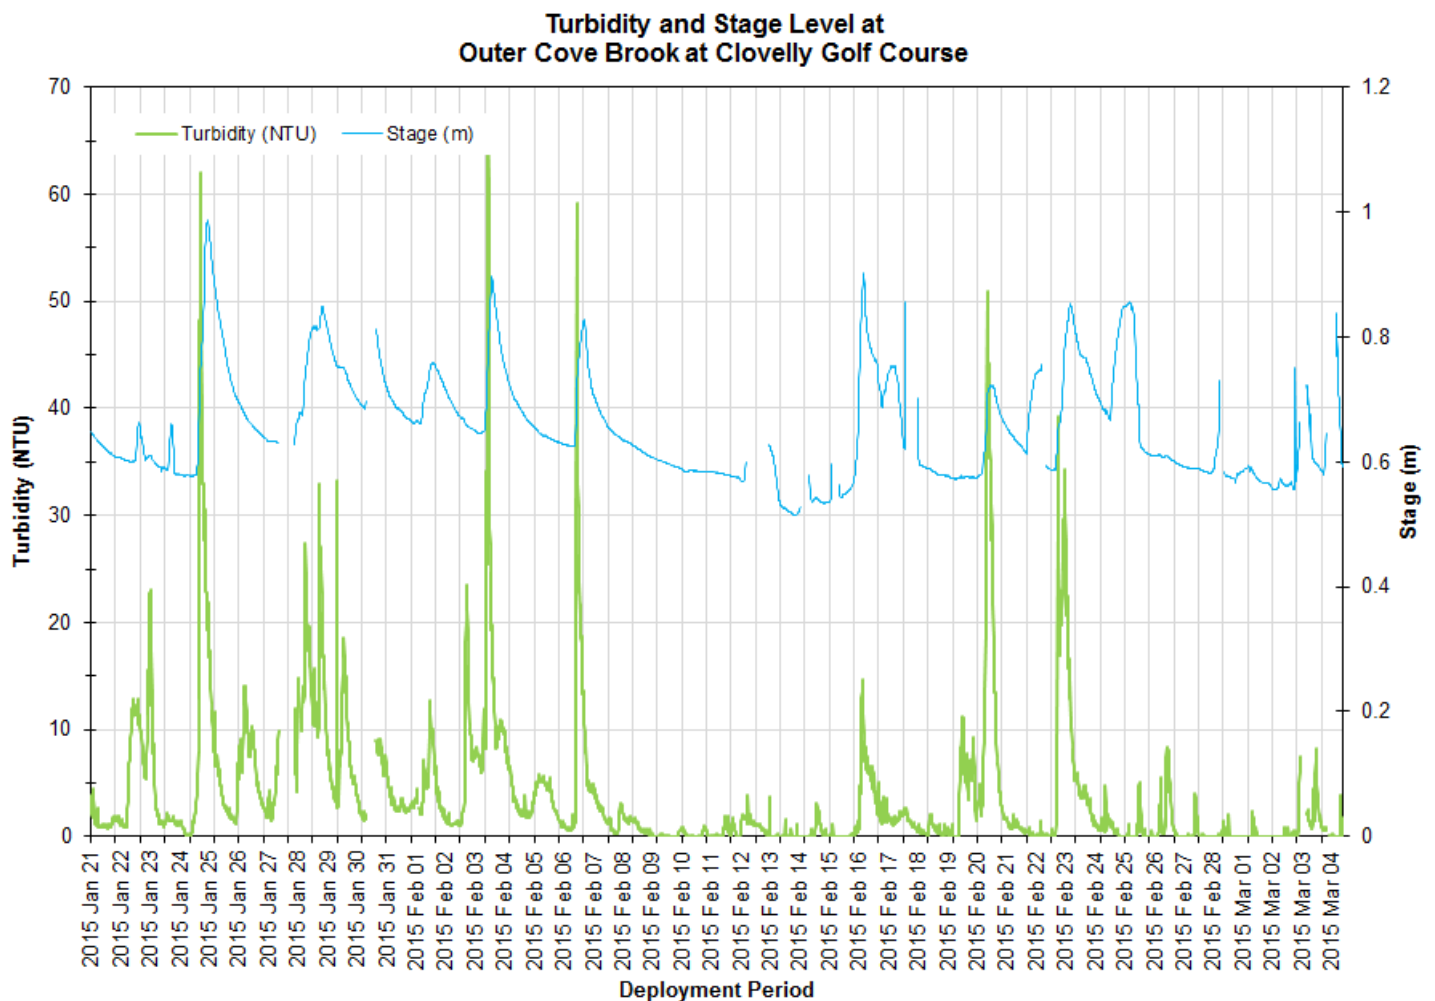
Turbidity levels during the deployment period ranged within 0.0 NTU and 67.4 NTU (Figure 12), with a median of 1.4 NTU.

As depicted on the graph there were several turbidity events during deployment. The majority of turbidity increases on the turbidity graph correspond with stage increases at the same time. The turbidity events at Clovelly station also correspond with high turbidity at Outer Cove Brook below Airport, which indicates that the same events caused these turbidity increases (Appendix II).

During removal of the instrument it was discovered to be encased in ice slush. Ice particles would have an effect on the turbidity sensor's ability to record accurate values.

Figure 12: Turbidity (NTU) and stage level (m) values at Outer Cove Brook at Clovelly Golf Course.

The turbidity sensor on the water quality instrument can read turbidity values between 0.0 NTU and 3000 NTU. However a turbidity reading of 3000 NTU is always identified as an error reading and during data grooming will be removed from the data set so to ensure it is not included in any statistical analysis.
