# Real-Time Water Quality Report

## Outer Cove Brook Network

Deployment Period  
March 5, 2015 to April 14, 2015

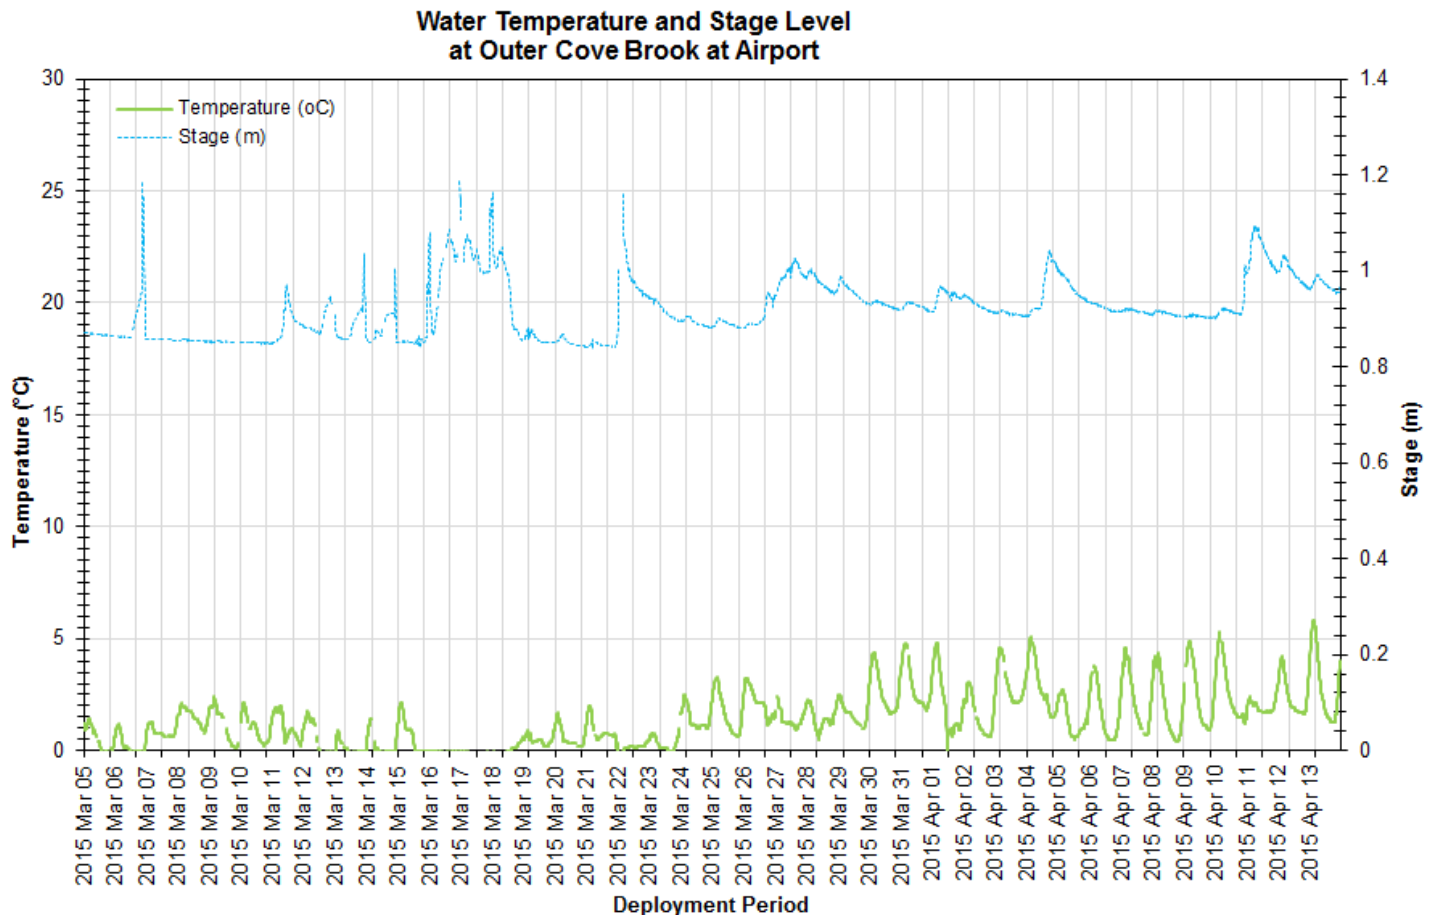
Water temperature ranged from  $-0.10^{\circ}\text{C}$  to  $5.30^{\circ}\text{C}$  during this deployment period (Figure 2). There were noticeable increases and decreases in the water temperature during this deployment period. This is consistent with ambient air temperatures over this time period, generally increasing during daylight hours and cooling overnight.

The water temperatures at this station do display diurnal variations although slightly exaggerated due to the climatic conditions during this deployment period. Shallow streams and ponds are highly influenced by natural diurnal variations in the surrounding air temperatures and precipitation events (Appendix I).

As the deployment period came to an end, the water temperature starts to increase overall. The spikes displayed by stage level was likely a result of ice buildup or freezing over of the brook. Please note, the stage data is raw data that is published on our web page. It has not been corrected for backwater effect. WSC is responsible for QA/QC of water quantity data. Corrected data can be obtained upon request to WSC.

Figure 2: Water temperature ( $^{\circ}\text{C}$ ) and Stage (m) values at Outer Cove Brook below Airport

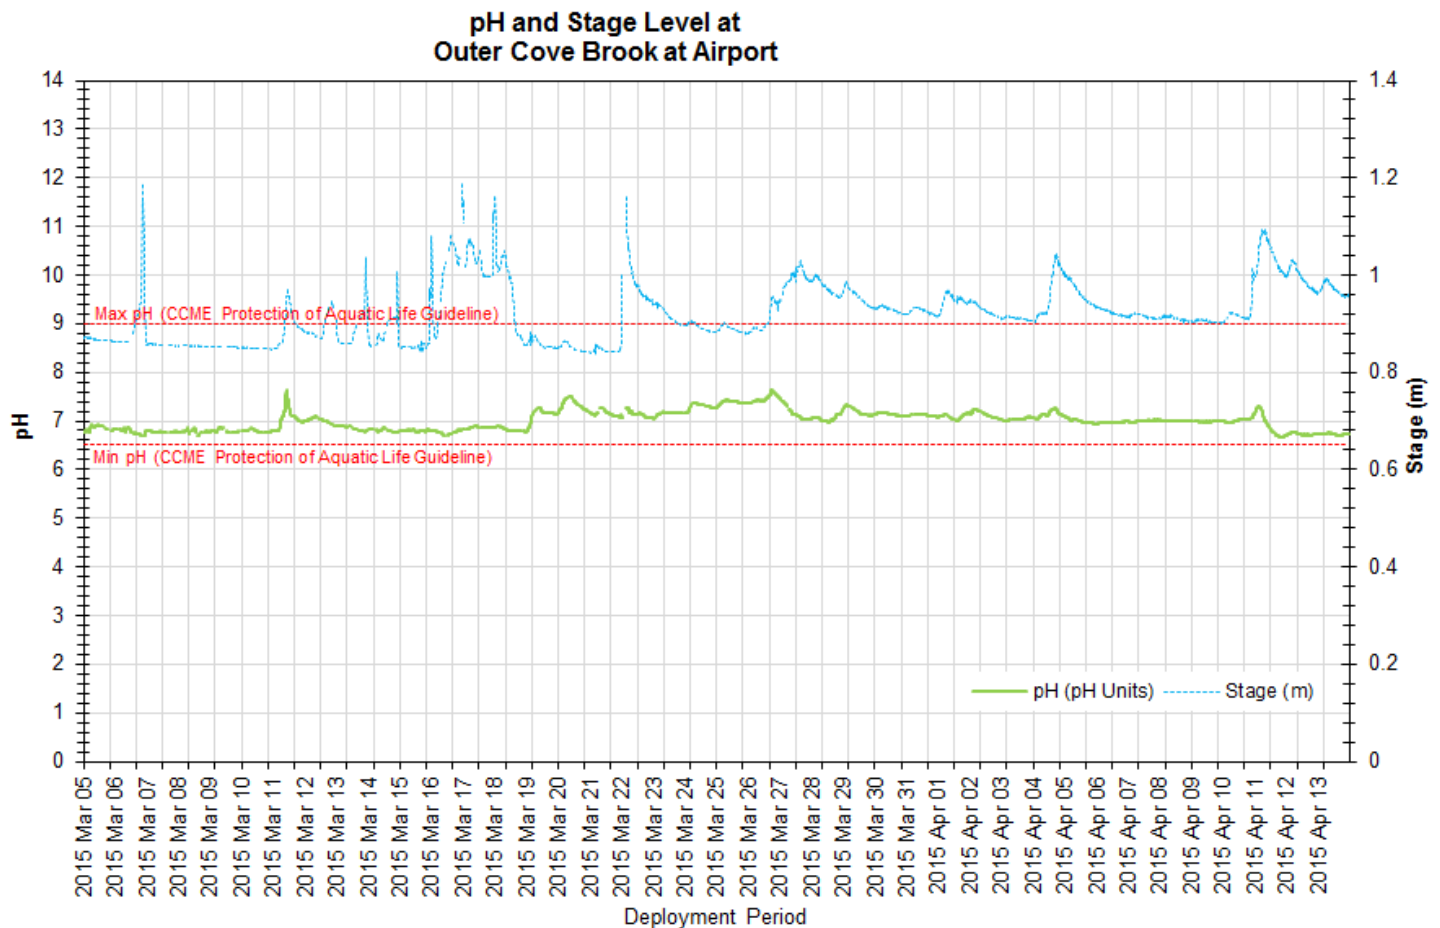
Throughout the deployment period, pH values ranged between 6.69 pH units and 7.65 pH units (Figure 3).

During this deployment, all pH values at this station were within the CCME Guidelines for the Protection of Aquatic Life (6.5 pH units and 9.0 pH units).

All increases in pH corresponded with increases in stage level for similar time frames. During the deployment period the increased stage levels caused a sharp increase and then decrease in pH values. The CCME guideline provides a basis by which to judge the overall health of the brook. Naturally, all streams and brooks are different. During the deployment period the median pH level was 7.02 pH units.

Figure 3: pH (pH units) and stage level (m) values at Outer Cove Brook below Airport

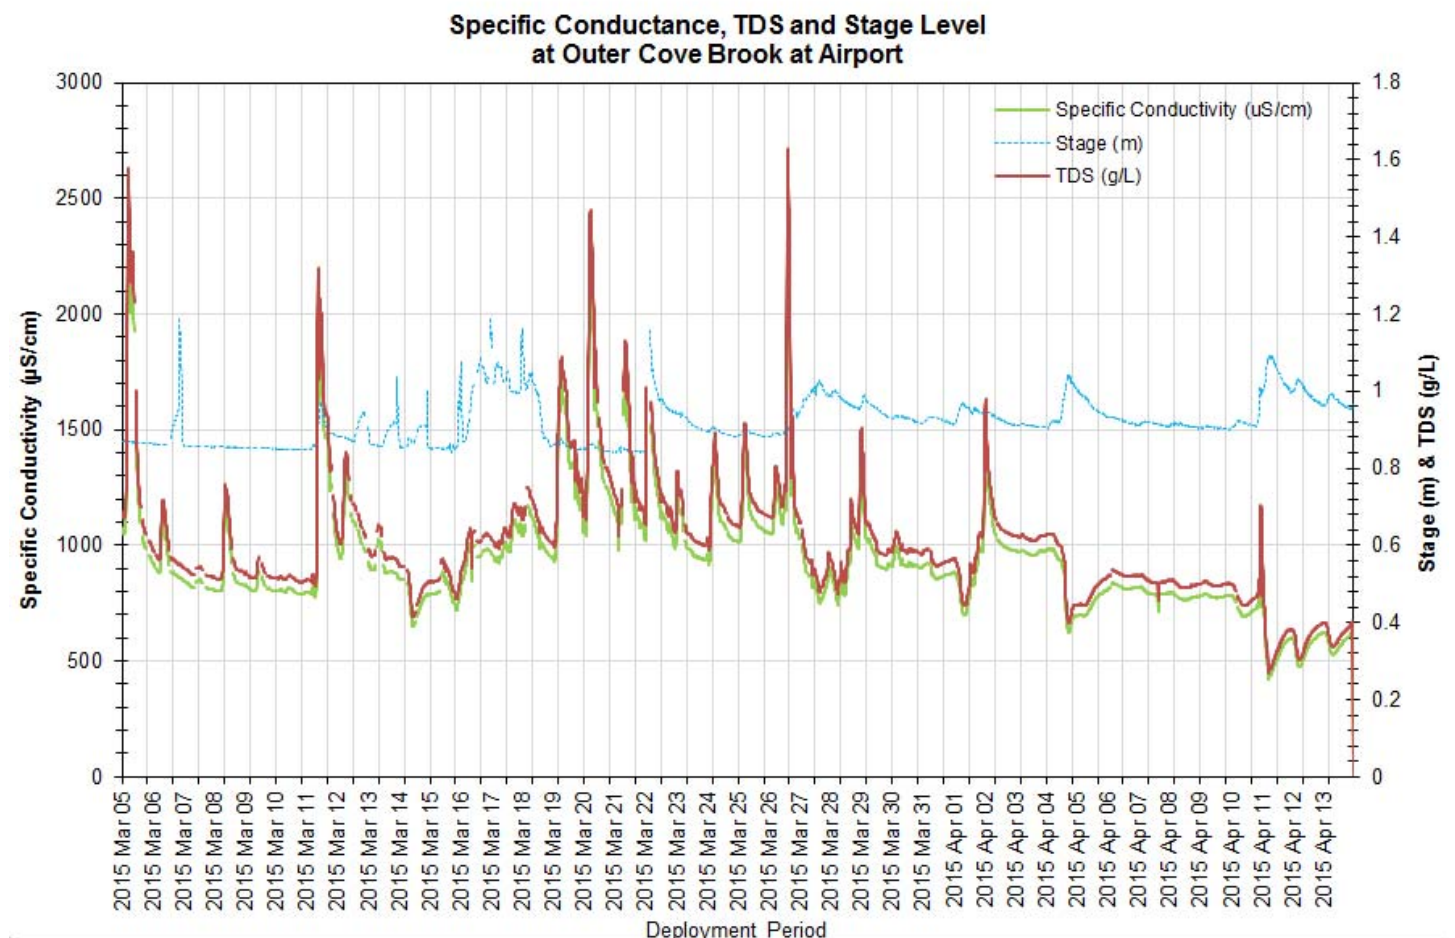
The conductivity levels were within 424  $\mu\text{S}/\text{cm}$  and 2539  $\mu\text{S}/\text{cm}$  during this deployment period.

Commonly the relationship between conductivity and stage level is inverted. When stage levels rise, the specific conductance levels drop in response as the increased amount of water in the river system dilutes the solids that are present. This was not the case during this deployment period.

The conductivity values that peaked together with stage levels were likely a result of road salt making its way into the brook after/during rainfall.  $0^{\circ}\text{C}$  or below  $0^{\circ}\text{C}$  air temperatures (Appendix I) create frosty and icy road conditions, therefore the roadways are salted and the conductivity levels increase as the residual salt is flushed into the brook through rainfall/runoff.

The dips in conductivity data after increases in stage indicate that the brook is being flushed naturally, the suspended matter and dissolved substances in the brook are flushed for a short period of time with the higher flow. This is evident on April 5<sup>th</sup> and April 11<sup>th</sup>, 2015.

**Figure 4: Specific conductivity ( $\mu\text{S}/\text{cm}$ ) and stage (m) values at Outer Cove Brook below Airport.**

At the station an influx of rainfall increased conductivity due to the dissolved salts from road salting being flushed into the brook. Rainfall also contributed to an increase in turbidity in the brook for short periods of time. pH values increased (alkalinity increased) after runoff from the surrounding environment flushed dissolved substances into the water column. The pH data is likely a combination of rainfall and road salting during the below 0°C temperatures (Appendix I).

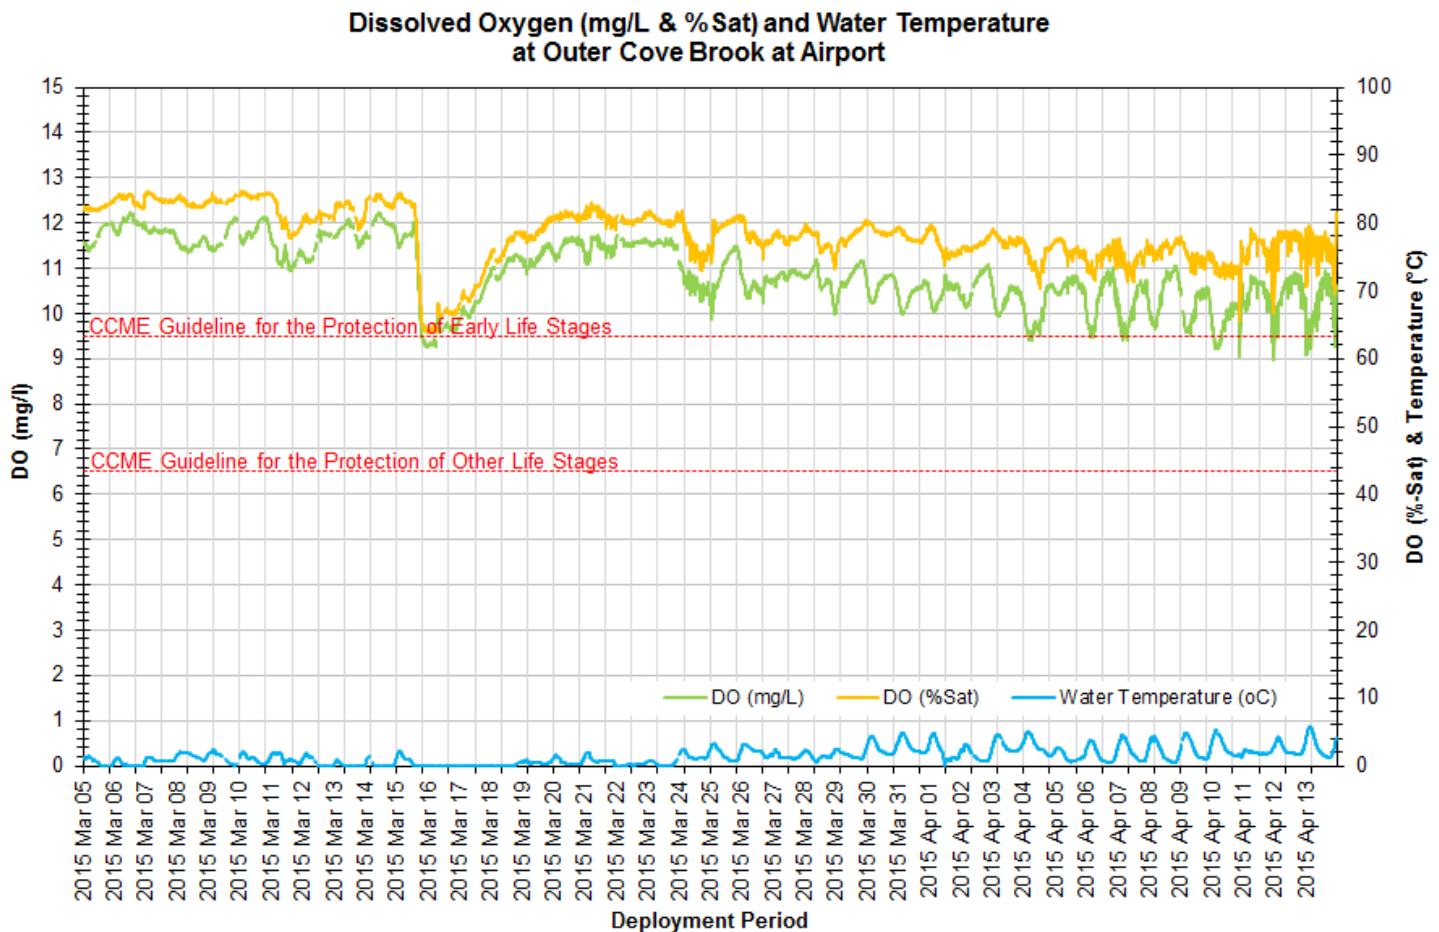
The Dissolved Oxygen % Sat levels were within 63.8 %Sat to 84.8 %Sat. Dissolved Oxygen (mg/L) measured 9.06 mg/L to 12.22 mg/L (Figure 5).

During the deployment the dissolved oxygen levels were reasonably consistent. There was an evident relationship between water temperature and dissolved oxygen. As water temperature decreased the level of dissolved oxygen consumed decreased, which means there is slightly more dissolved oxygen in the brook during the cooler temperatures.

There is dip in dissolved oxygen around March 15<sup>th</sup> to March 19<sup>th</sup>. It is not clear why the dissolved oxygen was low at that time. The dissolved oxygen levels do return to more normal levels after March 19<sup>th</sup>. During this time frame there was also 0°C or below 0°C water temperatures recorded.

Figure 5: Dissolved oxygen (mg/L & % sat) and water temperature (°C) values at Outer Cove Brook below Airport.

The cooler ambient air temperatures (Appendix I) influenced the water temperature during this deployment period. In turn, water temperature directly affects the amount of dissolved oxygen present in the brook and it is common to see mirroring trends in dissolved oxygen.

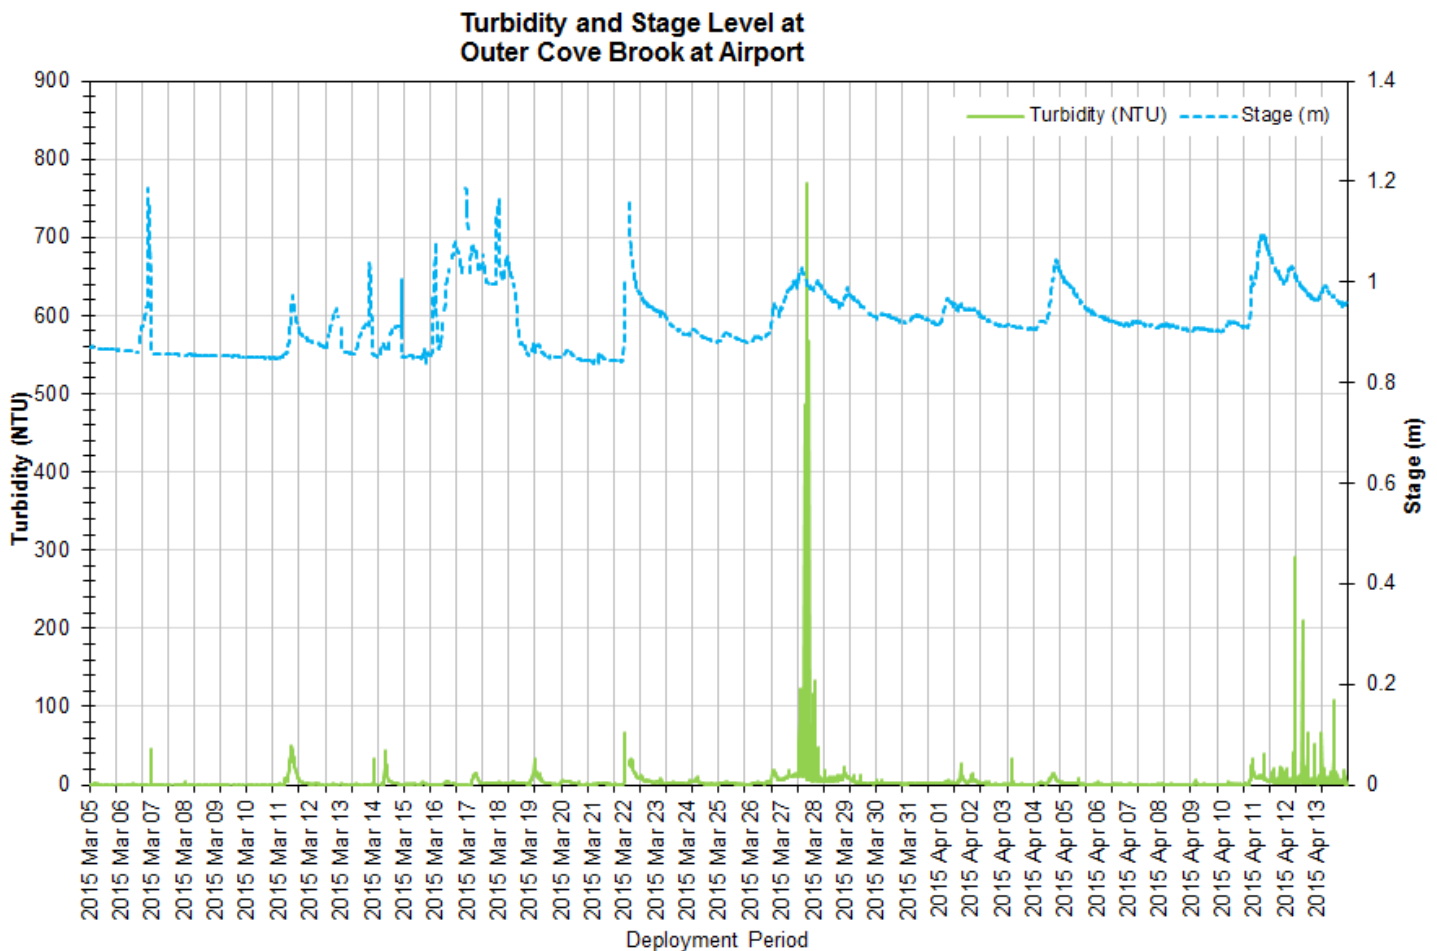
Turbidity levels during the deployment ranged within 0.0 NTU and 770.0 NTU (Figure 6). The deployment data had a median of 1.1 NTU.

The turbidity sensor on this instrument can read turbidity values between 0 NTU and 3000 NTU. However a turbidity reading of 3000 NTU is always identified as an error reading and should not be used as a valid reading or included in any statistical analysis.

Most of the turbidity events in the deployment period correlate with increases in stage potentially from precipitation (Figure 6). Precipitation (Appendix I) can increase the presence of suspended material in water. The large turbidity event on March 28<sup>th</sup> corresponds with a slight stage increase at that time. The turbidity data stabilizes within the same day. The turbidity peaks from April 11<sup>th</sup> to April 13<sup>th</sup> are also a result of increases in stage level due to increase precipitation.

**Figure 6: Turbidity (NTU) and stage level (m) values at Outer Cove Brook below Airport.**

The turbidity spikes mirror peaks in conductivity and pH occurring around the same dates. This can indicate that the turbidity in the brook was likely another factor from the road salting during these time frames.

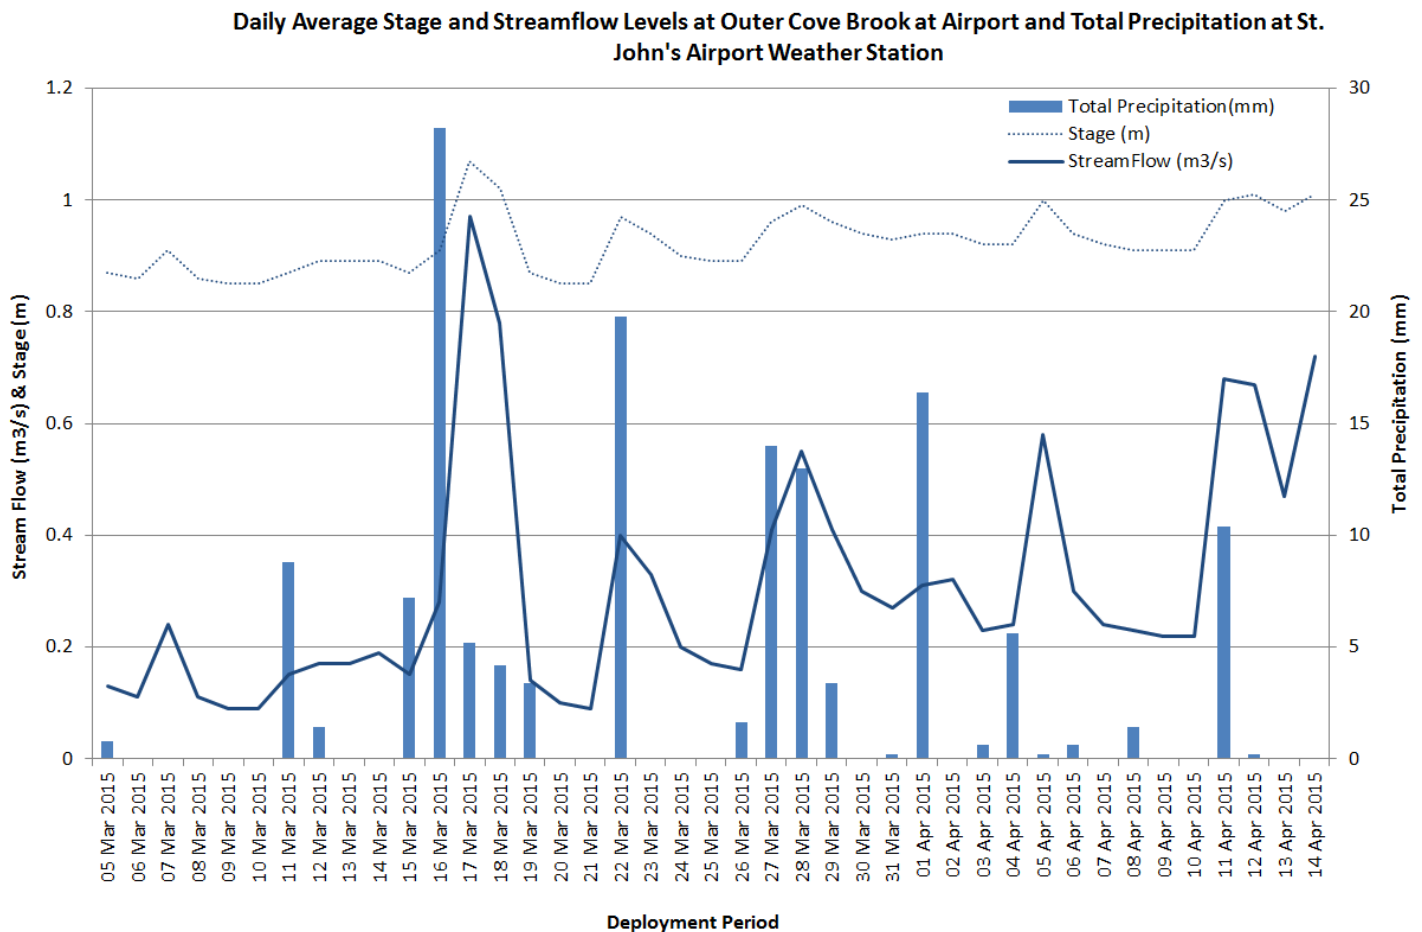
During the deployment period, the daily averaged stage data ranged from 0.84m to 1.19m. The larger peaks in stage do correspond with substantial rainfall events as noted on Figure 7.

Precipitation data was obtained from Environment Canada's St. John's Airport weather station. Precipitation ranges for the deployment period were a minimum of 0.0 mm and a maximum of 28.2 mm on March 16<sup>th</sup> which increased both stage and streamflow at that time.

**Figure 7: Daily average stage & stream flow values at Outer Cove Brook below Airport and daily total precipitation values from Environment Canada's St. John's Airport Station.**

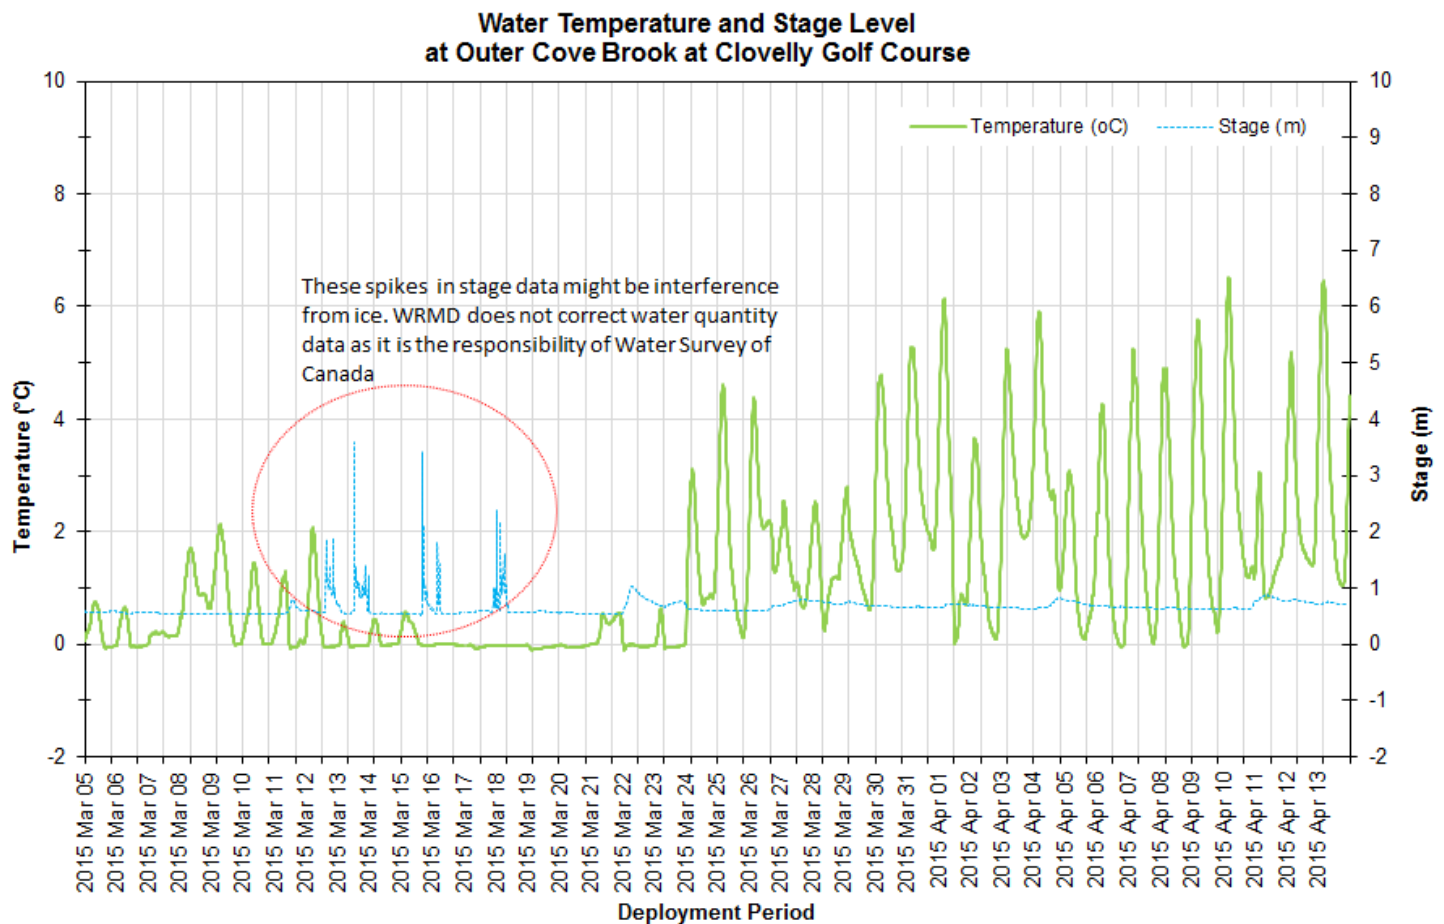
Water temperature ranged from  $-0.10^{\circ}\text{C}$  to  $6.52^{\circ}\text{C}$  during this deployment period (Figure 8).

During this deployment period the water temperature remains reasonably consistent until the middle of March. Water temperatures are still cooler into the middle of March. As the deployment period ends the water temperatures have increased, along with the air temperatures for this time of year. There is a more defined diurnal and exaggerated pattern in the water temperature into April.

Stage data displays several large spikes which could be ice on the brook interfering with the stage instruments ability to read the elevation. Please note the stage data graphed below is raw data that is published on WRMD web page. It has not been corrected for backwater effect. WSC is responsible for QA/QC of water quantity data. Corrected data can be obtained upon request to WSC.

**Figure 8: Water temperature ( $^{\circ}\text{C}$ ) and Stage (m) levels at Outer Cove Brook at Clovelly Golf Course.**

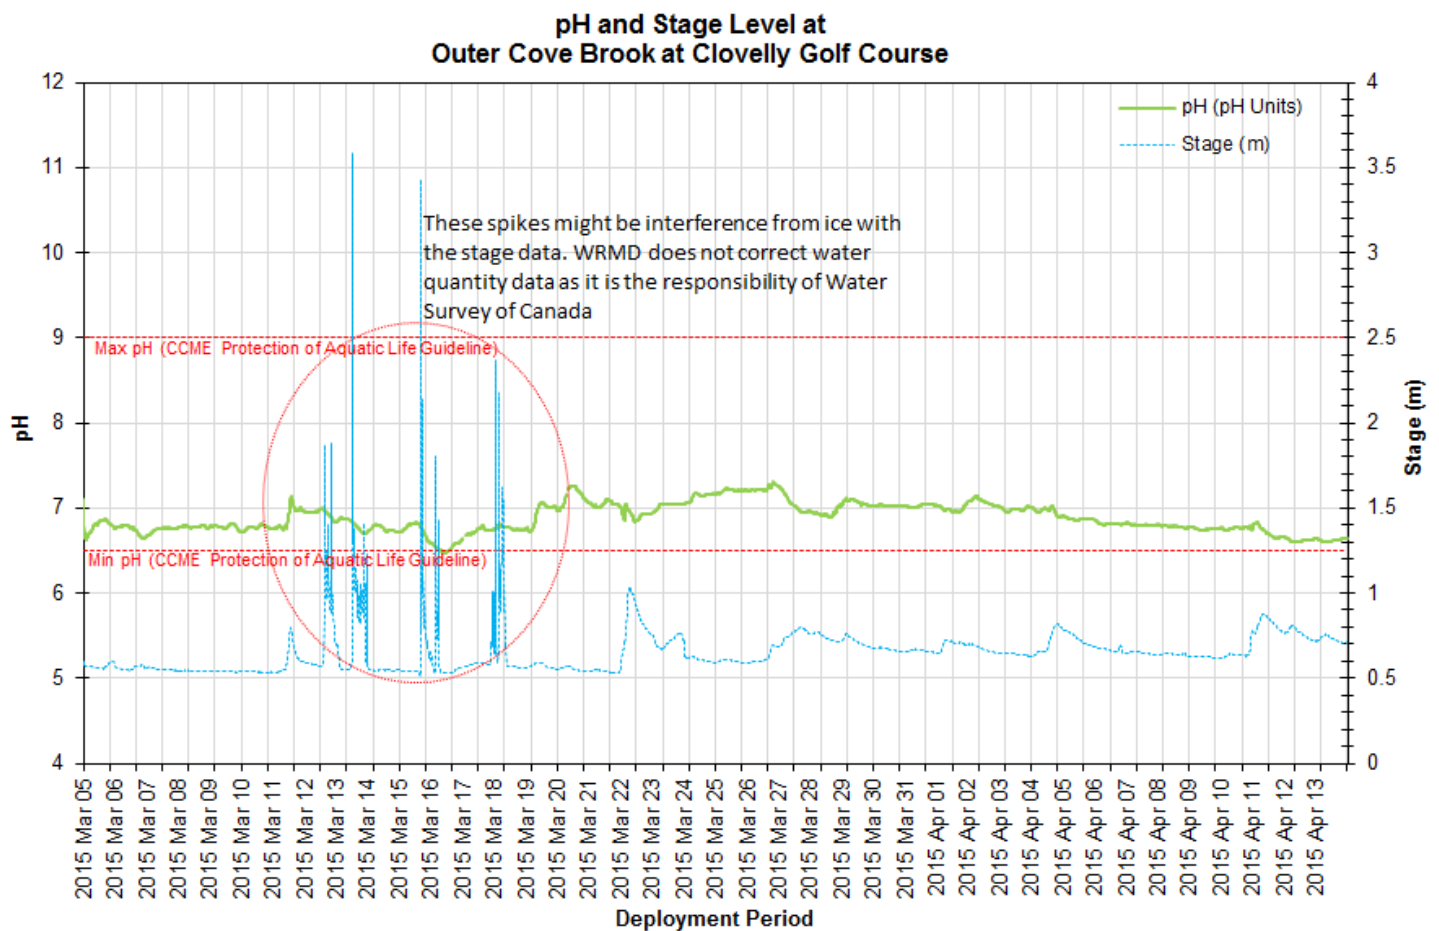
Throughout this deployment period pH values ranged between 6.47 pH units and 7.31 pH units (Figure 9).

During the deployment, the majority of the pH values at this station recorded within the minimum and maximum CCME Guideline for the Protection of Aquatic Life.

The pH data that did dip below the minimum guideline corresponded with increases in stage level. Increases in stage resulted in increases and then sharp decreases in pH values.

The CCME guideline provides a basis by which to judge the overall health of the brook. Naturally, all streams and brooks are different. During this deployment period the median pH level was 6.85 units (a slightly higher pH median from last deployment).

**Figure 9: pH (pH units) and stage level (m) values at Outer Cove Brook at Clovelly Golf Course.**

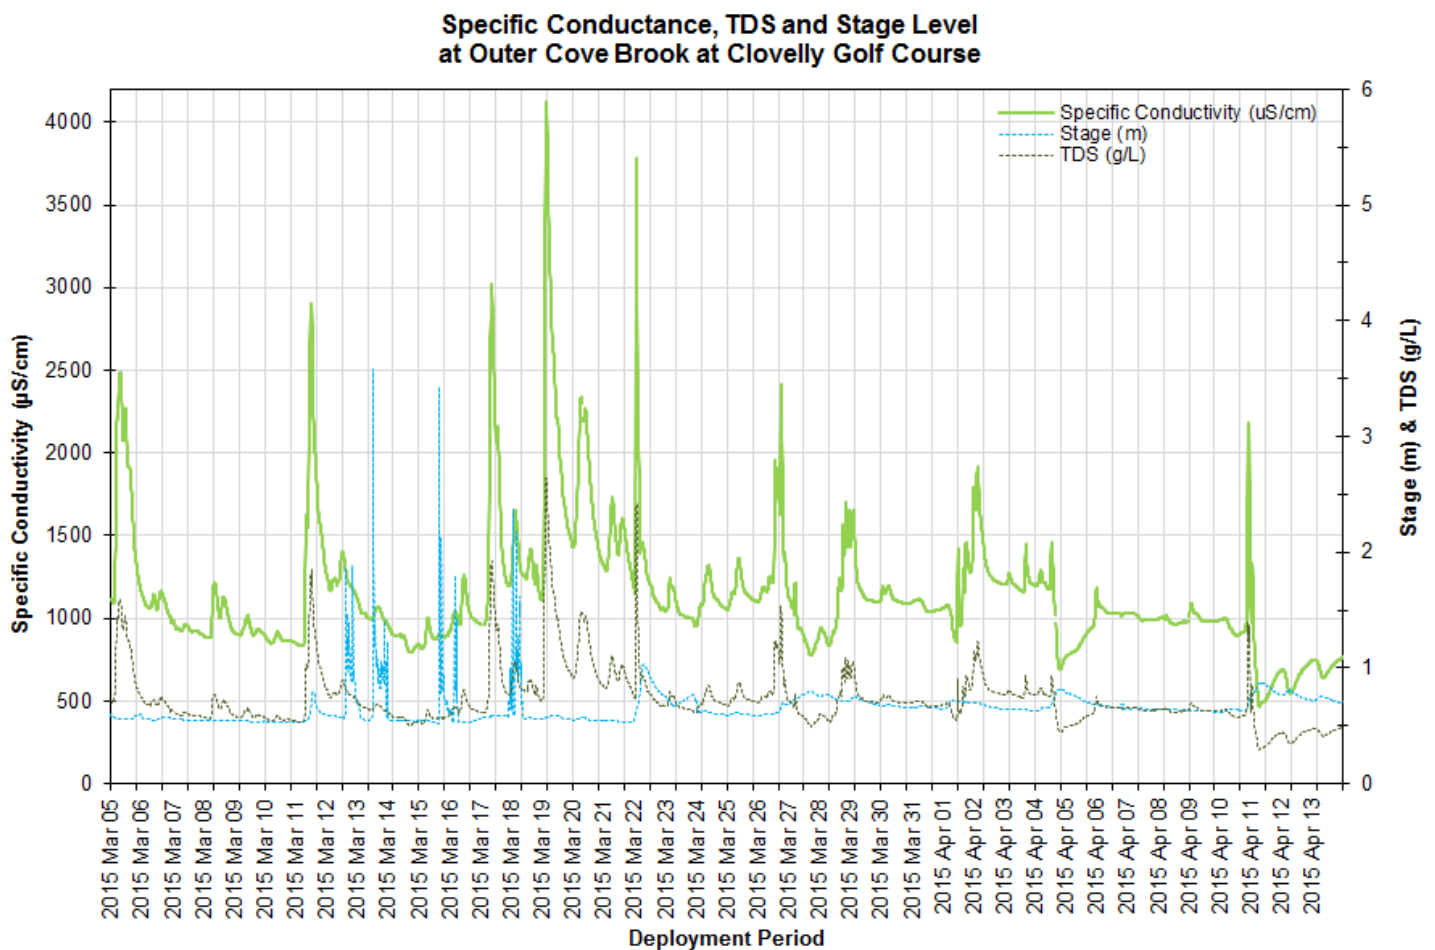
The conductivity levels were within  $466\mu\text{S}/\text{cm}$  and  $4130\mu\text{S}/\text{cm}$  during this deployment period. TDS ranged from  $0.2990\text{g}/\text{L}$  to  $2.6400\text{g}/\text{L}$  (Figure 10)

The conductivity probe measures the dissolved particles present in a water body, generally an increase in stage can indicate rainfall. Generally, rainfall saturates the brook and flushes the dissolved particles from the water column diluting the conductivity levels for a short period of time.

With the current icier temperatures (Appendix I), road salting has started on the roadways surrounding the brook. Road salting creates an opposite effect during high stage levels, the salt adds to the dissolved particles in the brook when it is flushed into the surrounding waterways and causes an increase in the conductivity values.

Total Dissolved Solids (TDS), is a parameter that the instrument calculates by an algorithm that utilizes the data from specific conductivity and water temperature to produce a TDS value and generally always mirrors specific conductivity.

**Figure 10: Specific conductivity ( $\mu\text{S}/\text{cm}$ ) and stage (m) values at Outer Cove Brook at Clovelly Golf Course.**

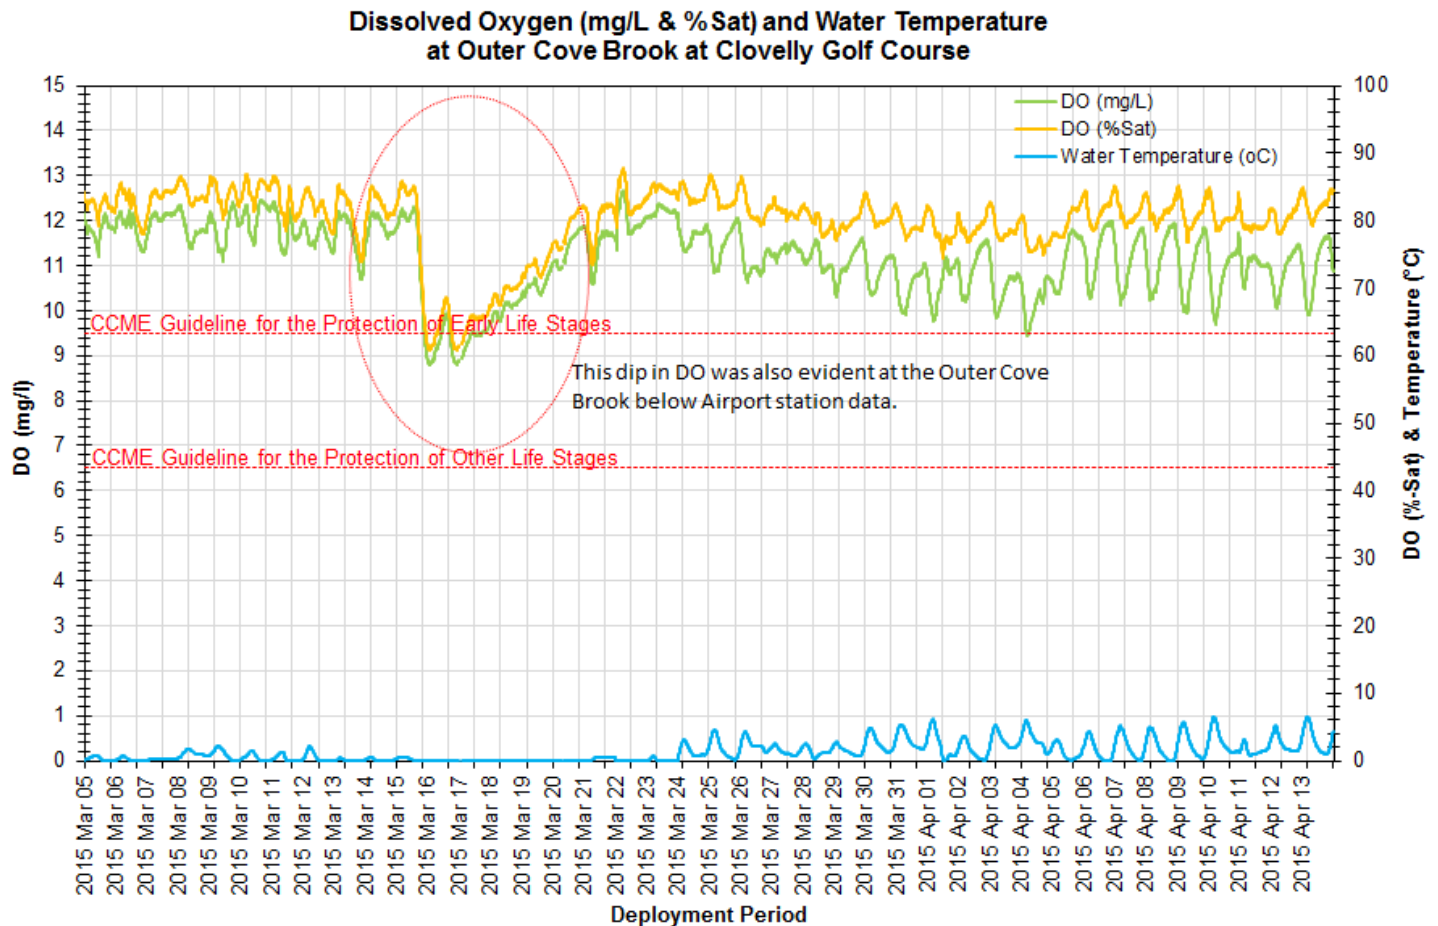
The Dissolved Oxygen %Sat levels within this deployment period were within 60.7%Sat to 87.7%Sat. Dissolved Oxygen (mg/L) measured 8.80mg/L to 12.67mg/L (Figure 11).

It should be noted that the warmer water temperatures decrease the amount of dissolved oxygen a water body can hold. As water temperatures increase (most likely during the day) the water dissolved oxygen levels decrease with consumption from the aquatic organisms and vegetation present in the brook.

The large dissolved oxygen decrease (circled in red) was also evident on the dissolved oxygen graph for Outer Cove Brook below Airport for the same time frame. It is not clear what may have caused the dissolved oxygen levels at both stations to decrease at this time.

**Figure 11: Dissolved oxygen (mg/L & % sat) and water temperature (°C) values at Outer Cove Brook at Clovelly Golf Course.**

- The dissolved oxygen at Outer Cove Brook at Clovelly Golf Course displays the significant dip starting on March 16, 2015 this decrease is also evident on the Airport station dissolved oxygen graph. It is not clear on the cause of the dip however there was significant rainfall (28.2 mm) and a stage increase recorded at Outer Cove Brook at Clovelly Golf Course for the same time frame.

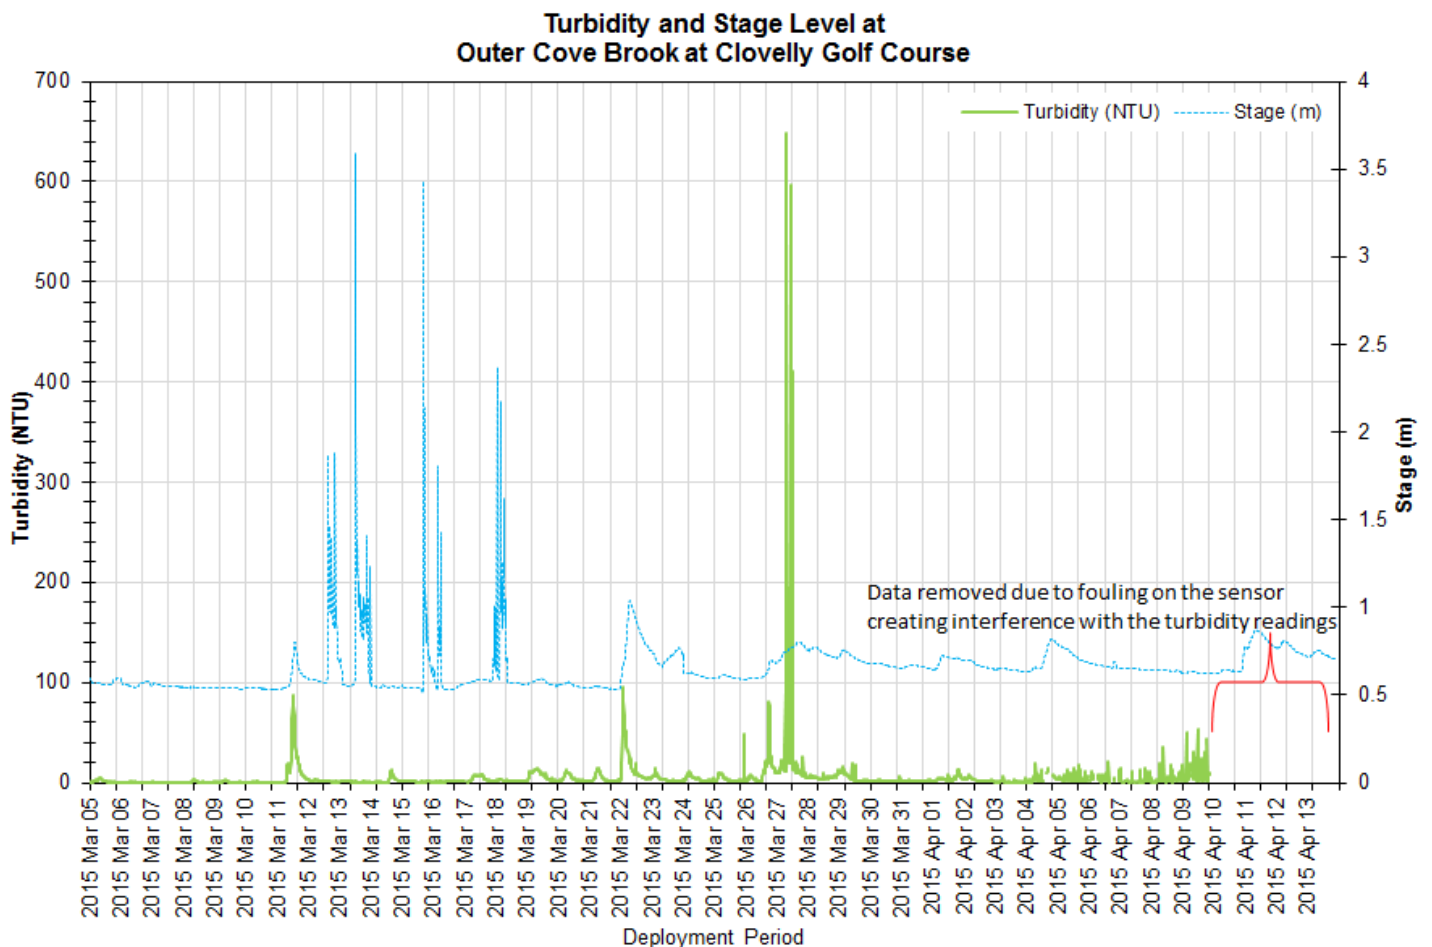
Turbidity levels during the deployment period ranged from 0.0 NTU to 649.0 NTU (Figure 12), with a median of 1.8 NTU.

The turbidity sensor on the water quality instrument can read turbidity values between 0.0 NTU and 3000 NTU. However a turbidity reading of 3000 NTU is always identified as an error reading and during data grooming will be removed from the data set so to ensure it is not included in any statistical analysis.

As depicted on the graph there were several turbidity spikes during deployment. The majority of turbidity increases on the turbidity graph correspond with stage increases at the same time. The largest turbidity event on March 27<sup>th</sup> 2015 was likely a result of an increase in stage level. The total precipitation data indicates that there was 2 consecutive days of rainfall above 10 mm which likely contributed to the increased turbidity.

At removal, this instrument it was discovered to be fouled with a slime-like substance which caused the turbidity data being recorded to be inaccurate. Therefore the data at the end of deployment was removed.

**Figure 12: Turbidity (NTU) and stage level (m) values at Outer Cove Brook at Clovelly Golf Course.**

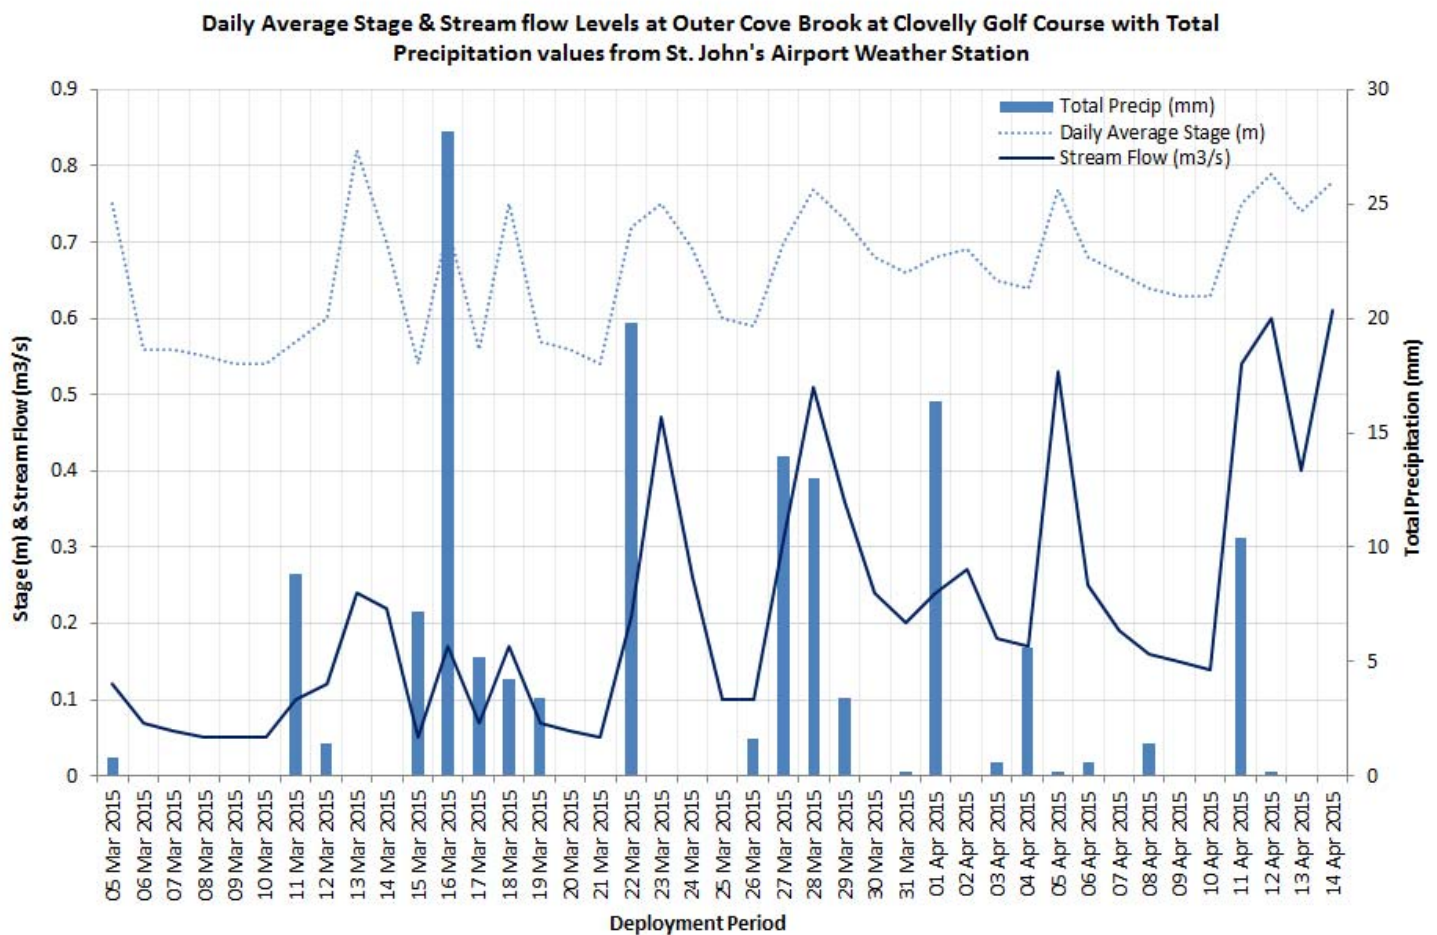
Stage levels during this deployment ranged from a minimum of 0.51m to a maximum of 3.59m. The precipitation ranged from a minimum of 0.0 mm a day to a maximum of 28.2 mm which was on March 16<sup>th</sup>, 2015. This rainfall event increased stage and stream flow at Outer Cove Brook at Clovelly Golf Course for a short period of time (Figure 13).

Precipitation data was obtained from Environment Canada's St. John's Airport weather station.

**Figure 13: Daily average stage & stream flow values at Outer Cove Brook at Clovelly Golf Course and daily total precipitation values (mm) from Environment Canada's Weather Station at St. John's International Airport.**

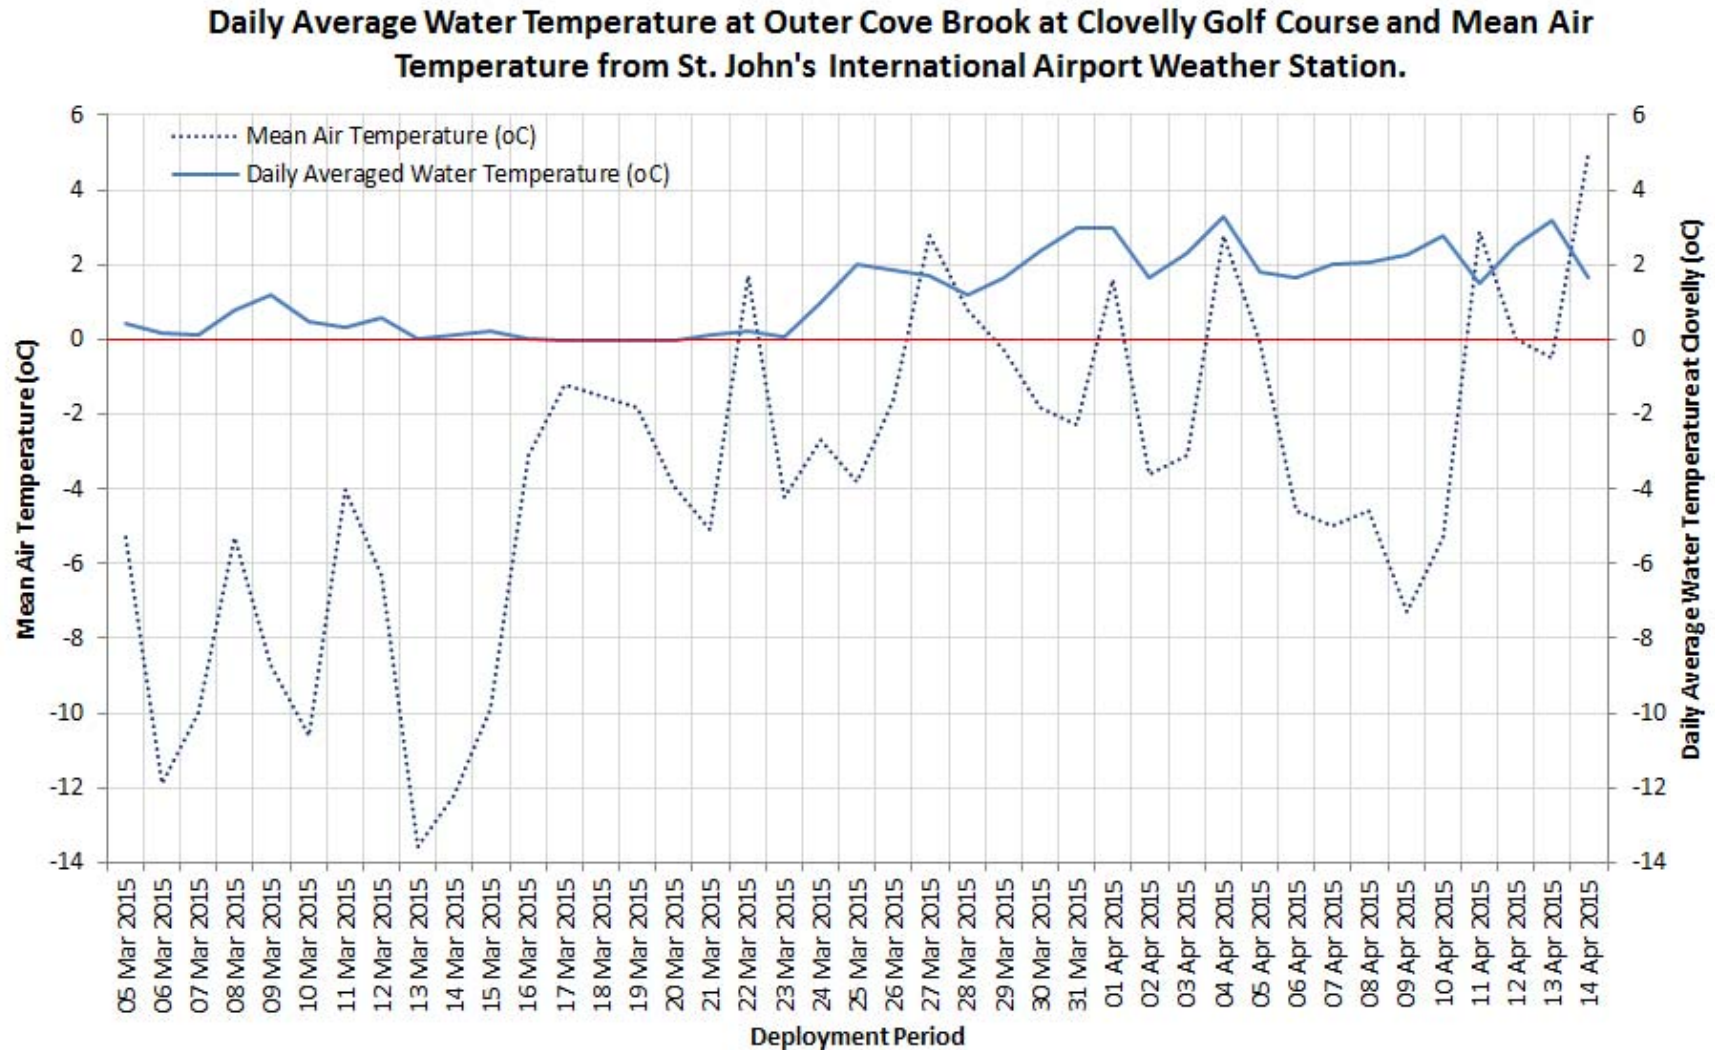
Figure 14: Daily average water temperature values from Outer Cove Brook at Clovelly Golf Course and air temperature values from Environment Canada's Weather Station at St. John's International Airport.
