# Real-Time Water Quality Report

## Outer Cove Brook Network

Deployment Period  
March 5, 2015 to April 14, 2015

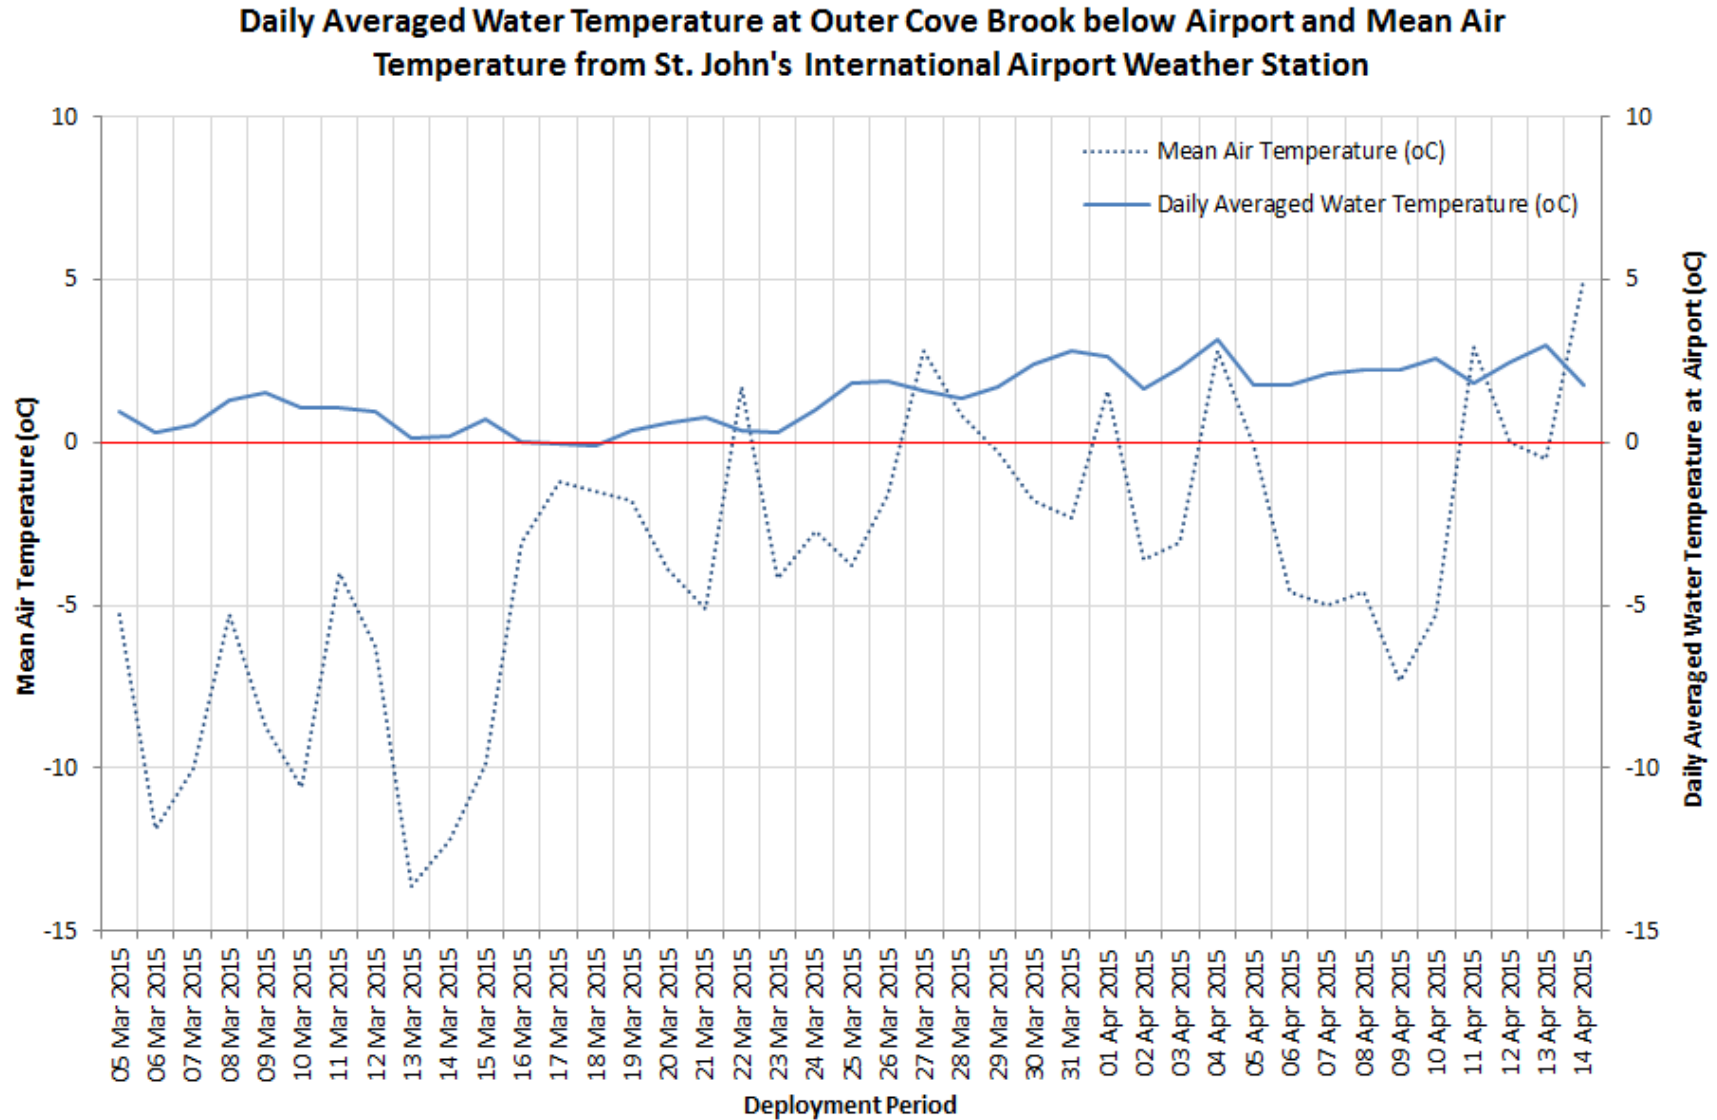
Figure 15: Daily average water temperature values from Outer Cove Brook below Airport and air temperature values from Environment Canada's Weather Station at St. John's International Airport.

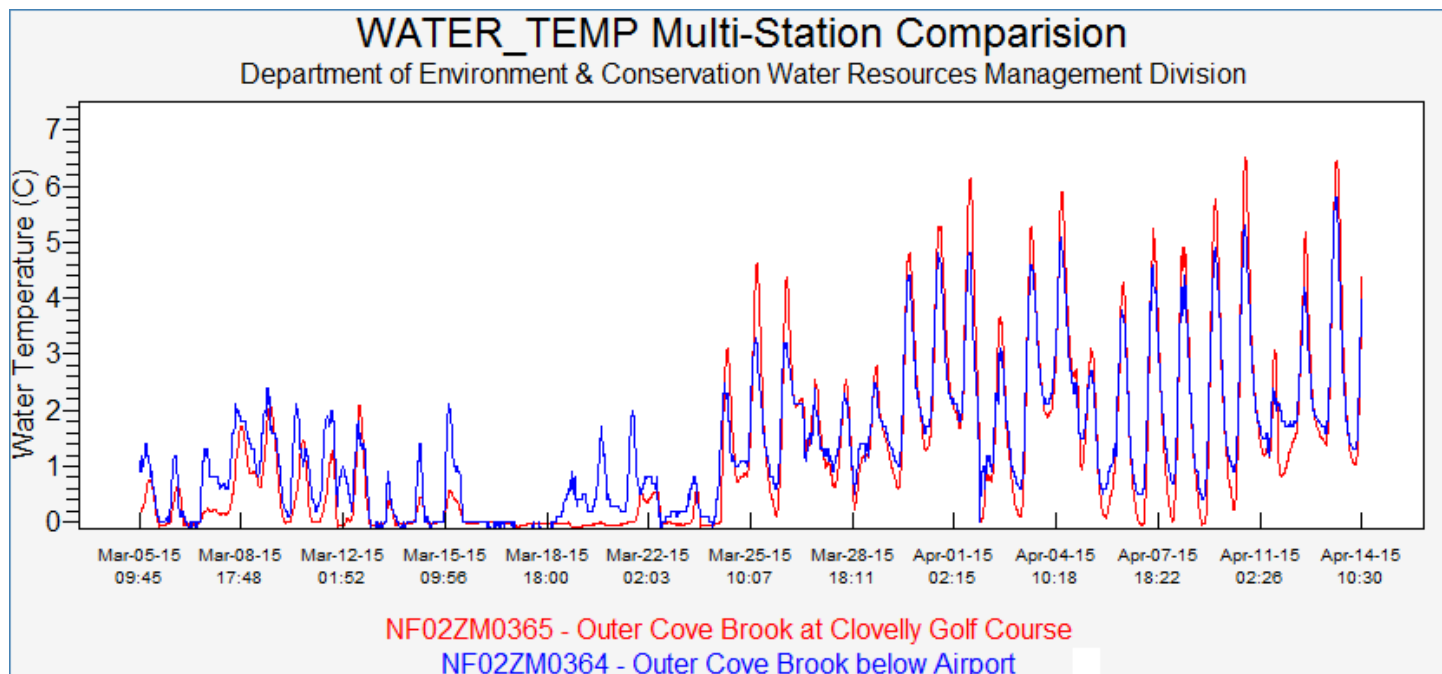
Figure 16: Comparison Water Temperature at the Outer Cove Brook Stations

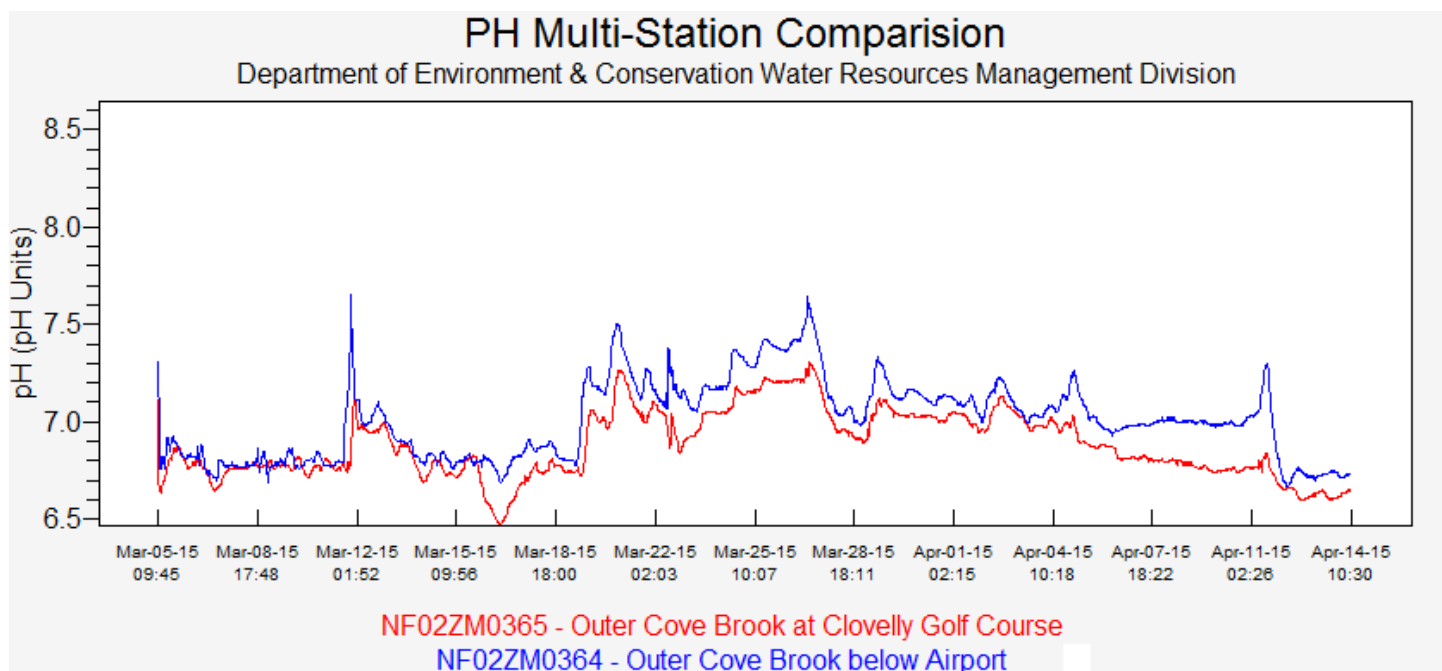
Figure 17: Comparison of pH units at the Outer Cove Brook Stations

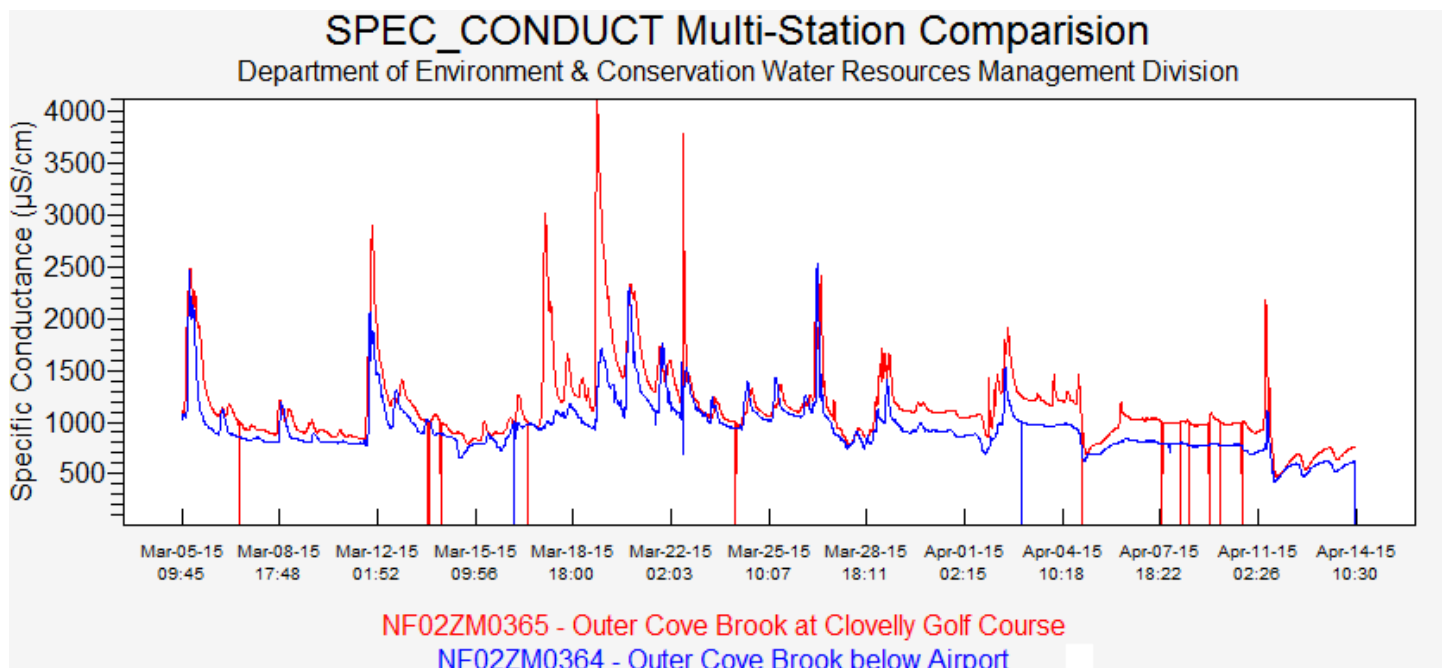
Figure 18: Comparison Specific Conductivity at the Outer Cove Brook Stations

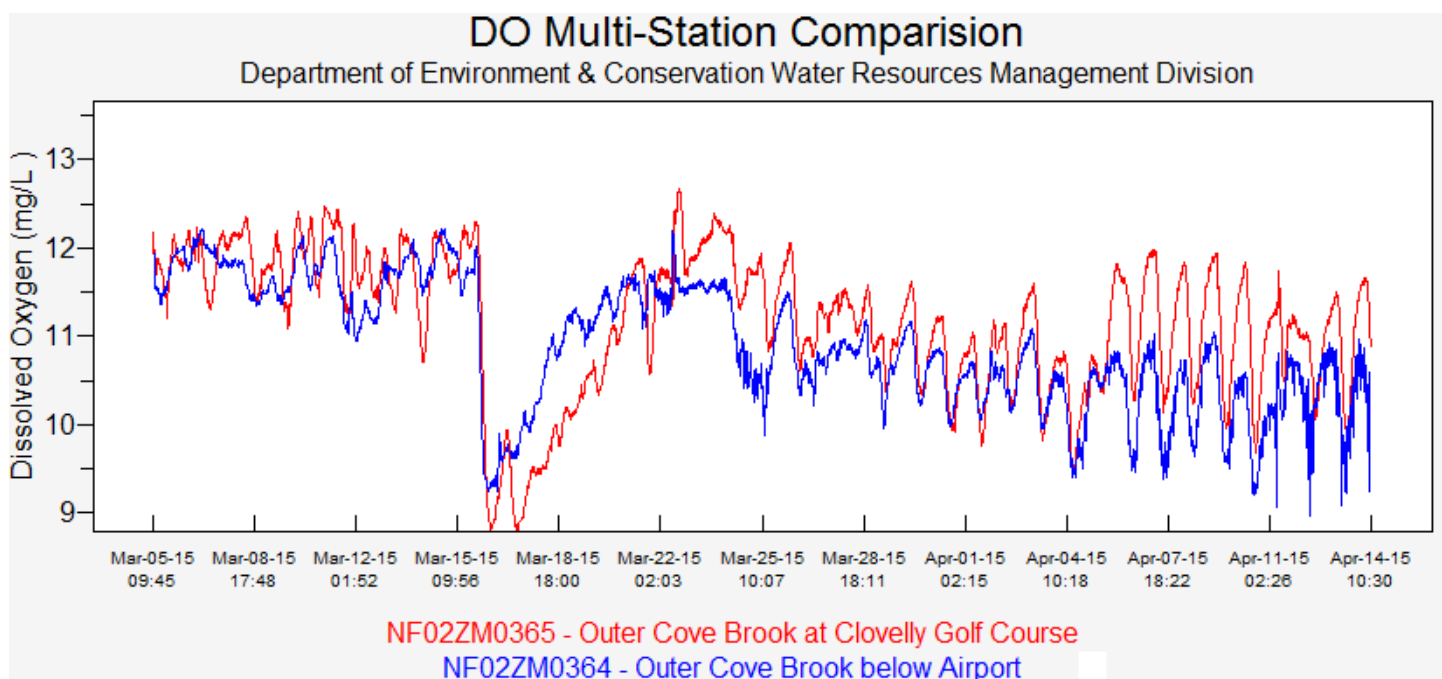
Figure 19: Comparison of Dissolved Oxygen ( $\text{mg}/\text{L}$ ) at the Outer Cove Brook Station

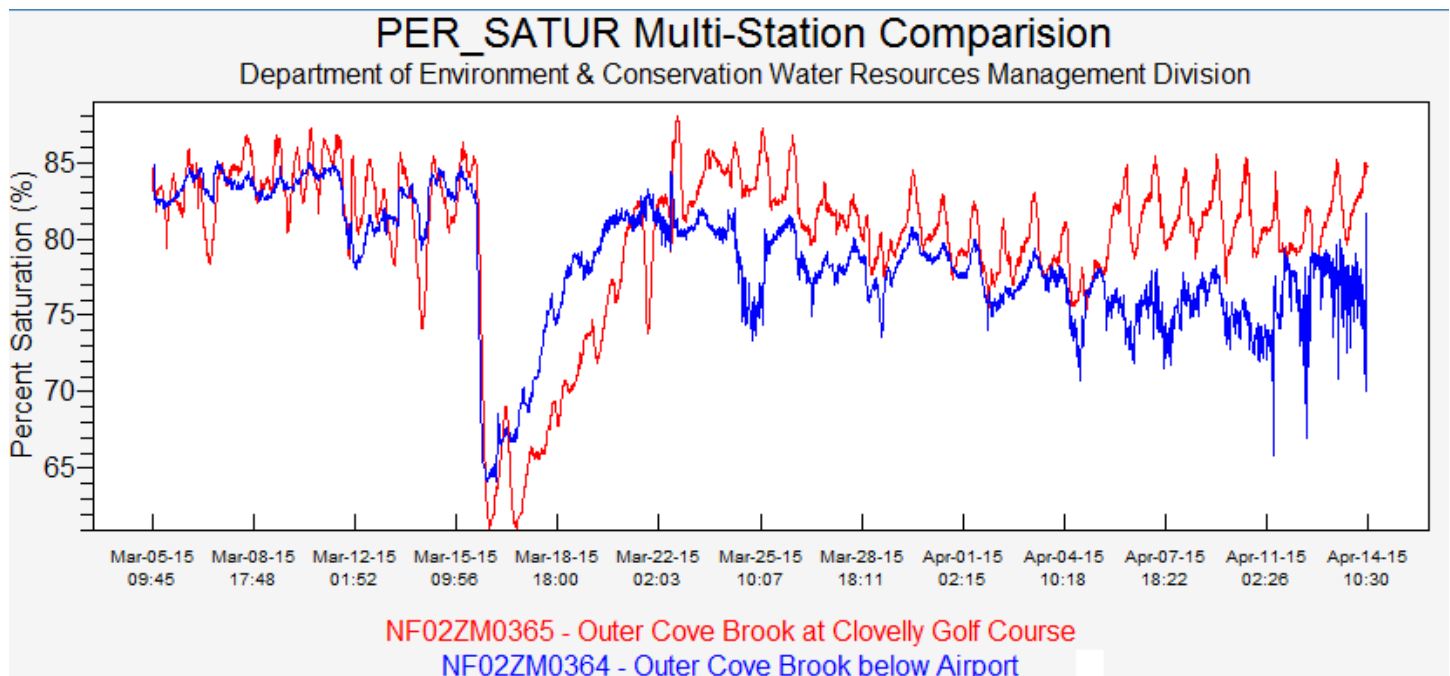
Figure 20: Comparison of Dissolved Oxygen (%Sat) of the Outer Cove Brook stations

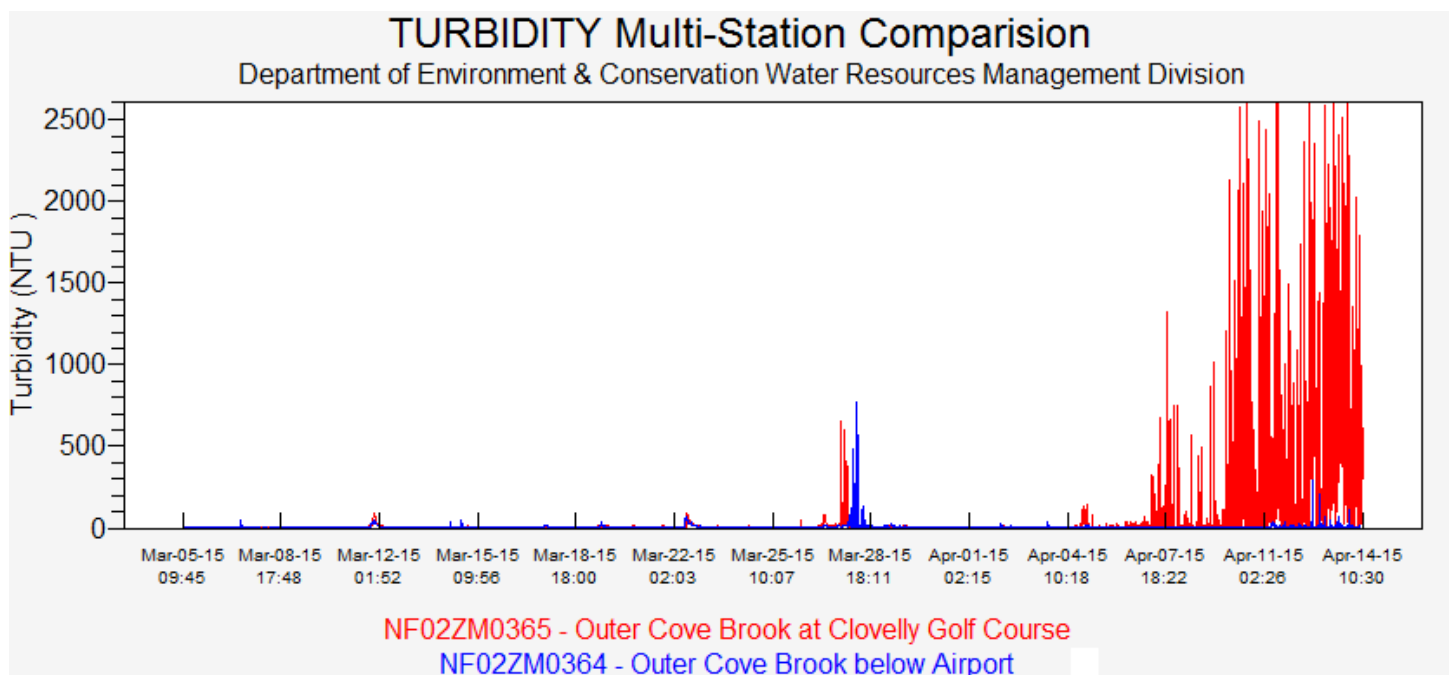
Figure 21: Comparison of Turbidity at the Outer Cove Brook stations

\*Please note: Turbidity data that was removed for the report is evident in the graph above, this data does not represent the water body.
